# 2008 Annual Reports

## Tailings

June 2, 2009

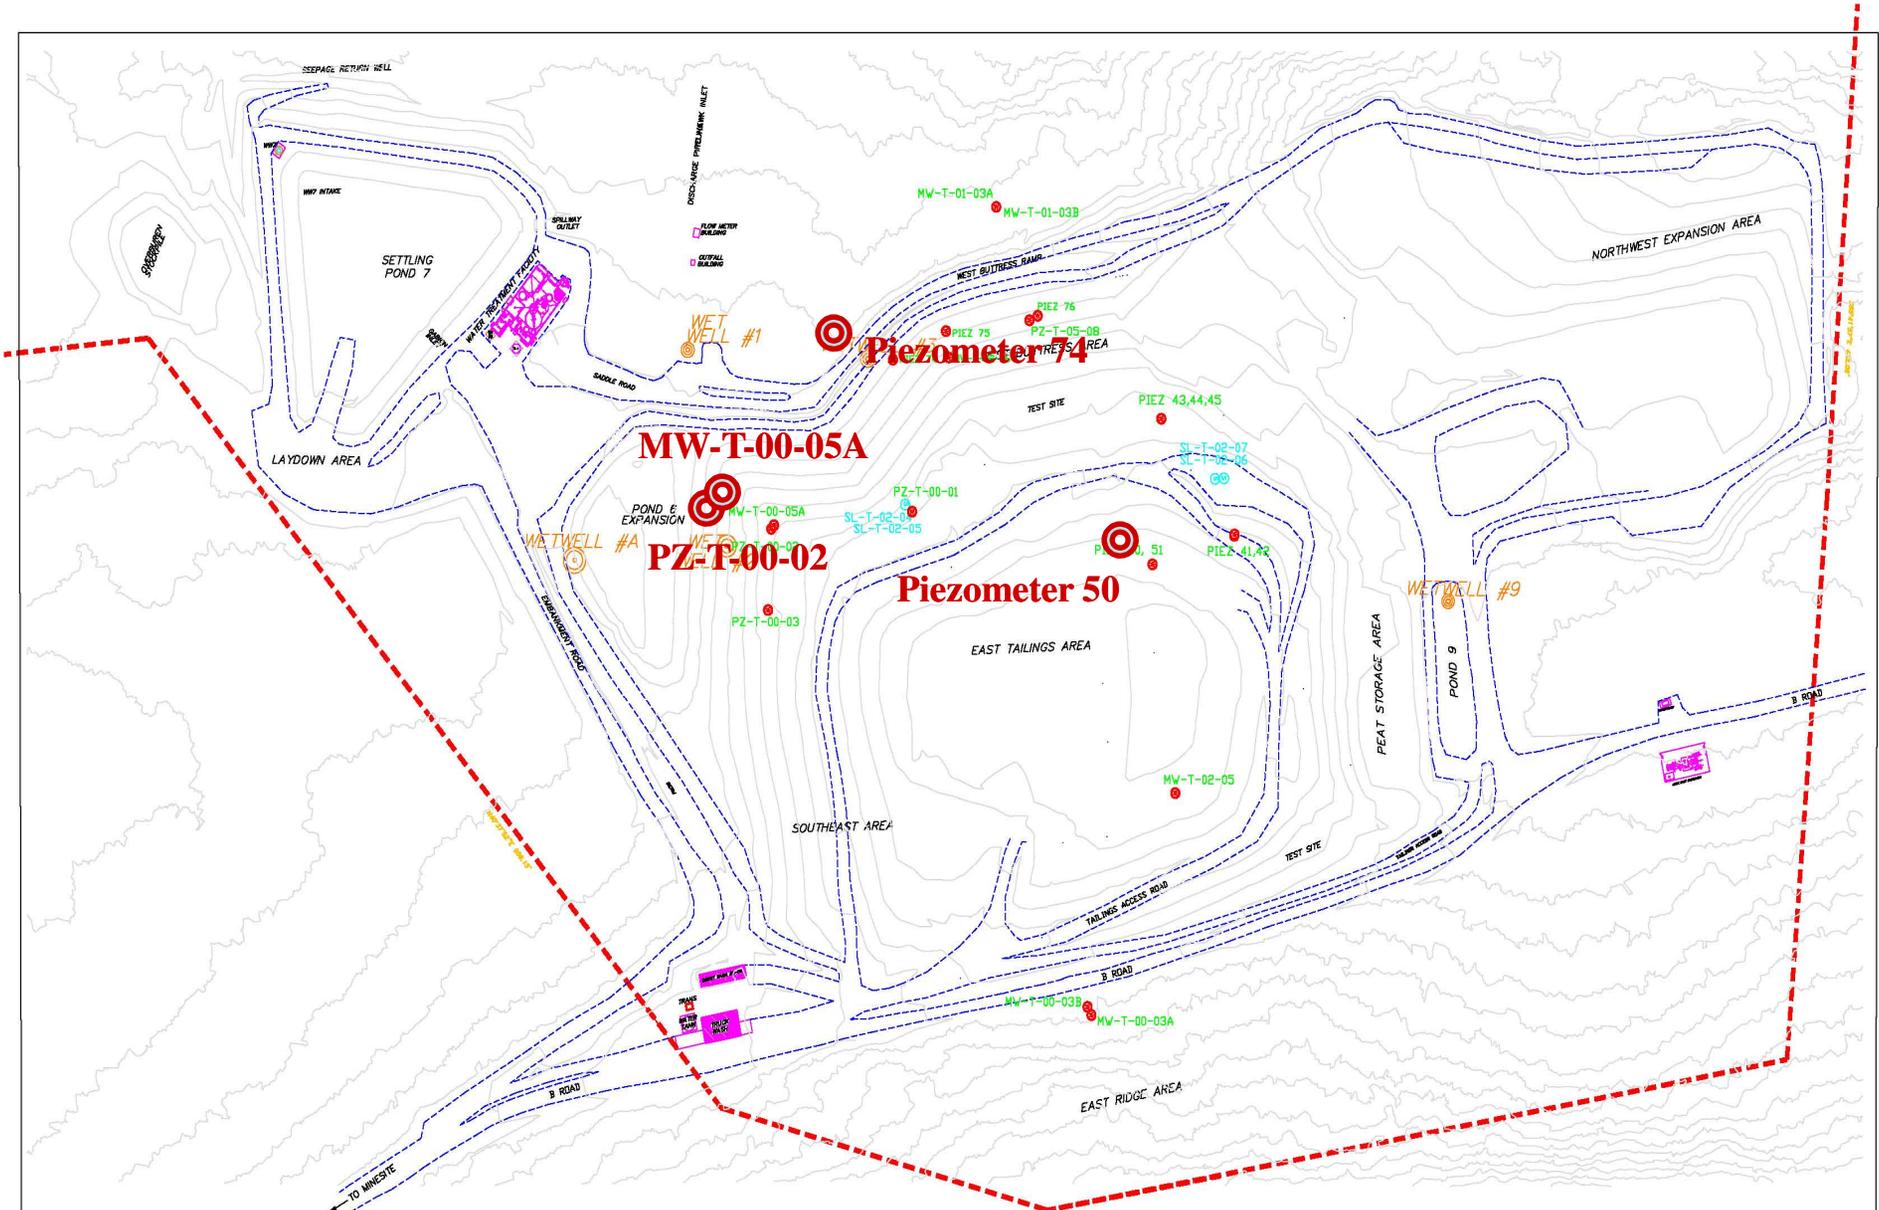
# Tailings Facility Monitoring Well and Piezometer Water Level Data

- Maximum saturated thickness 35 feet
- Toe foundations are well drained
- Water perches approximately 12 feet above the unsaturated underdrains

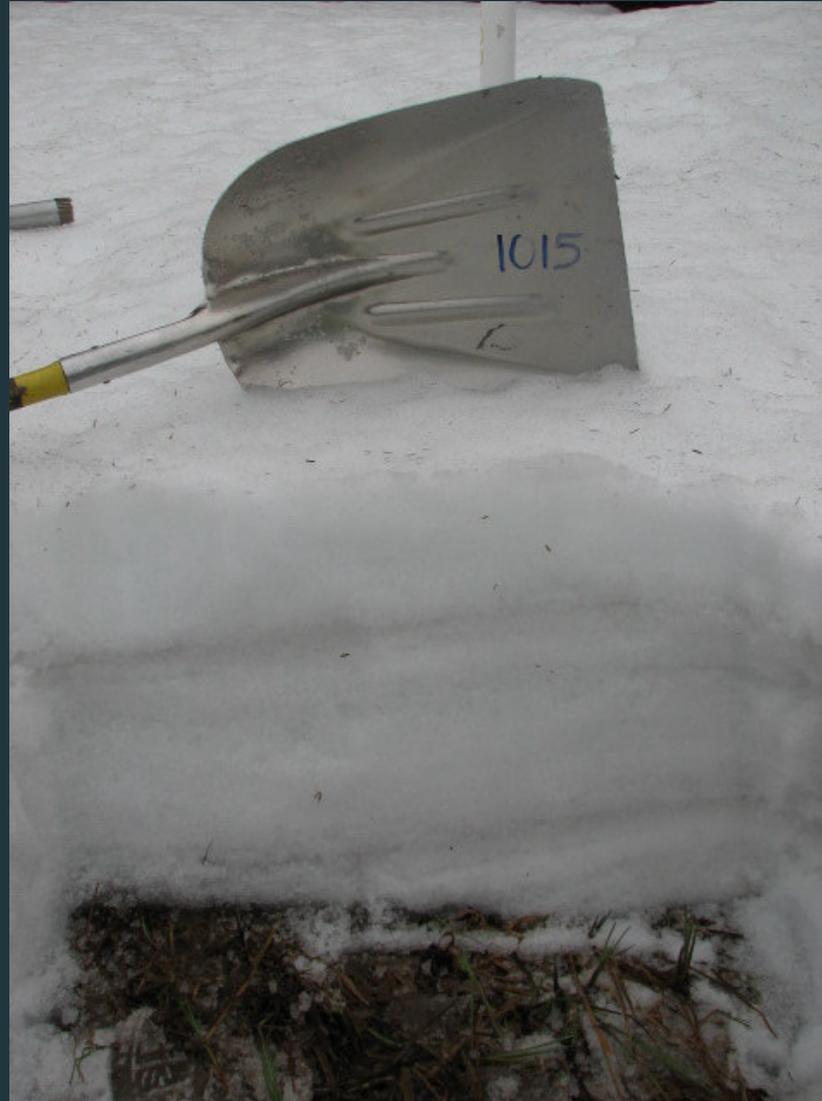
# Tails Snow Dust Sampling

- Mitigation
  - Snow Fences
  - Eco Blocks
  - Snow removal only in active placement area
- Lead levels in water do not directly correlate to lead loading values
- Observable up to approximately 1700 feet away
- Significant decrease in lead load over the past three years

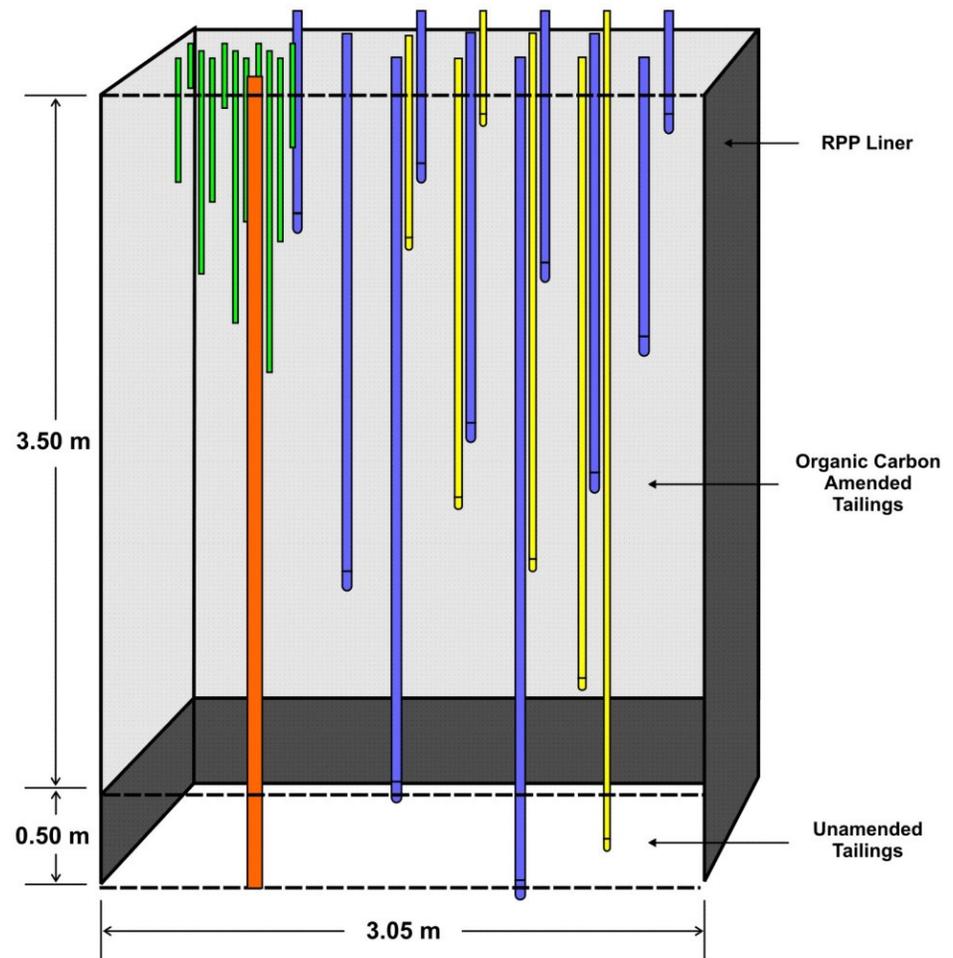
- Lysimeter
- Moisture Probe Access
- Tensiometer
- ◆ Pore Gas Tube

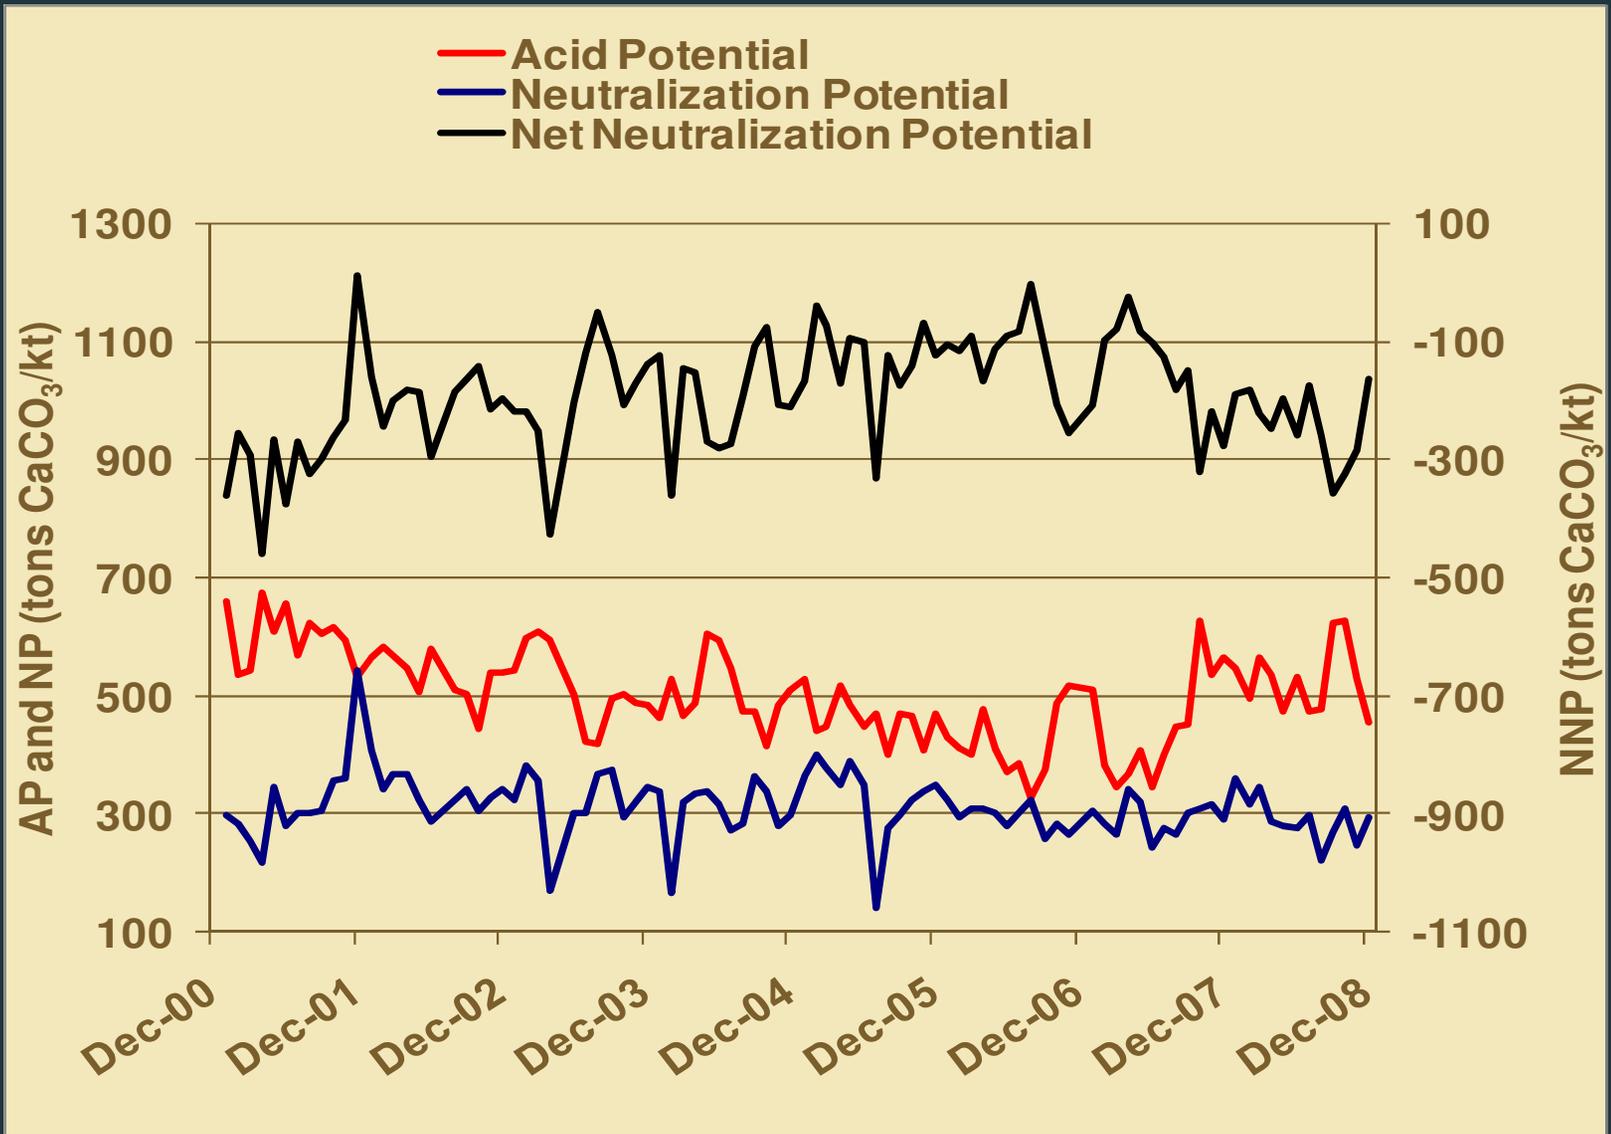
# Figure 2.32 Monthly Tailings Acid Base Accounting Data

- Tailings have the potential to generate acidic drainage if the buffering capacity of the tailings is consumed
- High carbonate content supports a long lag time for depletion of buffering capacity
- Long lag time (decades) allows time for construction and closure of the facility, including construction of an oxygen-inhibiting composite soil cover
