GREENS CREEK

2010 Annual Report

Site 23/D

Presentation Outline

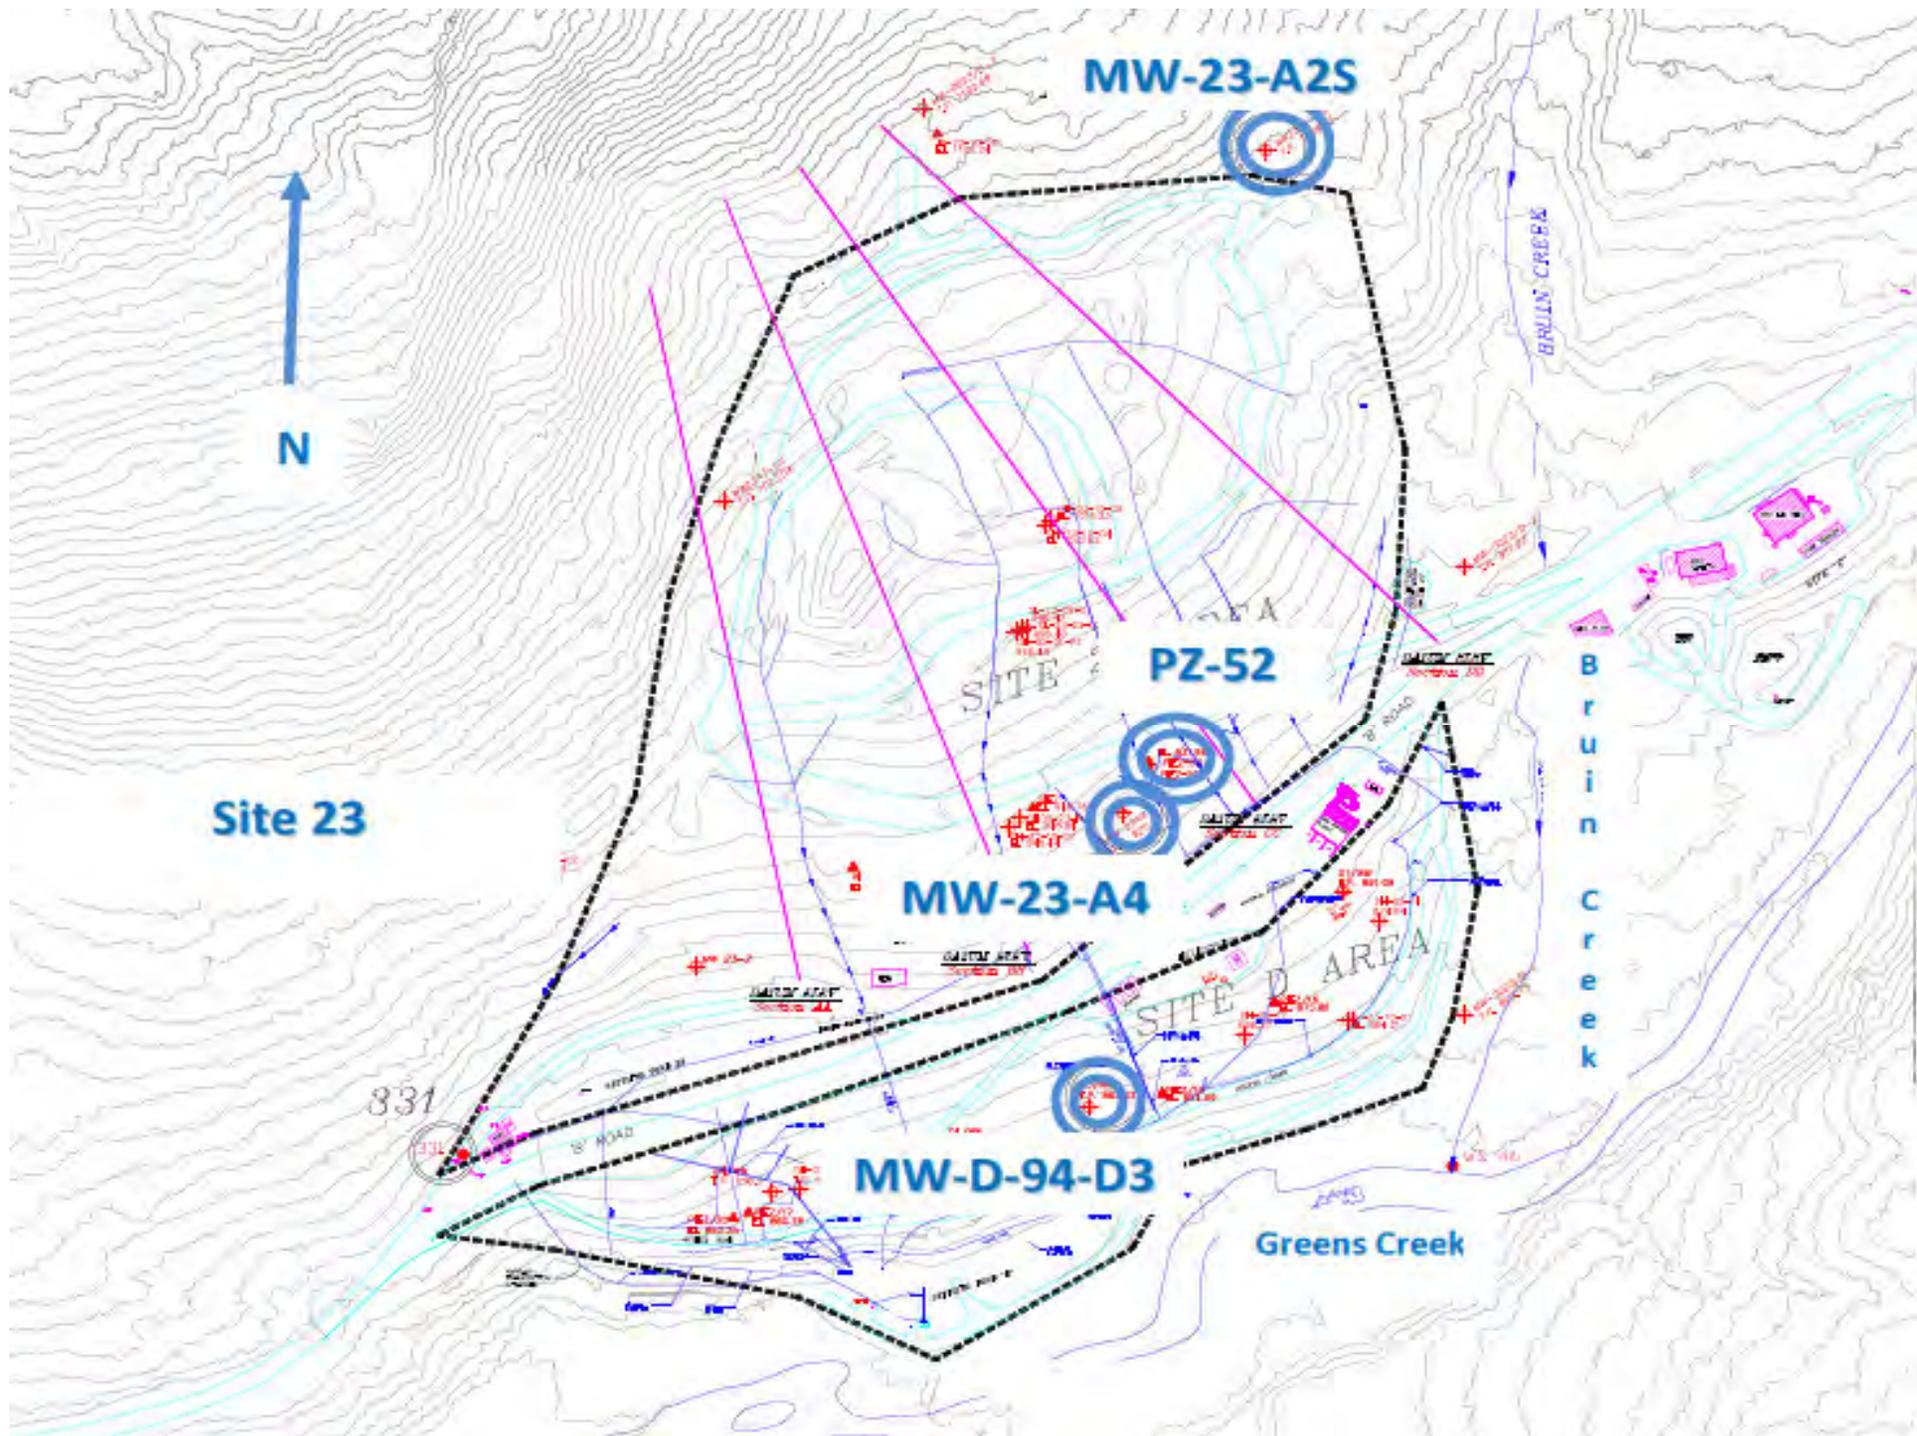
Figure 3.30 Inclinometer Incremental Displacement

- Compaction
 - Method specification includes spreading in less than 24" lifts with at least one pass with a bulldozer and four passes with a vibratory compactor
- Inspections
 - Results of operator, engineering, environmental and regulatory inspections revealed no visible signs of instability
 - No issues of non-compliance were noted in 16 USFS and 6 ADEC/ADNR inspections during 2010
- Slope monitoring
 - 10 survey hubs monitored with GPS during 2010
 - No large movements were identified
 - Inclinometer readings
 - Minor creep at 80' (~3mm/yr)

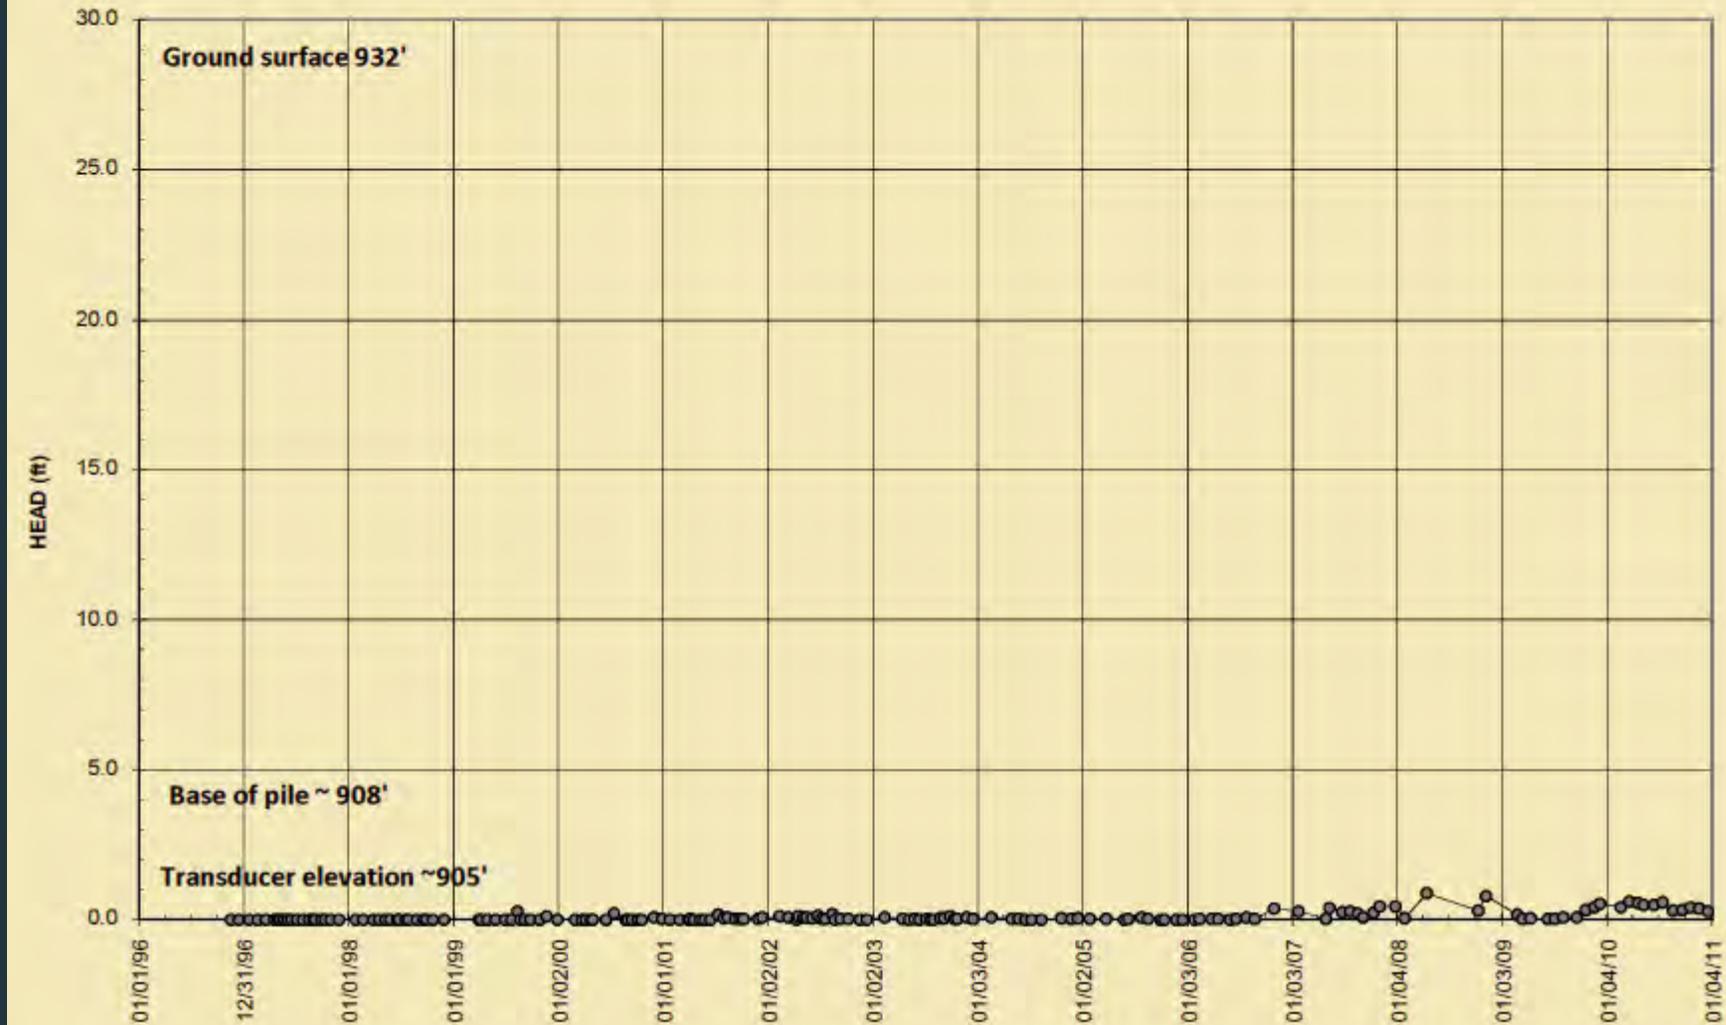
Figure 3.1 Pressure Data for Piezometer 52

- Water table is below base of pile
- Well-drained pile and foundation indicate pile stability is maximized
- Perched water tables in colluvial wedge and alluvial sands
- Braided flow paths
- Distinct seasonal pattern, especially in alluvial sands
- Silt/clay till below colluvial wedge inhibits downward water movement

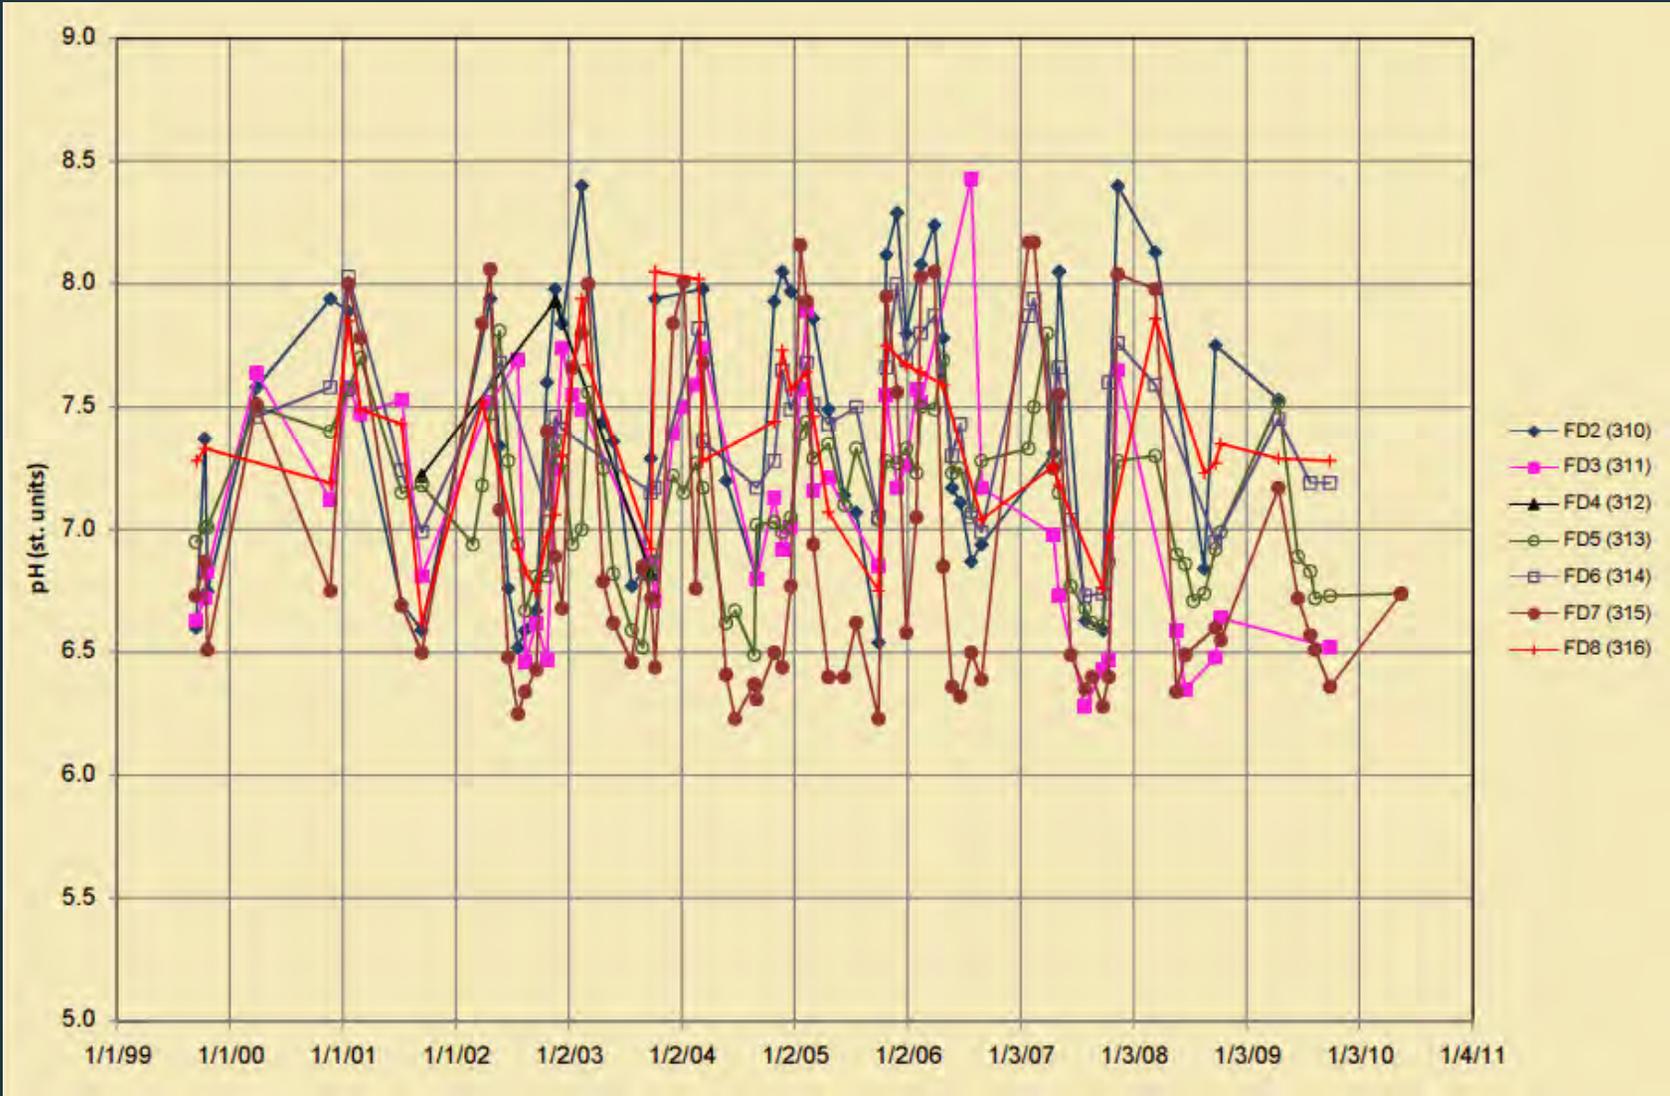
Figure 3.14a Site 23 Finger Drains pH

- Internal site waters are captured, treated, and discharged per HGCMC's NPDES/APDES permit
- pH values are between 6.0 and 8.5 (high buffering capacity)
- Conductivities are between 200 and 5000 umho/cm
- Variations in conductivity reflect differences in contributions of groundwater and infiltration, seasonal fluctuations
- Zinc concentrations are variable (typically less than 5 mg/l)
- Precipitation, mixing, and sorption mechanisms determine metals concentrations

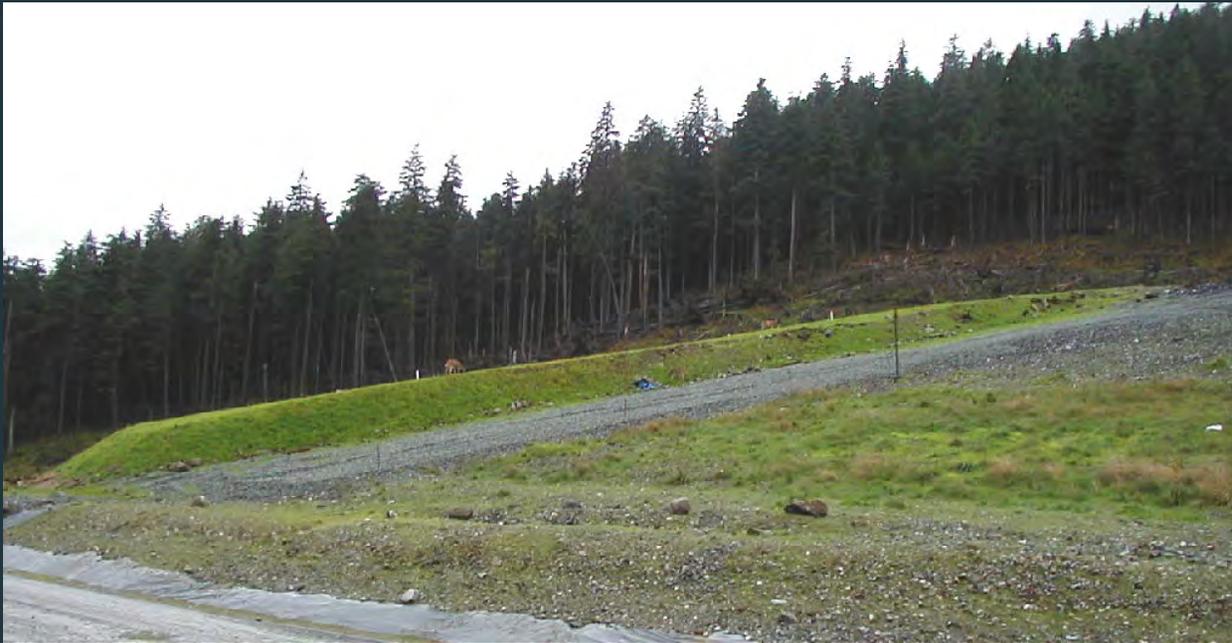
Cover Design

Growth Medium

Capillary Break

Barrier Layer

2 meters

- Greater than 85% water saturation in barrier layer minimizes oxygen ingress
- Water percolation through barrier layer 15-20% of annual precipitation
- Barrier layer does not freeze during the winter
- Trench flow was about 70-80% upper capillary break and 20-30% growth medium. The lag time between peak precipitation and peak trench flow is about 6 hours for dry conditions and 2 hours for wet conditions
- Modeling with Hydrus-2D/3D software compares favorably with field results
- Numerical modeling of alternative cover designs indicates that the upper capillary break is necessary to maximize lateral flow and prevent buildup of head pressures in the growth medium and barrier layer
- OSU vegetation assessment recommends allowing development of native spruce/hemlock vegetation with windthrow to promote nutrient mixing and minimize erosion

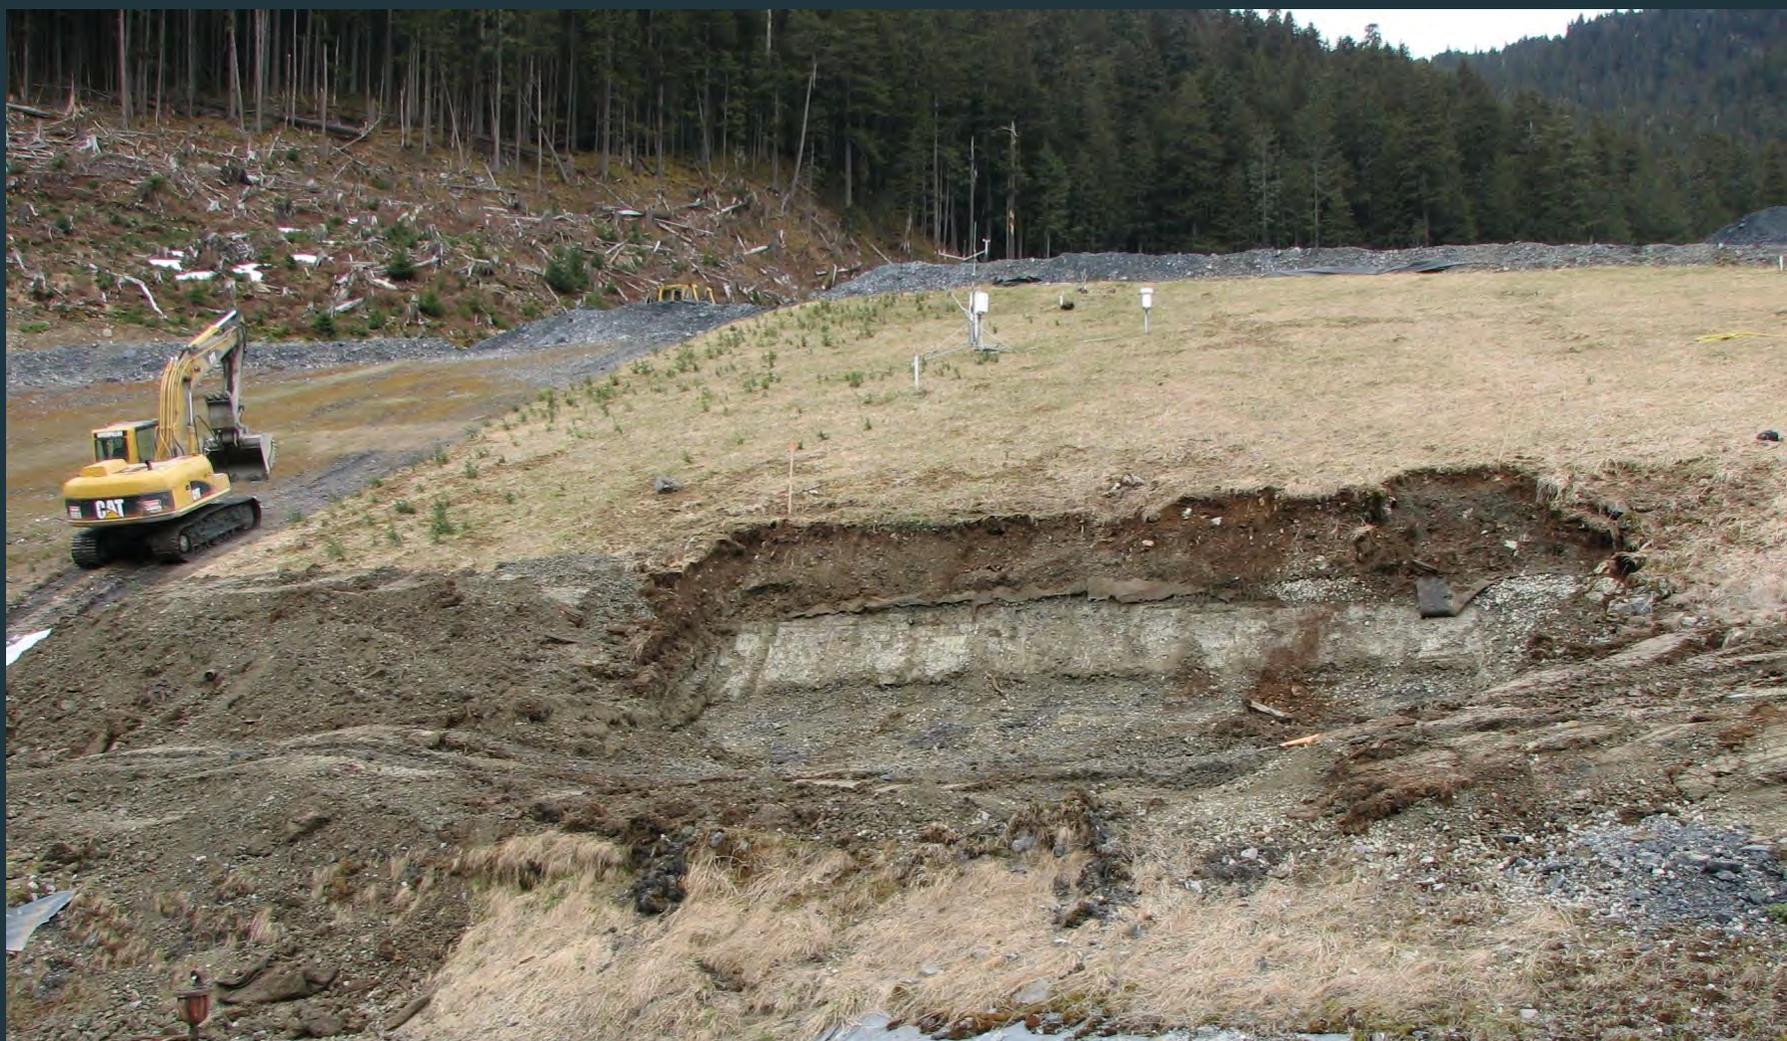
Site 23 Cover Excavation

Growth Medium

Capillary Break

Barrier Layer
