# Hecla Greens Creek 2012 Tailings Annual Report

July 9, 2013

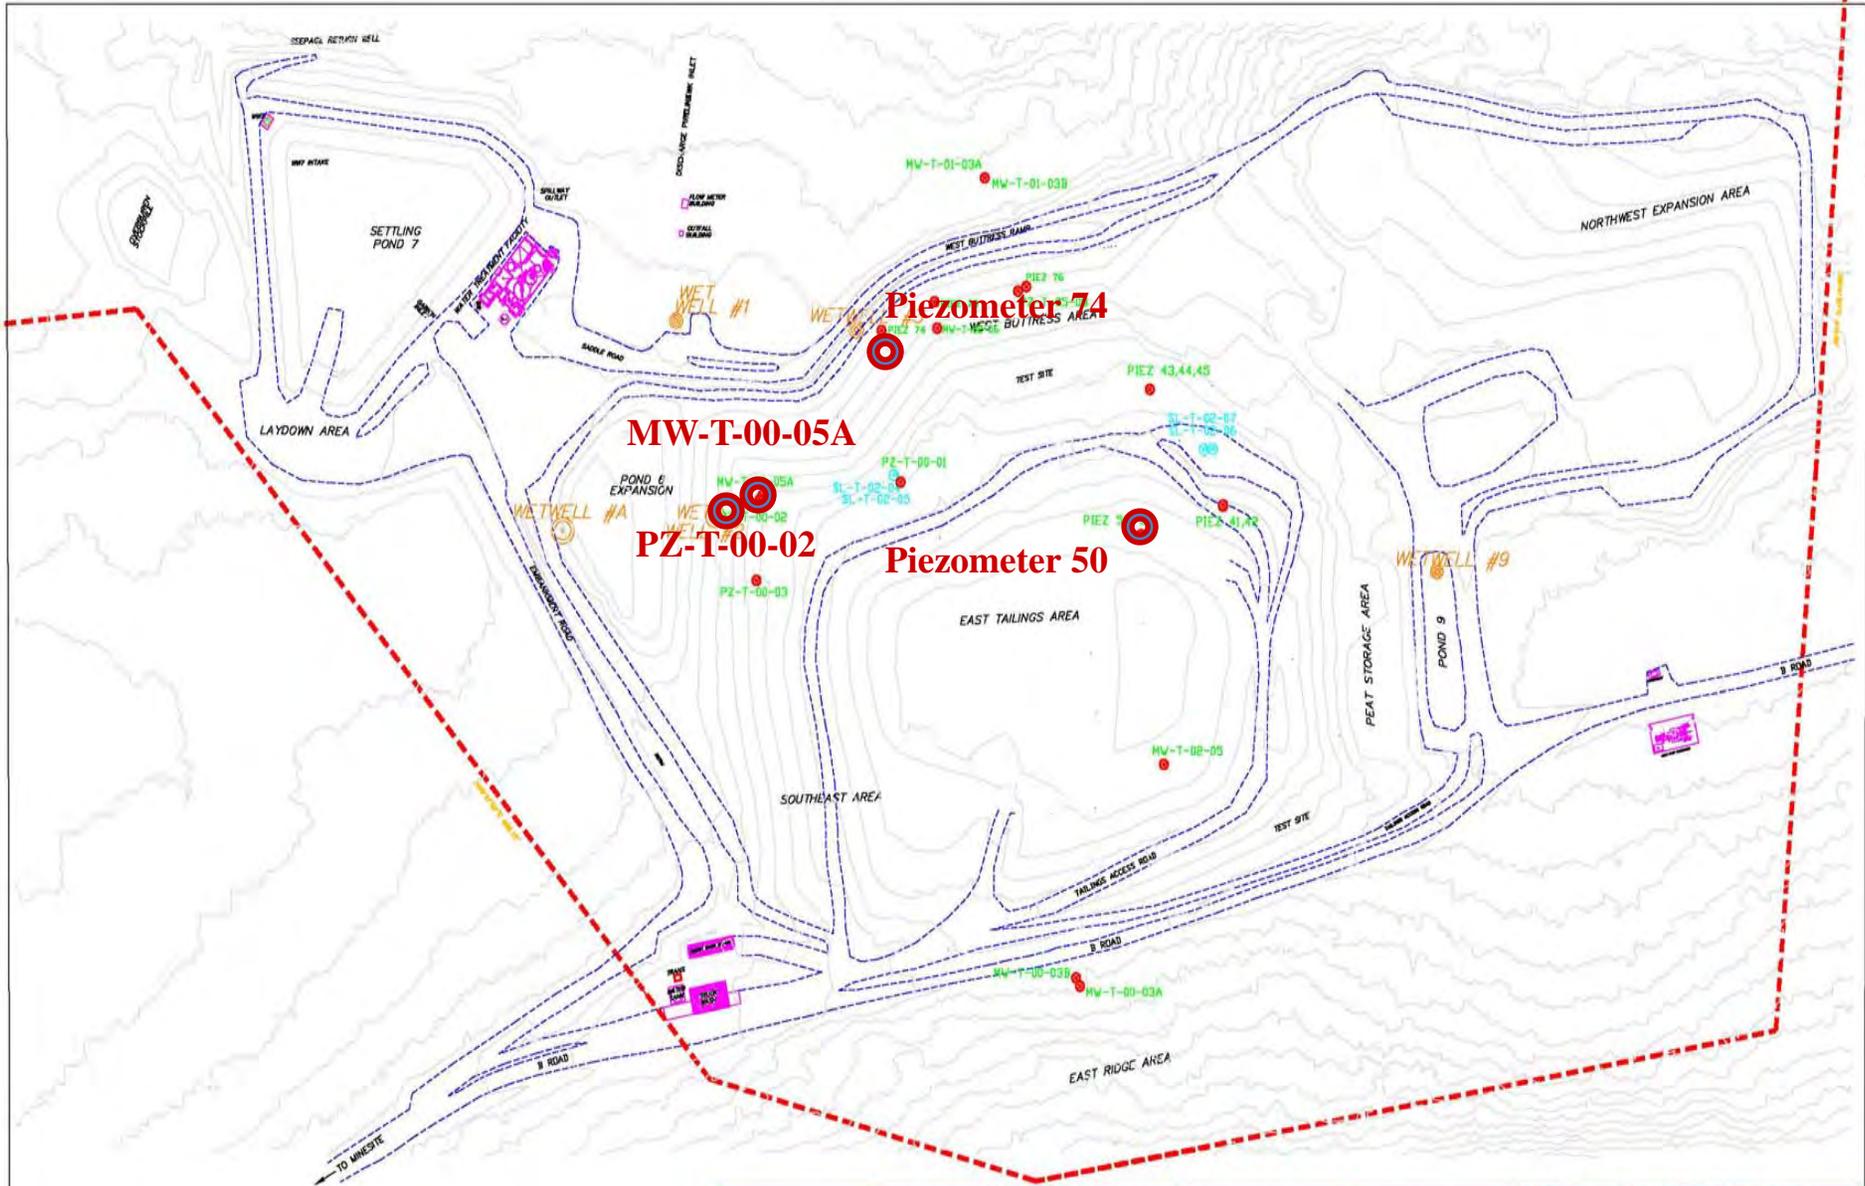
## Tailings Facility Monitoring Well and Piezometer Water Level Data

- Maximum saturated thickness 35 feet
- Toe foundations are well drained
- Water perches approximately 12 feet above the unsaturated under drains

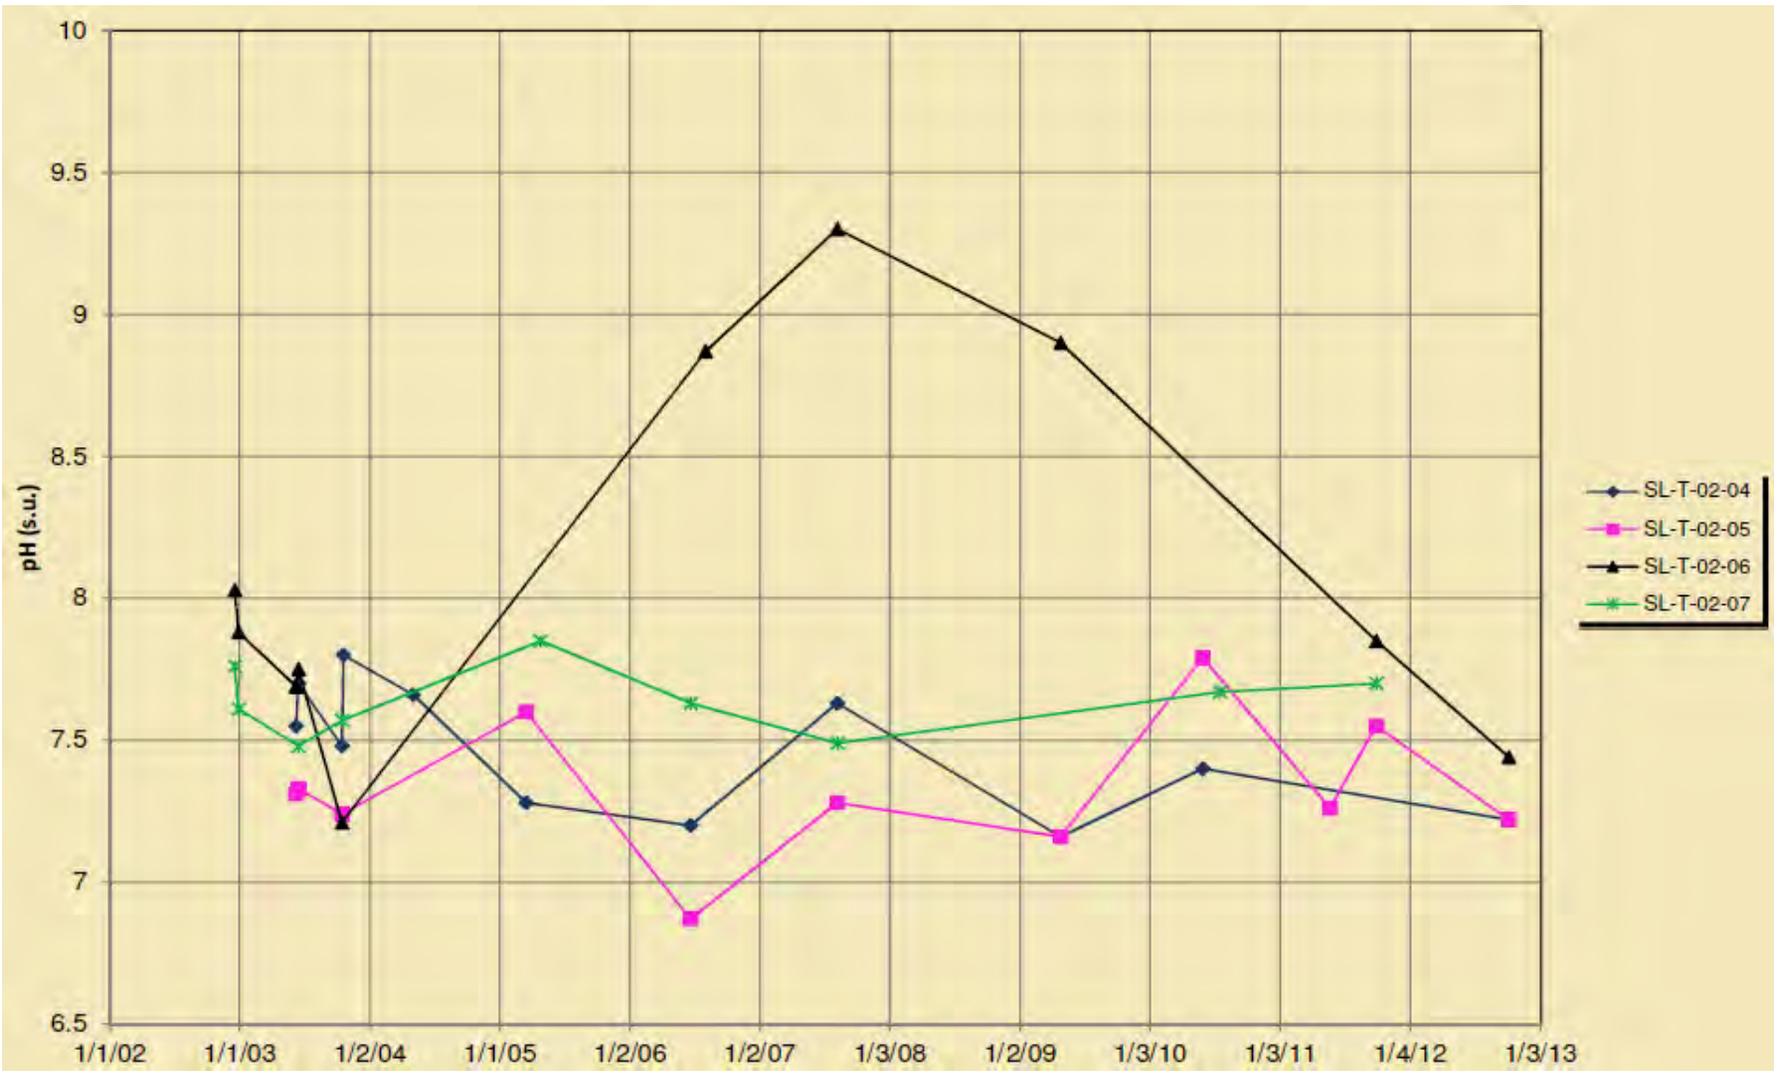
# Tailings Area Internal Sites pH - Figure 2.20c

- Internal site waters captured, treated, and discharged per NPDES/APDES permit
- pH between 6.0 and 8.5
- Alkalinity between 150 and 500 mg/L
- Conductivity in wet wells and tailings completion wells between 2000 and 4100 uS/cm
- Conductivity in suction lysimeters between 1400 and 5000 uS/cm
- Sulfate and hardness correlate with conductivity

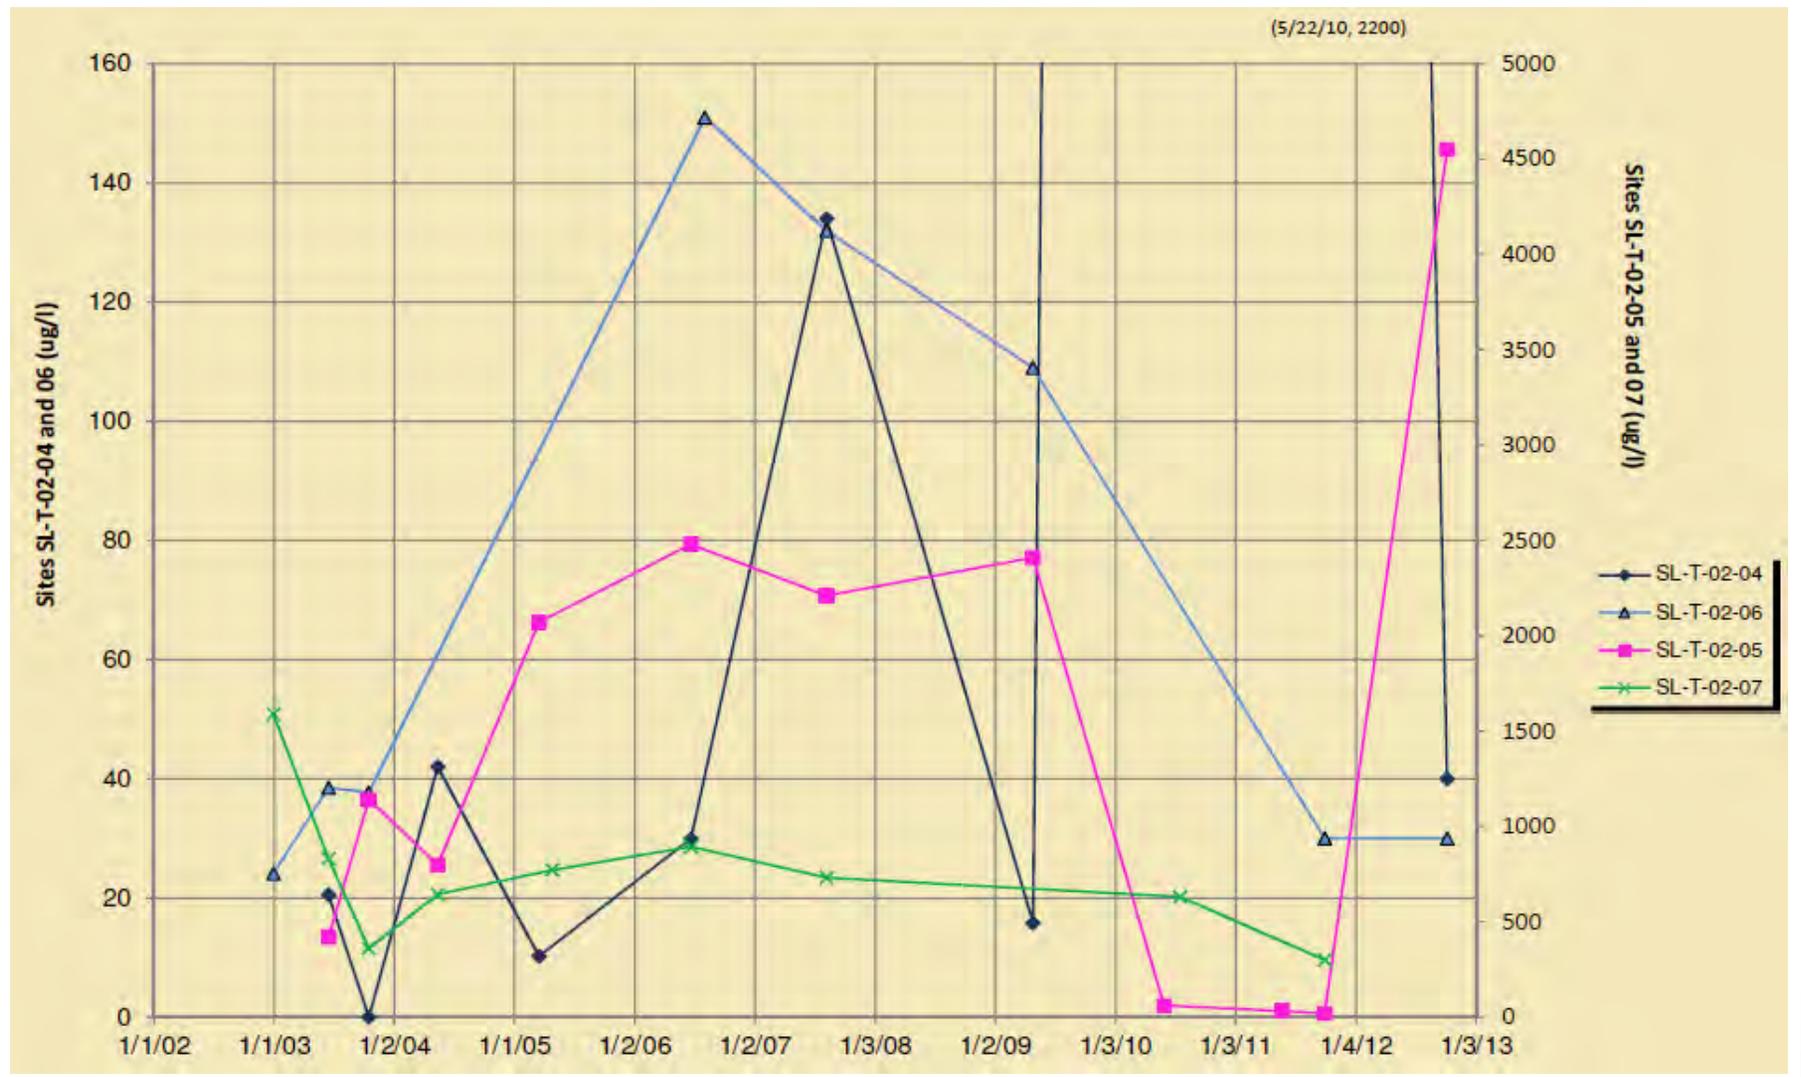
# Tailings Area Internal Sites Zinc - Figure 2.26c

- Fluctuations in saturated zone thickness and associated redox conditions influence arsenic and iron concentrations
- Zinc is considerably more mobile than other metals
- Thiosulfate disproportionation, sulfate reduction and base metal sulfide precipitation produces low metal concentrations in most saturated zone wells
- Shallow unsaturated zone and Wet Well 3 have higher metal concentrations
- Iron and manganese concentrations are elevated in wet wells, groundwater, and most of the suction lysimeters due to oxidation/reduction and buffering reactions

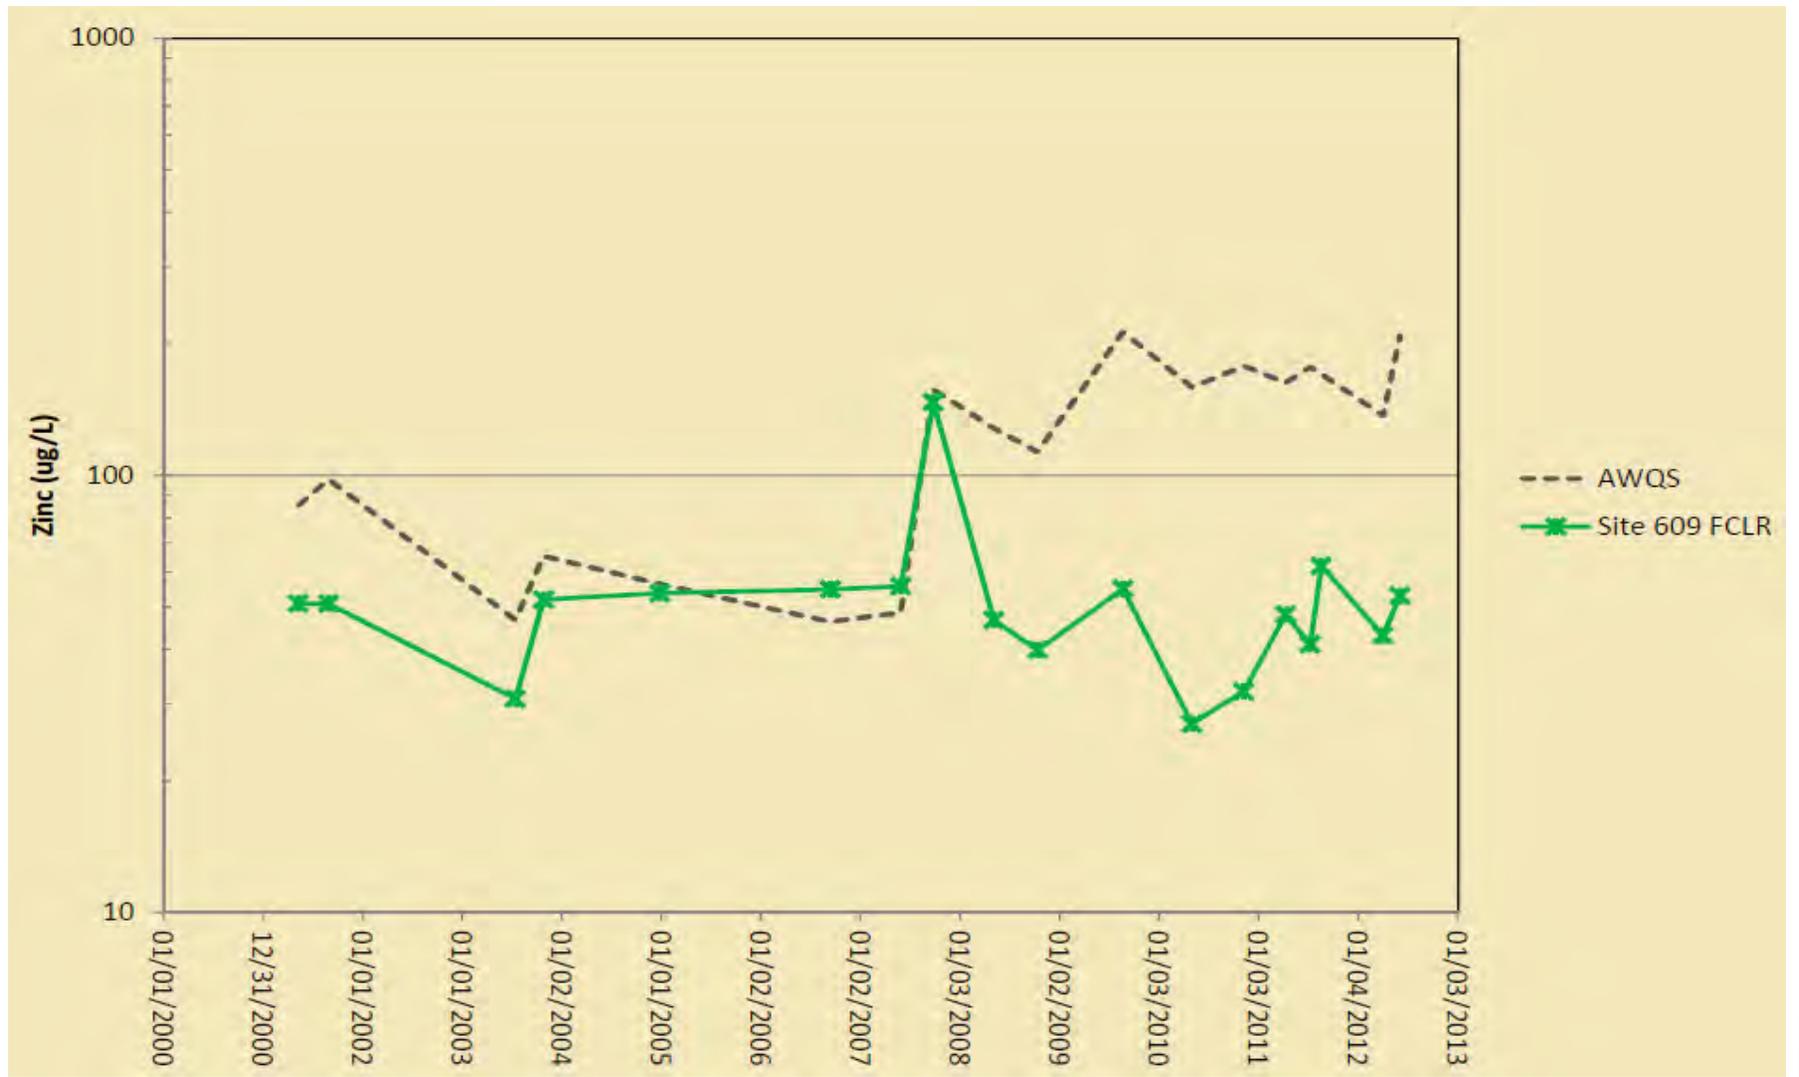
# Figure 2.40 Site 609 Zinc

- A complex history of disturbance poses challenges to identifying potential leakage from the facility
- Zinc in the drainage is an order of magnitude or more lower than contact water, suggesting that effects from seepage, if any, from the tailings pile are minimal
- Zinc at sites 610 and 609 increased with construction and tailings placement activity
- Zinc at site 611 increased from 2004 to 2009 but decreased in 2010 and 2011. The absence of manganese suggests the source of the increase was not tailings leachate
- Further Creek drainage is expected to improve. Some element concentrations may temporarily increase as the drainage returns to its naturally acidic, dilute condition

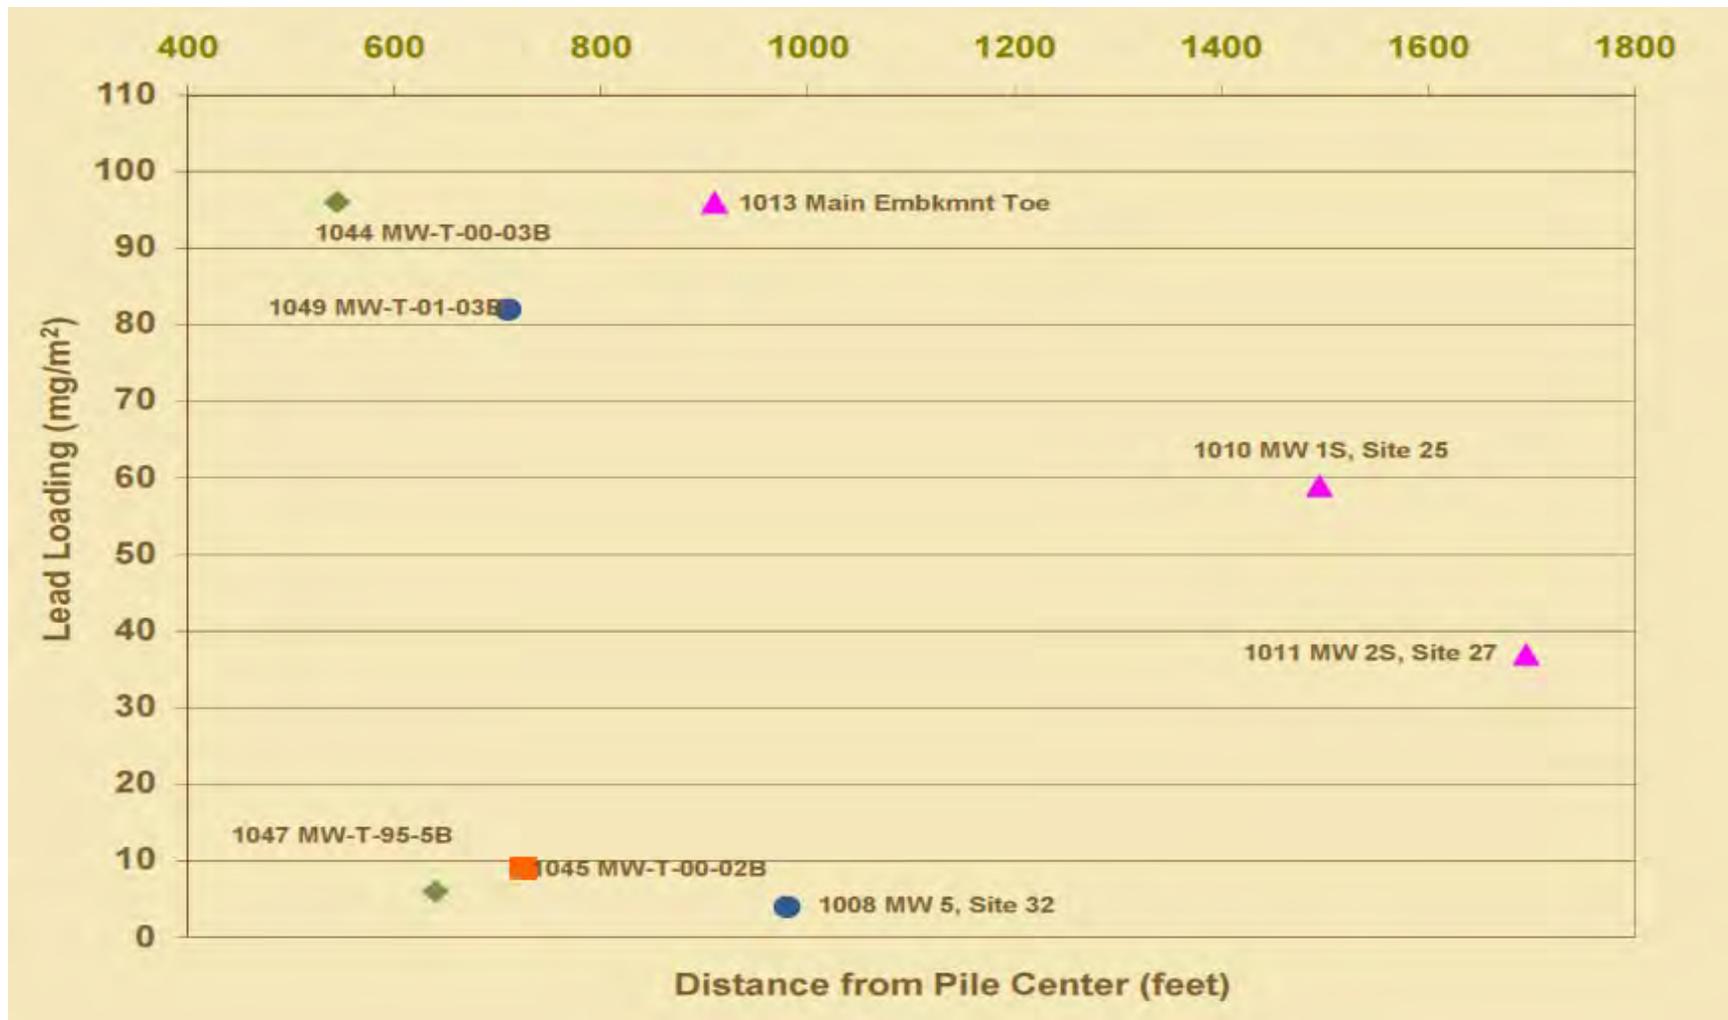
# Figure 2.3X Snow Survey Analysis

- Mitigation
  - Snow Fences
  - Eco Blocks
  - Snow removal only in active placement area
- Lead levels in water do not directly correlate to lead loading values
- Observable up to approximately 1700 feet away
- Significant decrease in lead load relative to 2006. Variability due to location of active placement areas

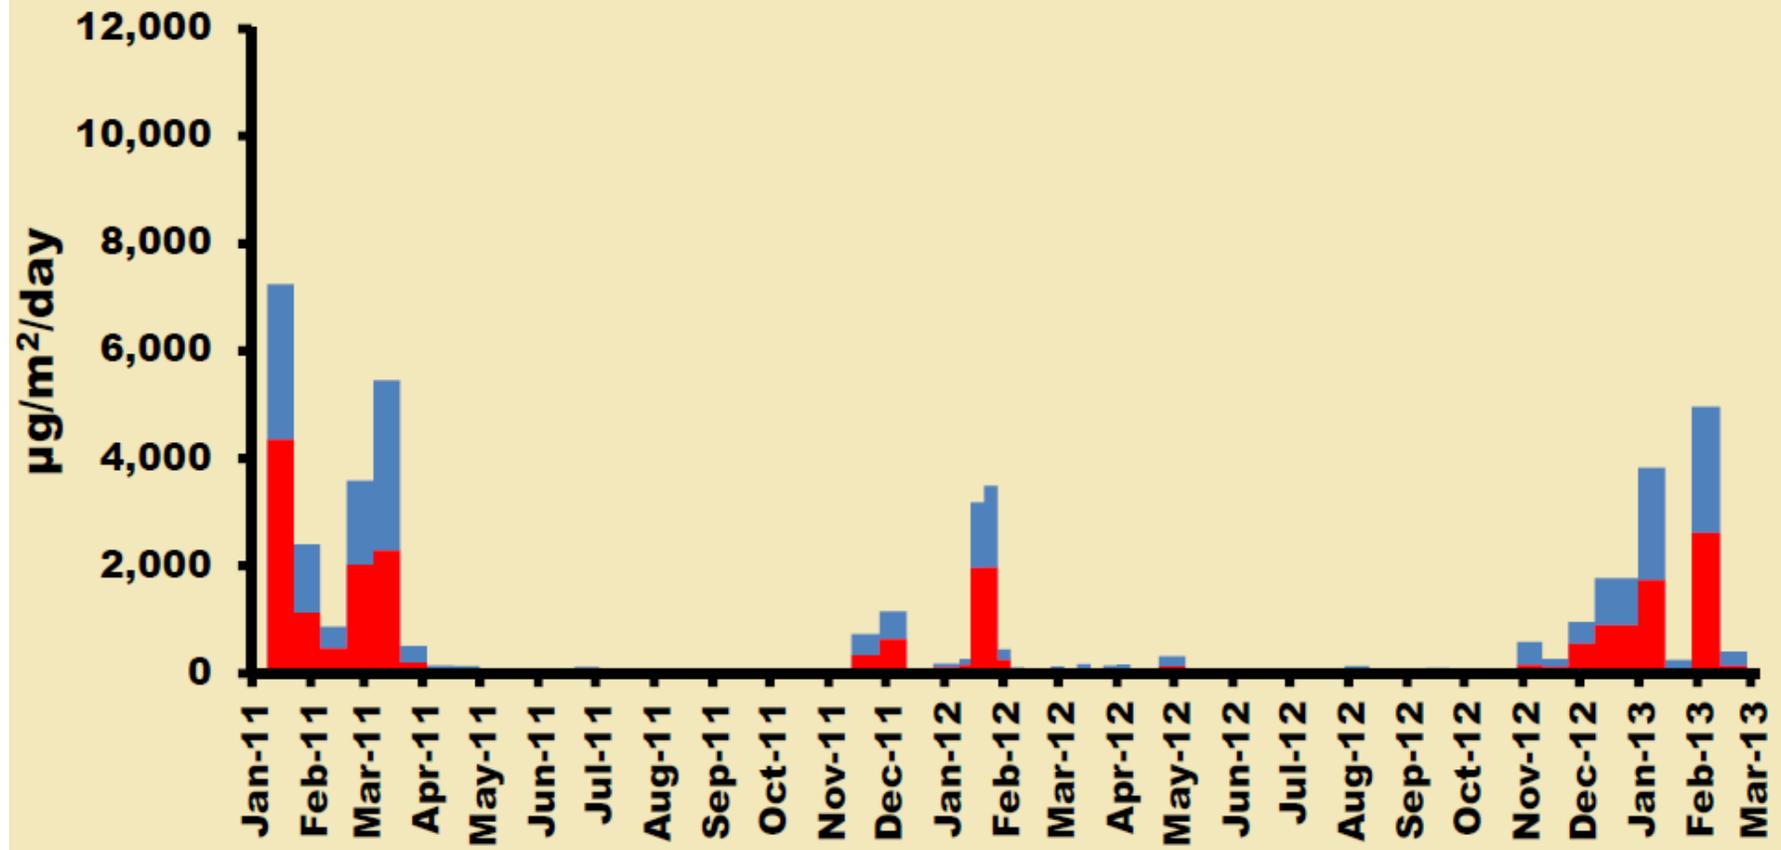
# Figure 2.37

Average **lead** and **zinc** daily loading of the ADP on the western side of the tailings disposal facility over a 2 year period.

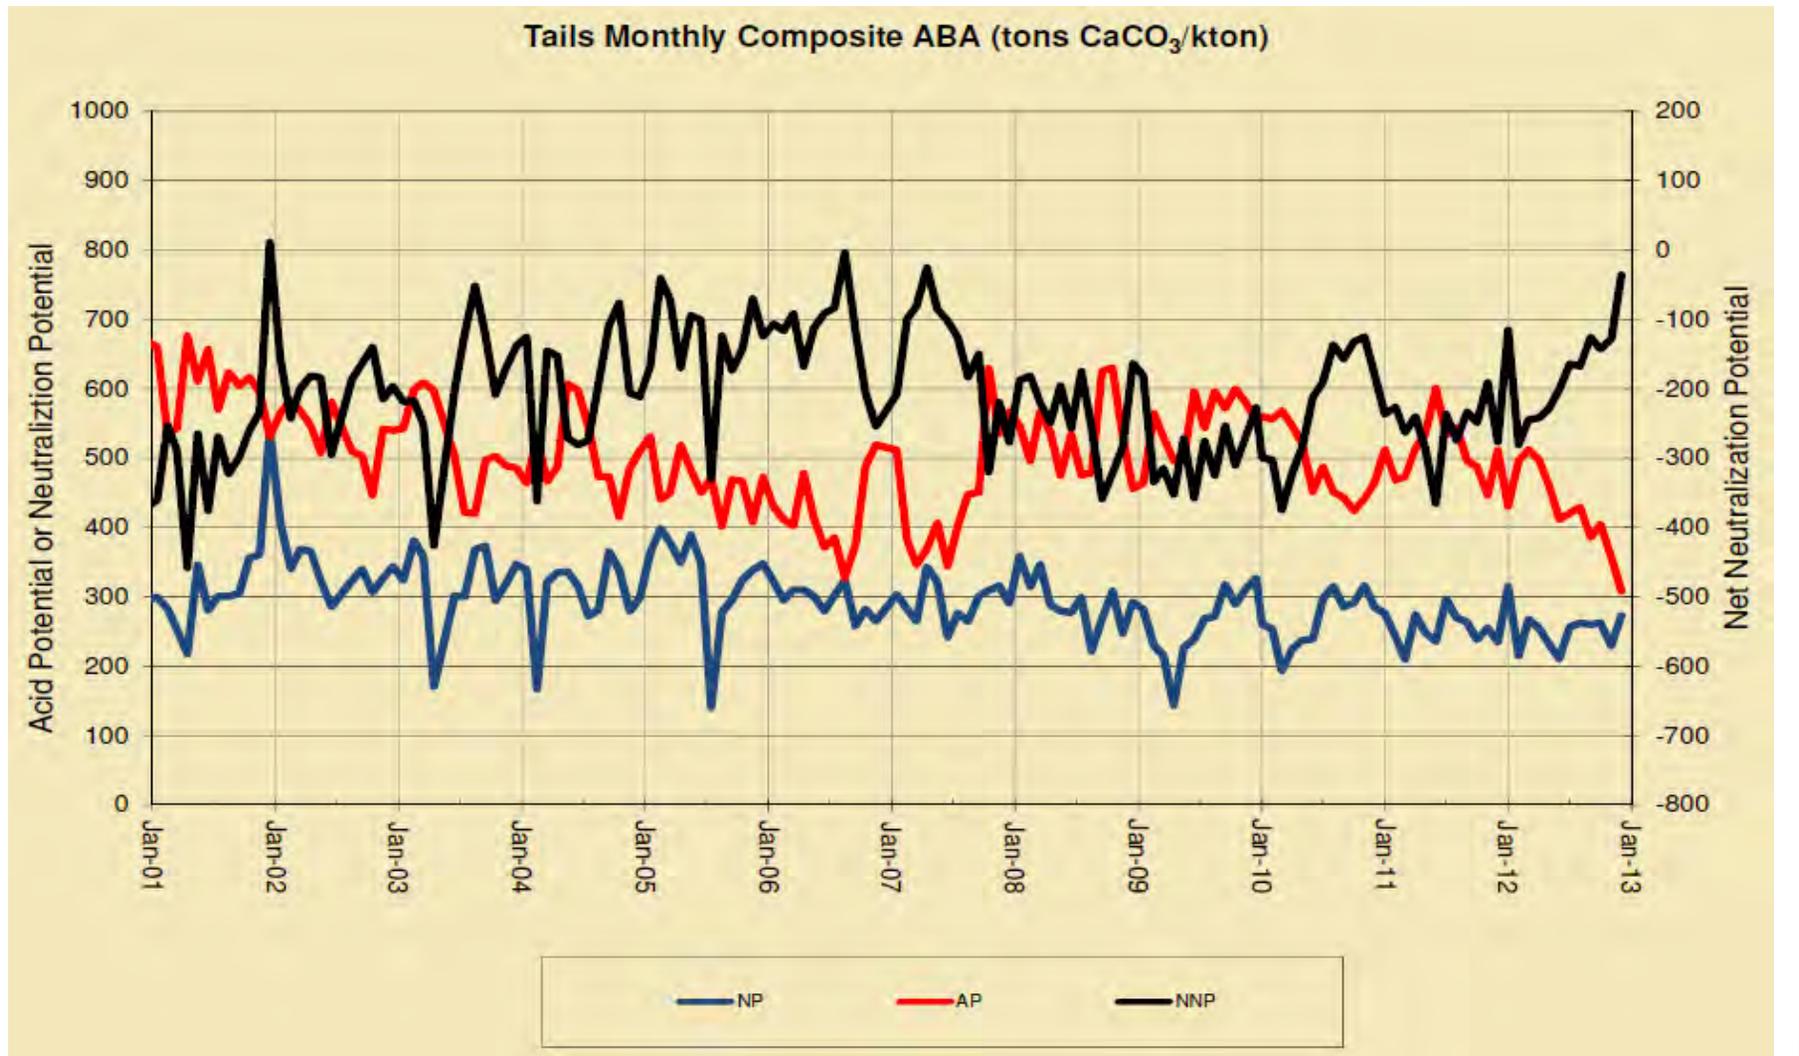
# Figure 2.32 Monthly Tailings Acid Base Accounting (ABA) Data

- Tailings have the potential to generate acidic drainage if the buffering capacity of the tailings is consumed
- High carbonate content supports a long lag time for depletion of buffering capacity
- Long lag time (decades) allows time for construction and closure of the facility, including construction of an oxygen-inhibiting composite soil cover
