# **Kensington Gold Project 2005 Annual Report**

Prepared by:  
Coeur Alaska, Inc.  
3031 Clinton Drive, Suite 202  
Juneau, AK 99801

for:  
U.S. Forest Service  
Alaska Region (R-10)  
Tongass Minerals Group  
Juneau Ranger District  
8465 Old Dairy Road  
Juneau, AK 99801

May 2006

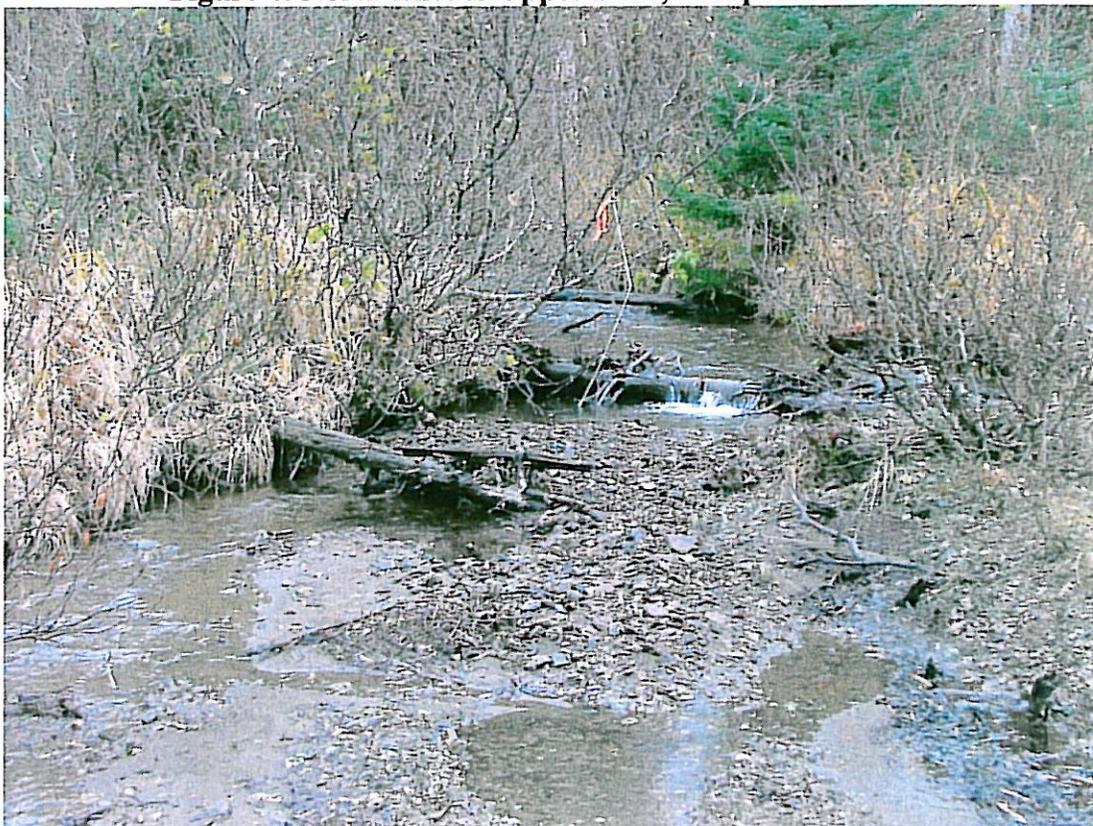
**Figure 4: North Inlet to Upper Slate; 4 traps set in creek**

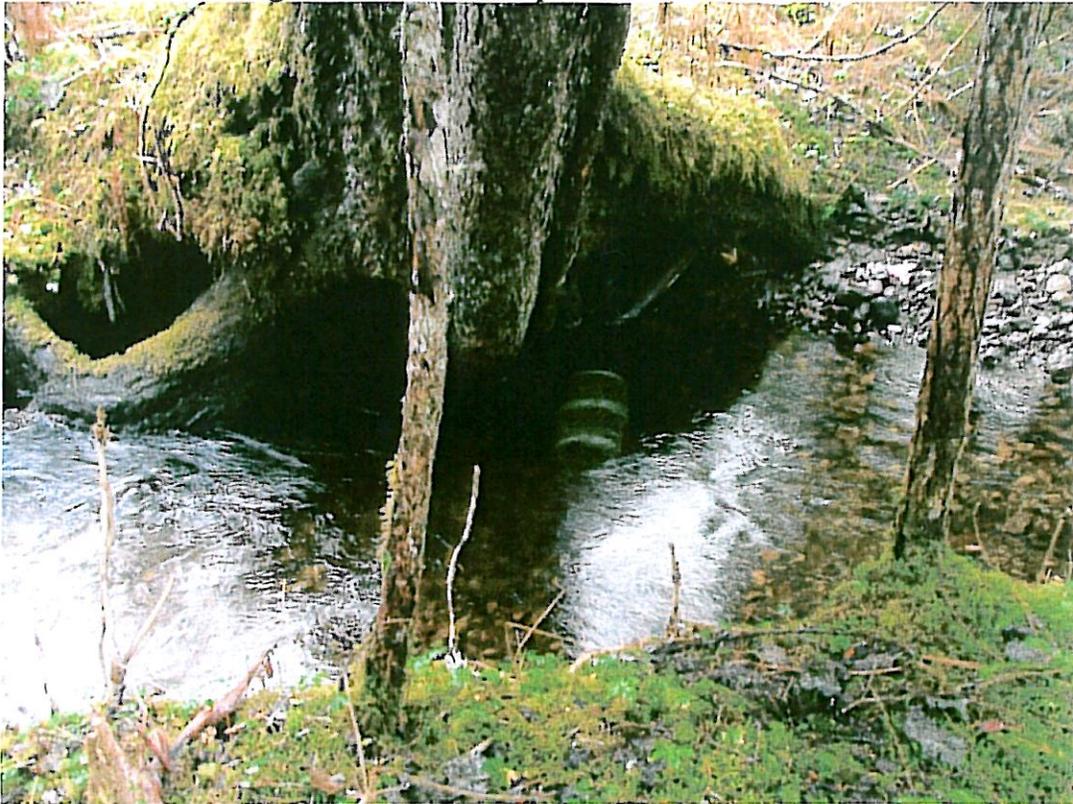
**Figure 5: Minnow trap in North Inlet Creek**
