KENSINGTON MINE ANNUAL MEETING for 2010

KENSINGTON GOLD MINE

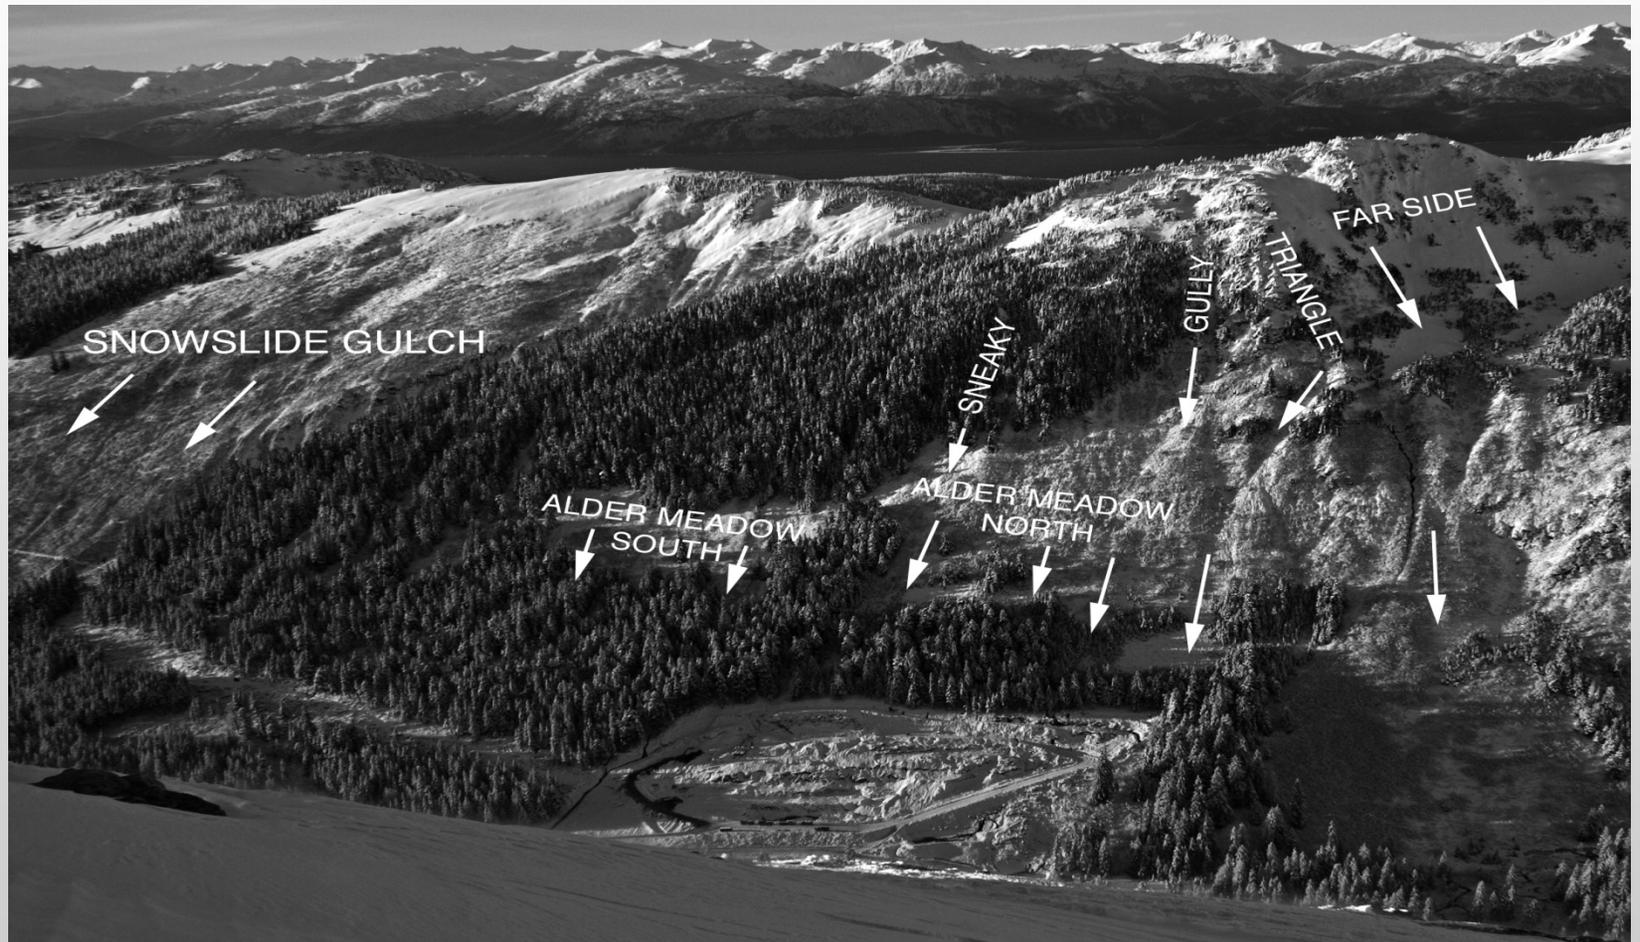
Sneaky, Gully, Triangle, & Alder Meadow North Avalanche Zones

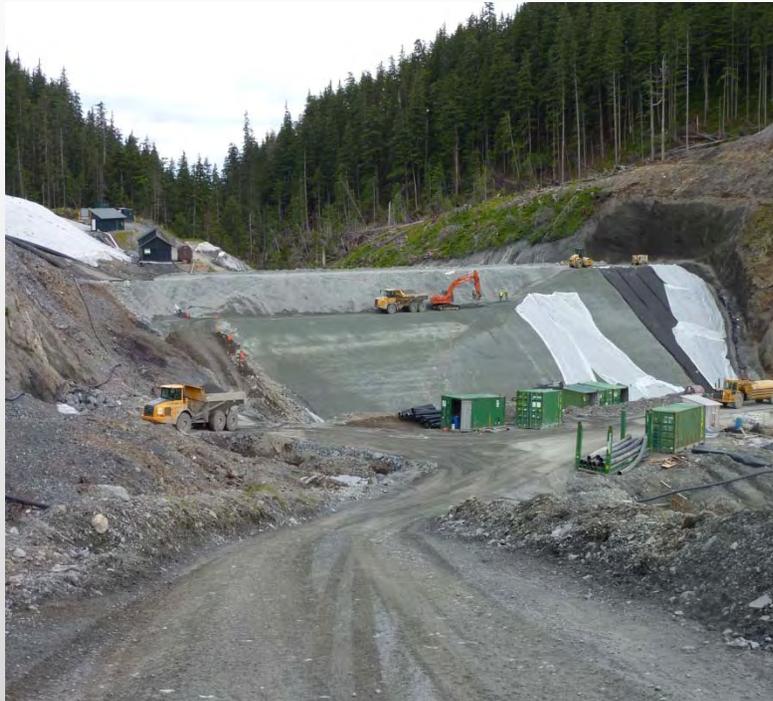
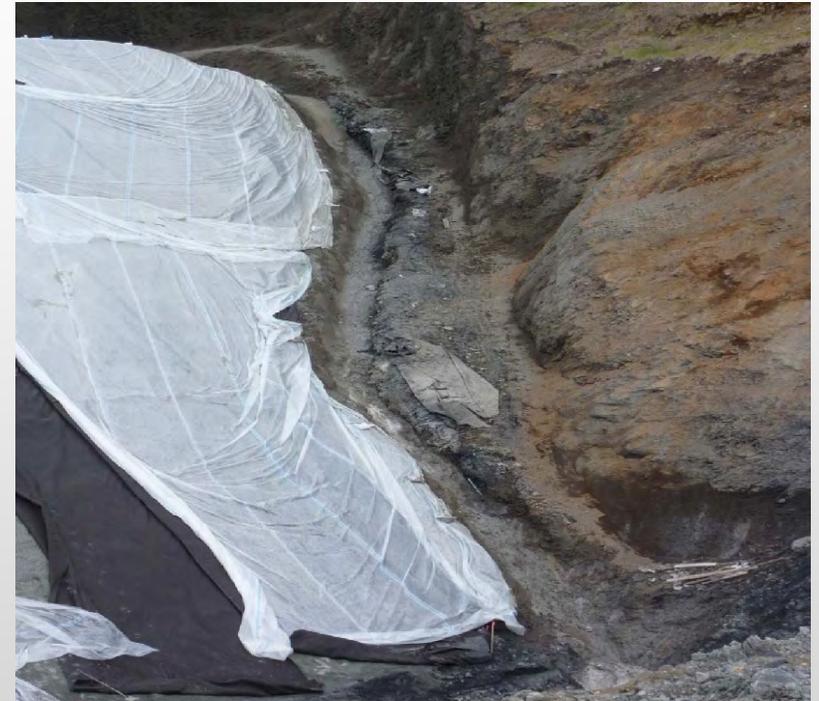
Tailings Treatment Facility - Dam Construction

- Installation of Zone D & F, 100-mil HDPE Liner, & Non-Woven Geo-textile Fabric
- Construction of Grout Trench

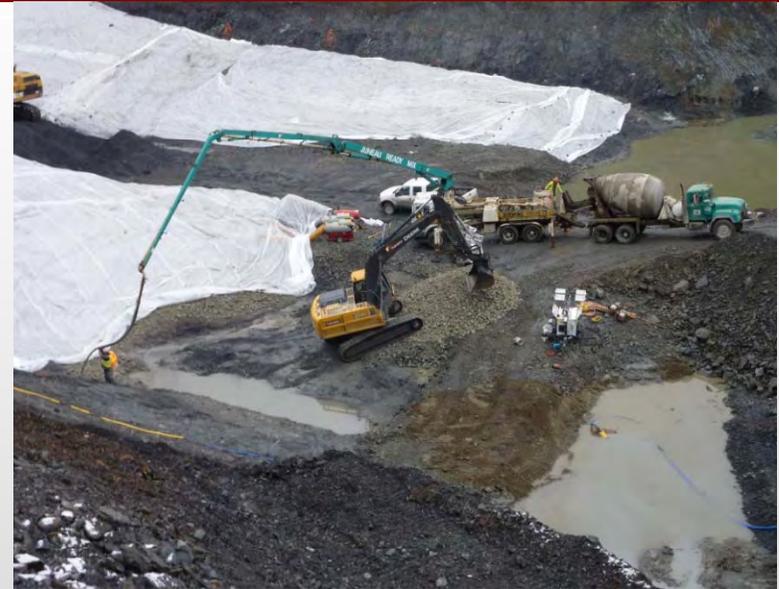
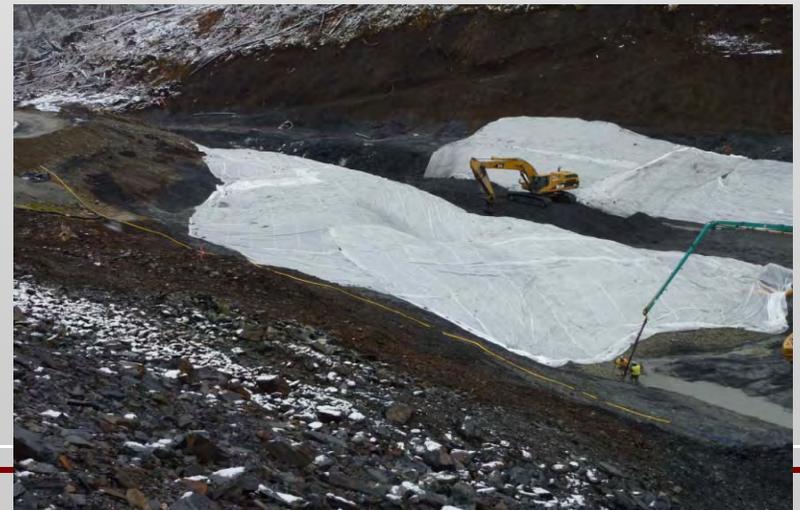
Dam Construction

- Placed Dental Grout on bedrock
 - Seal-Off Graphitic Phyllite
 - Due to Foundation Material not Meeting the Hardness Criteria

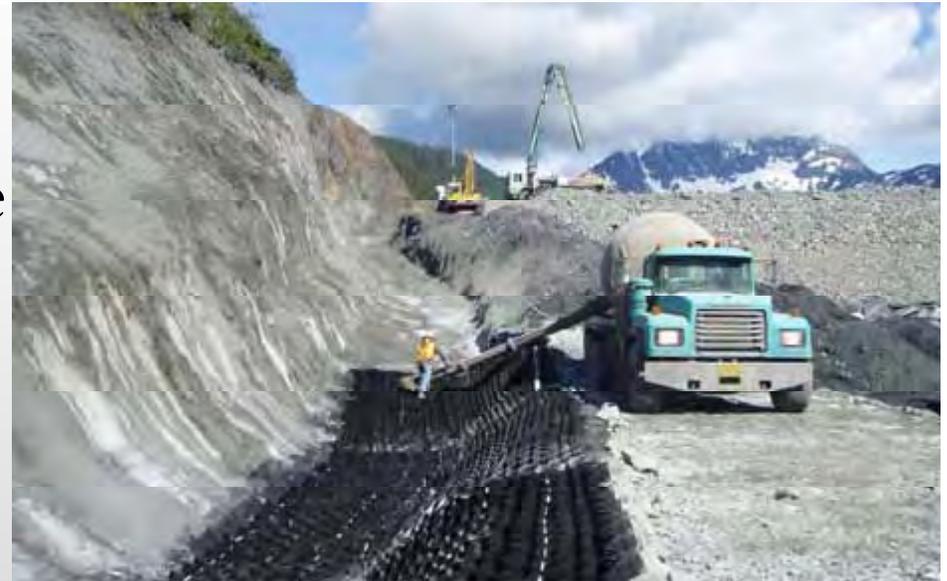
Dam Construction

- Construction of Stage 1 - Interim Spillway

Key Elevations	Elev.
Stage 1 Dam Crest	690 ft
Stage 1 Interim Spillway Invert	684 ft
Normal Upper Operational Level	668 ft

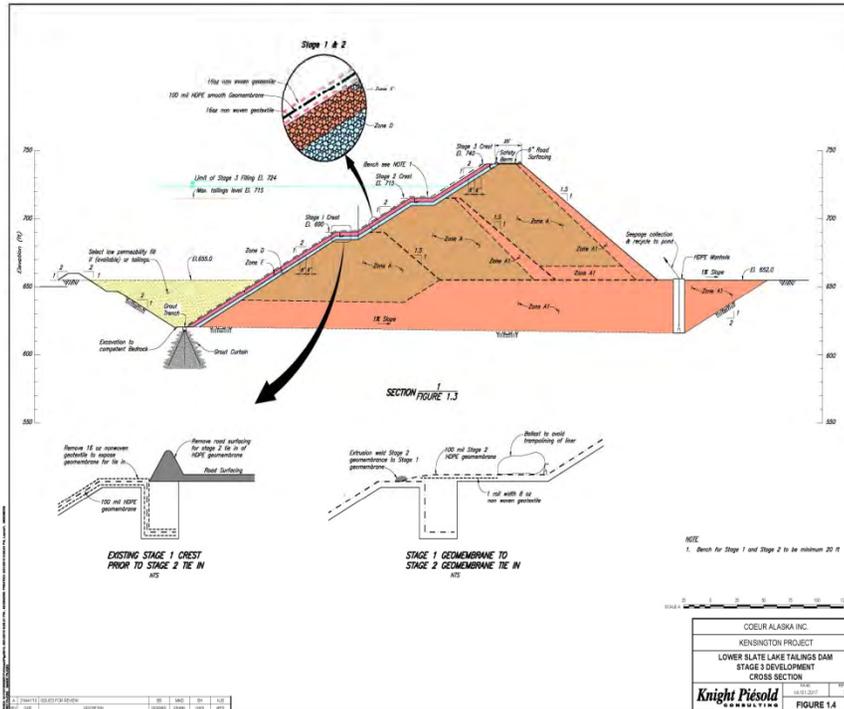
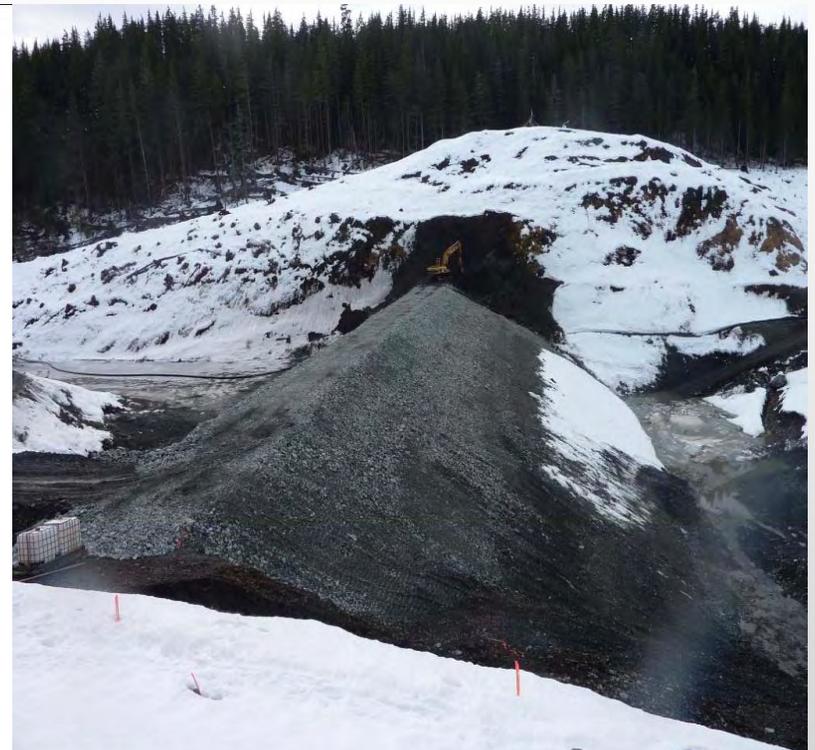
Dam Construction & Operation

- Completion of Pump-Back System
- Temporary Certificate to Operate A Dam issued in July
- Certificate to Operate Dam Issued on January 28th, 2011

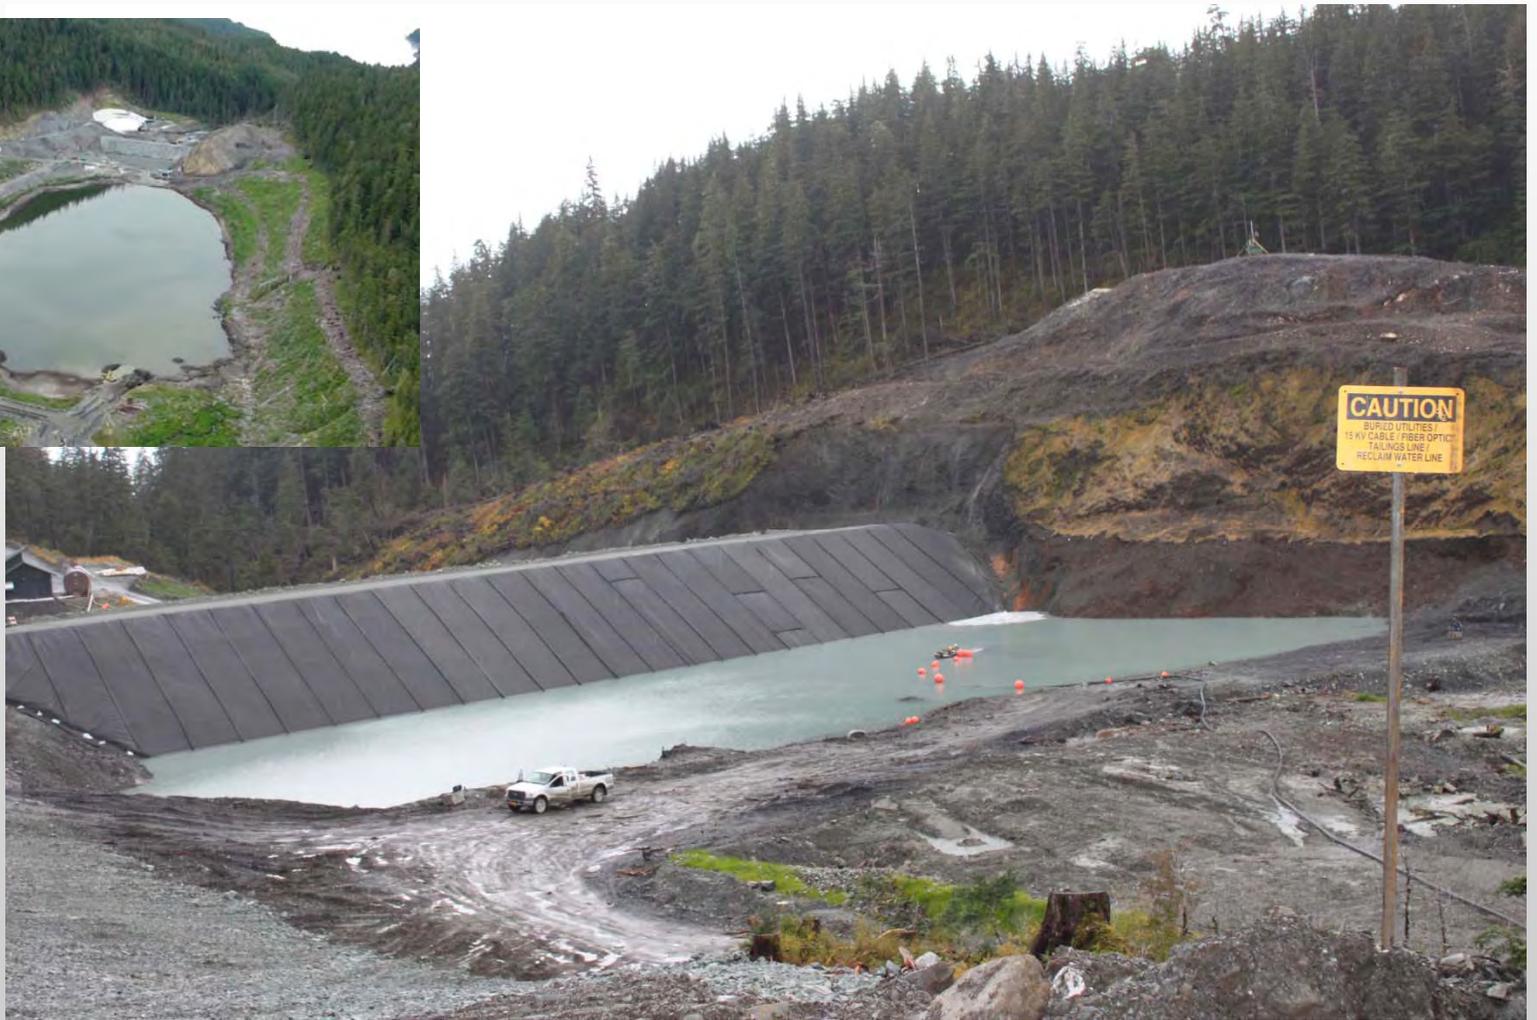
Dam Construction– Placement of Low Permeability Fill/Tailings

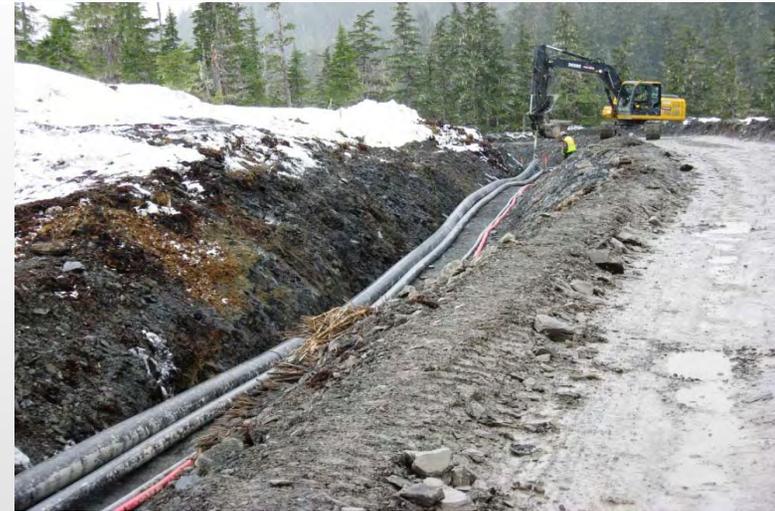
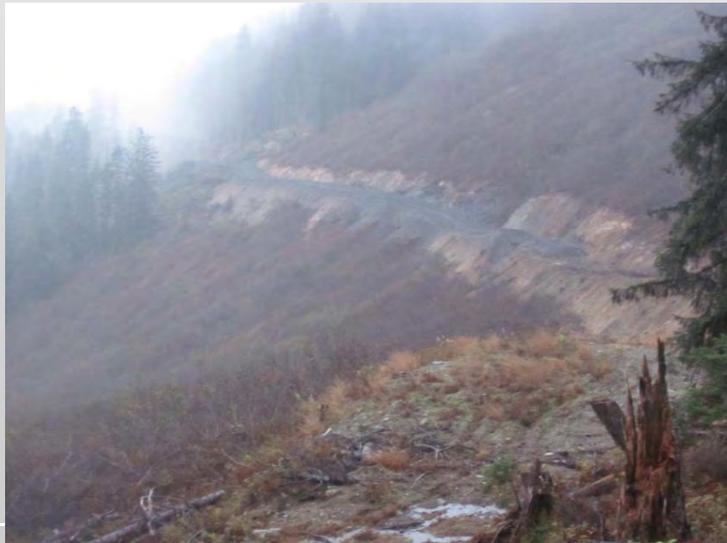
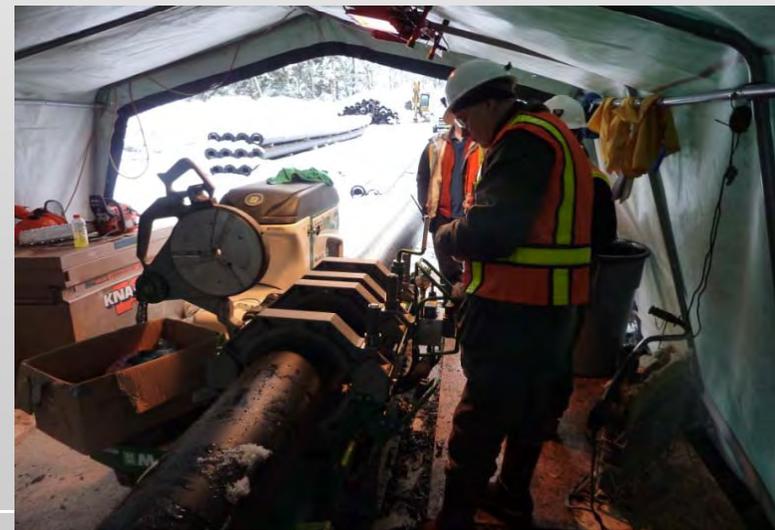
Tailings/Reclaim Water Line Construction

Installation of Dual-Walled Tailings Conveyance Pipe-Line, Single Wall Reclaim Pipeline, Power Cable, & Fibre Optic Cable

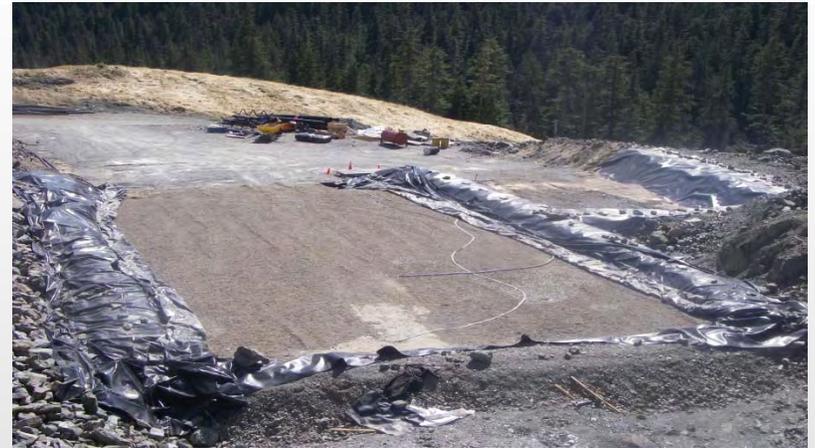
Graphitic Phyllite Temporary Storage Construction

- Portion of Bio-Cell converted to storage site for Graphitic Phyllite
- Water collected on underliner in cell and conveyed to sump
- Collected water transported to temporary package water treatment plant at TTF for treatment
- Under Liner sealed to Top Liner
- Temporary Storage until 2014 at which time it will be encapsulated in paste tailings in an underground stope

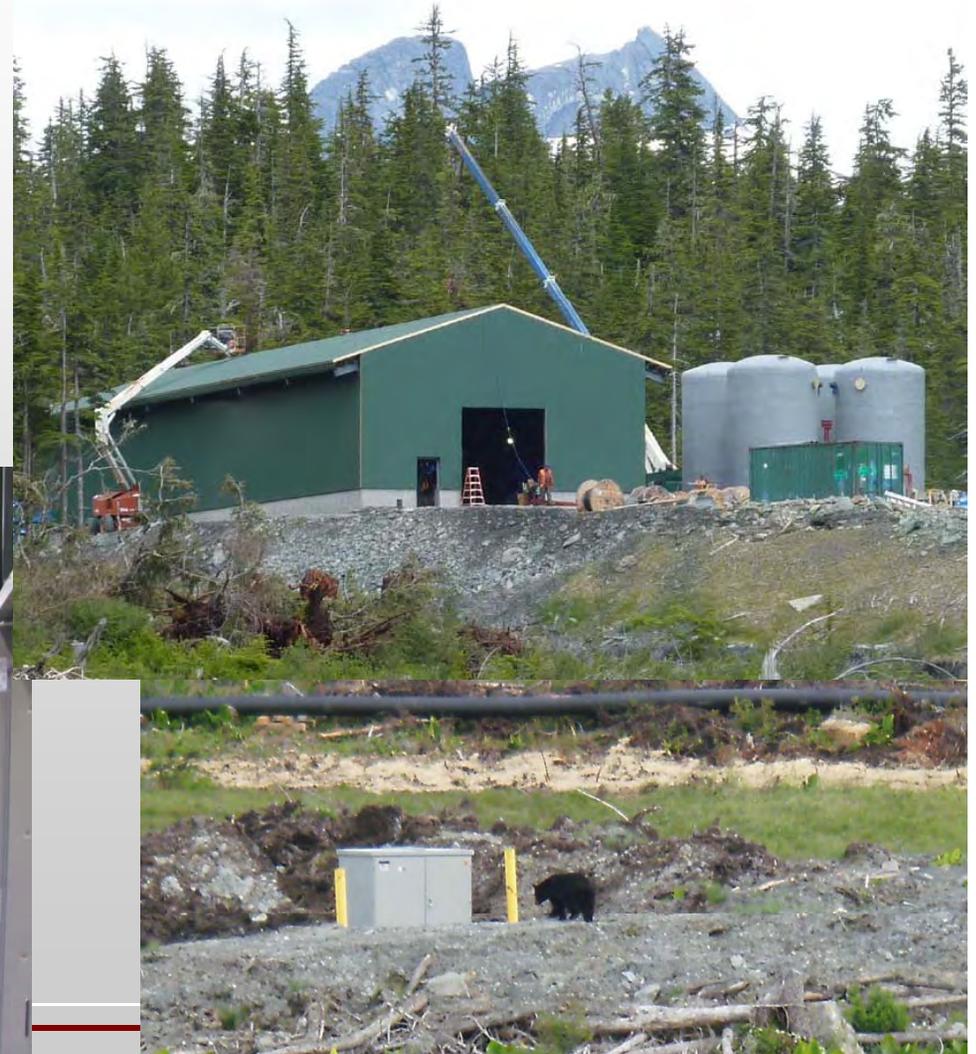
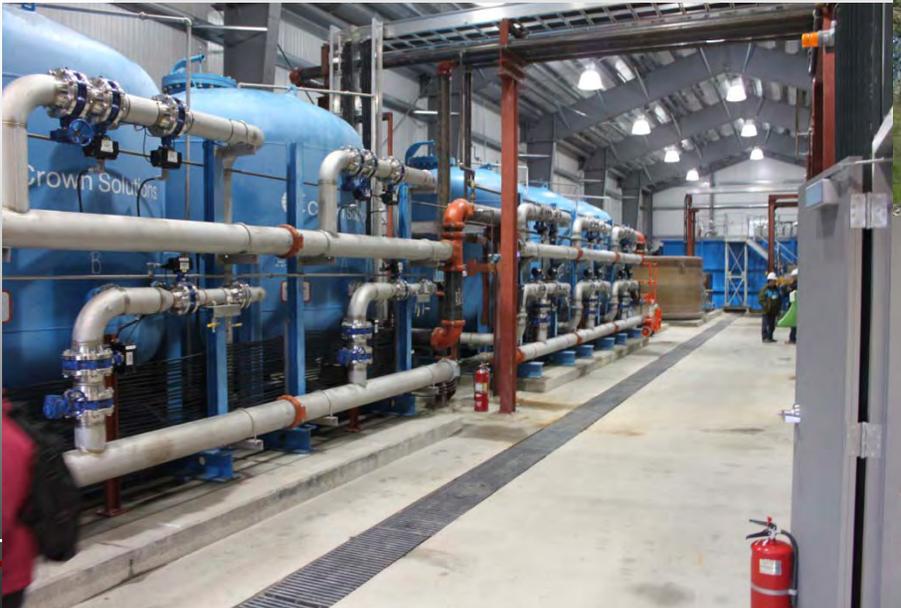
Tailings Treatment Facility -Water Treatment Plant

- 1500 gpm Capacity
- Actiflo Clarifier
- Multimedia Filters
- Activated Carbon Filters
- Sludge Thickener/Filter Press

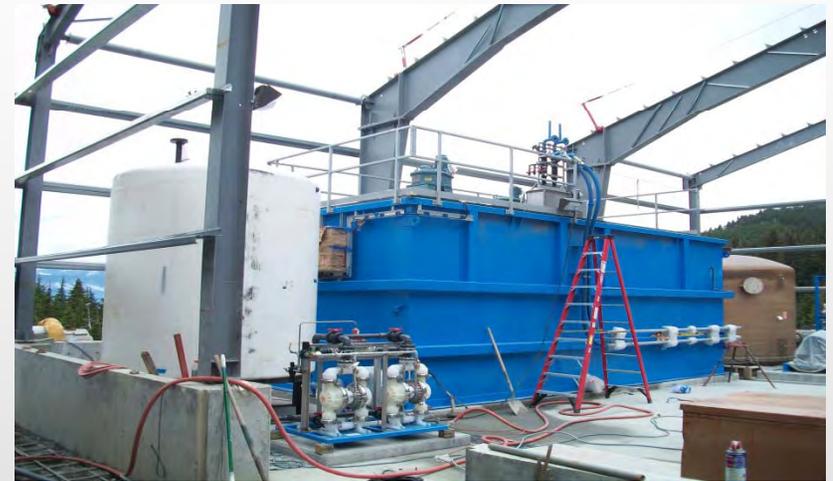
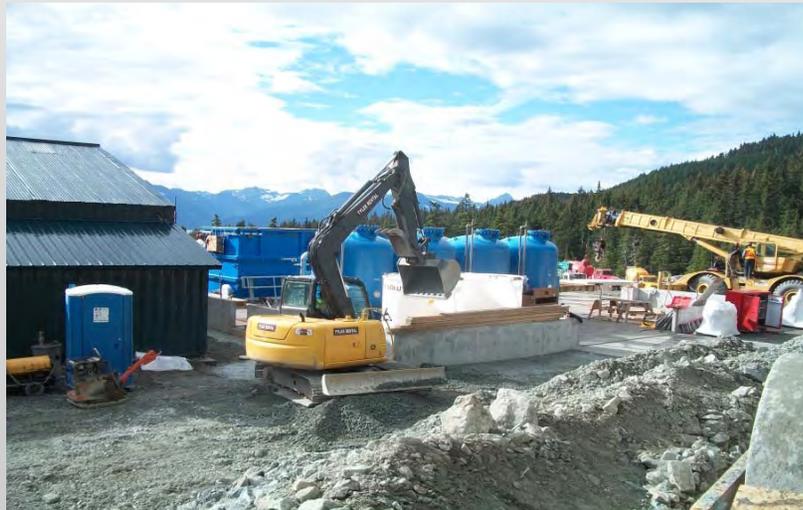
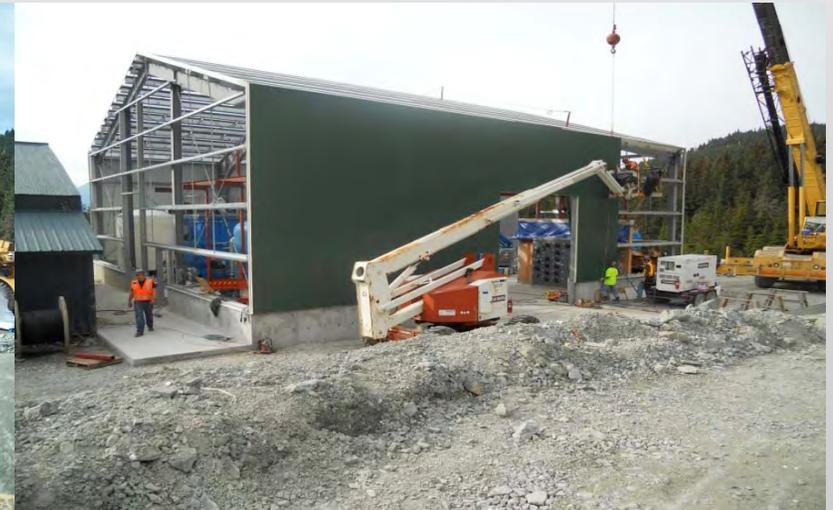
Comet Mine Water Treatment Plant

- Constructed new 1500 gpm Capacity Plant with similar Treatment Process as existing treatment plant
- Utilized Actiflo Clarifier
- Multimedia Filters
- Sludge Thickener/Filter Press

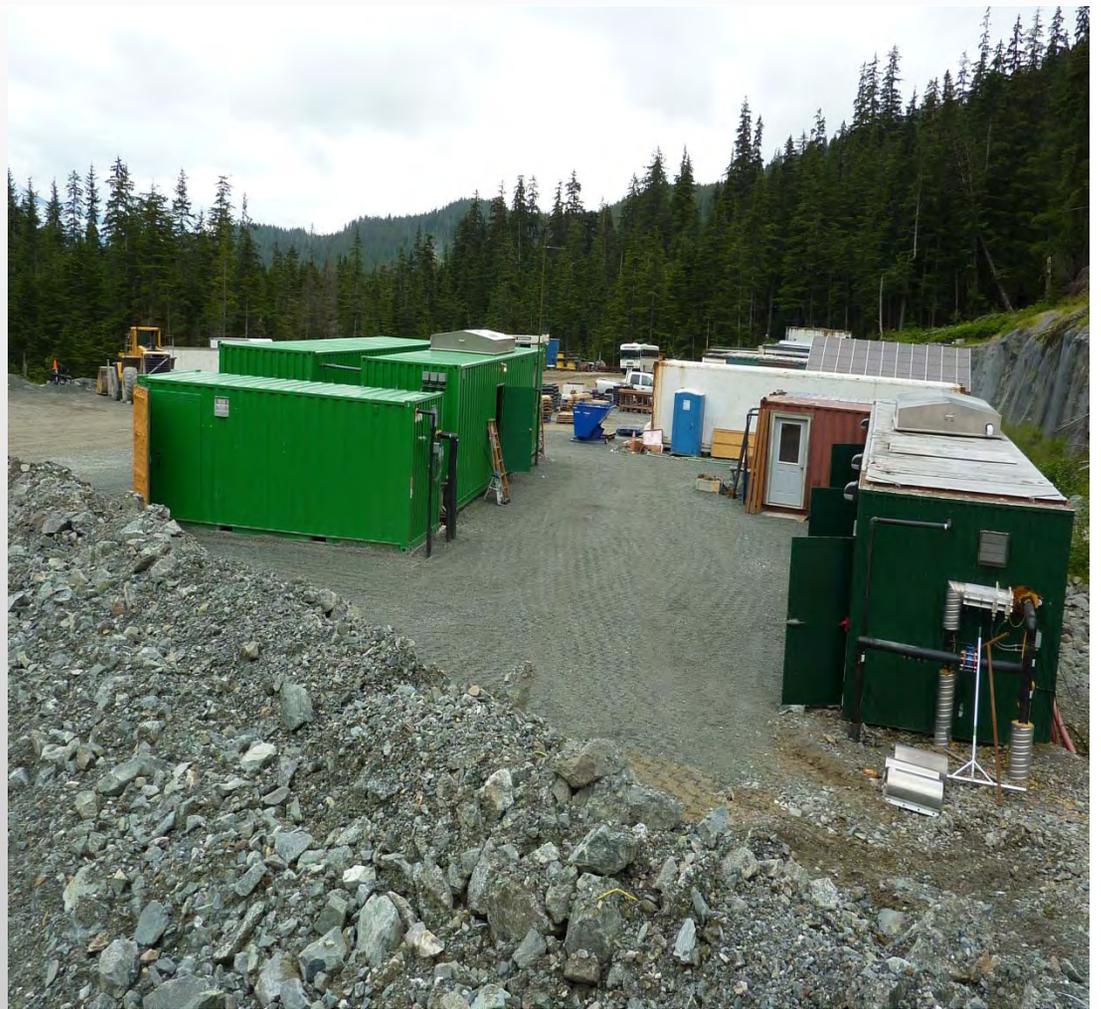
Wastewater Treatment Plant Expansion

- Installation of an additional bio-reactor treatment plant to increase overall system capacity to 10,000 gpd.
- New plant has capacity of 10,000 gpd and old plant has capacity of 5000 gpd for total capacity of 15,000 gpd

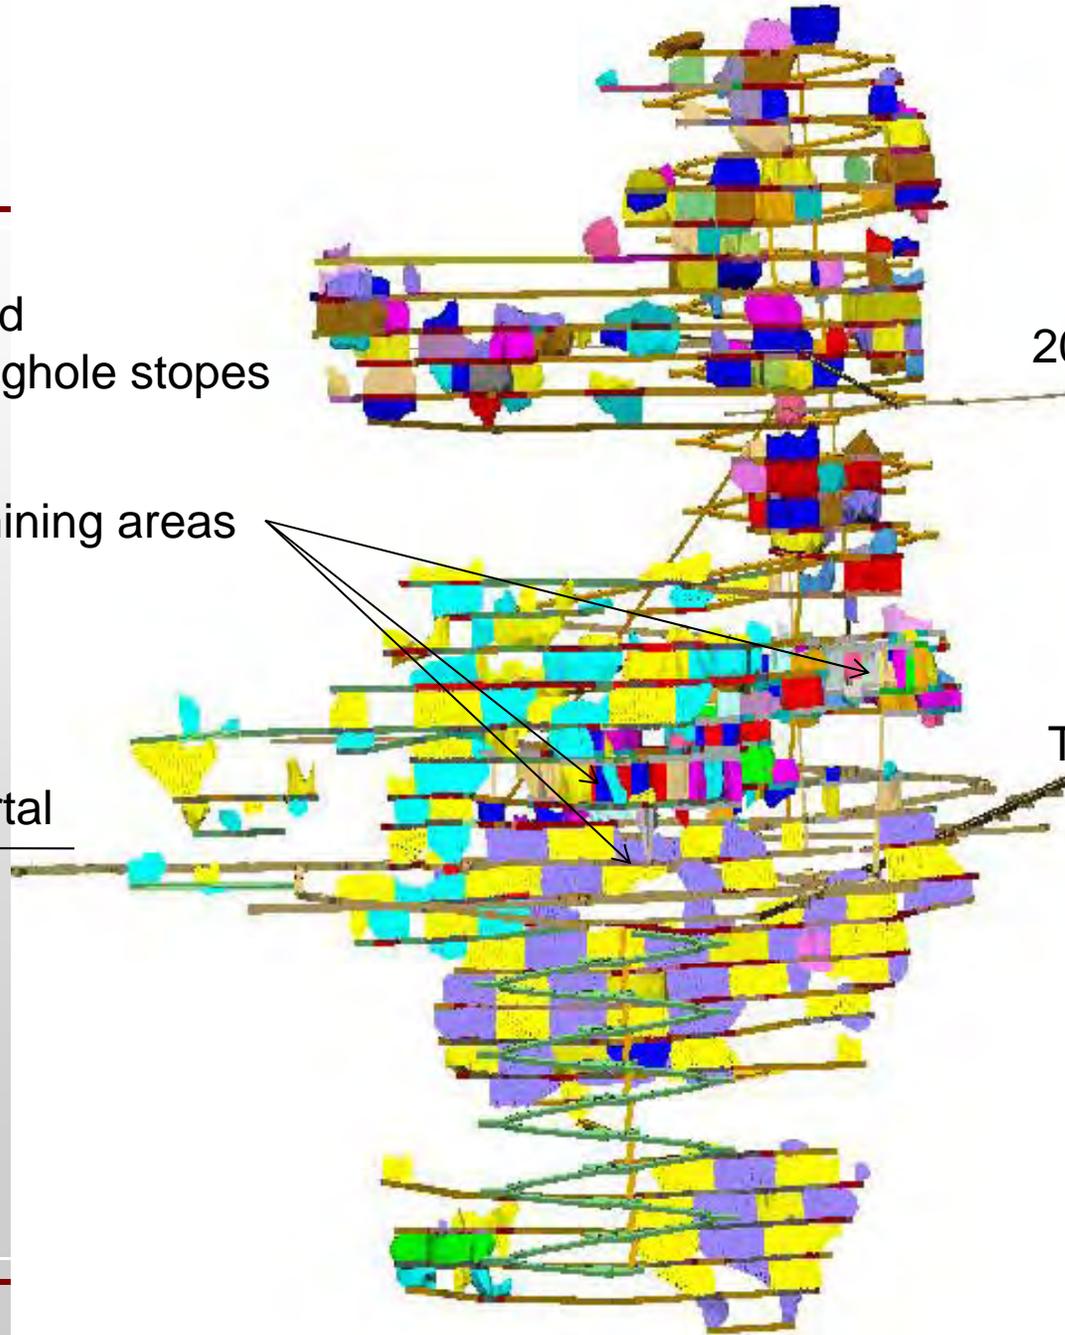
Existing and proposed development with longhole stopes

Current mining areas

2050 Level

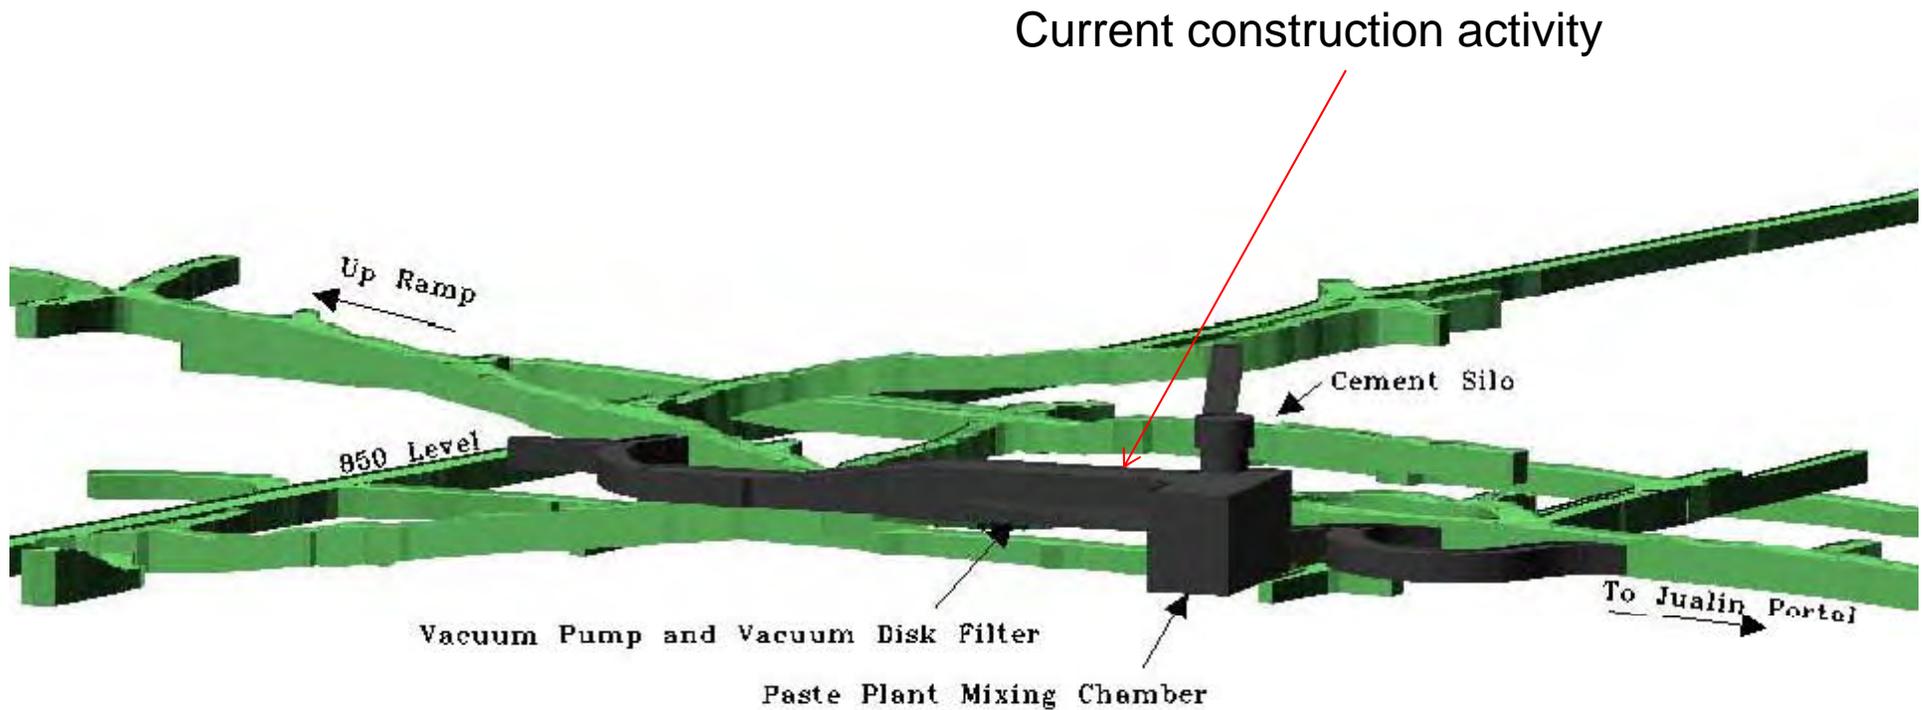
Paste Backfill Plant

Paste Plant currently Planned for Operation in December of 2011

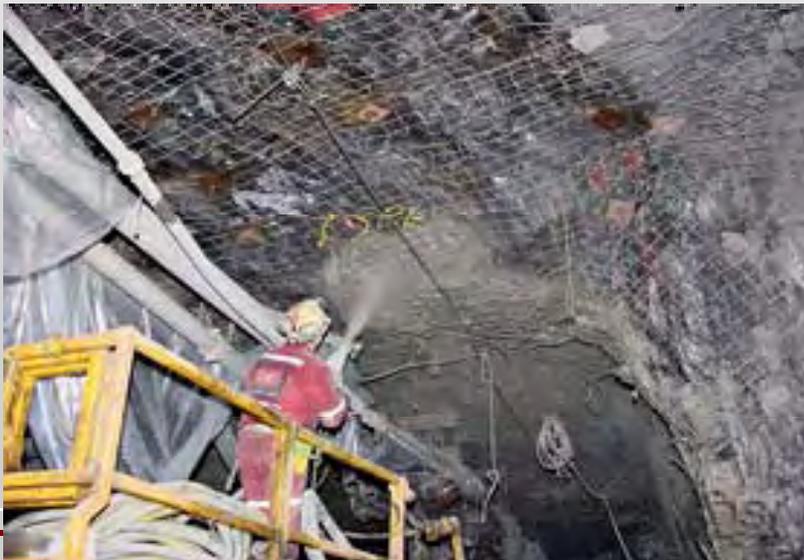
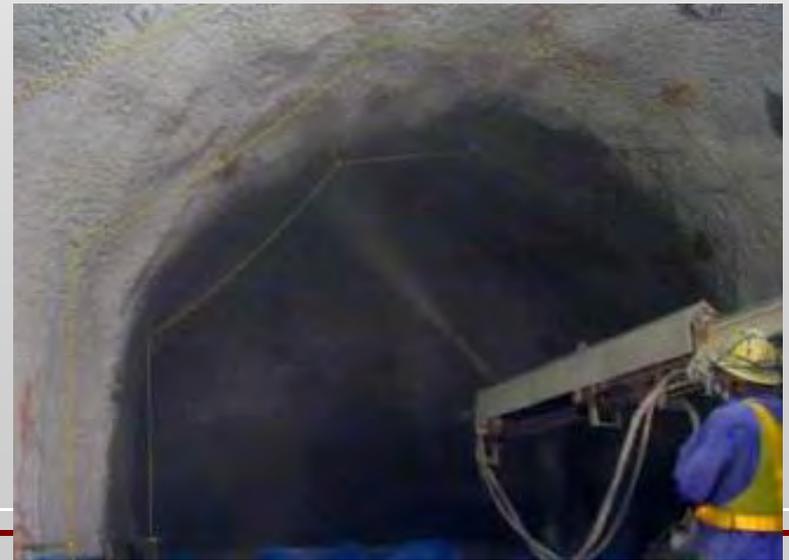
Mine Activities in 2010

- Focused on completion of infrastructure projects
 - Completed upgraded ventilation system end 3rd Qtr. including portal heaters, main fans, and booster fans
 - Paste plant excavation 73% by EOY, completed end 1st Qtr. 2011
 - Shotcrete, concrete, and cranes installed in main UG shop.

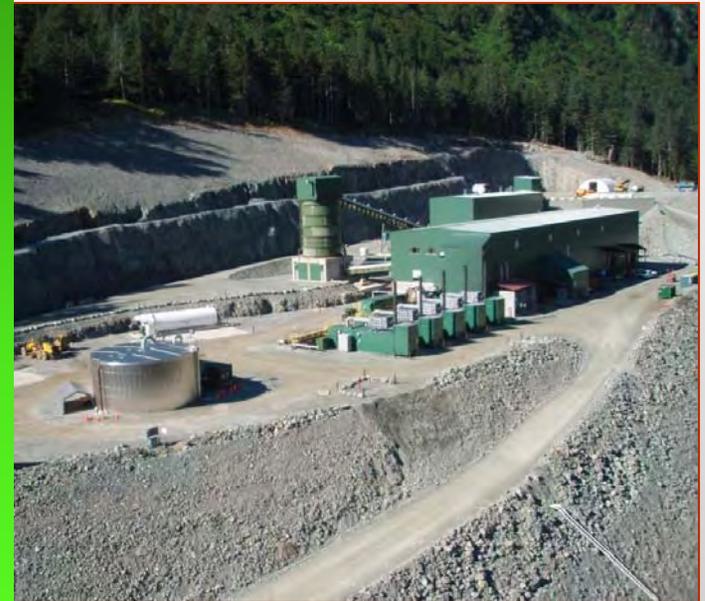
Mill Operations

- Mill Capacity: ~450,500 tpy
- Reserve Grade (diluted): 0.244 opt
- Gold Recovery: 93% - 95%
- Concentrate Produced: ~48 tpd
- Concentrate Grade: ~9 opt

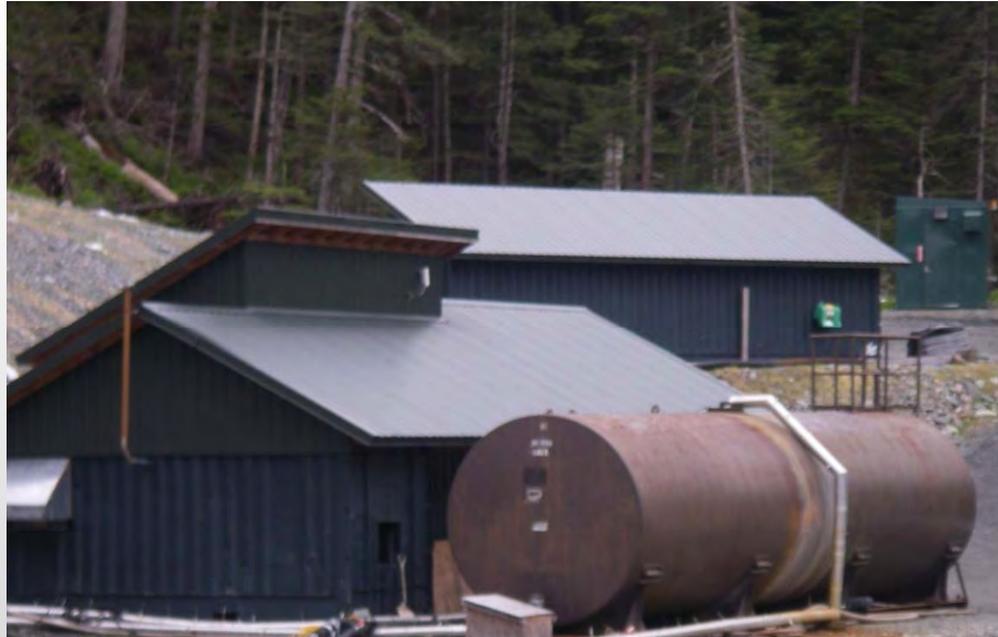
Temporary Package Water Treatment Plant at TTF

- Rotating Cylinder Treatment System (RCTS)
- Lime/Flocculant Addition
- Automated System
- Flows average 5-15 gpm

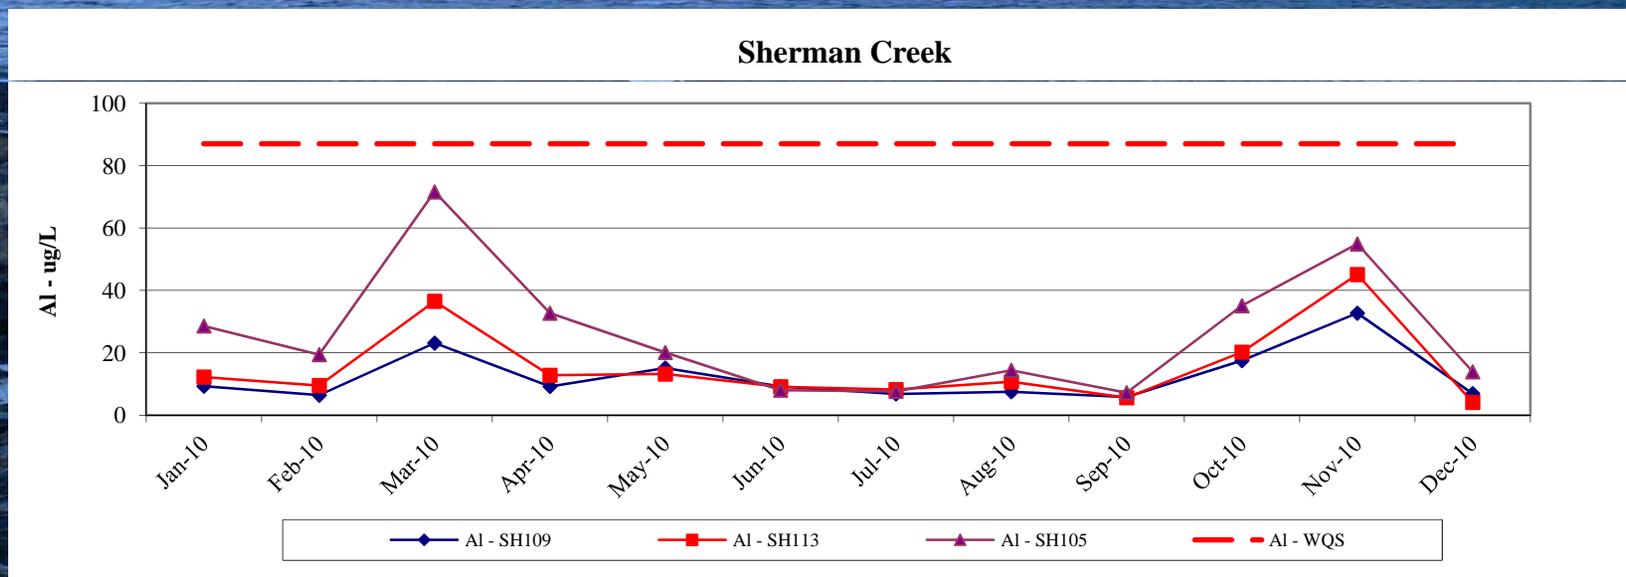
ALUMINUM, Dissolved

Figures from Volume 2: Water Quality 2010 in the NPDES Annual Report

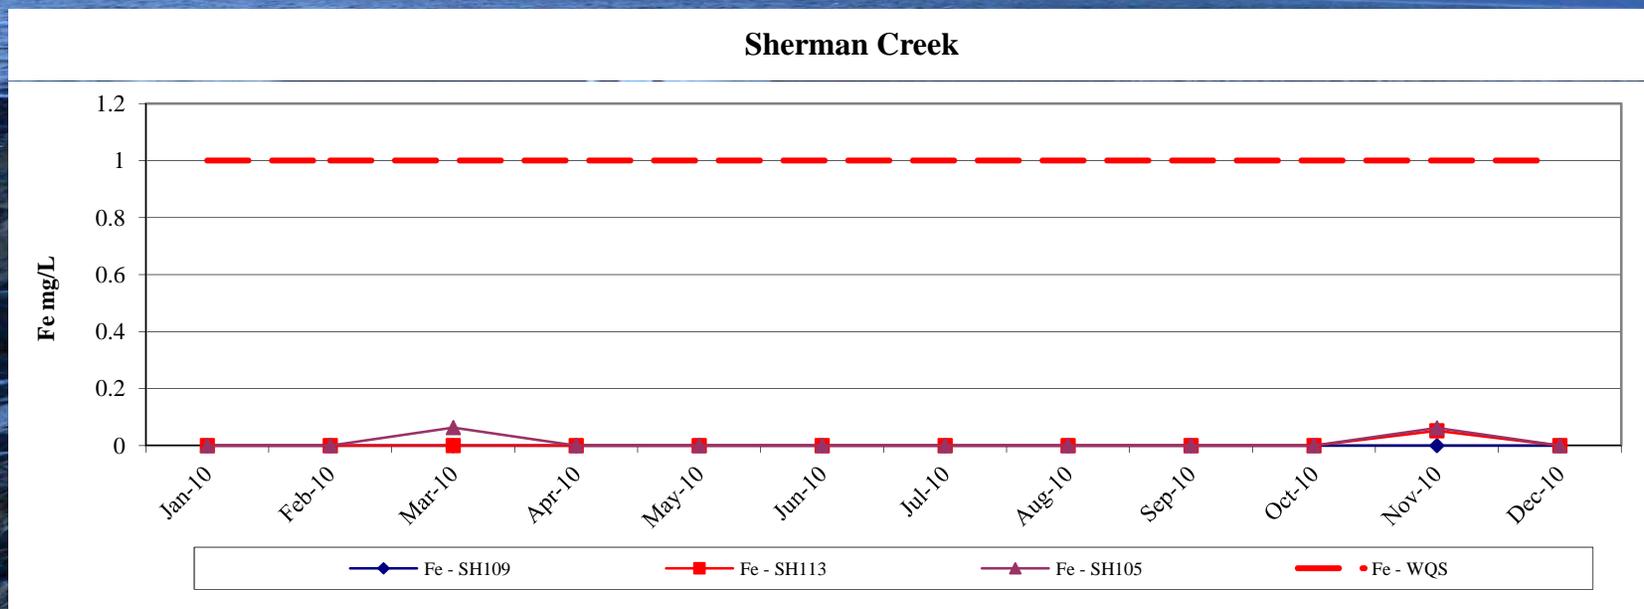
IRON, Dissolved

Figures from Volume 2: Water Quality 2010 in the NPDES Annual Report

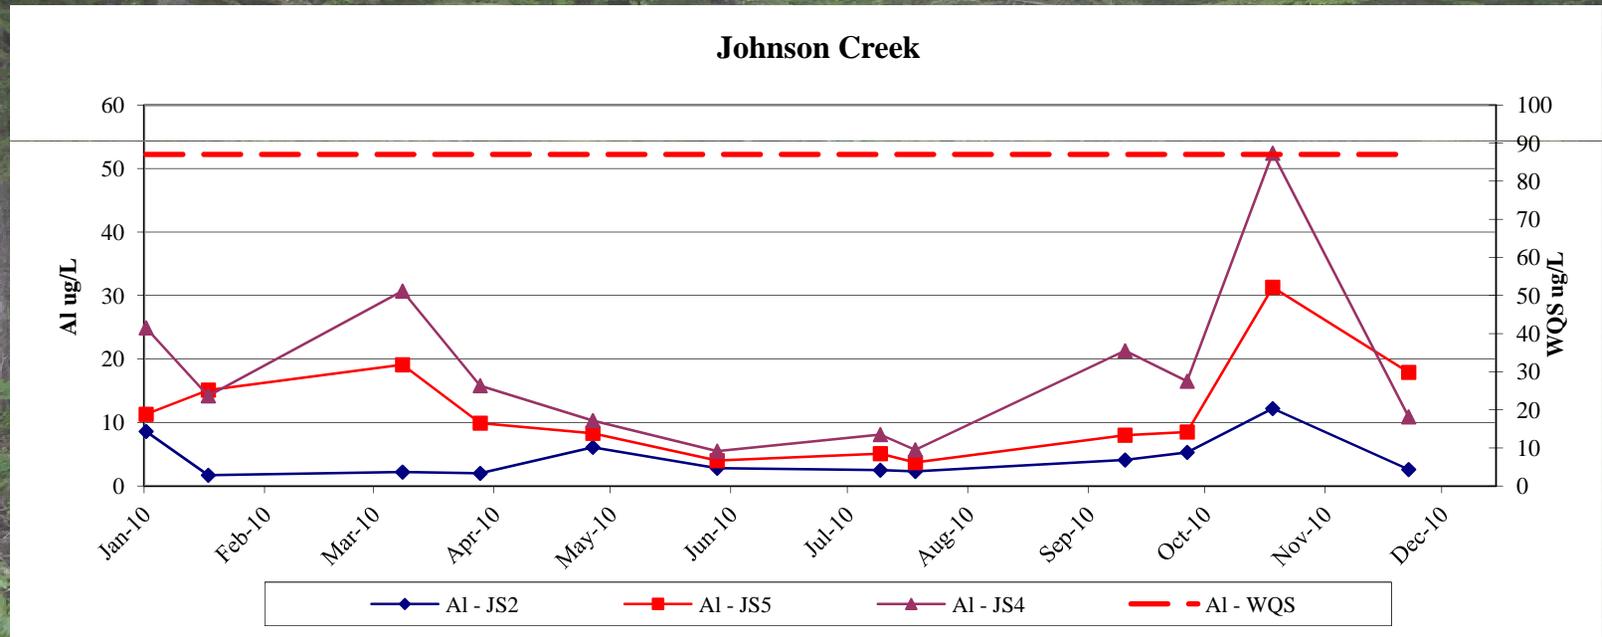
ALUMINUM, Dissolved

Figures from Volume 2: Water Quality 2010 in the NPDES Annual Report

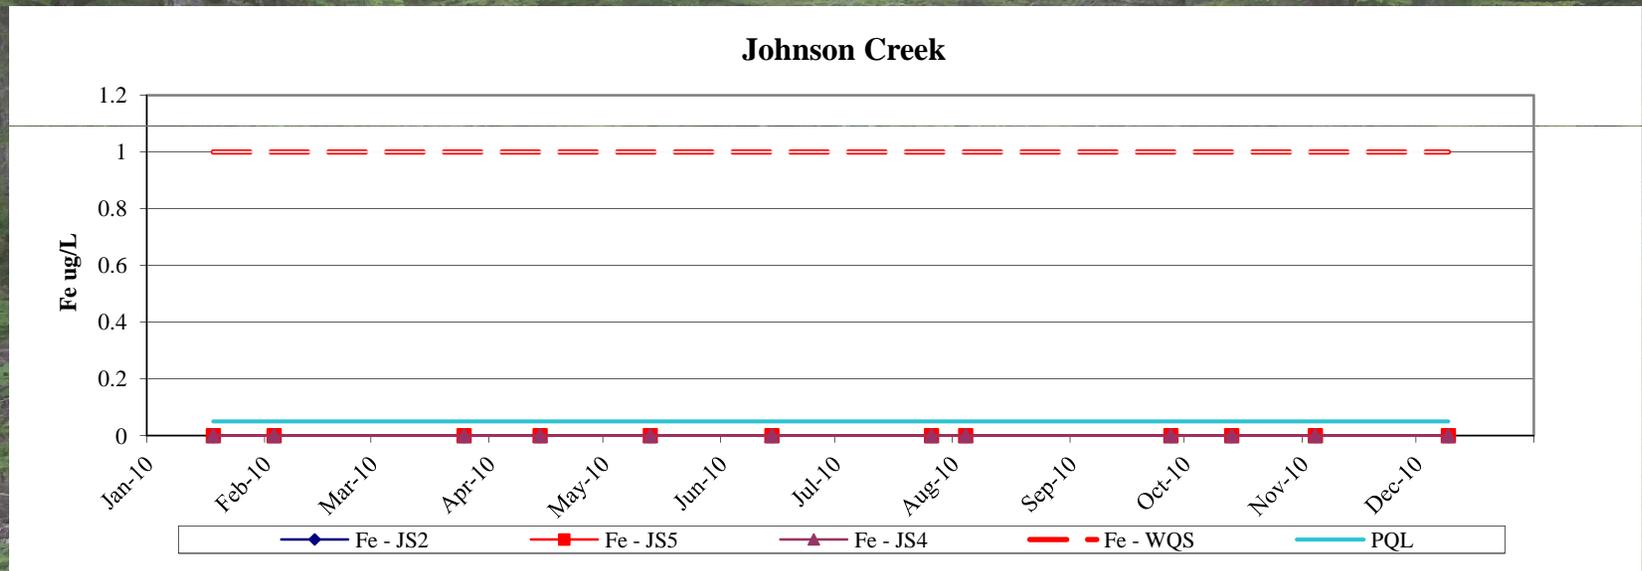
IRON, Dissolved

Figures from Volume 2: Water Quality 2010 in the NPDES Annual Report
