KENSINGTON MINE ANNUAL MEETING for 2010

KENSINGTON GOLD MINE

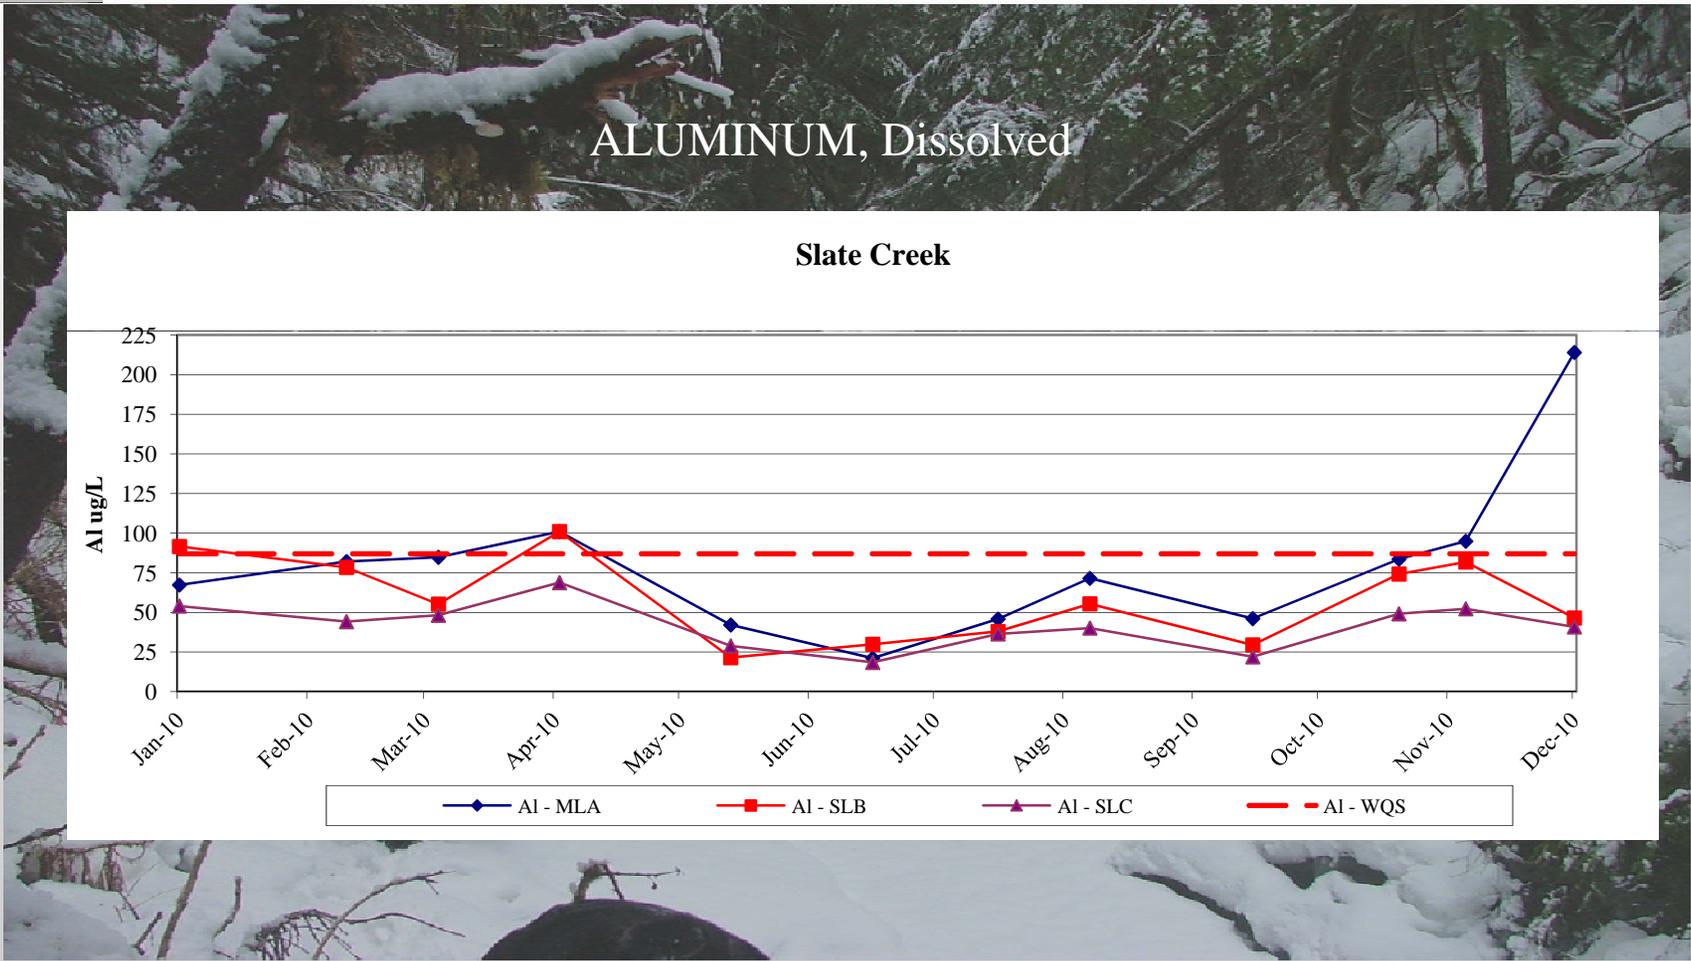
Water Quality – Slate Creek

Figures from Volume 2: Water Quality 2010 in the NPDES Annual Report

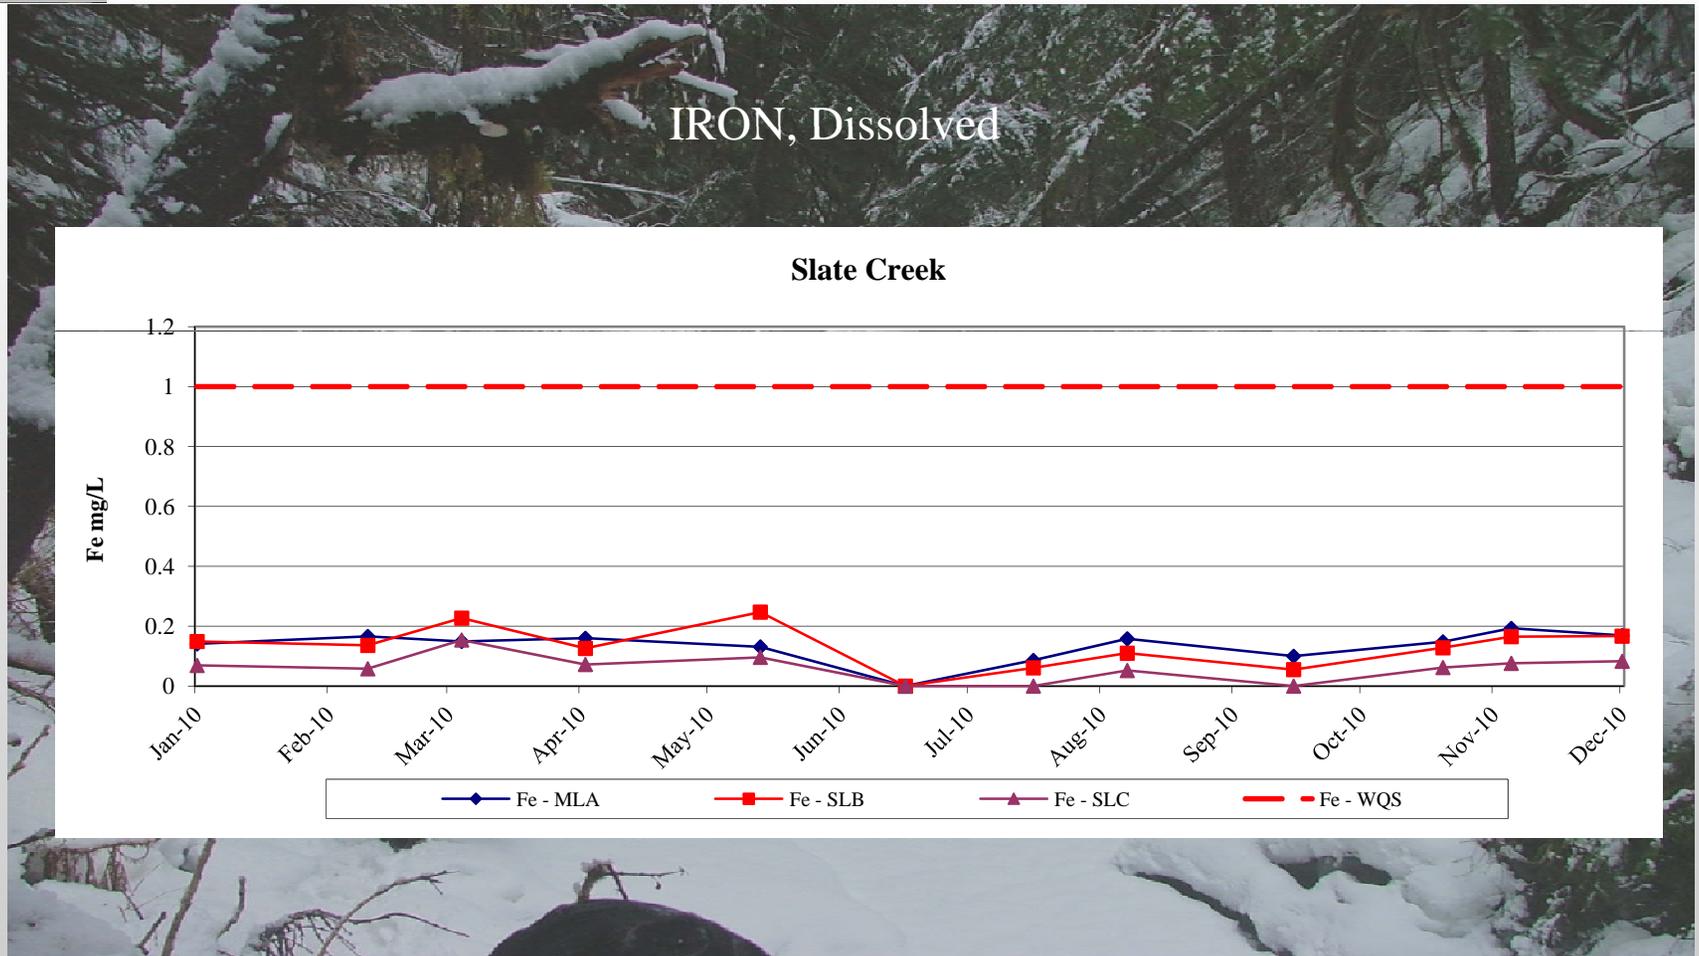
Water Quality – Slate Creek

Figures from Volume 2: Water Quality 2010 in the NPDES Annual Report

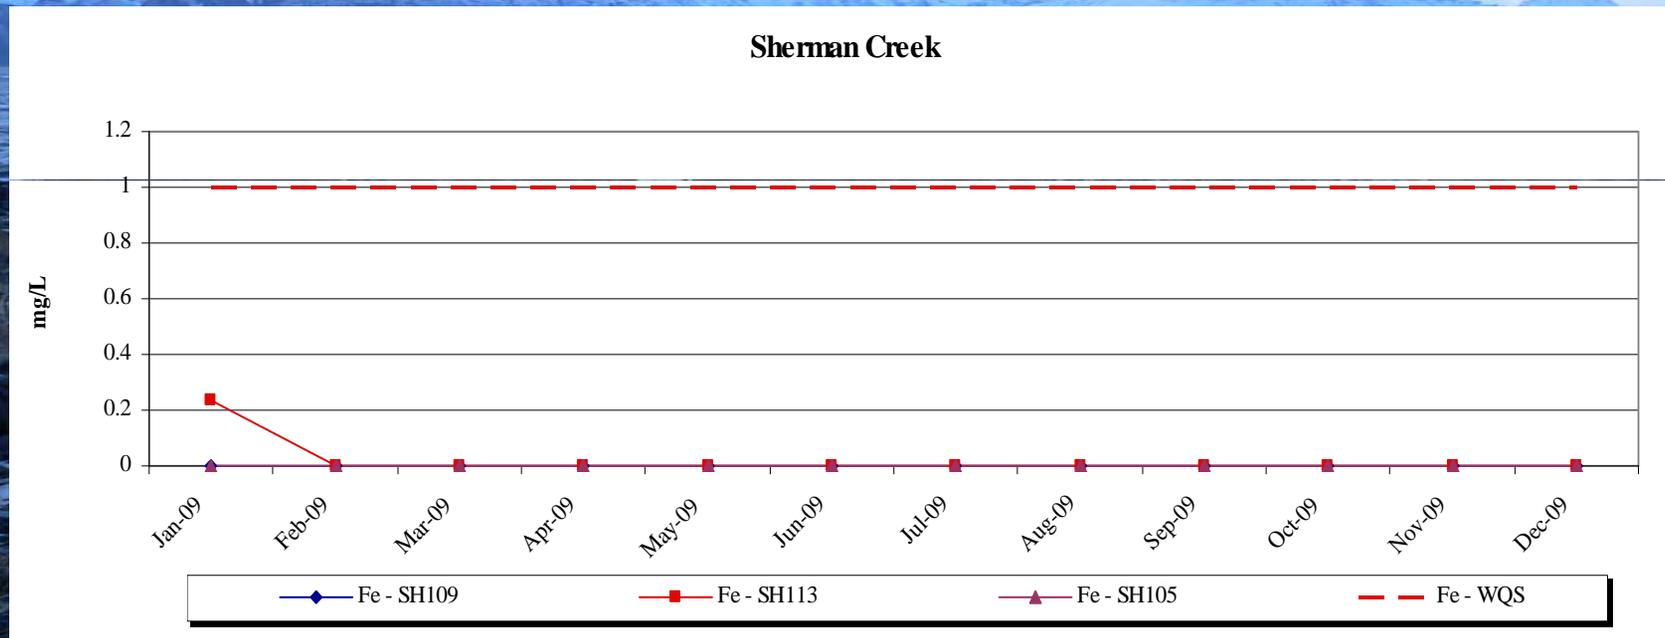
IRON, Dissolved

Figures from Volume 2: Water Quality 2009 in the NPDES Annual Report

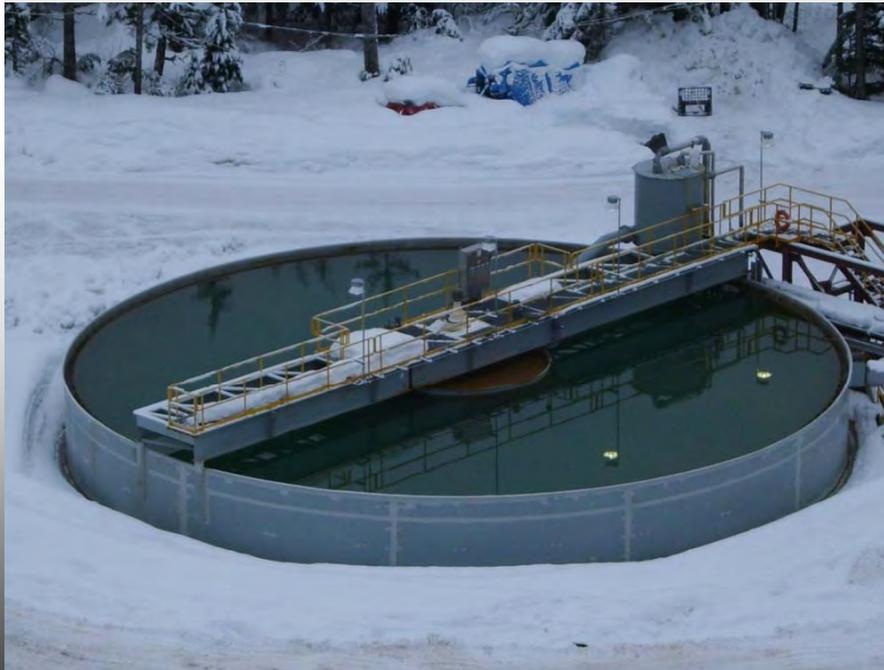
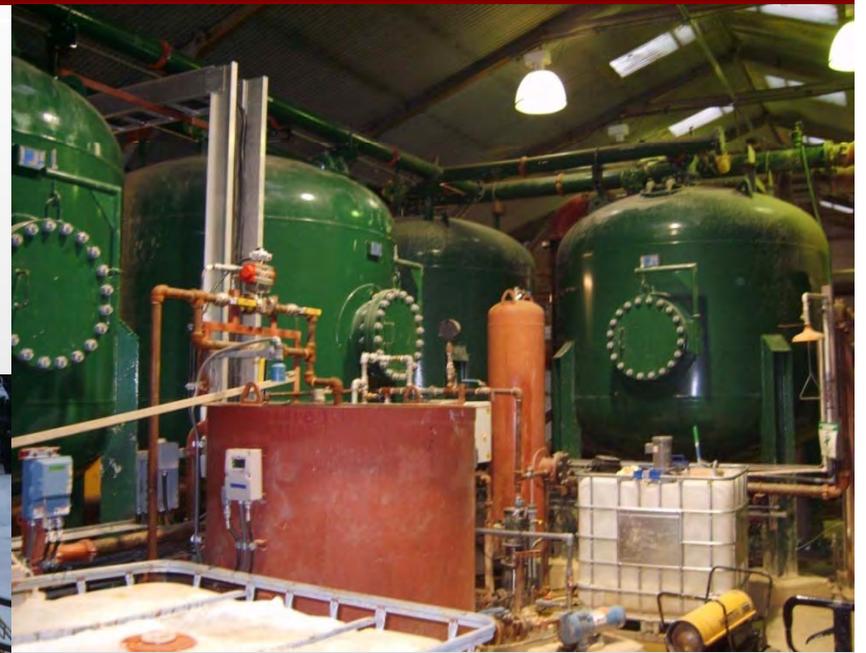
Water Quality- Outfall 001

Mine Water Treatment Plant

On the whole, Outfall 001 effluent discharges...

- Follow seasonal cyclic trends for temperature and dissolved oxygen
- Typically have very low levels of turbidity
- Contain total recoverable metals mostly at or only slightly above detection limits
- Are monitored for constituents that are typically well under permitted limits

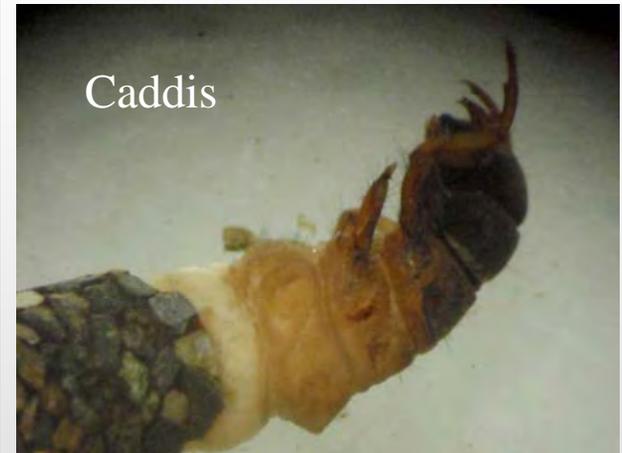
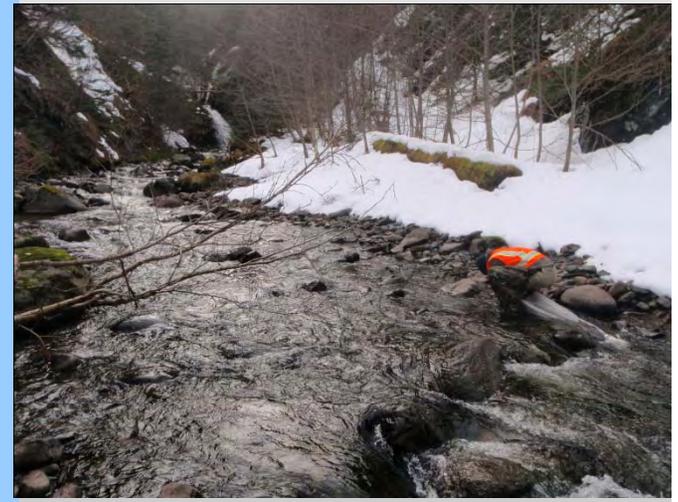
ANNUAL INVERTEBRATE MONITORING

- Samples were collected in March and April of 2010 during construction activity at the TTF. Samples were collected using a fine mesh net with 12x12 inch frame (Surber sampler) from two reaches of Lower Sherman and Lower Sweeny and one reach near Middle Slate and Middle Johnson.

- The number of EPT taxa, Ephemeroptera (mayflies), Plecoptera (stoneflies) and Trichoptera (caddis flies), was examined as these groups are the most sensitive to pollution.

- The mean number of taxa (20.7) was significantly higher in Johnson Creek than all other sites.
- Total number of taxa in all streams was similar to previous years.

- Densities in Johnson Creek were significantly higher than all other sites except Reach 1 of Sherman at 4800 invertebrates per m².
- Diversity was highest at Johnson Creek and lowest at Sherman and Sweeny Creek in 2010. Sherman and Sweeny Creeks both had lower diversity due to high numbers of a few dominant species.

- Slate had similar numbers EPT taxa as 2007 and 2008, though lower than 2005, 2006, and 2009.

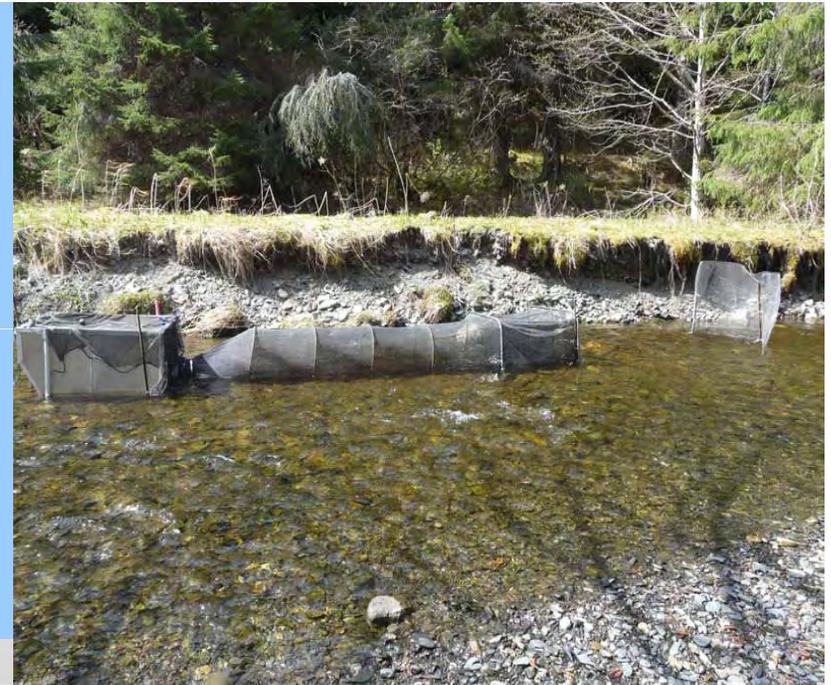
Slate Creek Fyke Net and debris trap

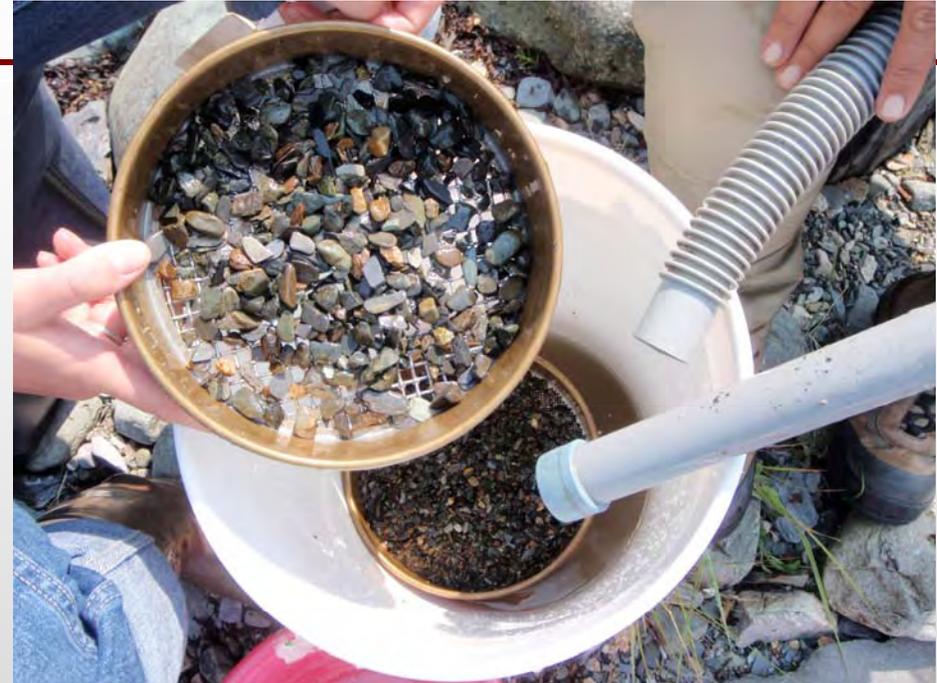
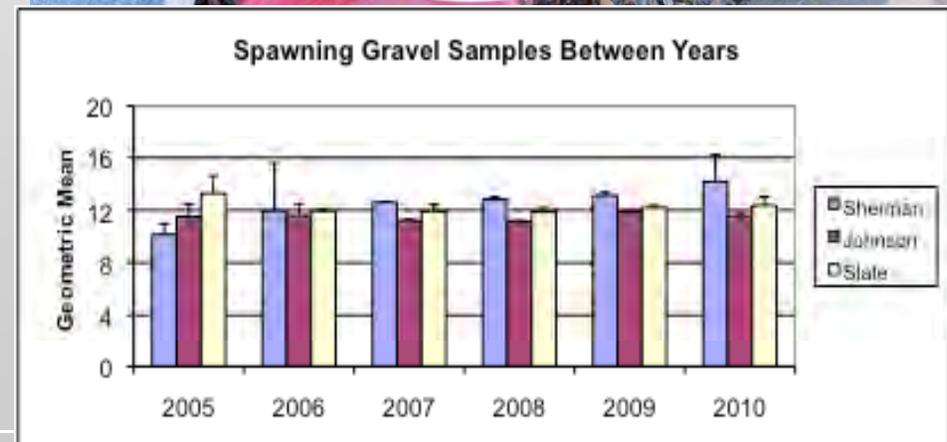
ANALYSIS of SPAWNING SUBSTRATE

- At each stream, core samples of spawning gravel are passed through sieves to separate into size classes. The volume of gravel in each size class is measured using water displacement. Fine material is measured using Imhoff cones.
- Fine sediment can affect oxygen transport to incubating embryos within the gravel. The coarser the material the higher the survival of salmon embryos. The higher the geometric mean, the better survival of salmon embryos.
- Geometric Mean was similar to previous years indicating little change in spawning gravel quality over time
- Sherman and Slate had similar gravel composition, while Johnson had smaller gravel.

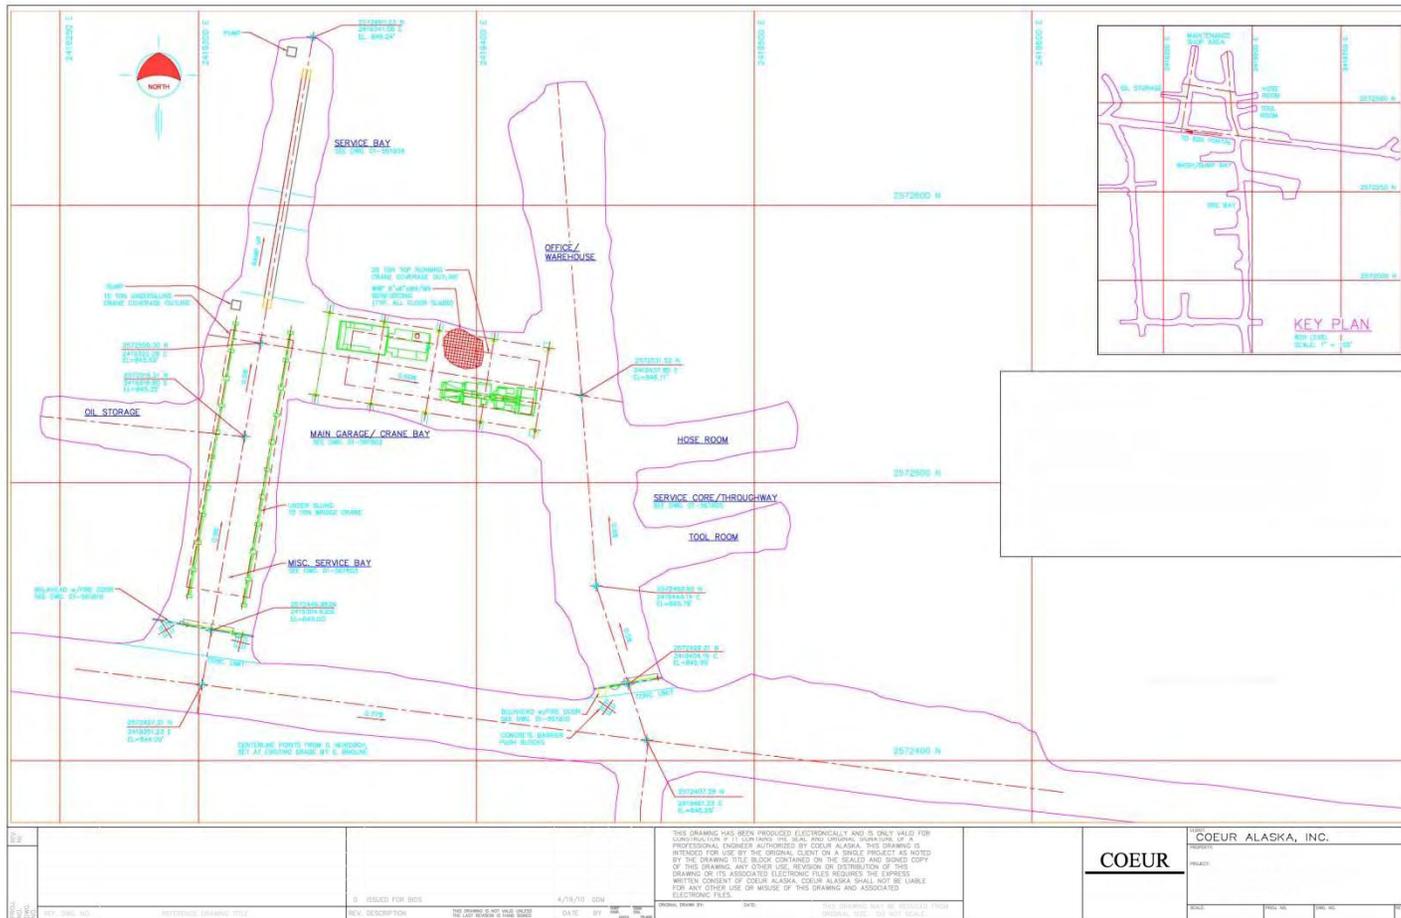
850 Level Maintenance Facility

18,000 ft² of workshop, service, and warehouse space. 25 and 10 ton cranes.

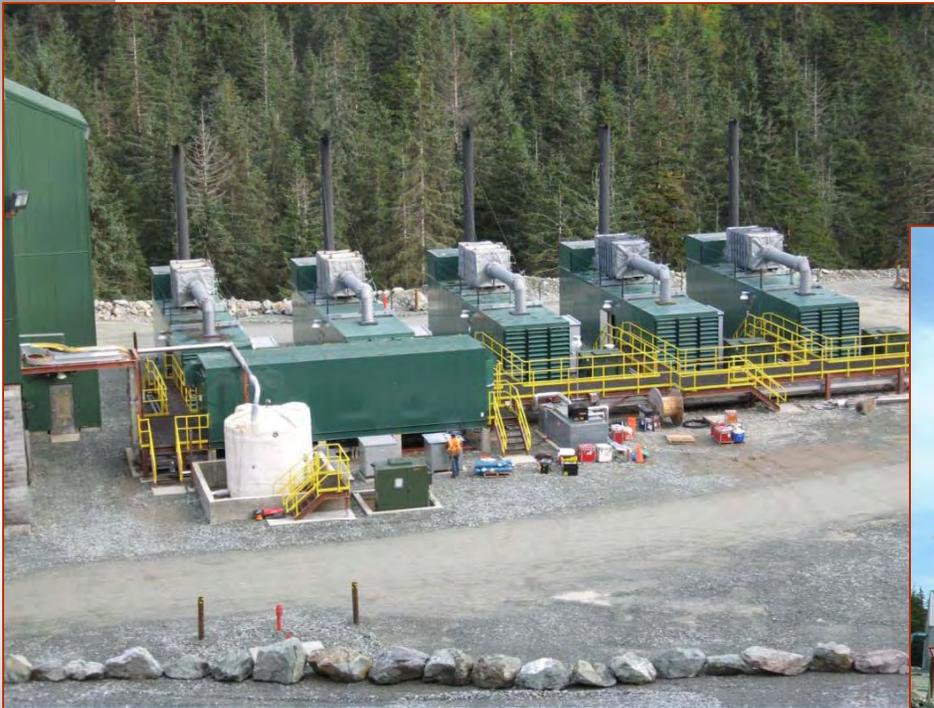
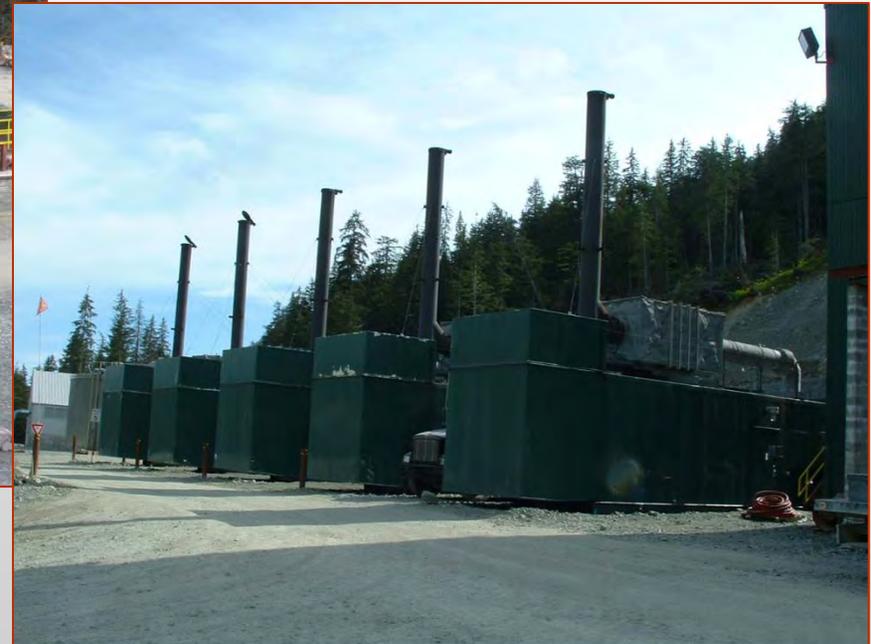
Power Generation

Five Independent, 1.75Mw (each) Diesel Powered Generators;
with a sixth gen-set being commissioned in June of 2011.

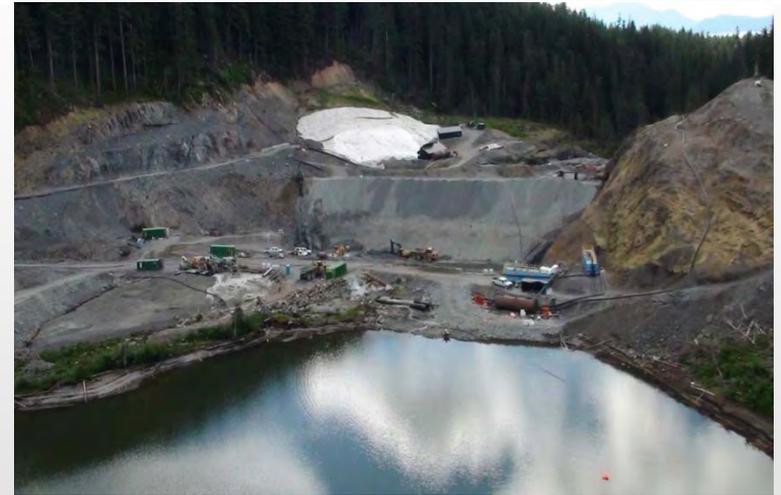
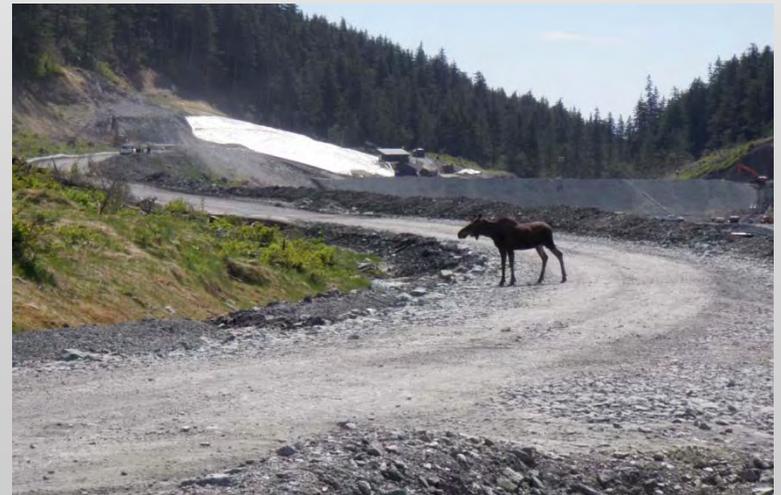
Tailings Treatment Facility

- Finalize Emergency Action Plan, Construction Reports, Geotechnical Reports, Operation & Maintenance Manual
- Construct Liner Protection System (log/pipe boom)
- Upgrade Reclaim Barge and Access

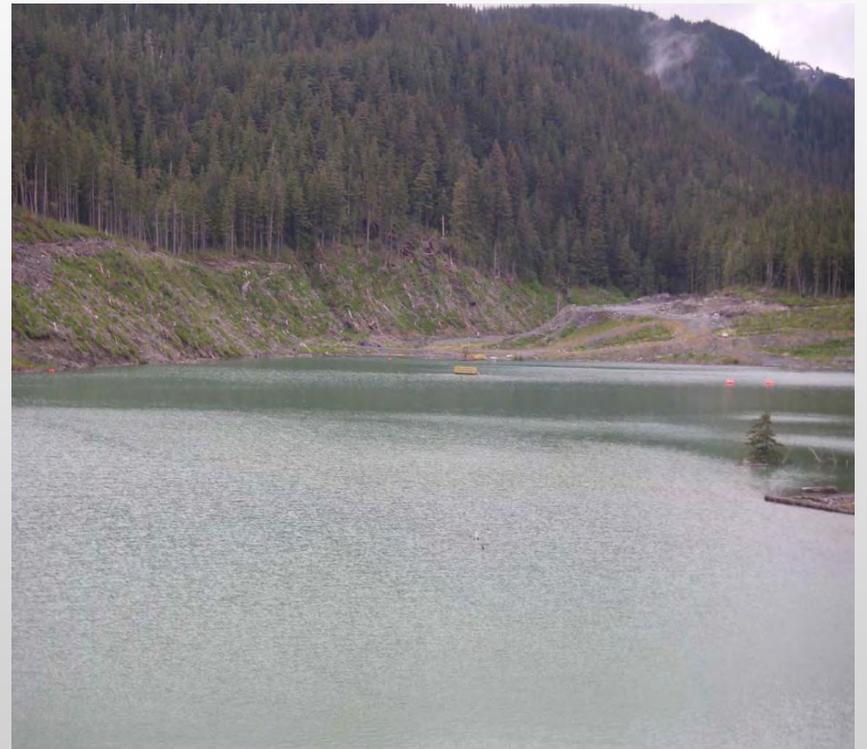
Tailings Treatment Facility

- Tailings Line Discharge Upgrade (bubbler system)
- 3rd Party Inspection of Facility
- On-going Monitoring of Facility
- Possible Kick-Off Design and Permitting of Phase 2 Embankment

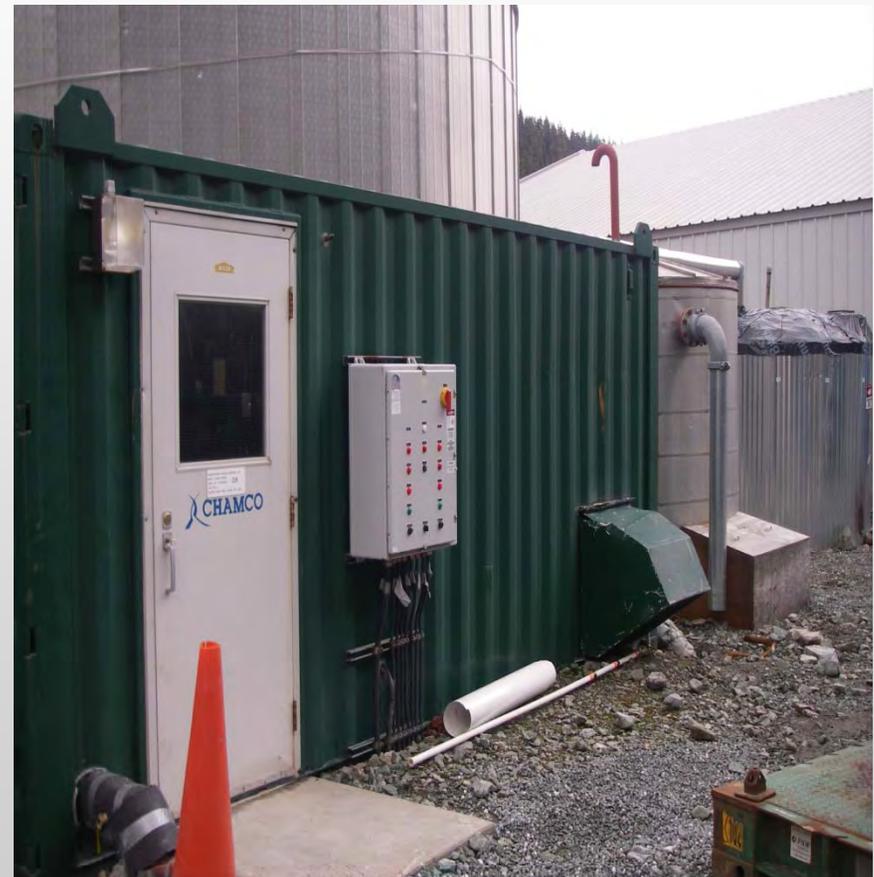
Potable Water System

- Expand Capacity of Treatment Plant from 6 gpm to 14 gpm
- Add additional storage tanks. (5000 gal to 11,000 gal.)
- Expand Influent pump
