Kensington Gold Project 2008 Annual Report

Prepared by:
Coeur Alaska, Inc.
3031 Clinton Drive, Suite 202
Juneau, AK 99801

February 2009

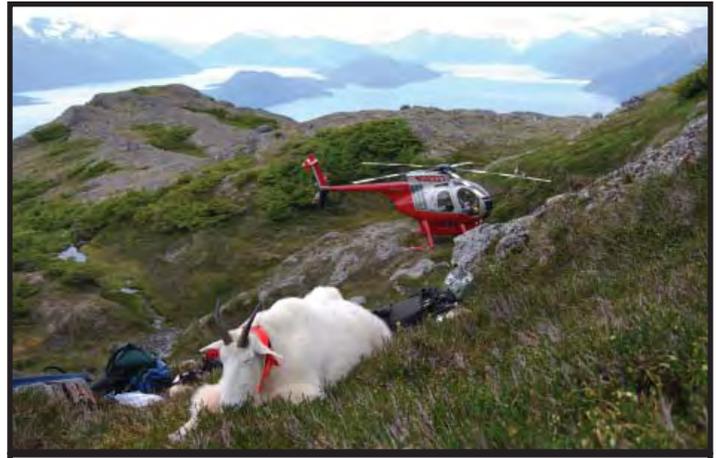
Figure 1: Mountain goat capture site near Mt. Selby. Photo shows LG101 (5 yr-old male) and HD500 helicopter. Orange colored GPS radio-collar and red ear tags, used for monitoring purposes and identification during aerial surveys, are also visible.

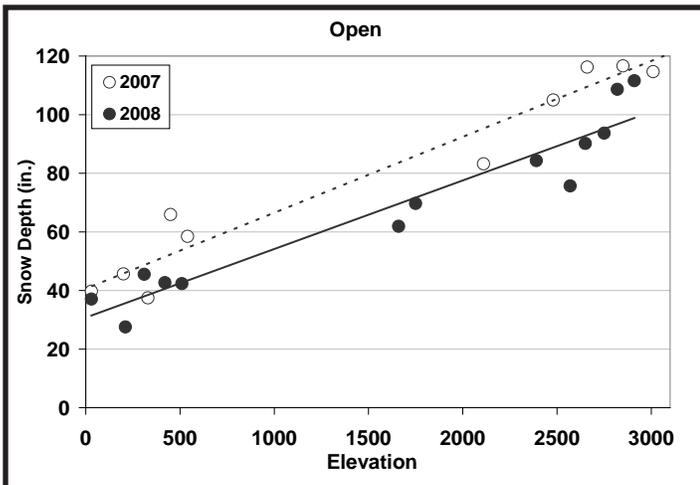
Figure 8: Relationship between snow depth and elevation in non-forested sites in late-March 2007 and 2008. Snow depth was about 10 inches less in 2008 than in 2007. Data were collected on Echo Ridge, AK.

Snow Surveys.—Field-based snow surveys were conducted during March 31, 2008 on Echo Ridge. This survey was conducted within 3 days of an identical survey conducted in 2007. Preliminary analyses of these data quantified the degree to which snow depth differs with increasing elevation between forested and non-forested sites (White et al.

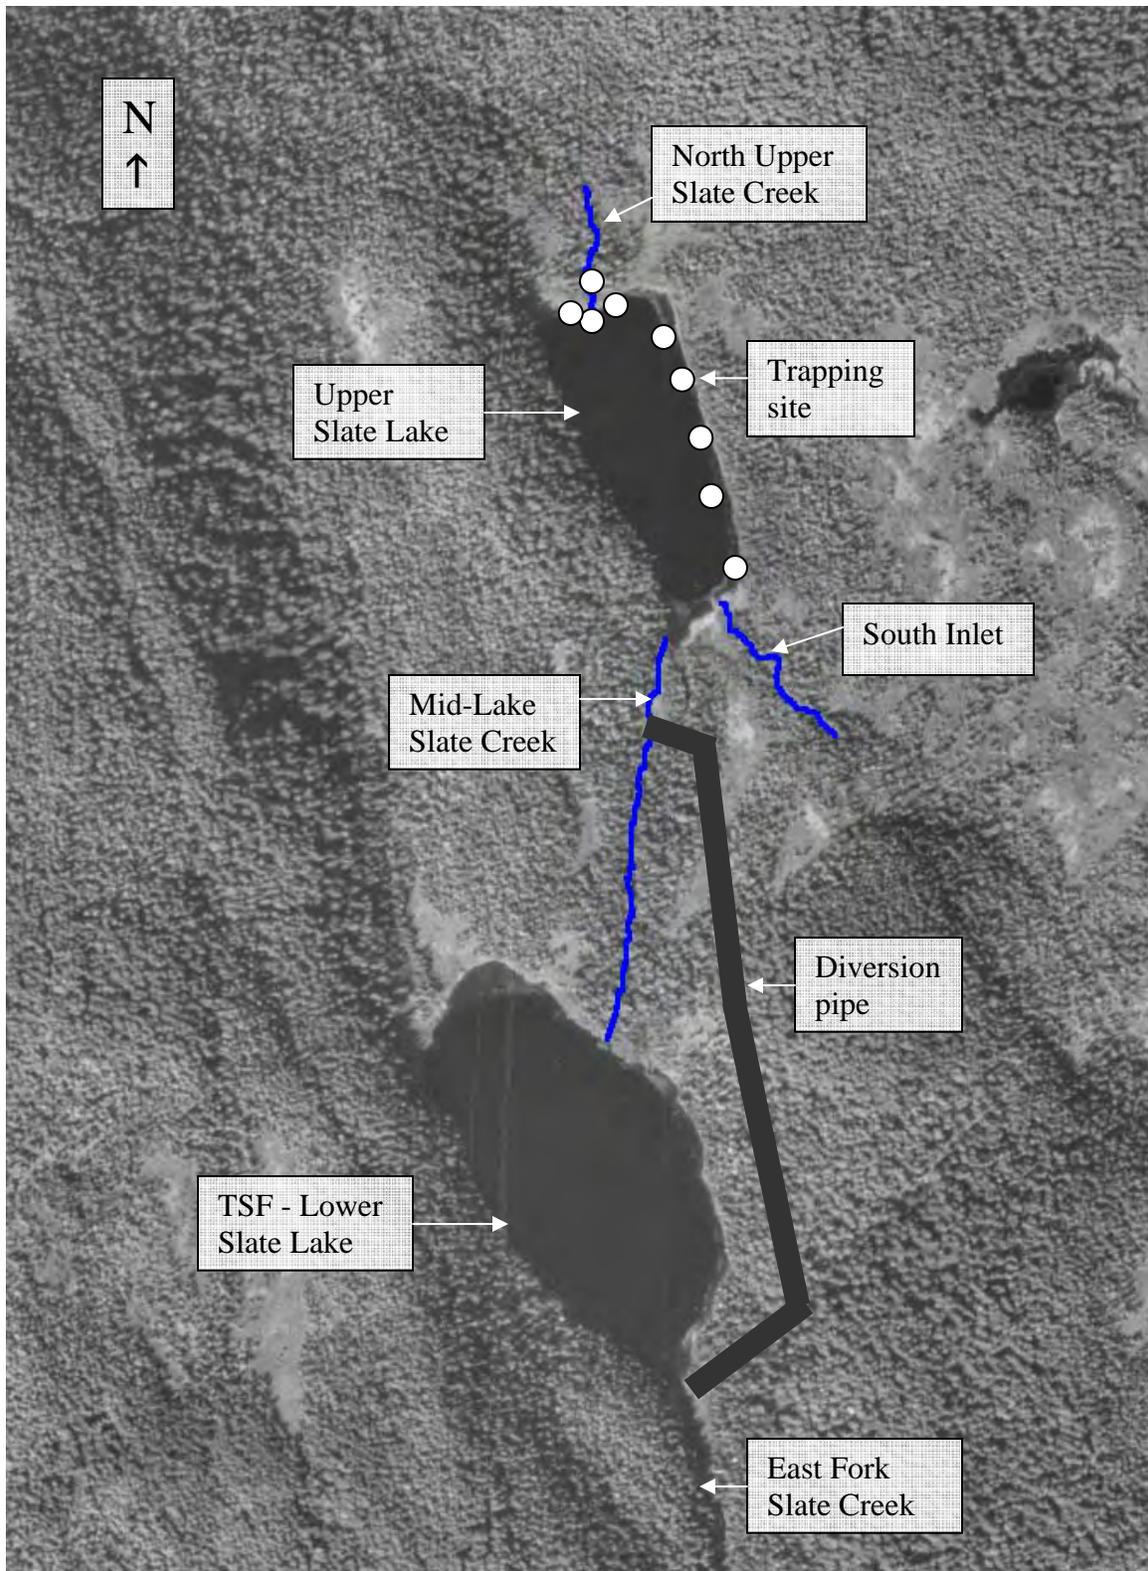
Figure 1: Upper Slate Aerial View. Mid-Lake Slate Creek is now diverted around the TSF through a pipe. Trapping sites for spawner surveys are shown by white circles.

Mid-Lake Slate Creek (MLSC) runs from Upper Slate Lake (USL) to Lower Slate Lake (LSL), however, water was diverted from the creek around LSL in 2006 to reduce the lake water level prior to dam construction. The creek begins at elevation 200m at Lower Slate Lake (LSL) and rises to 226m at Upper Slate Lake (Figure 3). The original creek was dominated by riffle and cascade habitat with few pools. The creek was 468m long prior to road construction in 2006, with a natural barrier to upstream fish migration at approximately 215m from LSL (Figure 4). Figures 5, 6 and 8 show how the stream looked prior to restoration, while Figures 7, 9 and 11 show the restored channel.

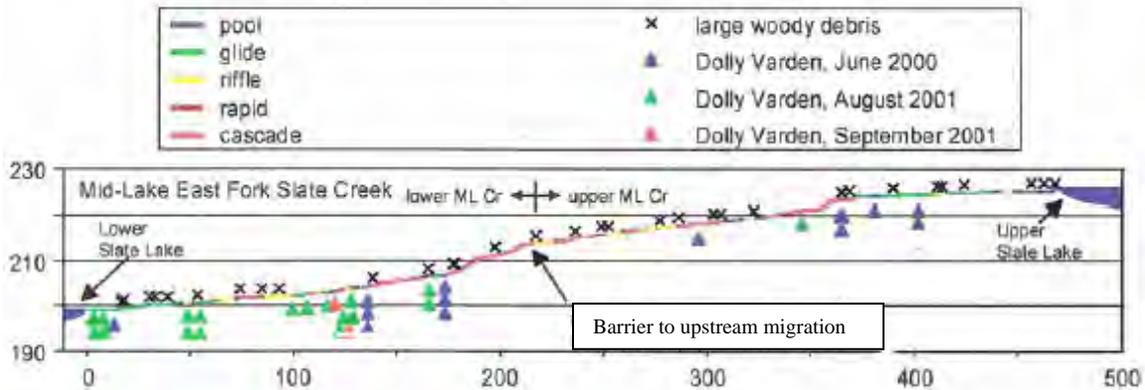
Figure 3: Profile of Mid-Lake Slate Creek. Earthworks Technology 2002.

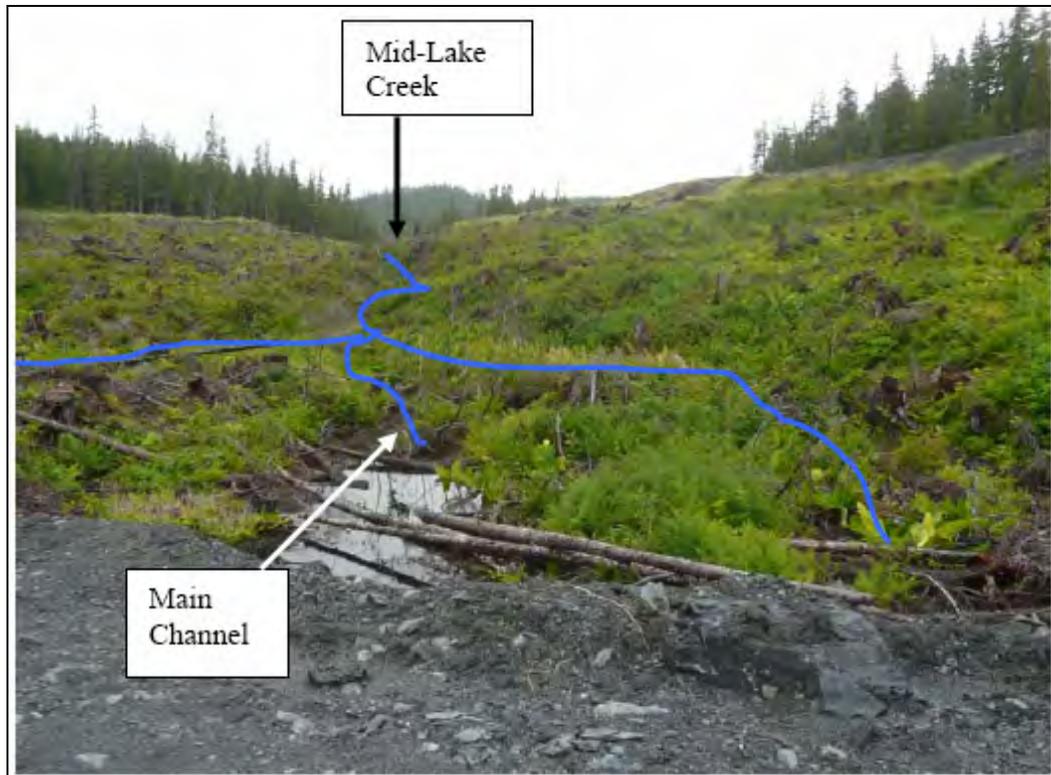
Figure 6: Before restoration the creek split into three channels.

The creek had been filled with slash from logging activities which diverted water into three channels at the lower end of the creek (Figure 6). All cut logs were removed to allow water to concentrate in the main channel. The original channel bed was dominated by bedrock and easily identified. Large boulders from the diversion intake were used to redirect water into the main channel near the lower end of the creek (Figure 6). Uncut woody debris was left in place to help maintain pool habitat such as that in Figure 5.

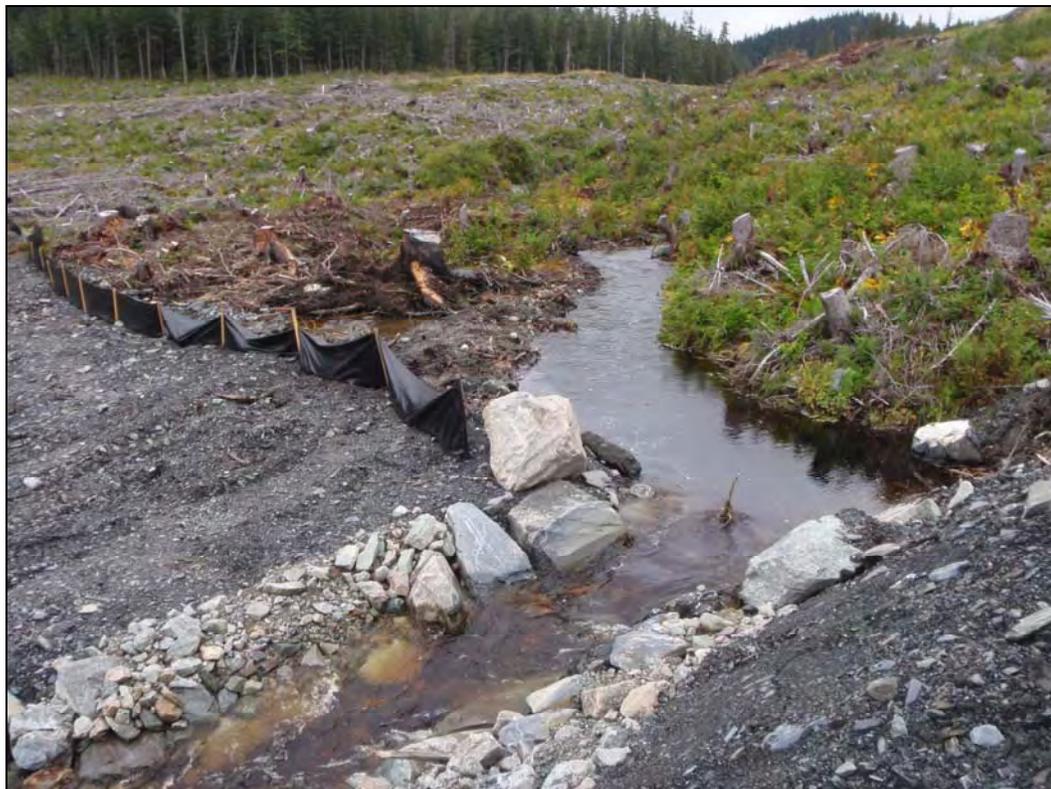
Figure 7: The creek restored to a single channel and slash cleaned out.

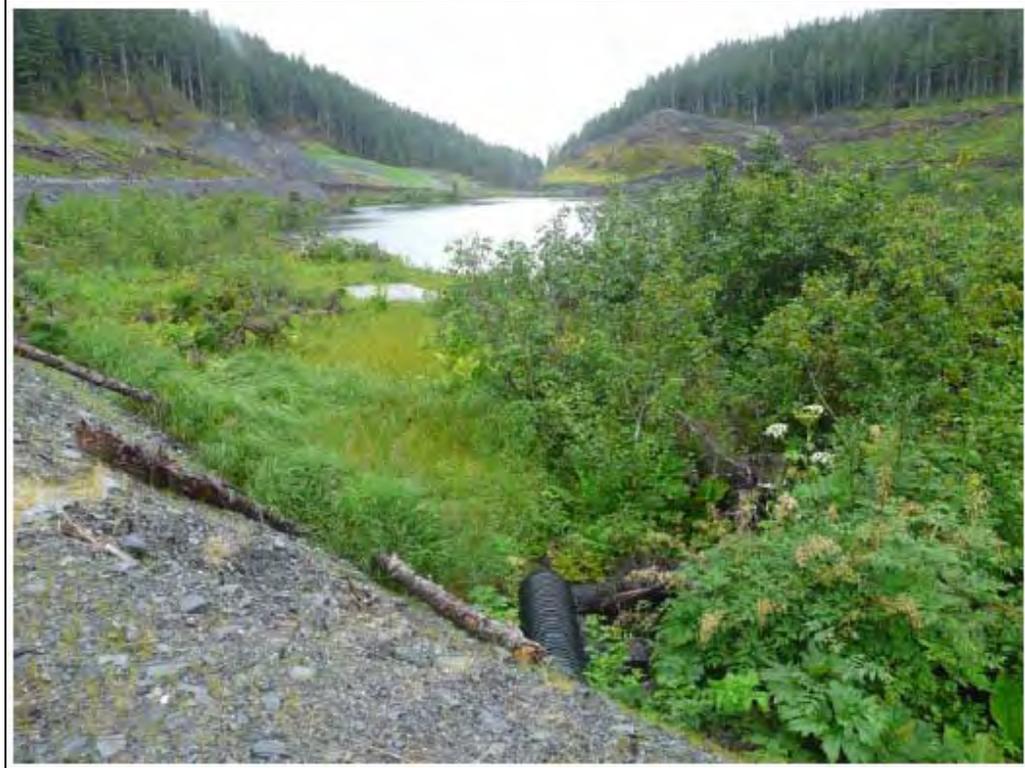
Figure 8: Culverts at the lower end had a damming effect on the creek.

A roadway constructed at the lower end of the creek had resulted in a near vertical drop of approximately 8ft from the creek into Lower Slate Lake. In addition, culverts at the lower end of the creek, installed after water was diverted, appeared to be having a damming effect on the creek and were situated too high above the lake for safe fish passage downstream (Figure 8). The roadway across the lower end of the creek was breached at the main stream channel and the roadway reshaped to a gradual slope down to the lake shore (Figure 9). This eliminated the need for culverts and their damming effect on the creek, as well as the vertical drop into the lake.

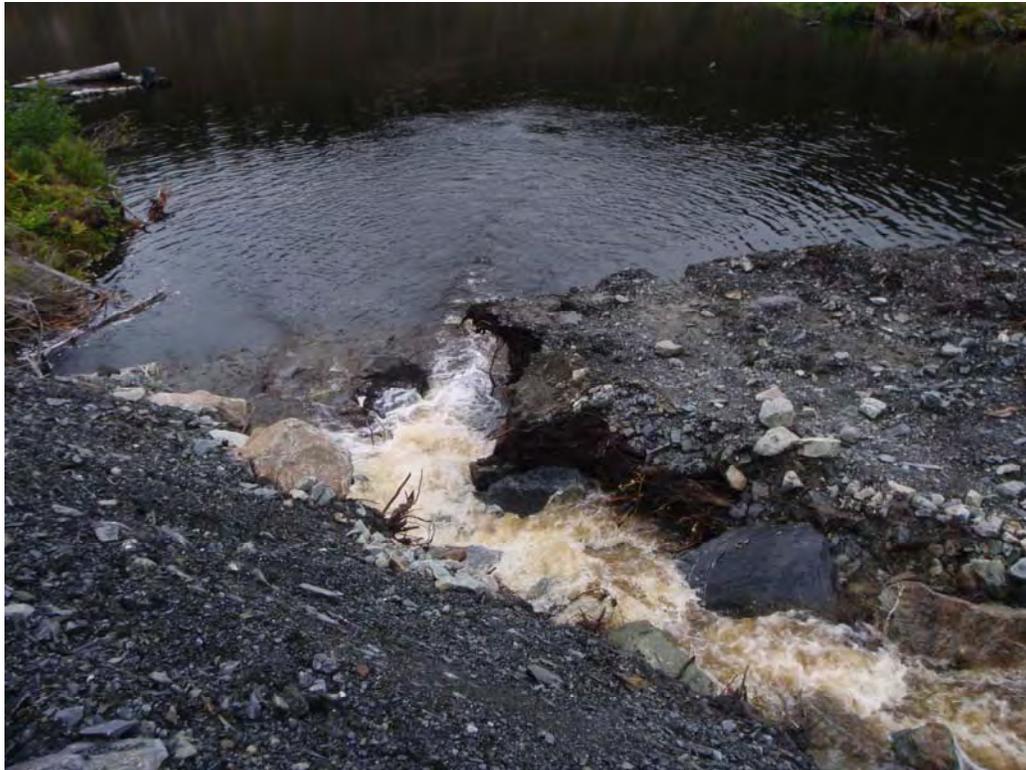
Figure 9: The restored channel has a gradual descent; culverts eliminated.

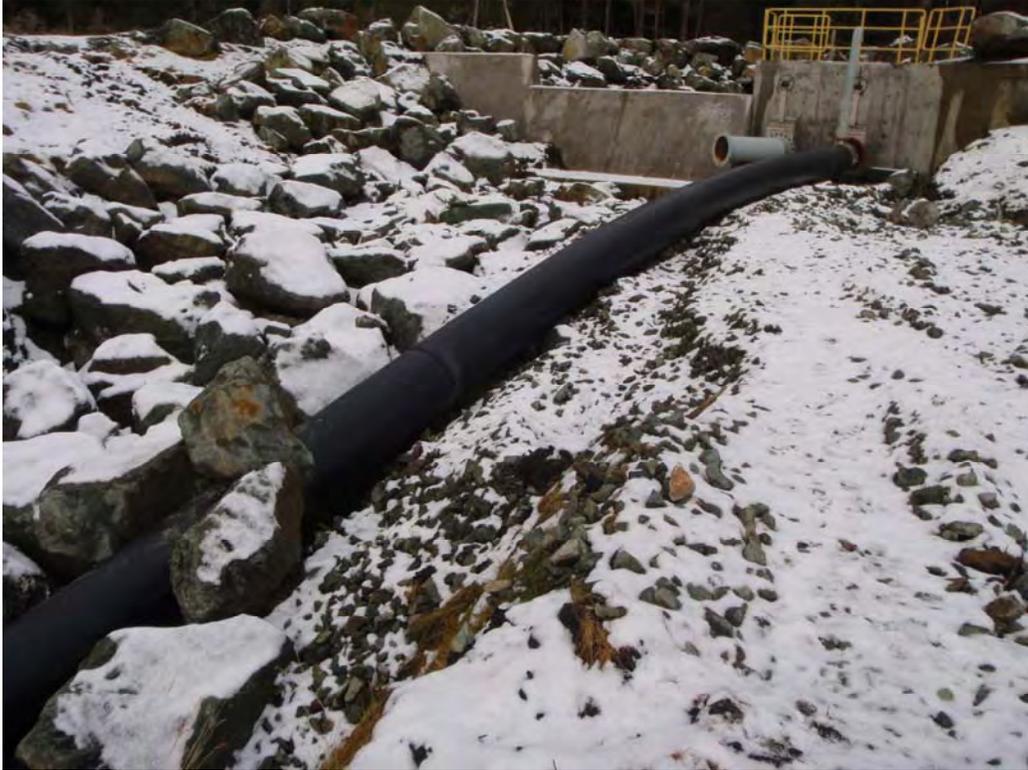
Figure 10: The penstock was extended past the boulder field.

The penstock from Upper Slate Lake was originally positioned 2.5ft above the entry plunge pool to the creek, which had a depth of 2.5 to 3ft. The recommended ratio for fish passage is 1:2 for drop height versus pool depth. The pipe was lowered by removal of material underneath it and the pool level was raised closer to the pipe by additional of material to the creek (Figure 11). The pipe drop was 1.02 ft and pool depth was 2.61 ft deep when measured on November 24, 2008, at which time the creek was declared suitable for downstream passage of fish. No minnow trap surveys have been conducted yet to determine fish passage down the creek. No fish were transported around the lake by hand in 2008. A large number of Dolly Varden were trapped and measured at Upper Slate Lake during spawning surveys.

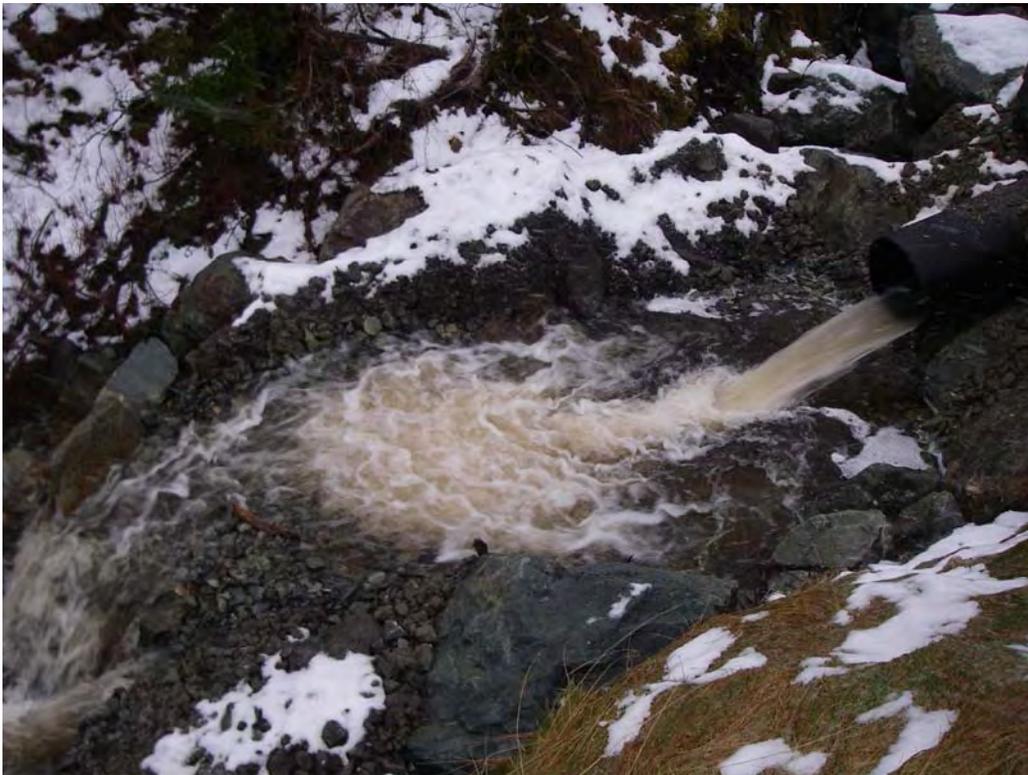
Figure 11: The pipe drop to pool depth ratio is 1:2.6ft.

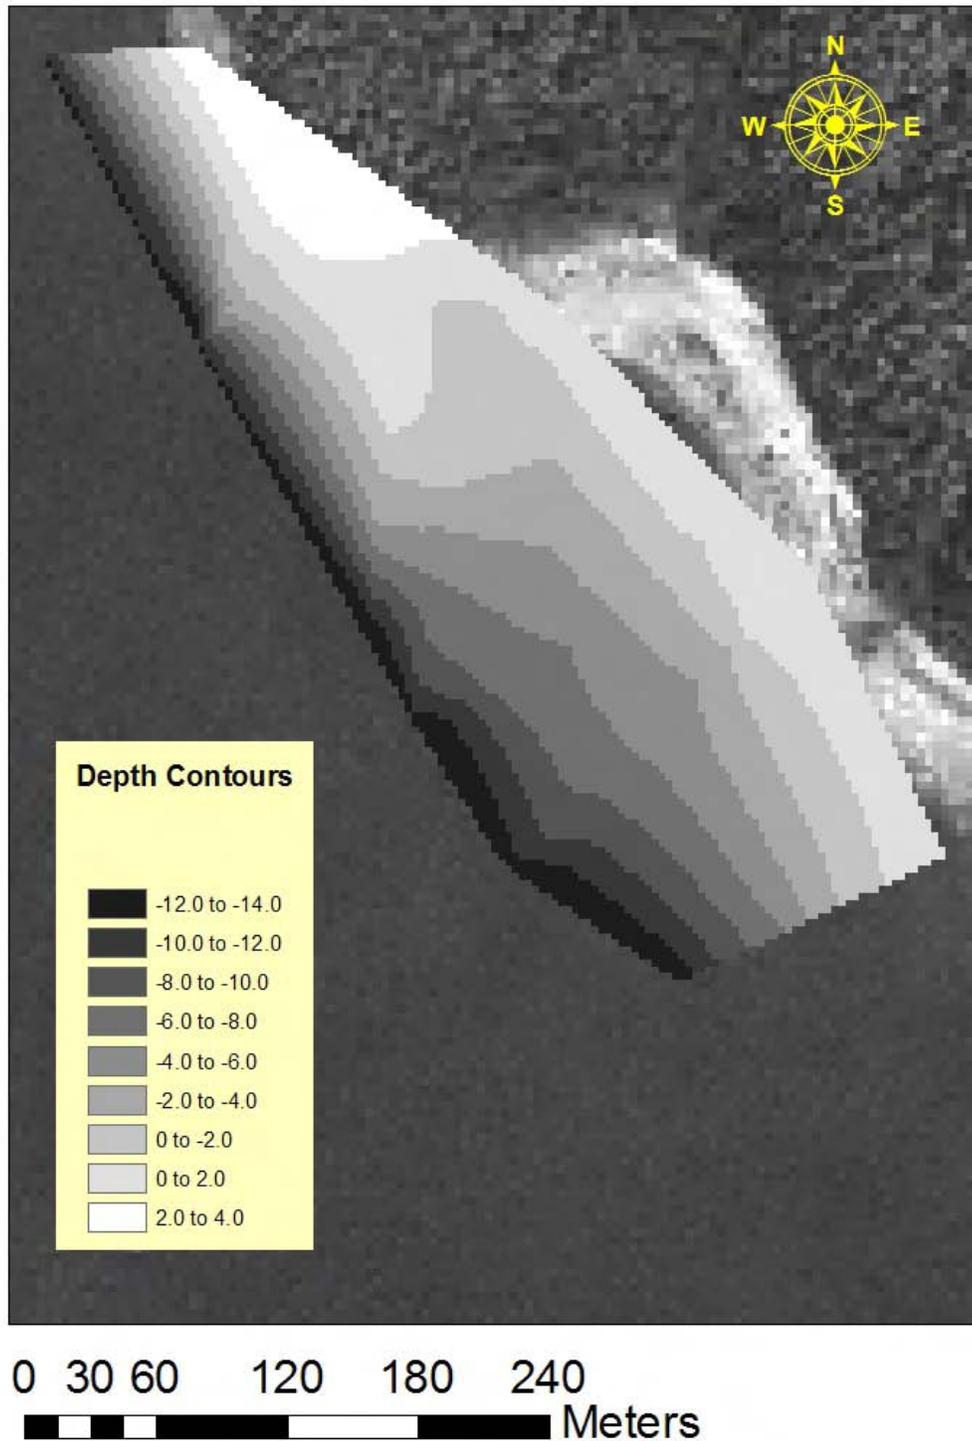
Figure 5.—Study area depth contours observed at Cascade Point during the 2005 and 2006 habitat surveys.

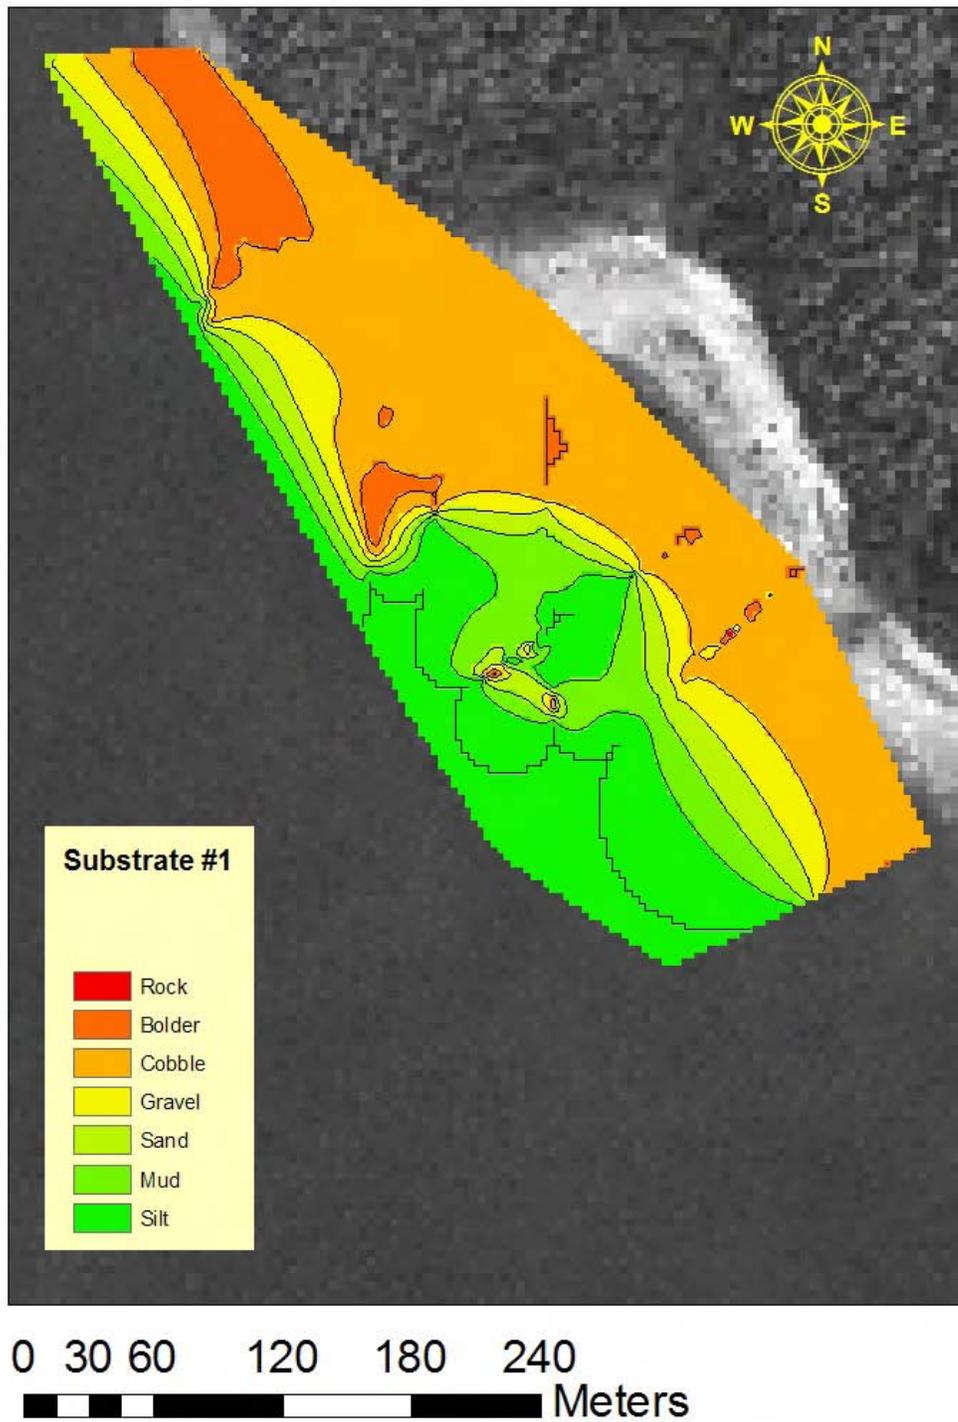
Figure 6.—Primary substrate distribution observed during 2005 and 2006 habitat surveys at Cascade Point.
