Niblack Property Prince of Wales Island, Alaska

Eelgrass Survey

March 2007

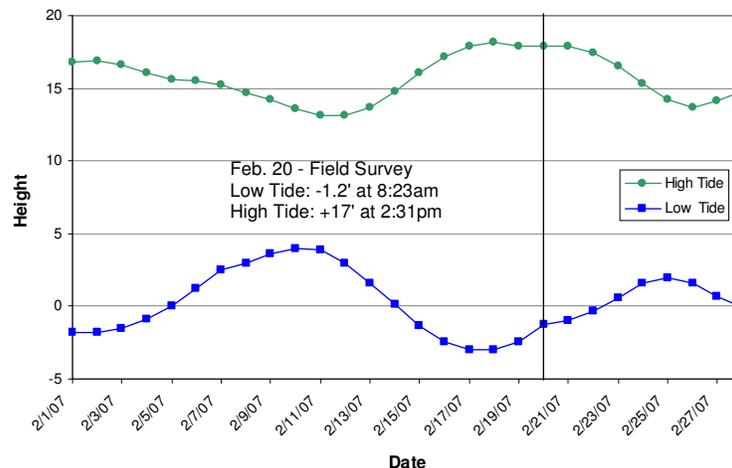
Figure 1. February 2007 NOAA Tide Predictions: Ketchikan¹

The survey was completed during a low tide event (1.2 feet (ft) below sea level (bsl) at 8:23am) on February 20, 2007 (Figure 1). February's tidal cycle is included above to show the average tide range for the area. The survey started at 7:53am and lasted approximately four hours. Weather and field conditions were favorable during the survey. An overcast sky with occasional clear periods was present during most of the survey. No wind was present and the water surface was flat. A light rain fell for approximately 10 minutes near the end of the survey.

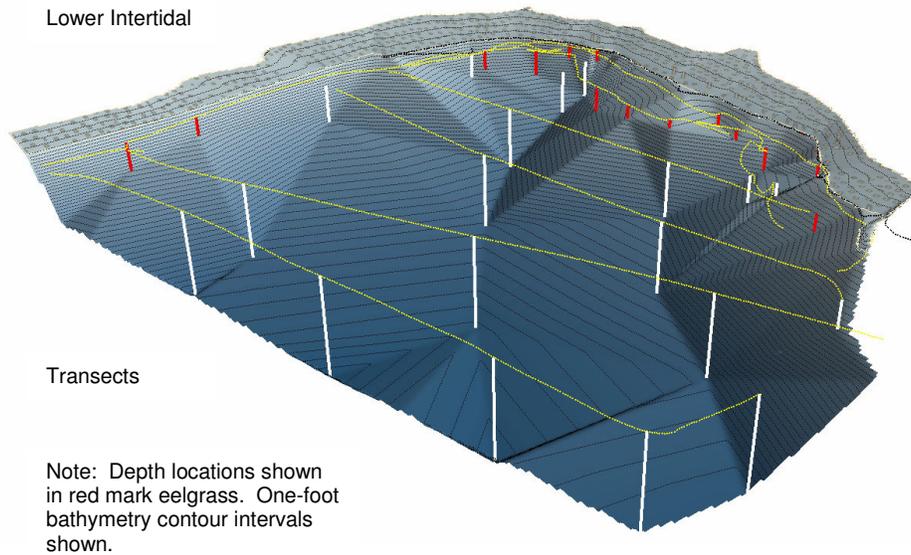
Figure 2. Bathymetry Model of Survey Area

Since a bathymetry layer was not available for the surveyed area, an estimate of water depths was collected by logging point locations into the GPS and noting the depths of each point using a commercial-grade depth finder on the skiff. This depth information was entered into a geographic information system (GIS) database where a surface model was interpolated to obtain estimated bathymetry contours for the study area (Figure 2).

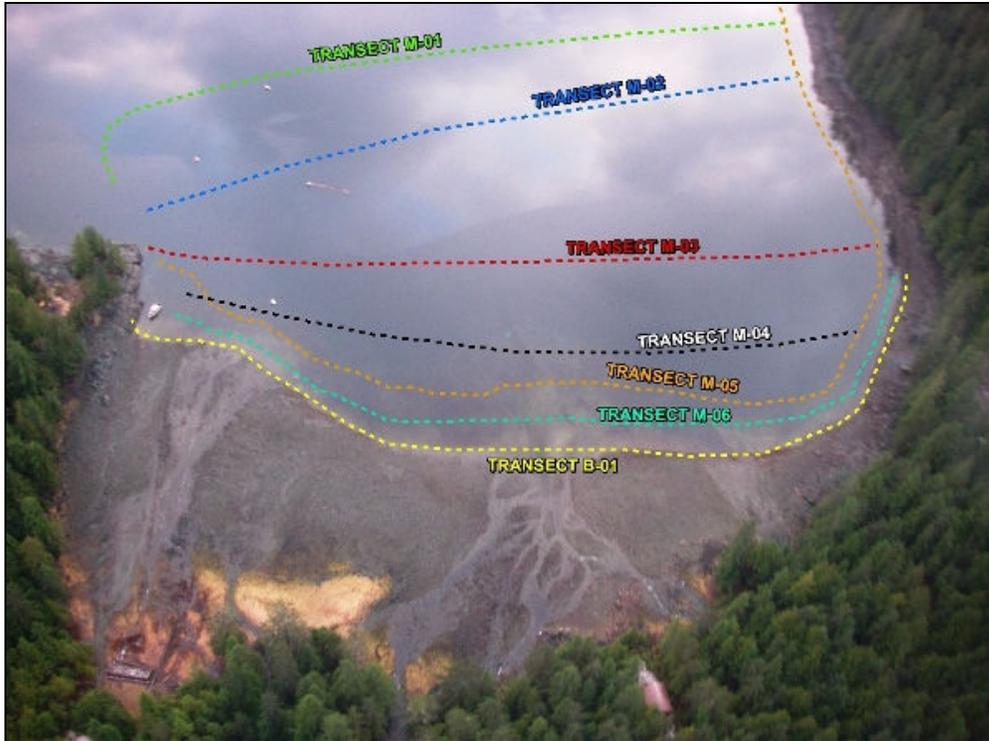
Figure 3. Approximate Locations of Survey Area Transects

A total of six marine transects and one beach transect were completed for the survey (Figure 3). GPS locations along each of these transects were collected where eelgrass was observed, where changes in substrate occurred, and where depth readings were collected. Notes taken at each of these GPS locations are included at the end this report. Point locations and GPS surveyed transects are shown on the attached map.

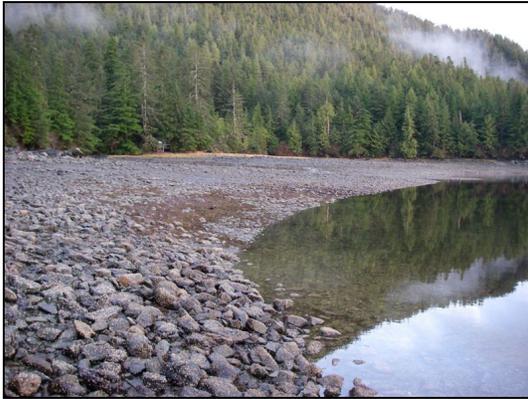
Eelgrass was observed at several locations within the study area. These locations are shown on Figure 5. In general, most subtidal areas were too deep to permit eelgrass growth; an estimated 76 percent of the surveyed subtidal areas are deeper than 15.0 ft bsl. The deepest elevation where eelgrass was observed was 11.9 ft bsl; the shallowest elevation was 3.0 ft bsl. During the survey, it was difficult to view the bottom of Niblack Anchorage at depths greater than 25.0 ft bsl. Eelgrass was absent within the entire intertidal zone that was surveyed (Figure 4 – photograph 1).

Photograph 1. Intertidal beach at low tide

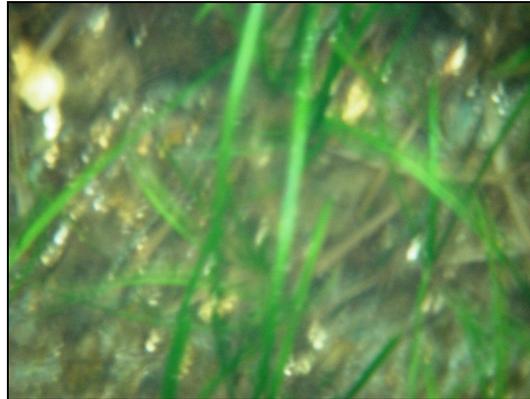
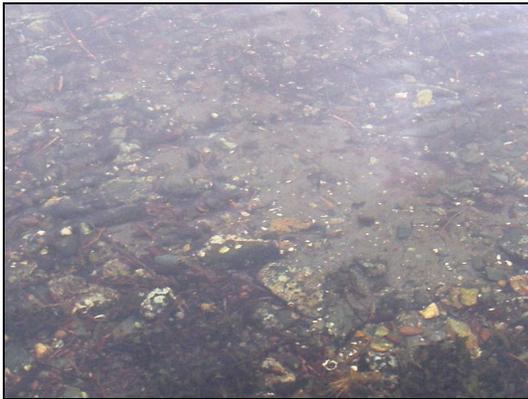
The largest bed of eelgrass is located approximately 20 ft beyond the intertidal and subtidal boundary in the northwestern portion of the study area (see GPS points 25, 26, 38, and 39 on the attached map). This bed was initially observed from the beach survey (GPS points 7 and 8) and then verified while conducting transects M-05 and M-06 (Figure 3 and 5). Plant density was greatest and most widespread within this bed. The underlying substrate within this bed is a mix of sand and gravel (Figure 4 - photographs 2 and 3).

Photograph 2. Eelgrass as seen from the AquaScope

Photograph 3. Sand/gravel mix substrate

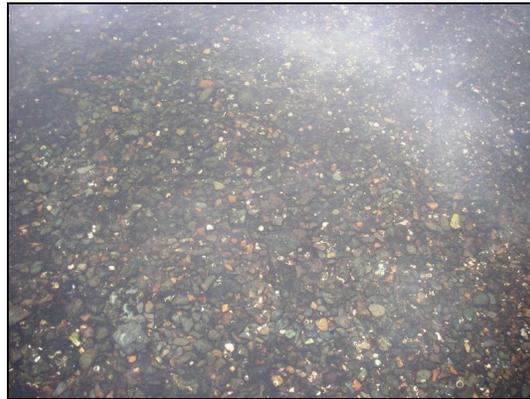
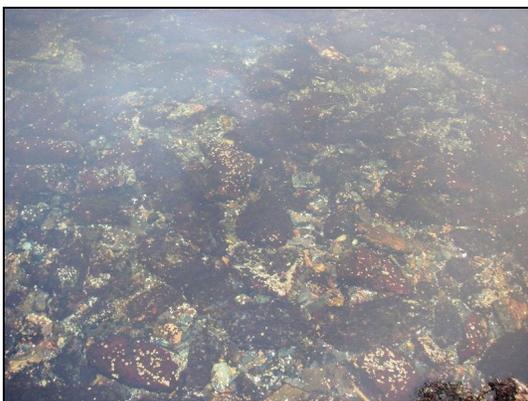
No eelgrass was seen growing in any of the rocky or coarse gravel beds surveyed (Figure 4 – photographs 4 and 5). A large area in the upper subtidal zone near GPS point 4 was covered by a thick layer of detritus (Figure 4 – photograph 6); no eelgrass was observed in that location.

Photograph 4. Coarse gravel substrate

Photograph 5. Rocky substrate

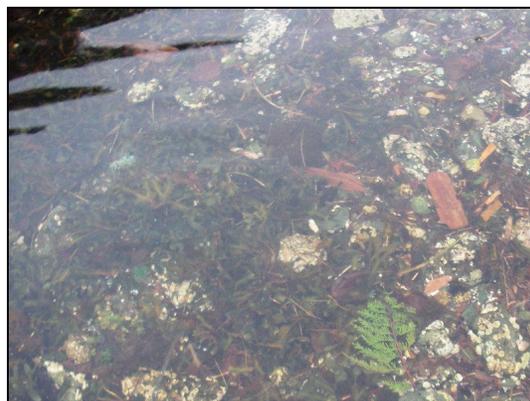
Photograph 6. Detritus covered substrate
