2014 Pogo Update

POGO MINE

Annual Activity and Monitoring Report Meeting

March 27, 2015

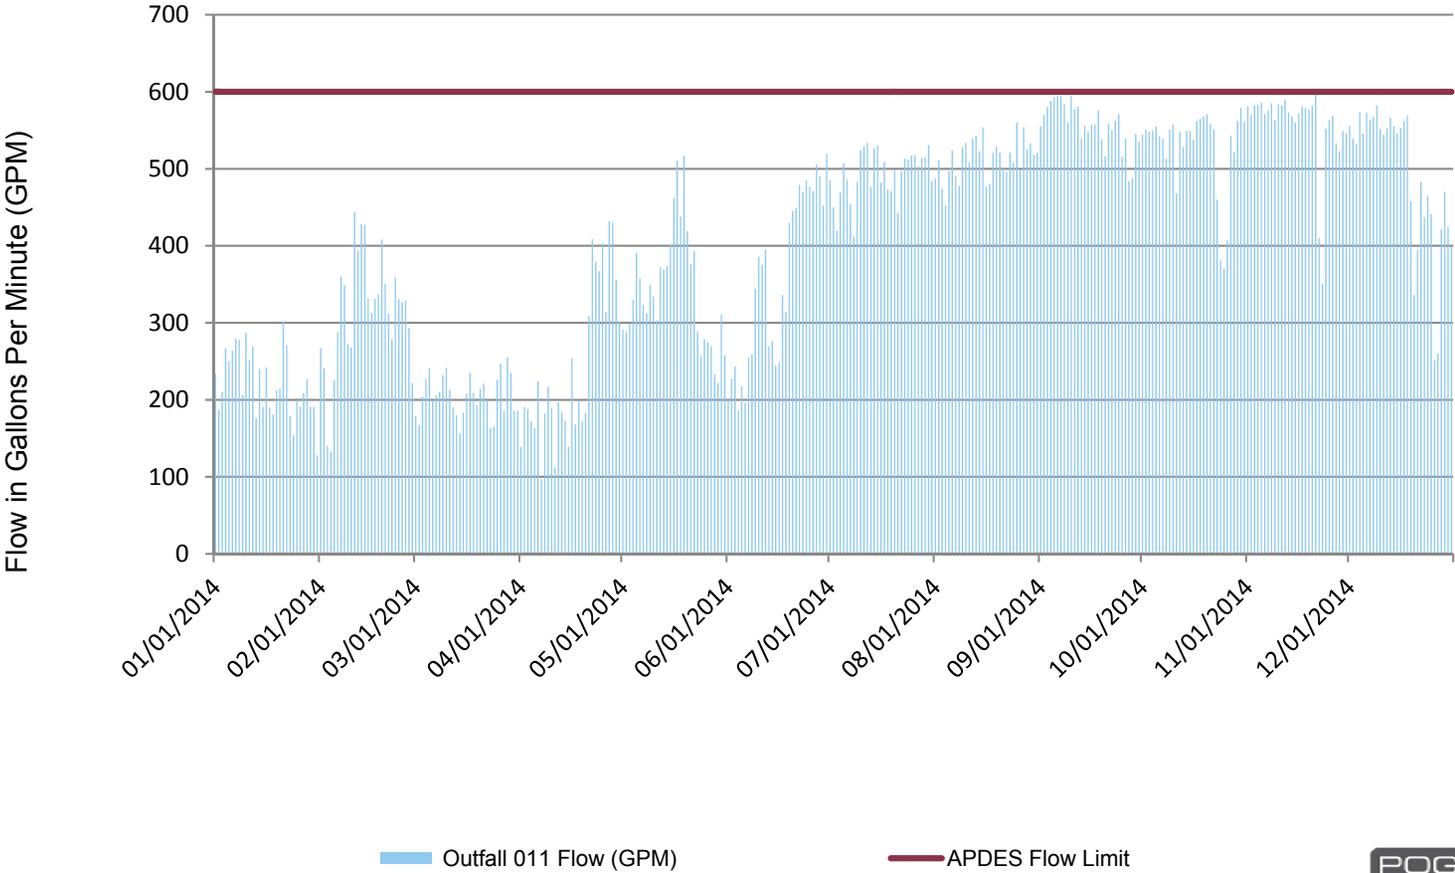
2014 Outfall 011 Flow (GPM)

211.1 Million Gallons Treated and Discharged

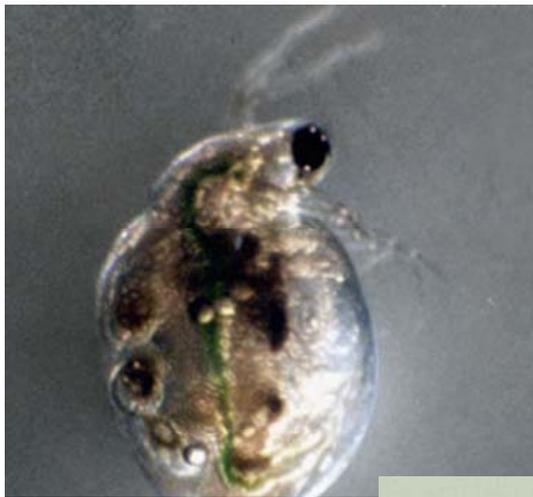
Ceriodaphnia dubia

Annual Whole Effluent Toxicity Testing took place in June. Water being discharged into the Goodpaster River was sent to the lab for biological assay.

Water fleas and Fat Head minnows were grown in different concentrations of effluent to see how it affected growth and death rates.

Test is duplicated, two labs are used every year. This year due to some lab problems, one of the tests was re-run.

All final results were within permit limits.

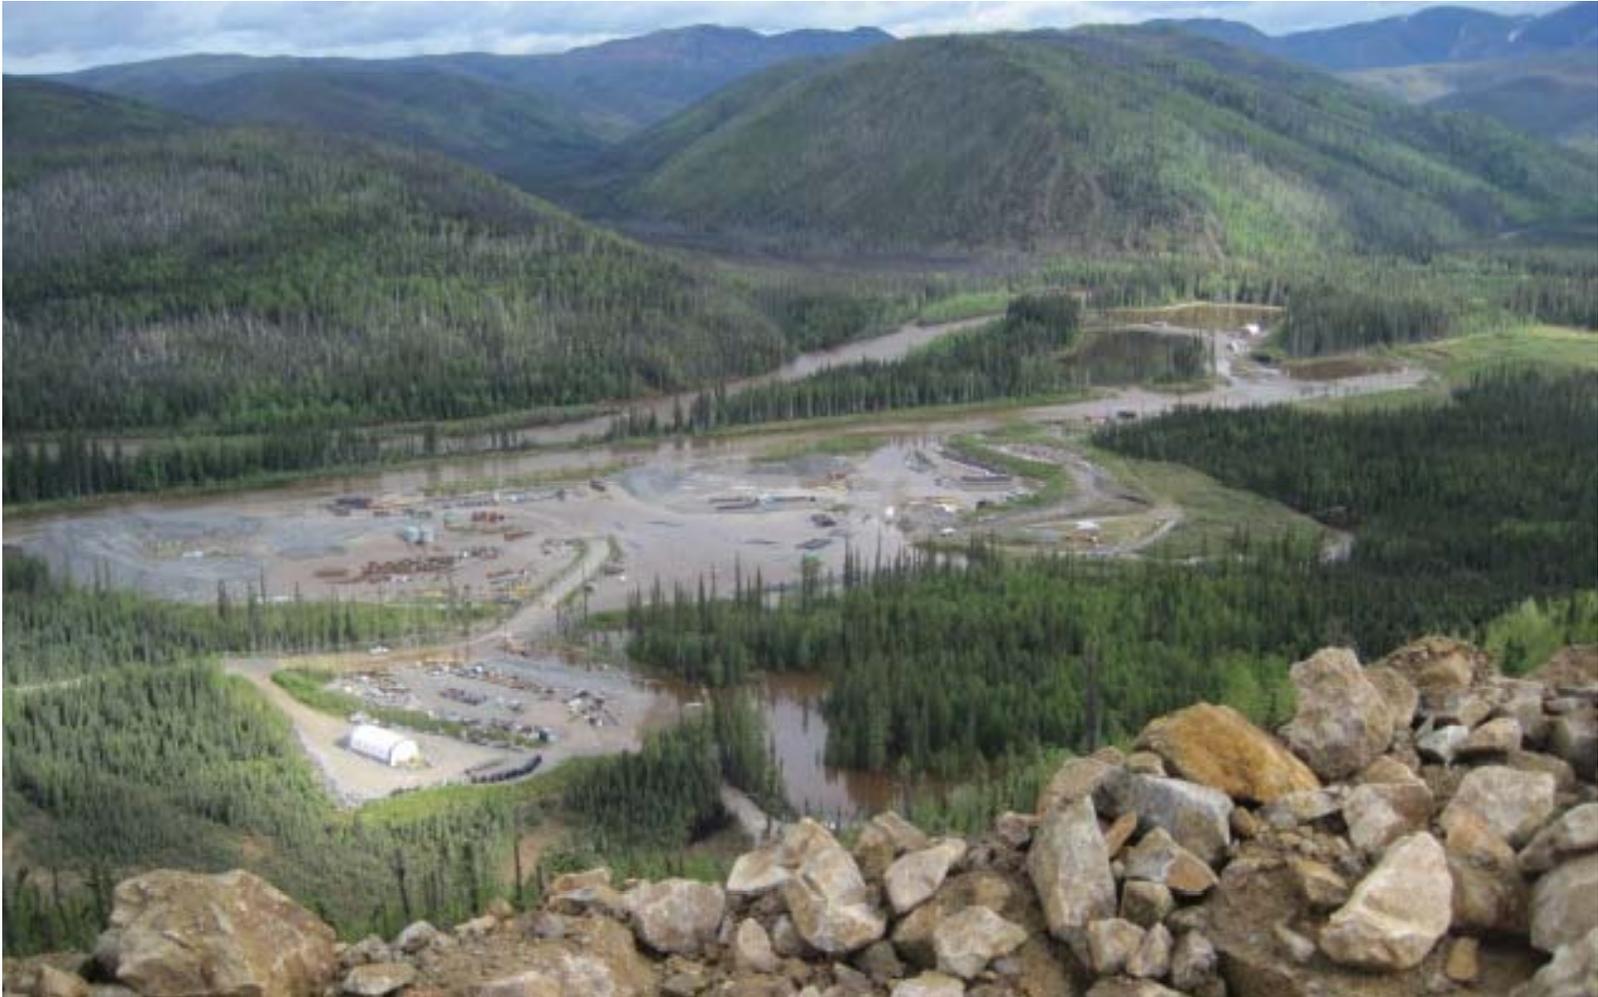
2014 June Record Flood Event

Outfall 001 Monitoring – High Turbidity

Goodpaster River flooded June 18. On June 19, discharge was ceased when approaching the Maximum Daily Limit for flow at Outfall 001 until permission was received from ADEC to continue discharge during flood conditions.

Heavy rainfall and subsequent flooding, resulted in high turbidity during June, however, it was not reported as an exceedance as it was a direct result of the high water event, and not mine water discharge.

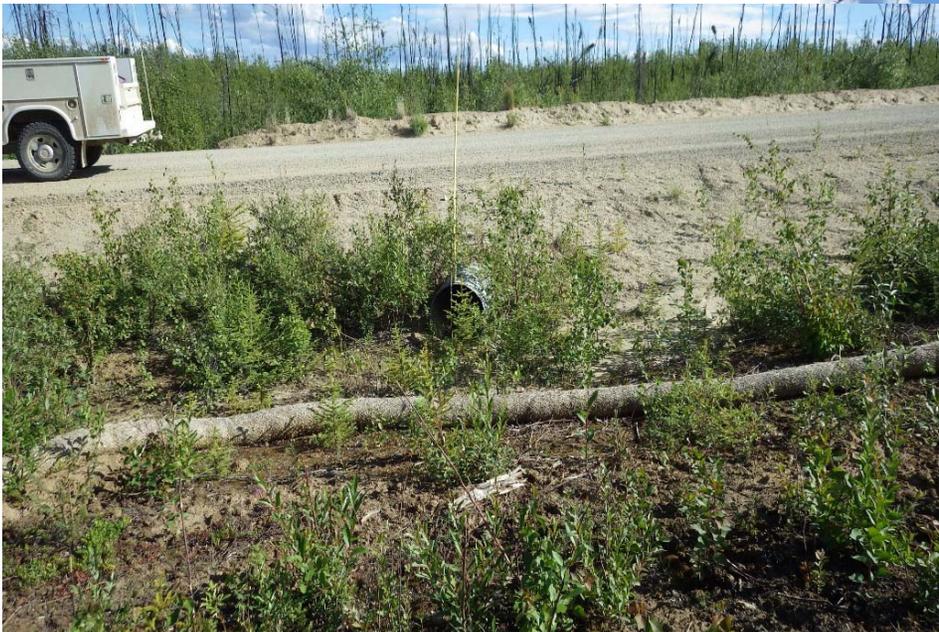
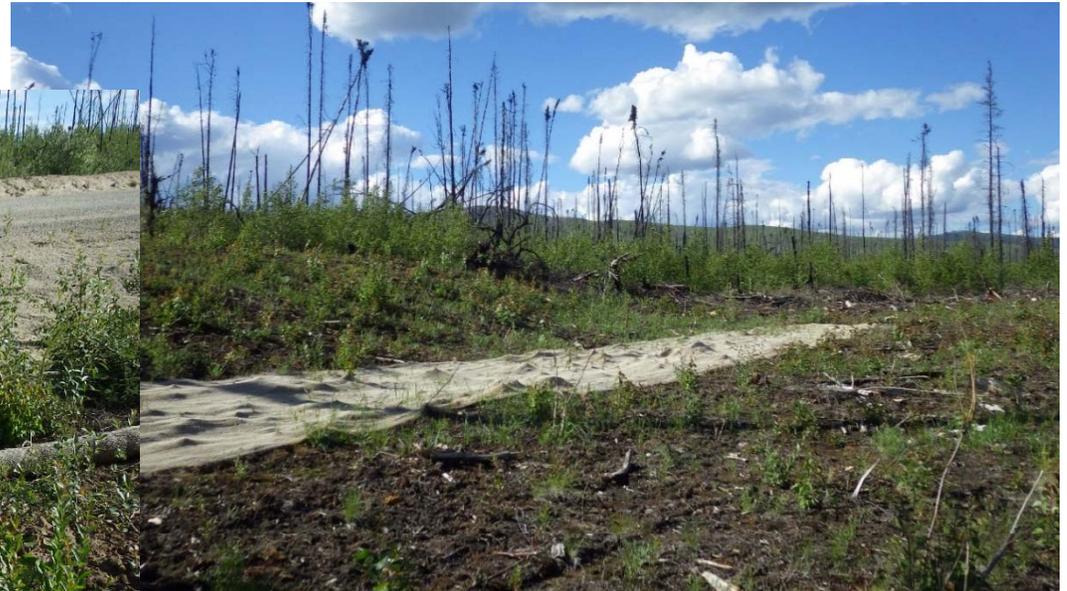
Transmission Line Right-of Way

- Clearing under transmission lines for fire prevention on the Access Road, caused some unintended, unpermitted, ground disturbance.
 1. Erosion control measures were put in place to mitigate ground disturbance.

- In 2015 additional fire-prevention clearing will occur:
 1. Environmentally Sensitive areas will be flagged to delineate boundaries.
 2. Equipment operators will be thoroughly briefed on the allowed clearing activities along the transmission line.

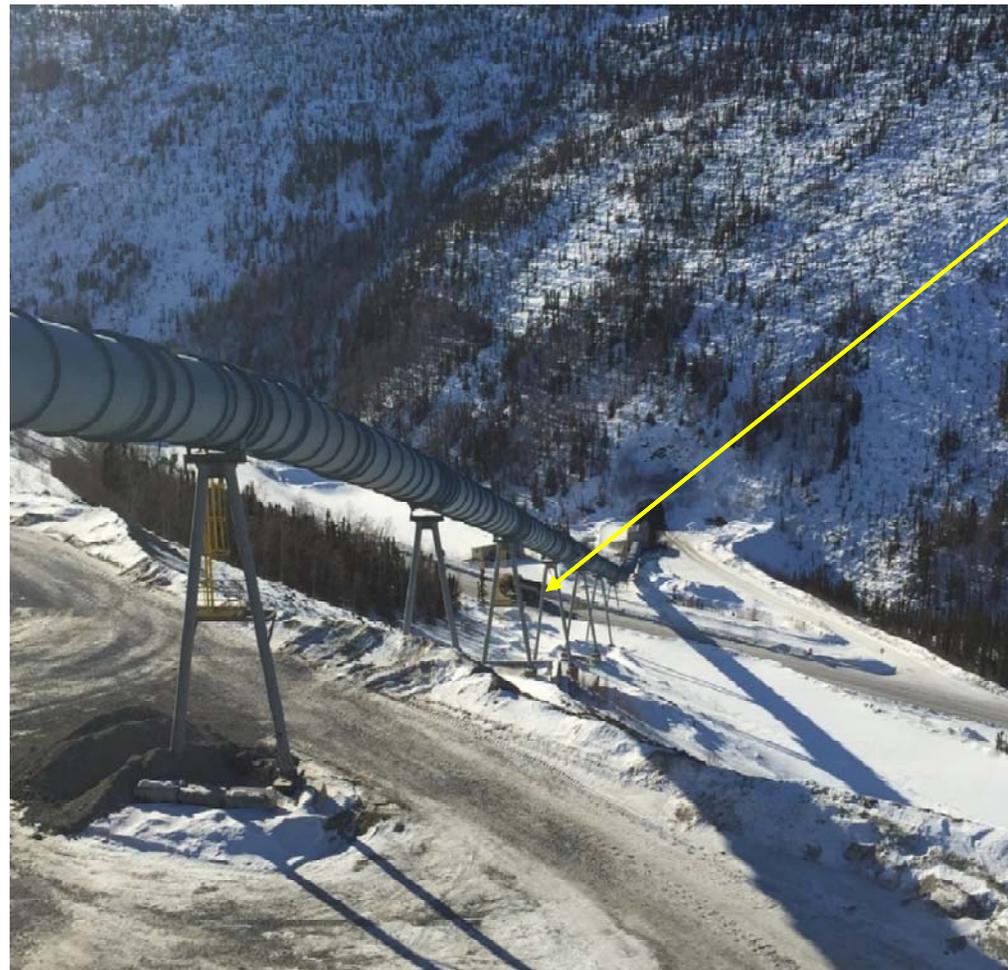
Haul Truck under Blue Tube

View from the top of the new CIP Tank

- 778,400 gallons.
- Tank-in-tank design for secondary containment.
- Used as a temporary Filter Feed Tank prior to using as CIP Stock Tank, allowing Pogo to empty, clean, inspect, and repair original Filter Feed Tank.

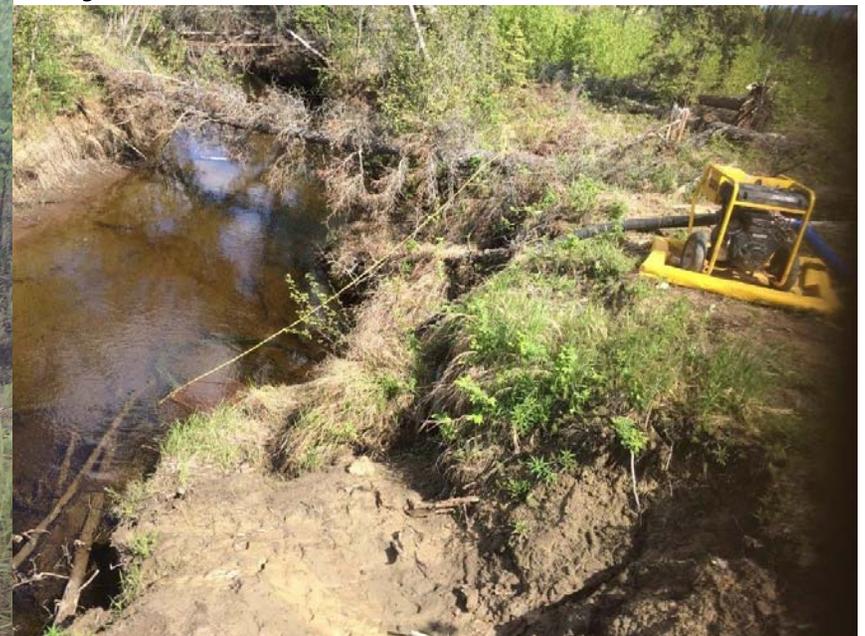
1. The fish screen was missing from the Gillies Creek water pump.

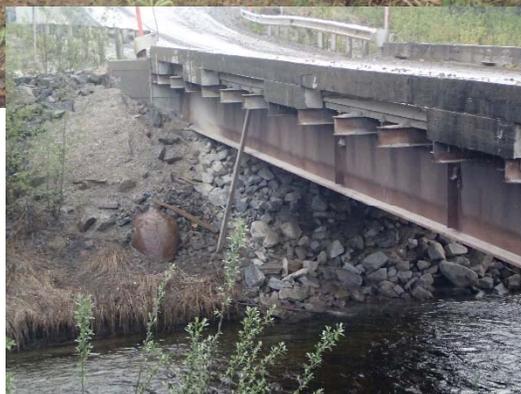
2. Some debris (2X4s) around the Shaw Creek Bridge.

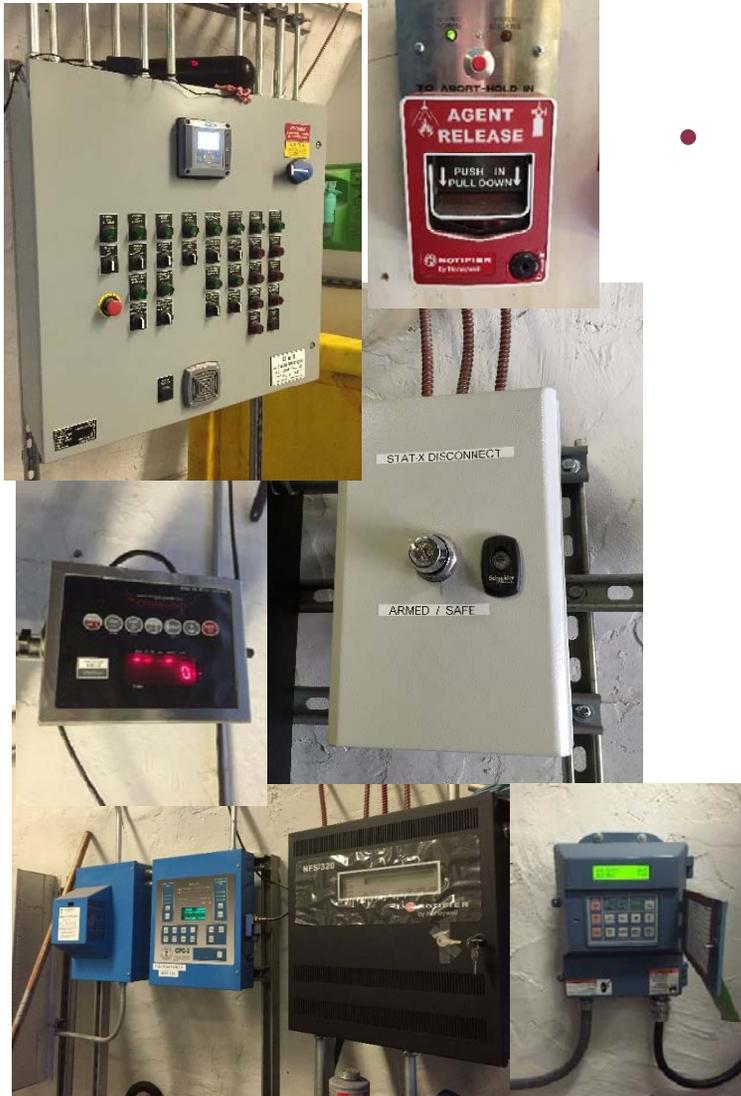
CISWI Rule - Managing Waste with our Remote Incinerator

- Operational Limits for Scrubber:
 - Total weight of trash that can be burned (a rolling 3-hour average),
 - pH above 8.5, to be recorded every 15 minutes while operating (rolling 1-hour average).
 - Water inflow above 10 gallons per hour (gph) recorded every 15 minutes while operating (rolling 1-hour average).
 - Pressure-drop across filter less than 2, to be recorded every 15 minutes while operating (rolling 1-hour average).
 - All deviations require reporting.

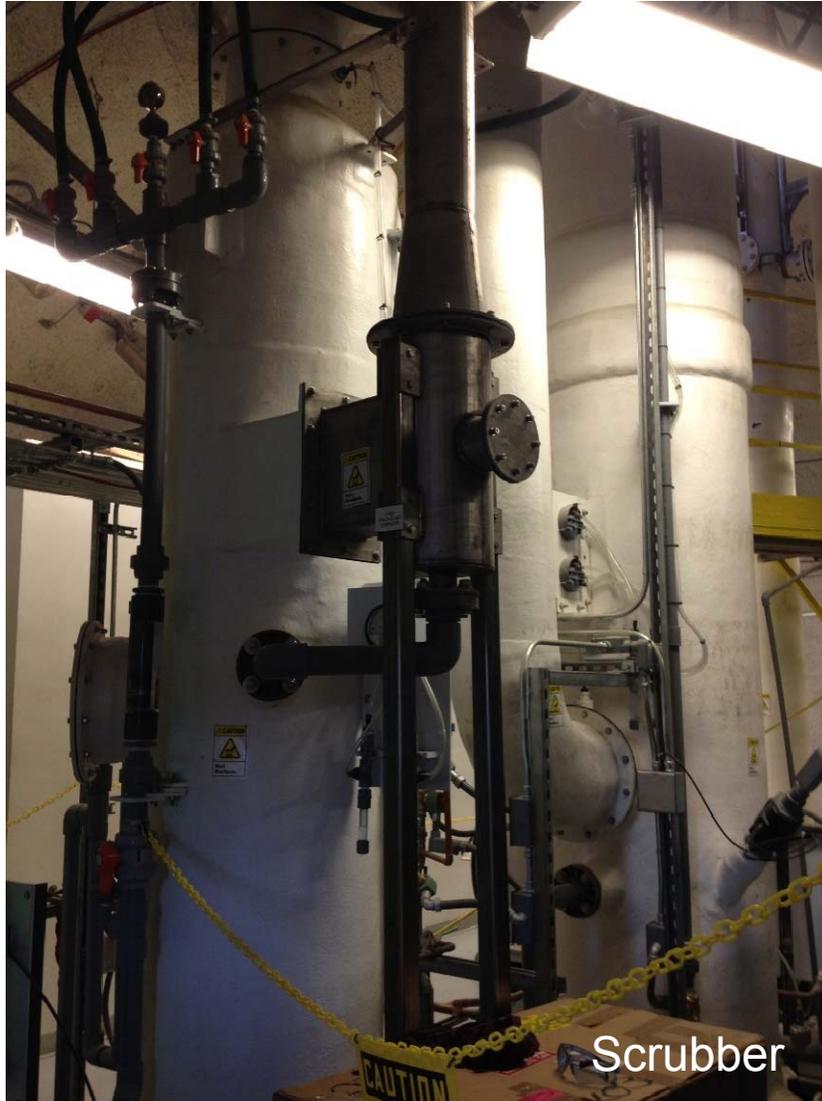
Incinerator Scrubber

- Scrubber discharge water has been monitored weekly since it was put into operation.
- Scrubber water discharge options still under consideration:
 - Sewage Treatment Plant
 - or
 - Mine Water Treatment Plant #2

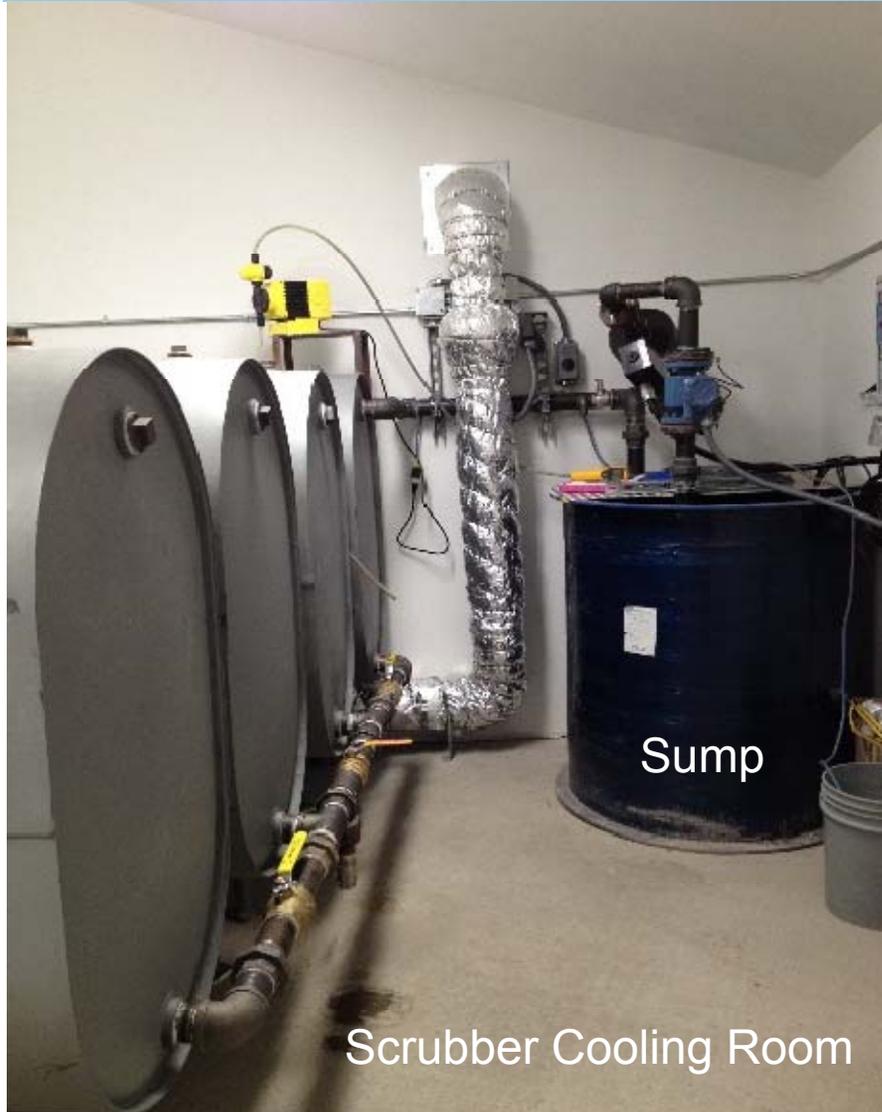
Incinerator Scrubber

- Scrubber discharge water is allowed to cool through a series of four tanks before exiting through the sump.

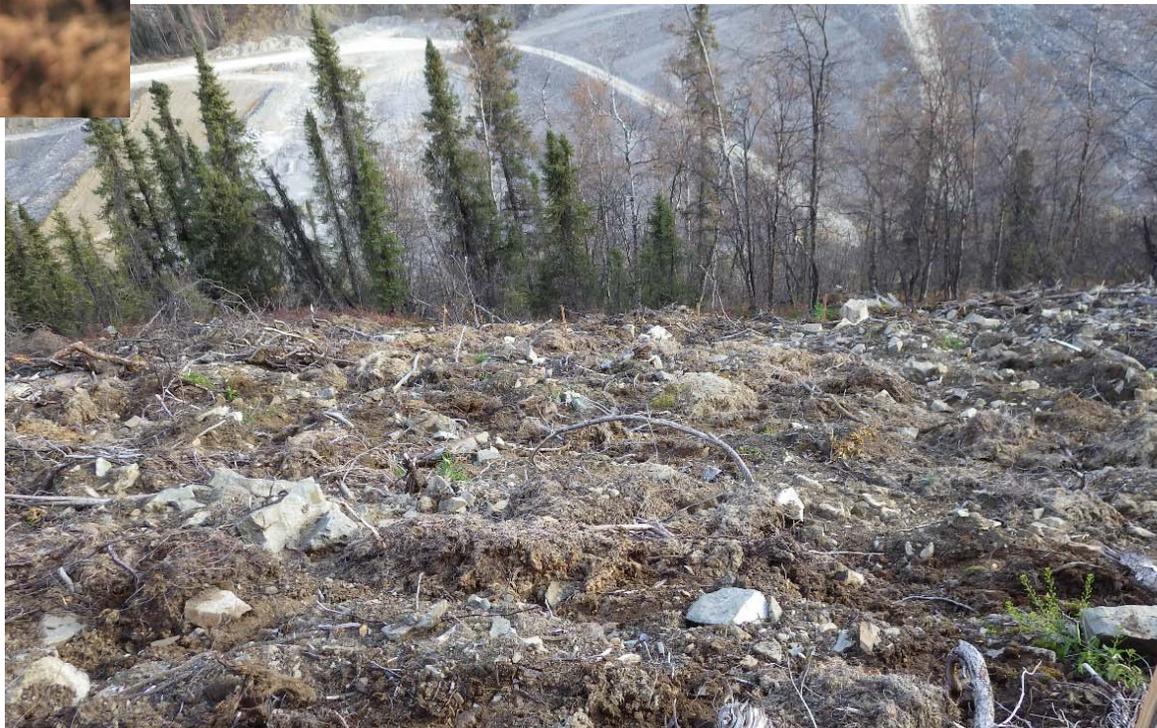
- Test plots were established for Broadleaf Forest plants with native grass species, birch, alder, aspen and white spruce collected locally.
- These will be seeded in the spring.
