Alaska Gold Company
A subsidiary of NovaGold Resources Inc.

ROCK CREEK MINE & BIG HURRAH PROJECT

2009 ANNUAL REPORT

March 5, 2010

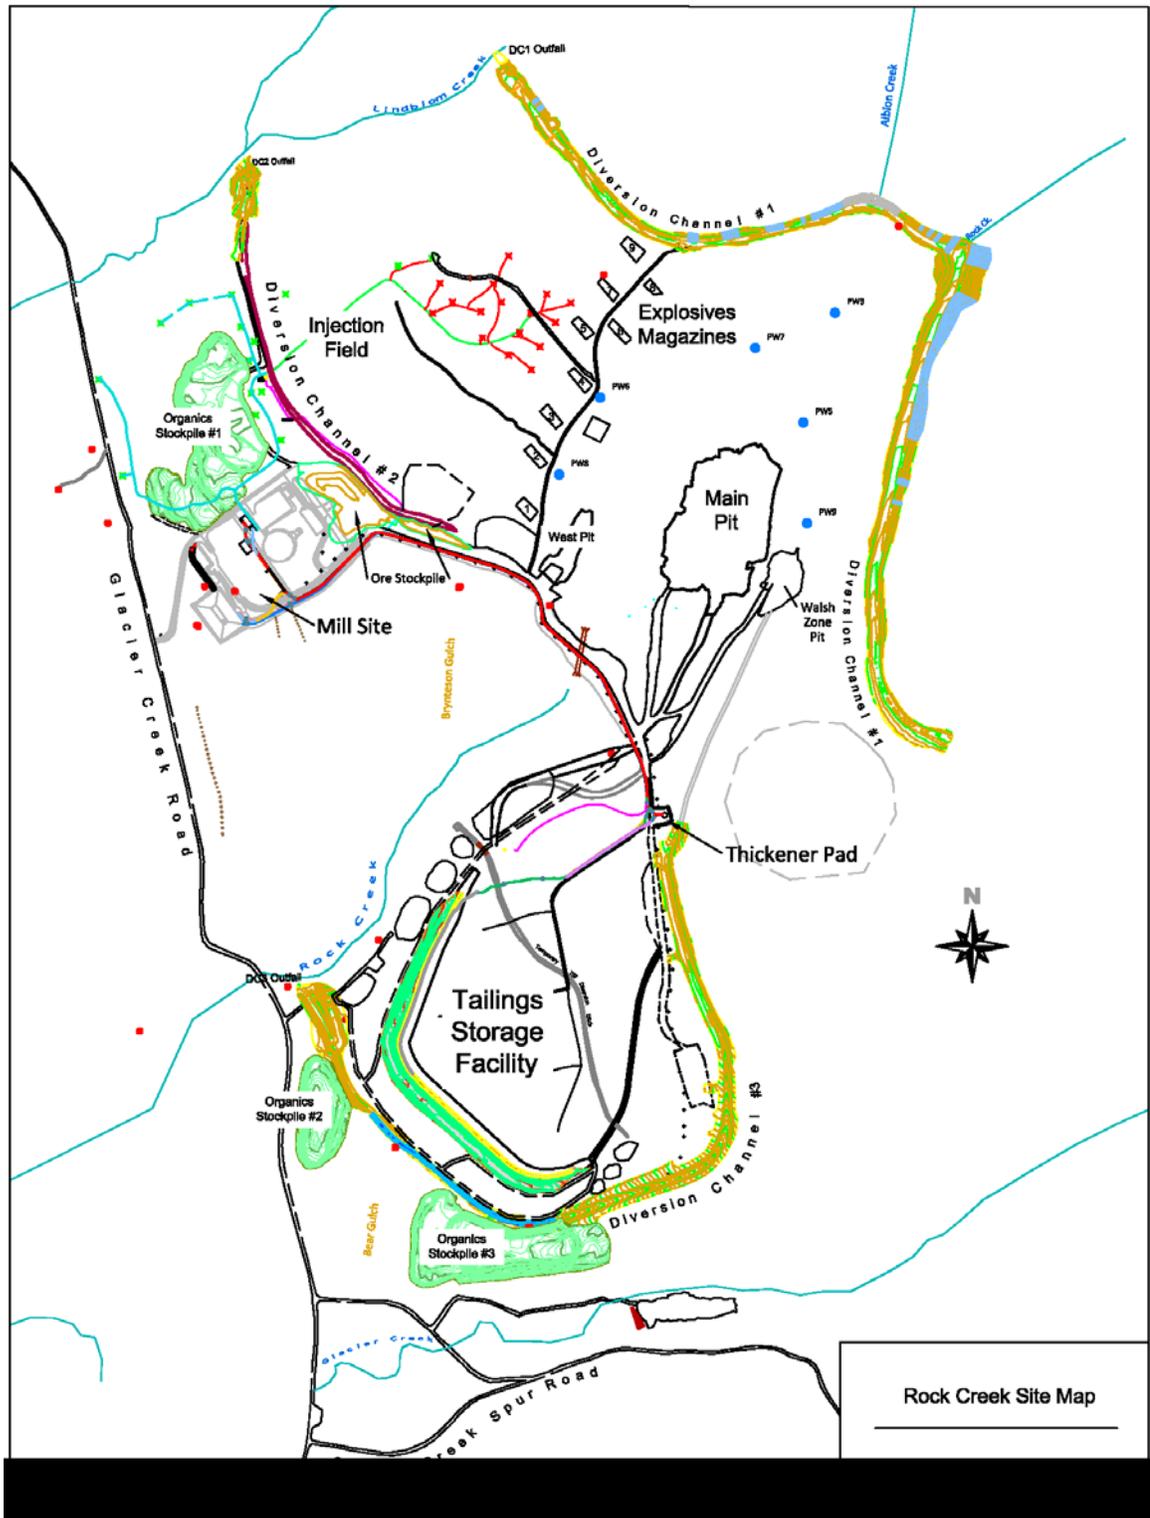
Figure 2: Rock Creek Site Map

The Rock Creek Mine is located approximately six miles north of Nome in the Snake River drainage on private lands owned by the Bering Straits Native Corporation and AGC. Mine facilities currently include an open pit, TSF, explosive storage areas, IWF, organic stockpiles, storm water diversion channels, and mine roads (Figure 2). Support facilities include the mill/gold recovery plant, maintenance shop, administration and mine dry buildings, warehouse, WTP, reagent storage locations, RWP, and fuel storage locations (Figure 3).

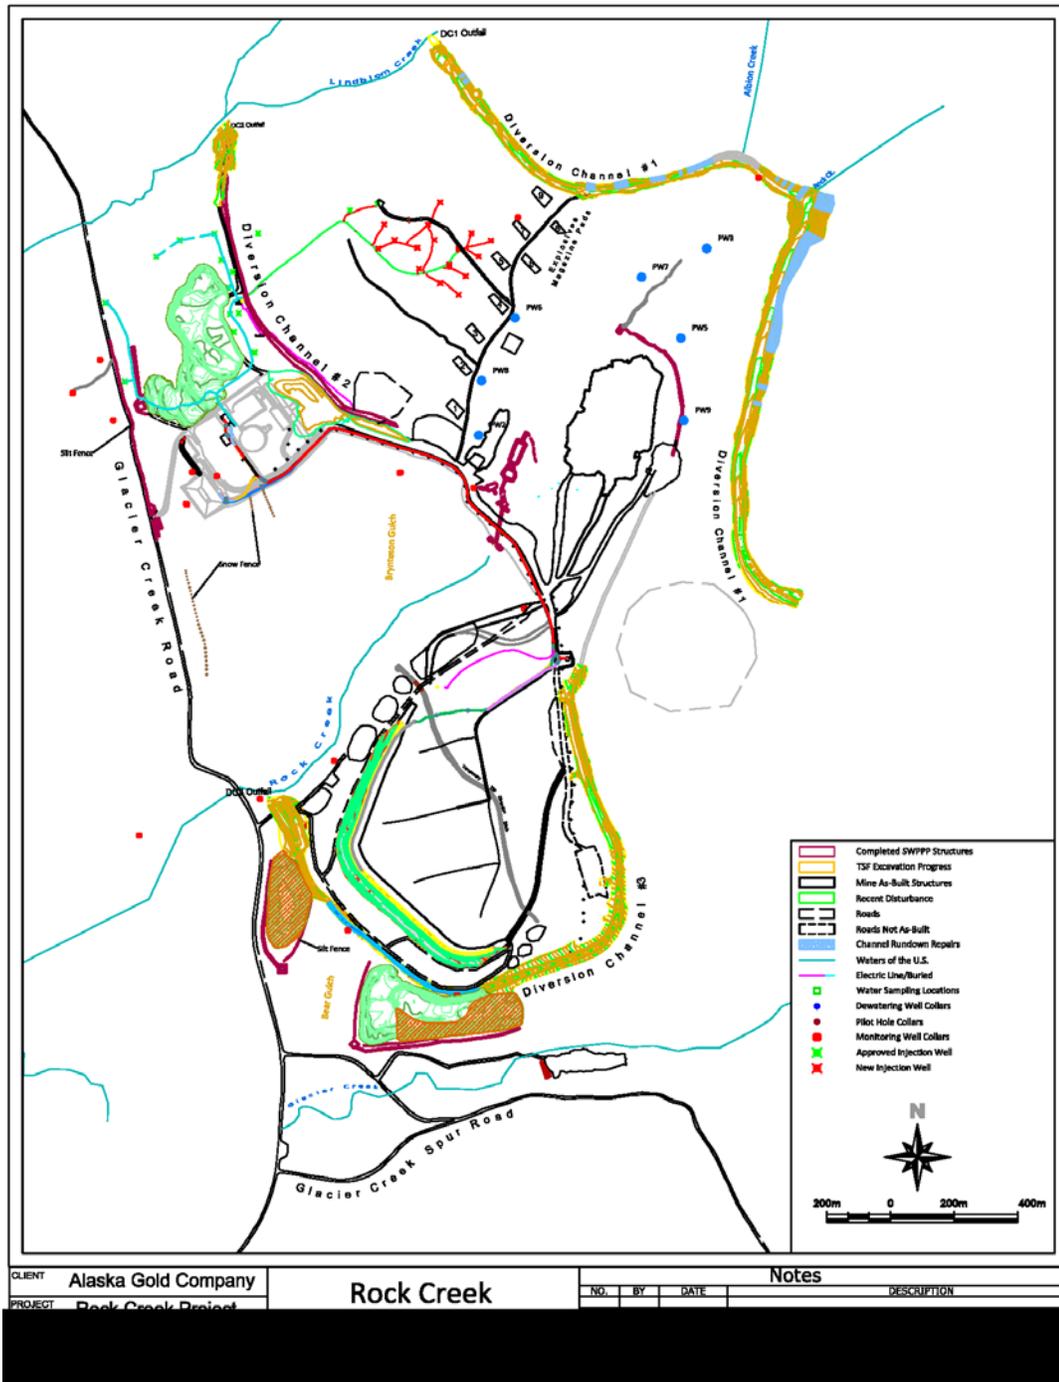
Figure 6: Rock Creek SWPPP Structures

Structural BMPs at the Rock Creek Mine include three diversion channels (DC-1, DC-2, and DC-3) to route storm water runoff, primarily during spring break-up, and limit sediment discharges from the site (Figure 6). During summer 2009, AGC conducted frequent turbidity sampling in Rock and Lindblom creeks to evaluate the need for additional sediment controls or improvements to existing structures. Elevated turbidity levels in Lindblom Creek downstream of the DC-1 and DC-2 outlets prompted AGC to develop plans to improve each diversion channel.

In August 2009, AGC contracted with Ecological Resource Consultants, Inc. (ERC) and HydroGeo, Inc. (HydroGeo) to evaluate improvement options for DC-1, including the need to incorporate additional rock protection along the channel. Based on contractor recommendations, AGC installed riprap in critical segments and installed rock runouts along unstable slopes upgradient of the channel. Hydroseeding was used to stabilize less critical areas in DC-1 and has proven to be effective in minimizing sediment loadings along these segments. AGC also re-evaluated the design of the DC-1 outfall and completed a reconstruction project.

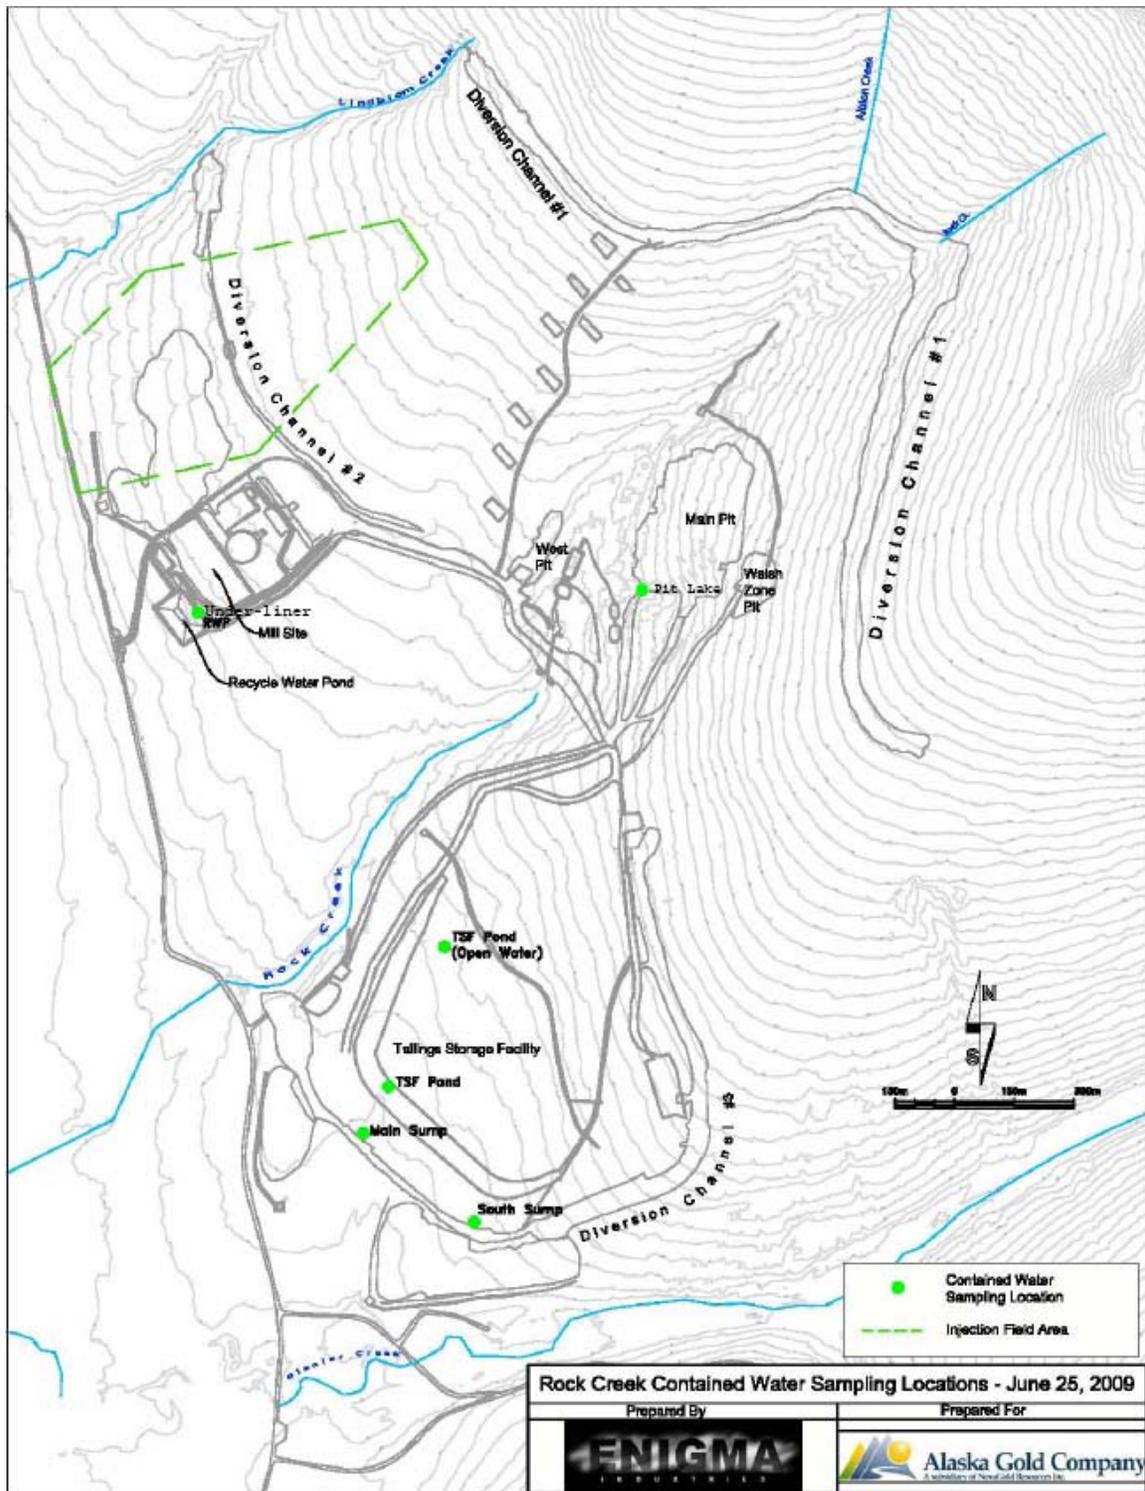
Figure 8: Contained Water Sampling Locations

Contained water sampling is conducted on a monthly basis and includes sampling of the TSF Pond, RWP, South Sump, Main Sump, Main Pit Lake, and RWP Underliner (Figure 8). TSF Pond, South Sump and Main Sump samples are used to monitor water quality in the TSF water management system while the RWP and RWP Underliner samples are used to evaluate the integrity of the RWP system. AGC is not required to monitor the Main Pit Lake, but collects monthly samples of the pit water to establish background chemistry of storm water runoff from the pit surfaces.

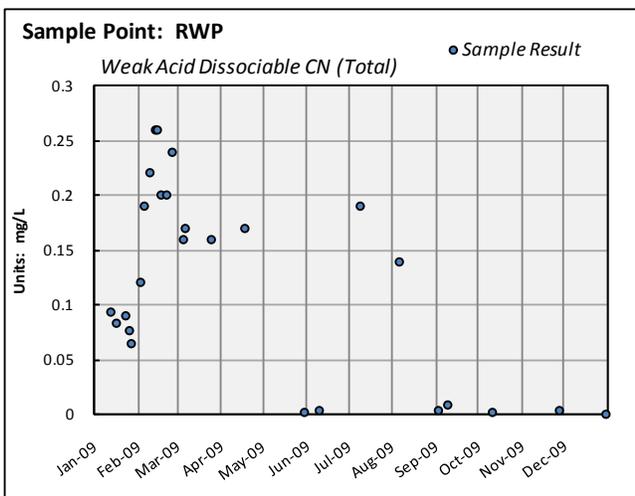
Figure 9: RWP WAD Cyanide

Water contained in the RWP may not exceed WAD cyanide levels of 25 mg/L for any one sample, nor may the 90th percentile of all samples exceed 10 mg/L (WMP Section 1.2.4). All RWP samples showed WAD cyanide levels well below this requirement (Figure 9). Samples collected from the RWP Underliner were also well below the permit limits (Figure 10). A single sample of the RWP sludge analyzed for WAD cyanide collected on October 12, 2009 showed a concentration of 0.11 mg/L.

Complete analytical data of all samples collected from the RWP and RWP Underliner are reported in Appendices A2 and A3. No adverse trends were identified.

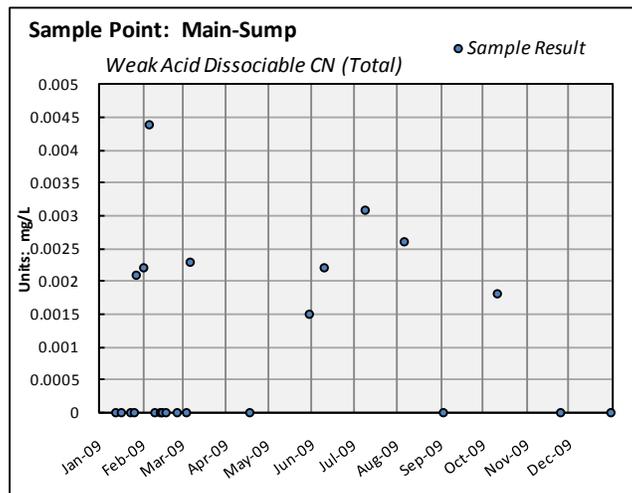
Figure 11: RWP WAD Cyanide

Water recycled to the TSF may not exceed a WAD cyanide level of 25 mg/L for any one sample, nor may the 90th percentile of all samples exceed 10 mg/L (WMP Section 1.2.4). Water samples collected from the Main Sump have routinely shown WAD cyanide concentrations well below the permit limits (Figure 11). There are no other permit limits that apply to the sump water.

Complete analytical data of all samples collected from the Main Sump and South Sump are reported in Appendices A4 and A5. These data are primarily used to monitor their input to the TSF, and thereby project potential changes in TSF water chemistry that could affect WTP treatment performance.

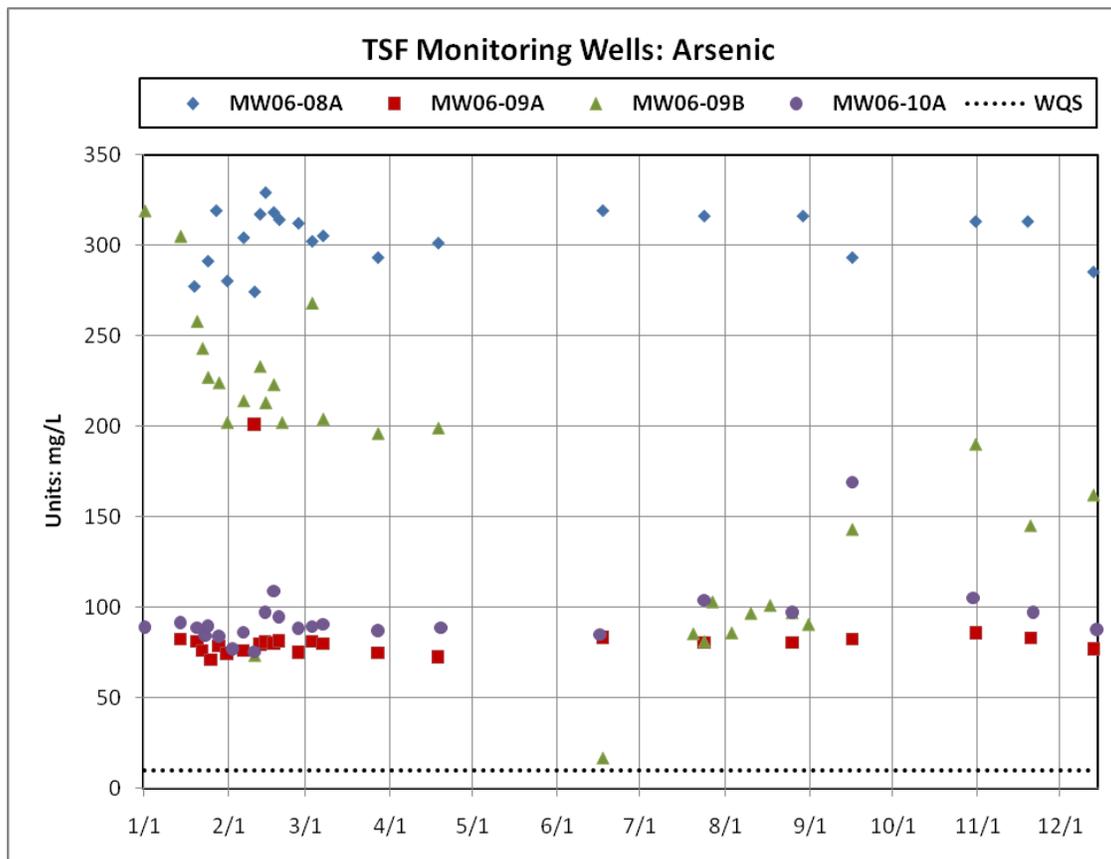
Figure 12: Arsenic Sample Data (TSF Monitoring Wells)

As required under WMP Section 1.2.10, AGC implemented an accelerated monitoring program to more accurately characterize background water conditions. Based upon analyses completed by Tetra Tech, AGC concludes that, with few exceptions, the water quality standard exceedances observed in the TSF monitoring wells during 2009 were consistently the result of natural background concentrations present in the groundwater. It is important to understand that the TSF only received small amounts of tailings during the limited operating period.

Under contract to AGC, Tetra Tech, Inc. conducted a detailed statistical analysis of baseline conditions for each well. Based on this analysis, AGC has proposed new action levels that more accurately reflect concentrations at which potentially adverse impacts to groundwater would occur and for which AGC would take specific action to address their cause. The proposed action levels reflect the applicable water quality standards except where background concentrations are higher, in which case the action level reflects the observed background value. AGC continues to monitor and report exceedances of both the water quality standards and TCP action levels, but proposes to only address conditions where the new action levels are exceeded.

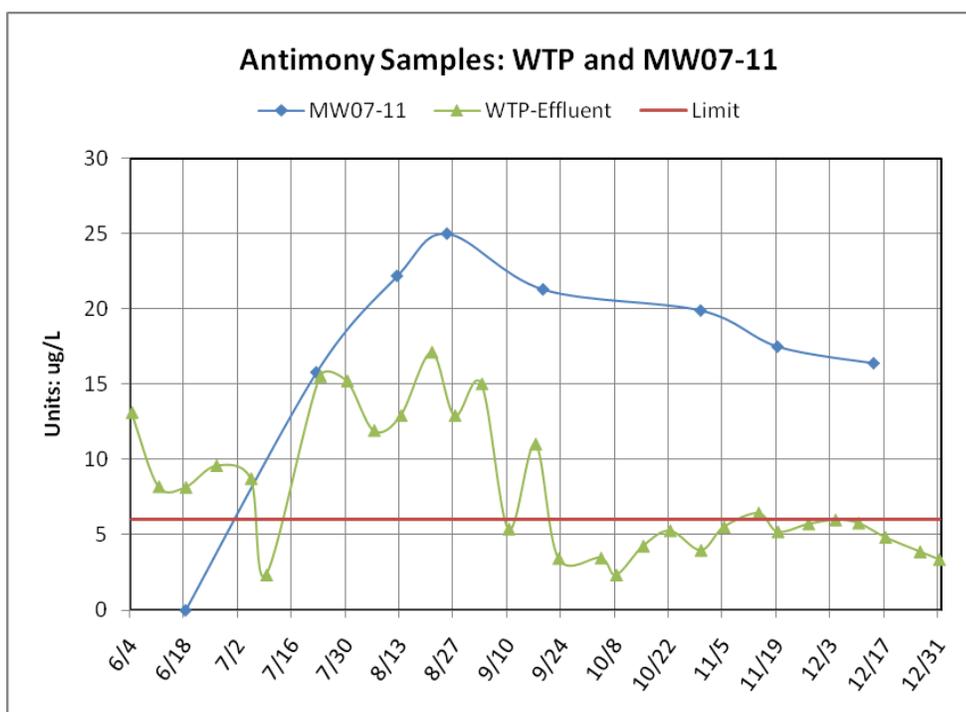
Figure 13: WTP and MW07-11 Antimony Samples

As required under WMP Section 1.2.10, AGC implemented an accelerated monitoring program to more accurately characterize background water conditions. Based upon analyses completed by Tetra Tech, AGC concludes that, with the exception of antimony, the water quality standard exceedances observed in the IWF monitoring wells in 2009 are the result of natural background concentrations present in the groundwater. Tetra Tech analyzed background data for the IWF monitoring wells as part of the groundwater evaluation discussed above. Based on this analysis, AGC concludes that, like the TSF wells, corrective action levels should be implemented for the IWF monitoring wells. AGC will continue to monitor and report exceedances of water quality standards, but proposes to only address conditions where the corrective action levels are exceeded.

There is insufficient background data to establish background-based action levels for monitoring well MW08-15A. As noted above, WTP effluent levels for the parameters listed in Table 13 are now consistently below water quality standards. As a result, AGC has assumed the late 2009 samples are representative of natural conditions and has not undertaken any corrective actions. During 2010, AGC will continue to review the data from MW08-15A to determine whether there are any detectable changes in water quality over time.

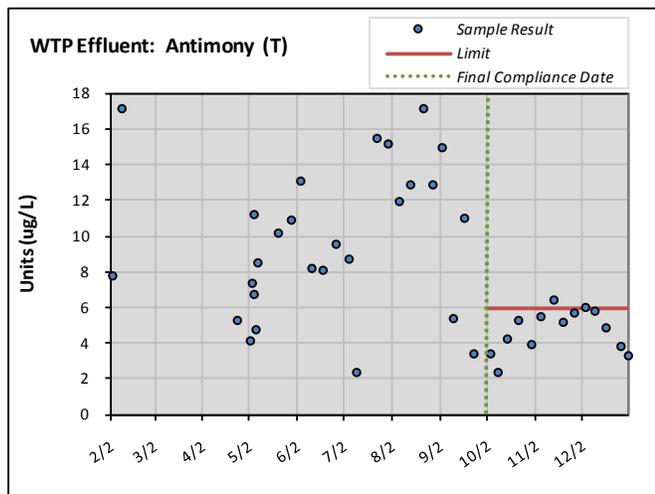
Figure 14: WTP Effluent (Antimony)

Since October 1, 2009, weekly sampling data have shown that apart from isolated issues concerning antimony and manganese, the WTP has performed as intended and satisfied COBC requirements. After October 1, 2009 AGC observed 1 minor antimony exceedance (Figure 14) and 3 minor manganese exceedances (Figure 15). Each exceedance was related to unanticipated malfunctions with the ozone generation system, which failed to inject ozone at the expected rate thereby reducing oxidation in the reaction tank. While oxidation is not essential to metals removal in the system, it generally improves the efficiency with which they are removed. AGC has documented these issues and notified ADEC by memorandum dated December 2, 2009. AGC continues to monitor the ozone system and began introducing supplemental oxidants to the WTP on December 20, 2009 to ensure adequate metals removal.

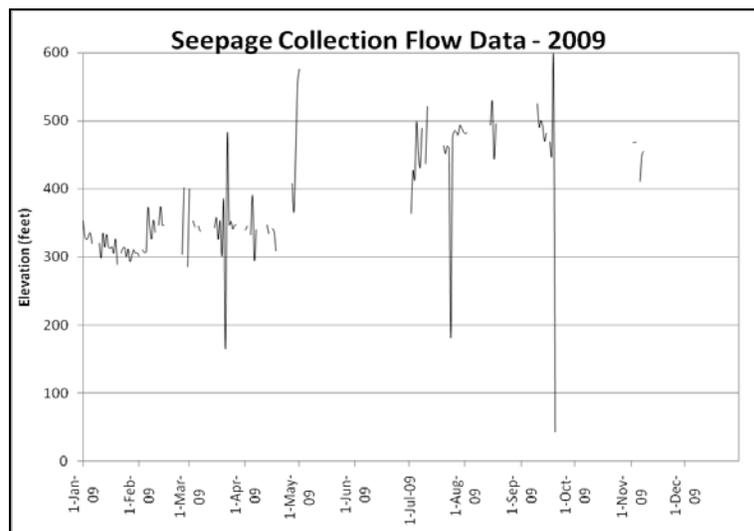
Figure 16: Seepage Collection System Flow Data

The Seepage Collection System was visually inspected each day by the process operator to ensure that no abnormal event has occurred. The sumps, pipe line and the pumps were inspected each day. Flow meters were read and recorded.

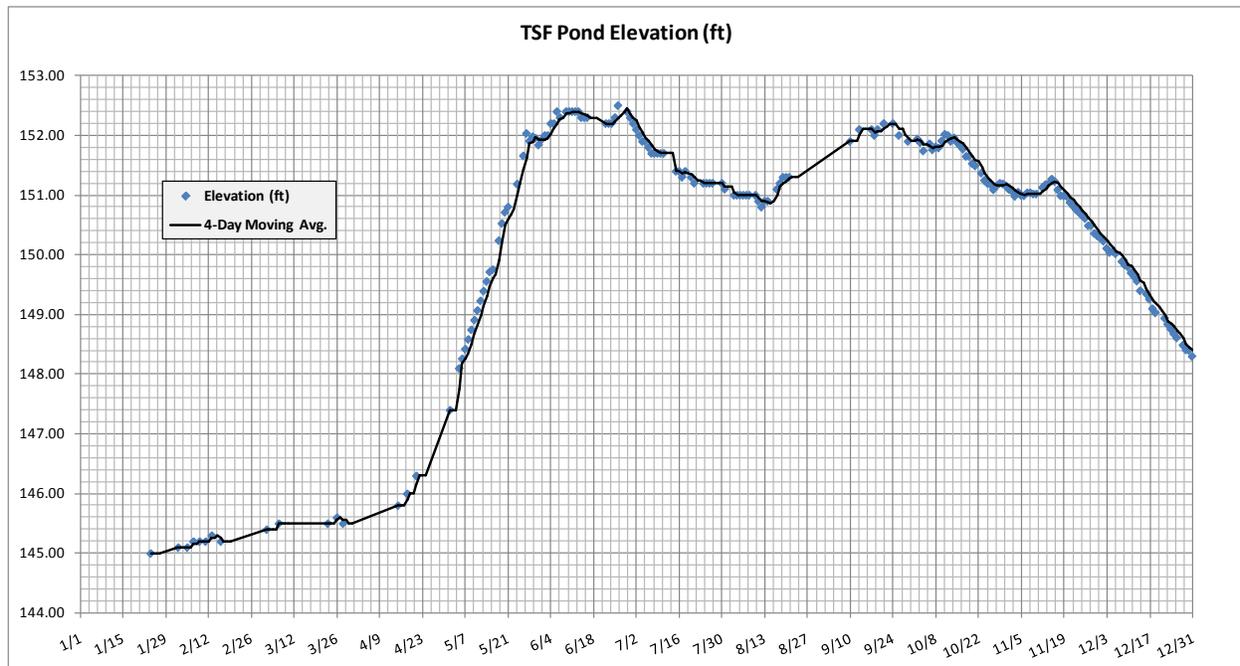
Figure 17: TSF Pond Elevation

The water surface elevations have been recorded on the daily TSF inspection log as per the Rock Creek Tailing O&M manual. After the expanded well field became fully operational in November 2009, the water level in the TSF has consistently been lowered at a higher rate than predicted by the theoretical site water balance. The COBC will terminate when the TSF water elevation falls below 140 feet.

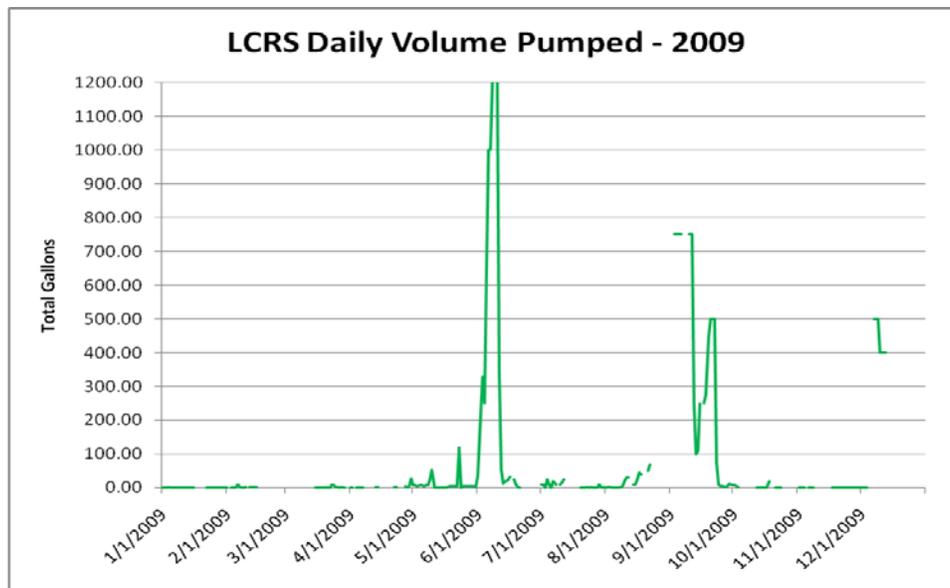
Figure 18: LCRS Pumped Volume

Flow at the LCRS is measured daily. The pumped volume is recorded on the RWP monitoring sheet along with notes from the visual inspection (Figure 18).

There is a direct correlation between the ground water level and the LCRS volume. At the 123-foot elevation, groundwater begins to infiltrate the LCRS. This is controlled with the pumping of the RPW-02 and the RWP Underliner pump. There were maintenance problems with both of these pumps throughout 2009. Specifically, the RPW-02 pump froze and the RWP Underliner pump failed in November 2009. Both pumps have since been repaired.

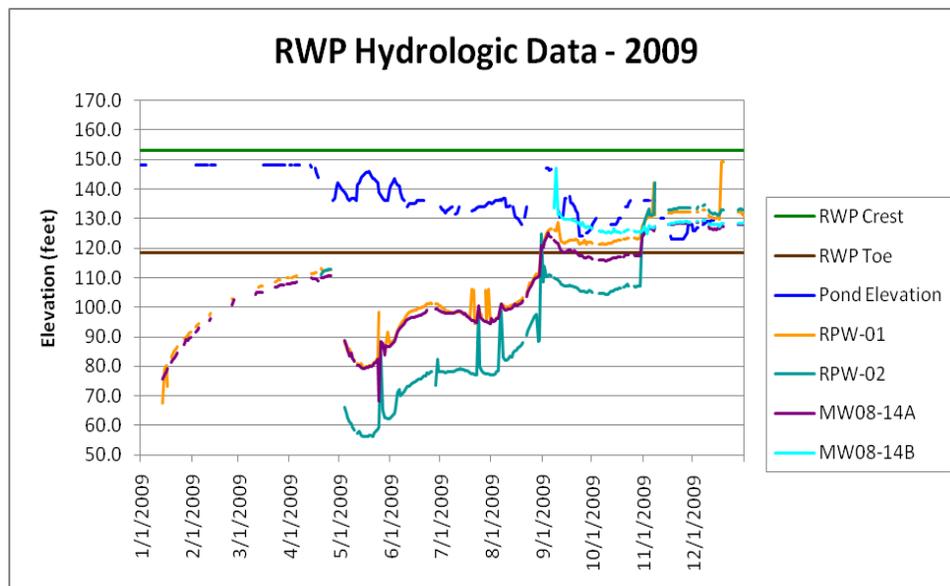
Figure 19: RWP Elevation Data

The surface of the water is monitored and recorded on the RWP monitoring sheet (Figure 19). During 2009, the RWP water elevation has occasionally exceeded the target level of 139 feet specified in the TCP. In late 2009, AGC specifically took steps to provide for removal of water and solids from the RWP and allow for pumping of well water to the WTP for treatment and injection. These actions, which will be completed during early 2010, will ensure adequate capacity for spring 2010 inflows to the RWP.

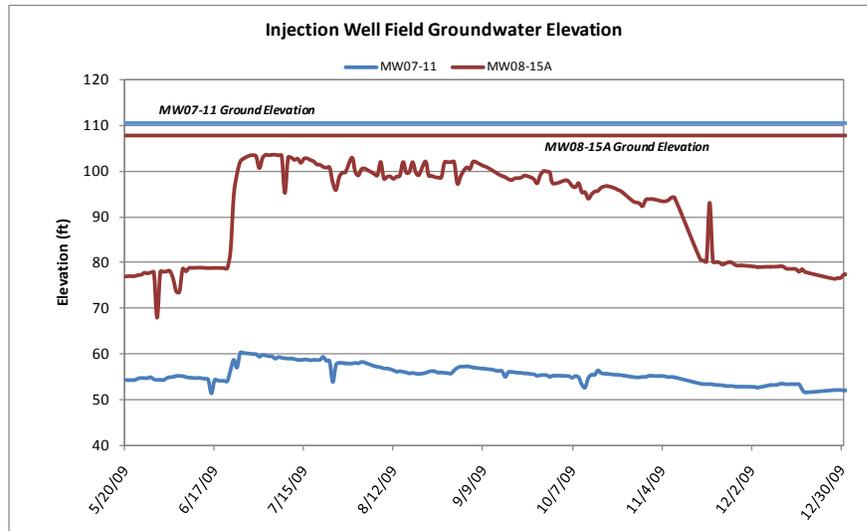
Figure 20: MW07-11 and MW08-15A Groundwater Elevations

Prior to treated water injection, water levels in the monitoring wells were stable at an approximate elevation of 54 feet in MW07-11 and 78 feet in MW08-15A (Figure 20). By the end of June 2009, the water level in well MW07-11 had risen from 54 feet to 60 feet amsl, while the increase in well MW08-15a rose from 79 feet to 102 feet amsl. From July through December water level elevations in both wells slowly decreased to 55 feet (MW07-11) and 77 feet (MW08-15A).

Water levels in the monitoring wells have always been below the ground surface elevation, indicating that the injection activities have not over pressurized the ground water system.

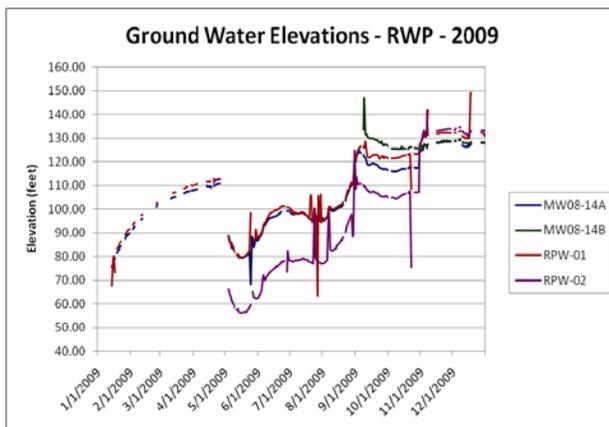
Figure 21: RWP Groundwater Elevations

AGC also monitors groundwater elevations at monitoring wells below the RWP and TSF. No anomalies or upwellings were observed.
