ROCK CREEK MINE & BIG HURRAH PROJECT

2010 ANNUAL REPORT

Alaska Gold Company
P.O. Box 640
Nome, Alaska 99762

March 1, 2011

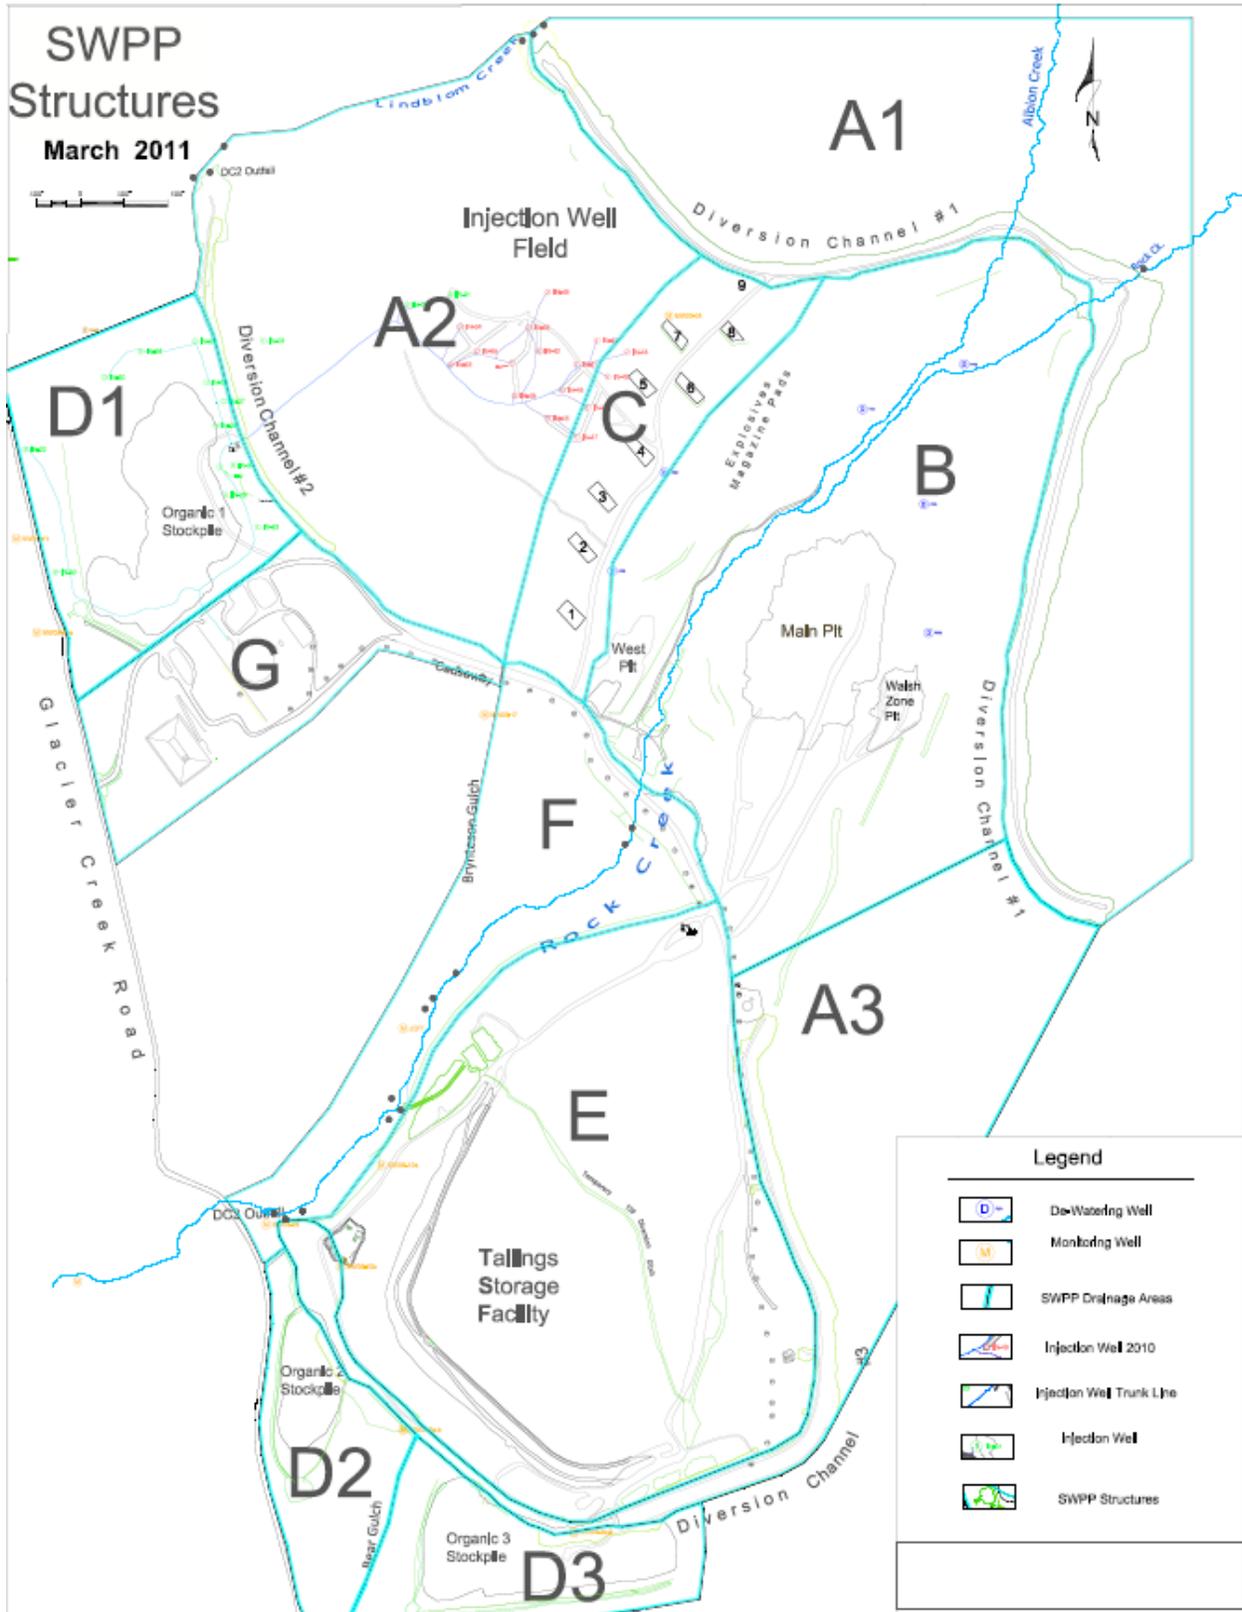
Figure 5: Rock Creek Mine SWPPP Structures

On May 15, 2010 AGC staff observed a breach in diversion channel #1 (DC-1). Ultimately it was determined that the channel was damaged for several hundred feet down-channel from Albion Creek. At approximately 500 feet down-channel from the Albion Creek intercept the channel developed a leak. The breach resulted in melt water running down the Rock Creek drainage below the intercept point and continuing to the Rock Creek Causeway. AGC immediately initiated temporary repairs, which included removal of existing snow and ice from the channel to minimize further runoff; plugging breaches with a mixture of dirt, rock and bentonite; installing a 60-mil HDPE liner over the affected area; slope stabilization; and general site cleanup. Temporary repairs were inspected frequently to ensure stability until permanent repairs to the channel could be completed.

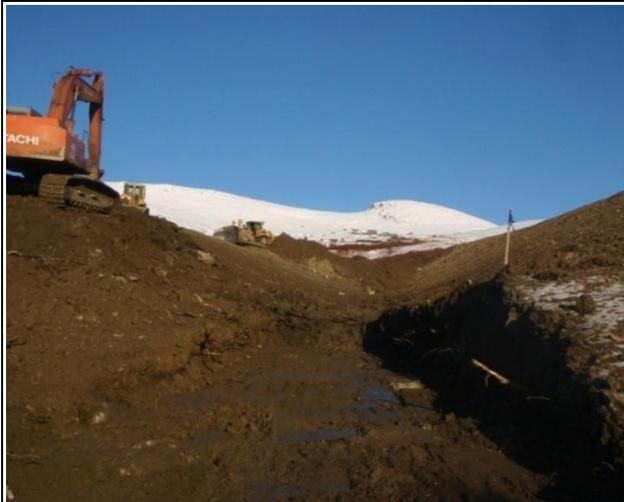
Figure 6. View upstream during Rock Creek realignment

On October 29, 2010 AGC began construction of the Rock Creek diversion across the DC-1 channel to redirect Rock Creek to the newly constructed channel. Material was placed in thin lifts and compacted by track walking. A toe drain was also constructed along the upstream and downstream edges of the dam to allow natural drainage water to be channeled around the fill area. Rock fill was placed along the downstream face to reinforce the structure and mitigate any erosion. Drain rock was placed on the upstream face of the embankment. Permanent realignment of Rock Creek was completed on October 30, 2010.

AGC determined the most appropriate permanent solution to prevent future upsets would be to restore Rock and Albion creeks to their natural channels. Permanent repairs began on October 13, 2010 with the realignment of Rock Creek. This process began with modifications to the access road (berms) and additional BMP installation (double line of silt fences) in the area to control runoff during the realignment project. Fill material that had been placed in the Rock Creek channel during DC-1 construction was removed to reestablish the natural drainage (figure 6). The excavated channel was then contoured to approximate the surrounding topography and promote more gradual drainage (figure 7). Blasted rock was used as backfill material and was tracked into the constructed channel bottom along the downstream portion (approximately 1/3 of the channel) to provide a stable channel foundation and a smooth transition to the existing channel. Woven geotextile were placed in the channel over the dredged backfill material and secured with an anchor trench prior to riprap installation (figures 8 & 9).

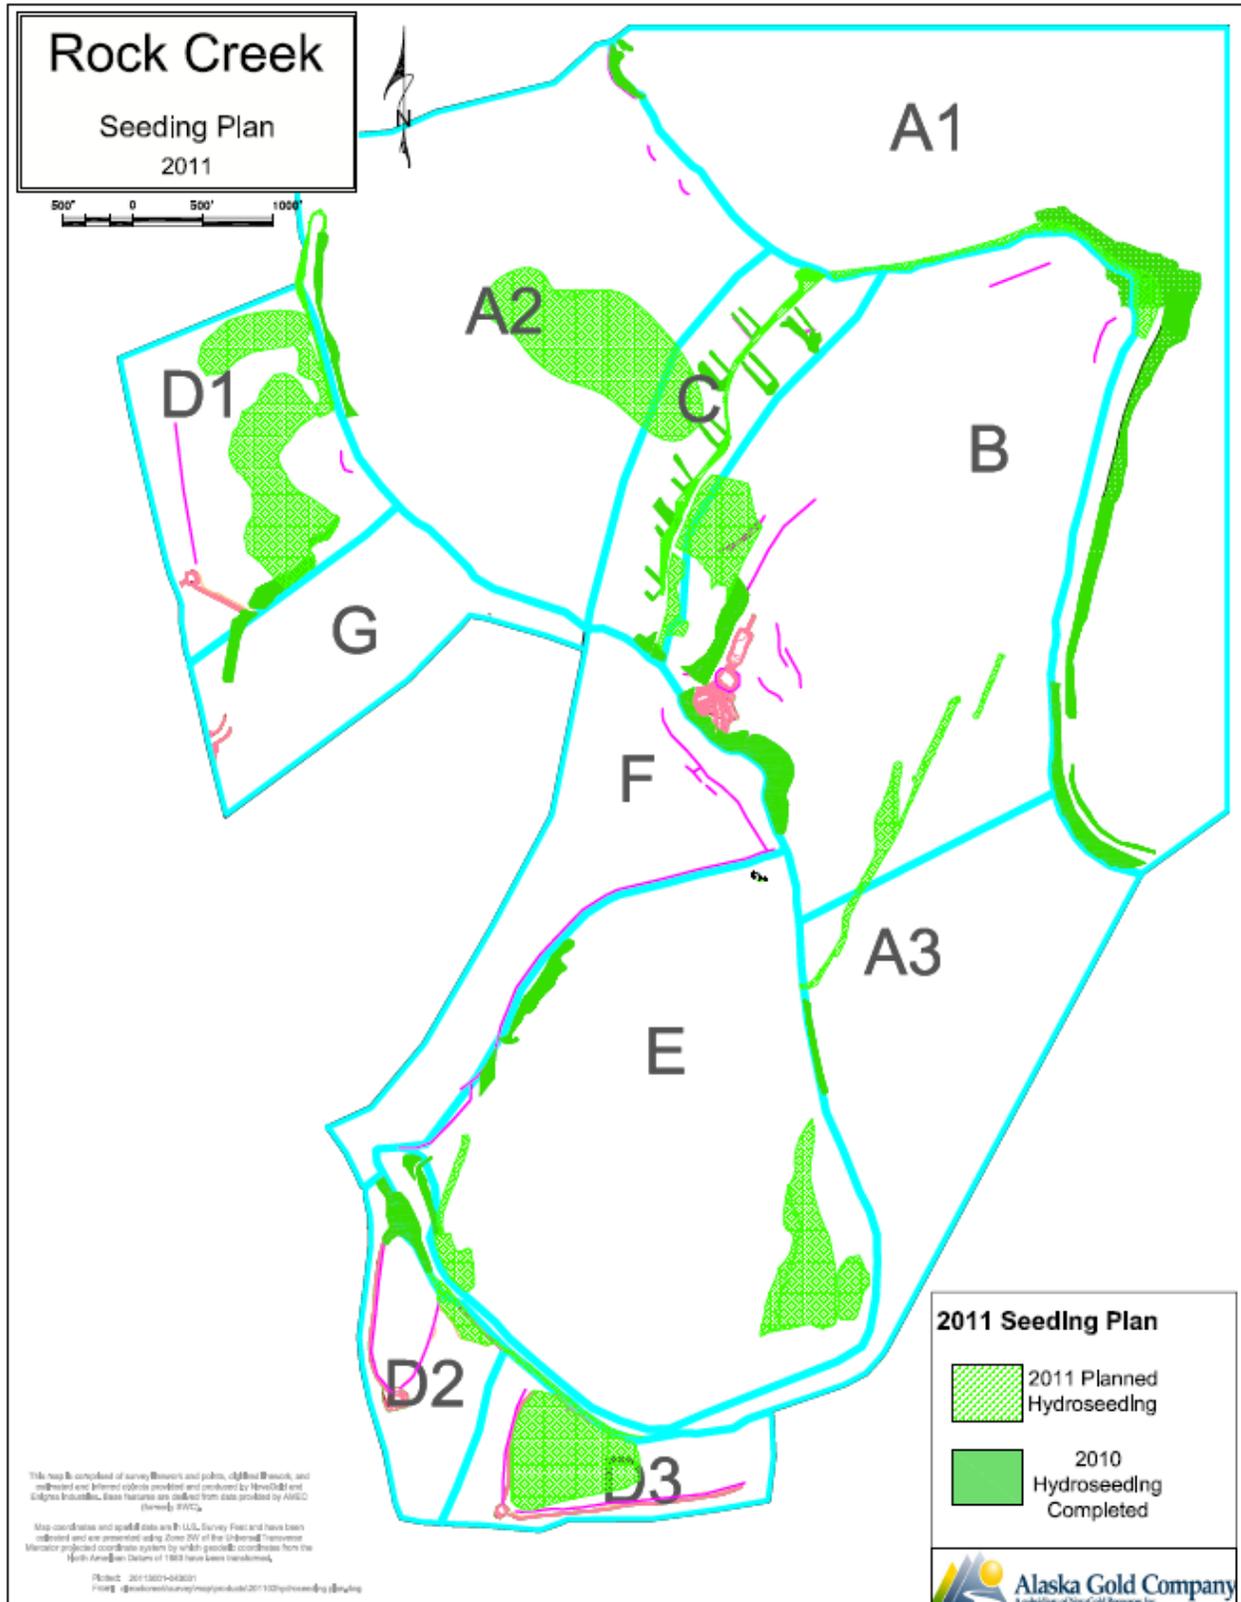
Figure 10: Rock Creek Mine Hydroseeding Area Map

Finally, during 2010, AGC undertook hydroseeding throughout the site to provide for final slope stabilization. The hydroseeding activities undertaken in 2010 and the activities planned for 2011 are shown in figure 10.

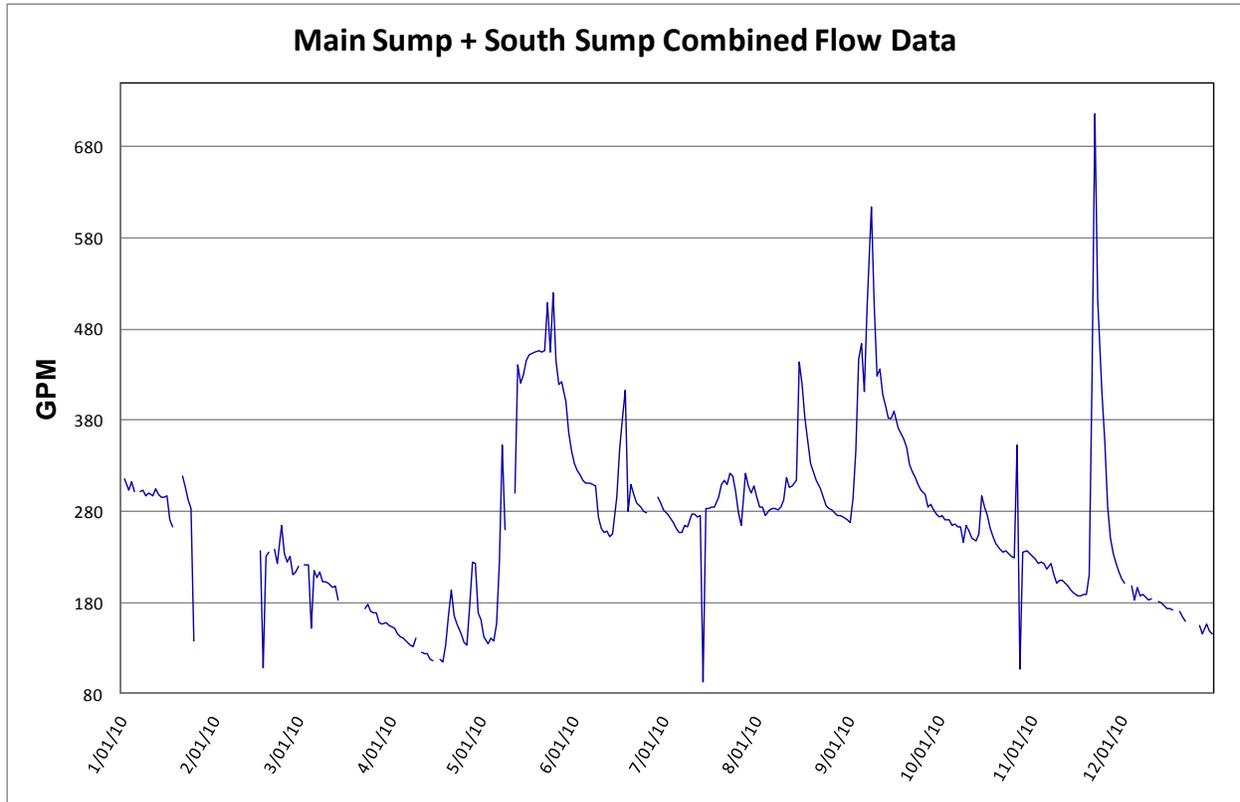
Figure 12: Main Sump + South Sump Combined Flow Data

The TSF seepage collection system (Main and South sumps) was visually inspected each day to ensure that no abnormal event has occurred. The sumps, pipe line and pumps were inspected each day. Flow meters were read and recorded (figure 12).

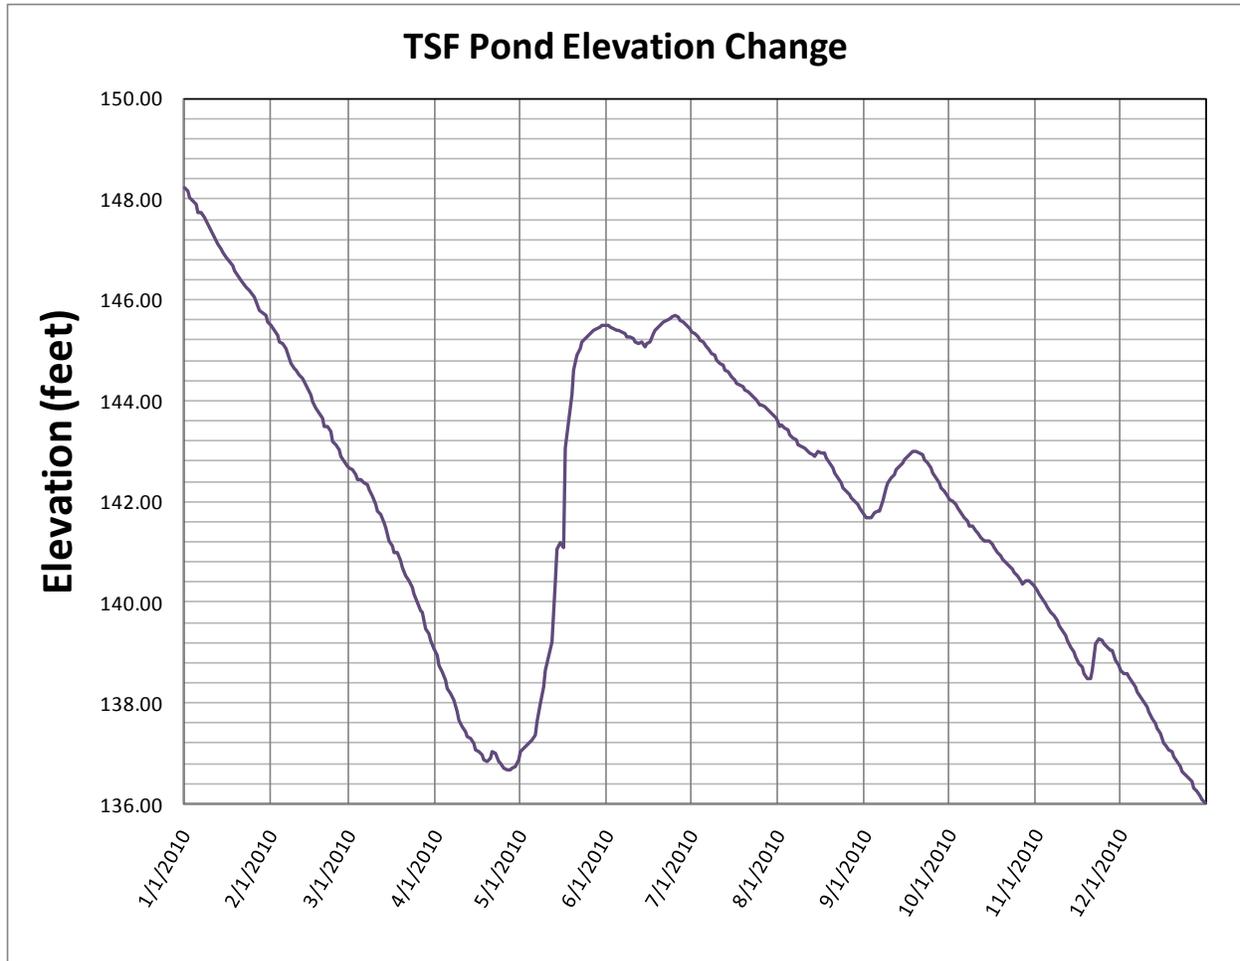
Figure 13: TSF Pond Elevation Change

The water surface elevations have been recorded on the daily TSF Inspection Log as per the Rock Creek Tailings O&M manual. After the expanded well field became fully operational in November 2009, the water level in the TSF has consistently been lowered at a higher rate than predicted by the theoretical site water balance. The COBC was terminated on April 1, 2010 when the TSF water elevation fell below 140 feet. The TSF elevation data for 2010 is presented in figure 13.

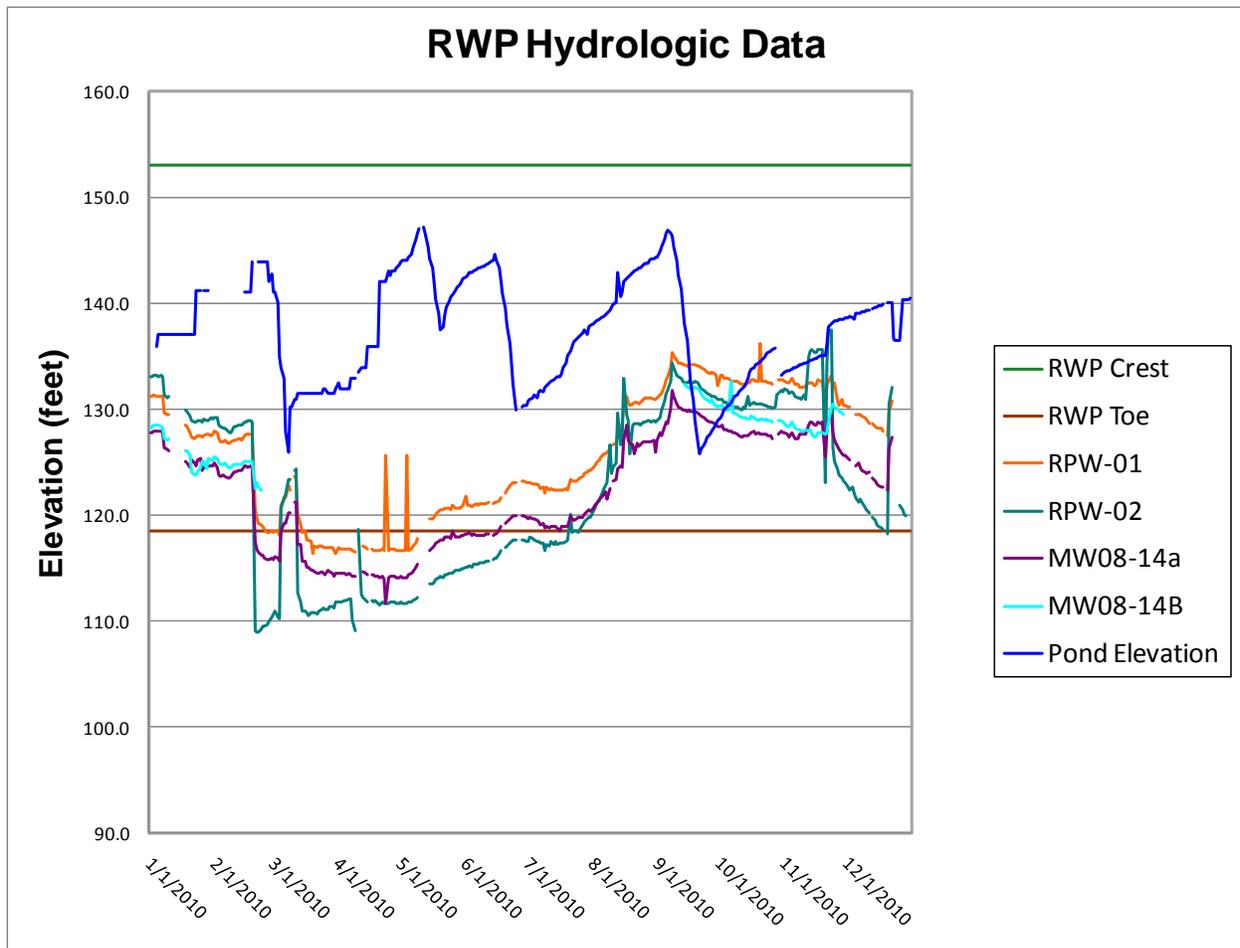
Figure 14: RWP Hydrologic Data

The figures below show groundwater elevations for 2010. Groundwater elevations were highest from September through October 2010.

The Rock Creek Tailings O&M manual specify an operating water level in the RWP be maintained at 139 feet elevation in order to accommodate storm water run-off from the mill site. As shown in figure 14, the target level of 139 feet was exceeded periodically during 2010. When in operations, this level would be maintained through the recycling of process water throughout the mill plant facility. During temporary closure Care and Maintenance operation, AGC does not maintain continuous pumping of the RWP to the TSF, and therefore periodically batches RWP pond water to the TSF when higher levels are reached. The RWP level is monitored on a daily basis to ensure adequate storage for any potential storm water run-off.

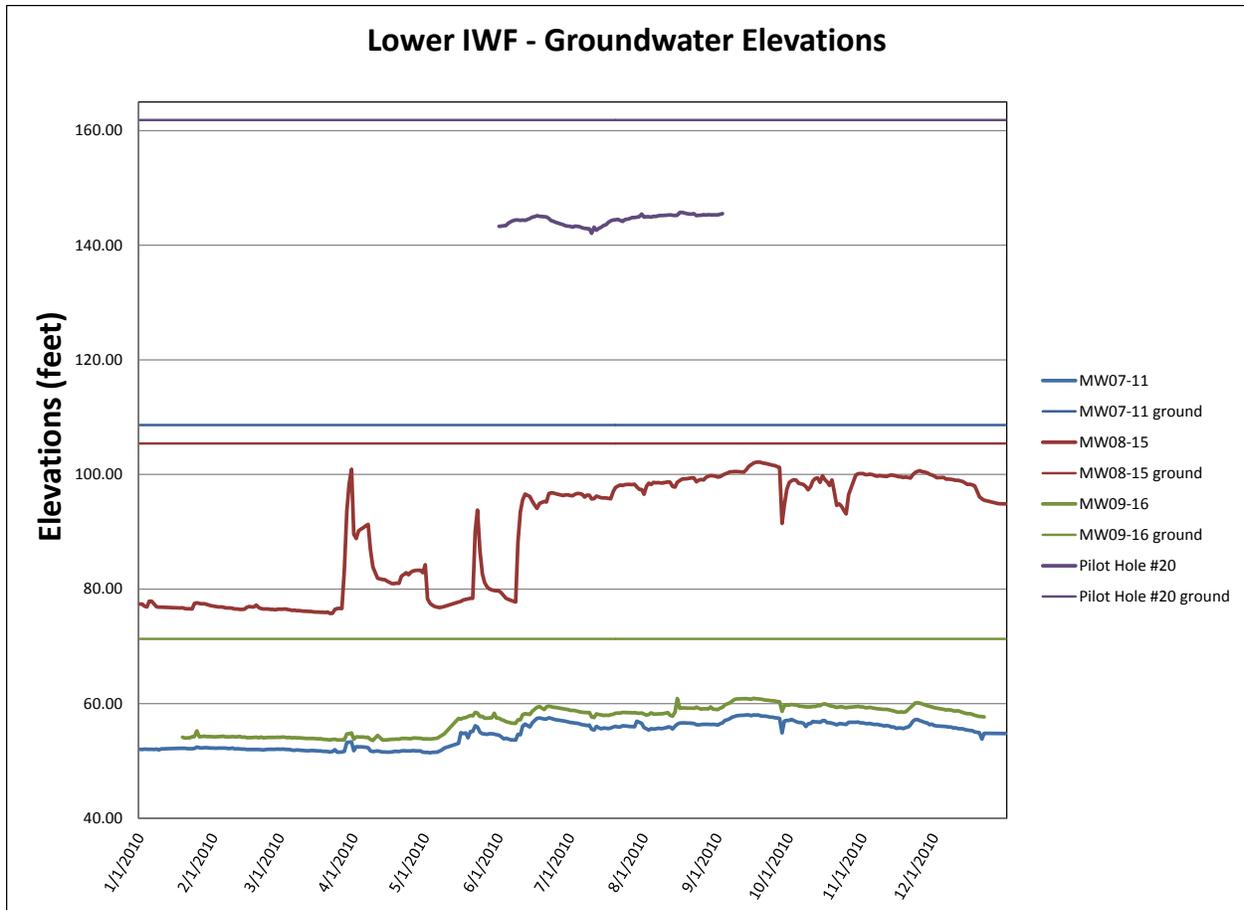
Figure 15: Lower IWF Groundwater Elevations

Water levels in the monitoring wells near the Lower IWF have always been below the ground surface elevation, indicating that the injection activities have not over-pressurized the groundwater system. In the Upper IWF, water levels in wells MW03-04, JEFF, and MW09-17 (MW03-07) are very close to or at ground elevation. Historic data show that water levels in wells MW03-04 and MW03-07 were at ground level during summer 2004, thus, groundwater in this area is naturally very close to the ground surface, and the high water levels are not caused by injection. No historic data are available for well JEFF; however, its location is close to Rock Creek which indicates that groundwater levels are naturally close to the surface.

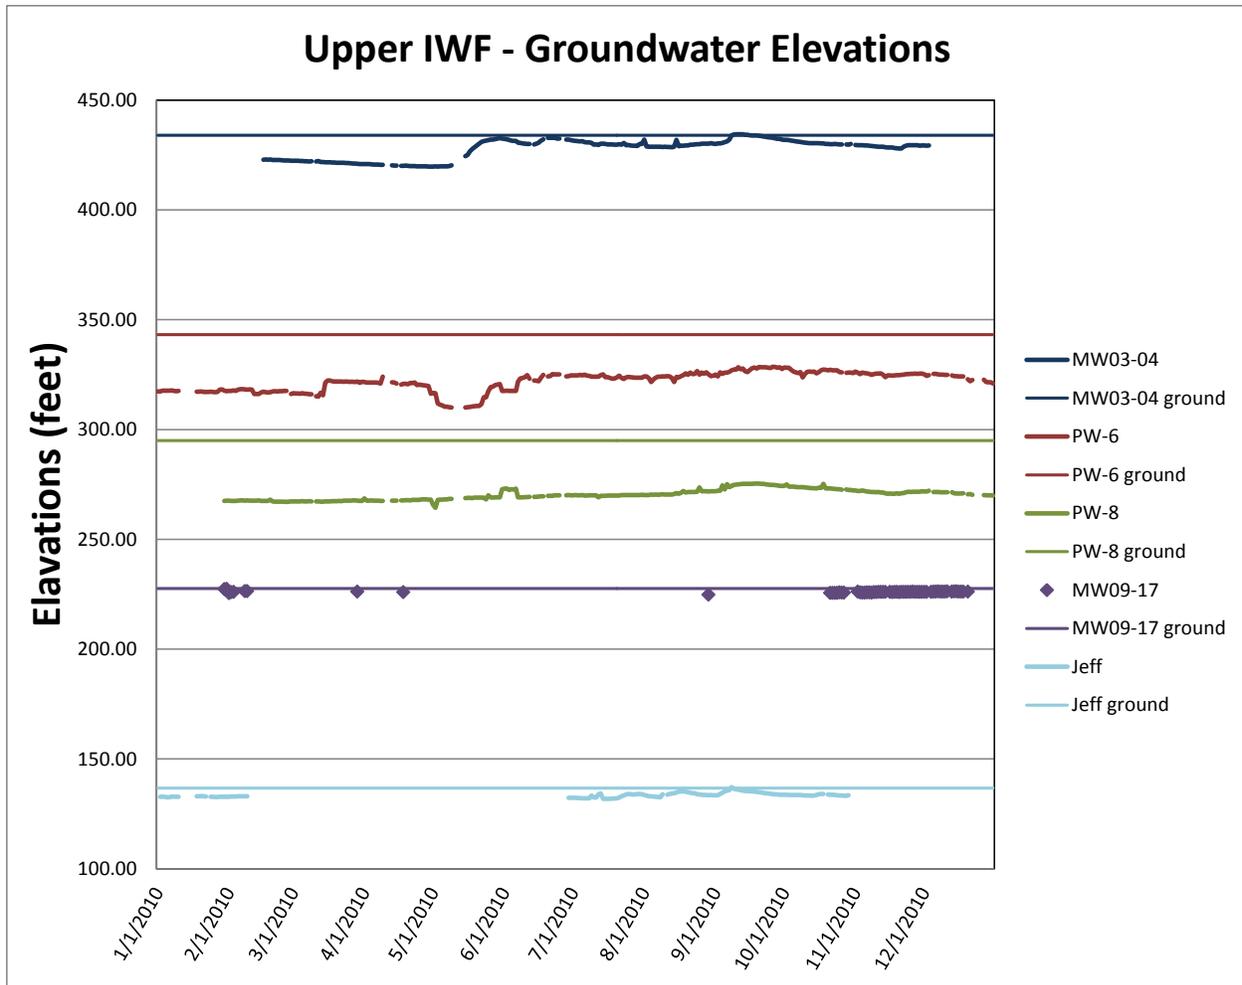
Figure 16: Upper IWF Groundwater Elevations

Not enough data have been collected for MW03-07 and its replacement well MW09-17 to discern any trends (figure 16).

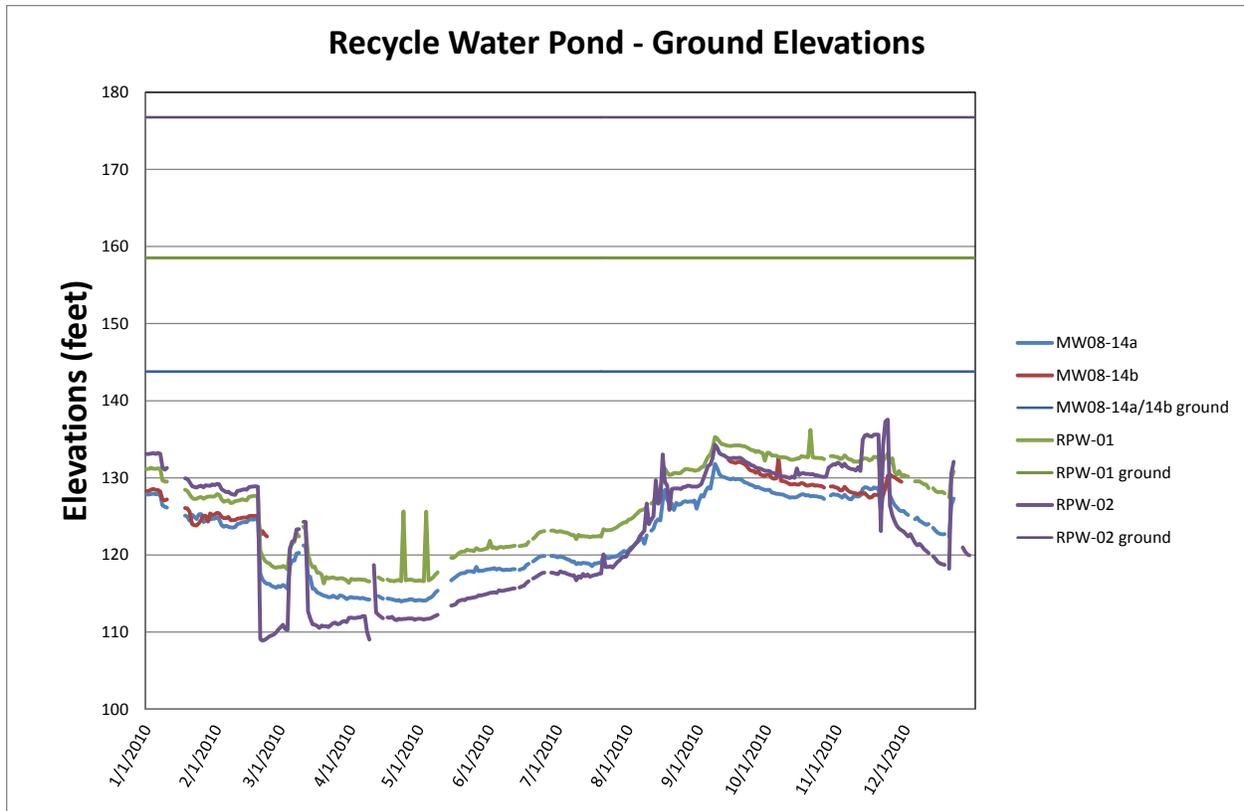
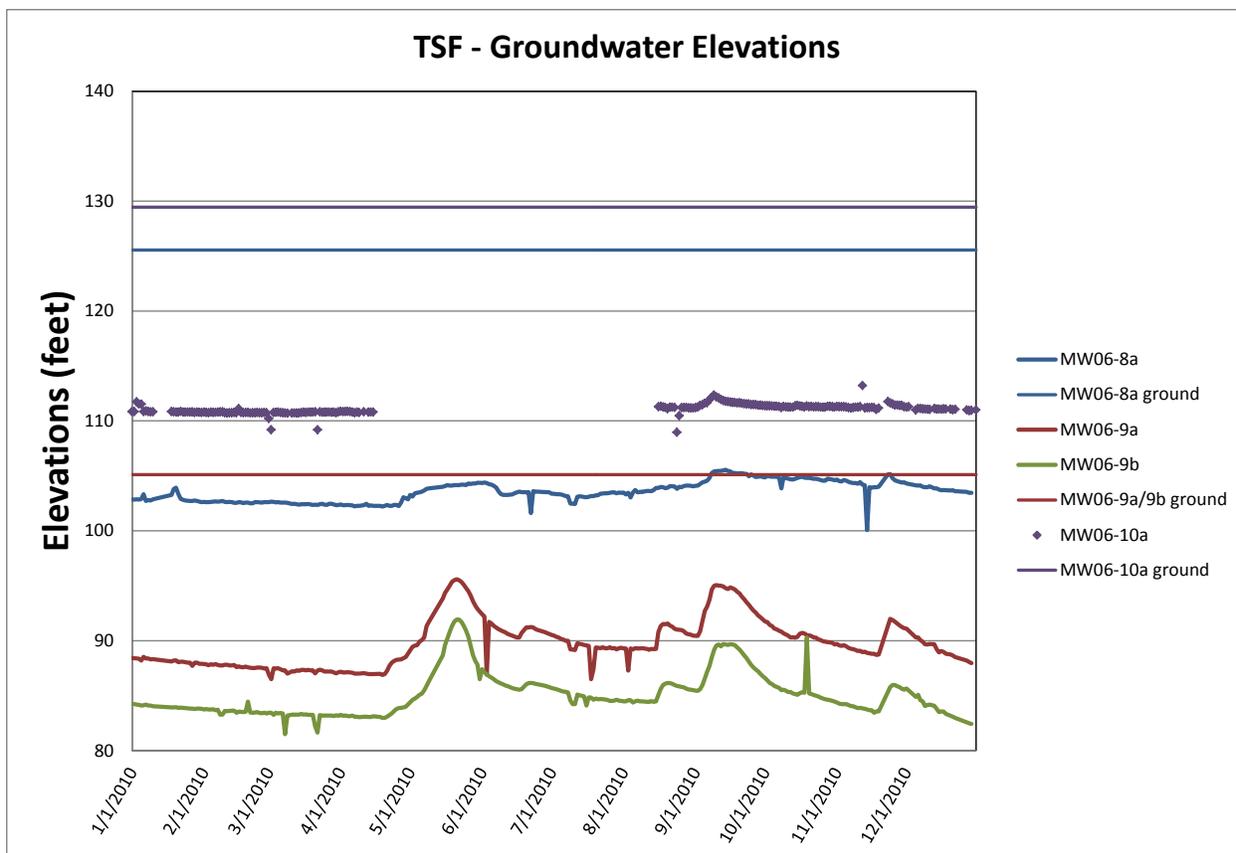
AGC also monitors groundwater elevations at monitoring wells below the RWP and TSF. No anomalies or upwellings were observed in these wells during 2010 (figures 17 & 18).
