## THE PHYSICAL AND HYDROLOGIC CHARACTERISTICS OF THE GULKANA RIVER, SOUTH CENTRAL ALASKA

State of Alaska  
Department of Natural Resources  
Division of Geological and Geophysical Surveys

October 1983

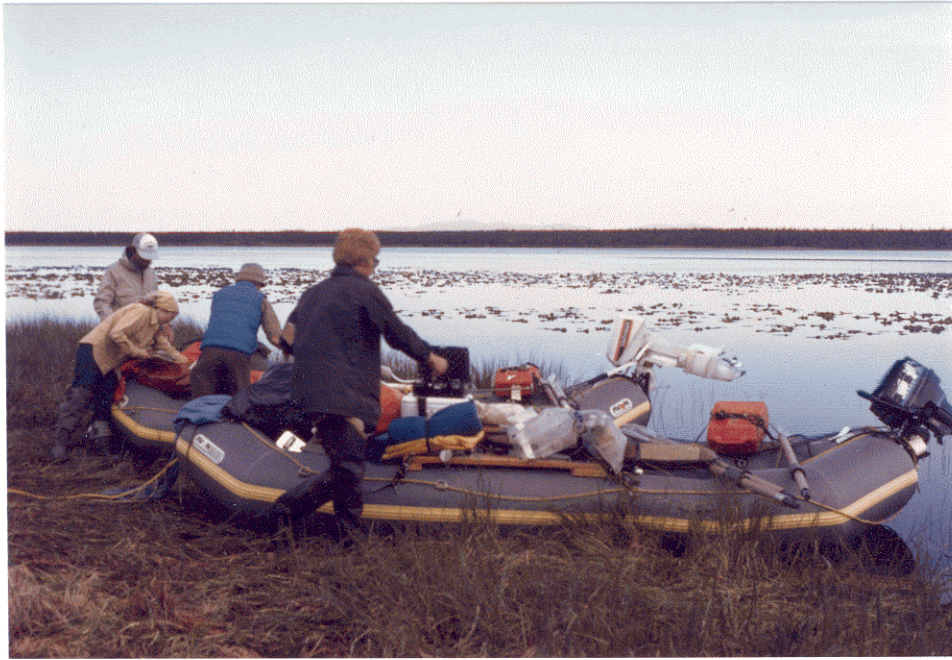
Lake #10 is located at approximately mile 84.2 on the West Fork mileage scale. The lake is about 2 miles long by 3/4 miles wide. Lily pad like vegetation characterizes the near shore shallow areas; no significant topography is found immediately adjacent to the bank. Banks are covered by grasses, sedge tussock, and black spruce along with willow and isolated deciduous trees. The maximum observed depth was 14 feet near the southern part of the lake. The water was clear with a turbidity reading of 1.2 NTU. See Gulkana C-6; and photo 1, Appendix 2.

1. Lake #10. Starting point of float trip mile 84.2; preparing for departure.

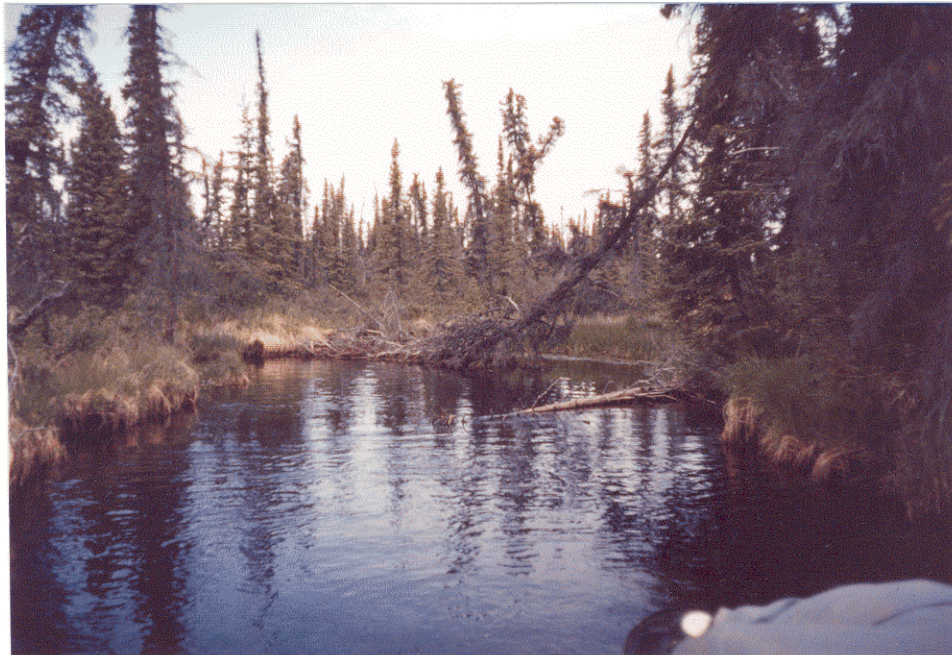
A short reach, extending from the outlet of Lake #10 at West Fork mile 84.2, downstream .7 miles to Lake #9, at mile 83.5. This reach is a meandering reach varying in width from 6 to 100 feet, and depths from 1 - 3 feet with some pools up to 5 feet deep. The banks are all made of silt sized material and covered with grass. The streambed is composed of materials from silt to boulder in size with gravel predominating. No channel bars were found. Maximum velocity measured near the inlet to Lake #9 was 2.5 feet per second (fps) or 1.7 mph. Discharge at that site was measured at 18.2 cfs. The water temperature was 60°F. See Gulkana C-6; and photo 2, Appendix 2.

2. Channel between Lake #10 and Lake #9, at mile 83.8. Photo is taken looking upstream.

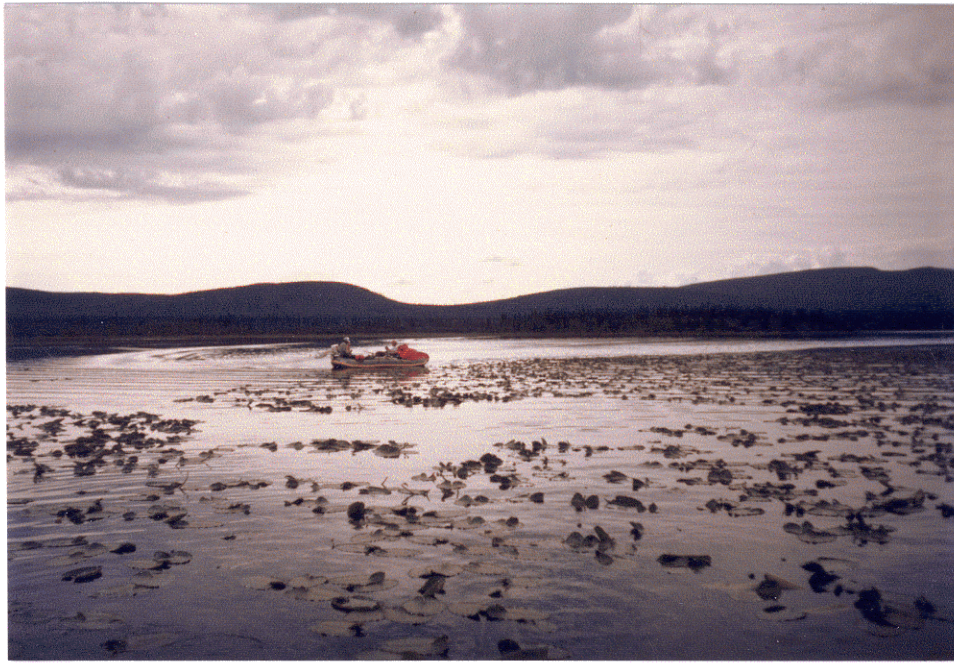
Lake #9 is located between mile 83.5 and 81.8 on the West Fork mileage scale. The lake is very similar in appearance to Lake #10. The vegetation, topography, and general character remained the same as Lake #10, however, it was 1.8 mile long by 1.5 miles wide and depths were never measured in excess of 3 feet. Additionally the water color appeared browner, more influenced by tannic acids, a probable result of the channel connecting Lake #10 to Lake #9. See Gulkana C-6; and photo 3, Appendix 2.

3. Lake #9, near outlet, mile 82.

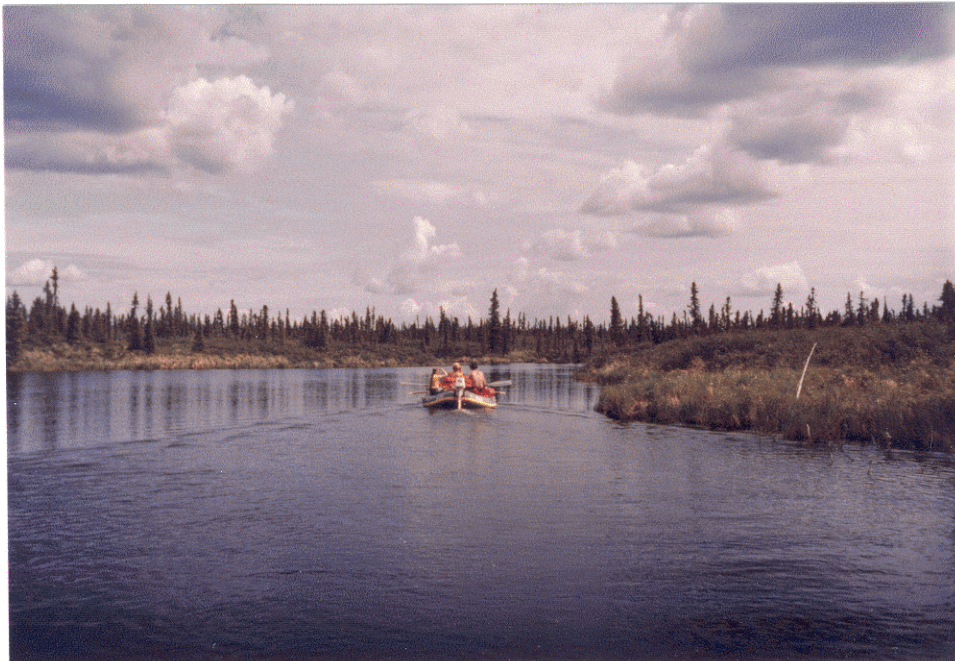
This reach began at the outlet for Lake #9 at mile 81.8, and extends downstream to mile 76.5. Generally, this reach is a low gradient, slow, meandering stream. Bank vegetation is similar to that observed in Lake #10 upstream, including grasses to waterline, sedge tussock, black spruce along with willow, and isolated deciduous trees. Lily pads existed in protected side channel areas. The channel was generally 50 to 100 feet in width, but in places narrowed to 30 feet. Depths were generally 3 to 4 feet, with some shallower riffle areas at mile 79 and 78.1. Surface velocity was estimated at less than 1 fps (less than .7 mph). The channel appeared stable within its banks. Many ice scars were seen on trees approximately 3 feet higher than stage, which was at or near bankfull. Meandering increased downstream and turbidity was low. Reach was largely motored. See Gulkana C-6; and photo 4, Appendix 2.

4. Reach #1, mile 77. Photograph is taken looking downstream.

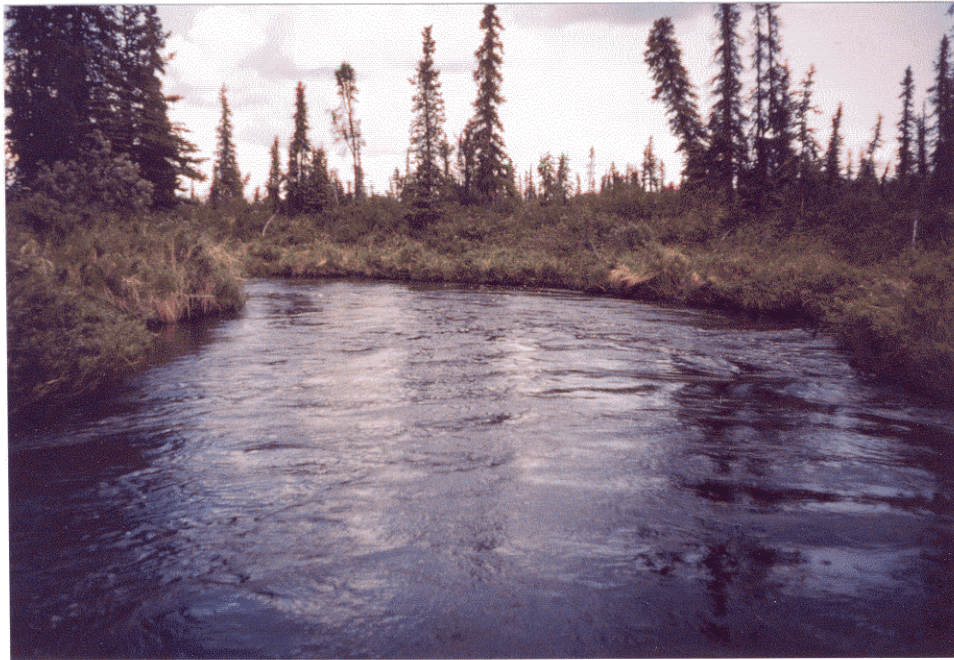
This reach exhibits an increased gradient, narrower channel with tighter meanders, and greater incision than Reach # 1. The channel was 30 to 60 feet in width, with depths usually 2 - 5 feet, with occasional pools to 6 feet. The immediate banks were grass covered, and made up largely of sand to silt sized material. Some organic debris was noted. Streambed material consisted

primarily of gravel to cobble sized material, with occasional larger boulders. See Gulkana C-6; and photo 5, Appendix 2.

5. Reach #2, mile 74.6. Photograph is taken looking downstream.

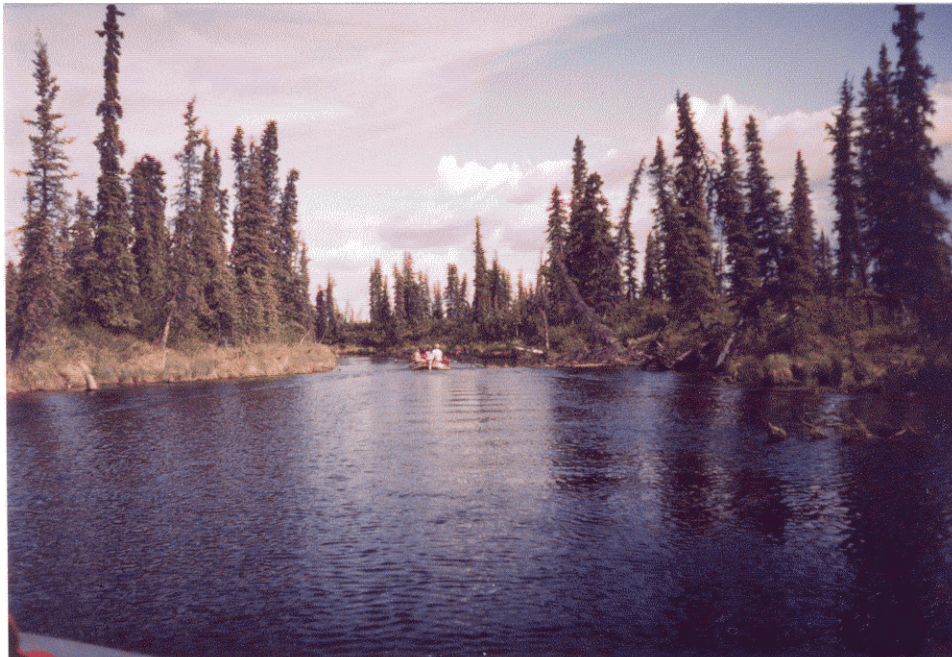
This reach ends at Headwaters Lake, and is characterized as wider and slower. Lakelike side bays are found, and meander bends seem more gentle. The meandering channel varies between 75 to 125 feet wide, and is usually between 3 - 5 feet in depth. The banks were composed of sand and silt, and covered to the waterline with grasses. Bed material was finer than those found upstream, mainly sand and silt. Some organic debris was seen. See Gulkana C-6; and photo 6, Appendix 2.

6. Reach #3, mile 71.5. Photograph is taken looking downstream.

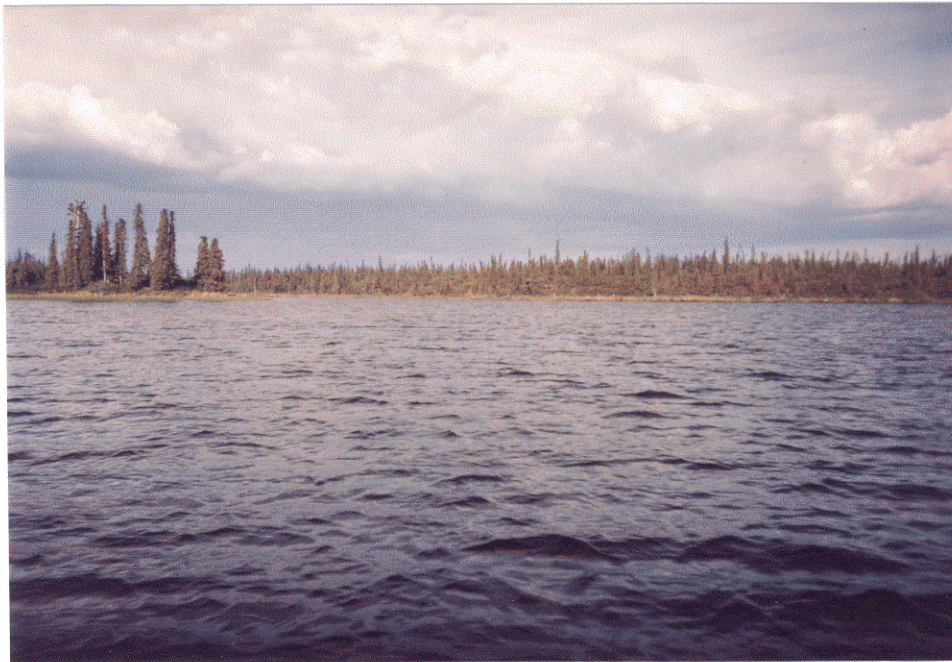
Headwaters Lake is located between mile 70.8 and 69.8. The lake is about 1 mile long and, at a maximum, .5 miles wide. Bed material was mostly silt in size. Generally, the lake was shallow, in the 1 to 3 foot range, with a grassy shoreline, and aquatic vegetation that occasionally comes to the surface. See Gulkana C-6 and C-5; and photo 7, Appendix 2.

7. Headwaters Lake, near outlet, approximately mile 70.

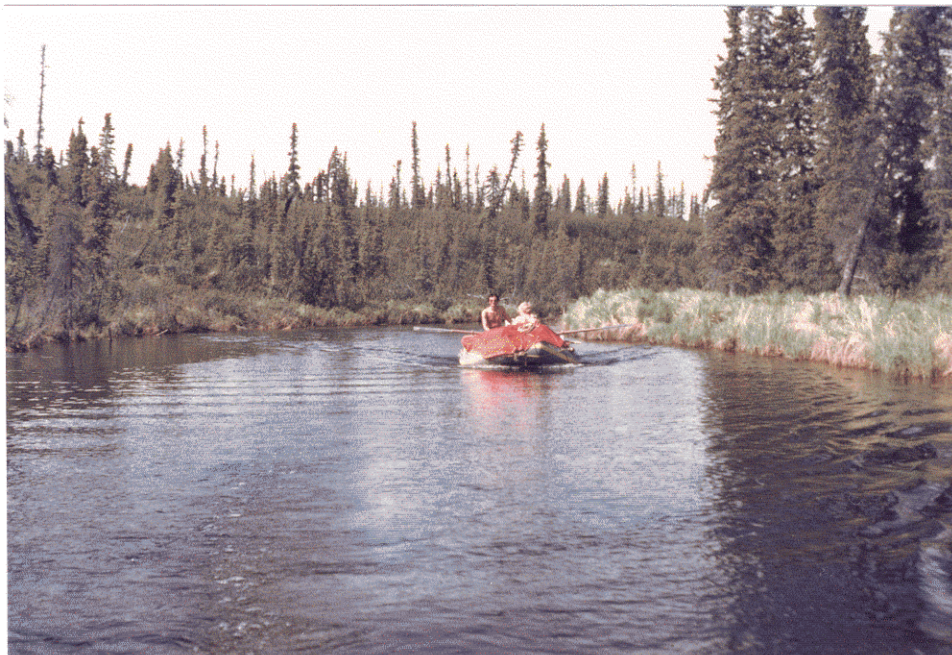
This reach began at the outlet for Headwaters Lake at mile 69.8 and is a 50 to 75 foot wide channel meandering between grass covered sand to silt sized particle banks. The bed material was composed largely of gravel and sand. Depths were generally 3 - 7 feet, however, pools up to 10 feet were measured. Water velocity was measured at 1 fps (.7 mph). At mile 64.2, a sweeper blocked the channel. The water was clear and measured 14 NTU. Discharge was measured (mile 69.5) at 122 cfs. Ice scars up to 4 - 5 feet over current stage were observed. See Gulkana C-5; and photos 8 - 9, Appendix 2.

8. Reach #4, mile 67.9. Photograph is taken looking upstream.

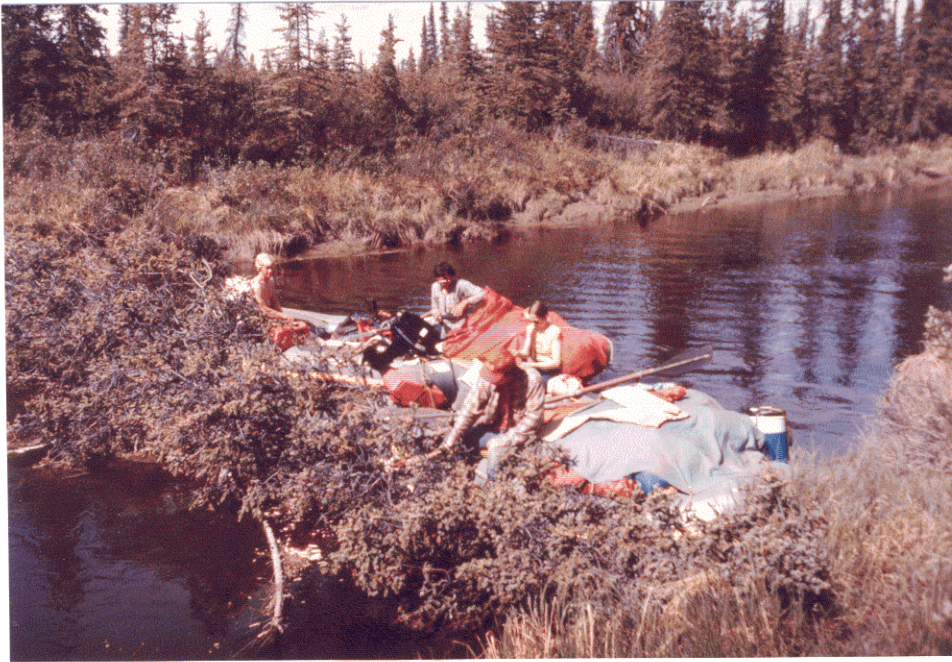
9. Reach #4, mile 64.2. Chopping sweeper to clear channel.

One sweeper and one log jam were encountered during the day. The first, a sweeper at mile 64.2, was a recently downed spruce that just barely blocked the entire width of the river. A Sandvik-brand brush axe was used to remove the top of the tree and clear a path. The delay took roughly 10-15 minutes. A log jam was found at mile 54.5. Ed put on waders and cleared enough of the jam in 15 minutes to allow the boats to be pulled through. Camp was made a few hundred yards downstream from mile 53.3 where Roger and Ed did a survey. A total of 16.5 miles were traveled during the day with clear, sunny, and warm weather prevailing.

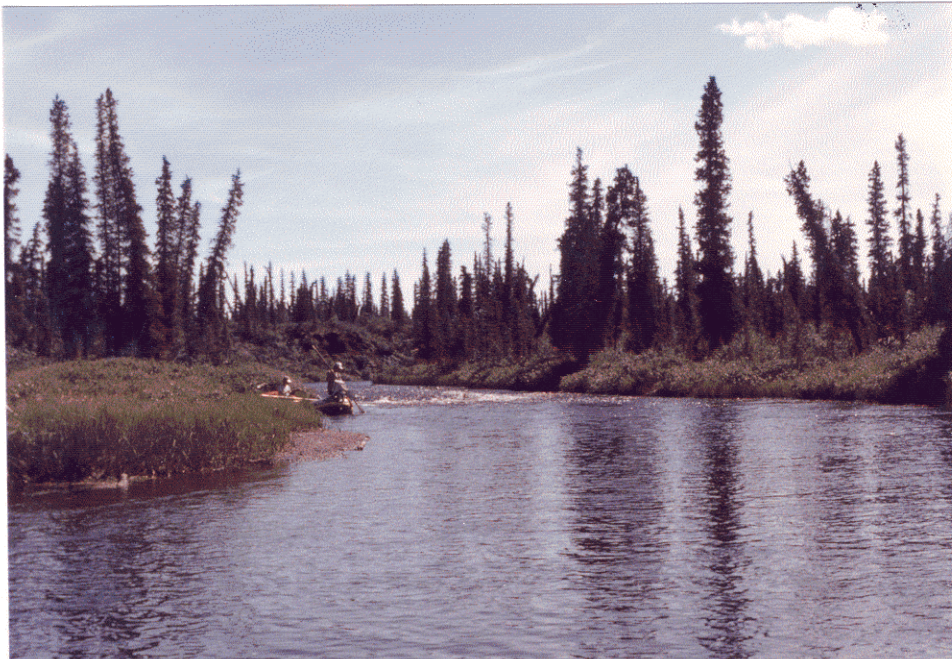
Reach #5 is a meandering channel between 50 to 75 feet wide and 1 - 4 feet deep. Generally, this reach exhibits more of a classic pool and riffle development than upstream. First evidence of point-bars were also noted. Bank materials varied from silt to gravel. Bed materials ranged from gravel to cobbles, with some boulders. Surface velocity estimates were 2 - 3 fps (1.5 - 2.0 mph). Additionally, surface velocity was measured at 2.5 fps, at mi 53.25. Water temperature was 69°F and pH was 7.95. The stage at the time of travel was about 6 in. below bankfull. Some active channel shifting was found between miles 57 - 55. A meander cut-off was found at mile 54.8, which created a log jam. Discharge was measured at 133.4 cfs at mile 53.2. See Gulkana C-5; and photos 10 - 11, Appendix 2.

10. Reach #5, mile 59.8. Photograph is taken looking upstream. Note small riffle.

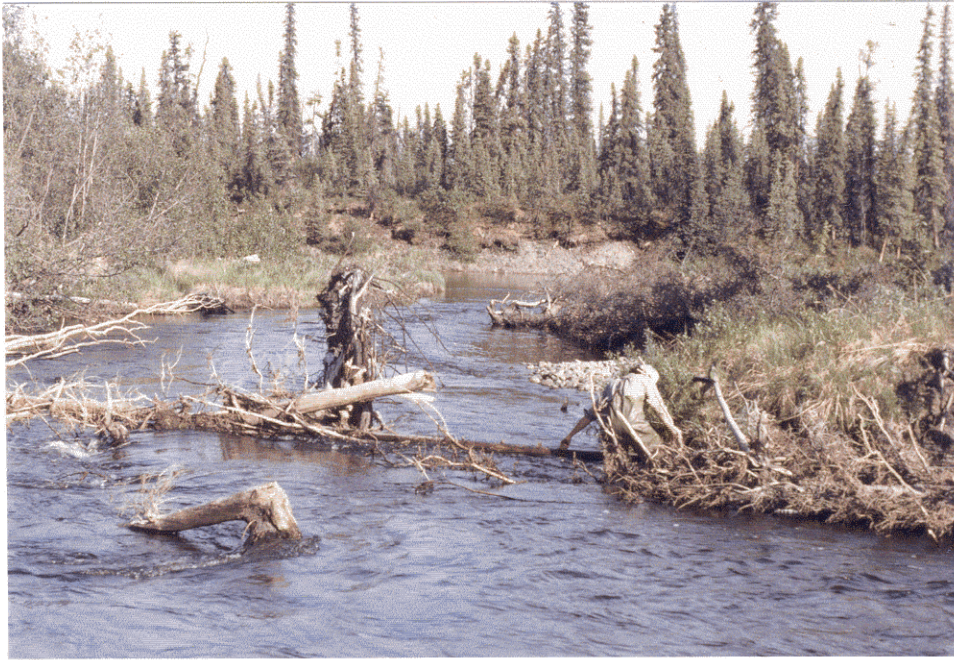
11. Reach #5, mile 54.5. Log jam.

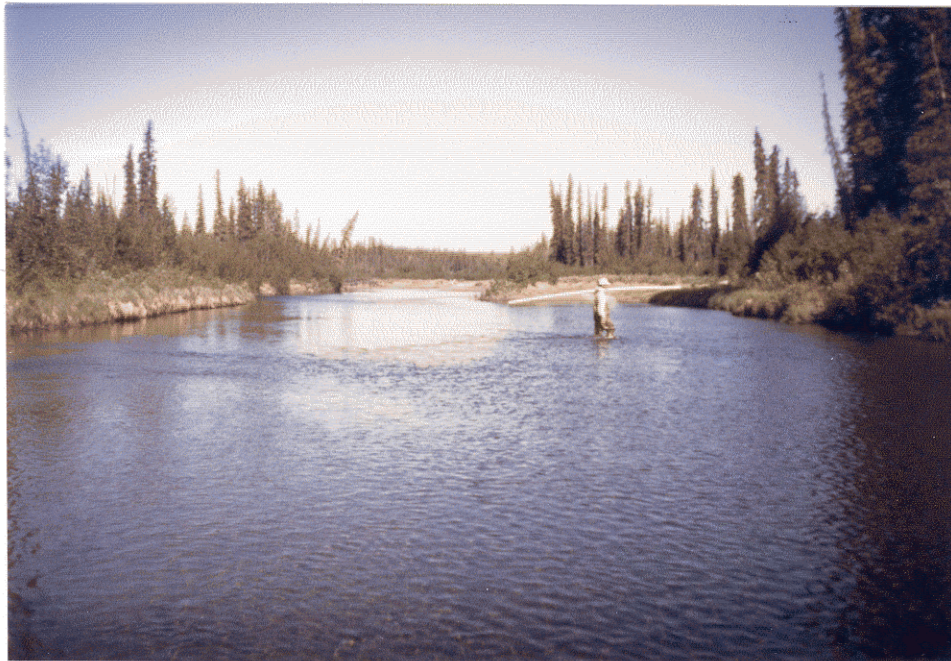
The North Branch channel near the confluence of the North Branch and West Fork was 75 feet wide and generally not more than 2.5 feet deep. Bed material was mostly gravel to cobble in size. Ice scars approximately 3 feet over stage were seen. A discharge measurement was made .8 miles above the confluence. At that site discharge was measured at 102 cfs, maximum flow velocity was measured at 2.1 fps (1.4 mph). The water was clear, with temperature at 55°F. See Gulkana C-5; and photo 12, Appendix 2.

12. North Branch Channel. Photograph is taken at gaging site .8 miles upstream on the North Branch from its confluence with the West Fork.

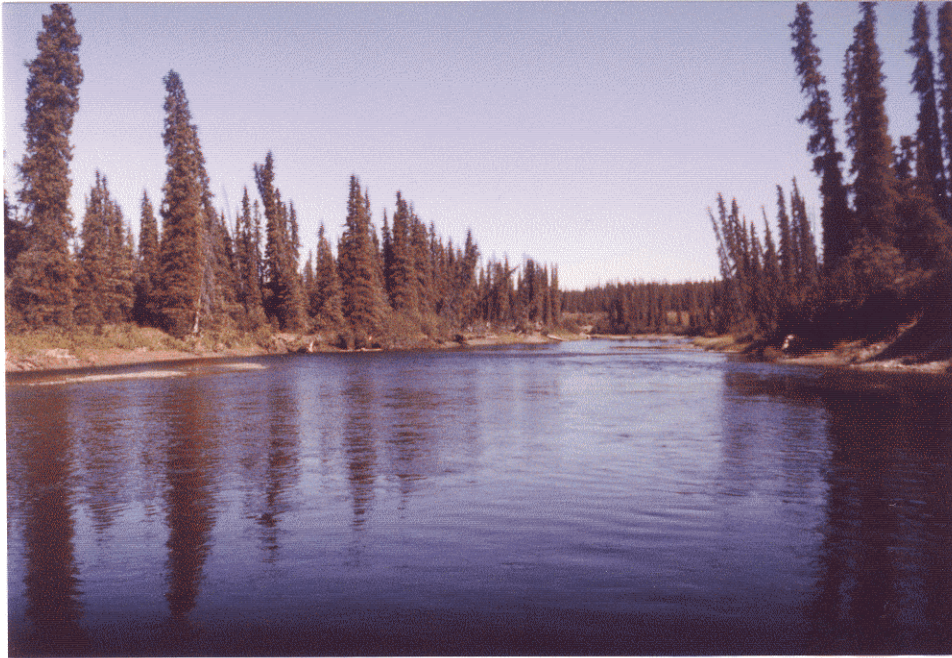
This reach begins at the confluence of the North Branch and West Fork at mile 52.7. The channel here is meandering, 50 to 150 feet wide, and 4 - 8 feet

deep. Banks are made of sand to gravel sized material, generally covered with grass, but occasionally raw, with some minor organic debris. Bed materials vary from gravel to cobbles, with some boulders. Occasional small channel bars, bare or covered with grass, are found. Surface velocity was estimated at 2 - 2.5 mph. Cutbanks exhibit some active cutting. Generally, this reach was wider and slower than the one above. Bankfull discharge was 2 - 3 feet over current stage. See Gulkana C-5; and photo 13, Appendix 2.

13. Reach #6, mile 50.3. Photograph is taken looking downstream.

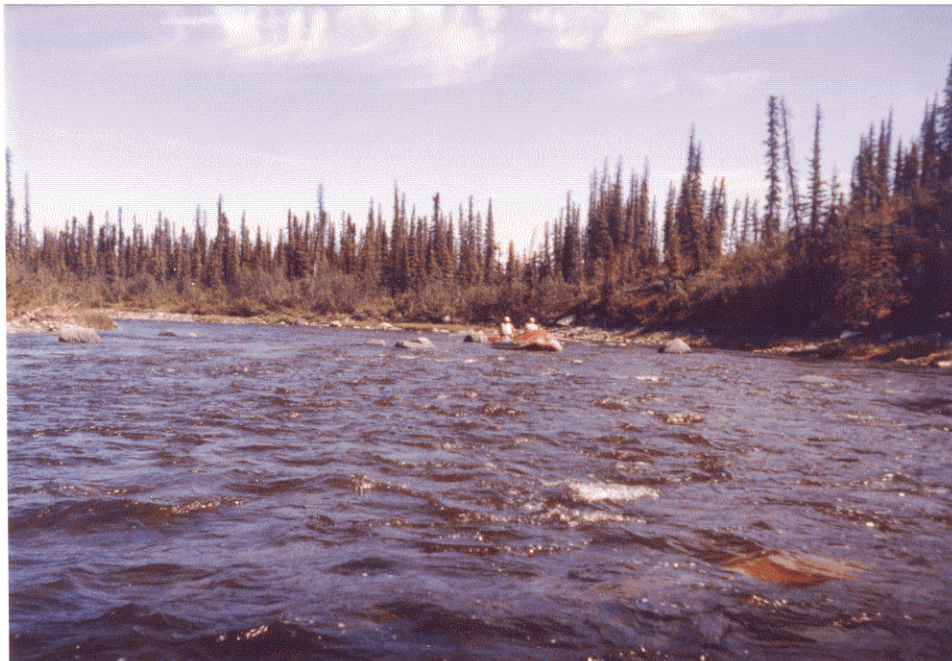
In this reach the channel becomes more incised, with higher gradient and more frequent riffles. At current stage, the meandering channel's width was 50 - 100 feet and depth was 2 - 4 feet. Bank materials are silt to gravel in size and covered by grass and willow or are raw and cut. Streambed material is mostly cobbles, with some boulders. Occasional channel bars with small amounts of grass and some minor amounts of debris were observed. Surface velocity was estimated at 2 - 3 mph. A few minor differences in the channel were noted in comparison with the Gulkana C-5 map. See Gulkana C-5; and photo 14, Appendix 2.

14. Reach #7, mile 44.7. Photograph is taken looking downstream.

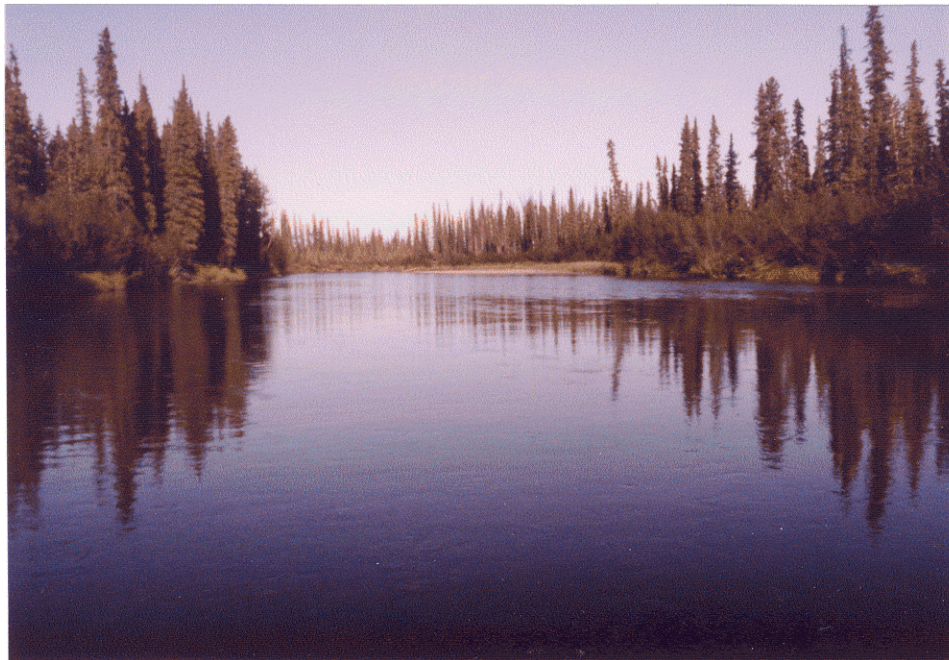
Generally a slower, deeper reach than the one upstream, with a few riffles. The meandering channel is 100 - 200 feet wide and 3 - 4 feet deep with pools to 7 feet. Surface velocity is approximately 2 mph. Banks are made of silt to gravel sized particles and are about 50 percent raw and 50 percent covered in grass and willow. The streambed consists of mainly gravel with 20 percent cobbles and occasional boulders. Sand is found on point bars and active cutting is going on outside banks. Bankfull flows appear to be 1.5 - 2 feet higher than current stage. Most of the reach was motored. See Gulkana C-5 and C-4; and photo 16, Appendix 2.

16. Reach #9, mile 33.5. Photograph is taken looking downstream.

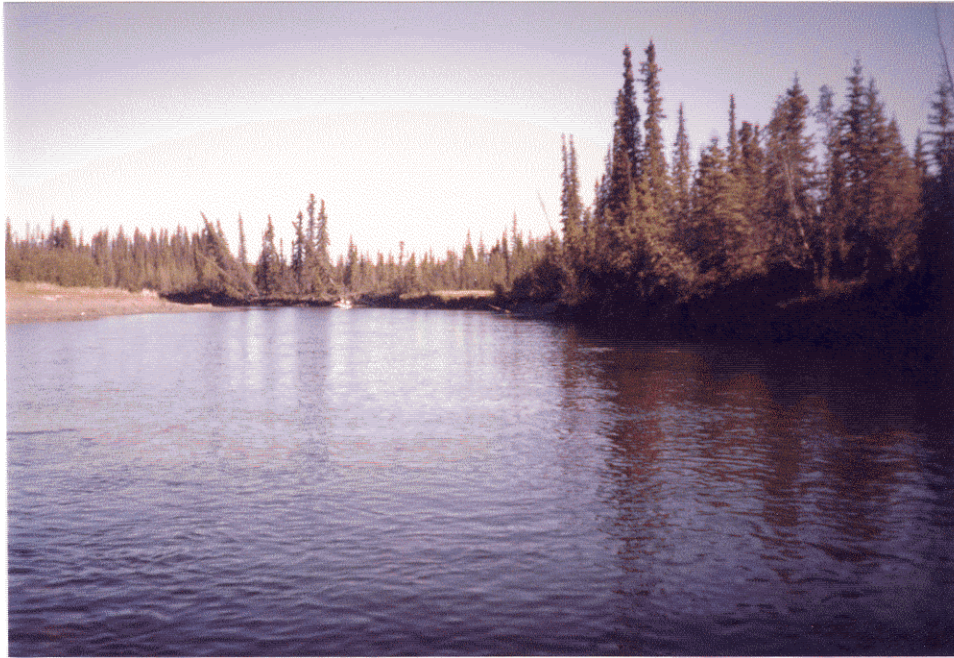
The river in this long reach is homogenous, completely losing its riffle reaches, with depths consistently above 3 feet. The extremely meandering stream varies from 75 to 100 feet wide. Banks are made of silt to gravel sized particles and are usually raw and appear easily eroded. Bankfull flows were estimated at 1 - 2 feet above current stage as evidenced from grass line. Surface velocity was fairly slow at 1 - 1.5 mph. Deciduous vegetation becomes more dominant. See Gulkana C-4; and photo 17, Appendix 2.

17. Reach #10, mile 28.1. Photograph is taken looking upstream.

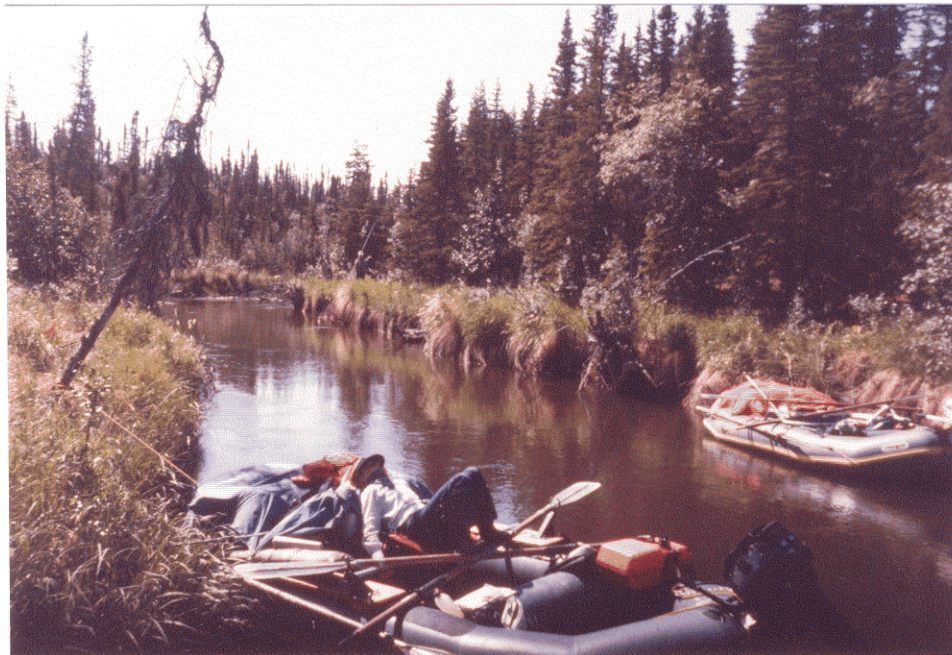
The channel near the confluence was 25 feet wide and up to 5 feet deep. The bed was made of silt sized particles. The banks were grass covered to the waterline and were slumping into the water. A discharge measurement was made about 1 mile up Fish Creek above the confluence with the West Fork. At this site discharge was measured at 101.4 cfs with a maximum surface velocity of 1.7 fps (1.2 mph). The water temperature was measured at 67°F. See Gulkana C-4; and photo 18, Appendix 2.

18. Fish Creek, channel and survey section. Photograph is taken looking upstream.

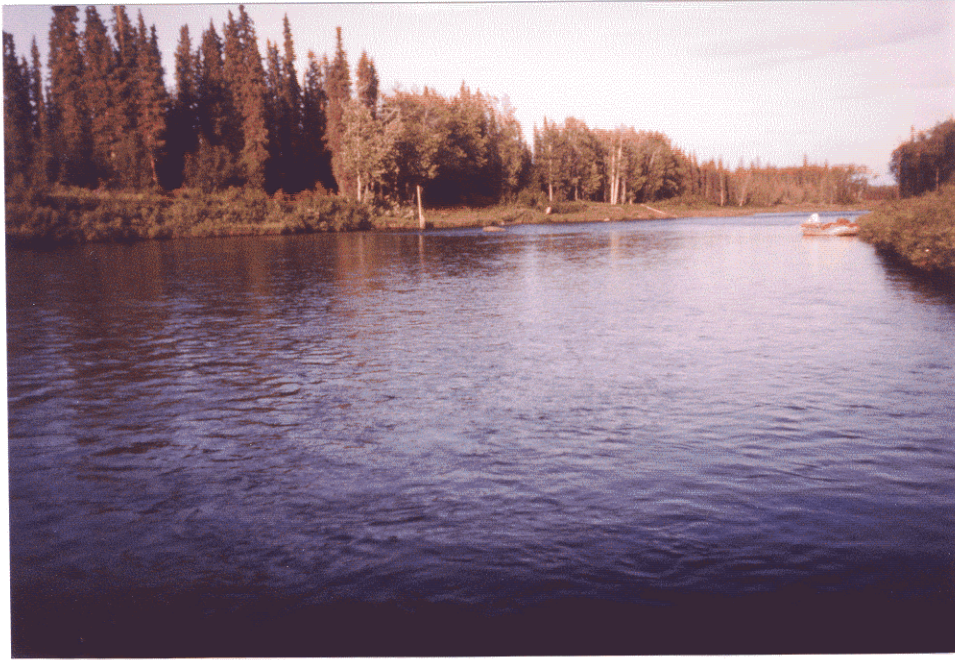
In this reach the channel becomes less meandering and varies between 75 - 150 feet in width, with 2 - 5 foot depths. Bankfull flows were estimated at 1 - 2 feet over current stage. Banks were composed of sand to cobble sized material and were about 50 percent raw and 50 percent covered in grass and willows. Streambed material was mostly gravel and cobble sized with up to 20 percent boulders. Small channel bars were noted. Surface velocity was measured .5 mi above the confluence with the main fork at 1.9 fps or 1.3 mph. Discharge at this site was measured at 446.2 cfs. See Gulkana C-4; and photo 19, Appendix 2.

19. Reach 11, mile 0.5. Channel and survey site. Photograph is taken looking downstream.

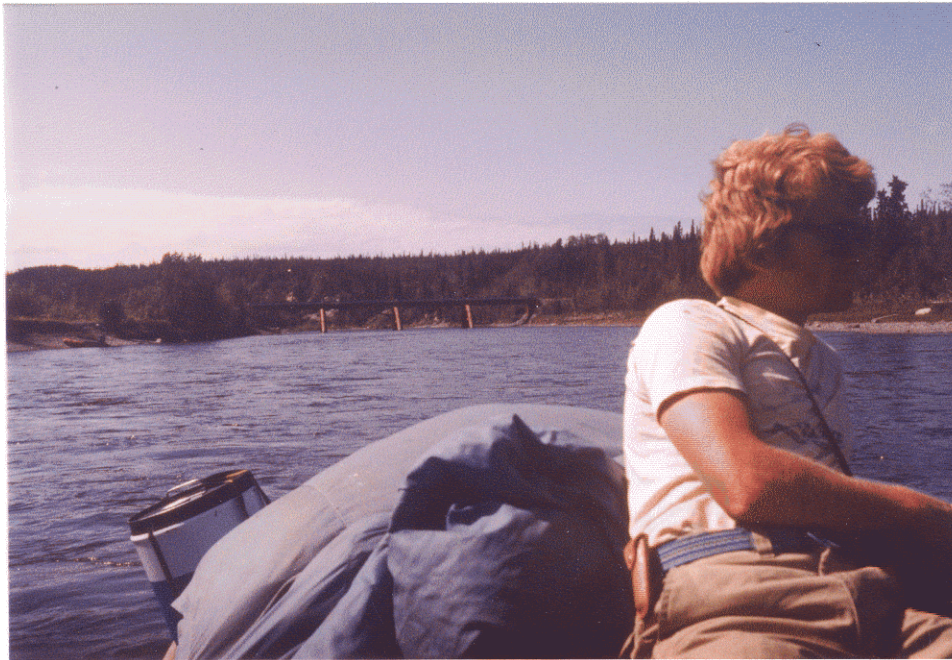
20. Gulkana River, Main Stem, mile 33.0. Note Sourdough Bridge (USGS gage site). Photograph is taken looking downstream.

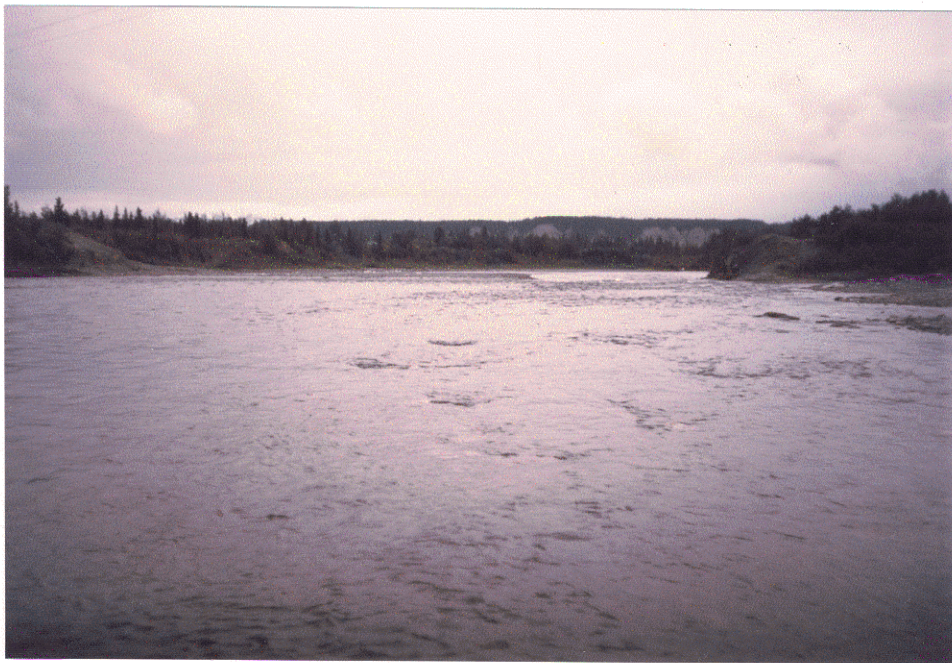
22. Gulkana River, Main Stem, mile 3.4. Photograph is taken looking downstream of the Richardson Highway Bridge. Mile 3.4 was the ending point of the float trip.
