Eagle River Greenbelt Access Pathway

Project # 55715

Wetlands Delineation Report

> > February 2006

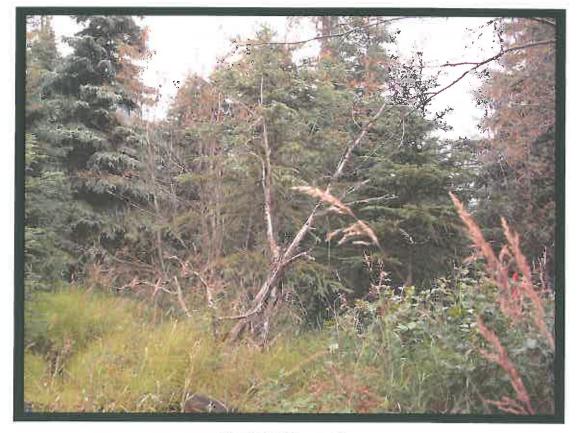
Wet #14 Vegetation

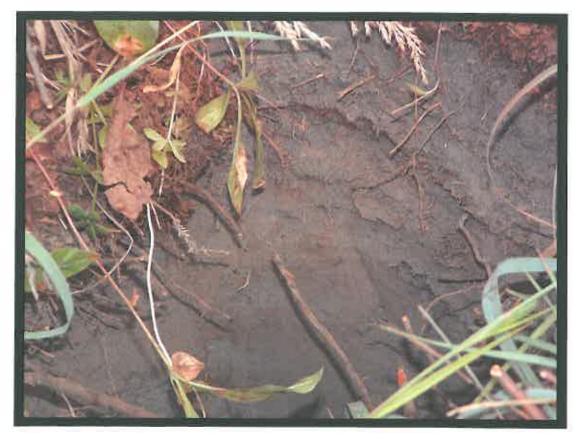
Wet #14 Soil Pit

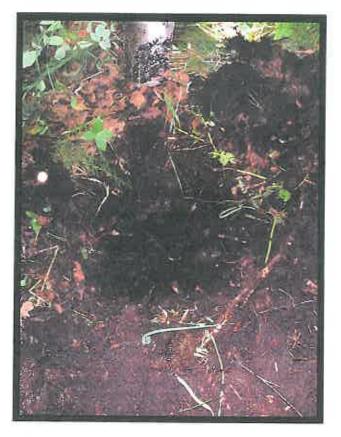
Wet #16 Soil Pit

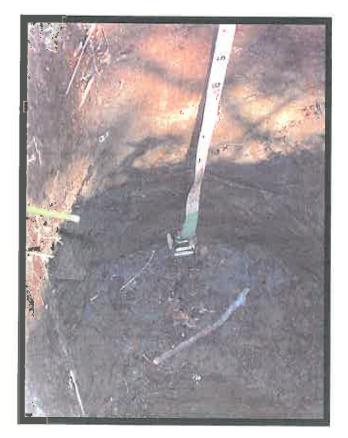
Wet #21 Soil Pit

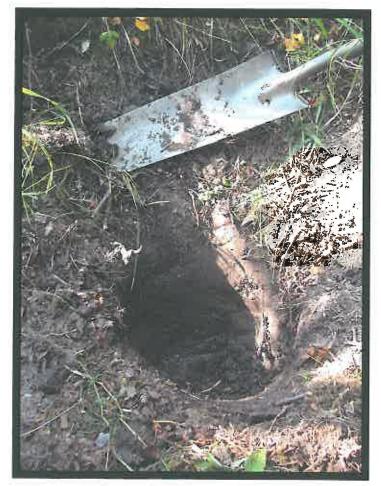
Wet #22 Soil Pit

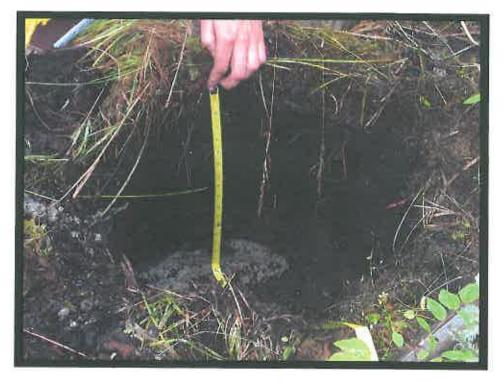
Wet #23 Soil Pit

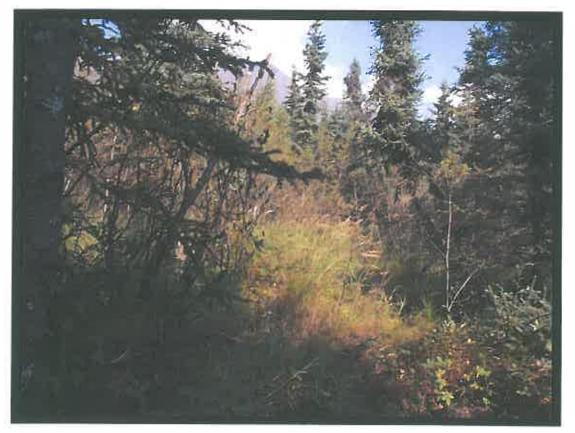
Dry 22 Vegetation

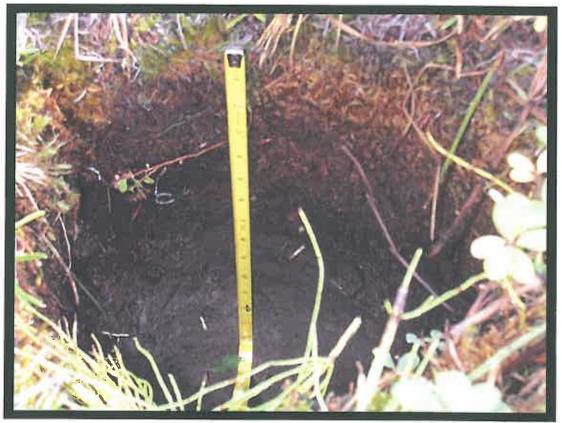
Dry22 Soil Pit

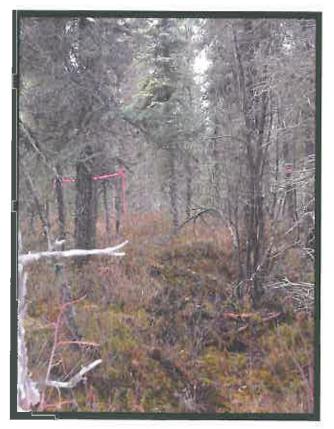
Wet #33 Vegetation

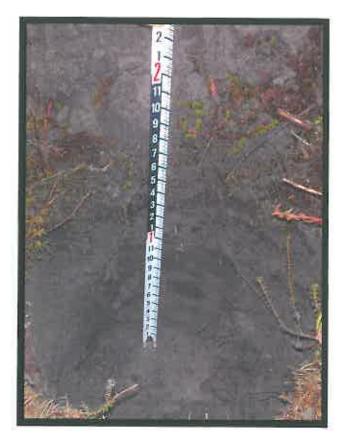
Wet #33 Soil Pit

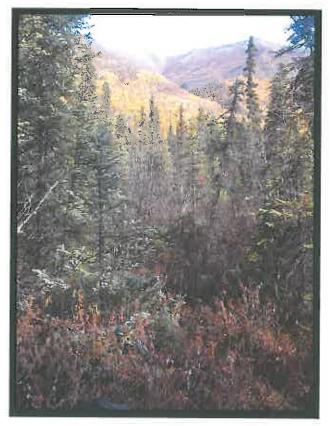
Wet #35 Vegetation

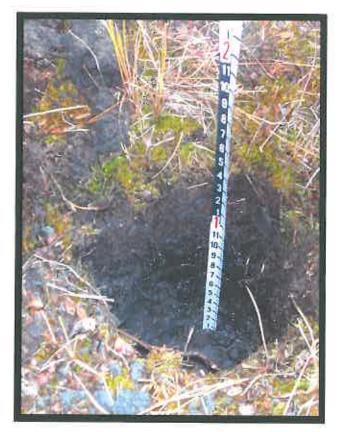
Wet #35 Soil Pit

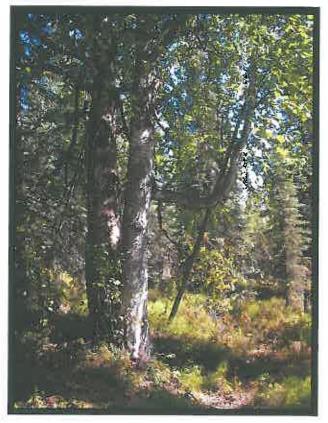
OMF (Open Mixed Forest)

General characteristics of this mixed forest in the project area include an overstory of Paper Birch (*Betula papyrifera* - FACU) and White Spruce (*Picea glauca* - FACU) with an understory of Prickly Rose (*Rosa acicularis* - FACU), and Field Horsetail (*Equiesetum arvense* - FACU). Both Open Mixed Forest (OMF) with less than 25-60% canopy cover and Closed Mixed Forest (CMF) with 60-100% canopy cover (Viereck, 1997) were found in the project area. Wetland Data Forms and photographs in Appendix A describe species abundances found in this community type.

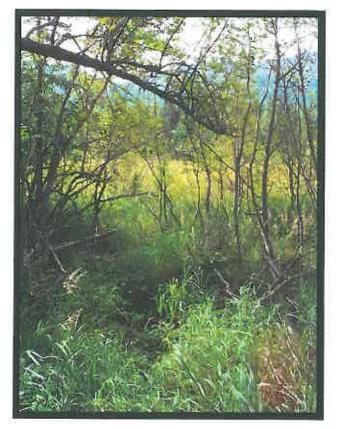
OTS (Open Tall Scrub)

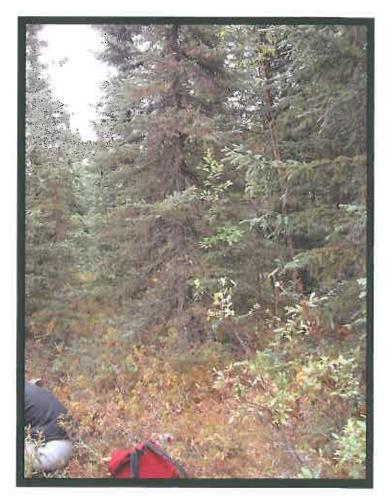
ONF (Open Needleleaf Forest)

General characteristics of needleleaf forests in the project area include an overstory of Black Spruce (*Picea mariana* - FACW) with an understory of Alder (*Alnus sinuata*). Less often the needleleaf forest was characterized by an overstory of White Spruce (*Picea glauca* – FACU) and an understory of (*Rosa acicularus* – FACU) and Wood Horsetail (*Equisetum sylvaticum* – FACU). Both Open Needleleaf Forest (ONF) with less than 25-60% canopy cover and Closed Needleleaf Forest (CNF) with 60-100% canopy cover (Viereck, 1997) were found in the project area. Wetland Data Forms and photographs in Appendix A describe species abundances found in this community type.

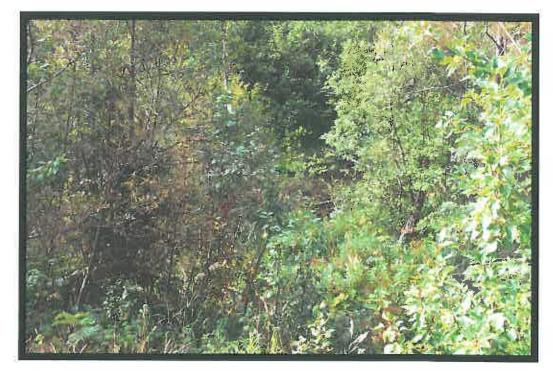
CTS (Closed Tall Scrub)

General characteristics of the tall shrub plant community found in the project area a shrub overstory of Alder (*Alnus spp.* - FAC) and an understory dominated by Field Horsetail (*Equisetum arvense* - FACU) and Bluejoint Reed Grass (*Calamagrostis canadensis* – FAC). Both Open Tall Scrub (OTS) with less than 25-75% canopy cover and Closed Tall Scrub (CTS) with 75-100% canopy cover (Viereck, 1992) were found in the project area. Wetland Data Forms and photographs in Appendix A describe species abundances found in this community type. Wetland data forms and photographs in Appendix A describe species abundances found in this community type.

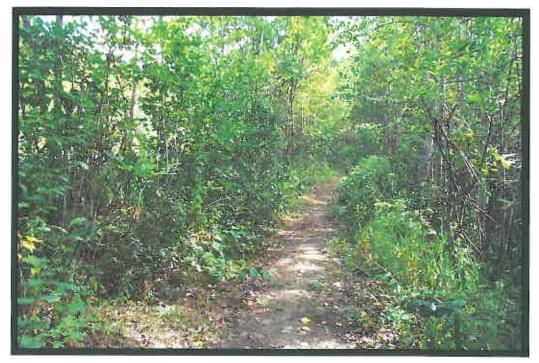
OBF (Open Broadleaf Forest)

General characteristics of broadleaf forests in the project area include an overstory dominated by an overstory of Paper Birch (*Betula Papyrifera* - FACU) with an understory of Prickly Rose (*Rosa acicularus* – FACU), Current (Ribes spp. – FAC) and Meadow Horsetail (*Equisetum pratense* – FACW). Both Open Broadleaf Forest (OBF) with less than 25-60% canopy cover and Closed Broadleaf Forest (CBF) with 60-100% canopy cover (Viereck, 1997) were found in the project area. Wetland Data Forms and photographs in Appendix A describe species abundances found in this community type.

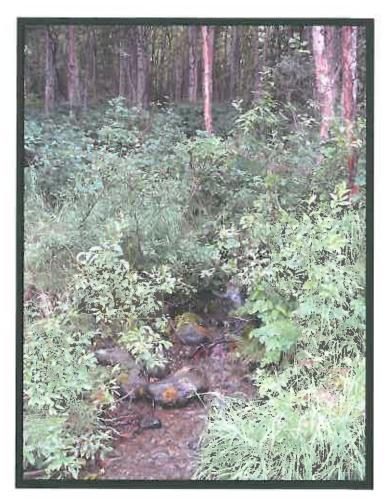
CBF (Closed Broadleaf Forest)

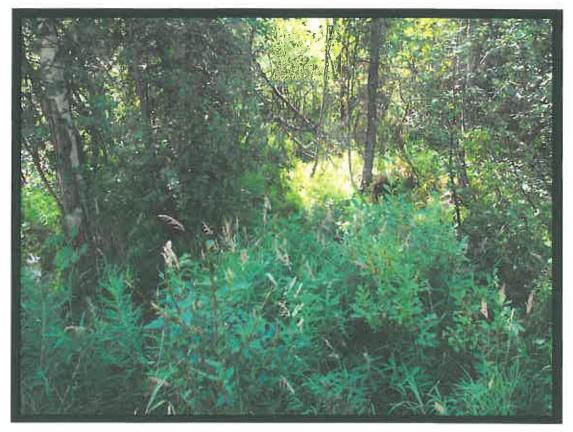
CMF (Closed Mixed Forest)

Upland areas in the project area consist primarily of a mixed broadleaf-needleleaf forest community. This is the most abundant plant community type in the project area. It is characterized by an upper tree canopy dominated by both paper birch (*Betula papyrifera* – FACU) and white spruce (*Picea glauca* – FACU) with a sparse understory of Alder (spp. – FAC), Prickly Rose (Rosa acicularus - FACU), and Field Horsetail (Equisetum arvense – FACU). Wetland Data Forms and photographs in Appendix A describe species abundances found in this community type.

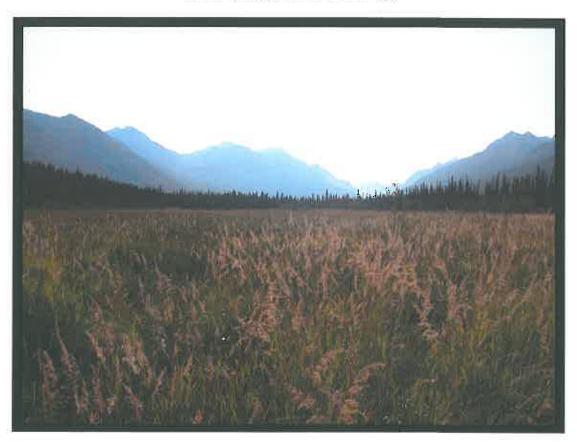
WGH (Wet Graminoid Herbaceous)

The Wet Graminoid Herbaceous (WGH) plant community (Viereck, 1992) is found in one area just east of the MEA Powerline. General characteristics of this plant community in the project area were a grass-herb layer predominated by Water Sedge (*Carex aquatilis*), Marsh Cinquefoil (*Potentilla palustris*), and Sweet Gale (*Myrica gale*). This vegetation is defined as emergent and

There is one 5-acre palustrine emergent wetland adjacent to the project area, located east of the powerline at waypoint 558. Emergent vegetation is defined as erect, rooted, herbaceous plants that may be temporarily to permanently flooded at the base but do not tolerate prolonged inundation of the entire plant (Cowardin et. al., 1979). The Wet Graminoid Herbaceous (WGH) plant community is found in this wetland with Water Sedge (*Carex aquatilis*), Marsh Cinquefoil (*Potentilla palustris*), and Sweet Gale (*Myrica gale*), predominating. Wetland Data Forms and photographs in Appendix A describe species abundances found in this community type.

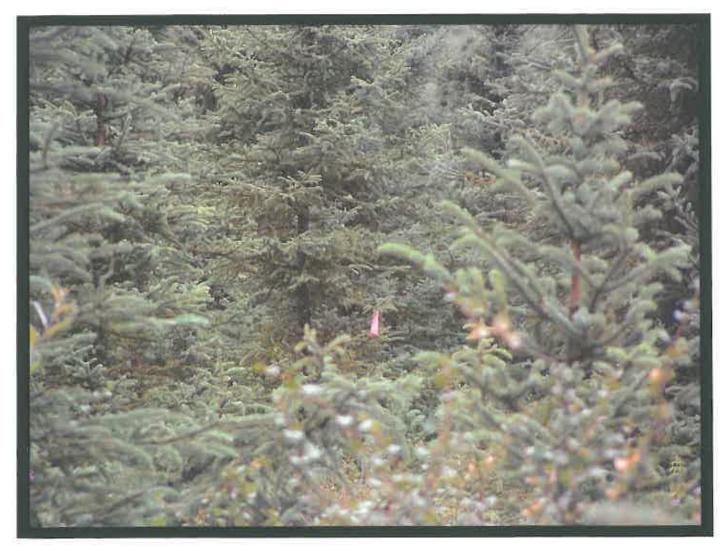
CNF (Closed Needleleaf Forest)

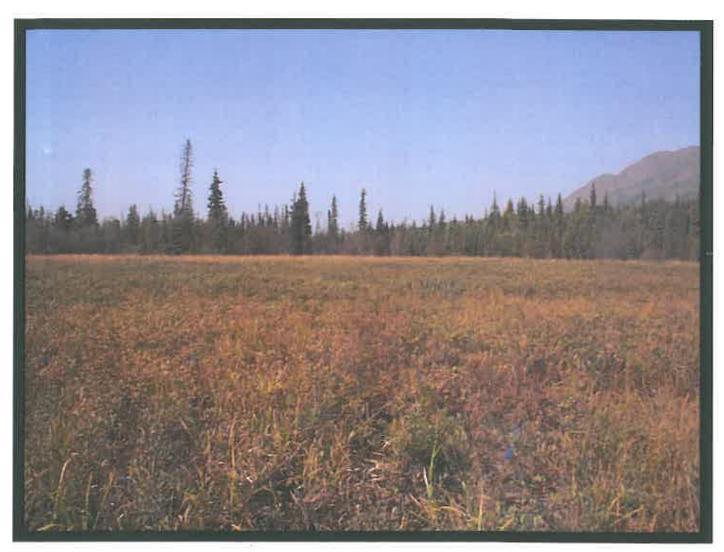
Scrub Shrub

Freshwater wetlands dominated by woody vegetation less than 20 feet tall, on saturated, organic soils (peat) represent palustrine scrub-shrub wetlands (Cowardin et al., 1979). Scrub shrub wetlands are located throughout the project area. They are common throughout the project site, occurring along in drainage areas and associated with scrub-shrub palustrine wetlands. The scrub-shrub wetlands in the project area are characterized by a shrub overstory of alder (FAC) and an understory dominated by field horsetail (FACU) and bluejoint grass (*Calamagrostis canadensis* – FAC). Wetland Data Forms and photographs in Appendix A describe species abundances found in this community type.
