December 13, 2011

OFFICE OF  
HISTORY AND  
ARCHAEOLOGY

GRUENING HISTORICAL PARK  
HISTORIC STRUCTURE REPORT

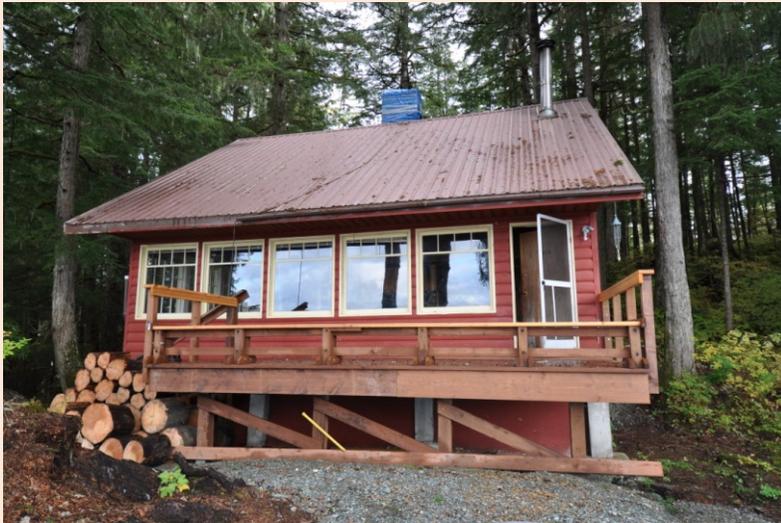
### WEST ELEVATION

The west elevation of the Gruening Cabin faces Favorite Channel and is one story tall. The wide overhang projects 3 feet 5 inches and the eave is enclosed with the same siding material as the rest of the house perpendicularly placed. Tiny circular metal vents are symmetrically placed under the eaves. A metal gutter is attached to the eaves for three quarters of the cabin's length; a large section is missing toward the north. The primary feature on the main elevation is the band of five - four over one transom windows. The

band of windows covers twenty-four of the west elevation's twenty-seven feet. A plain wood door occupies the remaining three feet of the elevation. A simple white aluminum screen door is placed over the door. A newly constructed deck with low profile rails projects from the building. Composite shingle covered stairs lead from the north side of the elevation to the deck. The deck covers roughly 2/3 of the main elevation.

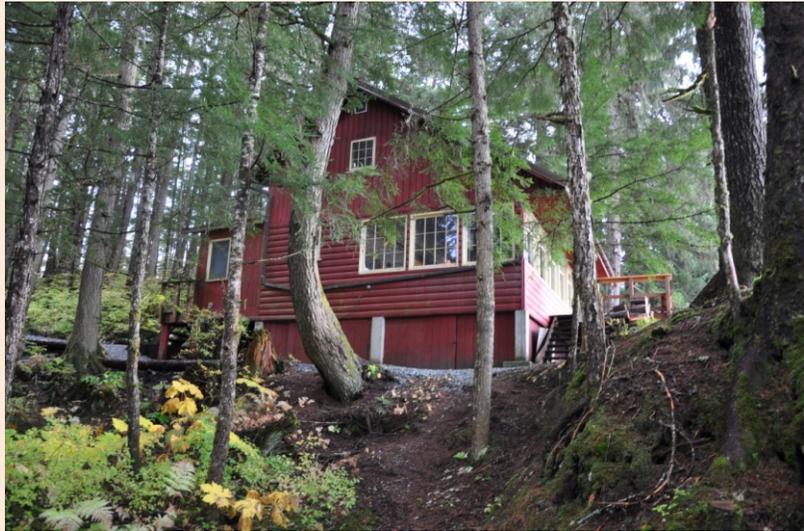
## NORTH ELEVATION

The north elevation is two stories tall with an offset roof apex accommodating the second floor towards the east. In addition to the two stories a substantial crawl space is under the house. Three different cladding materials (T1-11, horizontal shiplap, and vertical shiplap) highlight the three different levels of the elevation. The crawl space is covered with T1-11, the first floor has horizontally orientated cedar shiplap painted barn red, and the second floor is clad in vertically

orientated cedar shiplap painted barn red. A small wood louvered vent is positioned in the roof apex. Two nine light wood casement windows are located toward the east side of the second floor. The first floor contains one nine light casement window toward the east end of the elevation. Three twelve-light fixed wood windows are placed in the corner of the west side of the building accentuating the west elevation band. All three are closely spaced with less than four inches between each window. The crawl space contains three entrances clad in T1-11. An enclosed porch projects on the east end of the property along the same plane as the original construction. In this area, the crawl space is not enclosed. The eaves slightly project from the face of the elevation. Aluminum down spouts converge directly under the roof apex of the elevation below the first floor windows leading to the location of a removed cistern.

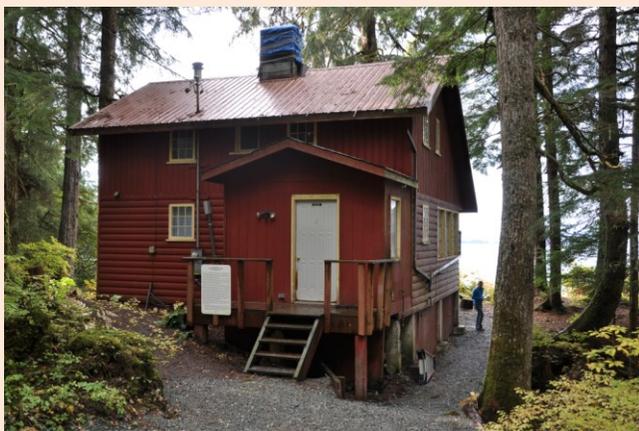
## EAST ELEVATION

The first visible elevation as people enter the park with their vehicle is the east elevation. This elevation is two stories with a one story gable roofed arctic entry/porch addition located on the northern edge. Again, the different levels of the original construction are accentuated with material variations. The second floor is clad in vertically orientated cedar shiplap, the first floor is horizontal orientated cedar shiplap and the crawl space is covered with plywood. The arctic entry/porch addition is covered with T1-11 and the porch is constructed with treated

timber. The entrance into home is located in the arctic entry. Four stairs lead up to the porch and arctic entry. A twelve panel hollow core aluminum door is located in the arctic entry the slightly offset from the apex of the gable. A two head security light is placed on the south side adjacent to the door. The windows are not talked about for this elevation

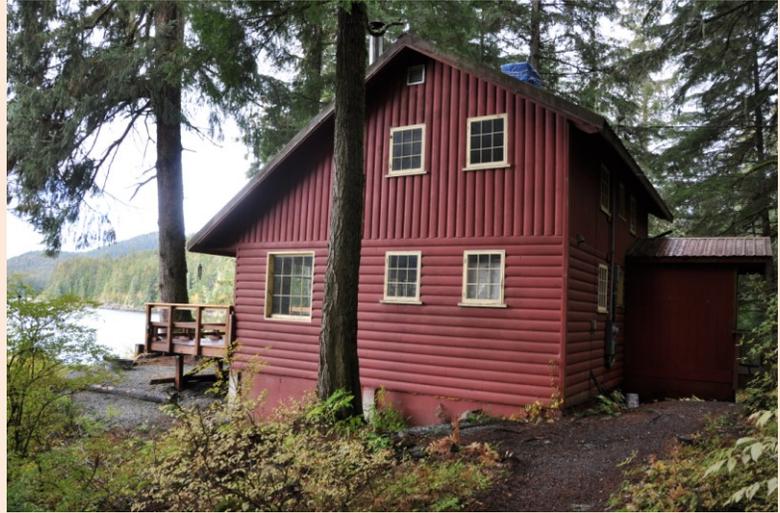
## SOUTH ELEVATION

The outline of the south elevation is nearly identical to the north elevation. It is two stories tall with an offset roof apex that houses the second floor on the east side of the elevation. Again, a crawl space is located under the house with more space towards the west due to the sloping topography of the site. Three different cladding materials (plywood, horizontal shiplap, and vertical shiplap) accentuate the three different levels of the elevation. Plywood covers the crawl space, situated between three symmetrically placed concrete piers. Horizontal shiplap covers the first floor while vertical shiplap sheathes the second floor. All cladding materials are painted barn red. A small wood louvered vent is positioned in the roof apex. Two nine light wood casement windows are located toward the east side of the second floor. The first floor contains two nine light casement windows toward the east end directly under the nine light windows on the second floor. One twelve-light fixed wood window is placed near the corner of the west side of the building. The crawl space contains one entrance clad in plywood. The eaves slightly project from the face of the elevation.

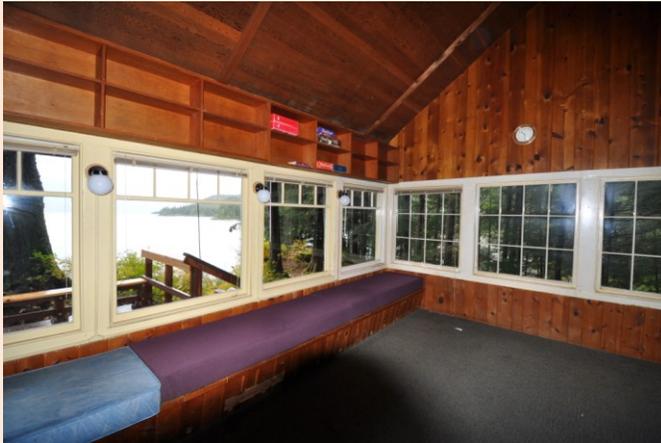
## INTERIOR

The interior has a great room, loft, enclosed porch and small enclosed space currently used as a restroom. The space circulates around the chimney, but the primary feature is the view from the great room through the band of windows. The built-in benches with in-seat storage and bookshelves that parallel the windows help emphasize the view while creating an efficient use of space. The volume of space in the great room is ample but not accentuated. Under the loft, a kitchen is positioned on the north end of the space while the small enclosed bathroom is

located on the south. Additionally, a circular stair case provides access to the loft. This stair case is located between the bathroom and chimney. The primary finish inside the Gruening Cabin is clear finished cedar shiplap.

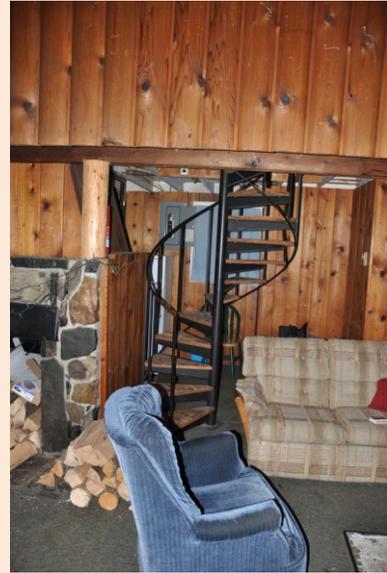
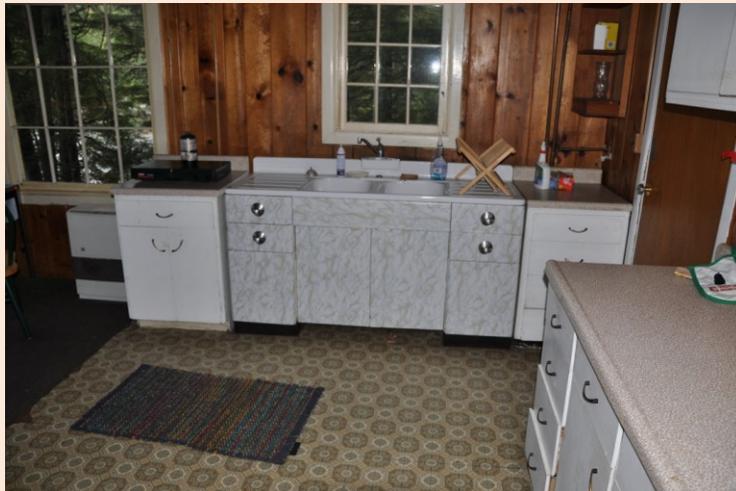
A substantial stone and pine veneer fire place is centrally located in the great room. The west face of the fireplace, also the primary side, is faced with a stone veneer. The opening of the fireplace is also quite substantial with a small sheet metal hood near the top. The south face of the fireplace has a cedar shiplap siding. The other two faces are painted concrete. Two small cedar posts are positioned at the fireplace corners extending to the base of the loft. In the loft space, the chimney is clad with the same veneer found throughout the building.

A metal spiral staircase between the chimney and bathroom provides access to the intimate loft space. These stairs were added during the renovations of the 1980s. A small pony wall constructed of vertical cedar ship lap is attached to the loft floor and finished with quarter round. From the loft, the area of original access is evident near the south wall.

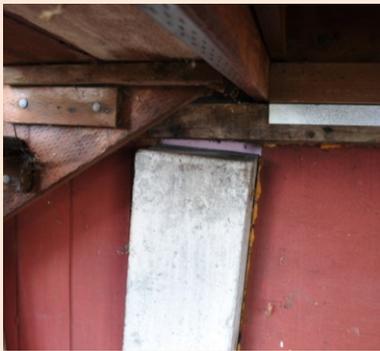
### FOUNDATION

The foundation of the Gruening cabin is concrete piers evenly spaced on the buildings perimeter. A pier is placed on each corner with another placed in the center of the north and south elevation. Two additional piers are centrally positioned on the east and west. Additionally, two piers are located under the original porch on the east elevation. A central pier on the west elevation is not in contact with the building evidenced in the included photograph. This condition must be corrected to provide adequate support to the house. The porch piers are also showing signs of serious decay. The concrete is severely spalled. The existing pier should be patched and if deterioration continues, a replacement should be fabricated.

All foundation piers must be evaluated for their soundness. Necessary repairs should take place. Two piers need immediate attention and repair. All piers must be in contact with the building and deteriorated piers must be replaced.

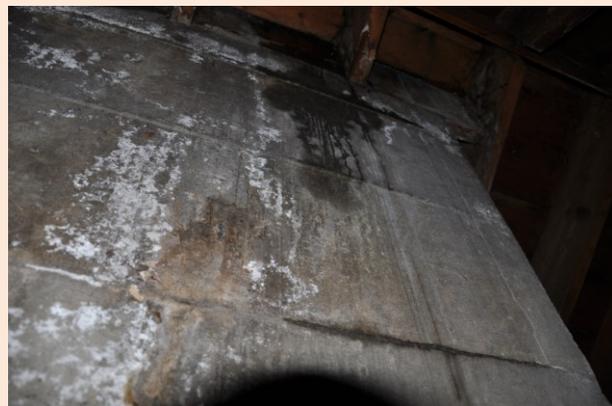
### CHIMNEY

A thorough investigation of the chimney was not conducted due to equipment limitations. However, the chimney is currently shrouded in a blue tarp due to spalling according to the area superintendent. From the ground it appears that there are breaks in the flashing at the base of the chimney. Access to the chimney was available on the interior of the building. Water damage and efflorescence was evident on the chimney in the attic. In the loft space the concrete is exposed on the east side of the chimney. Evident conditions include water penetration, cracking and staining. Although the chimney is not exposed on the other sides in the loft, water damage is evident on the ceiling in close proximity to the chimney. No critical conditions were found on the first floor of the chimney. The exposed east side is painted white and appears stable.

In addition to the original chimney, a wood stove was added during the renovations of the 1980s. The wood stove is positioned near the

south wall of the great room. The stove sits on a concrete base. A metal stove pipe extends through the roof, interrupting the volume of the great room.

The chimney must receive a full inspection to determine what work needs to be completed. At a minimum, all concrete must be repaired (especially the cap), water penetrations must be identified and repaired, flashing must be properly installed, and cricket installation should be considered to help divert water. FUNCTIONAL

To save costs, roof replacement should take place concurrently with the chimney repairs. To be historically accurate the new roof should be covered with a dark composite shingle. While the roof decking is exposed, the stove pipe needs to be removed and the hole patched before sheathing.  
GUTTERS

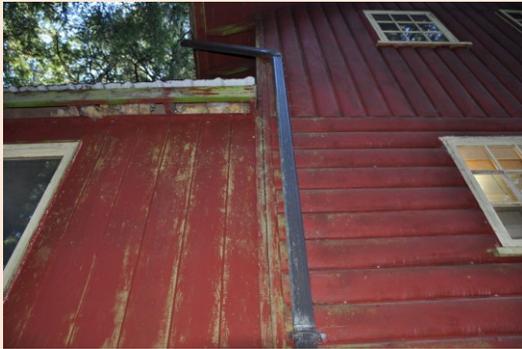
### ARCTIC ENTRY

The arctic entry was added to the cabin during the 1980s renovations and Alaska State Parks added the small porch in the 1990s. The arctic entry is pulling away from the cabin. This condition is evident near the roof line of the arctic entry. Additionally, the arctic entry is inadequately supported. When first constructed, the arctic entry only used the existing piers from the original porch. Later, ADPOR added a sill log and 4x4 to support the cantilevered portion of the arctic entry. At this point, the sill is extremely deteriorated due to inappropriate site drainage.

The arctic entry on the east side of the building needs to be removed. It should be replaced with a small simple deck with six stairs providing access. The area of the old deck is still evident. It should be measured and replicated in size. In the future, installation of a rain barrel as shown in the cover picture could be reproduced.

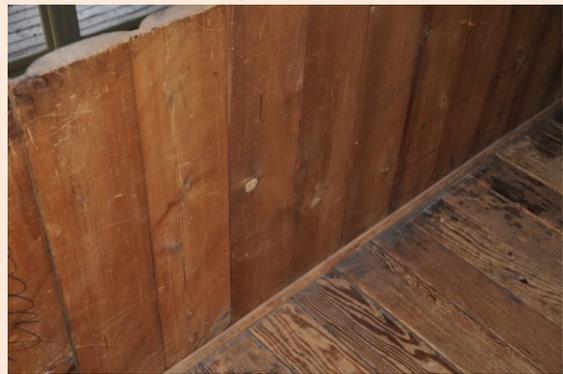
A metal circular staircase added during the 1980s currently provides access to the loft through the loft floor. The staircase is sandwiched between the chimney and bathroom. Originally, a steep open staircase afforded access to the loft along the south wall. Width of this stairway is visible in the addition of siding in the loft wall. Also a shadow on the wall is evident to approximate the placement and steepness.

The loft pony wall is comprised of vertical cedar siding, found throughout the building. It is attached at the floor boards. Each piece of siding is attached by four nails. Quarter round finishes the wall on the loft side. Evidence that the pony wall is pulling away from its vertical orientation is seen near each wall. This attachment method creates an unstable wall and a safety concern.

Additional structural support needs to be added to the loft pony wall to ensure the loft is a safe place. The frame should be constructed on the loft side of the wall and affixed to the floor and side walls. The current wall components can be attached to the frame. All finishes on the loft interior should be stained to match the existing wood work.
