## Fort Abercrombie State Historical Park Preservation Plan

Alaska Division of Parks and Outdoor Recreation  
Department of Natural Resources  
12/14/2010

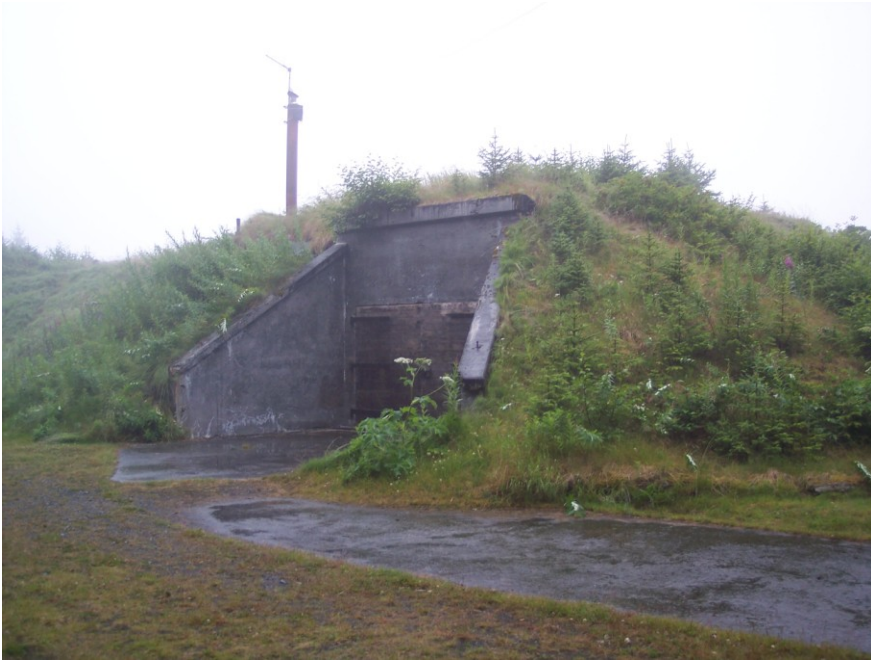
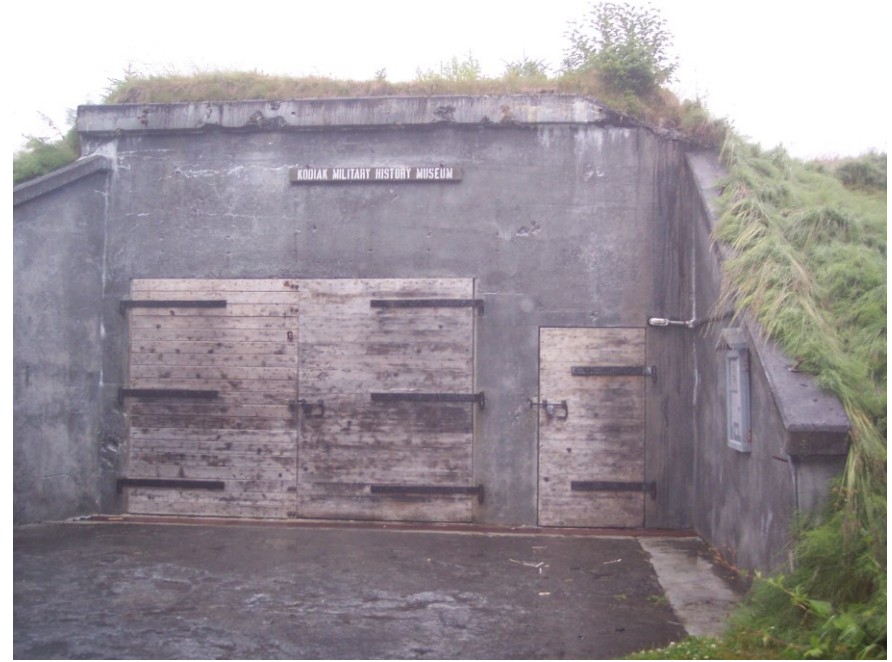
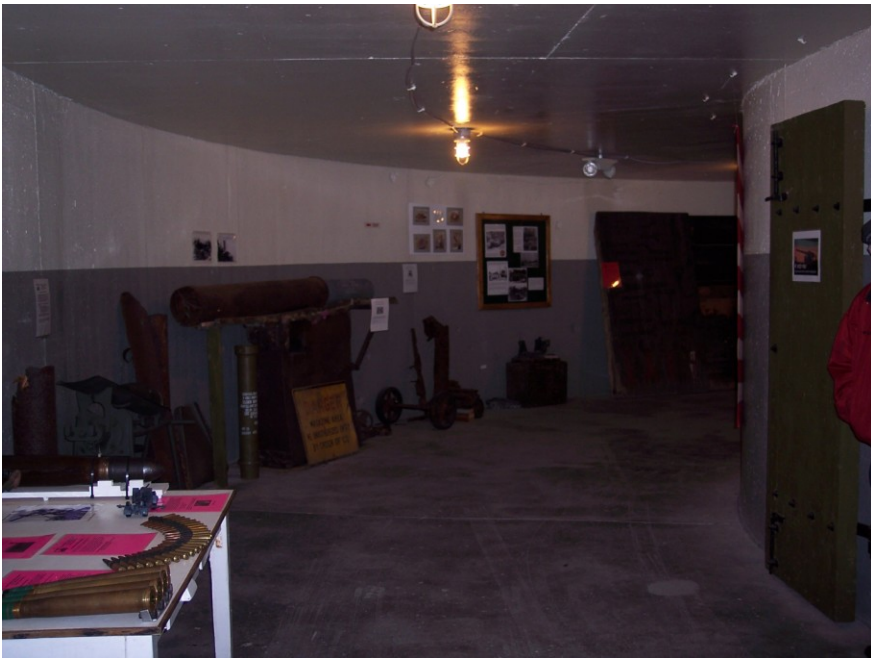
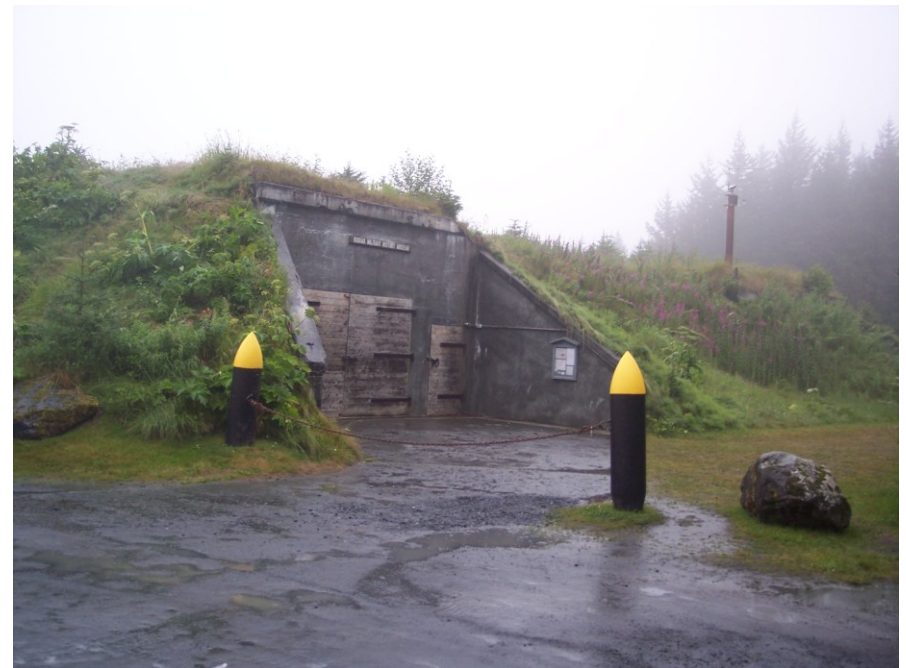
AHRS #: KOD-811

1. Concrete	1. Tar	1. Concrete	1.
2.	2.	2.	2.
Architectural Description (Include setting & outbuildings): <i>(use continuation sheets)</i> The Generator House is a rectangular concrete building located in south of the Ready Ammunition Bunker. The shed roof has an extremely low pitch with metal??? flashing around the edge. A double door opening is the only opening on the building facing north. No door is present. The metal frame is extant. The forms are evident in the concrete.  The roof is covered with organics. All sides of the building are also covered with organics. There is minor efflorescence and minor spalling.		Statement of Significance: <i>(use continuation sheets)</i> A contributing resource to the Kodiak Naval Operating Base and Forts Greely and Abercrombie National Historic Landmark.	
Eligibility:		Criteria Considerations:	
<input checked="" type="checkbox"/> Yes <input type="checkbox"/> No If yes: <input checked="" type="checkbox"/> A <input type="checkbox"/> B <input type="checkbox"/> C <input type="checkbox"/> D		<input type="checkbox"/> A <input type="checkbox"/> B <input type="checkbox"/> C <input type="checkbox"/> D <input type="checkbox"/> E <input type="checkbox"/> F <input type="checkbox"/> G

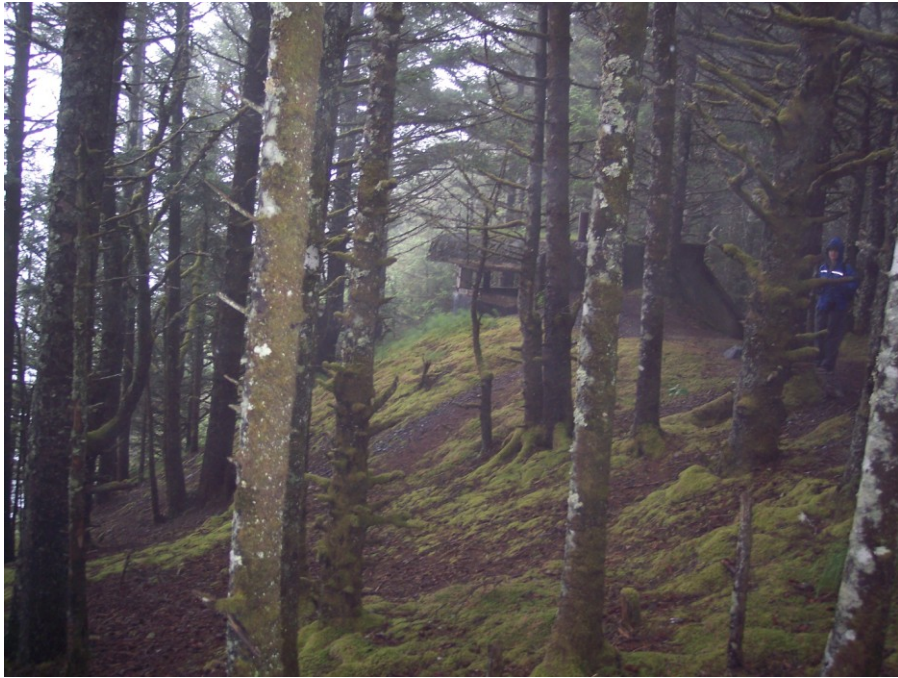
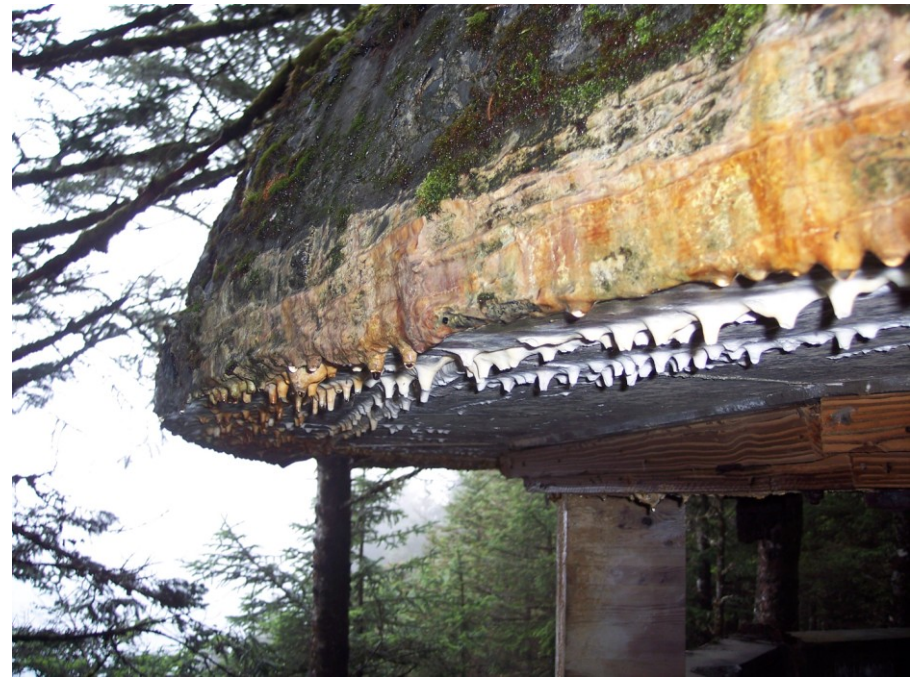
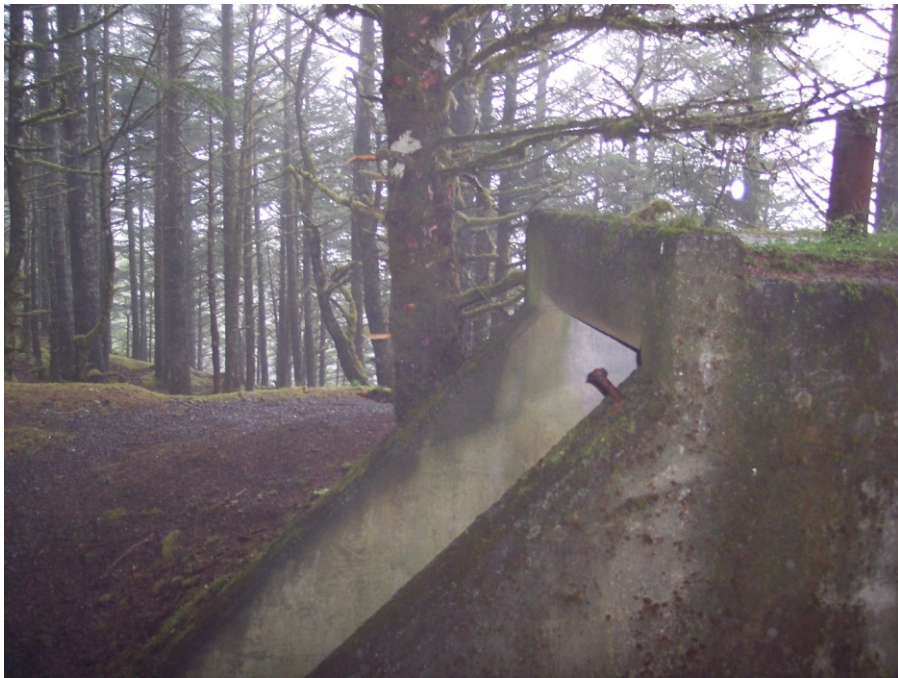
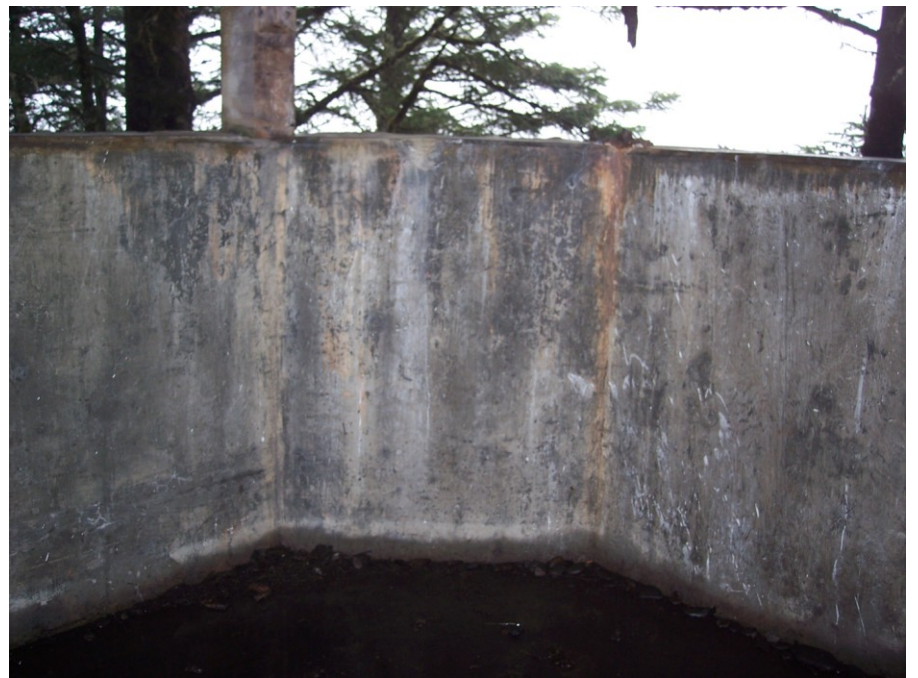
AHRS #: KOD-810

Historic Name	AHRS Number	Associated Historic District	City/Town/Village
DEC Bunker - Miller Point	KOD-810	KOD-137	Kodiak
<p>Preservation issues of note include extremely heavy effloresence, minor graffiti, minor cracking, extreme spalling, extreme organic growth and lack of structural support for the cap. Extreme attention should be paid to removal of any organics on this structure. In some cases the moss is holding the large aggregate concrete together. Removal of the organics could cause the loss of original building fabric.</p>

The narrow band of windows and the heavy concrete lid characterize the DEC Bunker. The spalling found on the DEC Bunker is extreme. It appears that two different sized aggregates were used in the construction. The small aggregate is relatively stable; however, the large aggregate is quickly crumbling. Vegetative growth on the

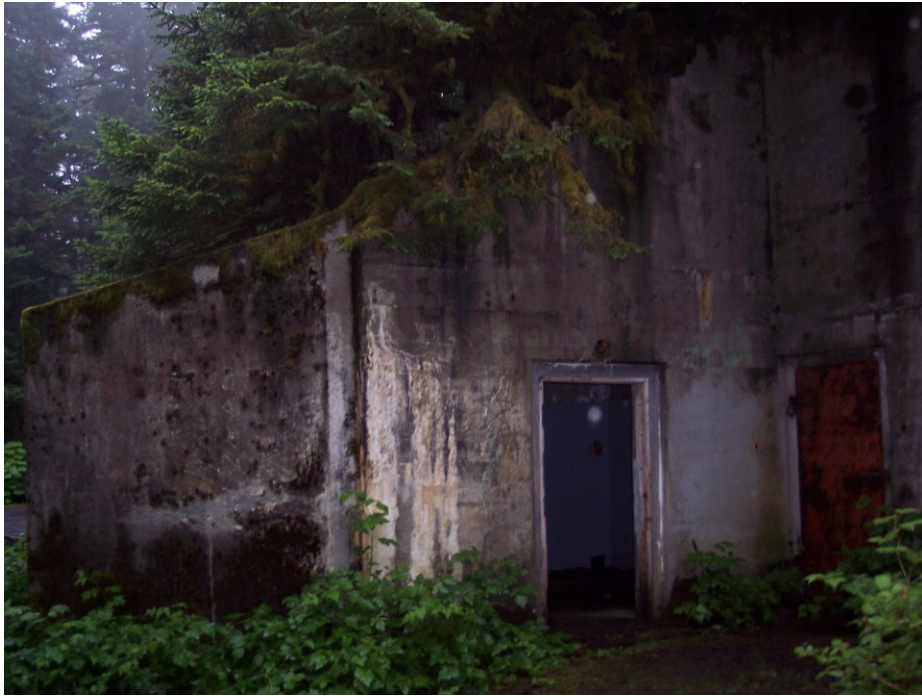
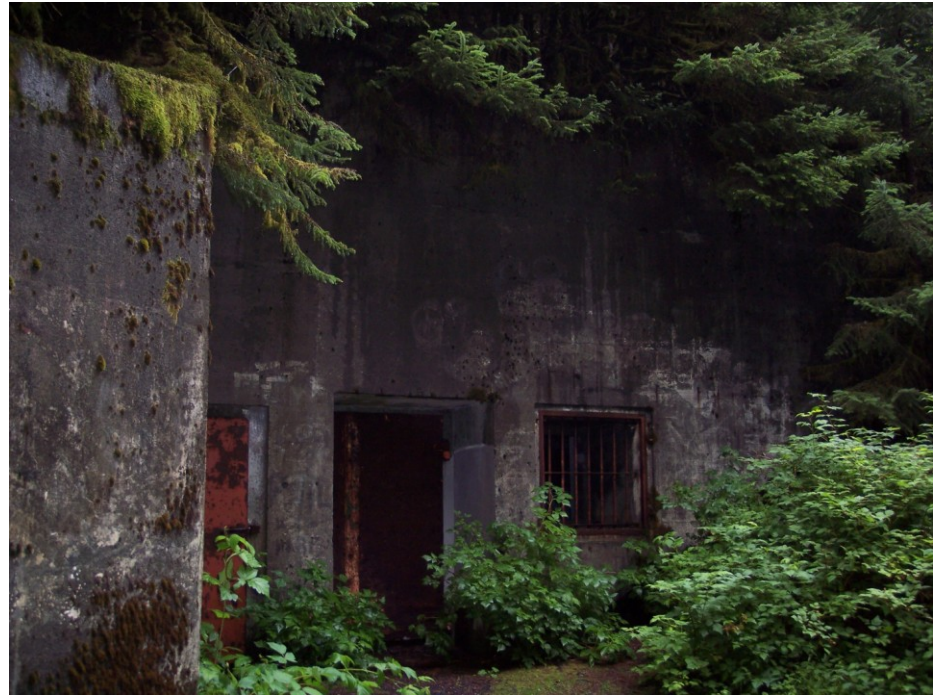
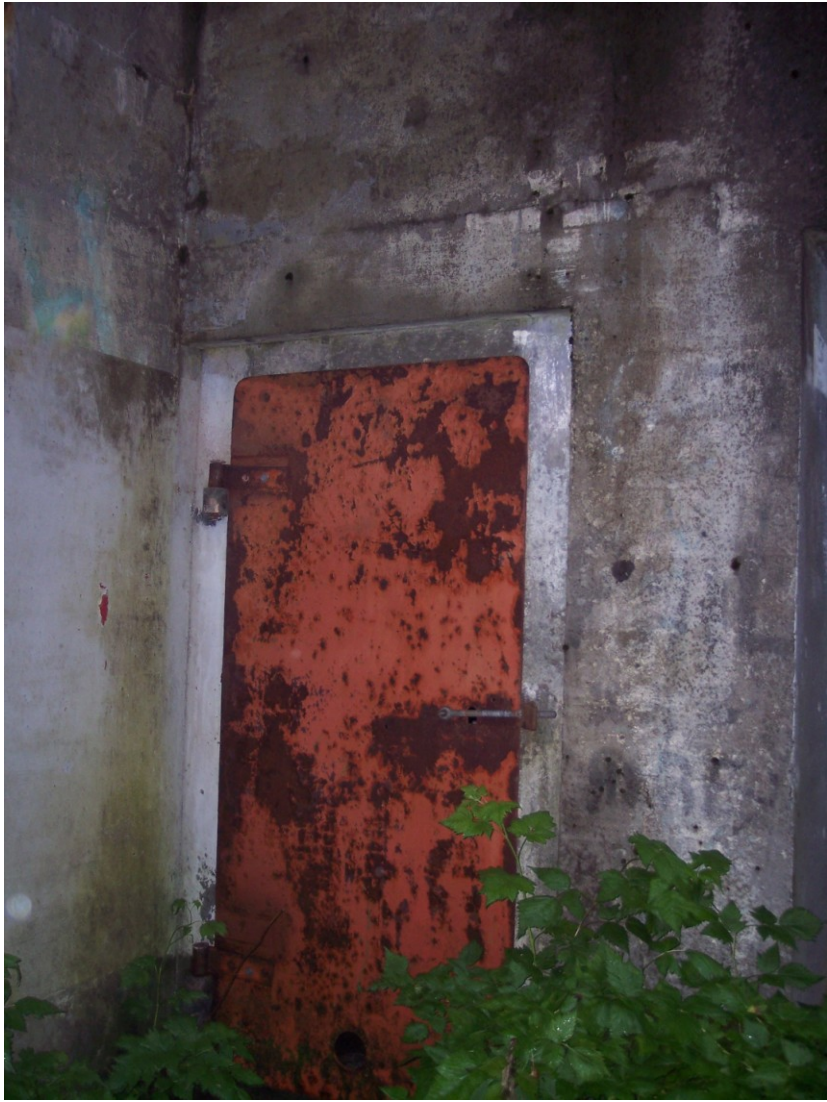
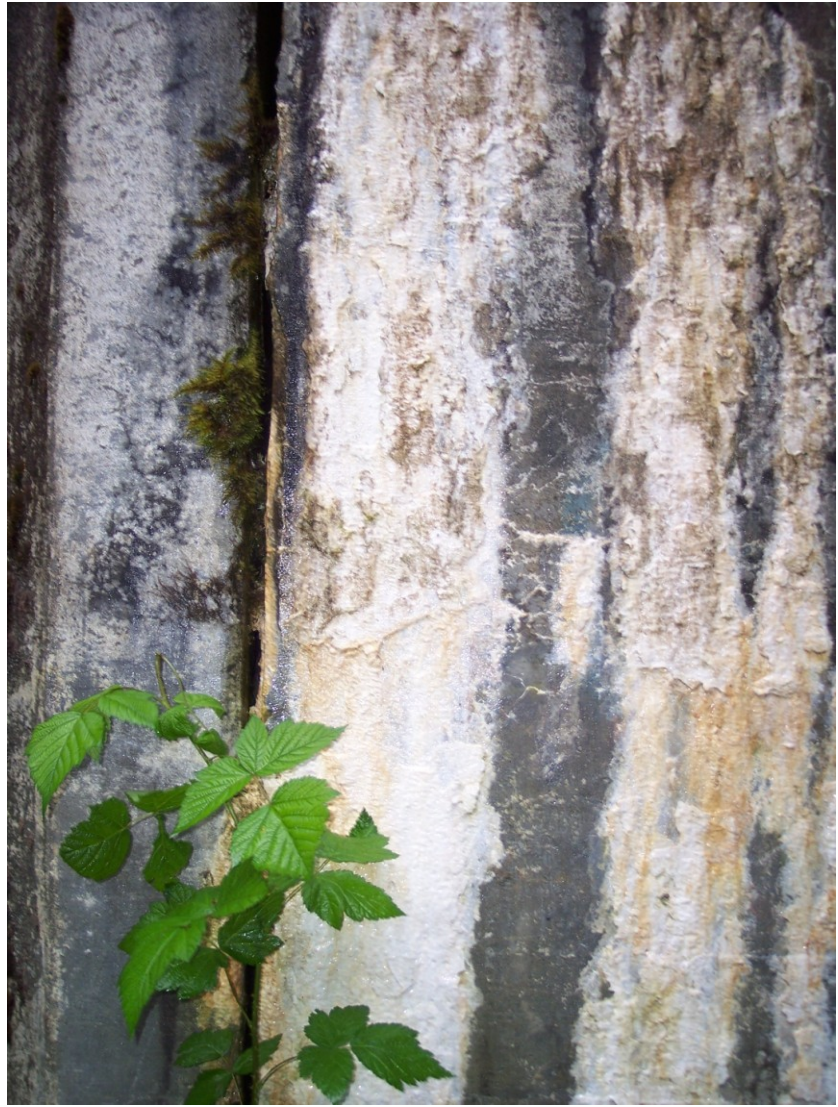
AHRS #: KOD-815

1. Concrete	1. Concrete	1. Concrete	1. Metal
2.	2. Earth	2.	2.
Architectural Description (Include setting & outbuildings): <i>(use continuation sheets)</i> Large concrete building with an 'L' floor plan divided into a series of rooms of a central corridor. Fenestration is limited to a few personnel doors and windows on front facade. There are two heavy steel doors on the longer portion of the L. Also situated on the same elevation is a small window secured with bars. Left and back elevations are tucked into a hill. The roof is covered by a young forest. Building measures approximately 40 feet by 100 feet. Tar is evident on the exterior of the building.  Issues include heavy rusting on the doors, efflorescencse, organics impacting the roof structure, water penetration in the one room investigated, and minor graffiti. A new restroom facility and parking lot is in close proximity to this feature. The functionality of this building makes it a preservation priority.		Statement of Significance: <i>(use continuation sheets)</i> A contributing resource to the Kodiak Naval Operating Base and Forts Greely and Abercrombie National Historic Landmark.

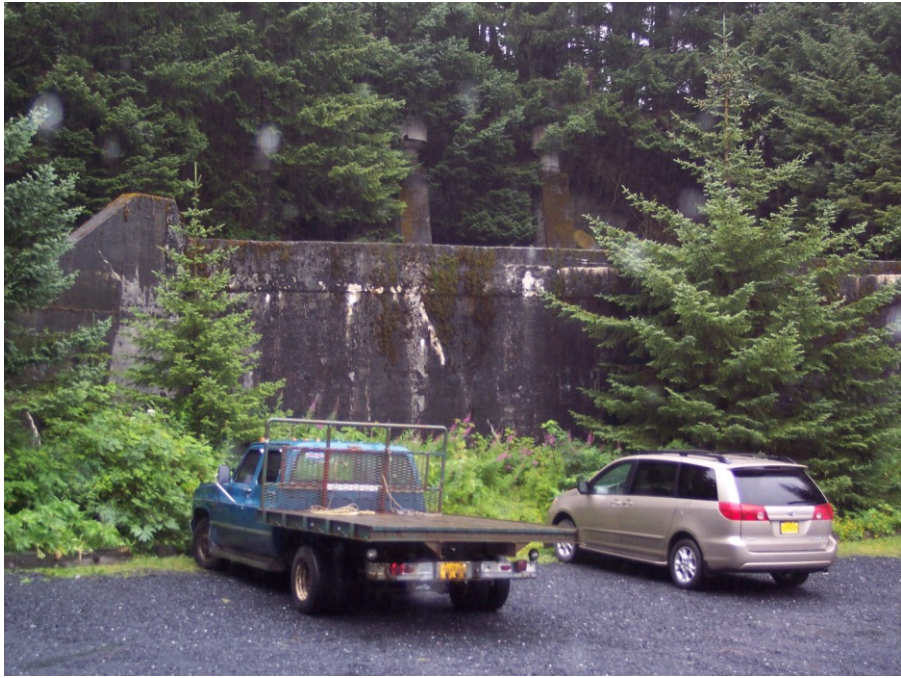
AHRS #: KOD-817

1. Concrete	1. Tar	1. Concrete	1. Metal
2.	2. Concrete	2.	2.
Architectural Description (Include setting & outbuildings): <i>(use continuation sheets)</i> Large concrete bunker measuring approximately 20 feet by 120 feet uncovered by soil with flat roof. A room extends behind this into the hillside that measures approximately 20 feet by 80 feet. Access is by end wall of the 20x120 and then three doors off interior room into the 20x80 portion. Cambered retaining walls flank the main elevation. Two large concrete chimneys are symetrically placed on the roof and rest against the hillside. The roof was recently rehabilitated with an EPDM roof. The Park currently uses the building as storage and maintenance facility.  Issues include water penetration near the back wall, effloresence, and organics.		Statement of Significance: <i>(use continuation sheets)</i> A contributing resource to the Kodiak Naval Operating Base and Fort Greely and Fort Abercrombie National Historic Landmark.

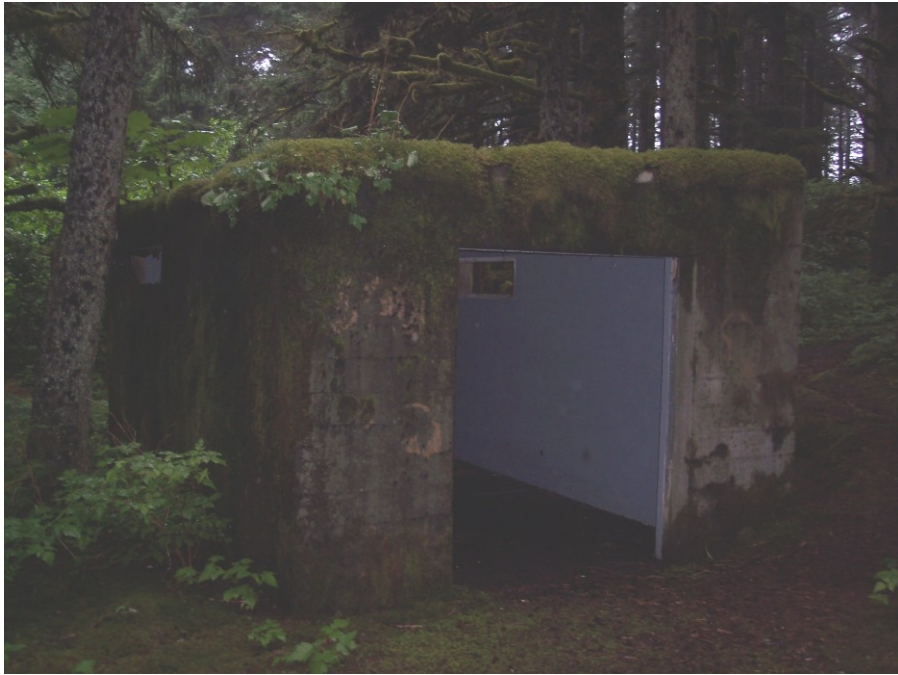
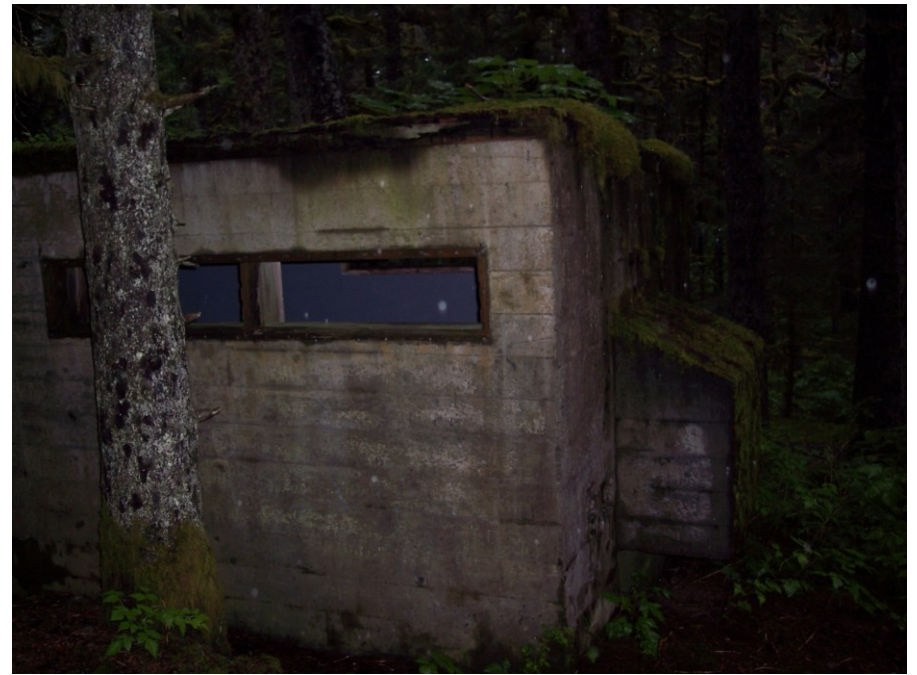
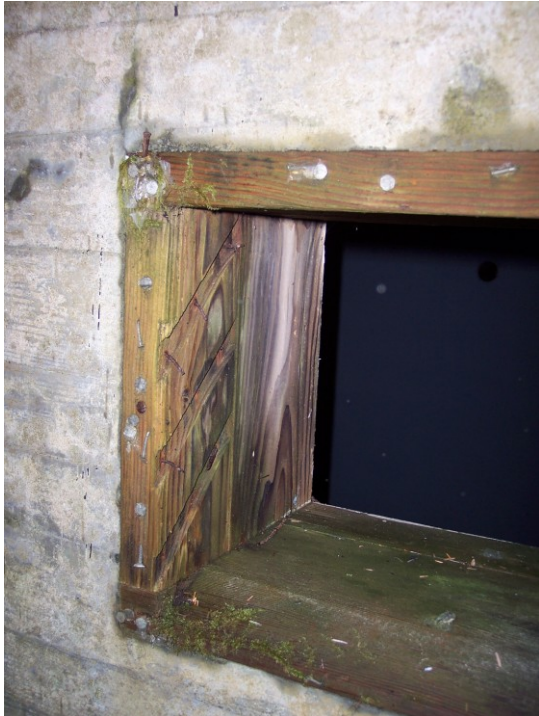
AHRS #: KOD-798

1. Concrete	1. Concrete	1. Concrete	1. Wood
2.	2. Tar	2.	2.
Architectural Description (Include setting & outbuildings): <i>(use continuation sheets)</i> This Generator House is a rectangular concrete building that meaures 10 feet by 12 feet. The shed roof has an extremely low pitch with metal??? flashing around the edge. A double door opening is the only opening on the building facing north. No door is present. The metal frame is extant. The forms are evident in the concrete. There a two ribbon window openings on the side elevations. Frames are present. It appears that the openings housed louvers and not windows.  The roof is covered with organics. All sides of the building are also covered with organics. There is minor efflorescence, minor graffiti, and minor spalling. Not visited.		Statement of Significance: <i>(use continuation sheets)</i> A contributing resource to the Kodiak Naval Operating Base and Forts Greely and Abercrombie National Historic Landmark.

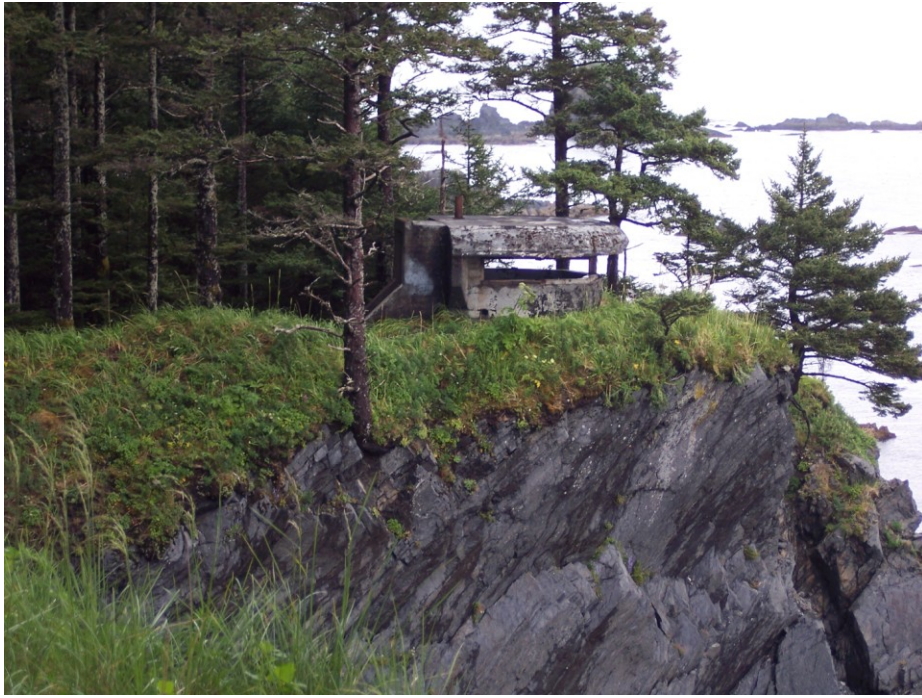
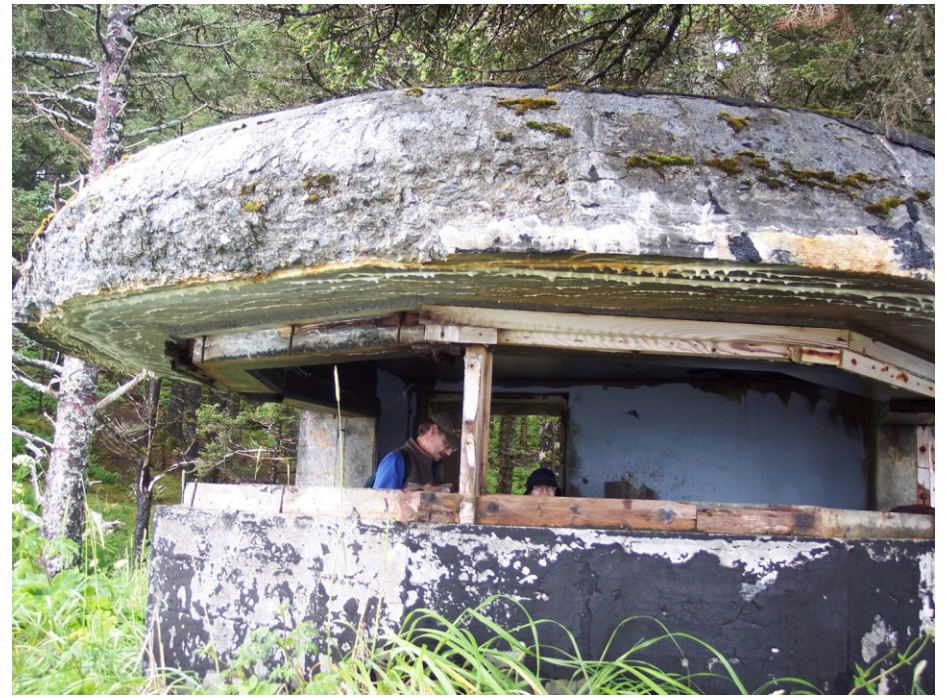
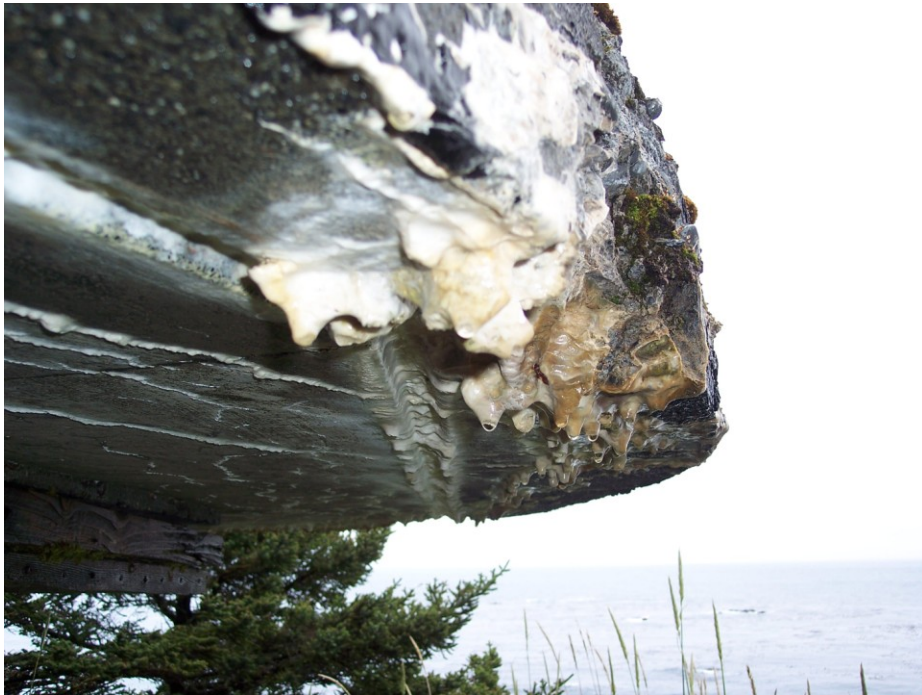
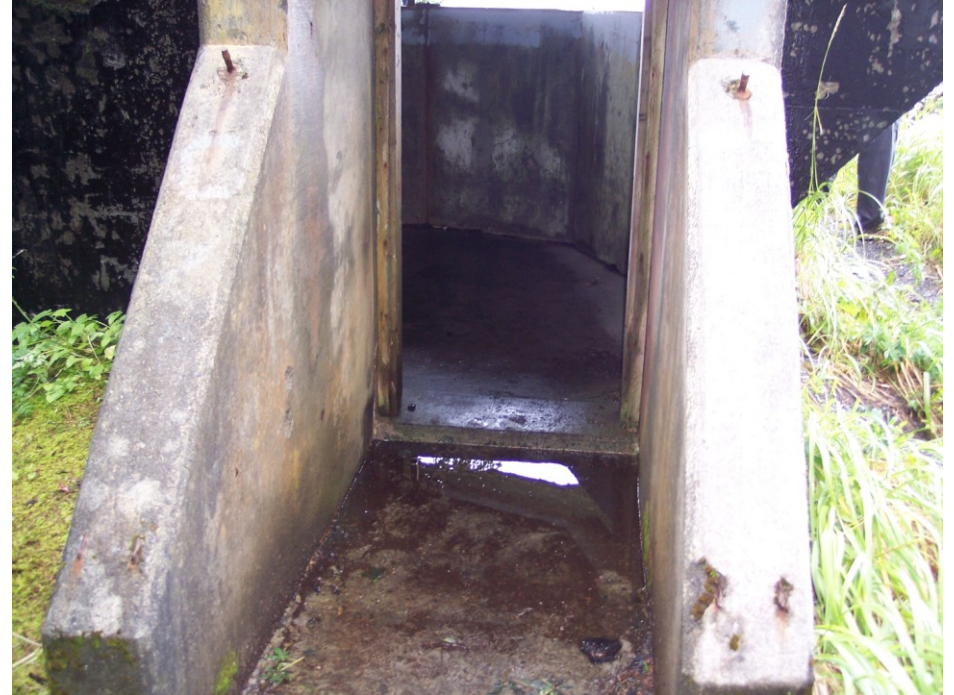
AHRS #: KOD-819

Architectural Style: No Style		Building Type:	
Number of Ancillary Structures: 0	Plan: Rectangular	Cultural Affiliation: EuroAmerican	
Foundation Materials: 1. Concrete 2.	Roof Materials: 1. Concrete 2.	Exterior Wall Materials: 1. Concrete 2.	Other Materials: 1. 2.
Architectural Description (Include setting & outbuildings): <i>(use continuation sheets)</i> The Searchlight Bunker at Piedmont Point is a 14 x 20 foot rectangular concrete building, one story in height. The bunker is balanced on a point surrounded by trees and steep cliffs on all three sides. Approaching the bunker from the northwest, the flat roofed structure has one door opening asymmetrically placed near the north of the building. The doors are no longer present but four hinges are in place suggesting double doors for this entry point. From the point side of the building, a door opening is located near the south end of the façade. Again, doors are absent, but four sets of hinges are still extant. A small window opening is located near the north end of this elevation. Wood framing is present. Three round holes are symmetrically located near the roof line of the structure. A concrete track leads from the door. This track allowed the searchlight to be rolled out from the structure when needed by the military. All other elevations are blank walls. Evidence of forms is found on all walls. Some preservation issues noted by the project team include efflorescence near the doors, organics on the roof, impact holes on the exterior and interior, spalling near the corners, young tree growth near the perimeter of the building, and minor graffiti on the interior of the building. Overall the condition of the building is fair.		Statement of Significance: <i>(use continuation sheets)</i> A contributing resource to the Kodiak Naval Operating Base and Forts Greely and Abercrombie National Historic Landmark.

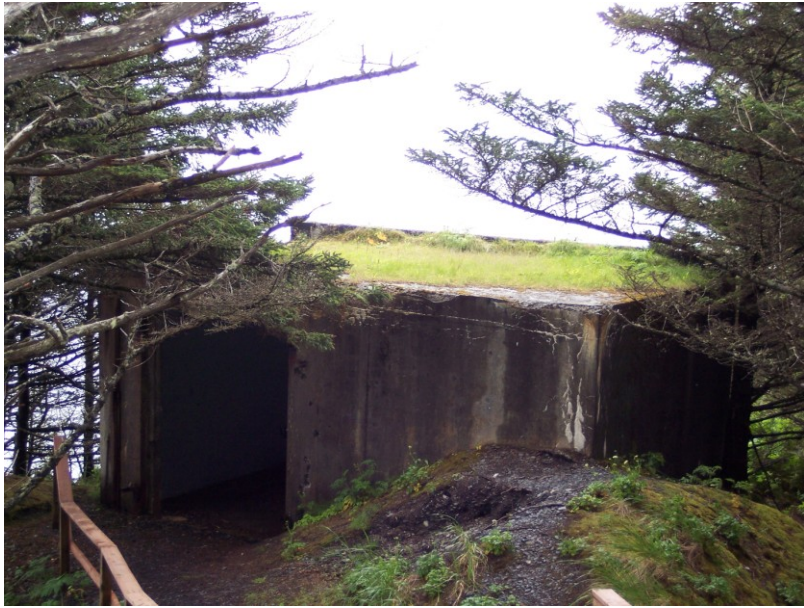
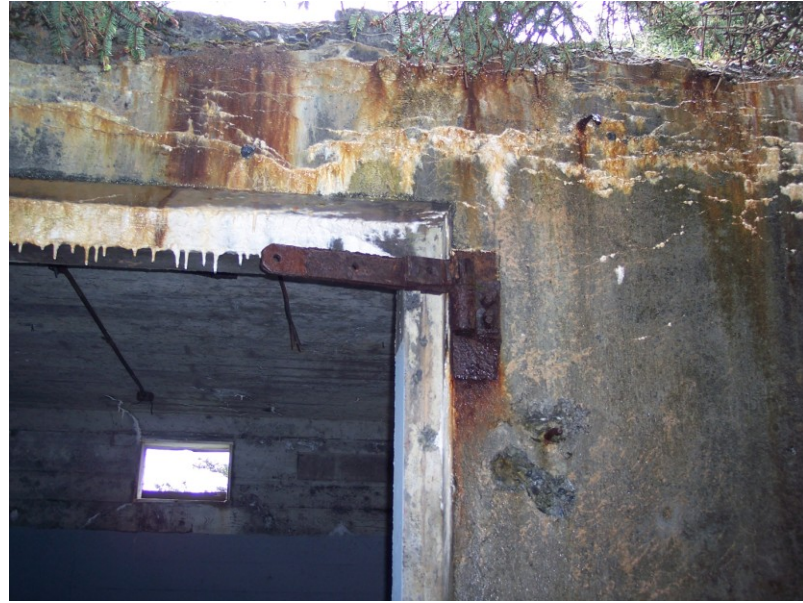
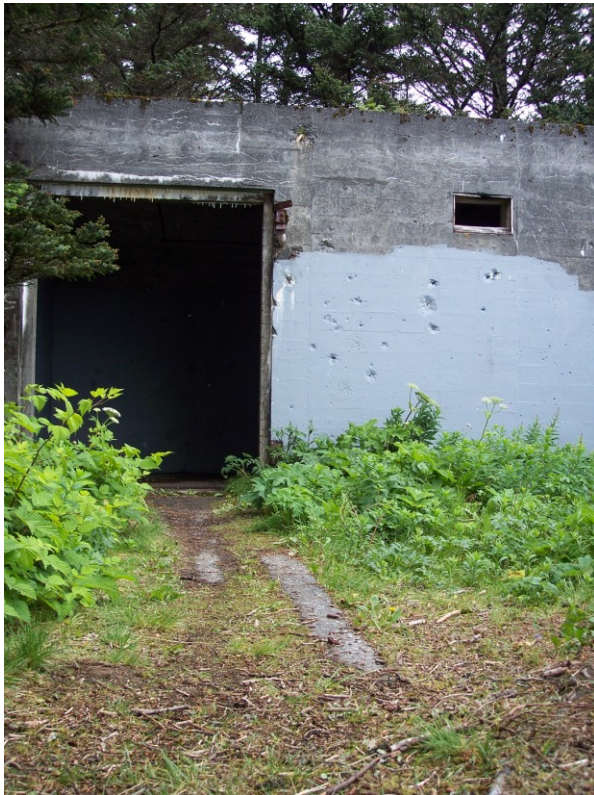
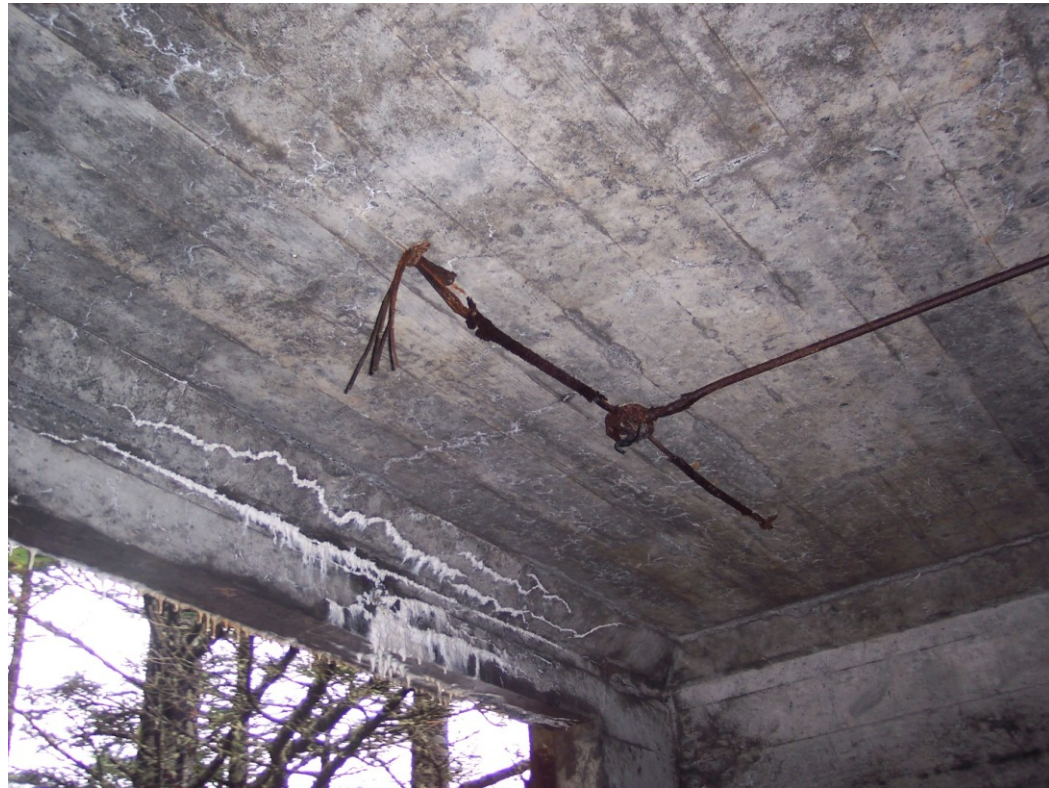
AHRS #: KOD-820

Architectural Style:		Building Type:	
Number of Ancillary Structures:		Plan: Rectangular	Cultural Affiliation: EuroAmerican
Foundation Materials:  1. Concrete  2.	Roof Materials:  1.  2.	Exterior Wall Materials:  1.  2.	Other Materials:  1.  2.
Architectural Description (Include setting & outbuildings): <i>(use continuation sheets)</i> The Radar Transmitting and Receiving foundation is located near the radar tower piers. The foundation is all that remains and is considered a contributing element to the National Historic Landmark. Three concrete steps lead up to the top of the foundation in the southern side. These provided access into the building when the building stood. The foundation is heavily covered with organics. Minor spalling is occurring at the corners. Heavy efflorescence was noted on all visible sides of the foundations.		Statement of Significance: <i>(use continuation sheets)</i> Contributing resource to the Kodiak Naval Operating Base and Forts Greely and Abercrombie National Historic Landmark.
