## **Fort Knox Mine and Gil Project Inspection Report**

| <b>Inspection Date:</b> | August 18, 2025 |
| <b>Inspection Objectives:</b> | Site Inspection |

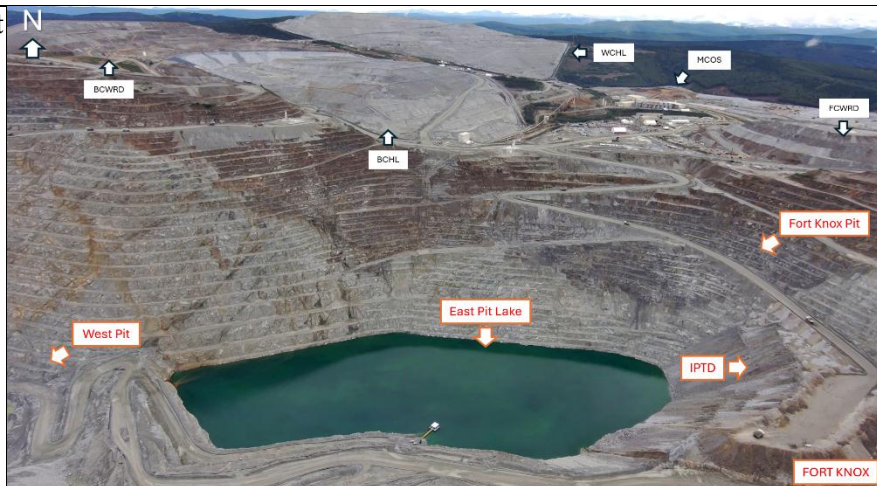
Photo 1: View of the **Fort Knox Pit** and **In-pit Tailings Disposal** with views of Barnes Creek and Walter Creek HLs, Barnes Creek and Fish Creek WRDs, and Manh Choh Ore Stockpile.

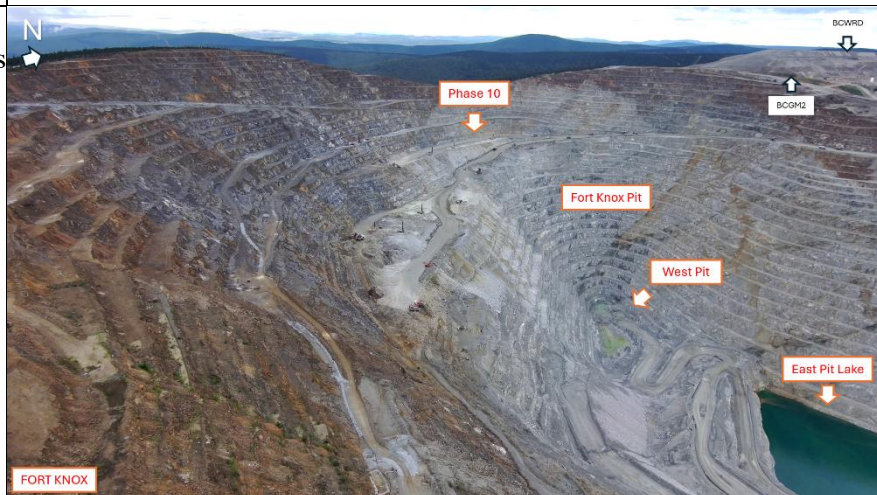
Photo 2: West side of **Fort Knox Pit** with views of **Phase 10** drilling and blasting program and distant views of Barnes Creek WRD and GM2.

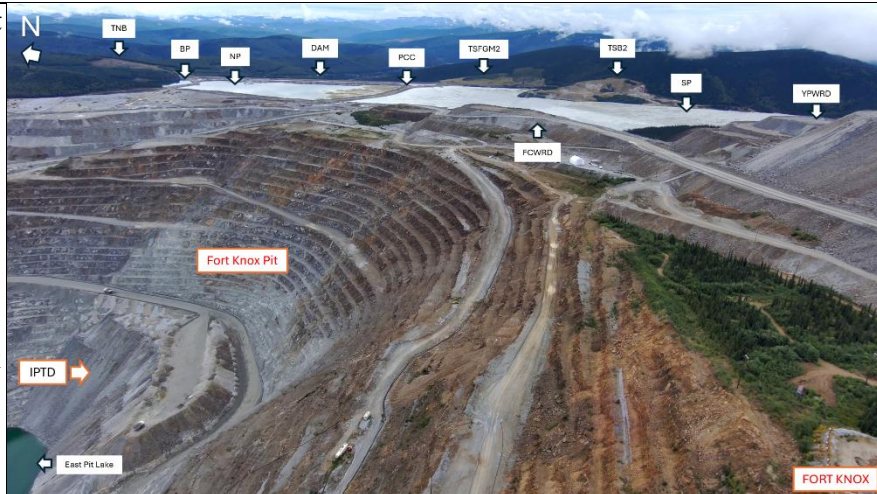
Photo 3: East side of **Fort Knox Pit** including a partial view of the East Pit Lake, **In-pit Tailings Disposal** with distant views of Tailings North Borrow, North, South, Barge ponds, Pearl Creek Causeway, TSF South GM2, Tailings South Borrow 2, and Fish Creek and Yellow Pup WRDs.

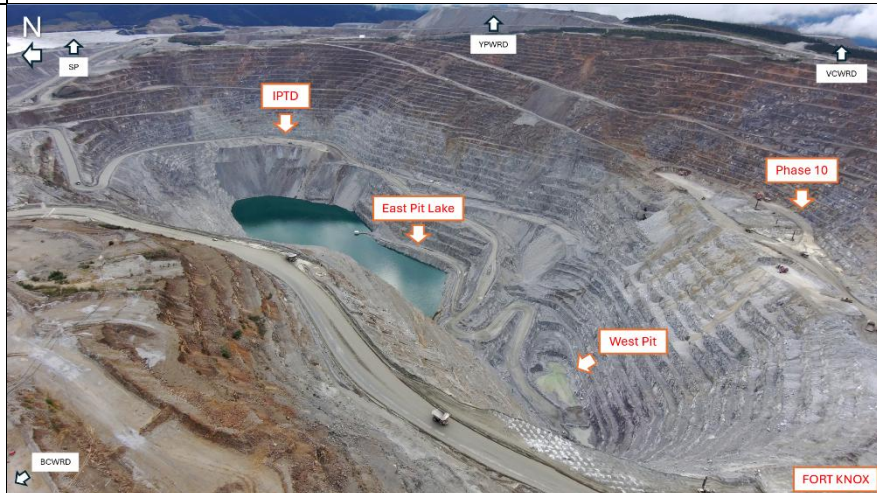
Photo 4: South side of **Fort Knox Pit** including views of the **In-Pit Tailings Disposal**, **East Pit Lake**, **West Pit**, and **Phase 10** drilling and blasting program.

Distant partial views of South Pond and the Yellow Pup and Victoria Creek WRDs.

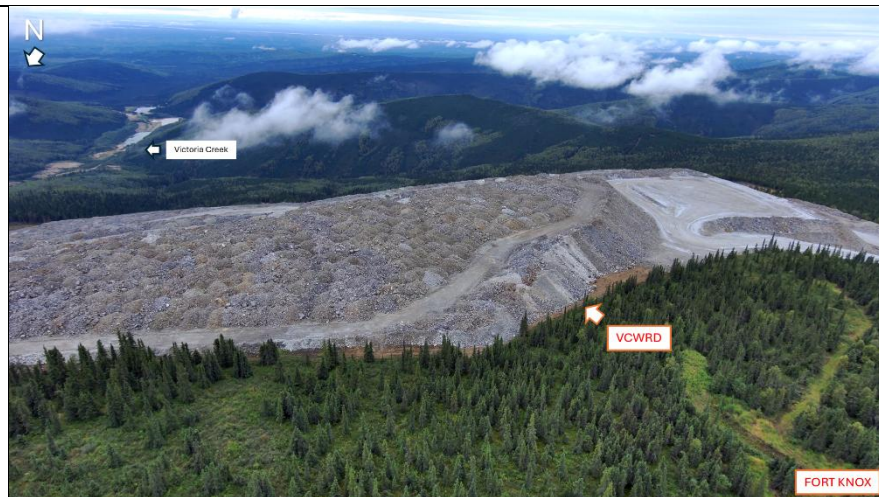
Photo 5: Top of **Victoria Creek WRD** with view of Victoria Creek placer operations in the background.

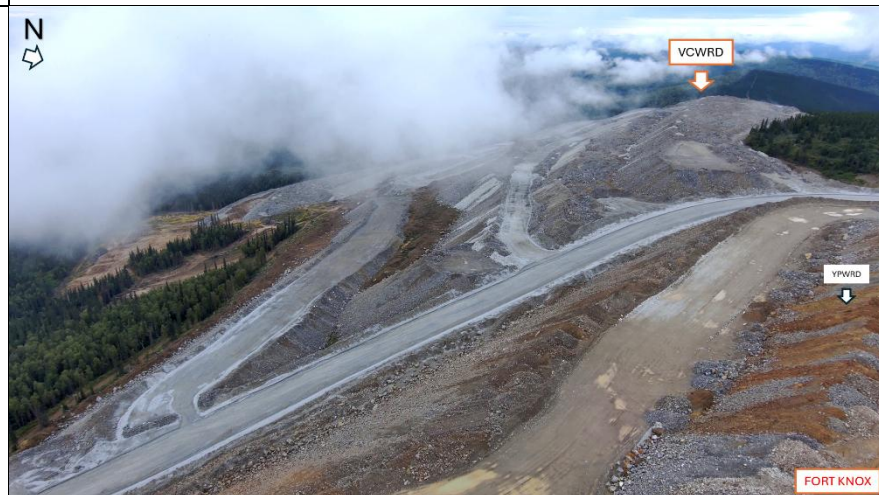
Photo 6: View of **Victoria Creek and Yellow Pup WRDs**.

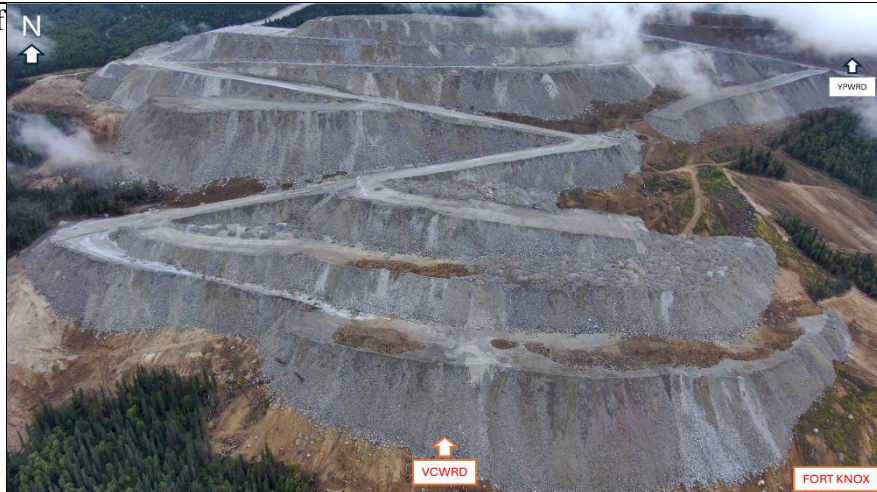
Photo 7: Northern view of **Victoria Creek WRD** and partial view of the **Yellow Pup WRD**.

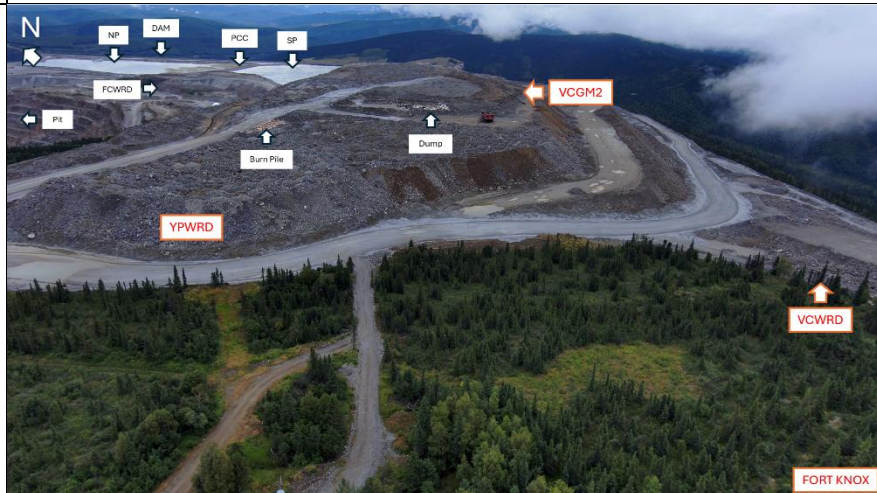
Photo 8: **Yellow Pup WRD and Victoria Creek GM2** with views of the burn pile and garbage dump.

Partial and distant views of east side of Fort Knox Pit, Victoria Creek and Fish Creek WRDs, North and South ponds, Pearl Creek Causeway, and the TSF Dam.

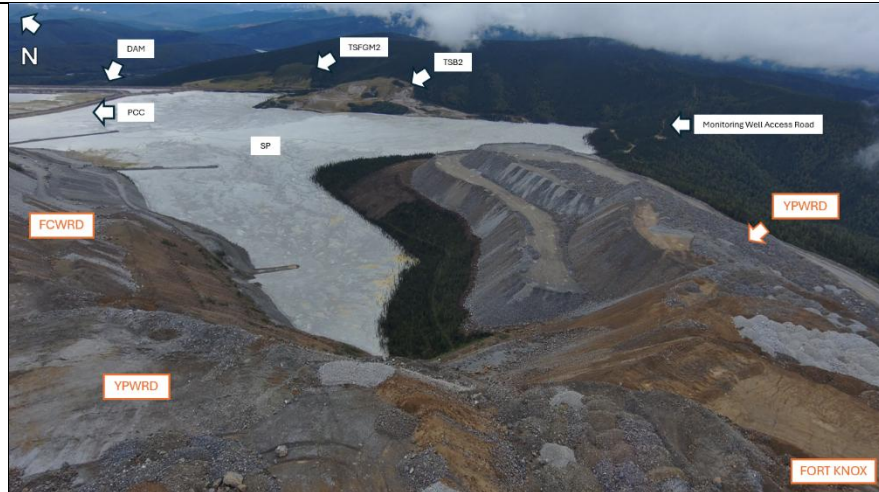
Photo 9: **Yellow Pup WRD** with views of the South Pond, Dam, Pearl Creek Causeway, TSF South GM2, Tailings South Borrow 2, monitoring well access road, and partial view of Fish Creek WRD.

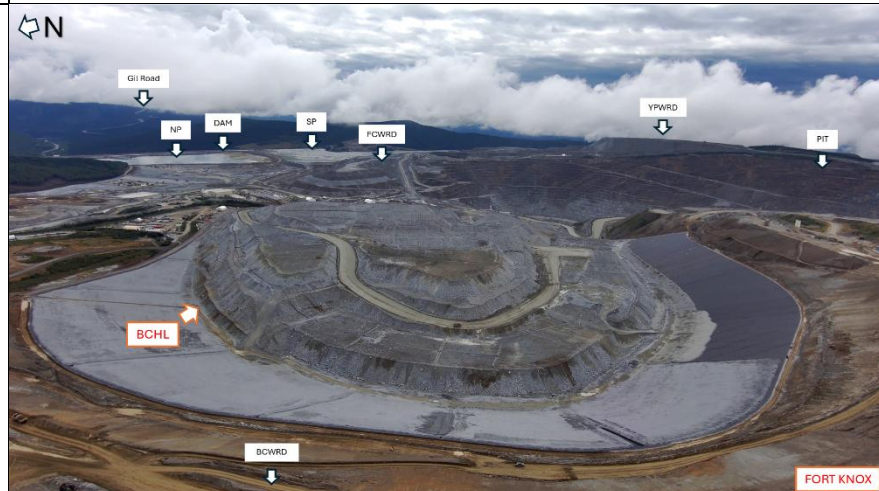
Photo 10: **Barnes Creek HL** and lower levels of the WRD with distant views of the south Fort Knox pit wall, Yellow Pup and Fish Creek WRDs, North and South ponds separated by the Pearl Creek Causeway, and TSF Dam and distant view of the Gil Road.

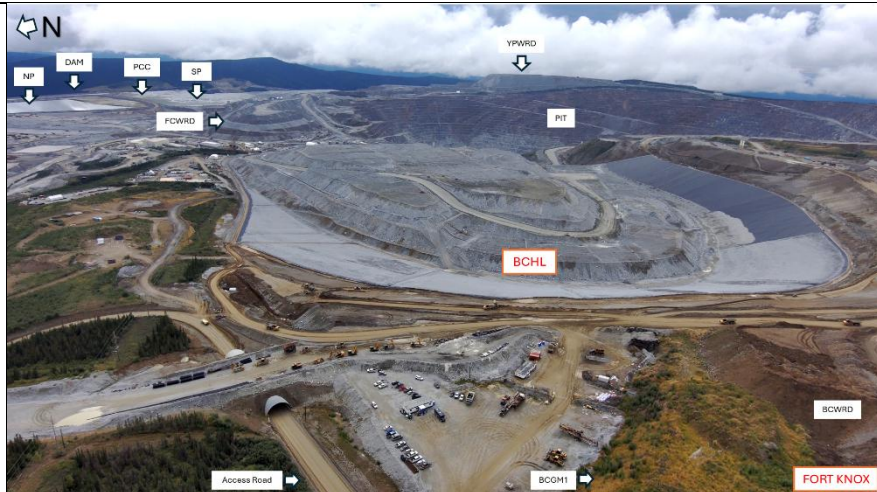
Photo 11: **Barnes Creek HL** with partial views of south Fort Knox pit wall, Yellow Pup and Fish Creek WRDs, North and South ponds, Pearl Creek Causeway, Barnes Creek WRD and GM1, and Fort Knox access road.

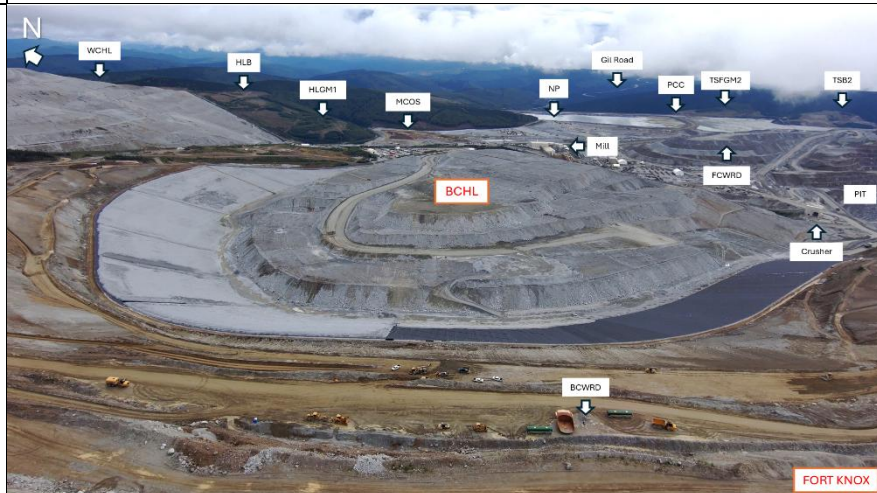
Photo 12: **Barnes Creek HL** with partial views of Walter Creek HL, HL Borrow HL GM1, Manh Choh Ore Stockpiles, North and South Ponds, Pearl Creek Causeway, GM2, Fish Creek WRD, Tailings South Borrow 2, Fort Knox pit, Gil road, and the Mill and Crusher.

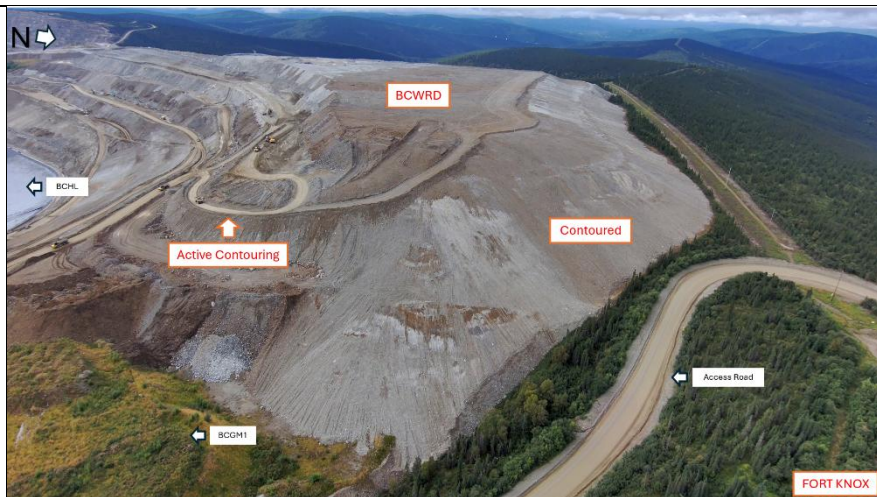
Photo 13: **Barnes Creek WRD** including partial views of Barnes Creek HL and GM1 and Fort Knox access road.

Note the active reclamation and contouring of the eastern side of Barnes Creek WRD and previous contouring work on the north side.

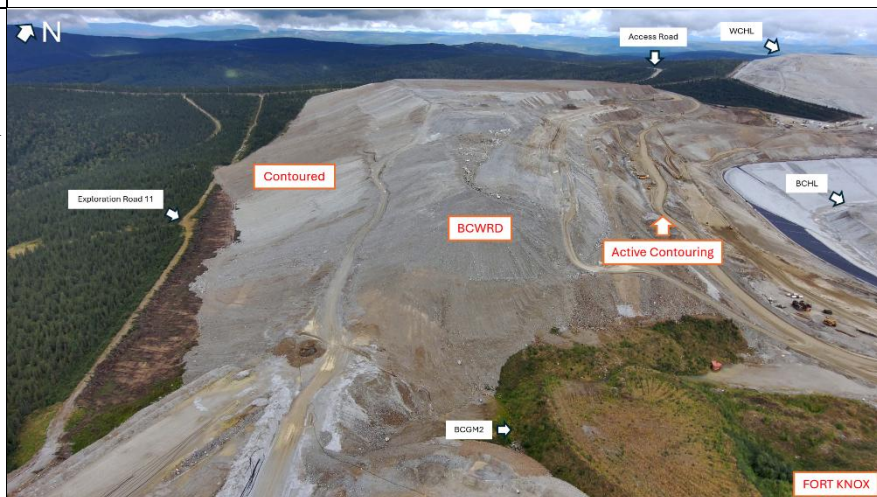
Photo 14: **Barnes Creek WRD** including partial views Walter Creek HL and Barnes Creek HL and GM2.

Note the active reclamation and contouring of the eastern side of the Barnes Creek WRD and previous contouring work on the west side.

Note the locations of the Fort Knox access road and Exploration Road 11 (currently blocked by contouring).

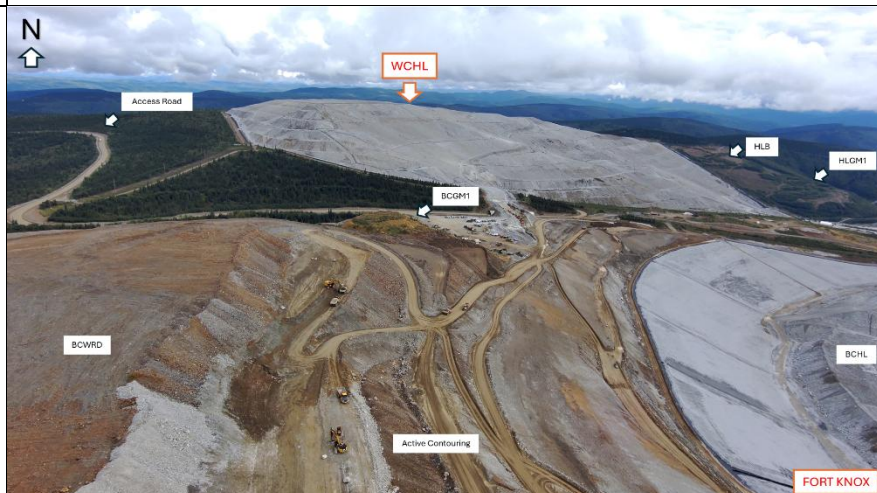
- 1.8. Walter Creek HL: No work on this facility was observed during this visit (photos 1, 16, and 38). The stacking of ore on the facility was completed in 2021, and concurrent reclamation was initiated in 2022 including re-sloping of benches in preparation for growth media application. It covers about 435 acres.

Photo 16: **Walter Creek HL** with partial views of Barnes Creek GM1, WRD, and HL, HL Borrow, HL GM1, and Fort Knox access road.

Note the active reclamation (contouring) of the eastern side of Barnes Creek WRD.

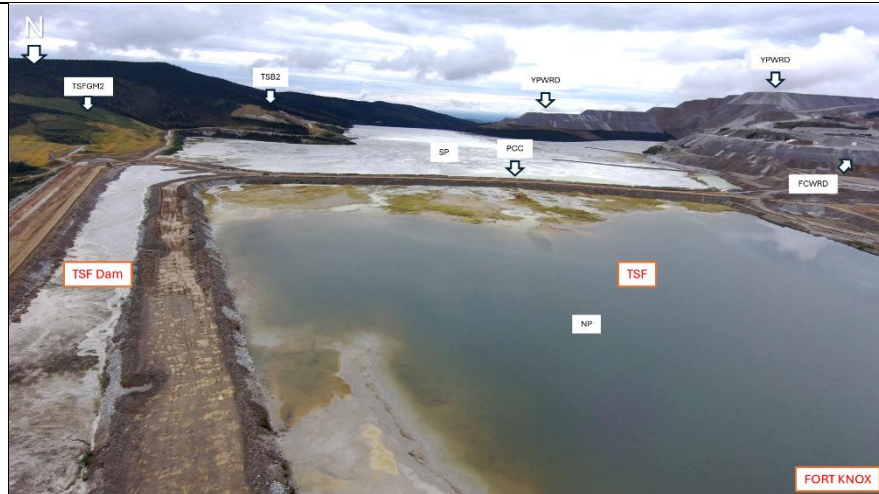
Photo 17: **Tailings Storage Facility** with views of Pearl Creek Causeway, North and South ponds, dam crest, Fish Creek WRD, upper and lower portions of the Yellow Pup WRD, Tailings South Borrow 2, and TSFGM2.

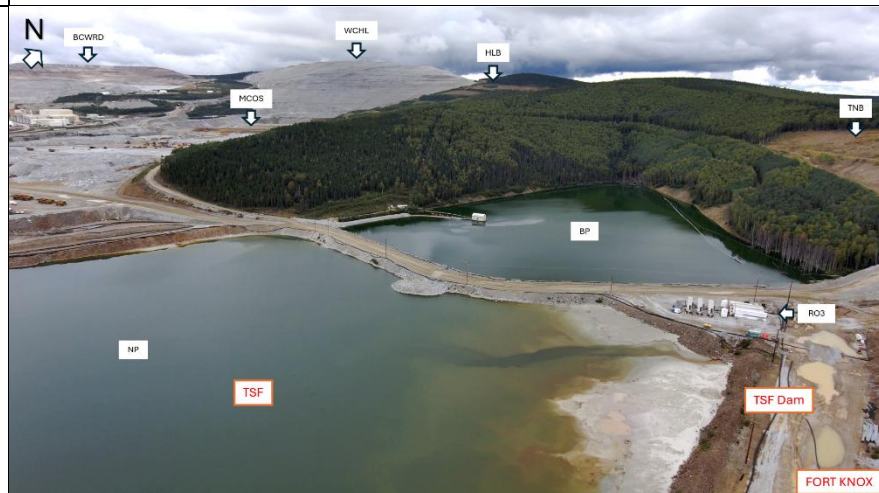
Photo 18: **Barge Pond and RO3 Water Treatment Plant** including views of the dam crest, North Pond, Tailings North and HL borrows, Manh Choh Ore Stockpile, Walter Creek HL, and Barnes Creek WRD.

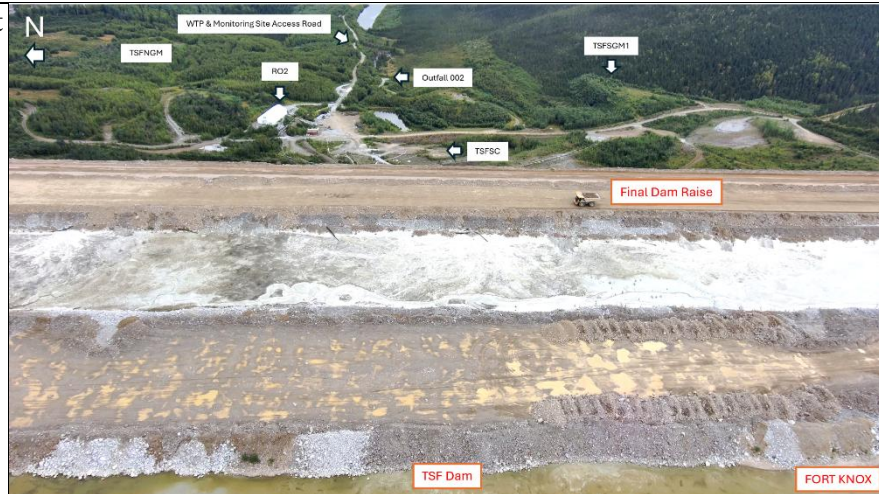
Photo 19: **TSF Dam** crest and final dam raise including views of RO2 Water Treatment Plant, Outfall 002, and GM stockpiles.

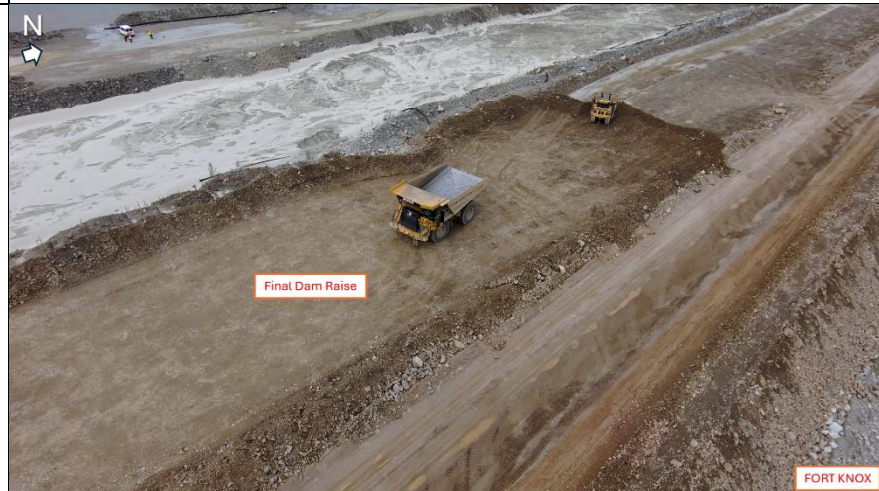
Photo 20: **TSF Dam** and view of final dam raise active construction.

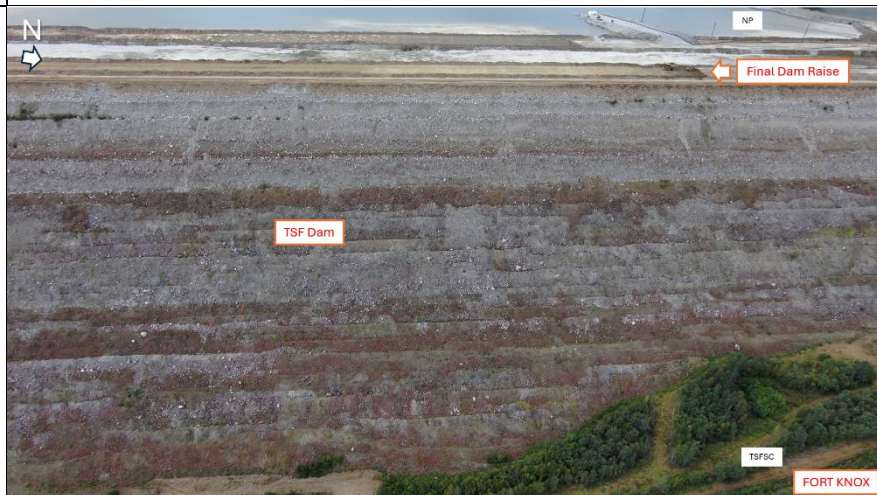
Photo 22: Western view of the **TSF Dam** including final dam raise.

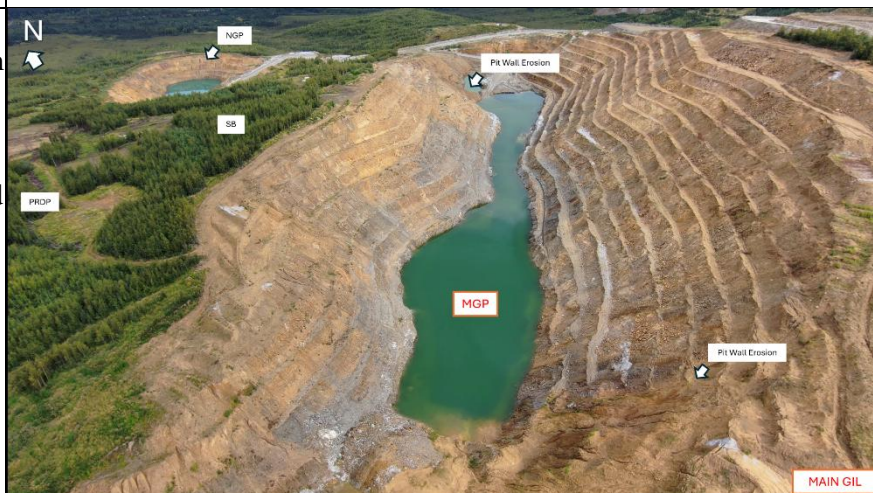
Photo 24: **Main Gil Pit** exhibiting pit wall erosion and groundwater inflill. Note the location of the Snack Bar, Partially Reclaimed Drill Pads, and North Gil Pit

It is recommended that FGMI evaluates the slope conditions within the Gil Main Pit and Sourdough pits to determine if BMP's may be used to provide stability during a temporary closure.

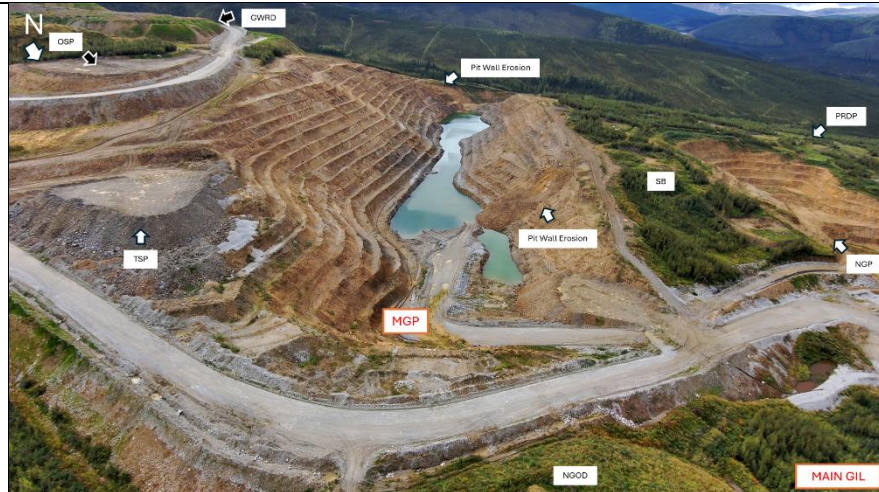
Photo 25: MGP exhibiting areas of pit wall erosion and groundwater inflow.

Note locations of the TSP, GWRD, OSP, SB, NGOD, and NGP.

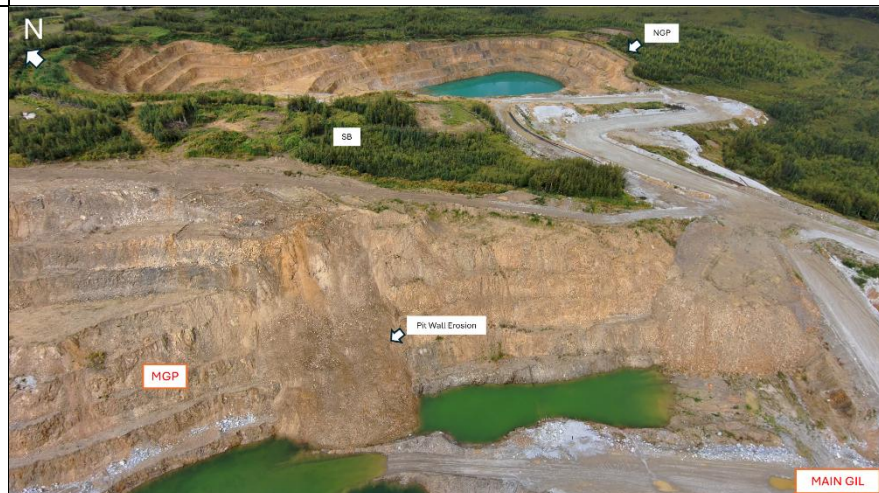
Photo 26: MGP pit wall erosion and groundwater inflow.

Note locations of SB and NGP.

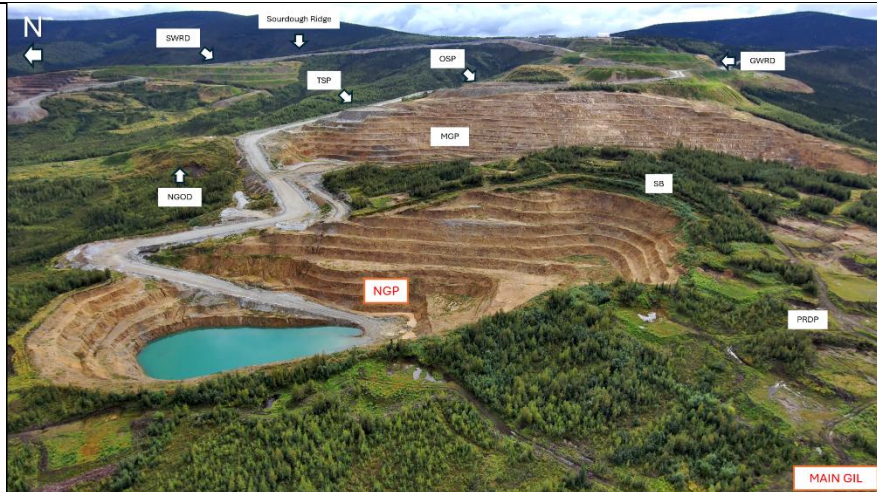
Photo 27: NGP with views of partially reclaimed drill pads, SB, MGP, NGOD, TSP, OSP, NOD, and GWRD.

Note the successful hydroseeding application of the GWRD.

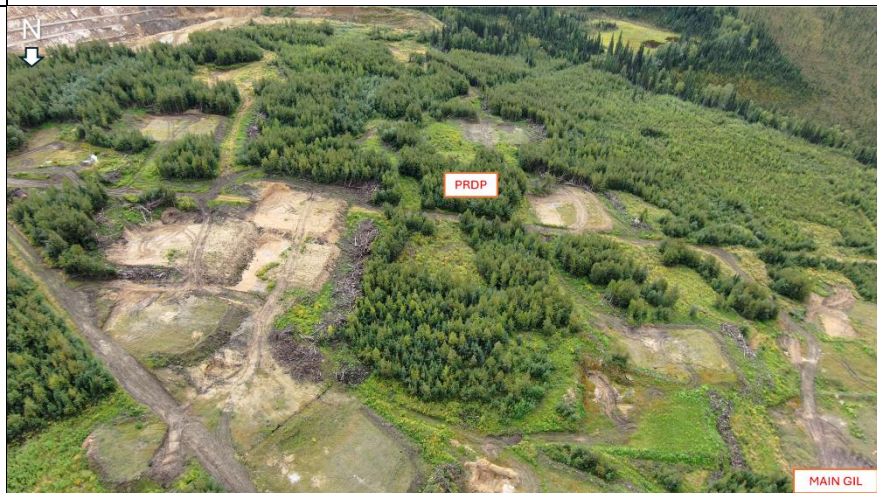
Photo 28: View of the SB and PRDP.

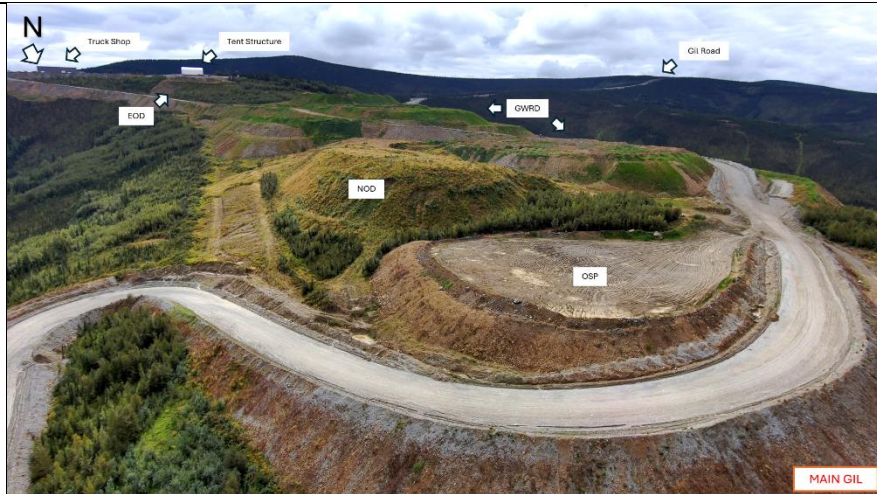
Photo 29: View of Main Gil including truck shop, organic dumps (EOD and NOD), waste rock dumps (GWRD), and OSP.

Note the successful hydroseeding application on the GWRD.

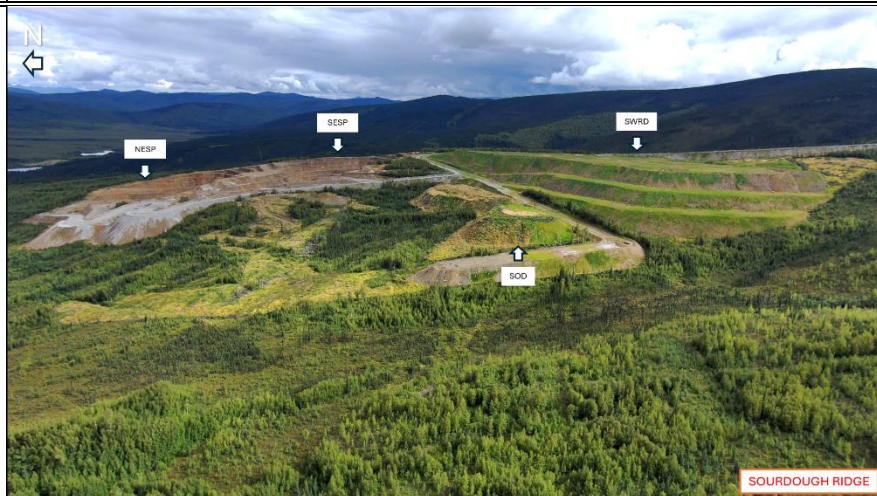
Photo 30: View of Sourdough Ridge from Main Gil including Northeast Sourdough Pit (NESP) and Southeast Sourdough Pit (SESP), Sourdough Waste Rock Dump (SWRD), and Sourdough Organic Dump (SOD).

Note the successful hydroseeding application on the SWRD and SOD.

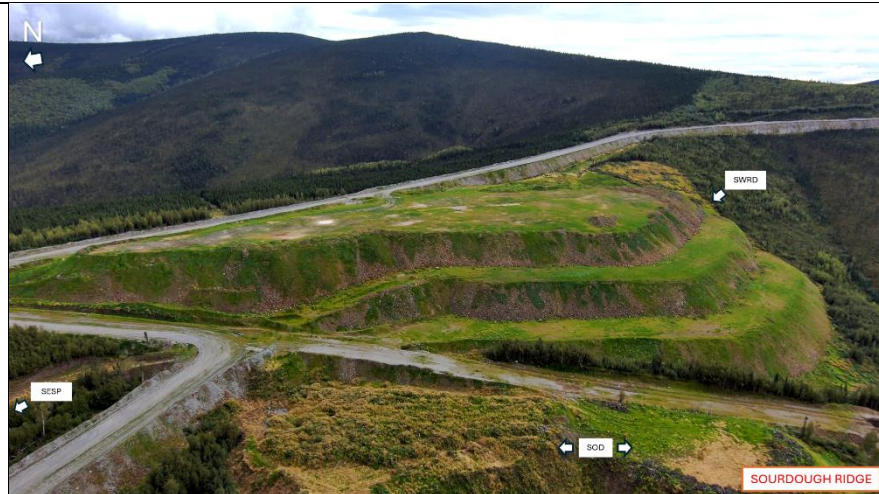
Photo 31: Sourdough Ridge including views of SWRD and SOD.

Note the successful hydroseeding application on the SWRD.

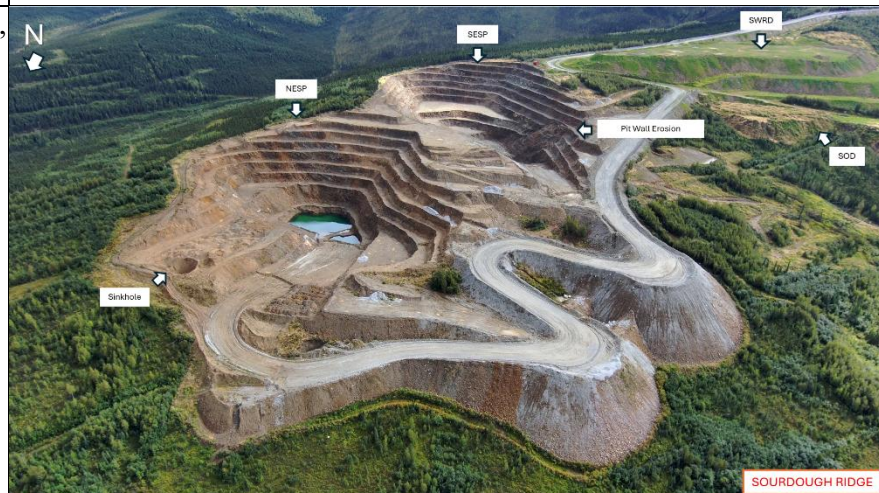
Photo 32: Sourdough Pits, NESP and SESP with views SOD and SWRD.

Note the sinkhole in NESP and pit wall erosion in SESP.

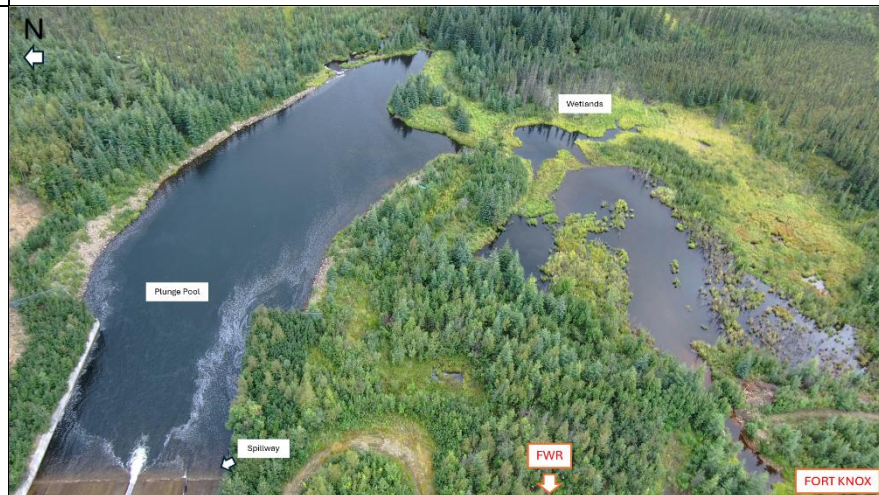
Photo 34: FWR spillway, plunge pool, and wetlands.

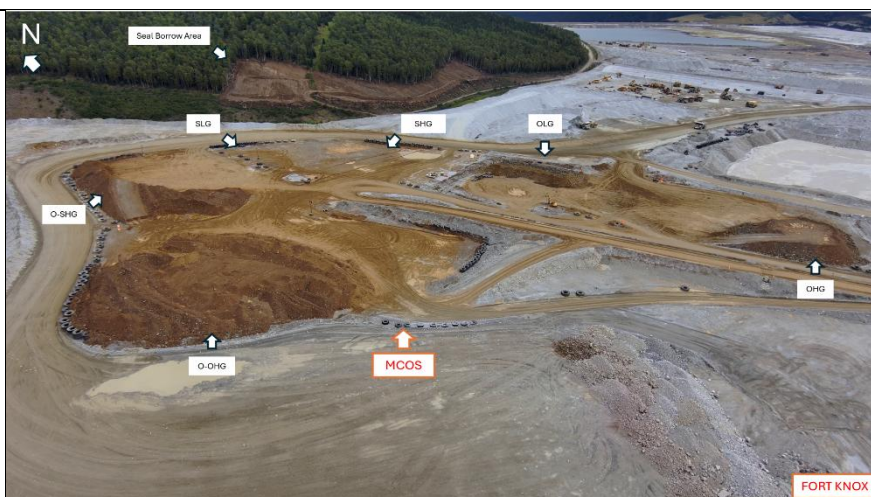
The Manh Choh Ore Storage Pad was active at the time of inspection. Ore from Manh Choh mine is deposited into stockpiles consisting of high-grade oxide, low-grade oxide, high-grade sulfide, and low-grade sulfide just southwest of the Walter Creek HL (photo 37). Manh Choh tailings have been deposited into the Fort Knox Pit since July 2024.

Photo 37: Manh Choh ore stockpiles (MCOS) include the following:

Stockpile 6 Overflow  
OHG-Oxide High Grade

Stockpile 5 Overflow  
SHG-Sulfide High Grade

Stockpile 4 SLG Sulfide  
Low Grade

Stockpile 3 SHG-Sulfide  
High Grade

Stockpile 2 OLG-Oxide  
Low Grade

Stockpile 1 OHG-Oxide  
High Grade

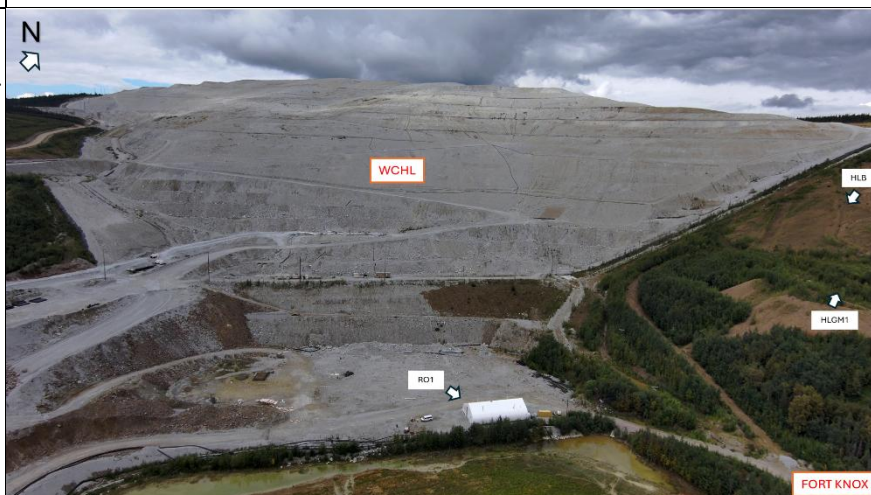
Photo 38: Walter Creek Heap Leach – WCHL, RO1, and partial views of HLB, and HLG1.
