**INACTIVE PRODUCTION ROCK SITES AND QUARRIES
2005 ANNUAL REPORT**

Kennecott Greens Creek Mining Company

June 2006

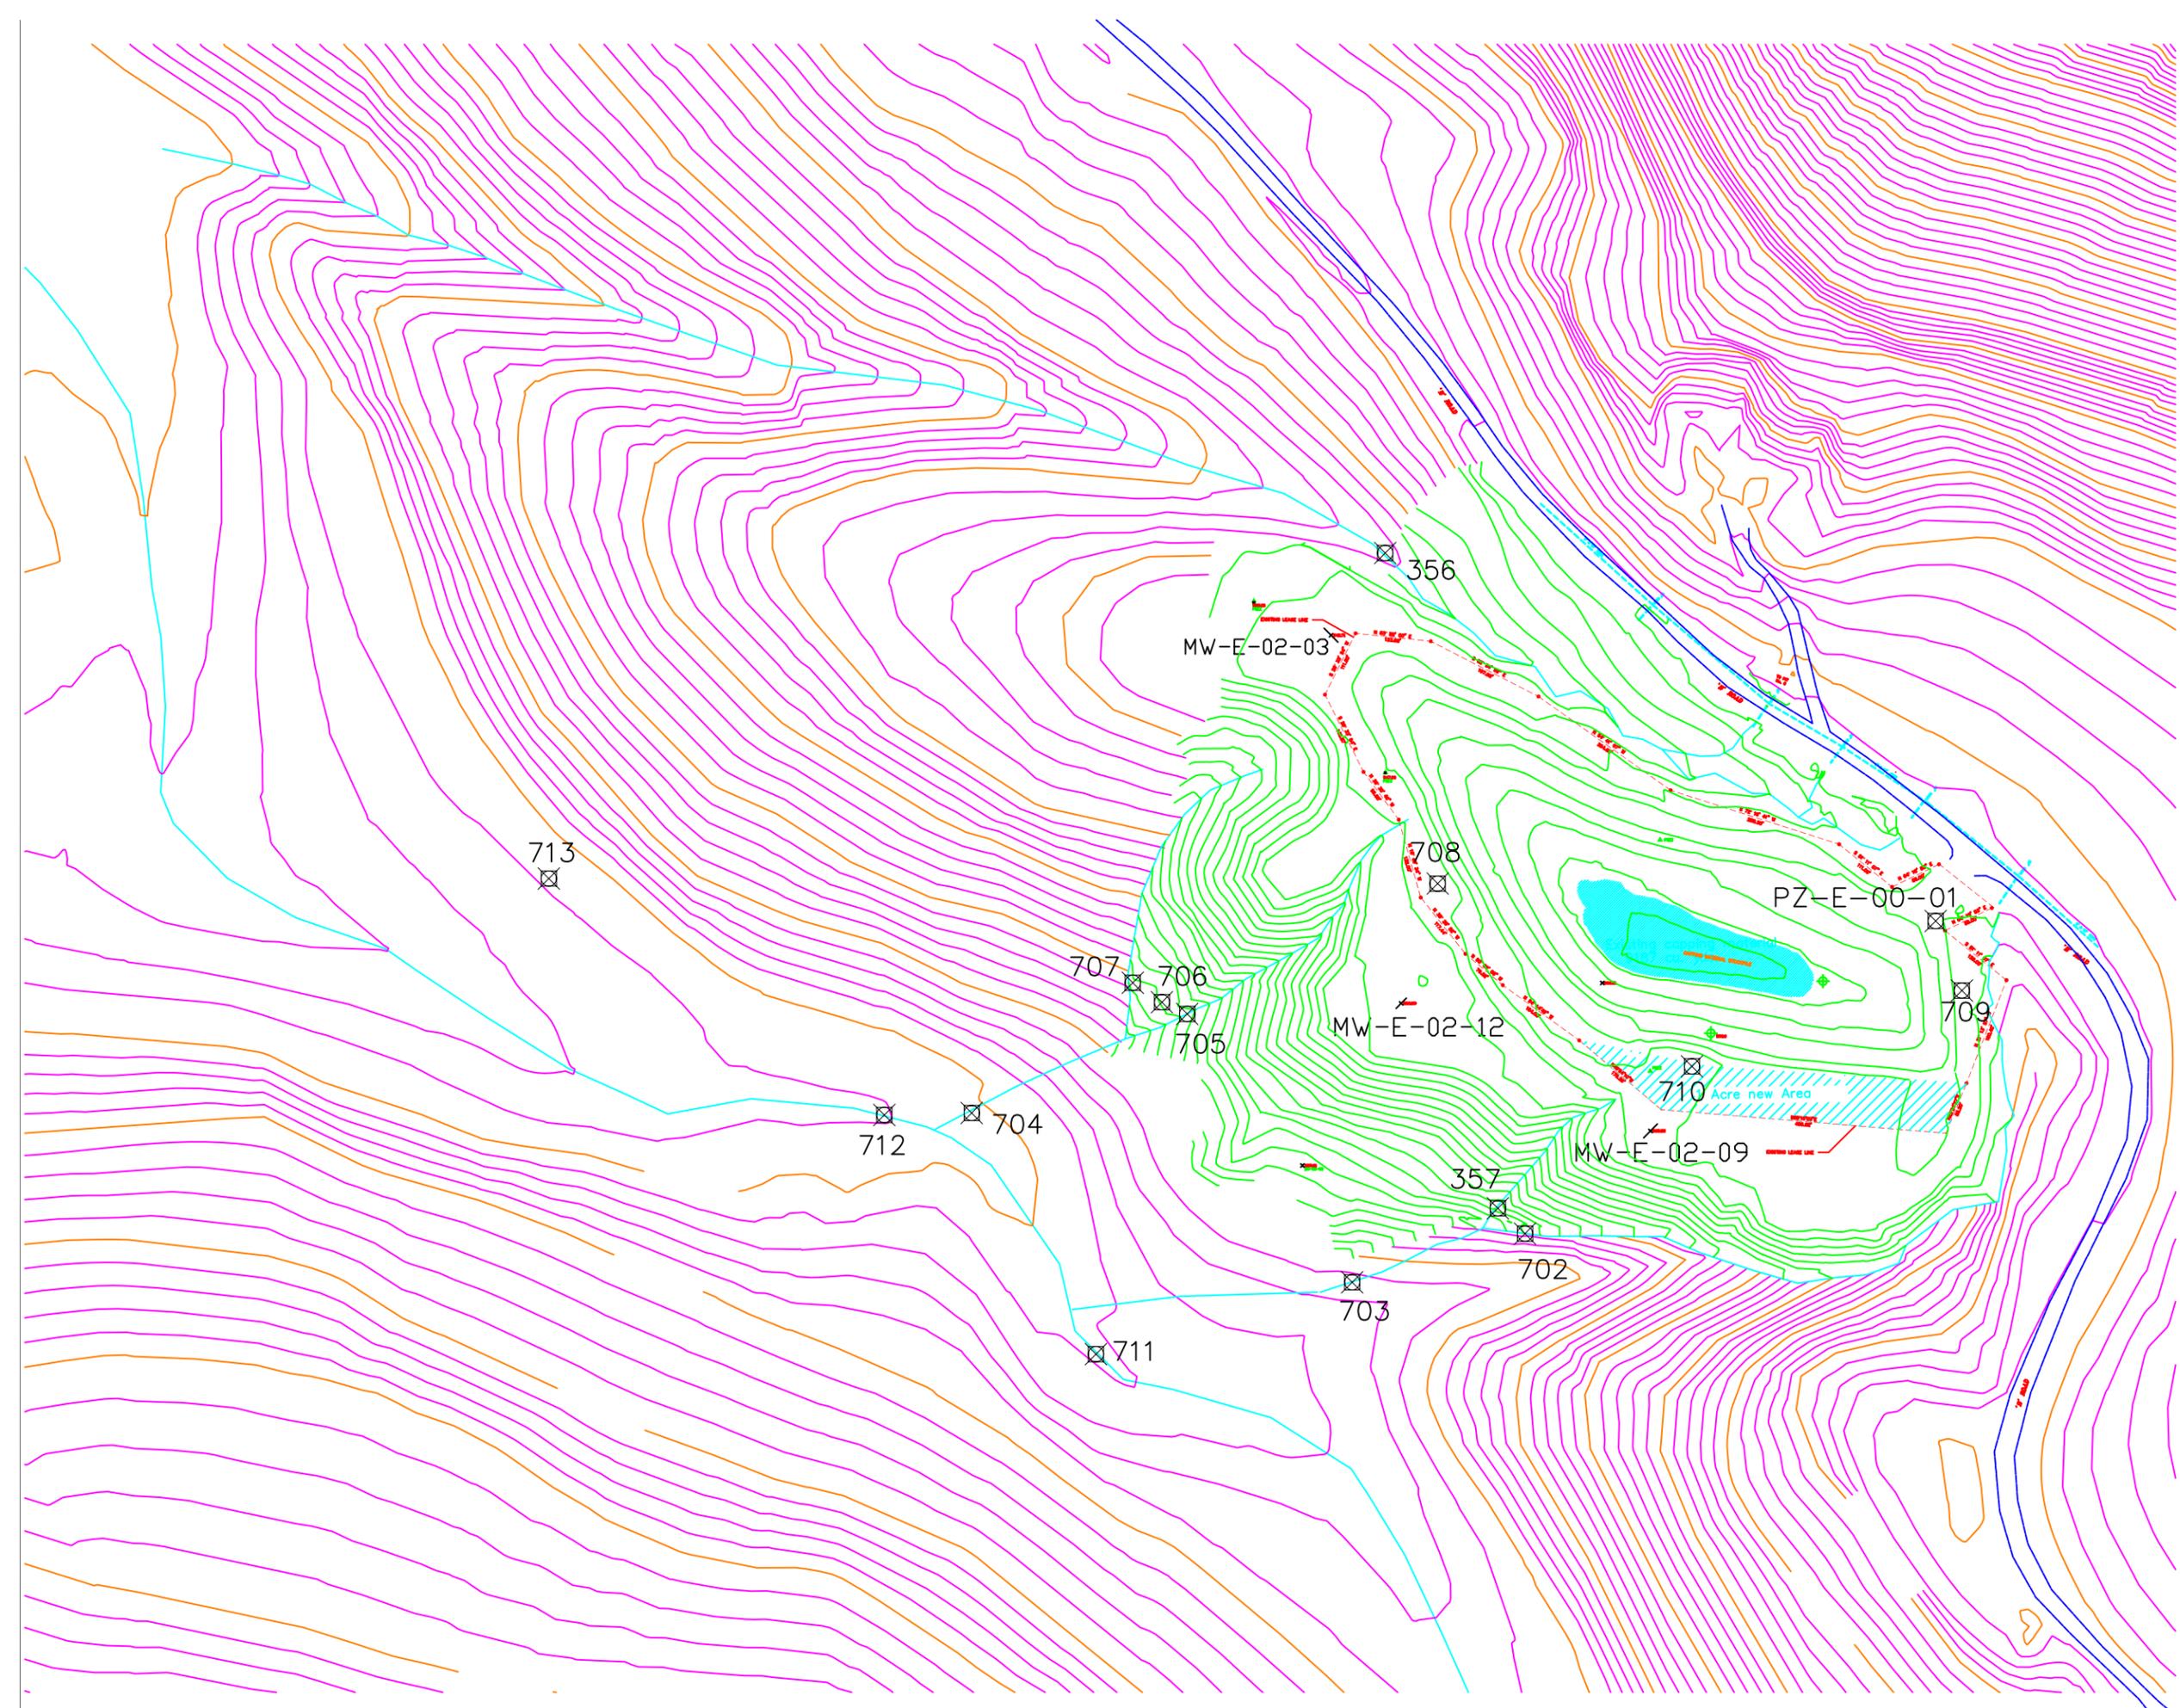
FIGURE 2-2
WASTE SITE E ASBUILT

Site E is located 4.6 miles up the B Road halfway between the Hawk Inlet port facility and the 920 Mill facility (Figure 2.1). Approximately 365,000 cubic yards of glacial till and production rock were placed at the site from 1988 to 1994. The glacial sediments were excavated from the 920 site during construction of the Mill facility. There were no grid samples taken at Site E in 2004 or 2005. However, results from water sampling in 2004 at the toe of the site demonstrate that the production rock continues to buffer the pH of the drainage near neutral. Sulfate and metal loading in these samples is relatively high (but consistent with exposed carbonate buffered pyritic production rock). Flows from the site are minimal because it sits on a topographic high and only receives water from direct precipitation (e.g., no run-on or groundwater input).

In late 2002 and in 2003, three new monitoring wells were installed and 13 new surface water sampling sites were established at Site E to better understand the potential pile influence on the area. Figure 2.2 shows the locations of these sites. Water quality data for the wells and seven of the 13 surface water sites are shown on Figures 2.21 to 2.34. One of the wells (MW-E-02-03) is completed in till to a depth of approximately 99 feet, and the two other wells are completed in gravels at 76 and 86 feet (MW-E-02-09 and MW-E-02-12). The seven new surface water sites depicted in the figures represent water quality at the toe of the pile (708, 709, and 710, along with the old sites 356, South Toe and North Toe), two downgradient drainages (703 and 704) that report to Greens Creek, and two sites in Greens Creek, one upgradient of Site E (711) and one downgradient (712). Although there are a limited number of data points thus far for these new locations, in general sulfate and metal concentrations decrease as the distance from Site E increases. However, the downgradient site in Greens Creek (712) showed slightly elevated sulfate and zinc concentrations when compared to the upgradient site (711). Samples from Sites 711 and

KGCMC plans to relocate the Site E production rock material to the surface tailings facility over a two-year span from 2007 through 2008 using dedicated personnel and trucks. KGCMC anticipates recovery of the dewatered till material originally placed at this site from the Mill backslope excavation. This till material will serve to enhance the barrier layer performance of future reclamation capping efforts. Once the rock materials are removed, and the till material is assessed and consolidated as needed, KGCMC expects to utilize the remaining Site E area for the storage of additional reclamation material, minimizing the need for future disturbances in other areas.

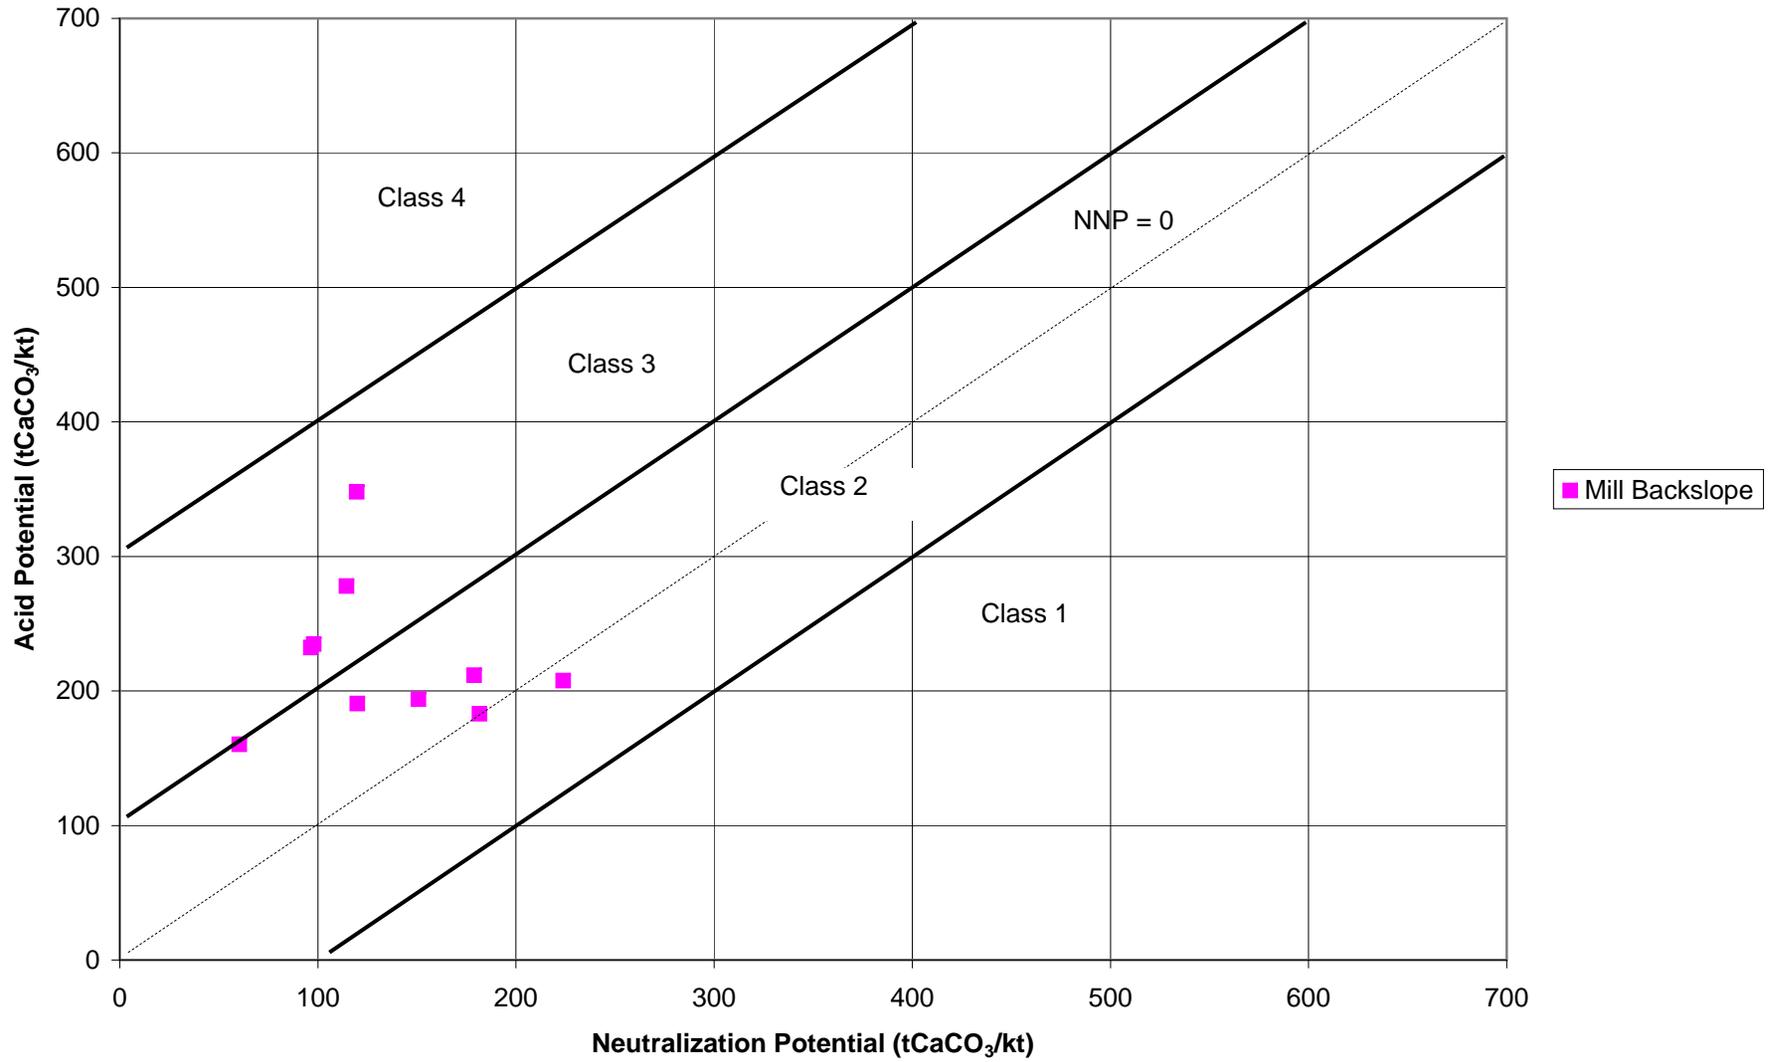
Figure 2.3 2005 Inactive Production Rock Site Acid-Base Accounting Analyses

Figure 2.3 compares Acid Potential (AP) with Neutralization Potential (NP) from 2005 surface grid samples. Surface grid samples were taken from the Mill backslope in 2005, during and after material removal activities. The inactive sites were constructed prior to development of the classification protocol that KGCMC currently uses. At the time the inactive piles were constructed KGCMC did not classify or segregate its production rock. Symbols in Figure 2.3 represent actual laboratory data points. Lines indicating the currently utilized production rock classes are shown on Figure 2.3 for reference only. Figure 2.3 shows the distribution of potentially acid generating (upper left half of figure) and potentially acid neutralizing (lower right half of figure) samples. Six of the ten samples would be classified as Class 2 under the current classification procedure. Regardless of pyrite content, almost all production rock at Greens Creek contains substantial carbonate (5 to 40%). This carbonate content indicates that there is a relatively long lag time to potential acid generation for the majority of the samples.

A long lag time to potential acid generation explains why only a few samples show signs of acidification and indicates sufficient time remains available to reclaim the sites, pending availability of backfill space underground, development of suitable disposal space at the tailings facility and development of cover material borrow areas. Figure 2.4 shows the relationship between surface rock grid sample rinse pH and net neutralization potential (NNP) for Mill backslope samples taken in the area where removal activities occurred in 2005. NNP is the balance between NP and AP. A negative NNP typically indicates the sample is potentially acid generating. Rinse pH is a measure of the pH of a one-to-one mixture of “as-received” fines and water. Rinse pH is different than paste pH, which is the pH of the sample after it has been pulverized and moistened. Rinse pH is often lower than paste pH because pulverizing the sample exposes fresh, sometimes alkaline, mineral surfaces. The rinse pH method also uses more water, which can dissolve surface oxidation products, lowering the pH of the solution. The previous years’ rinse pH data for the inactive production sites demonstrate that the majority of the samples retain enough buffering capacity to maintain pHs above 6.0 (KGCMC, 2004; KGCMC, 2005). The data shown in Figure 2.4 show the majority of rinse pHs to be less than 6.0 in 2005; however, these samples were taken to help identify material to be removed and are atypical for inactive production rock sites.

Grid sampling of the Mill backslope rock cover and access road (Figures 2.3 and 2.4) indicates that this rock is acid generating. The average NNP for the backslope samples (-90 tCaCO₃/kt) reflects a high sulfide content and low carbonate content in the rock. The low carbonate content is likely a combination of deficient initial composition and depletion of carbonate from the fines fraction through weathering.

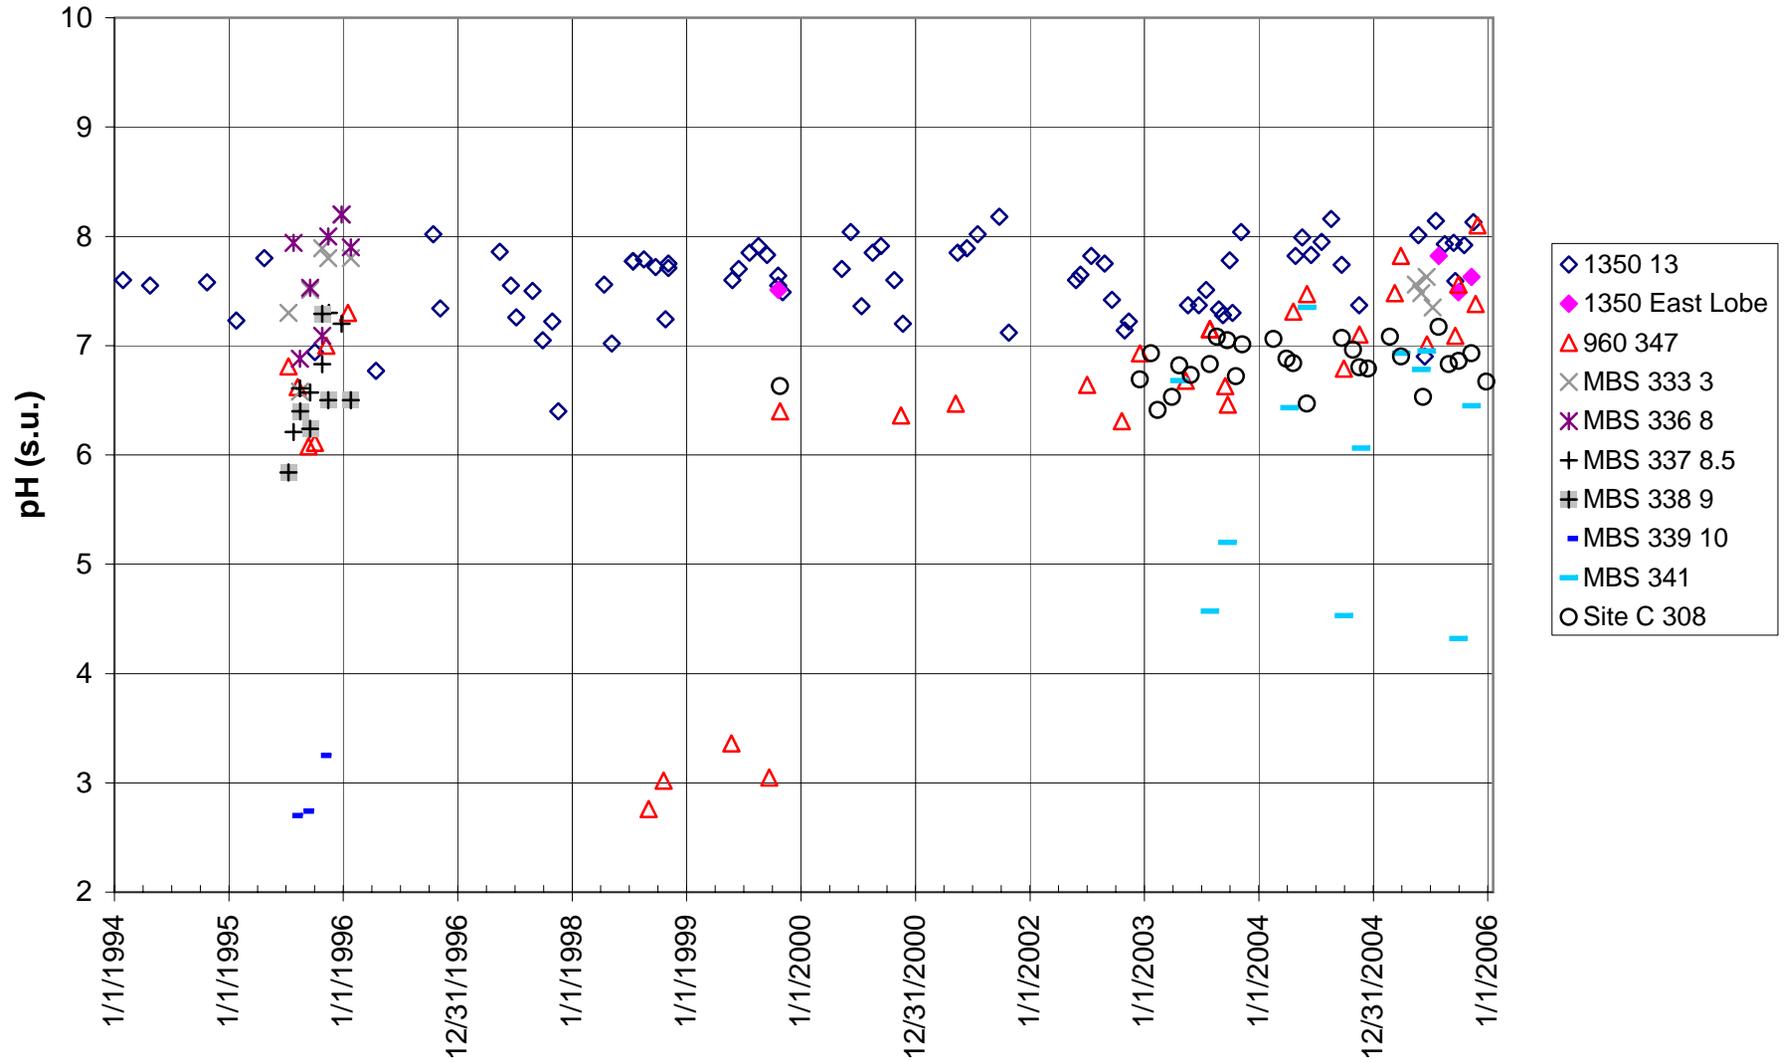
Figure 2.6 Inactive Production Rock Site pH Data

Figures 2.6 and 2.21 show pH data from inactive site sampling locations. Lower pH values can represent influences from pyrite oxidation and/or organic acids from muskeg and forest soils. The data show that the vast majority of the site drainage remains above pH 6.0. The sample from the Mill backslope in 1995 was runoff collected from a bench containing zones of heavily pyritized rock. For a brief period in 1998 and 1999, acidic conditions began developing at Site 960 347. KGCMC applied lime and removed 1000 cubic yards of oxidized pyritic rock from the site in 2000. The pH of the drainage quickly rebounded and has remained near-neutral since 2000. Removal of additional material in 2003, 2004 and 2005 is discussed below in Section 2.3. The material removal activities may also be responsible for the pH of 8.0 measured at the 960 site in 2005. This is the highest recorded for this site. The reason for the elevated pH is likely due to the removal of pyritic rock that had consumed much of its readily available buffering capacity. Fresh carbonate mineral surfaces exposed during the excavation and the placement of the toe buttress may have contributed to the higher pH values observed. One of the four Mill backslope

site samples in 2004 and in 2005, both in September, had a pH less than 6.0. Alkalinity data presented in Figures 2.7 and 2.22 are consistent with the pH results in Figures 2.4, 2.6, and 2.21. Except for the current Mill backslope site all sample locations maintain measurable alkalinity provided by dissolution of carbonate minerals.

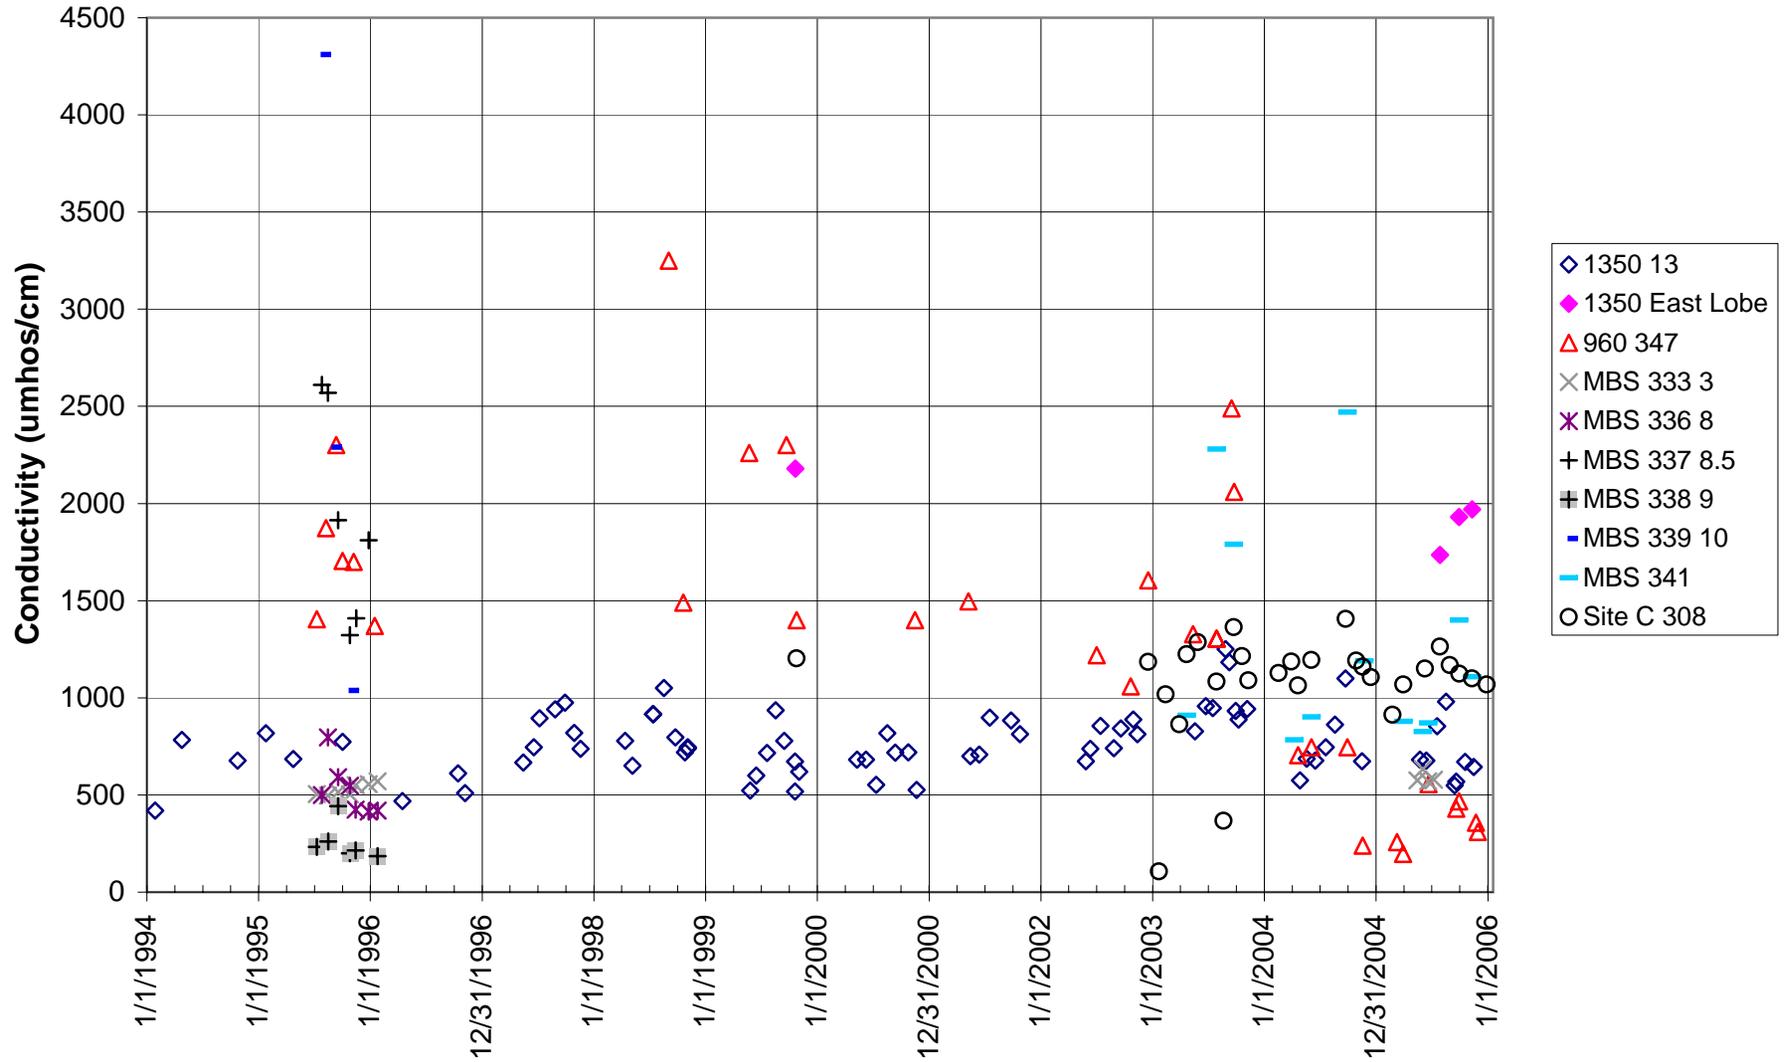
Figure 2.8 Inactive Production Rock Site Conductivity Data

Conductivity data are shown in Figures 2.8 and 2.23. Conductivity indicates the amount of dissolved constituents in the water. KGCMC samples having higher conductivity values usually have higher sulfate, calcium and magnesium (hardness) concentrations, reflecting influences from sulfide oxidation and carbonate mineral dissolution. Water that has contacted production rock is expected to have higher conductivity values than background waters. Site E 356 and Site 960 347 show an overall decreasing trend in conductivity, and Site 1350 remains unchanged. Historical conductivity data (1995-1996) from the Mill backslope Site 333-3 was slightly lower than conductivity data from 2005; however, the samples in 2005 were taken during removal activities and may reflect this disturbance. The combined drainage from the Mill backslope area (Site 341) showed a lower average dissolved load in 2005 than the past two years. Site C had a slightly lower average annual conductivity in 2005 than 2004 (1065 $\mu\text{mhos/cm}$ in 2005 versus 1107 $\mu\text{mhos/cm}$ in 2004). The trends apparent in Figures 2.8 and 2.23 are the result of decreasing reactive surface area available for oxidation and dissolution. The reactive surface area decreases as reactants are consumed and mineral surfaces become coated with oxidation products. The results for sulfate, magnesium and hardness, shown in Figures 2.9 and 2.24, 2.10 and 2.25, and 2.11 and 2.26, respectively, correlate with conductivity results and are consistent with the concept of generally decreasing or static reactive surface area.

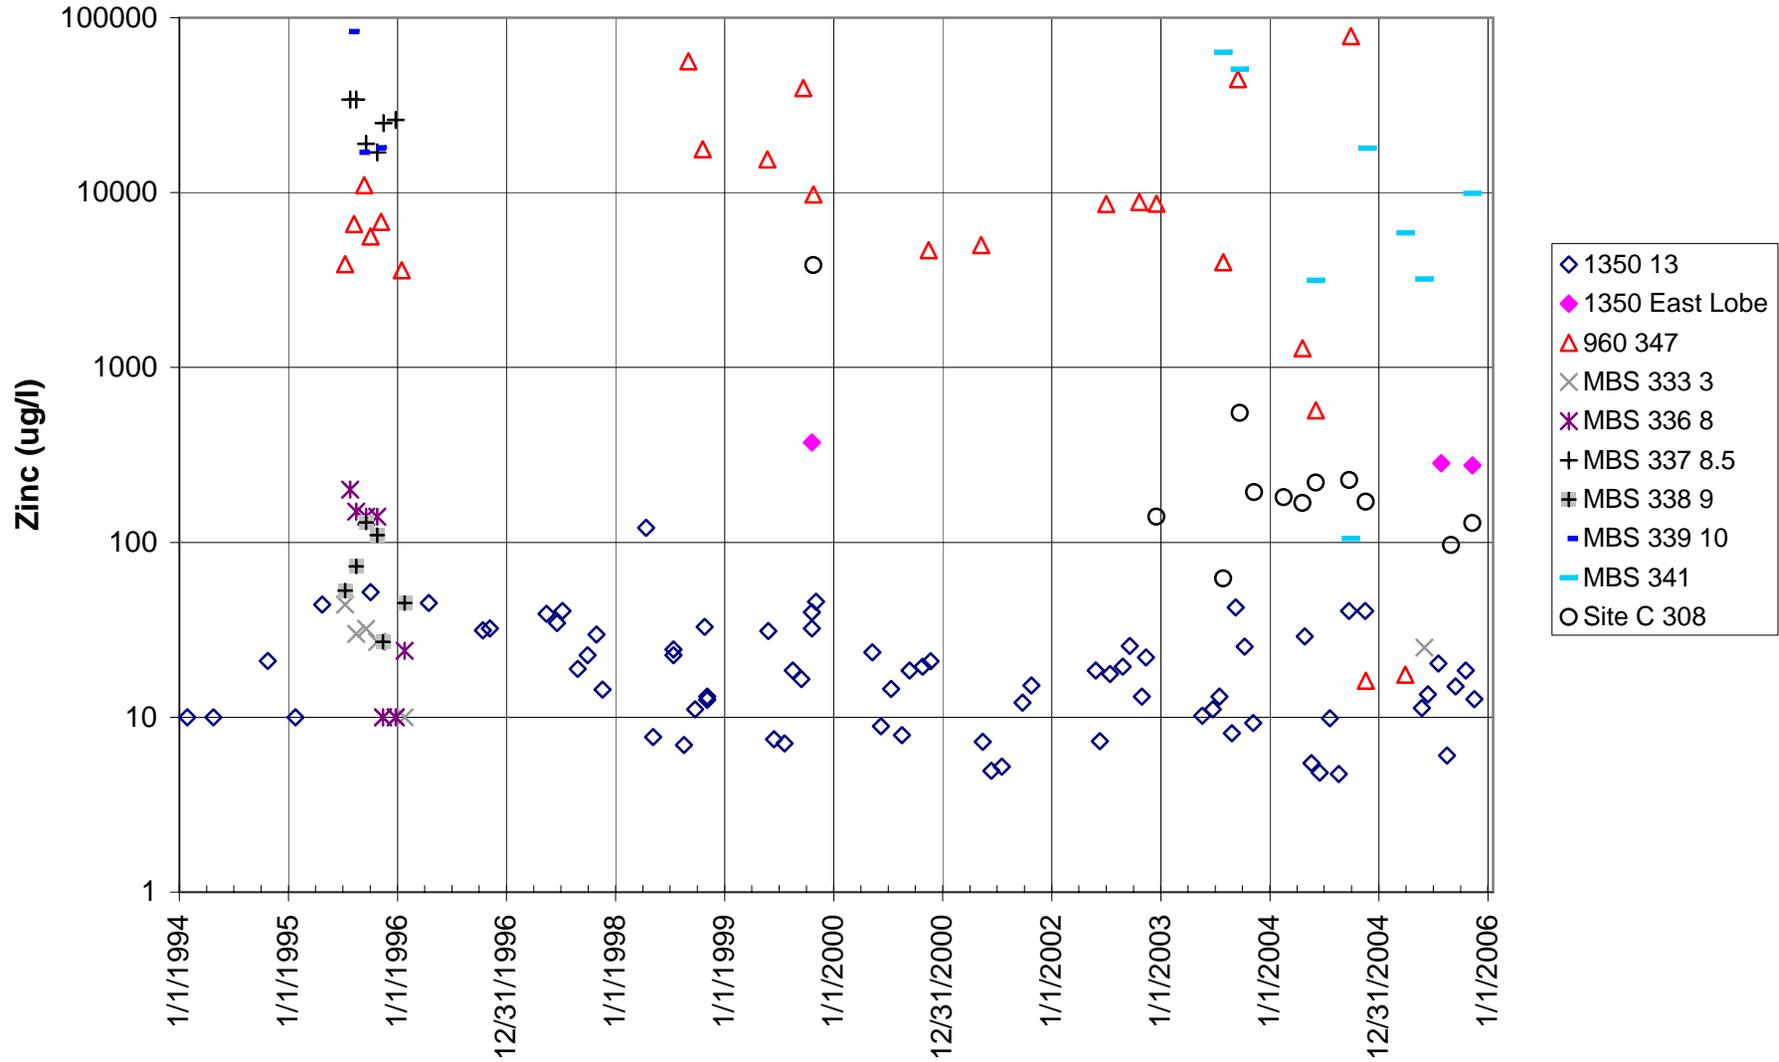
Figure 2.12 Inactive Production Rock Site Zinc Data

The data for zinc, copper, lead, cadmium, nickel, arsenic, iron and manganese are presented in Figures 2.12 to 2.19 and Figures 2.27 to 2.34. Sample results that were less than the detection limit are plotted at one half the limit value. While this allows the results to be plotted on a logarithmic scale, it causes non-detect results with high detection levels to appear more concentrated than they actually are. Detection limits have varied with time and are often evident on the graphs as horizontal groupings of symbols. The results for metals generally correlate with conductivity values. Zinc concentrations reflect the higher solubility of this element relative to the other metals. Manganese concentrations are elevated at most of the inactive sites, indicating the generation of secondary products from localized oxidation-buffering reactions. Metal loads from inactive sites have either remained relatively constant or decreased with time. The decrease in metal loading is attributed to the reduction of reactive surface area discussed above. Site 960 showed some elevated copper, zinc and cadmium concentrations in 2004. This was likely due to the removal of production rock from the area, which exposed additional production rock materials in the base of the road, and rerouted additional water sources into the sampling area, confounding comparative water sampling with pre-removal data. Data in 2005 for 960 showed a decrease in most metal concentrations, with close to an order of magnitude decrease in cadmium, nickel, manganese and zinc.

Non-detect results shown at 1/2 detection limit; Data are a composite of dissolved, total and total recoverable results

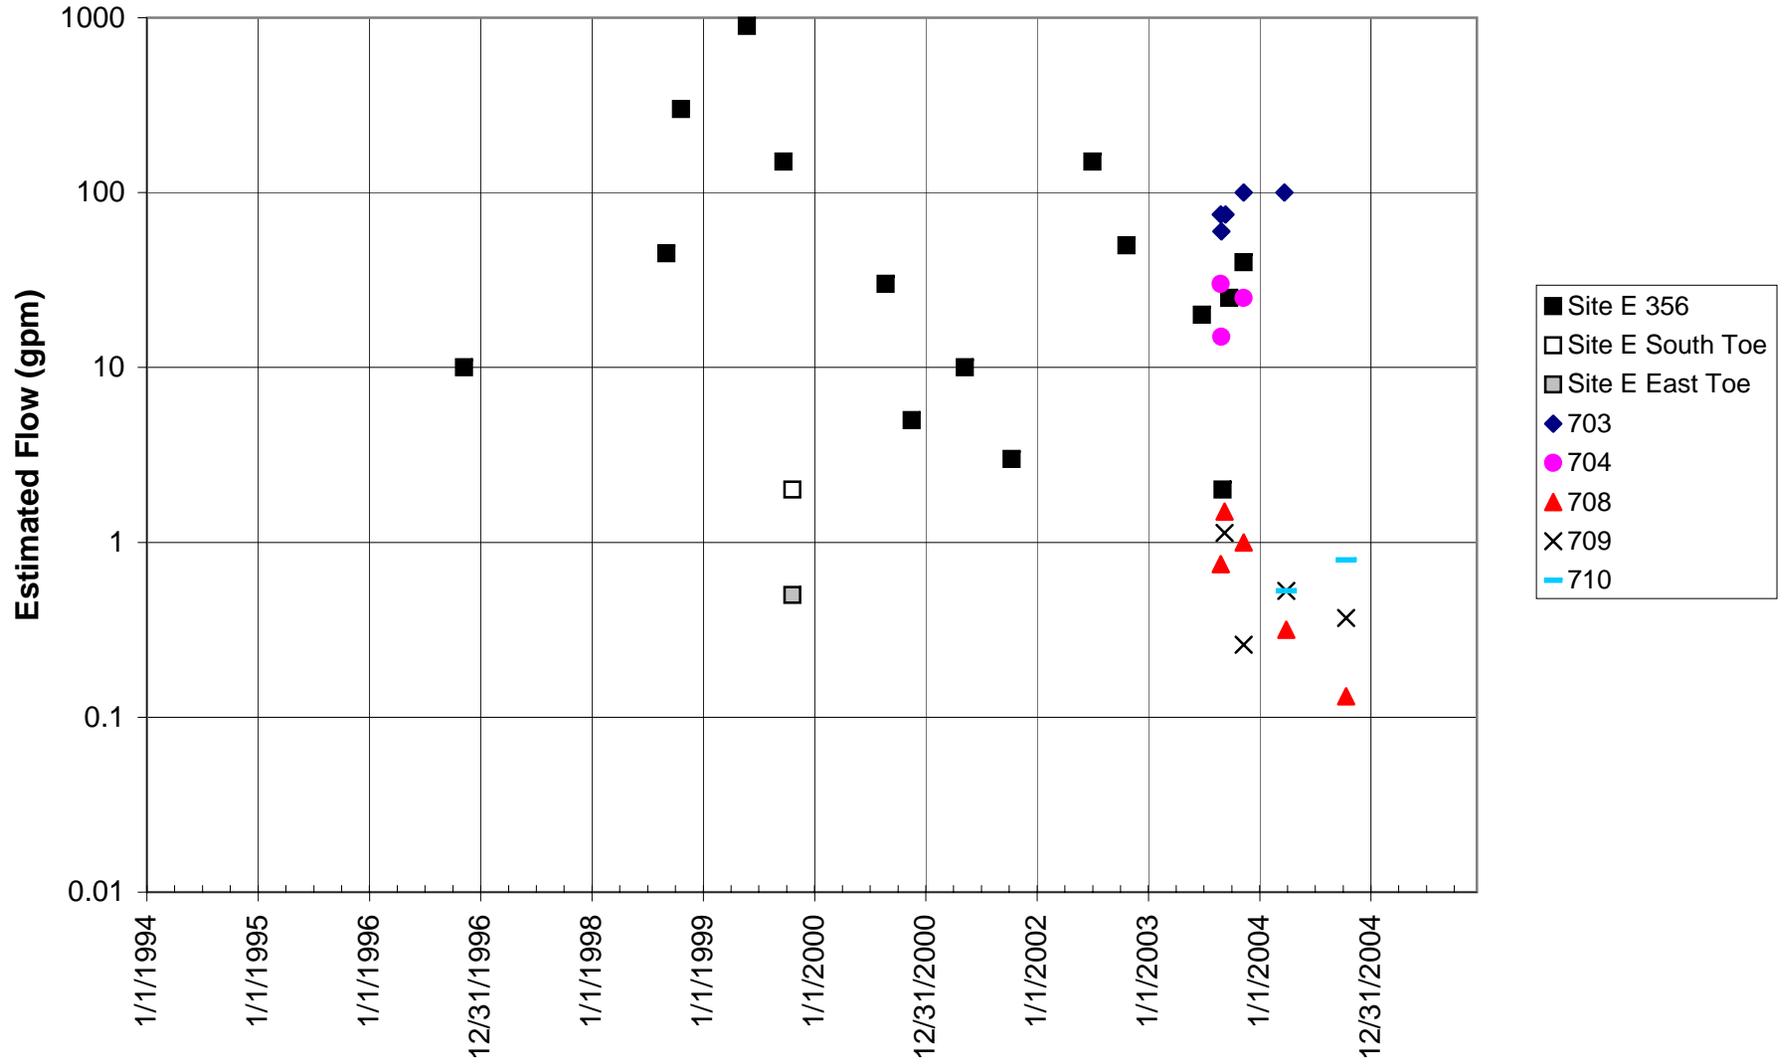
Figure 2.20 Inactive Production Rock Site E Flow Data

Flow data presented in Figures 2.5 and 2.20 demonstrate that flows at most of the sample locations are generally low (less than 10 gpm). Some of the flow data were collected as part of the NPDES stormwater monitoring program. Collected during or following storm events, flow data from these locations (e.g. Site E 356, 960 347) represent short-term maximum flow values in response to relatively large precipitation events. Lack of significant flow from inactive sites is a positive characteristic because it reflects minimization of potential off-site impacts.

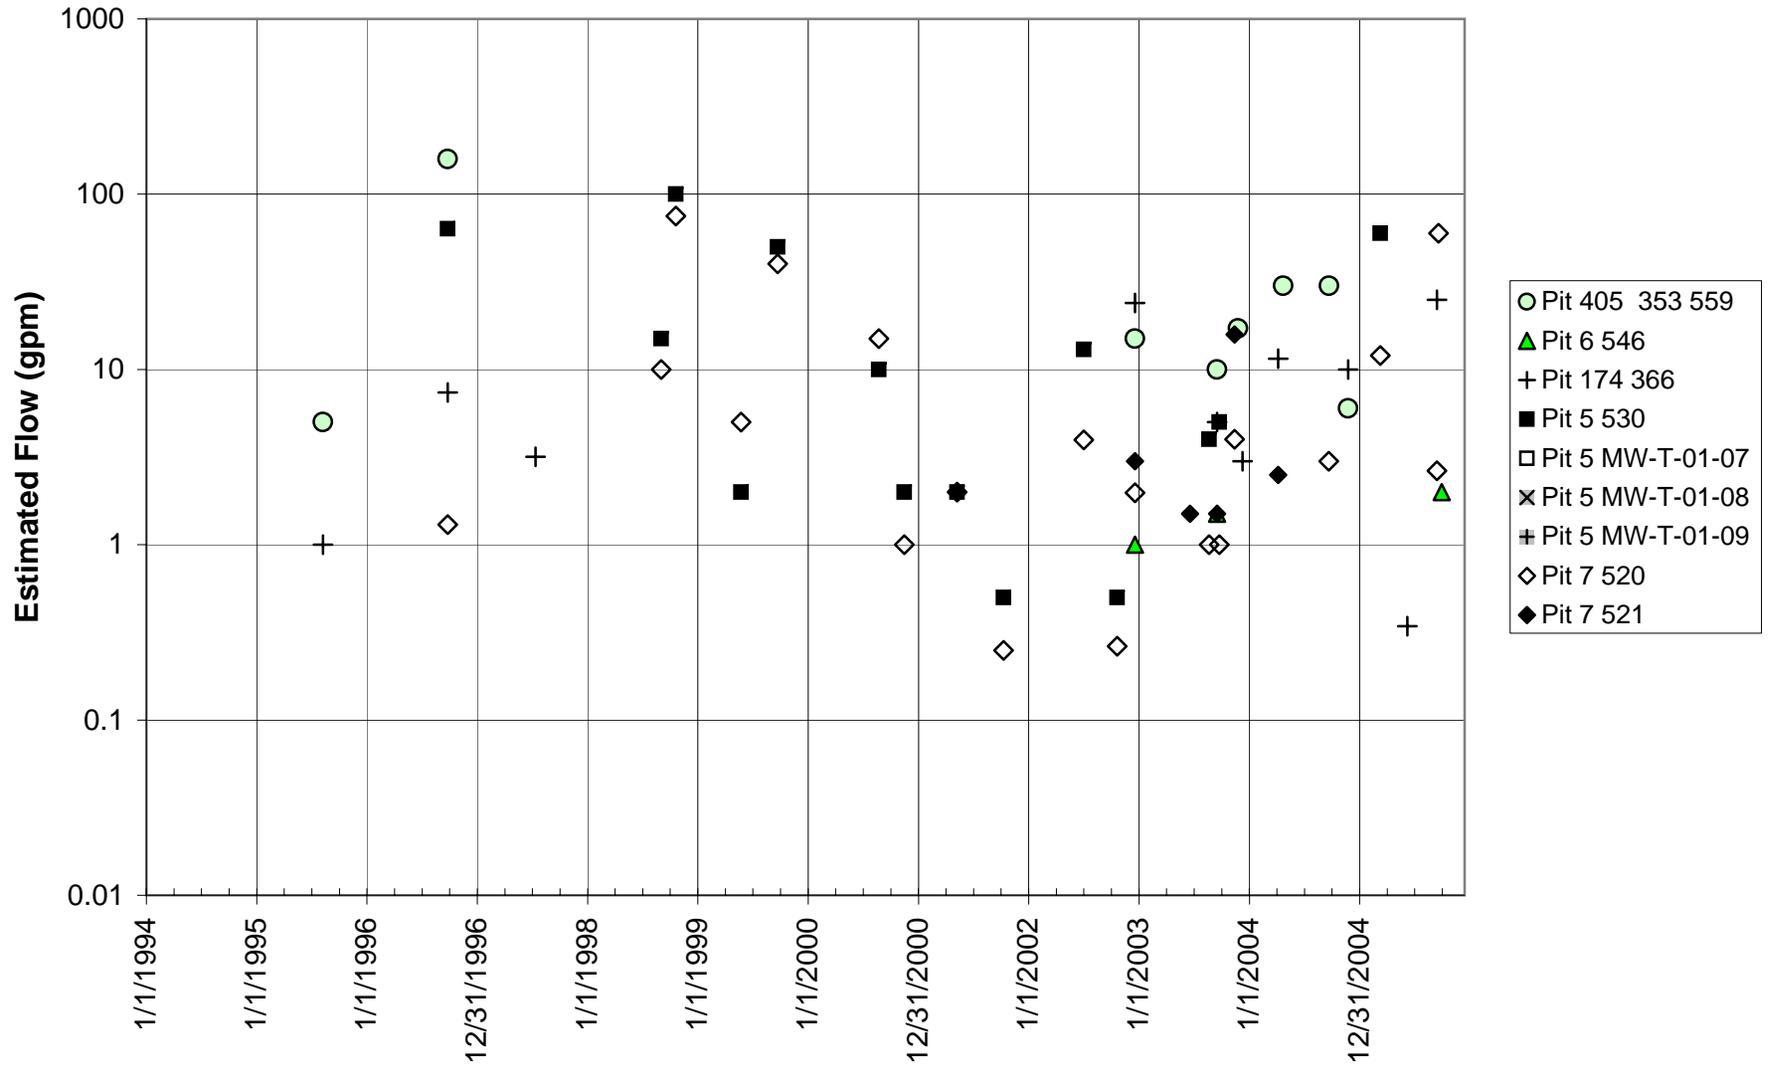
Figure 3.1 Quarry Site Flow Data

Flow data for the quarry sites are presented in Figure 3.1. Much of the flow data prior to 2003 were collected during or shortly following storm events and represents maximum flow values. Flow estimates vary from just over 100 gpm to less than 1 gpm with most less than 10 gpm. The bowl-shaped geometry and low permeability of the quarry walls and floors tend to focus flow toward the entrance of the pits.

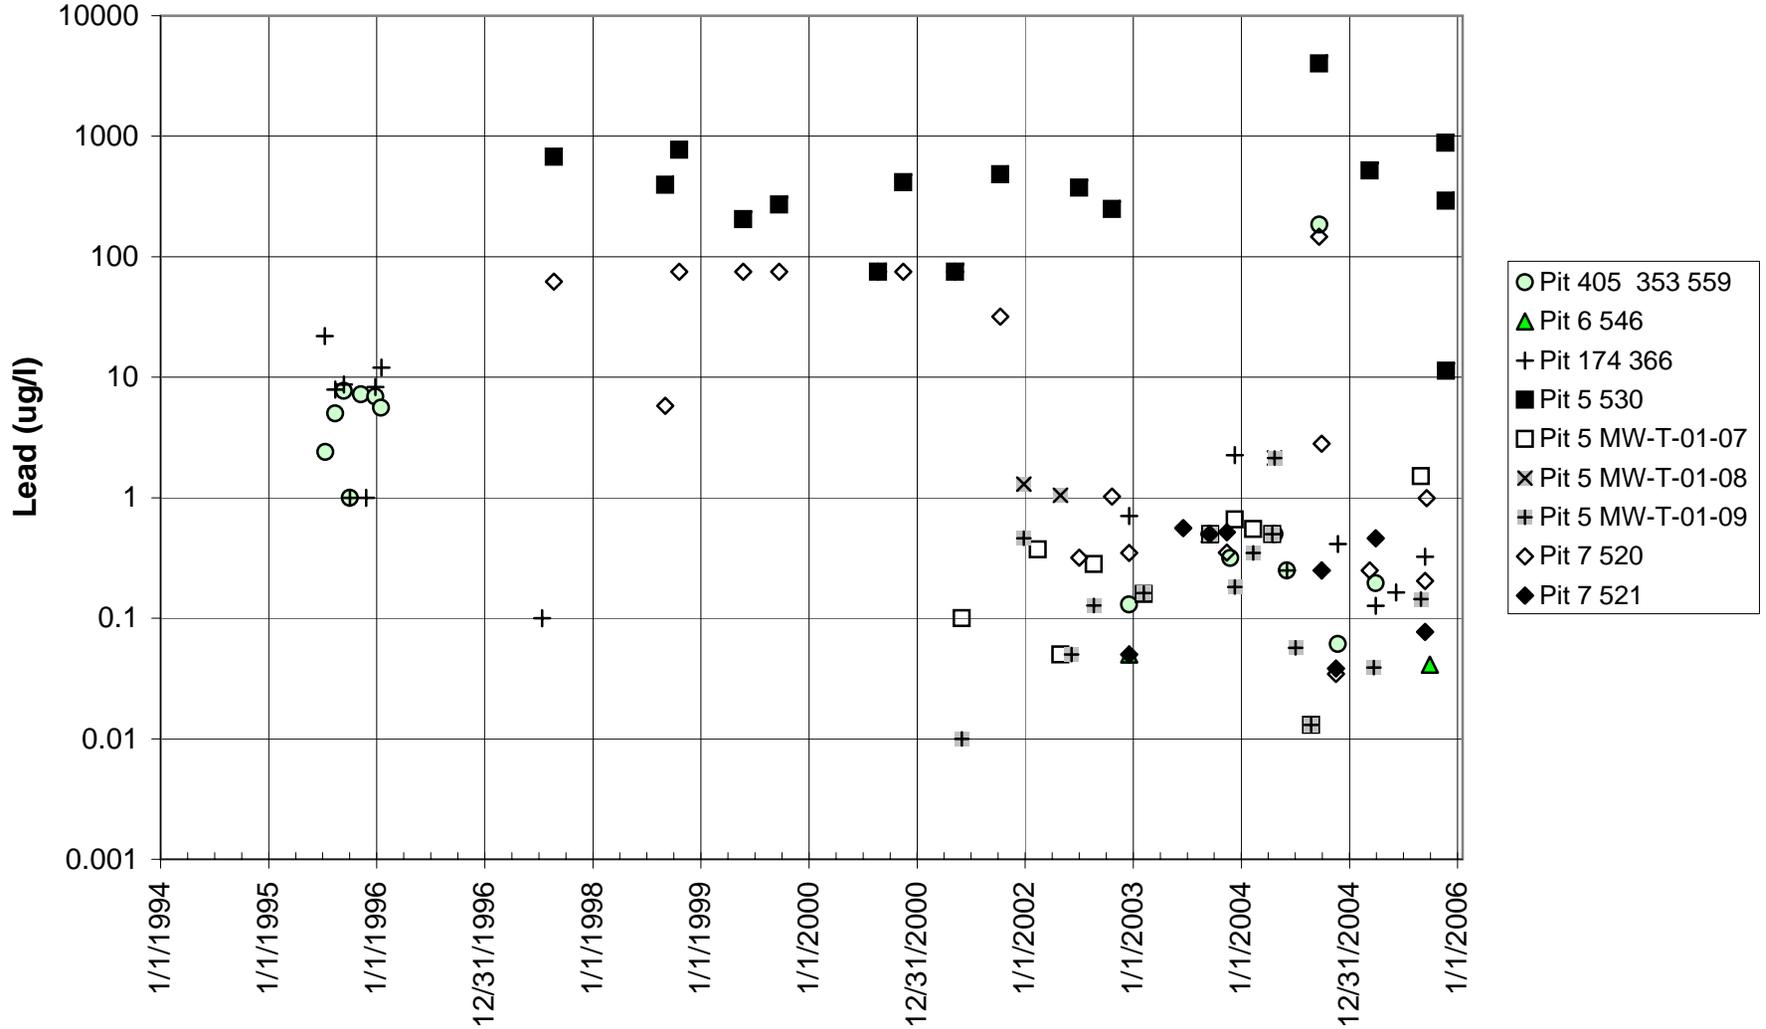
Figure 3.10 Quarry Site Lead Data

The data for zinc, copper, lead, cadmium, nickel, arsenic, iron and manganese are presented in Figures 3.8 to 3.15. Sample results that were less than the detection limit are plotted at one half the limit value. While this allows the results to be plotted on a logarithmic scale, it causes non-detect results with high detection levels to appear more concentrated than they actually are. Detection limits have varied with time and are often evident on the graphs as horizontal groupings of symbols. The results for metals generally correlate with conductivity values. Zinc and manganese concentrations reflect the higher solubility of these elements relative to the others at the near-neutral pH conditions. Metal loads from quarry sites have been consistently relatively low and either remained fairly constant or decreased with time. The decrease in metal loading is attributed to a reduction of reactive surface as reactants are consumed and coatings form on mineral surfaces.

Non-detect results shown at 1/2 detection limit; Data are a composite of dissolved, total and total recoverable results

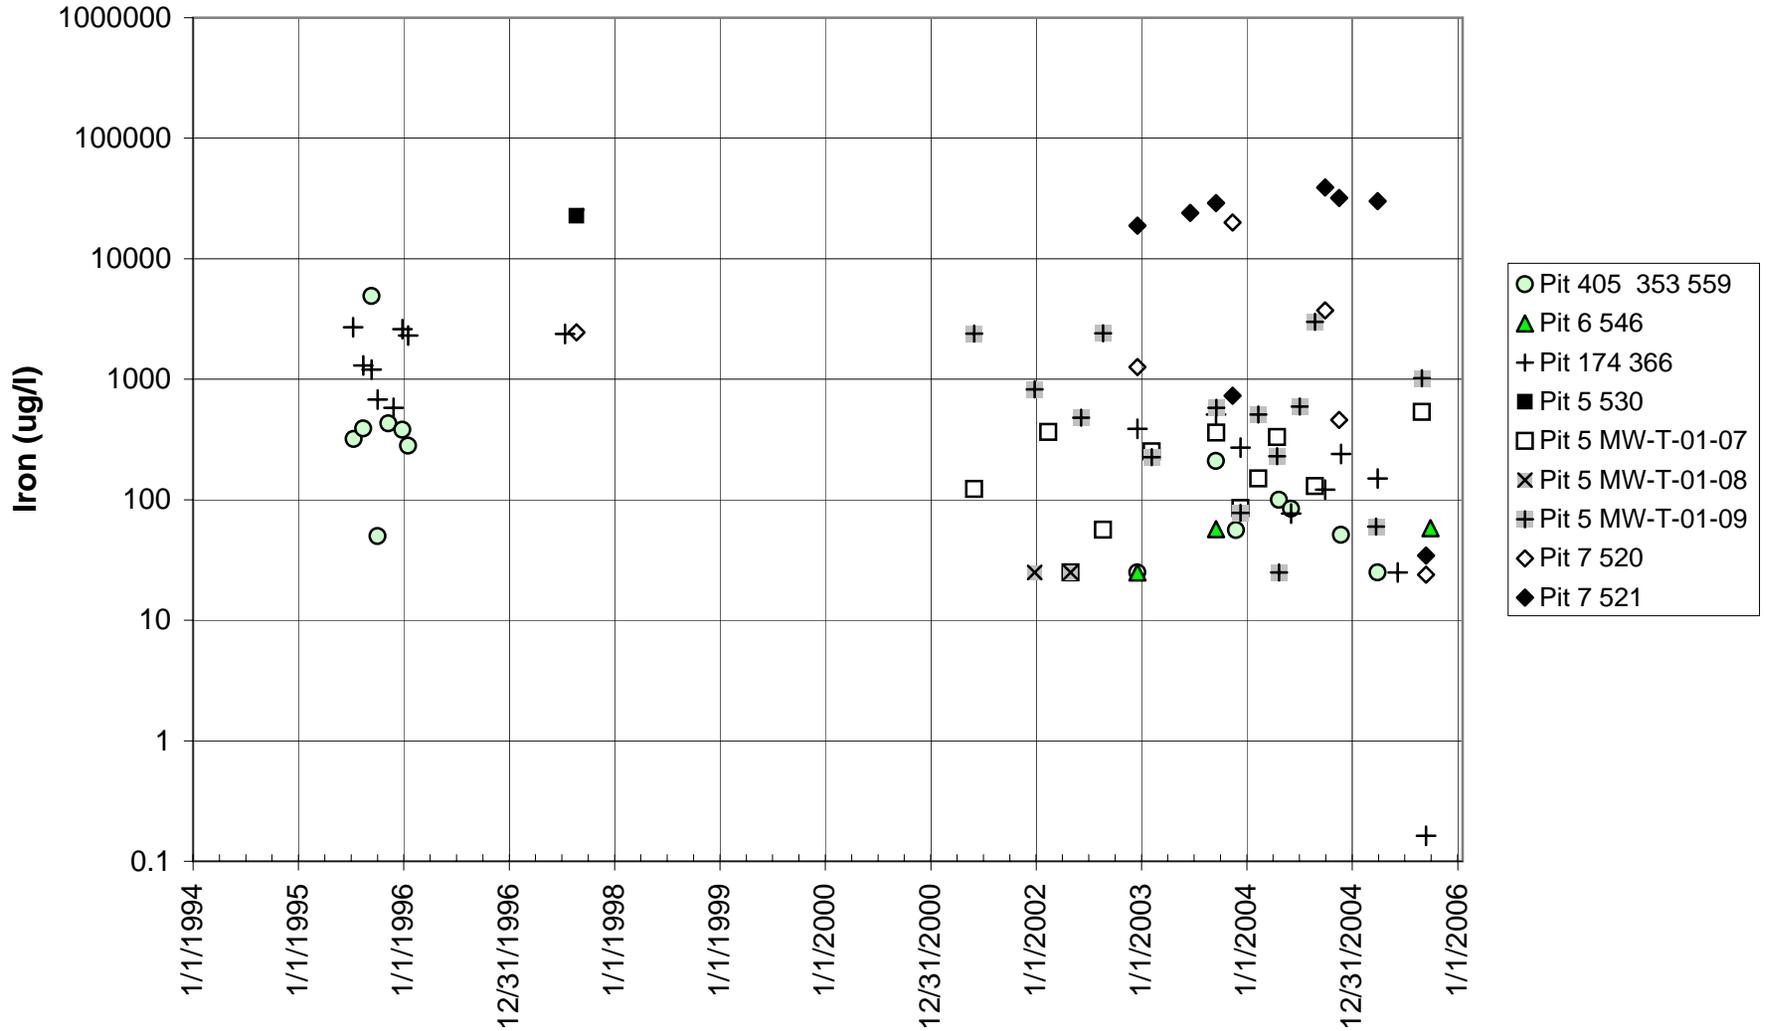
Figure 3.14 Quarry Site Iron Data

Non-detect results shown at 1/2 detection limit; Data are a composite of dissolved, total and total recoverable results
