**INACTIVE PRODUCTION ROCK SITES AND QUARRIES
2005 ANNUAL REPORT**

Kennecott Greens Creek Mining Company

June 2006

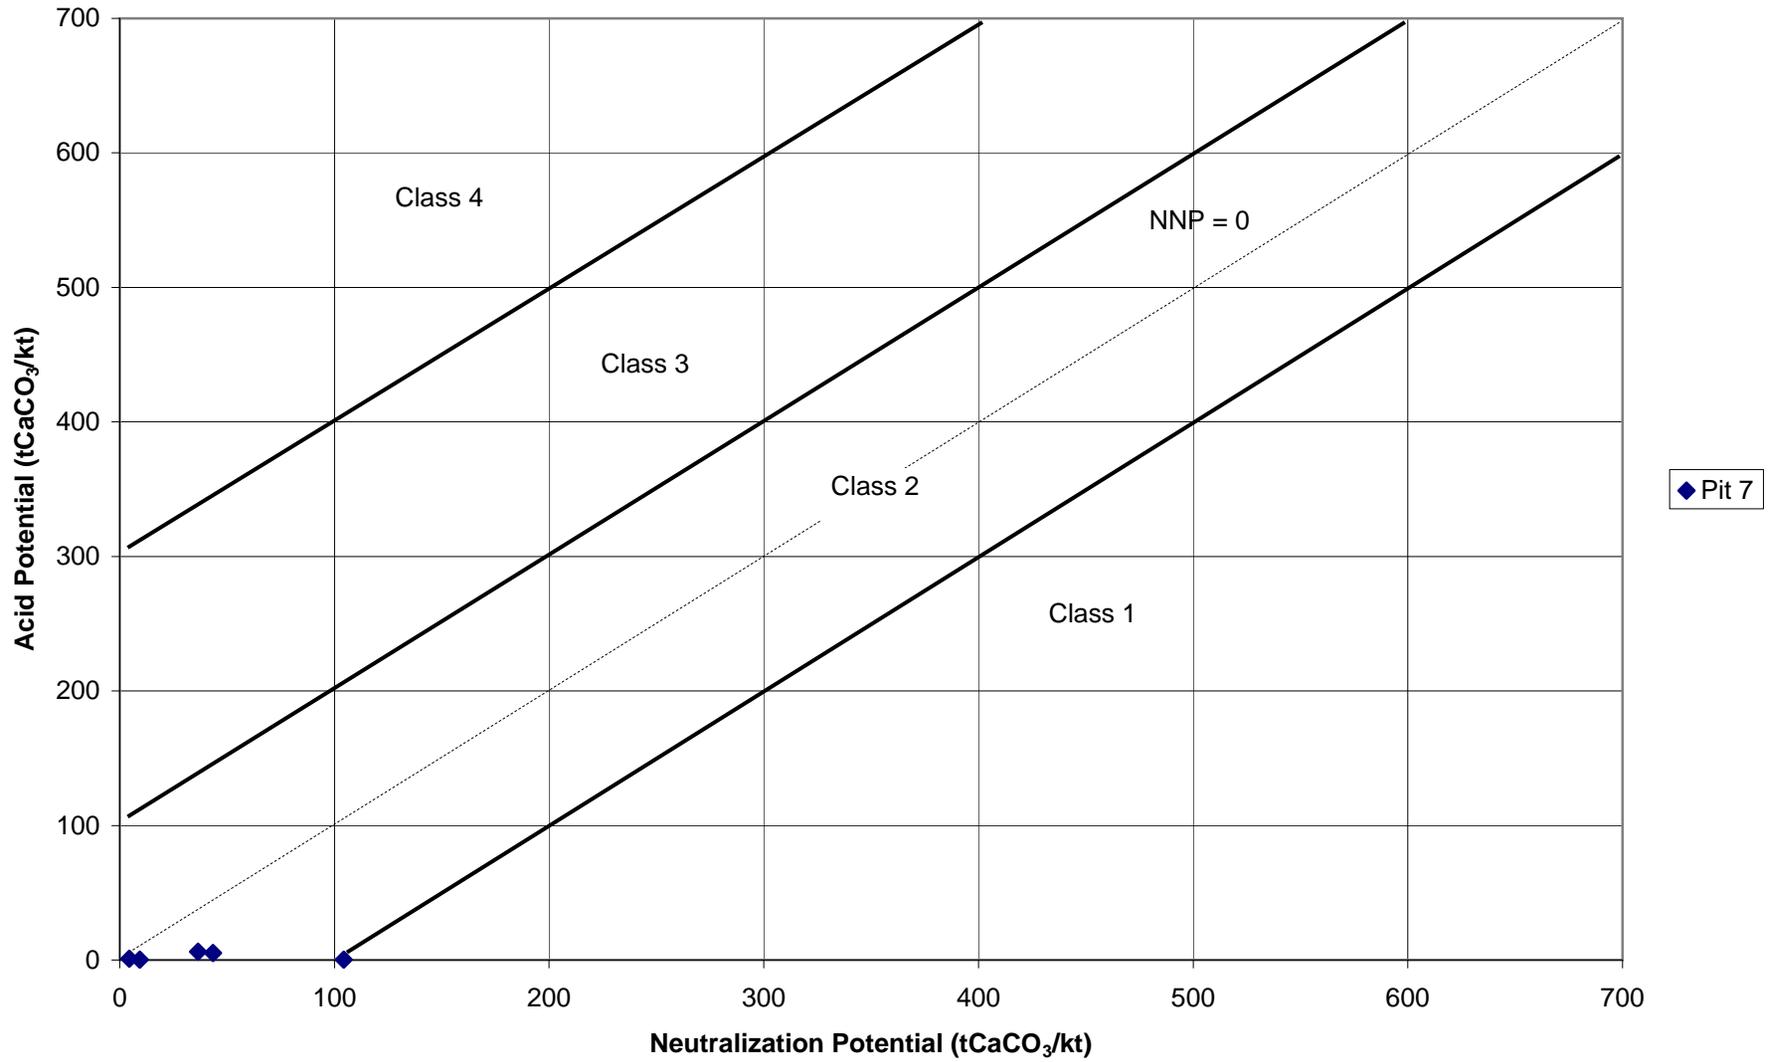
Figure 3.16 Pit 7 Acid-Base Accounting Analyses

Pit 7 is located at 1.8 mile on the A Road between Hawk Inlet and Young Bay. The pit was initially developed in 1987 to support construction of the roads and other mine facilities. Pit 7 has been partially backfilled with tree stumps and reclamation materials derived during expansion of the tailings pile and development of the sand pit at 1.4 mile on the A Road. During the placement of these materials, the drainage at the site was rerouted, mainly to Site 571, and Site 521 was decommissioned. Despite iron staining on the south pit wall, iron staining observed in the drainage from the pit is mostly due to dissolution of iron-rich oxide horizons in the peat and gravel fill rather than from the pit walls themselves. Temporary hydroseeding of the peat has resulted in a productive grass cover of these materials. ABA analyses (Figure 3.16) from the samples of the pit walls indicate the potential for acid generation; however, the sulfur content of the samples is relatively low (<0.5%). Monitoring results of drainage from the pit is shown in Figures 3.2 to 3.15. Relatively low sulfate concentrations (approximately 200 mg/l) and low metal values support the conclusion that sulfide oxidation is not significant at Pit 7. Dissolution of iron and manganese oxides in the fill stored in the pit has produced elevated concentrations of these metals in the drainage. Oxidation of the drainage and re-precipitation of the metals is expected in the constructed wetlands at the entrance to the pit.
