**INACTIVE PRODUCTION ROCK SITES AND QUARRIES
2006 ANNUAL REPORT**

Kennecott Greens Creek Mining Company

May 2007

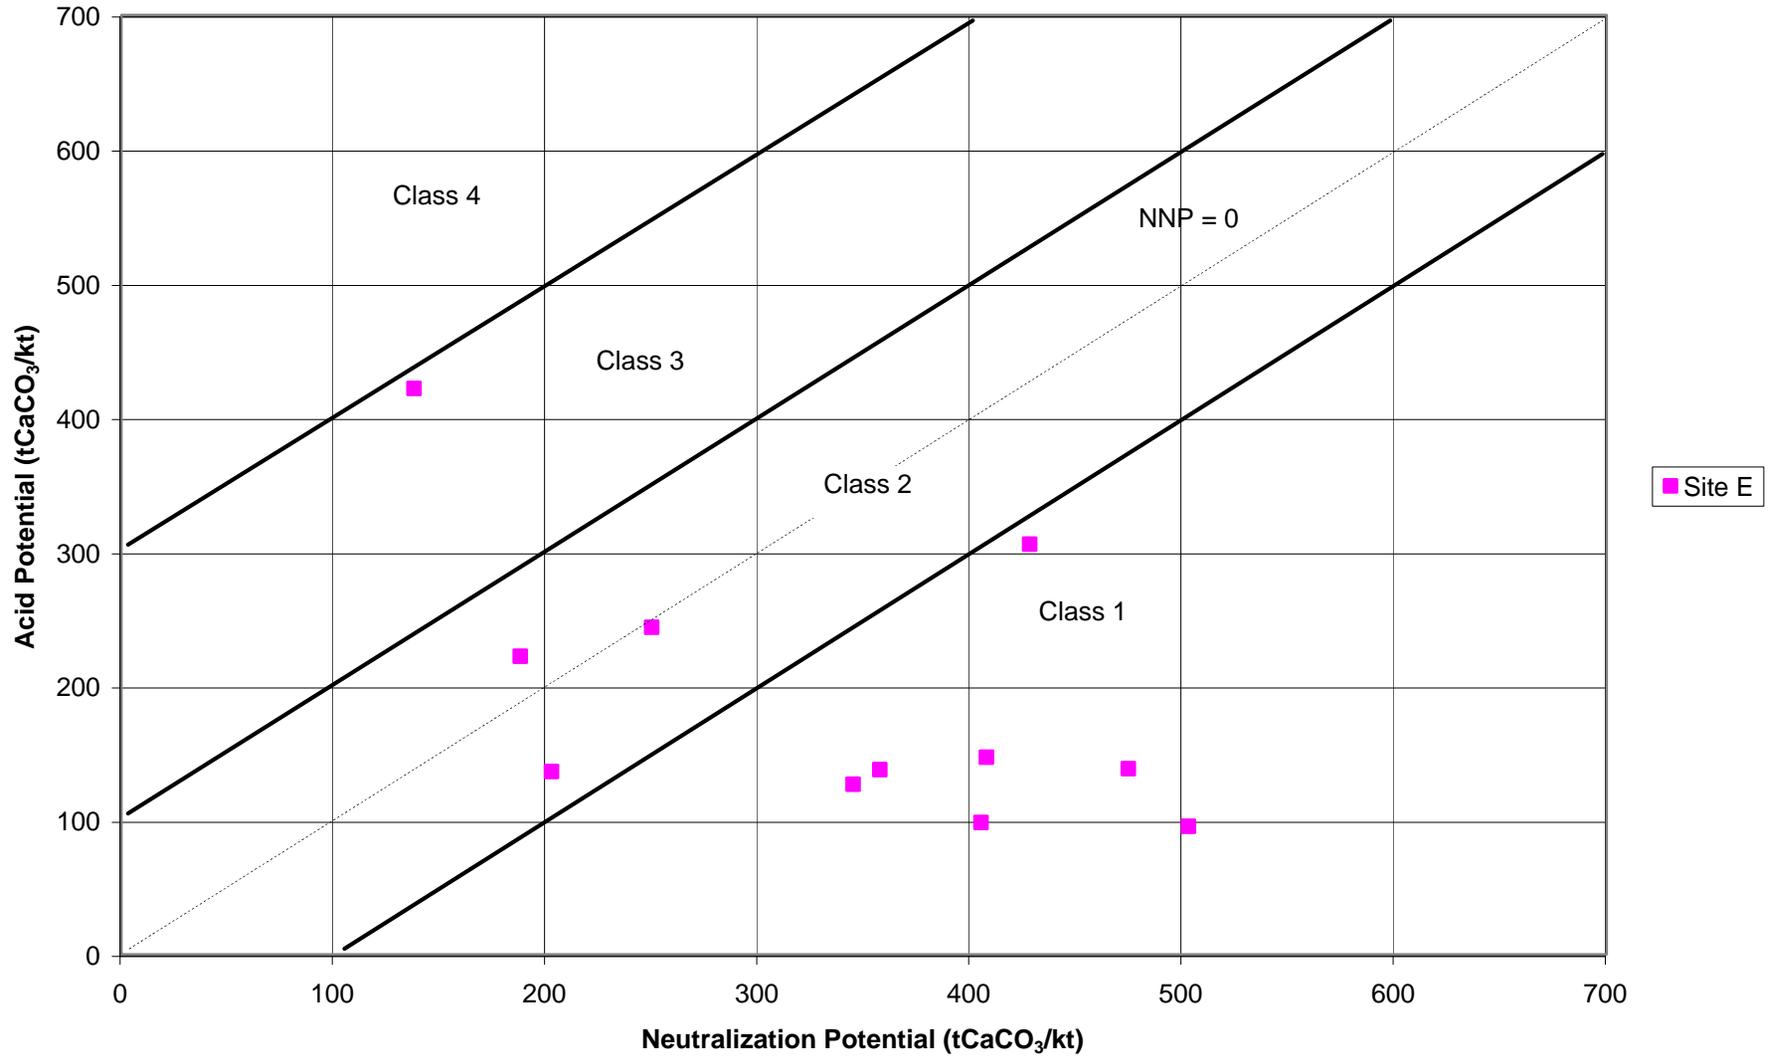
Figure 2.3 2006 Inactive Production Rock Site Acid-Base Accounting Analyses

Figure 2.3 compares Acid Potential (AP) with Neutralization Potential (NP) from 2006 surface grid samples. Figure 2.4 shows Site E after the removal of 7,100 cubic yards of material. The inactive sites were constructed prior to development of the classification protocol that KGCMC currently uses. At the time the inactive piles were constructed KGCMC did not classify or segregate its production rock. Symbols in Figure 2.3 represent actual laboratory data points. Lines indicating the currently utilized production rock classes are shown on Figure 2.3 for reference only. Figure 2.3 shows the distribution of potentially acid generating (upper left half of figure) and potentially acid neutralizing (lower right half of figure) samples. Seven of the eleven Site E 2006 samples would be classified as Class 1 (acid neutralizing) under the current classification procedure. Regardless of pyrite content, almost all production rock at Greens Creek contains substantial carbonate (5 to 40%). This carbonate content indicates that there is a relatively long lag time to potential acid generation for the majority of the samples.

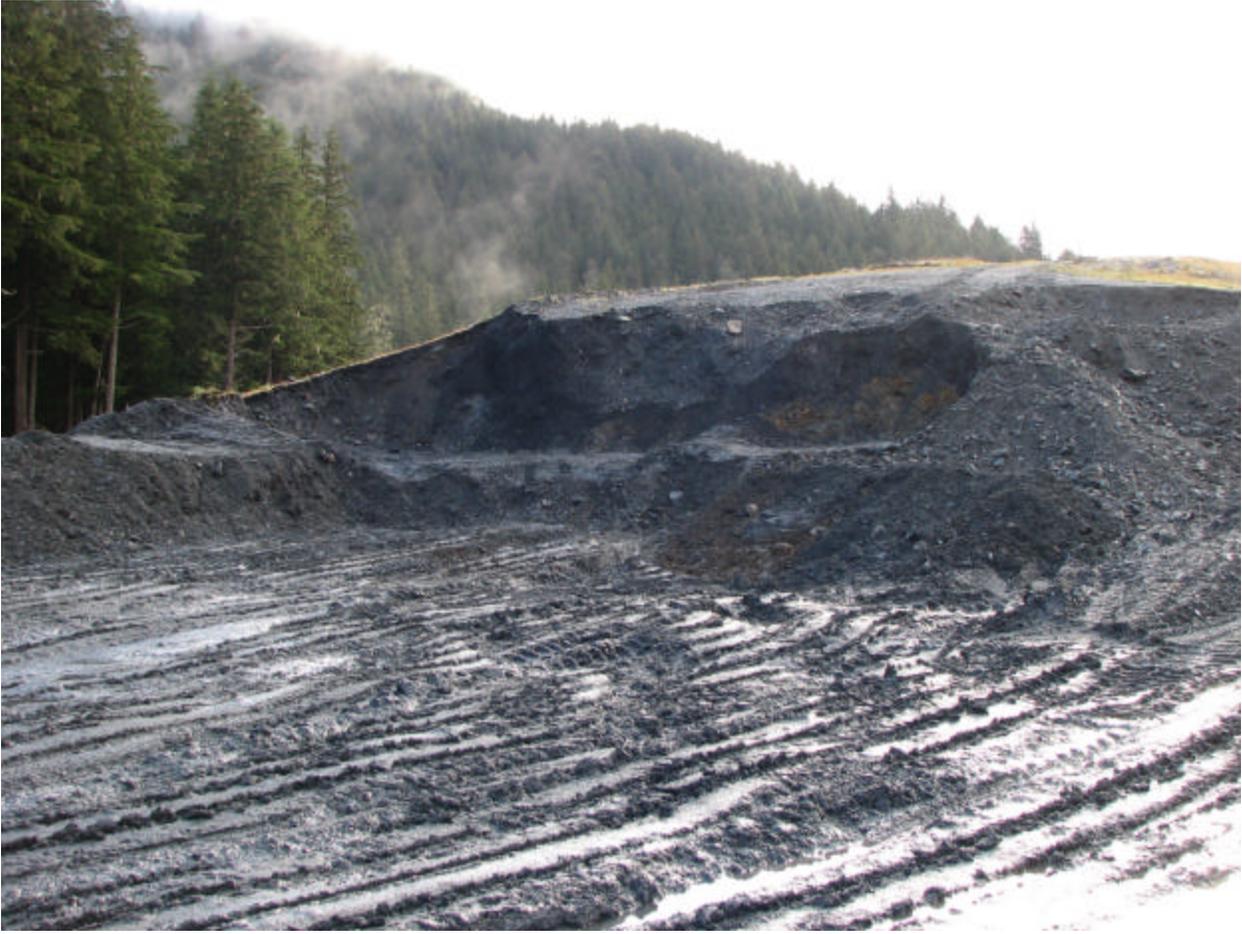
Figure 2.4 Photo of Site E excavation area, Oct-2006 (USFS).

A total of 7,100 cubic yards of waste rock from Site E was hauled to the tailings facility to create a stabilizing berm in the Southeast II area. A portion (1 acre) of the Site E pile was covered in the Fall of 2006 to reduce the moisture content of the waste rock in preparation for removal in 2008 and 2009. Unusually wet weather during most of 2006 delayed expansion efforts at the tailings facility, which in turn has delayed scheduled large scale removal of Site E waste rock. Surface water and groundwater monitoring at the site continues. KGCMC plans to relocate the Site E production rock material to the surface tailings facility over a two-year span from 2008 through

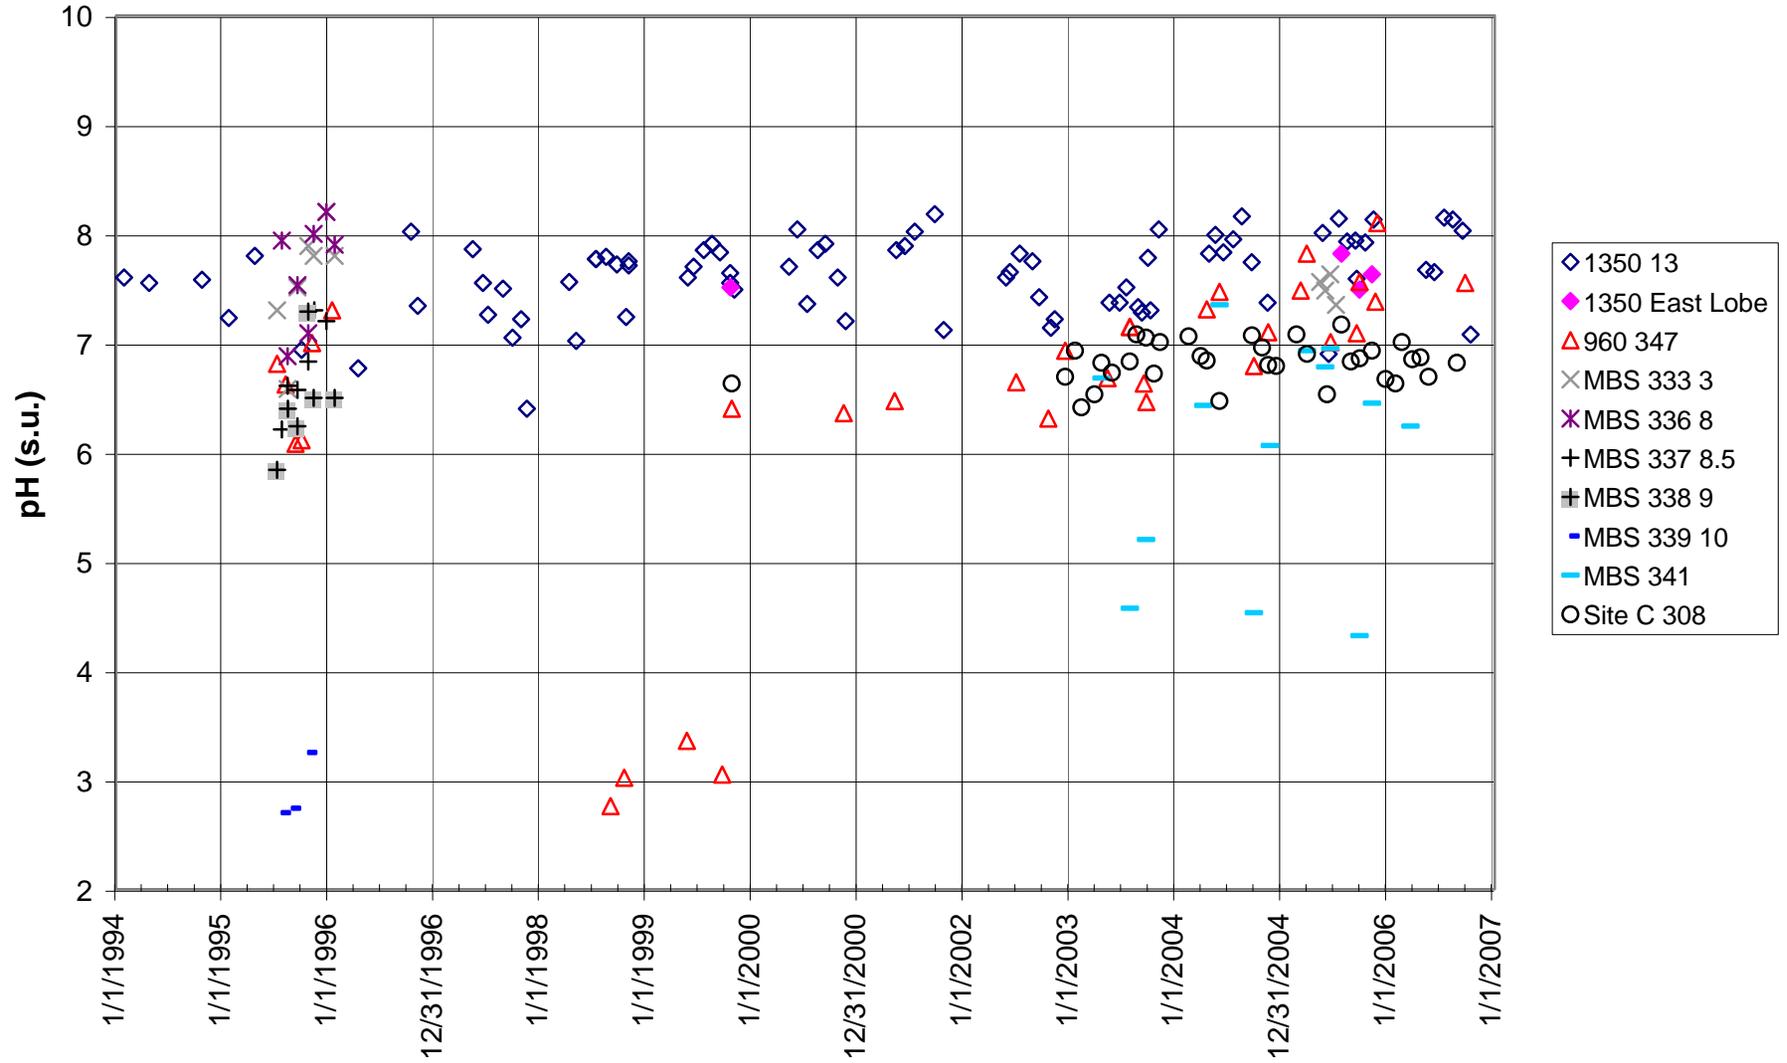
Figure 2.6 Inactive Production Rock Site pH Data

Figures 2.6 and 2.21 show pH data from inactive site sampling locations. Lower pH values can represent influences from pyrite oxidation and/or organic acids from muskeg and forest soils. The data show that the vast majority of the site drainage remains above pH 6.0. The sample from the Mill backslope in 1995 was runoff collected from a bench containing zones of heavily pyritized rock. For a brief period in 1998 and 1999, acidic conditions began developing at Site 960 347. KGCMC applied lime and removed 1000 cubic yards of oxidized pyritic rock from the site in 2000. The pH of the drainage quickly rebounded and has remained near-neutral since 2000. Removal of additional Site 960 material in 2003, 2004 and 2005 is discussed below in Section 2.3. The material removal activities may also be responsible for the pH of 8.0 measured at the 960 site in 2005. This is the highest recorded for this site. The reason for the elevated pH is likely due to the removal of pyritic rock that had consumed much of its readily available buffering capacity. Fresh carbonate mineral surfaces exposed during the excavation and the placement of the toe buttress may have contributed to the higher pH values observed. Alkalinity data presented in Figures 2.7 and 2.22 are consistent with the pH results in Figures 2.6 and 2.21. All 2006 sample locations maintained measurable alkalinity provided by dissolution of carbonate minerals.

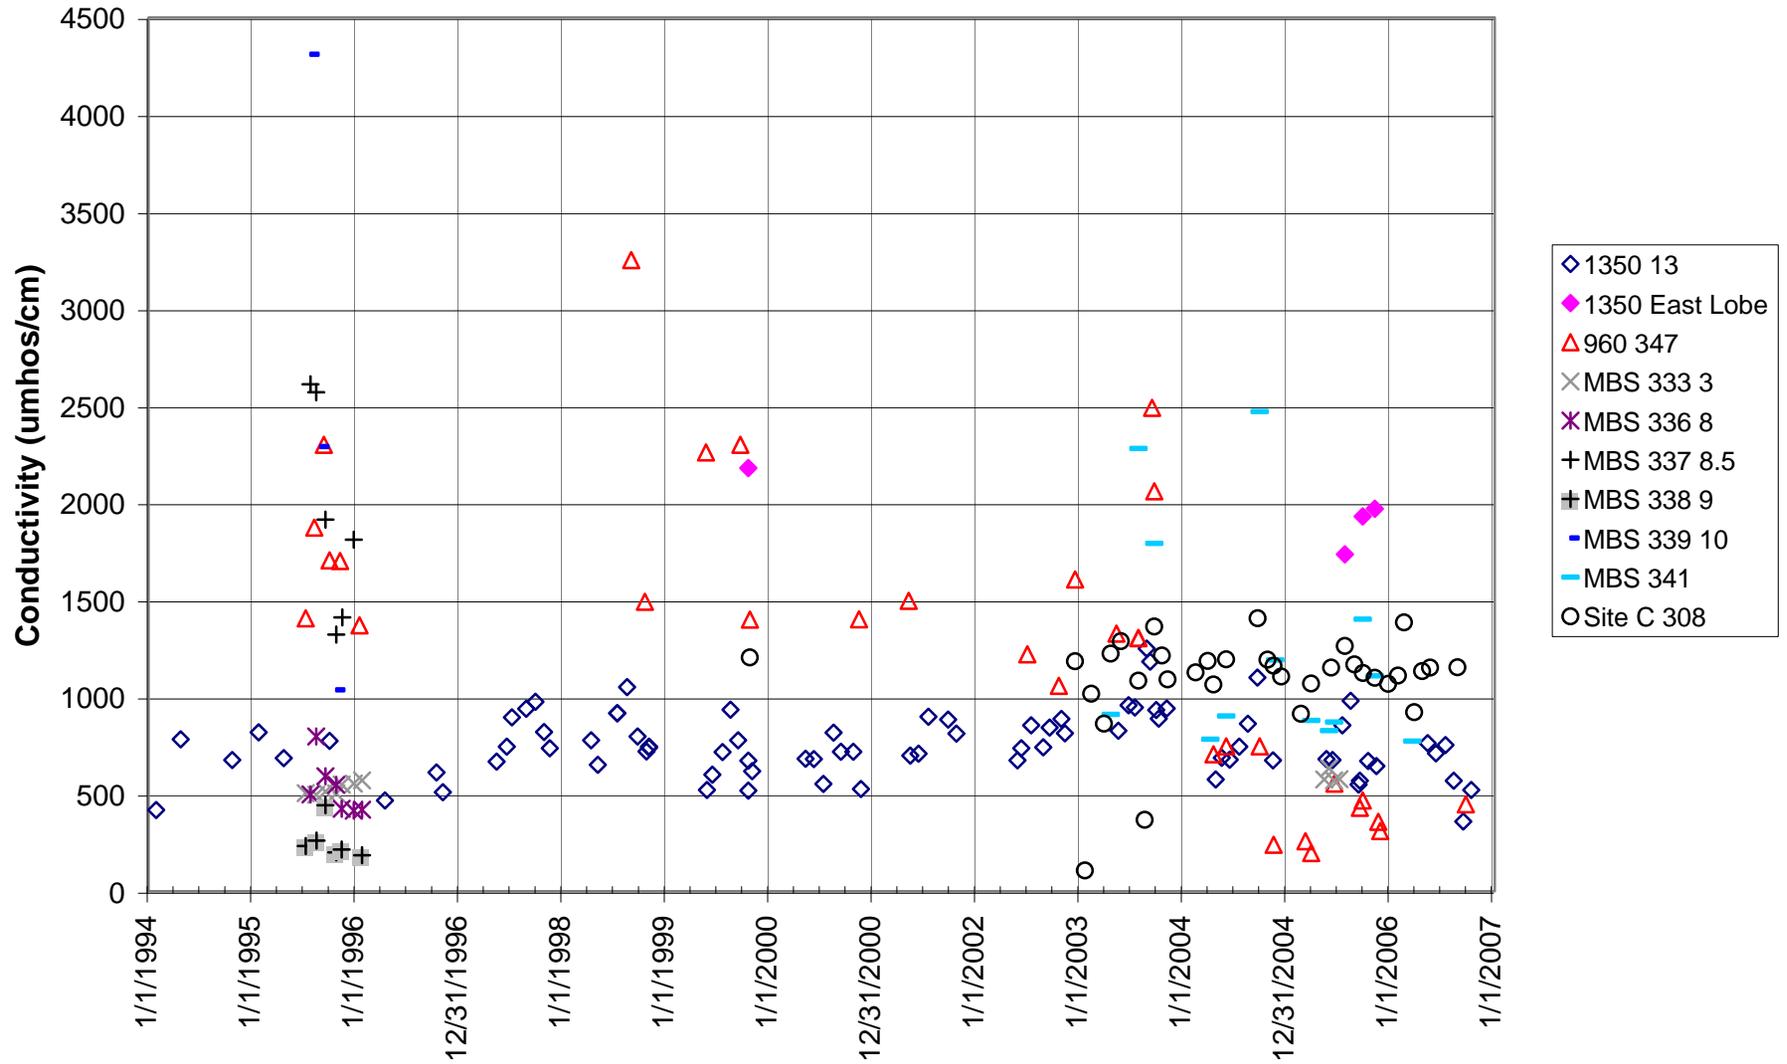
Figure 2.8 Inactive Production Rock Site Conductivity Data

Conductivity data are shown in Figures 2.8 and 2.23. Conductivity indicates the amount of dissolved constituents in the water. KGCMC samples having higher conductivity values usually have higher sulfate, calcium and magnesium (hardness) concentrations, reflecting influences from sulfide oxidation and carbonate mineral dissolution. Water that has contacted production rock is expected to have higher conductivity values than background waters. Site 960 347 shows an overall decreasing trend in conductivity, while the Site 1350 data remains unchanged. Historical conductivity data (1995-1996) from the Mill backslope Site 333-3 was slightly lower than conductivity data from 2005; however, the samples in 2005 were taken during removal activities and may reflect this disturbance. The combined drainage from the Mill backslope area (Site 341) showed a decrease in dissolved load for 2006. Site C had a slightly higher average annual conductivity in 2006 than 2005 (1143 $\mu\text{mhos/cm}$ in 2006 versus 1065 $\mu\text{mhos/cm}$ in 2005). The trends apparent in Figures 2.8 and 2.23 are the result of decreasing reactive surface area available for oxidation and dissolution. The reactive surface area decreases as reactants are consumed and mineral surfaces become coated with oxidation products. The results for sulfate, magnesium and

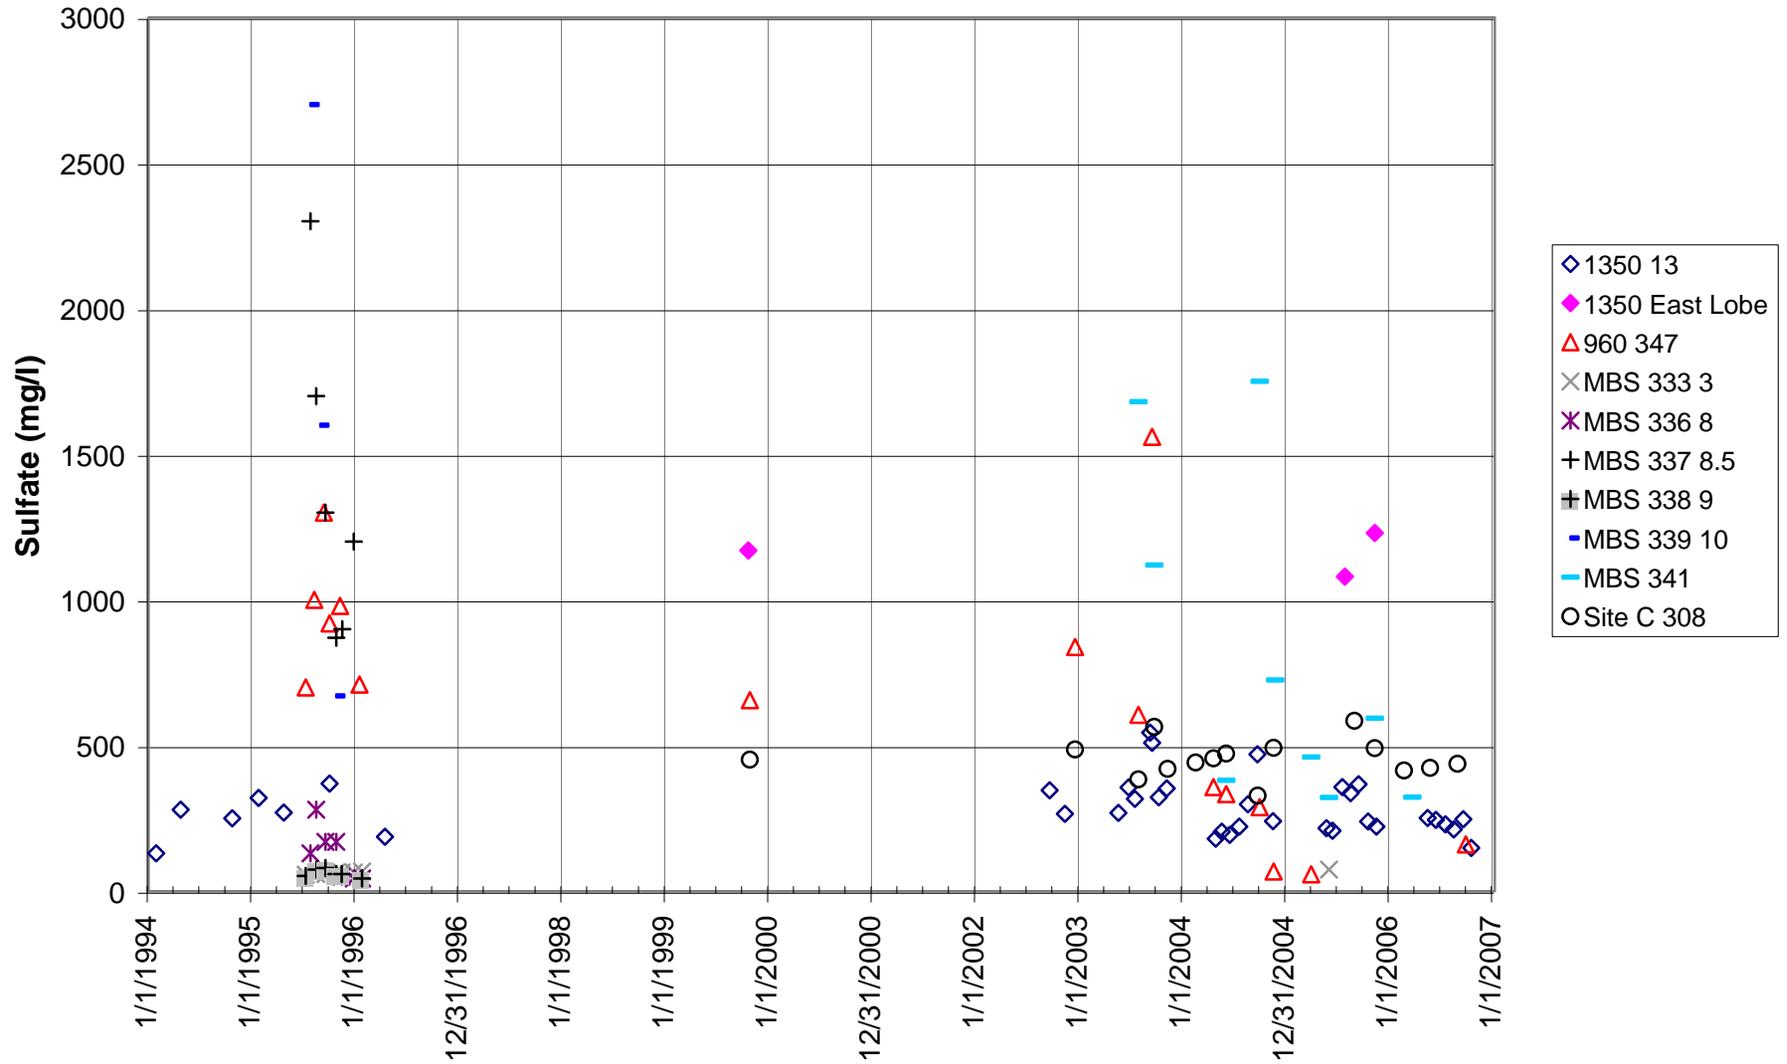
Figure 2.9 Inactive Production Rock Site Sulfate Data

hardness, shown in Figures 2.9 and 2.24, 2.10 and 2.25, and 2.11 and 2.26, respectively, correlate with conductivity results and are consistent with the concept of generally decreasing α static reactive surface area.

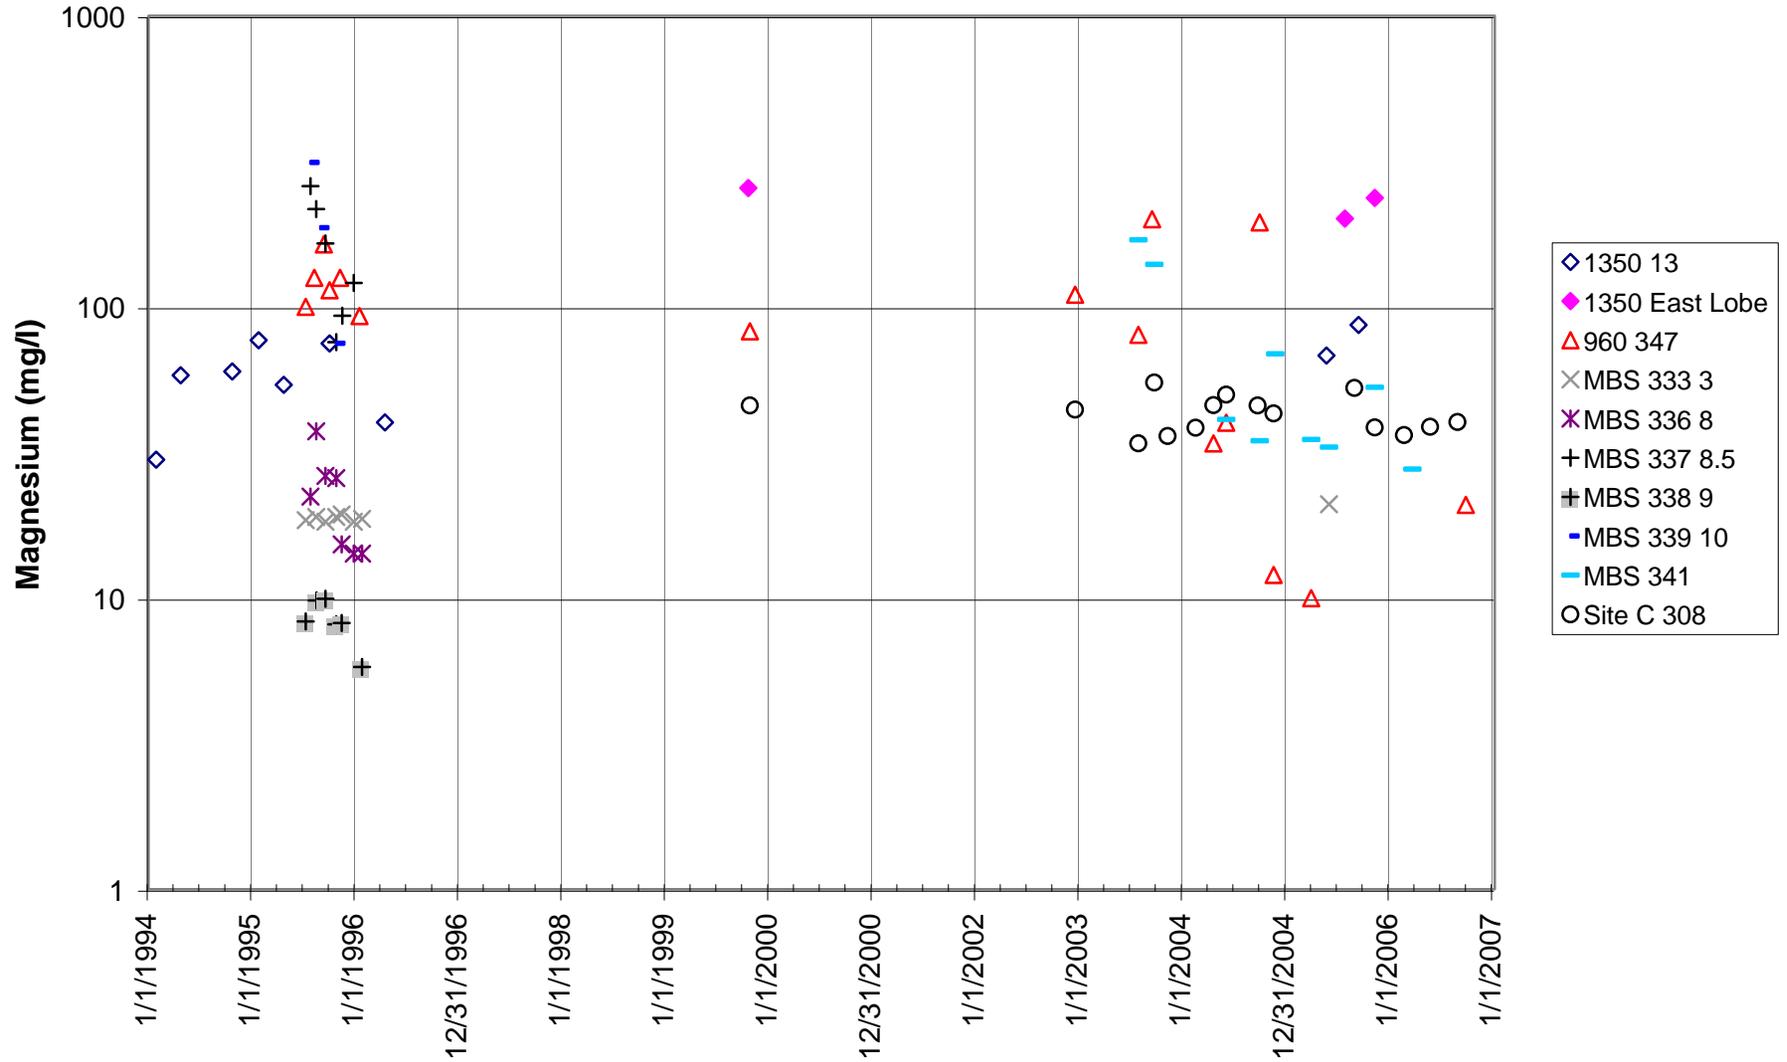
Figure 2.10 Inactive Production Rock Site Magnesium Data

Non-detect results shown at 1/2 detection limit; Data are a composite of dissolved, total and total recoverable results

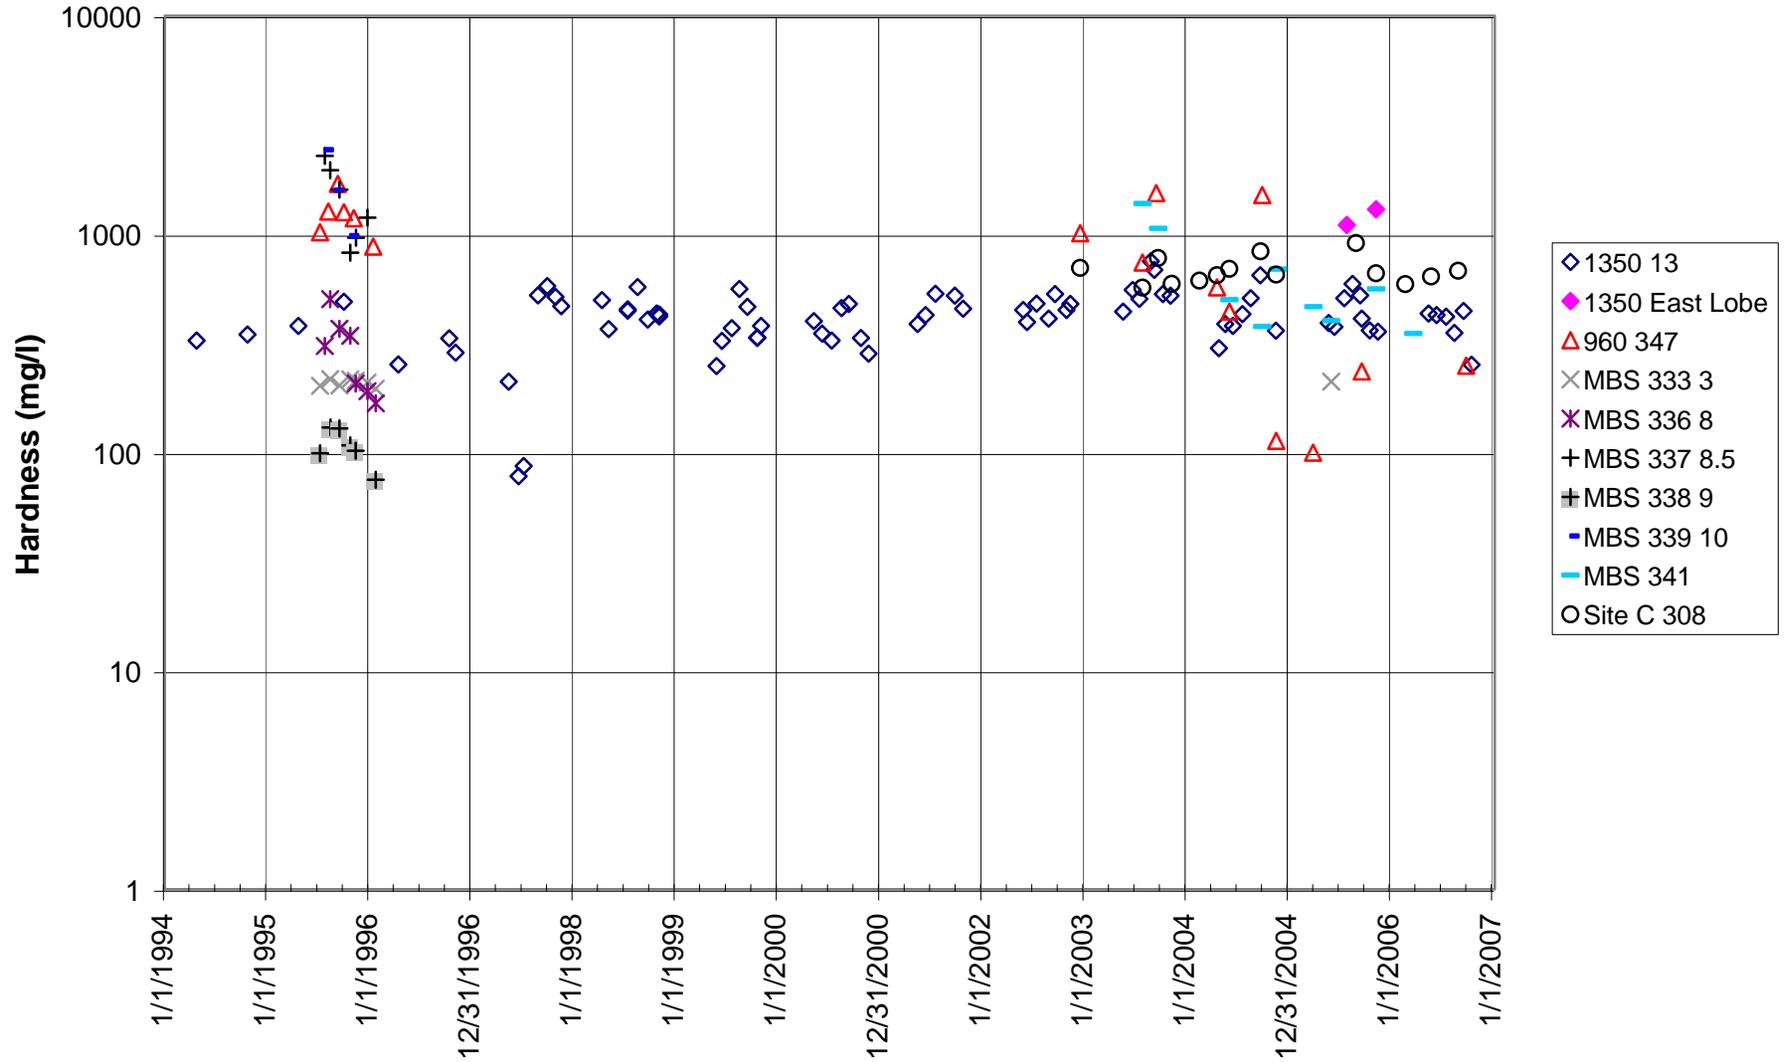
Figure 2.11 Inactive Production Rock Site Hardness Data

Non-detect results shown at 1/2 detection limit; Data are a composite of dissolved, total and total recoverable results
