**INACTIVE PRODUCTION ROCK SITES AND QUARRIES
2006 ANNUAL REPORT**

Kennecott Greens Creek Mining Company

May 2007

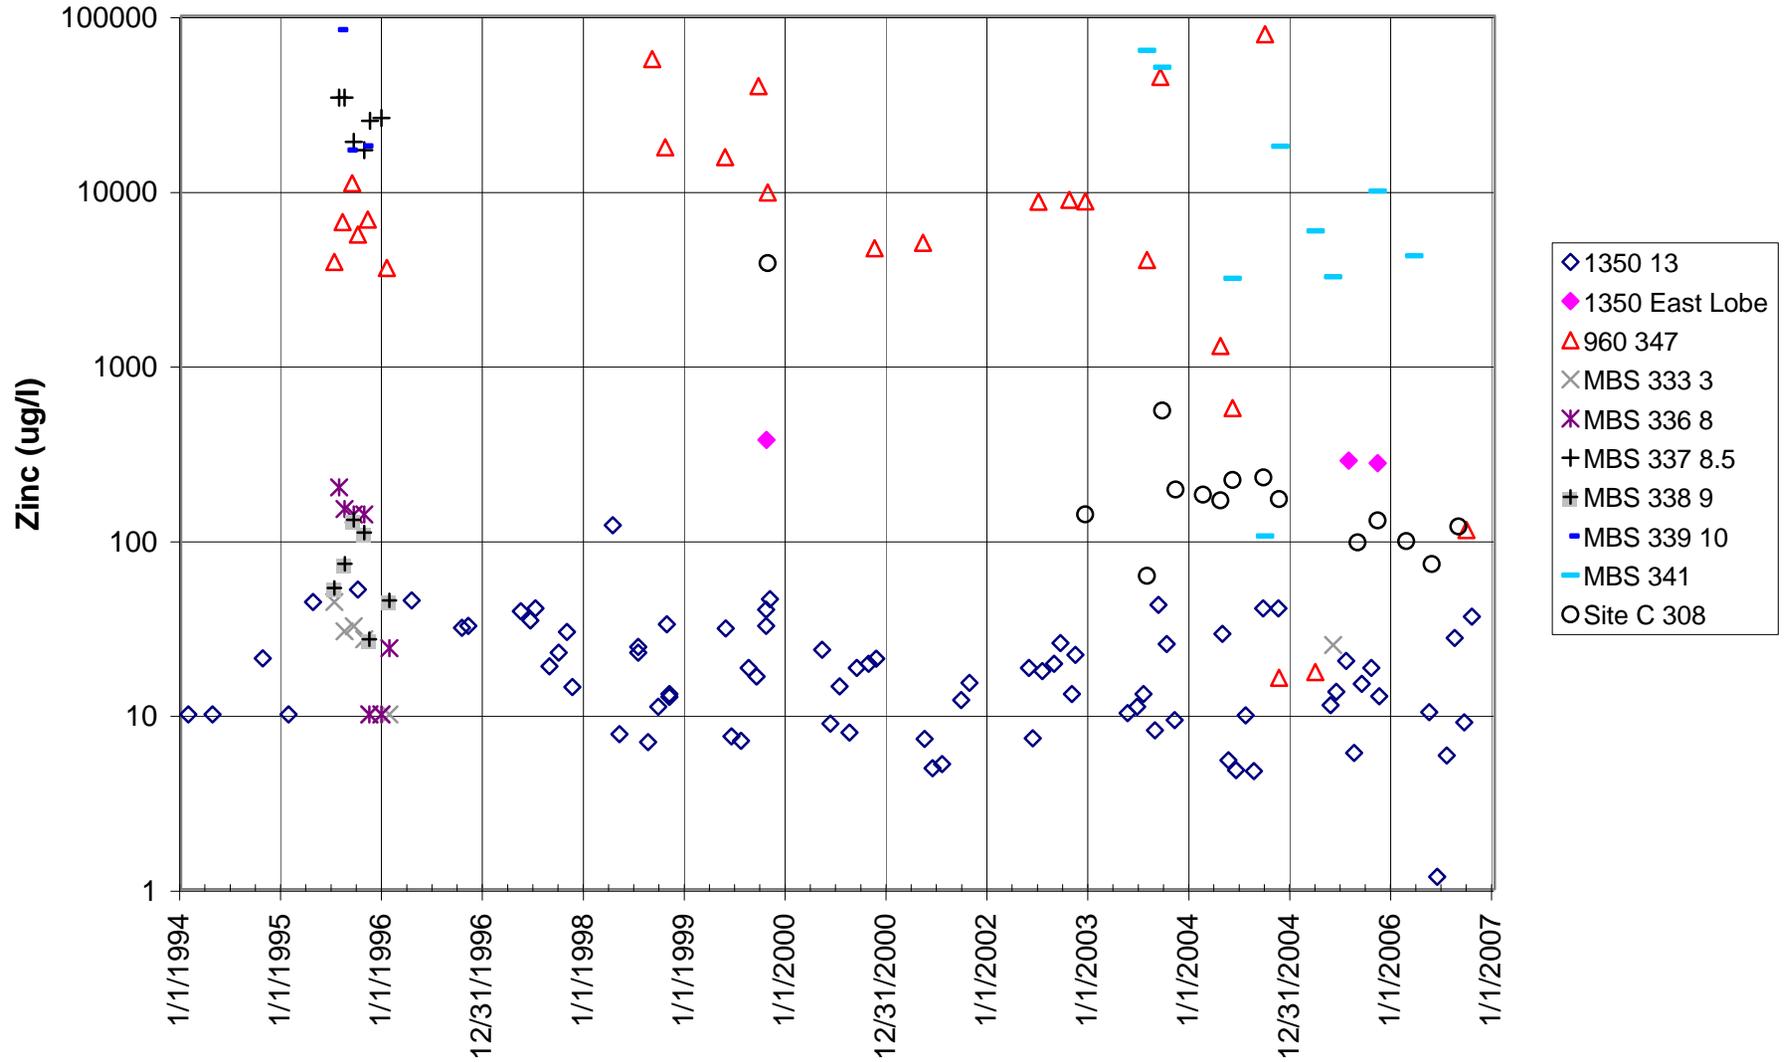
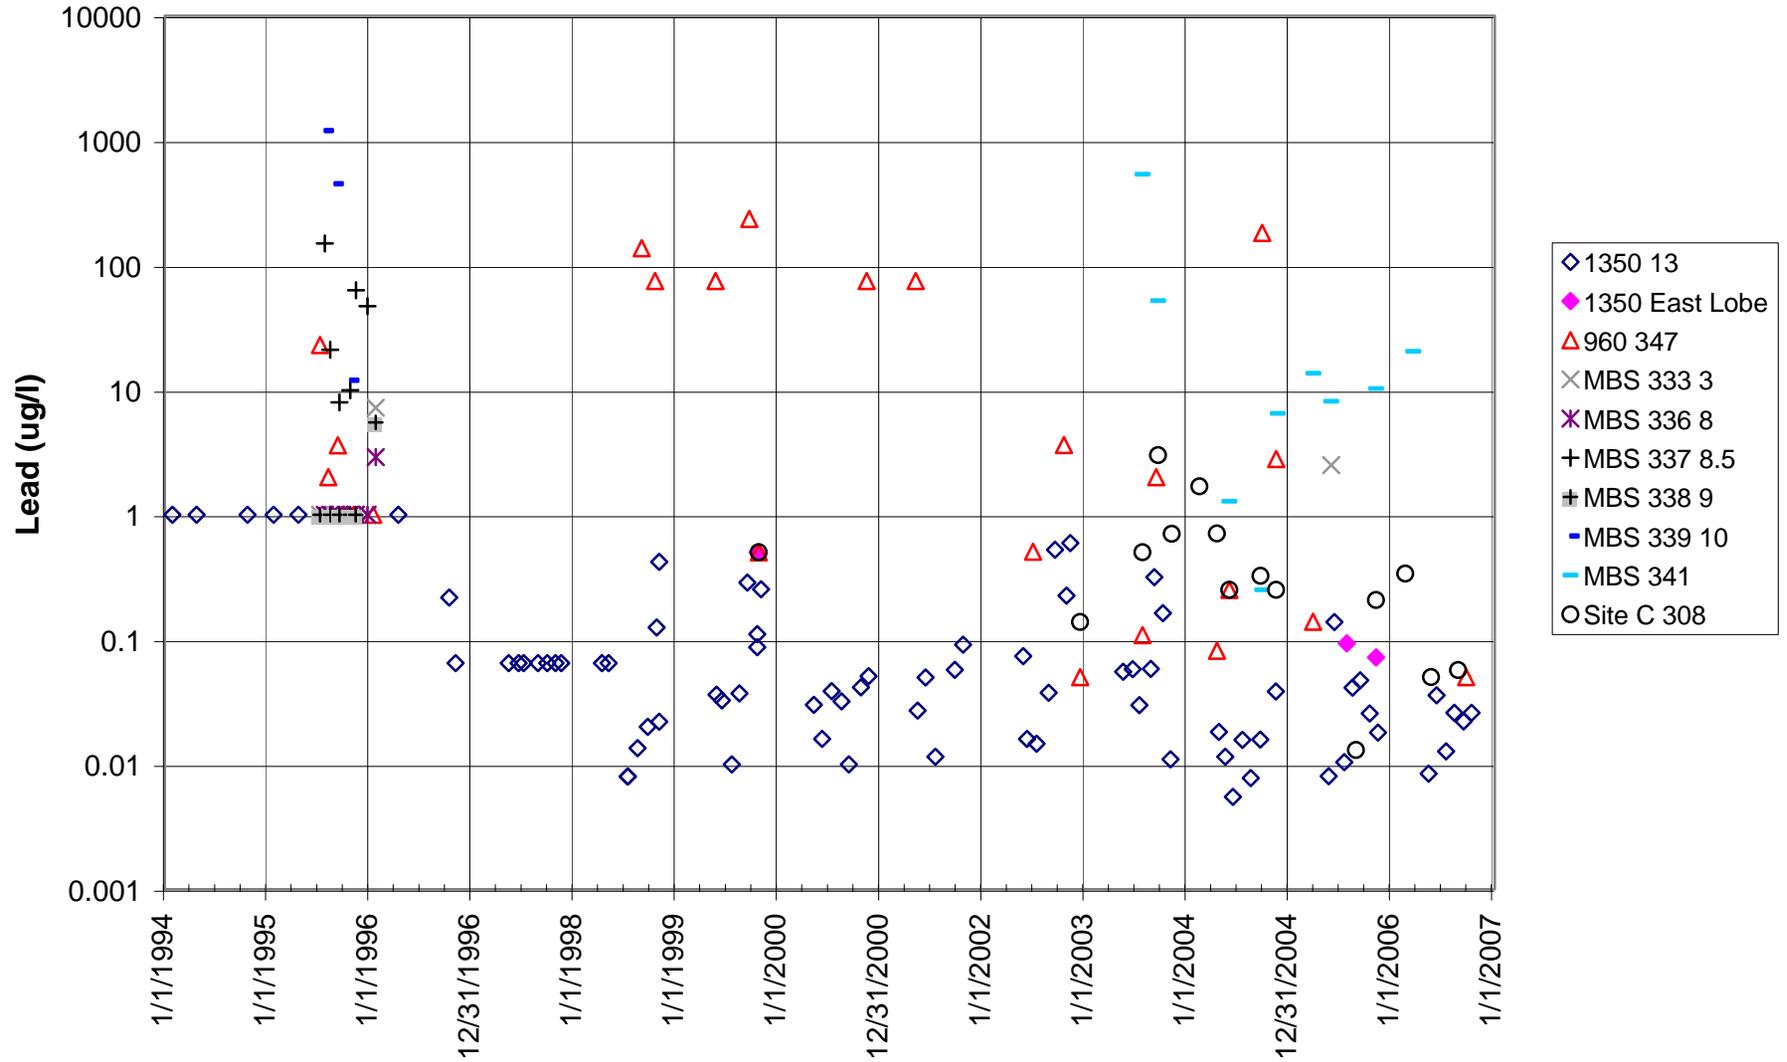
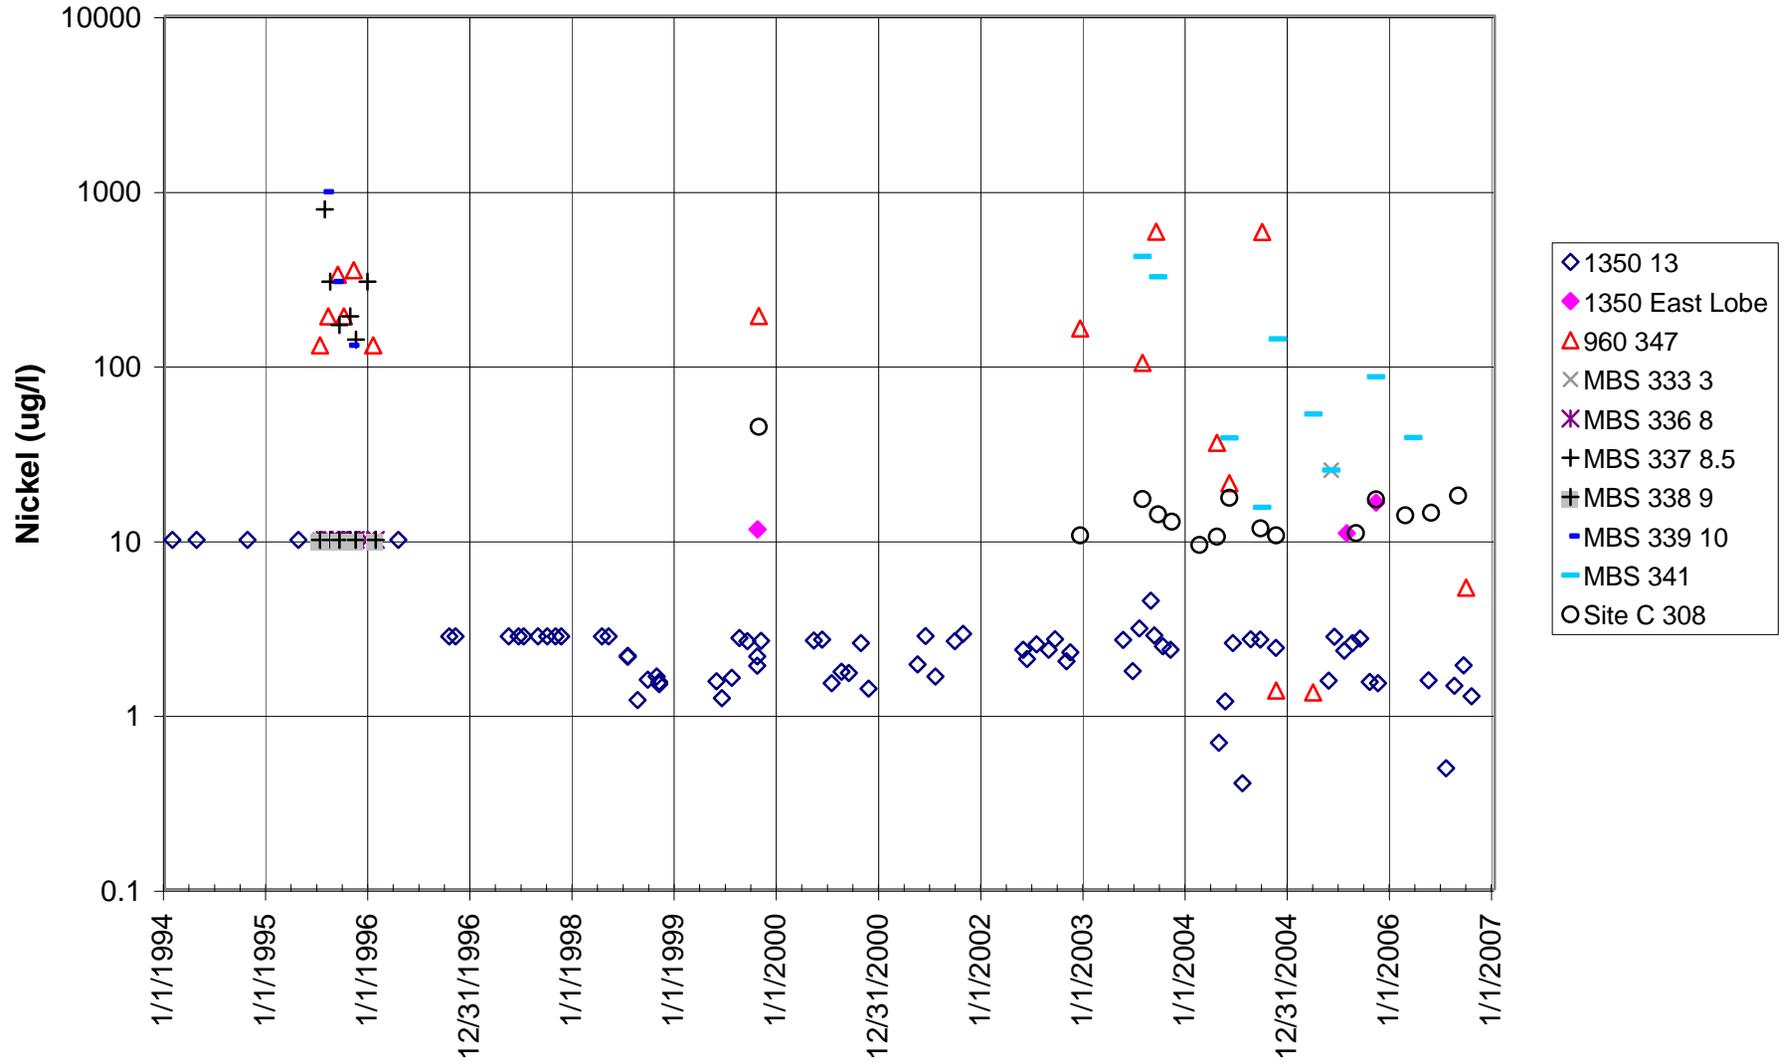
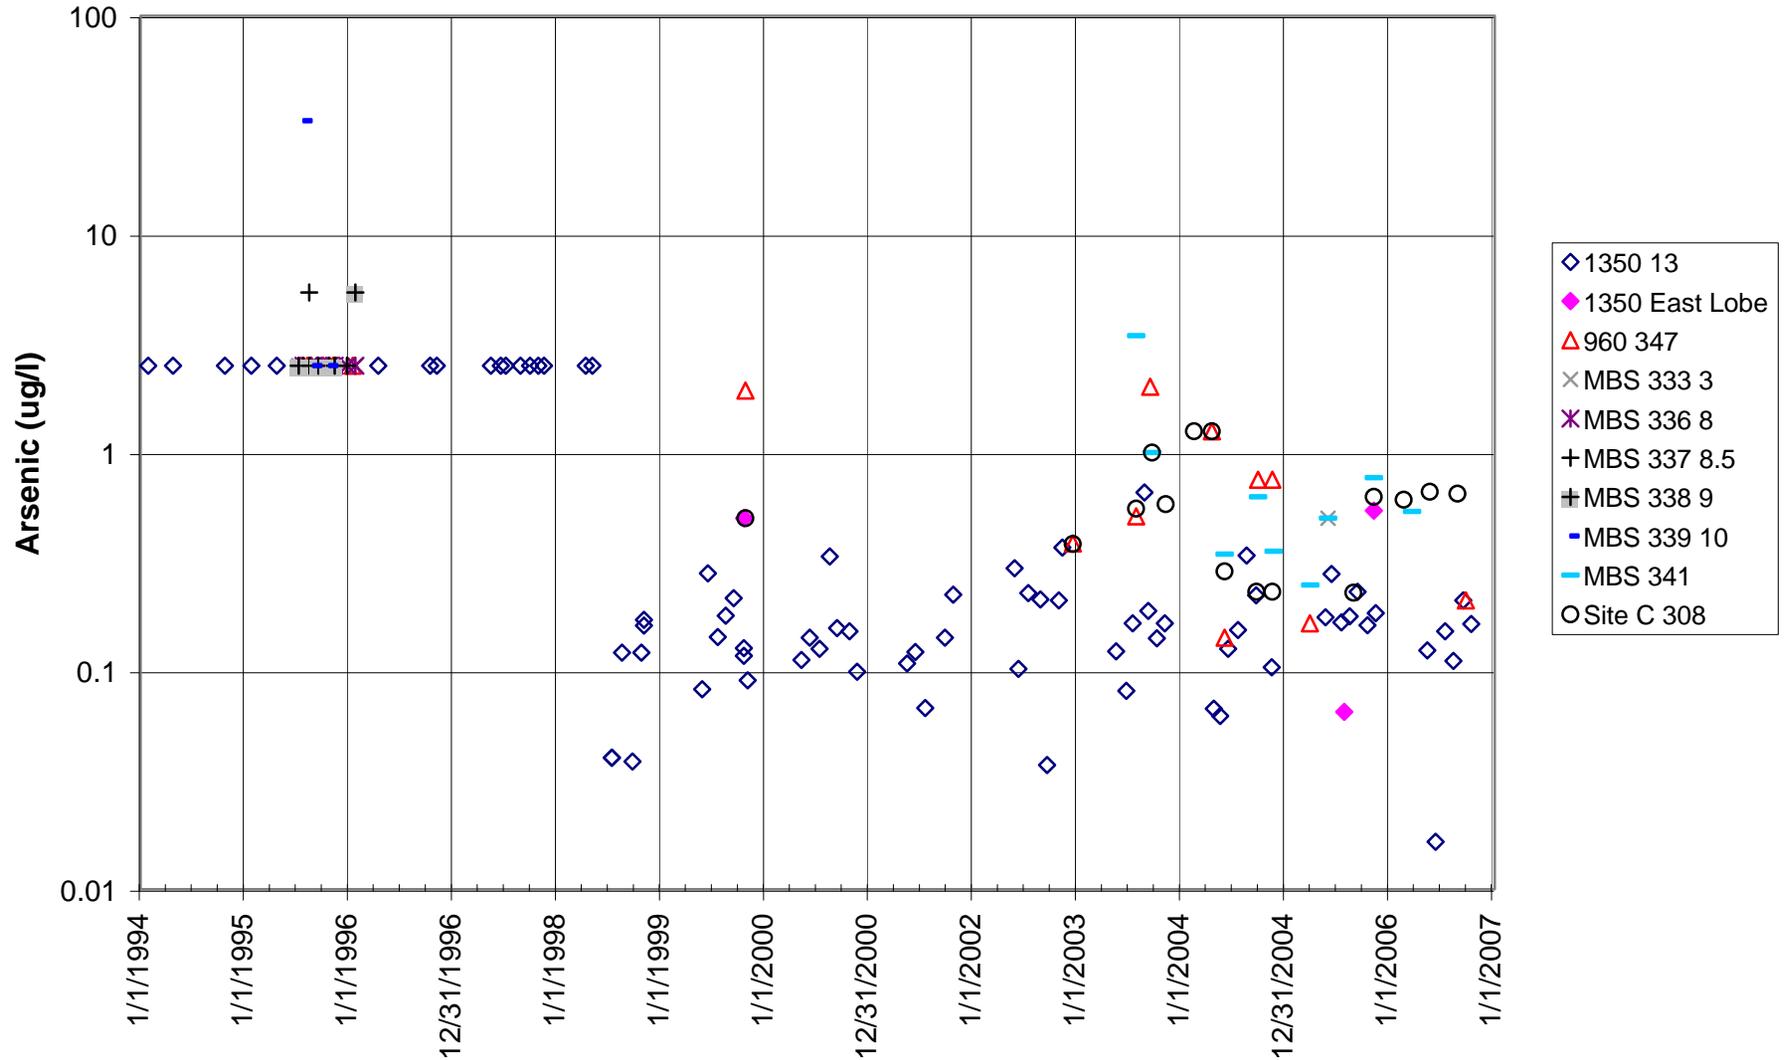
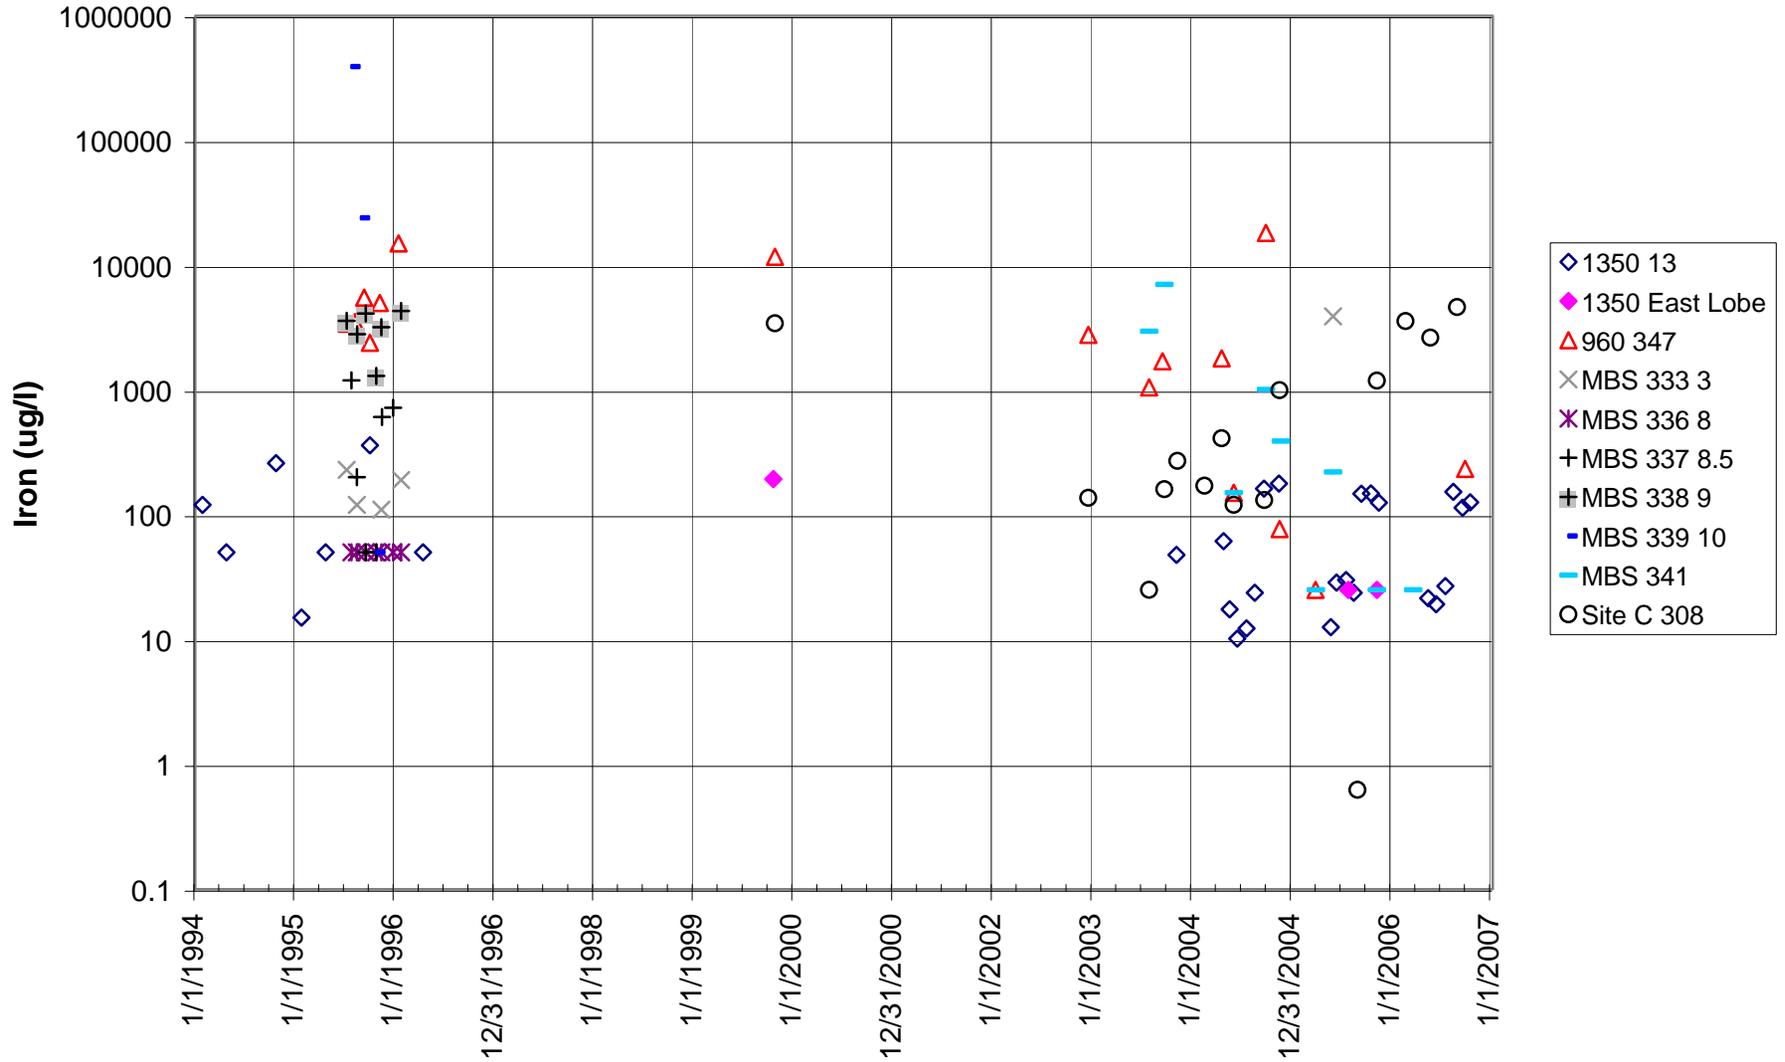
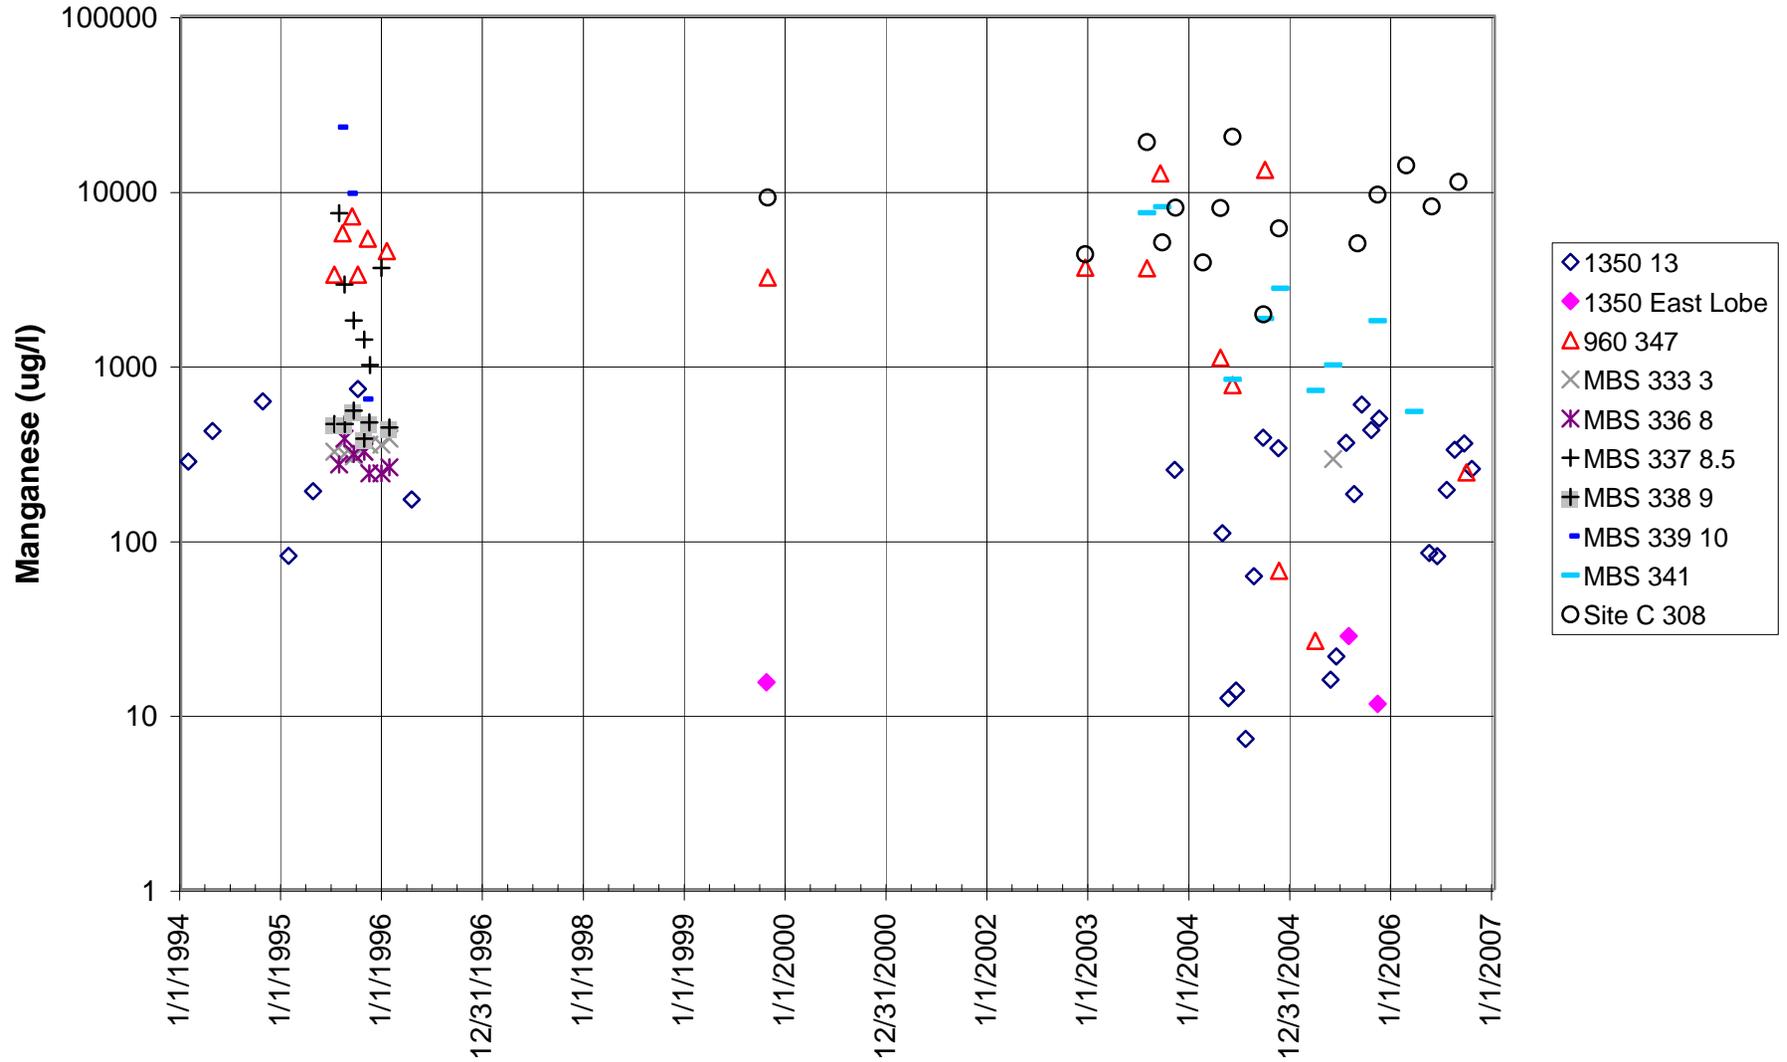
The data for zinc, copper, lead, cadmium, nickel, arsenic, iron and manganese are presented in Figures 2.12 to 2.19 and Figures 2.27 to 2.34. Sample results that were less than the detection limit are plotted at one half the limit value. While this allows the results to be plotted on a logarithmic scale, it causes non-detect results with high detection levels to appear more concentrated than they actually are. Detection limits have varied with time and are often evident on the graphs as horizontal groupings of symbols. The results for metals generally correlate with conductivity values. Zinc concentrations reflect the higher solubility of this element relative to the other metals at these near-neutral pH conditions. Manganese concentrations are elevated at most of the inactive sites, indicating the generation of secondary products from localized redox and buffering reactions as well as this metal's higher solubility in the prevailing pH conditions. Metal loads from inactive sites have either remained relatively constant or decreased with time. The decrease in metal loading is attributed to the reduction of reactive surface area discussed above. Site 960 showed some elevated copper, zinc and cadmium concentrations in 2004. This was likely due to the removal of production rock from the area, which exposed additional production rock materials in the base of the road, and rerouted additional water sources into the sampling area, confounding comparative water sampling with pre-removal data. Post removal Site 960 data in 2005 and 2006 showed a decrease in most metal concentrations, with close to an order of magnitude decrease in cadmium, nickel, manganese and zinc.

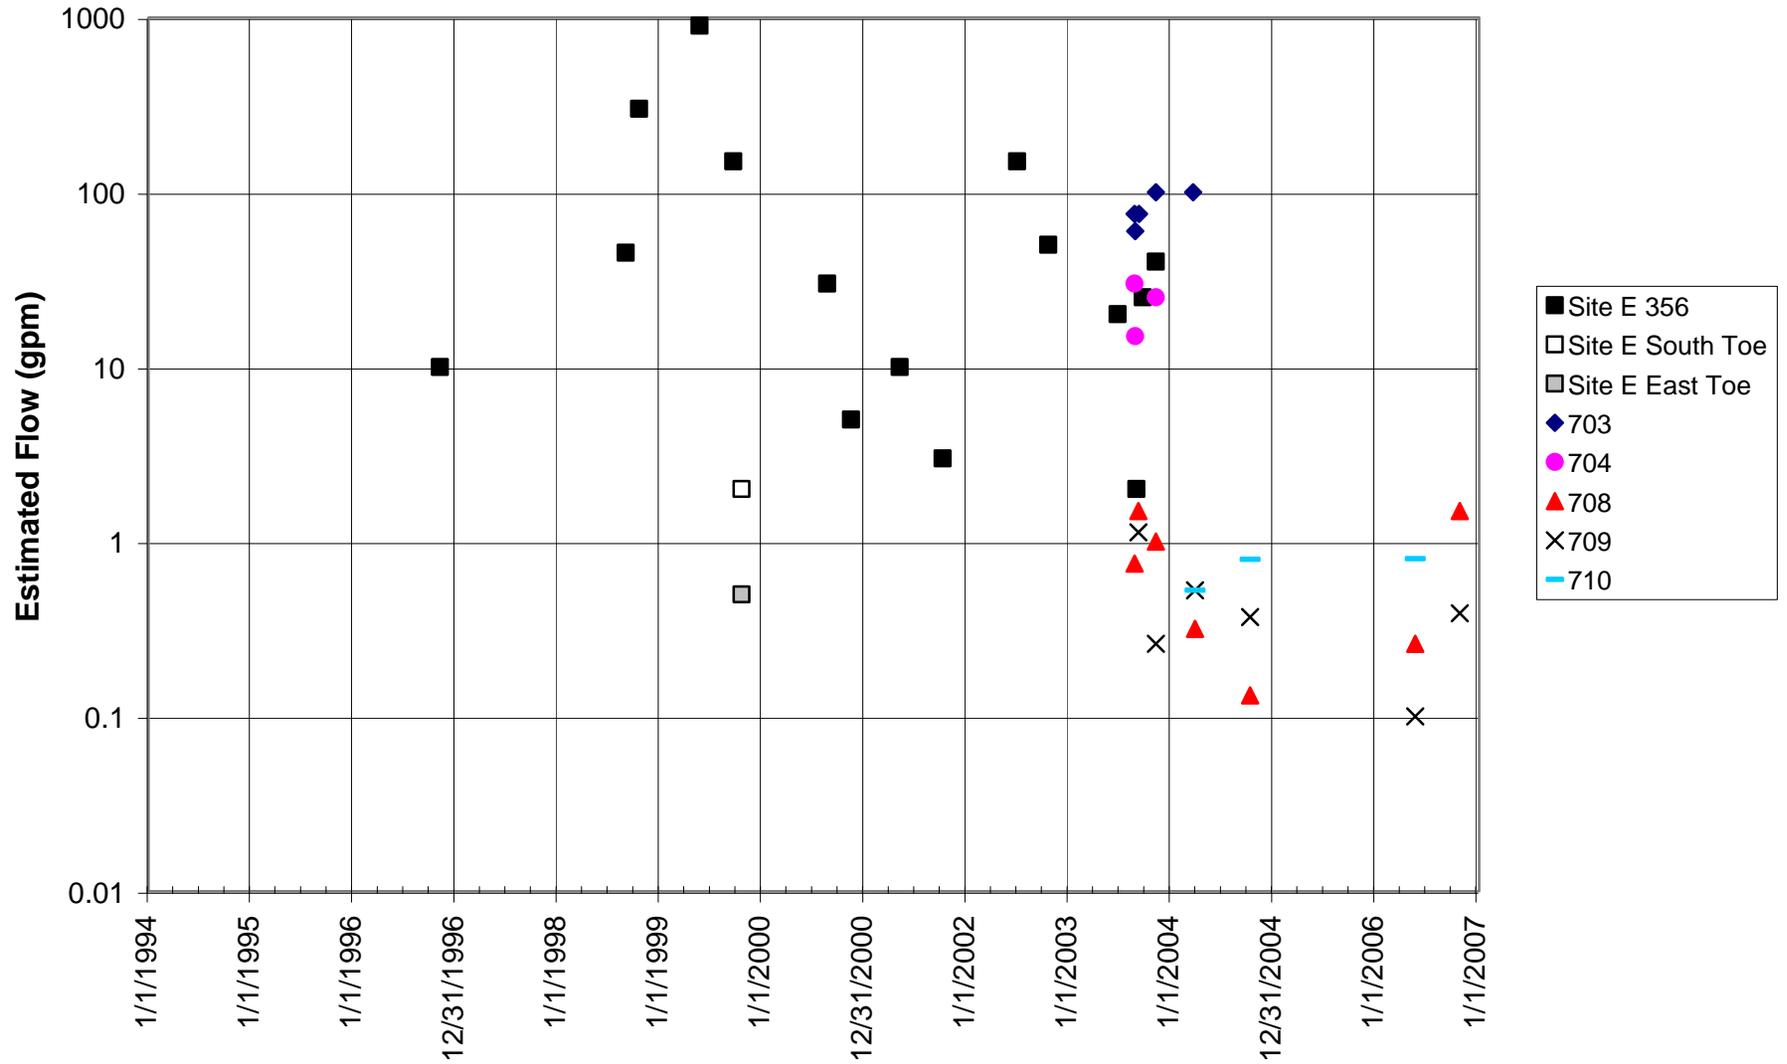
Figure 2.20 Inactive Production Rock Site E Flow Data

Flow data presented in Figures 2.5 and 2.20 demonstrate that flows at most of the sample locations are generally low (less than 10 gpm). Some of the flow data were collected as part of the NPDES stormwater monitoring program. Collected during or following storm events, flow data from these locations (e.g. Site E 356, 960 347) represent short-term maximum flow values in response to relatively large precipitation events. Lack of significant flow from inactive sites is a positive characteristic because it reflects minimization of potential off-site impacts.

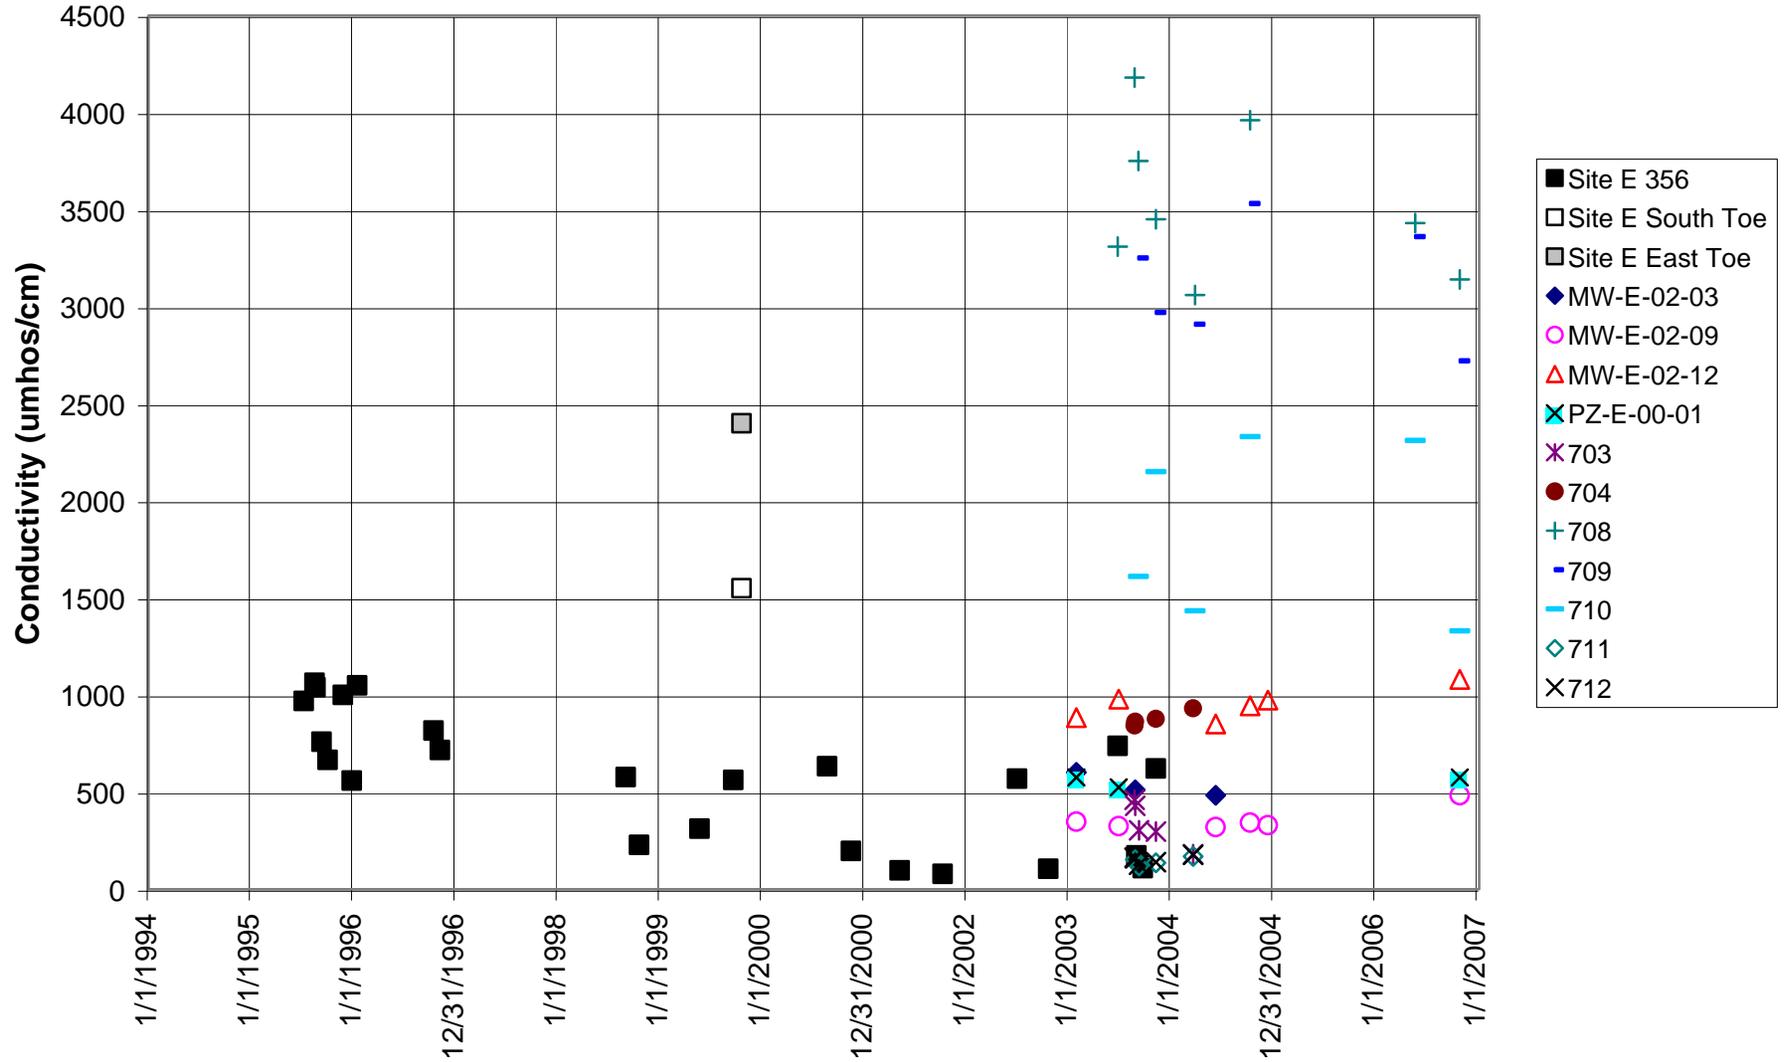
Figure 2.23 Inactive Production Rock Site E Conductivity Data

Conductivity data are shown in Figures 2.8 and 2.23. Conductivity indicates the amount of dissolved constituents in the water. KGCMC samples having higher conductivity values usually have higher sulfate, calcium and magnesium (hardness) concentrations, reflecting influences from sulfide oxidation and carbonate mineral dissolution. Water that has contacted production rock is expected to have higher conductivity values than background waters. Site 960 347 shows an overall decreasing trend in conductivity, while the Site 1350 data remains unchanged. Historical conductivity data (1995-1996) from the Mill backslope Site 333-3 was slightly lower than conductivity data from 2005; however, the samples in 2005 were taken during removal activities and may reflect this disturbance. The combined drainage from the Mill backslope area (Site 341) showed a decrease in dissolved load for 2006. Site C had a slightly higher average annual conductivity in 2006 than 2005 (1143 $\mu\text{mhos/cm}$ in 2006 versus 1065 $\mu\text{mhos/cm}$ in 2005). The trends apparent in Figures 2.8 and 2.23 are the result of decreasing reactive surface area available for oxidation and dissolution. The reactive surface area decreases as reactants are consumed and mineral surfaces become coated with oxidation products. The results for sulfate, magnesium and

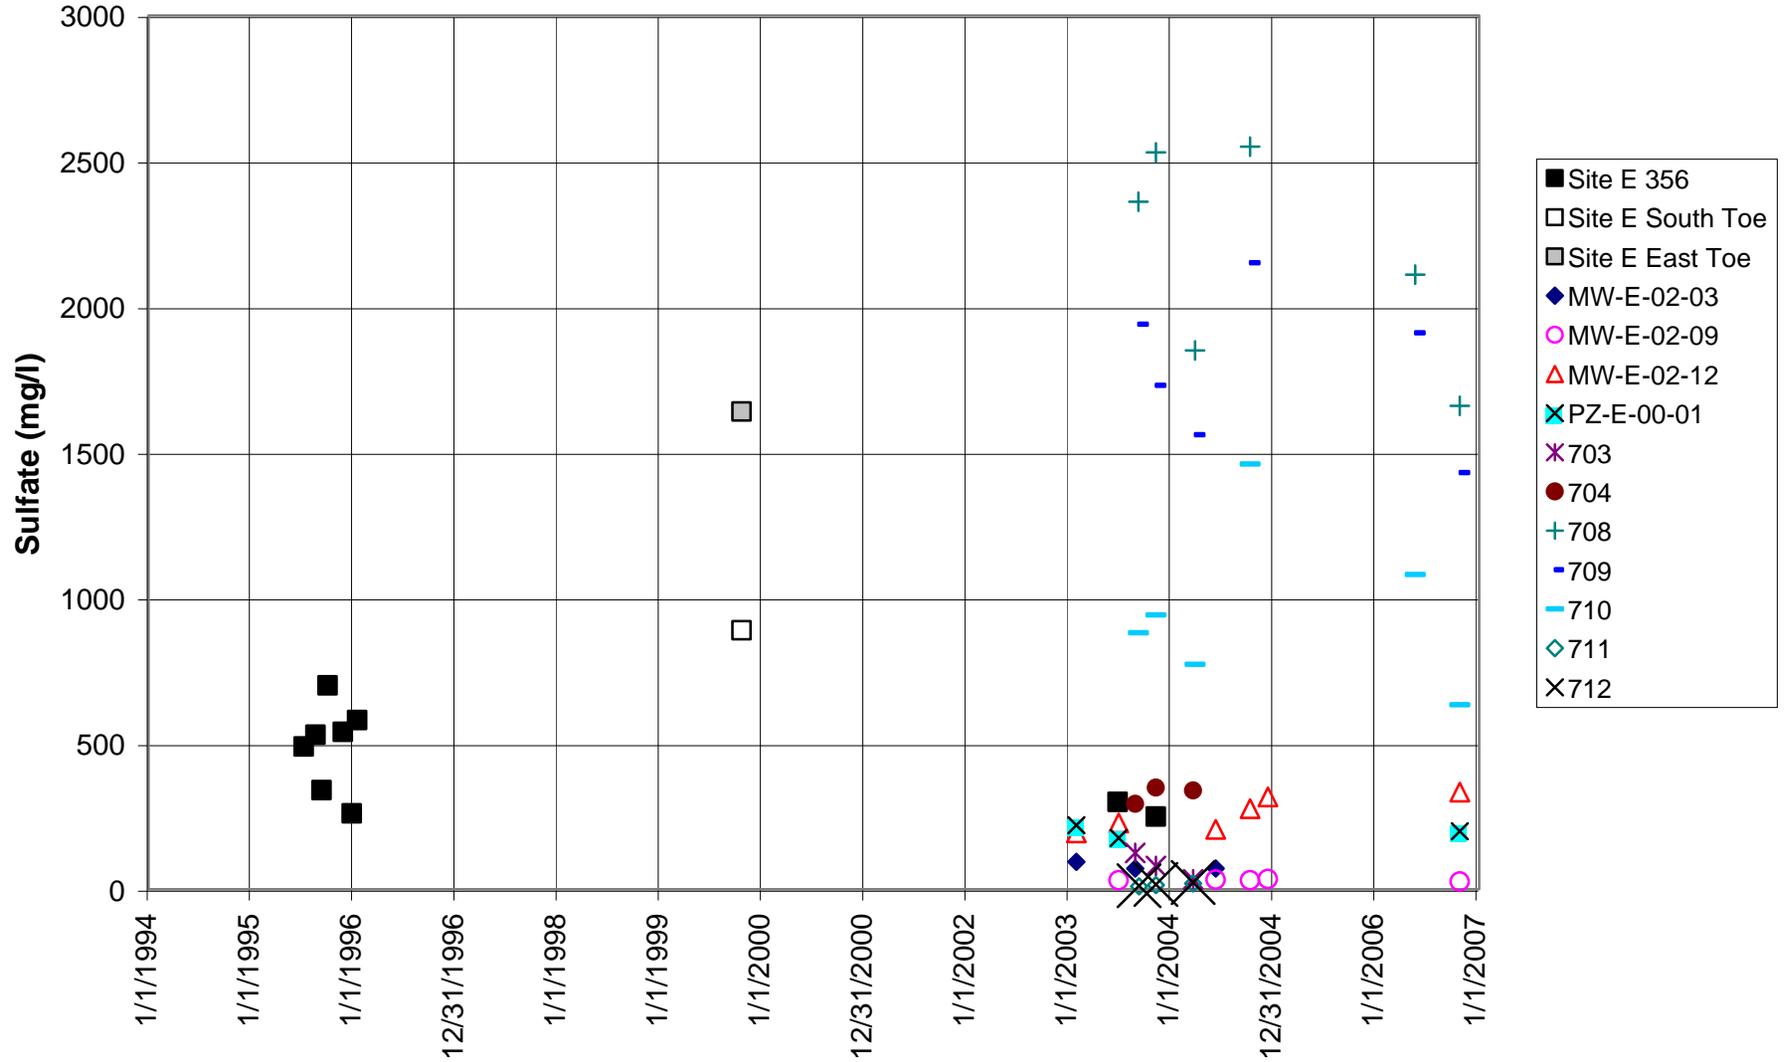
Figure 2.24 Inactive Production Rock Site E Sulfate Data

hardness, shown in Figures 2.9 and 2.24, 2.10 and 2.25, and 2.11 and 2.26, respectively, correlate with conductivity results and are consistent with the concept of generally decreasing α static reactive surface area.
