**INACTIVE PRODUCTION ROCK SITES AND QUARRIES
2006 ANNUAL REPORT**

Kennecott Greens Creek Mining Company

May 2007

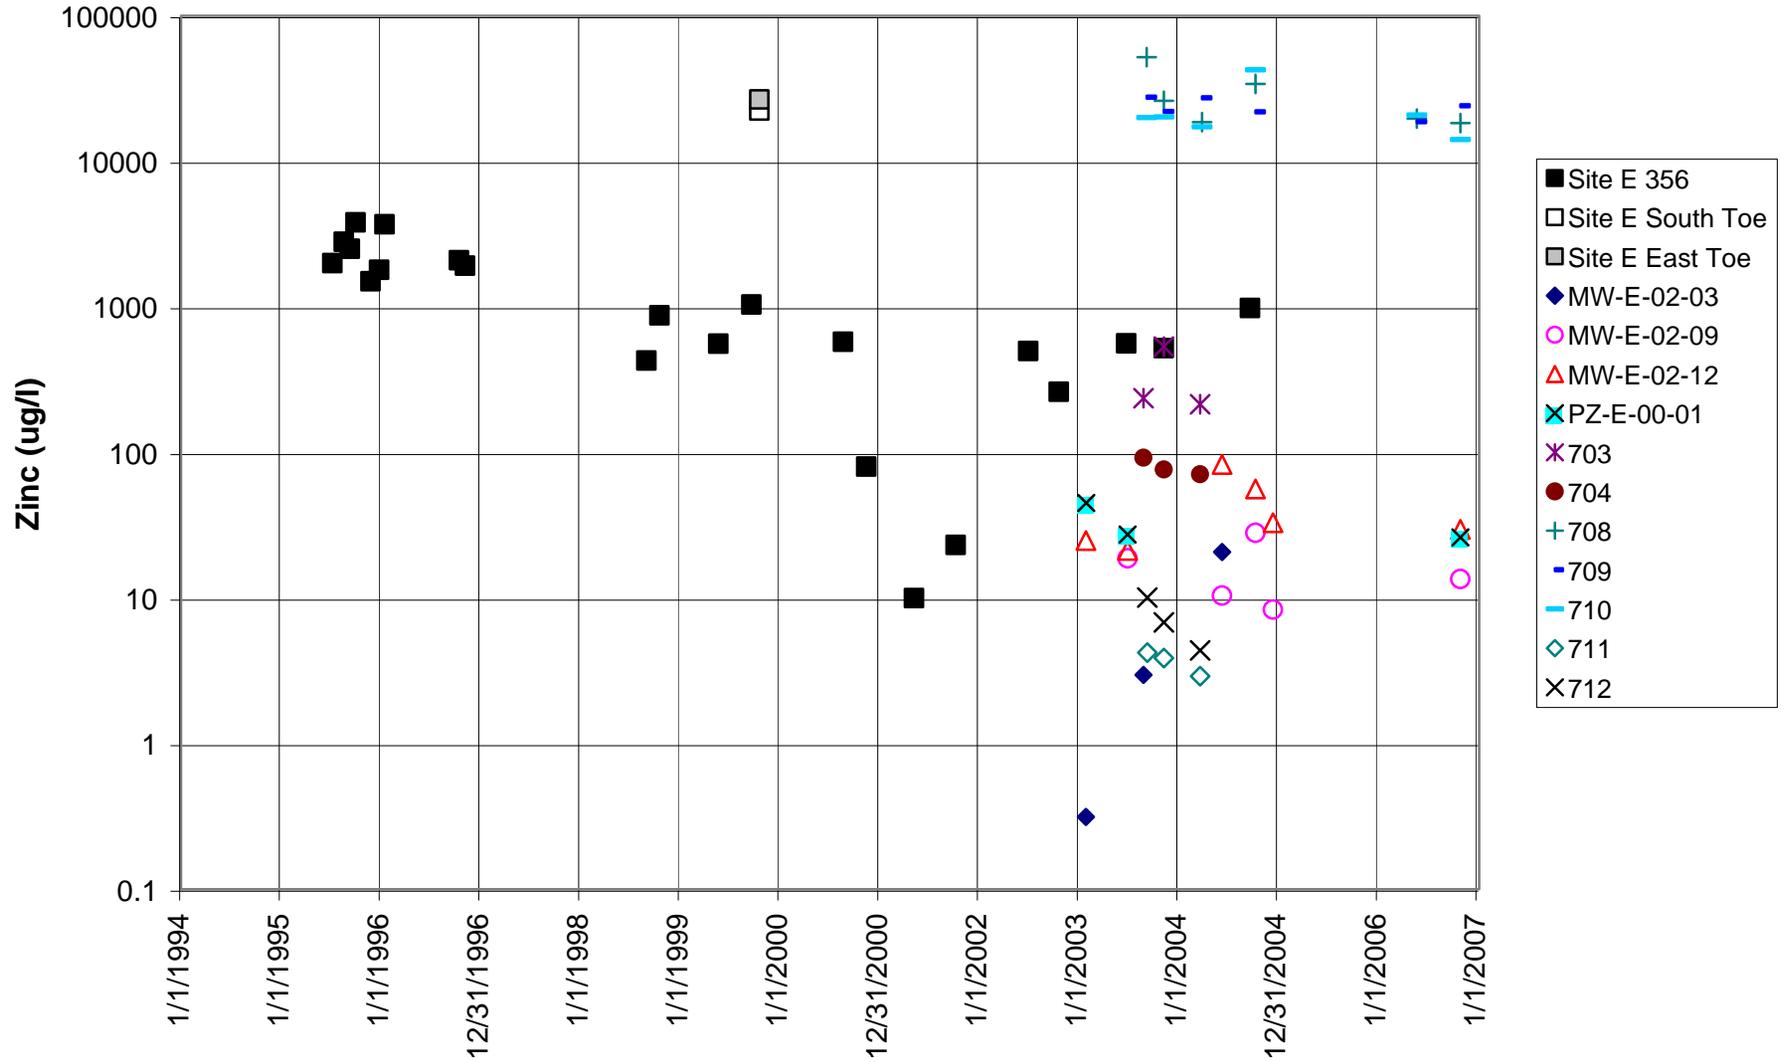
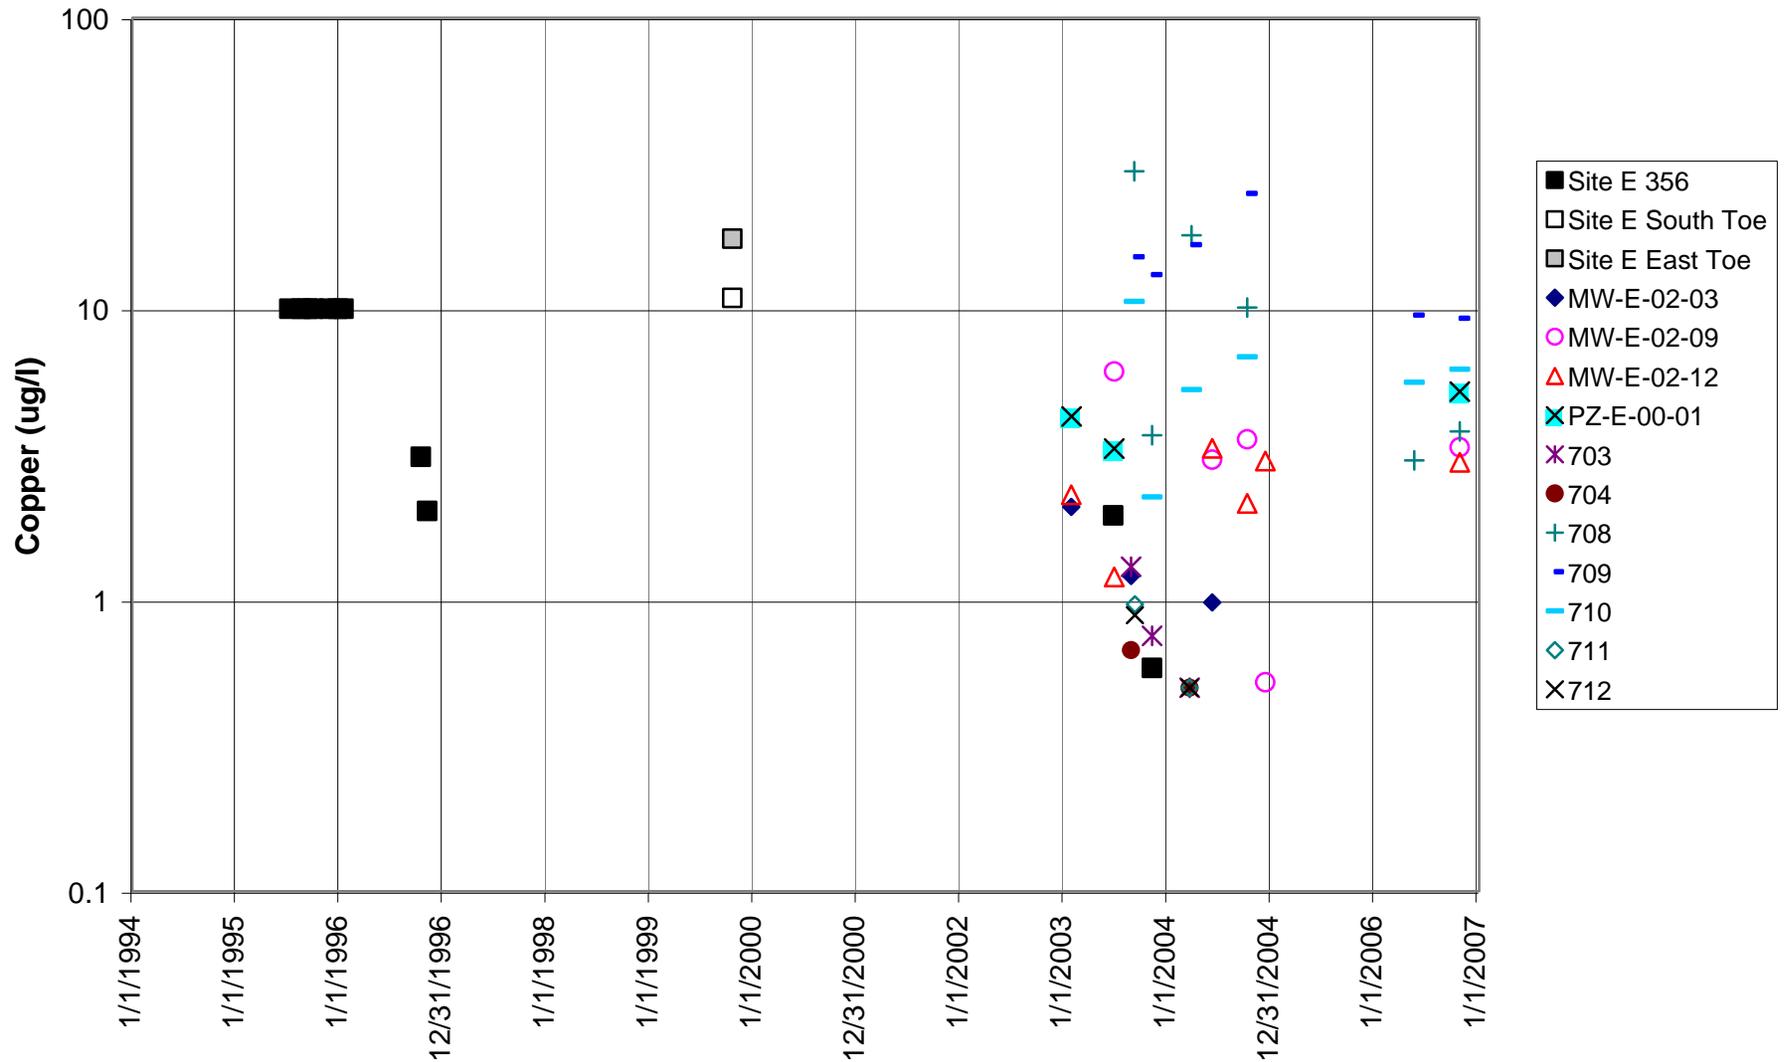
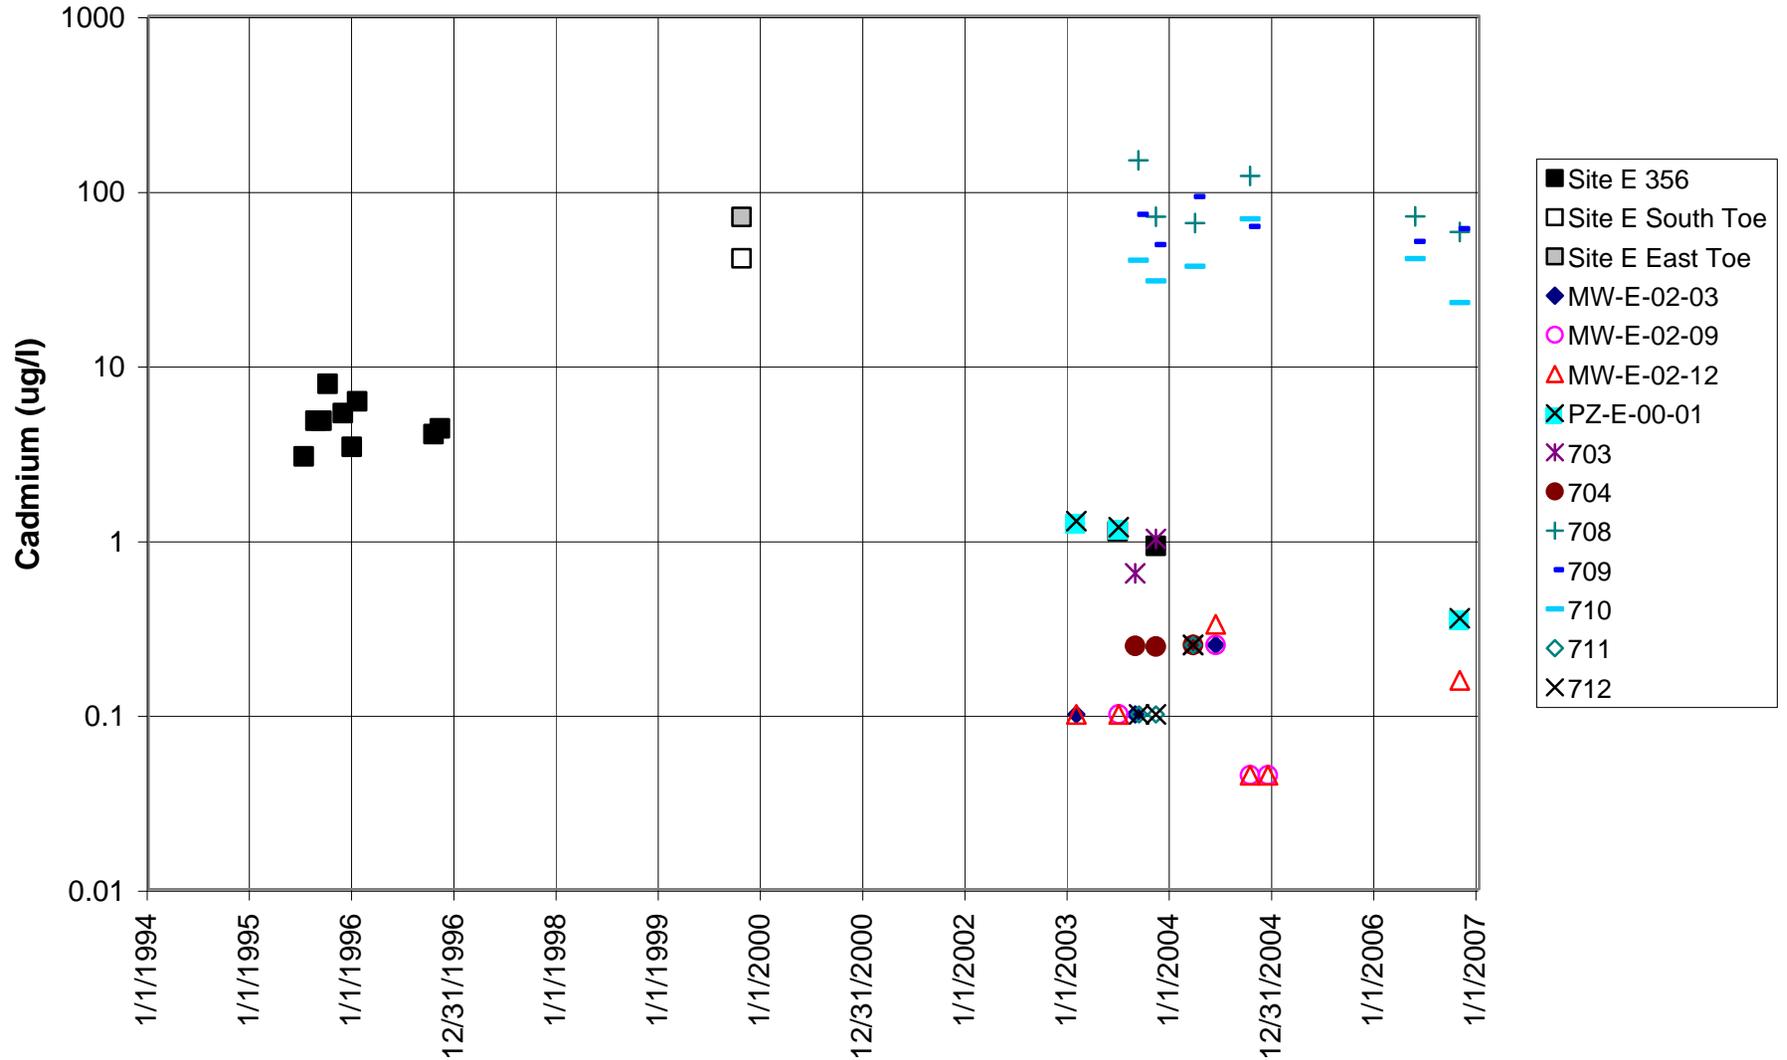
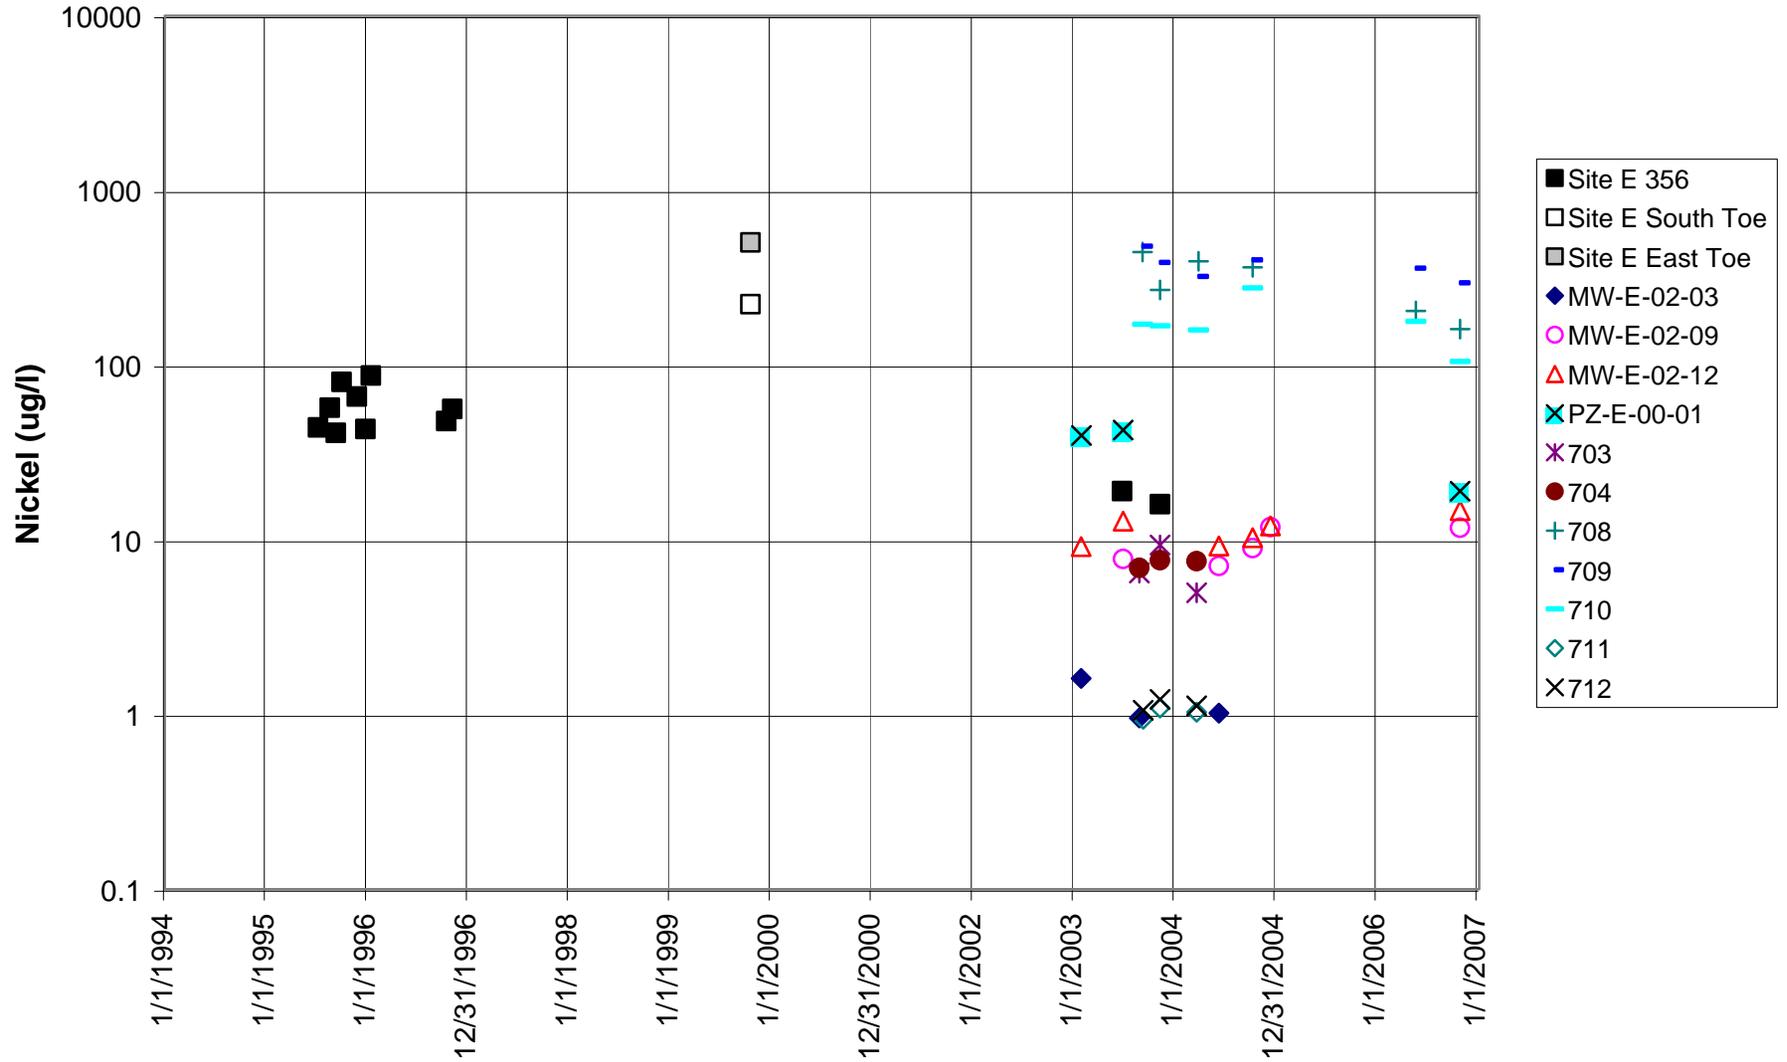
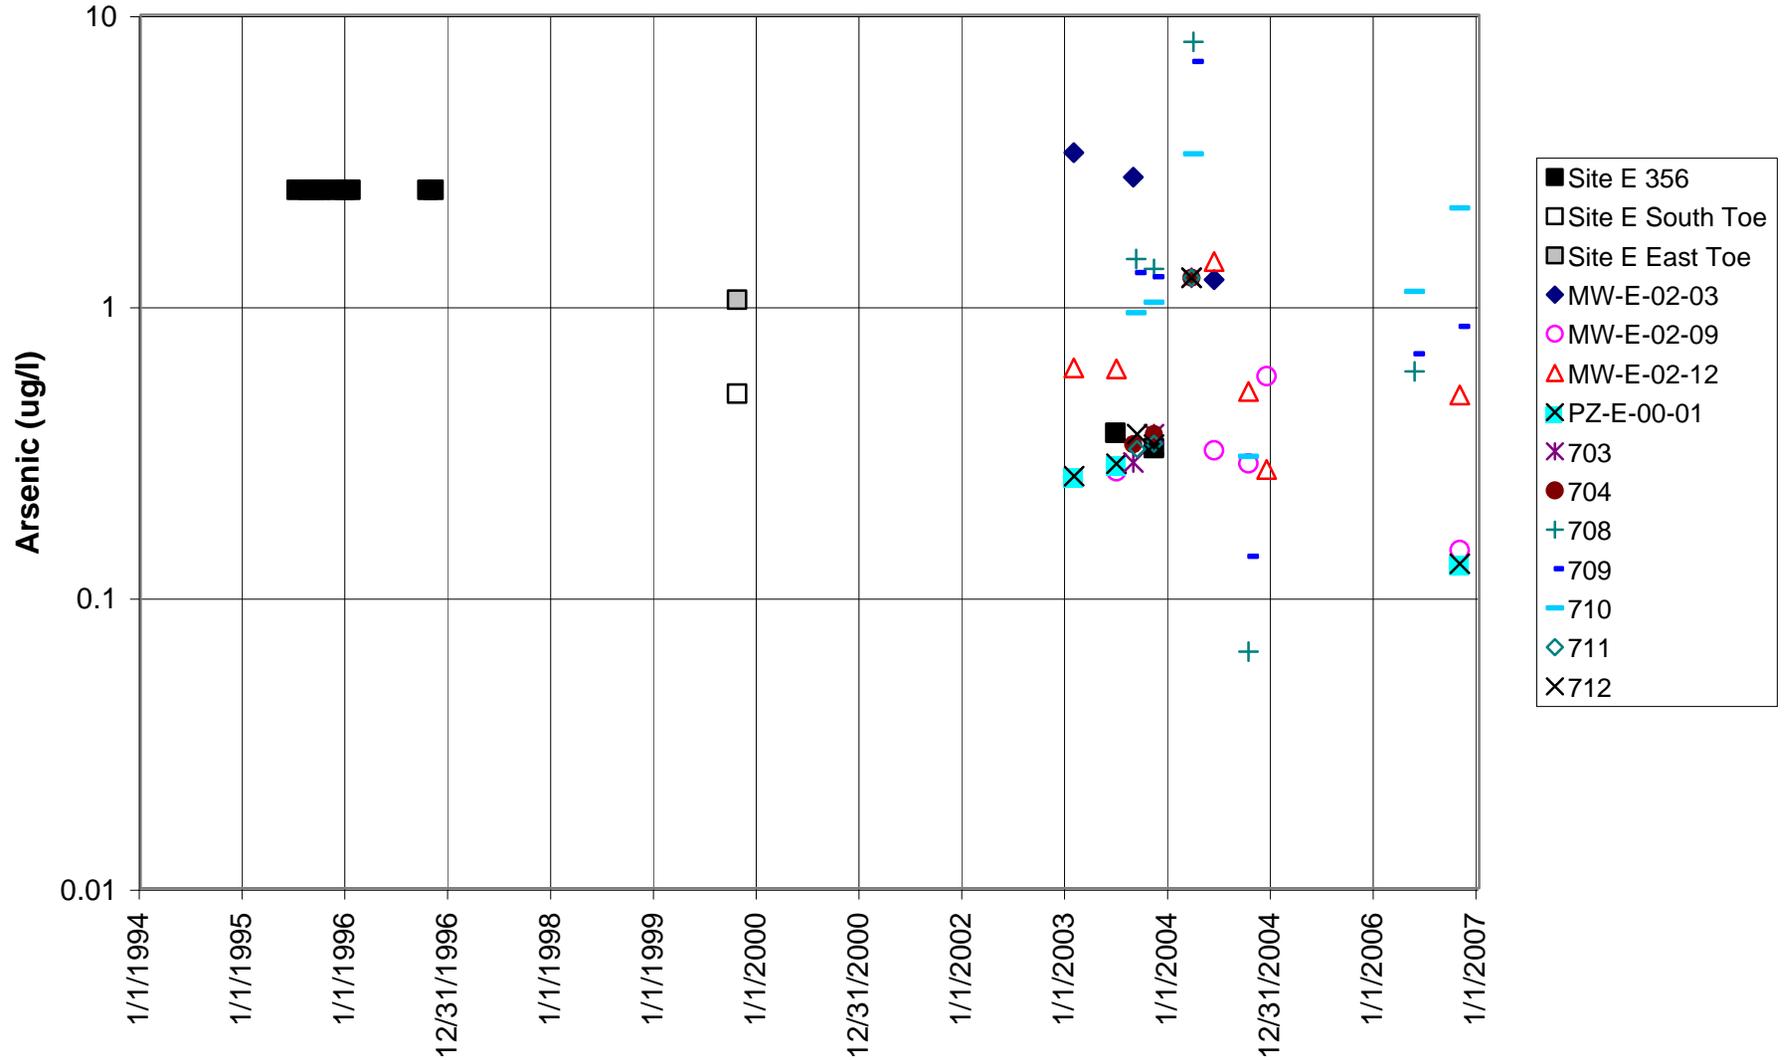
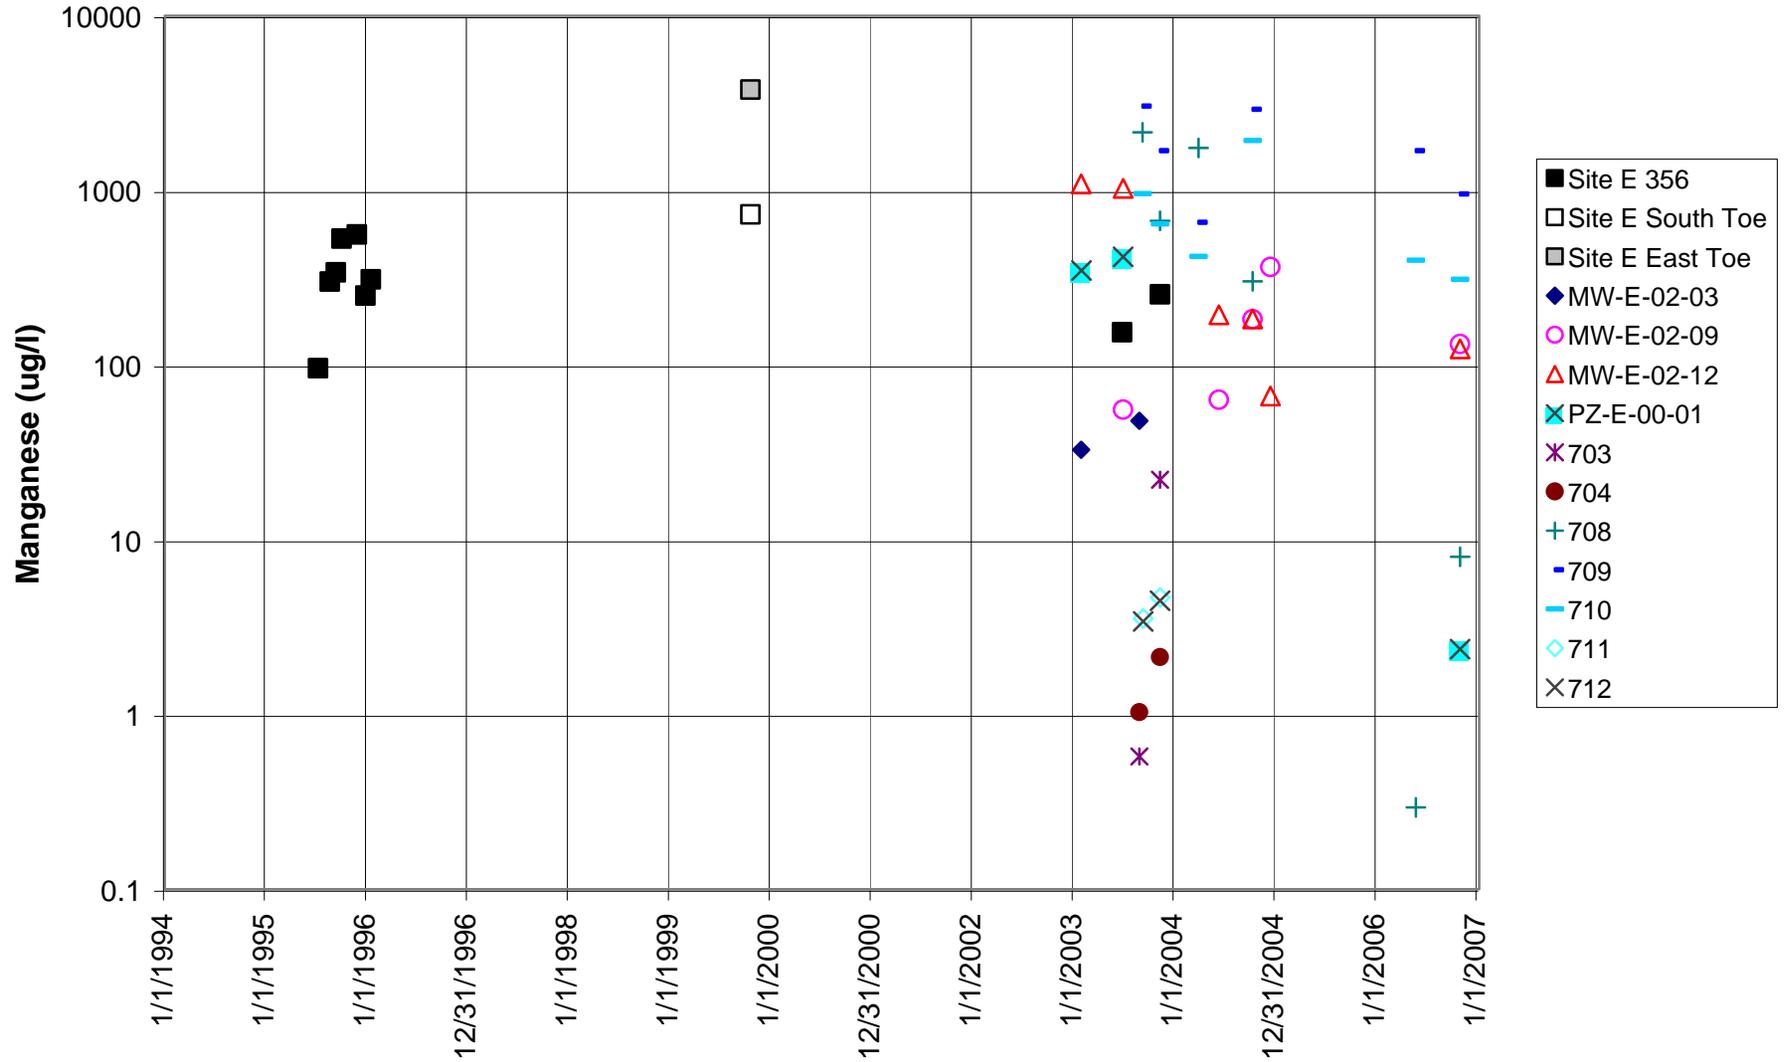
The data for zinc, copper, lead, cadmium, nickel, arsenic, iron and manganese are presented in Figures 2.12 to 2.19 and Figures 2.27 to 2.34. Sample results that were less than the detection limit are plotted at one half the limit value. While this allows the results to be plotted on a logarithmic scale, it causes non-detect results with high detection levels to appear more concentrated than they actually are. Detection limits have varied with time and are often evident on the graphs as horizontal groupings of symbols. The results for metals generally correlate with conductivity values. Zinc concentrations reflect the higher solubility of this element relative to the other metals at these near-neutral pH conditions. Manganese concentrations are elevated at most of the inactive sites, indicating the generation of secondary products from localized redox and buffering reactions as well as this metal's higher solubility in the prevailing pH conditions. Metal loads from inactive sites have either remained relatively constant or decreased with time. The decrease in metal loading is attributed to the reduction of reactive surface area discussed above. Site 960 showed some elevated copper, zinc and cadmium concentrations in 2004. This was likely due to the removal of production rock from the area, which exposed additional production rock materials in the base of the road, and rerouted additional water sources into the sampling area, confounding comparative water sampling with pre-removal data. Post removal Site 960 data in 2005 and 2006 showed a decrease in most metal concentrations, with close to an order of magnitude decrease in cadmium, nickel, manganese and zinc.

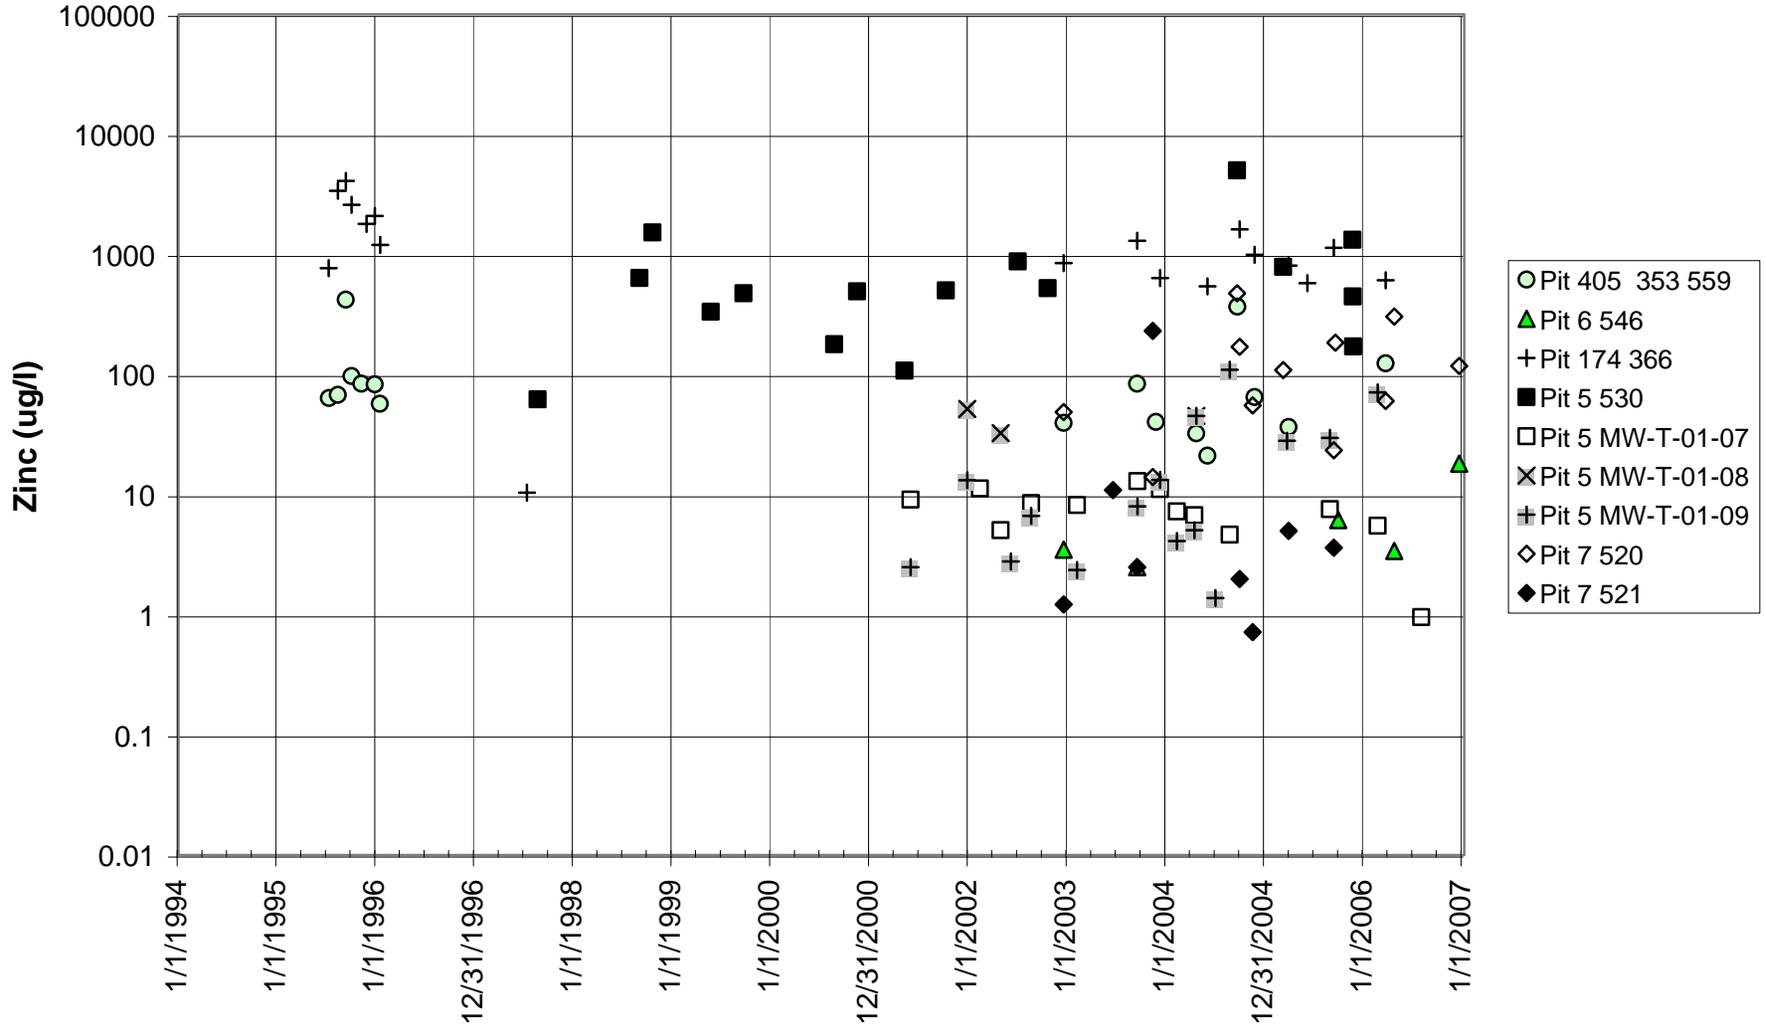
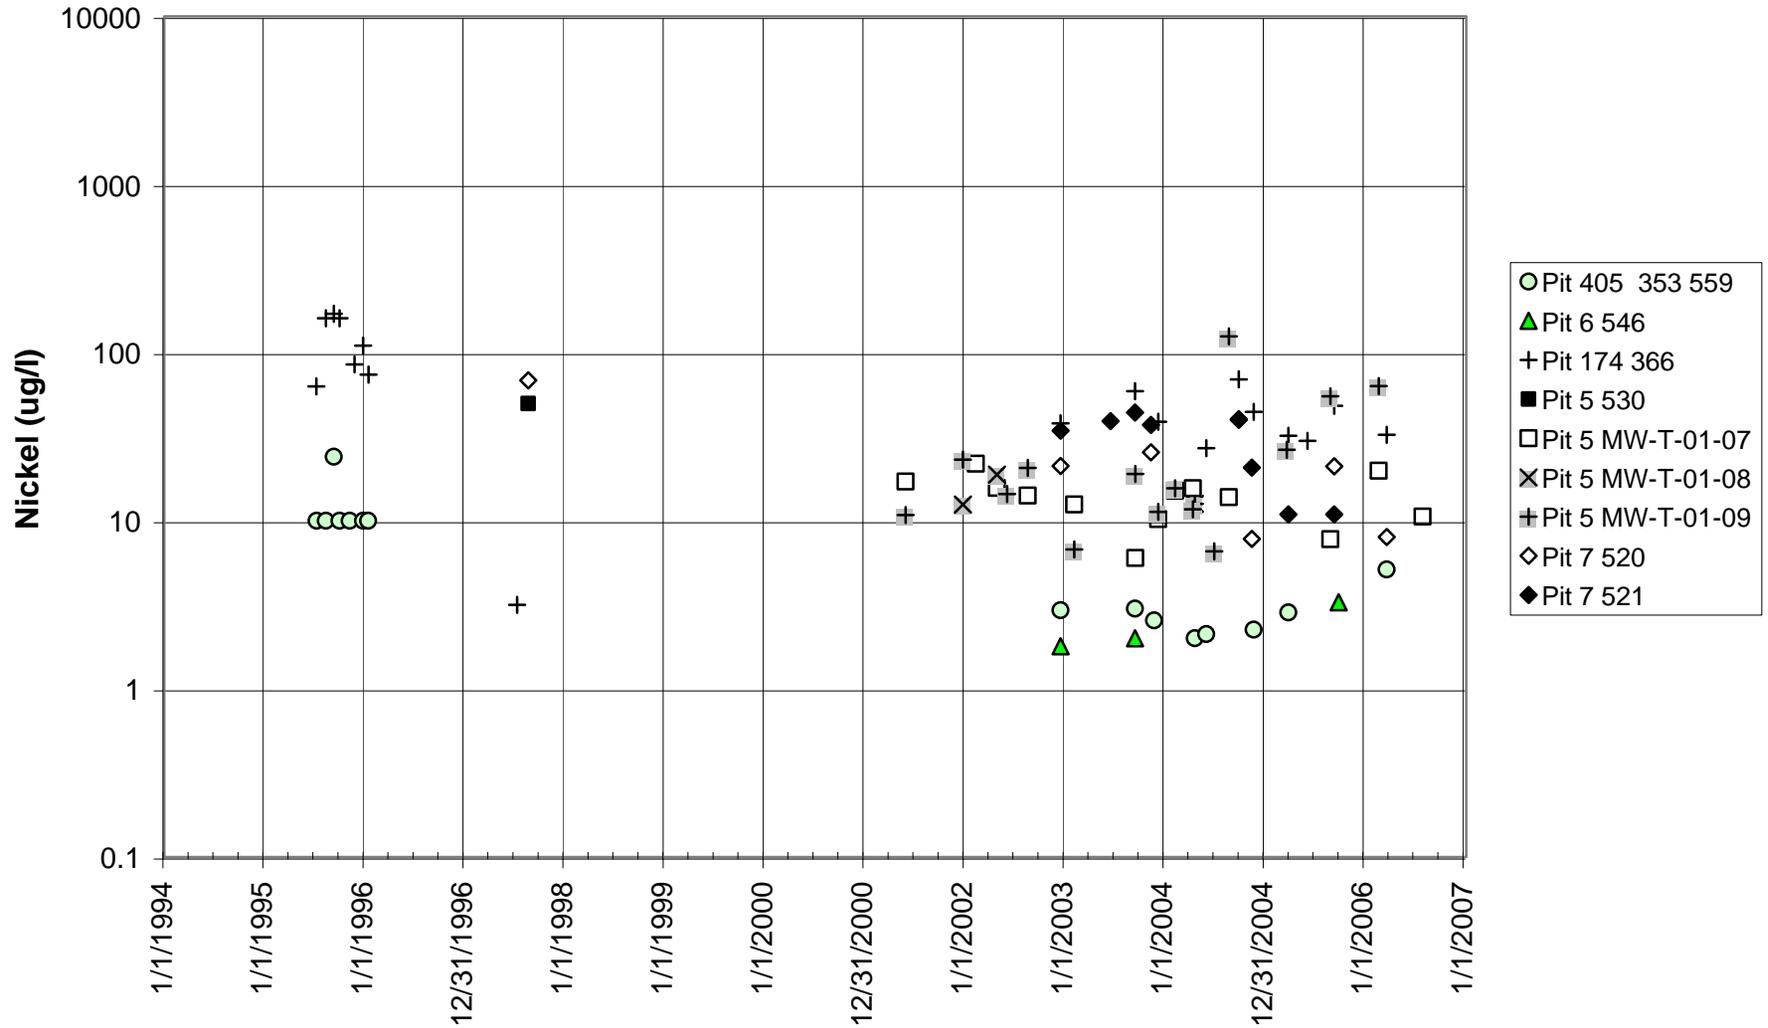
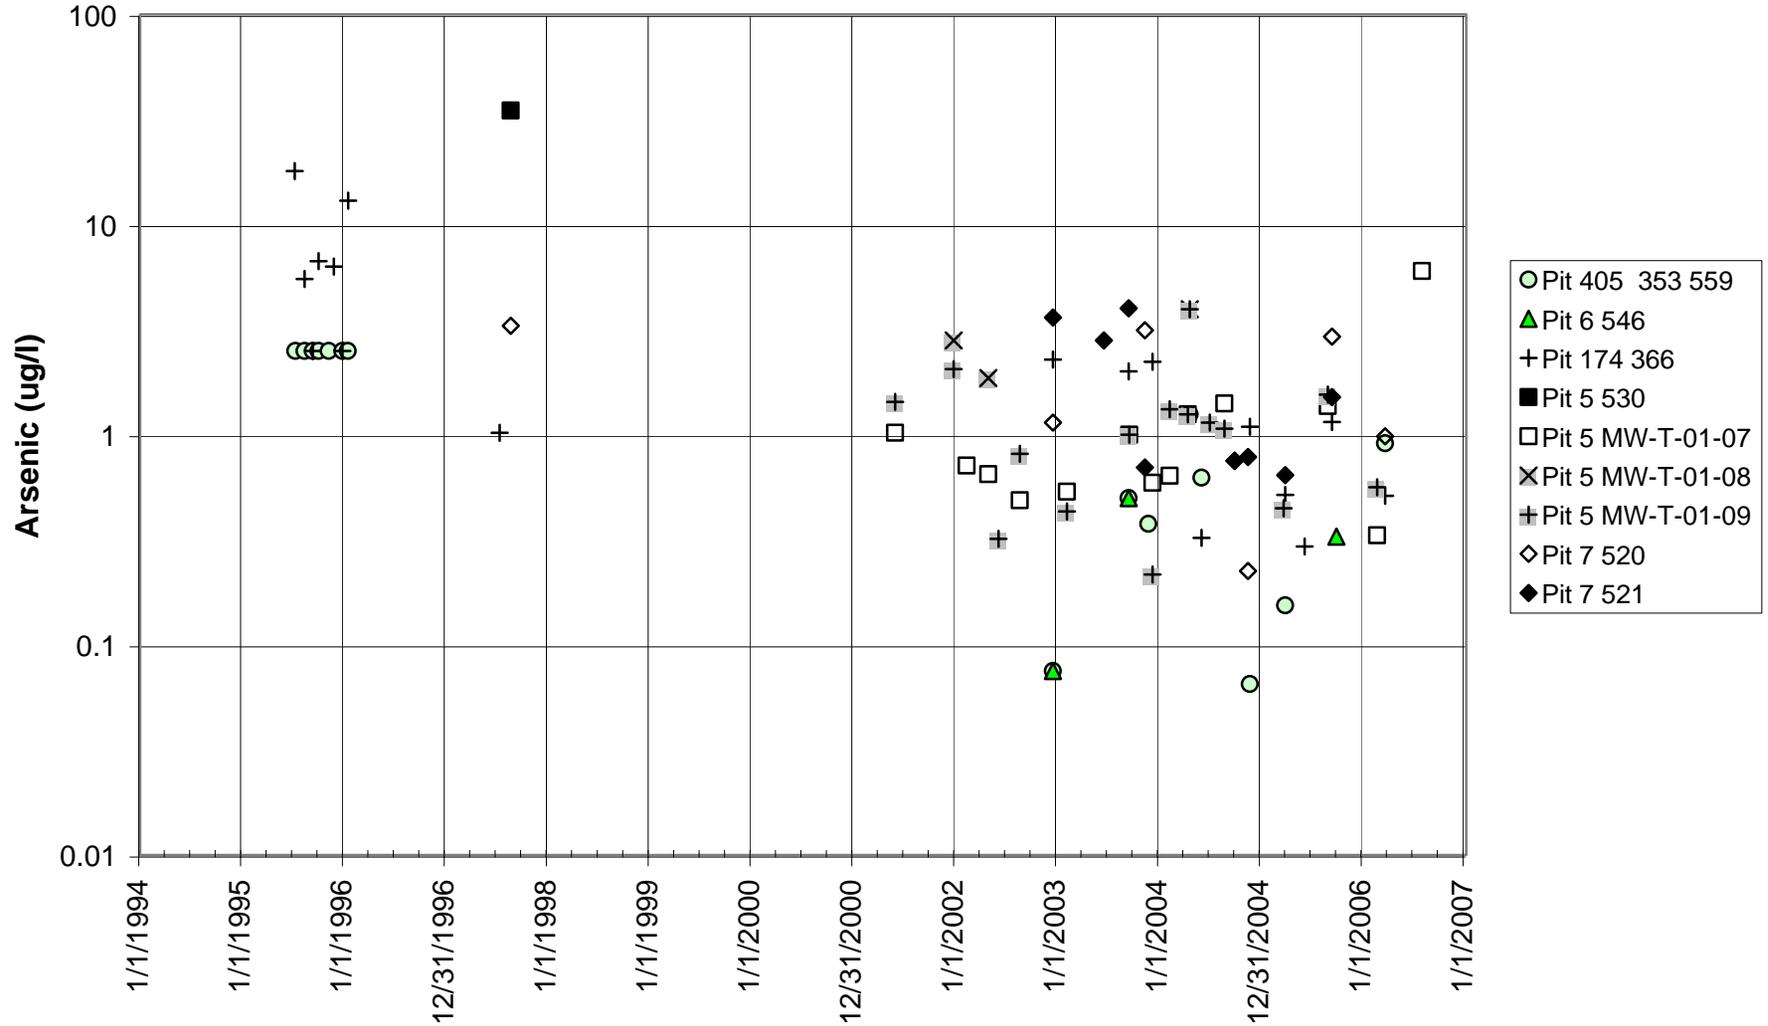
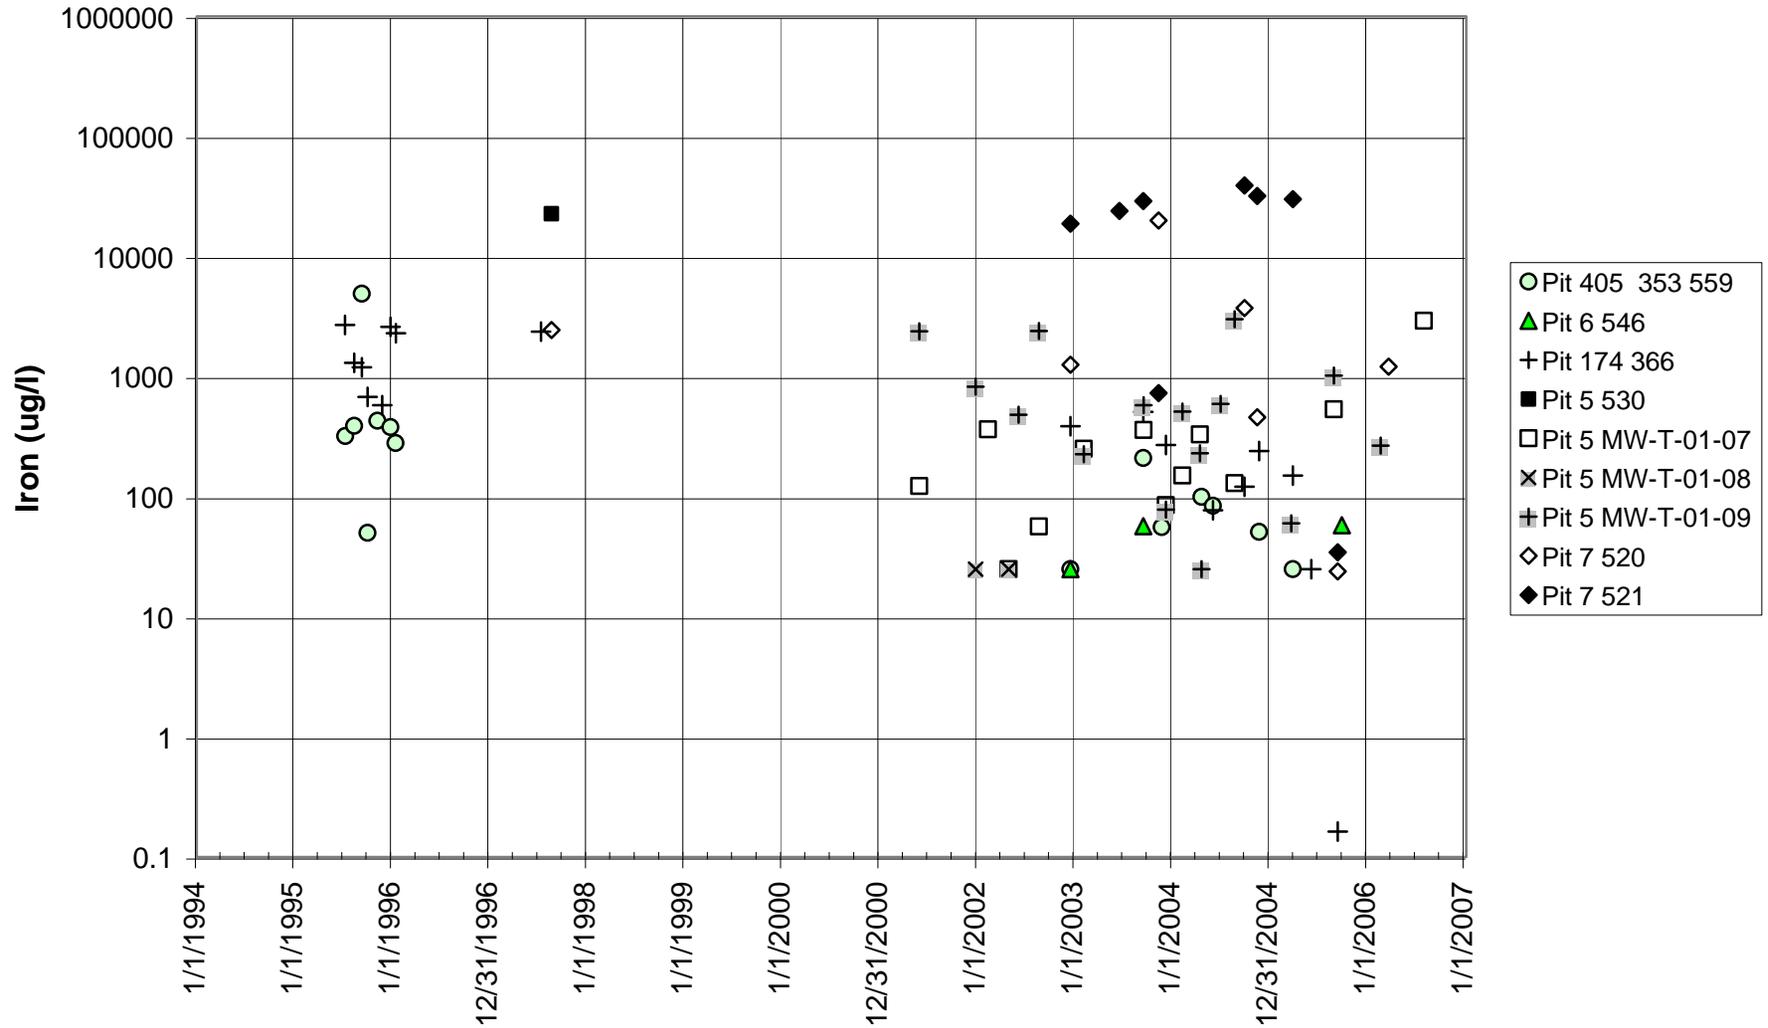
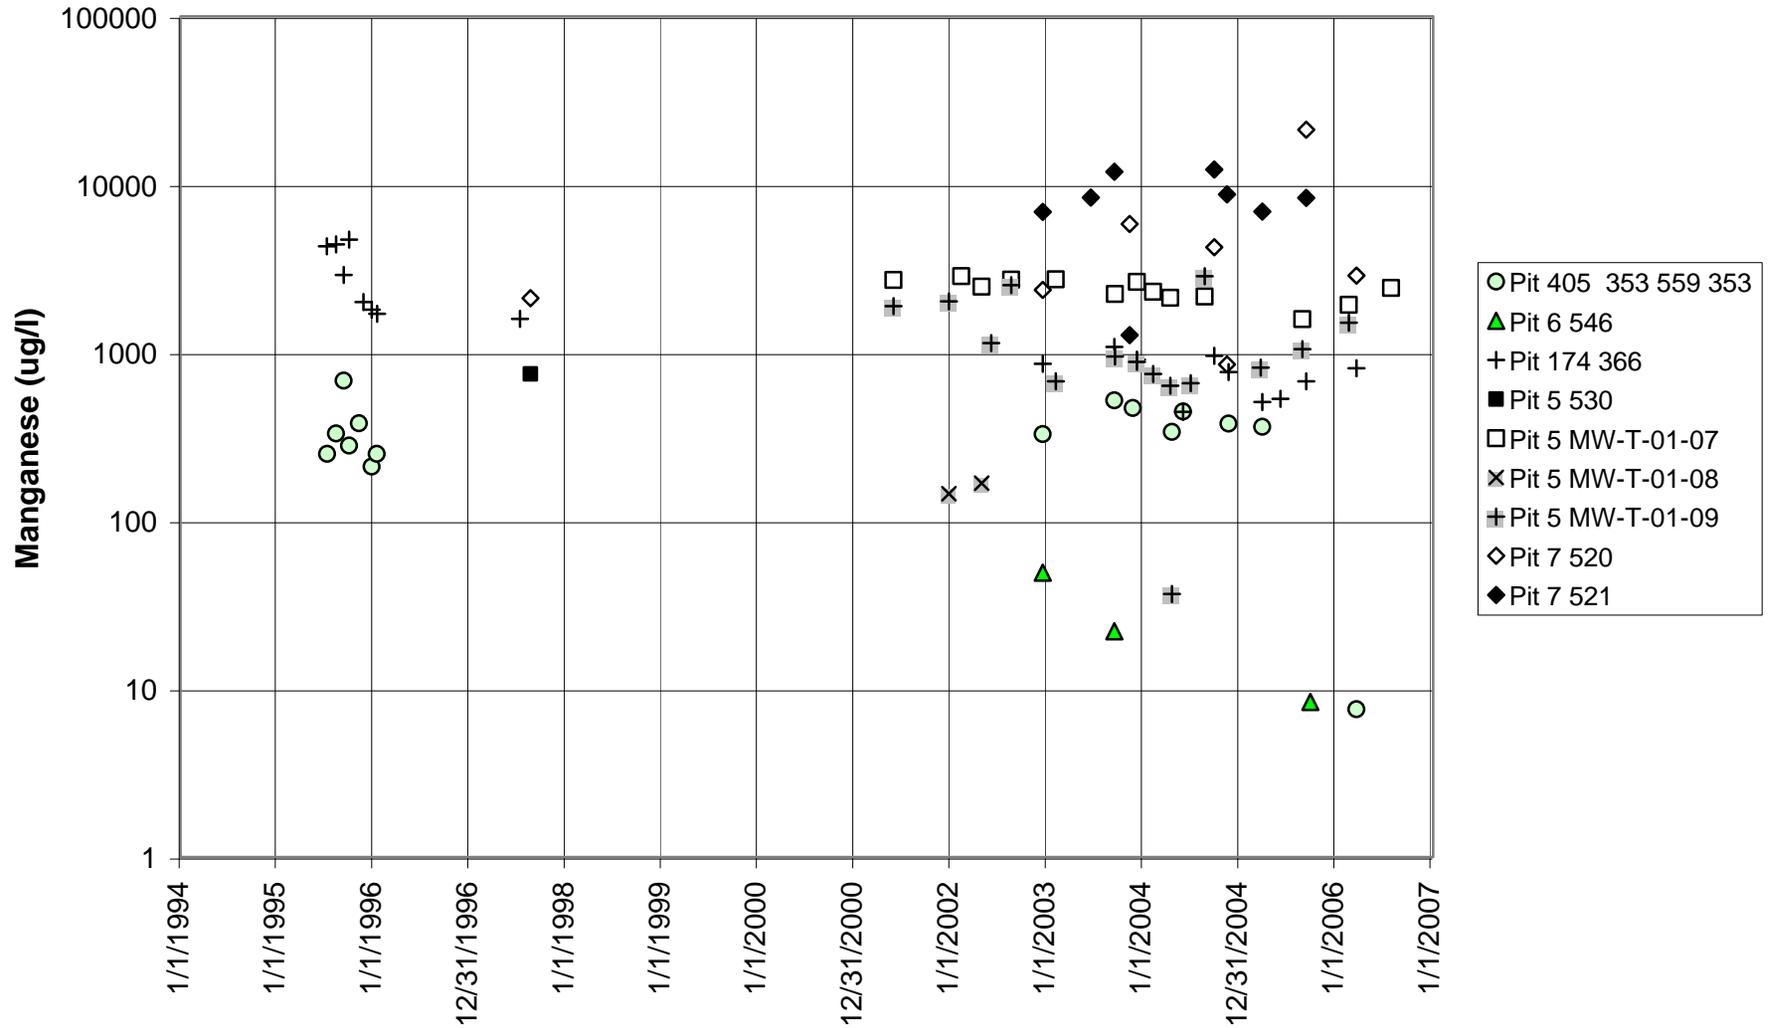
The data for zinc, copper, lead, cadmium, nickel, arsenic, iron and manganese are presented in Figures 3.8 to 3.15. Sample results that were less than the detection limit are plotted at one half the limit value. While this allows the results to be plotted on a logarithmic scale, it causes non-detect results with high detection levels to appear more concentrated than they actually are. Detection limits have varied with time and are often evident on the graphs as horizontal groupings of symbols. The results for metals generally correlate with conductivity values. Zinc and manganese concentrations reflect the higher solubility of these elements relative to the others at the near-neutral pH conditions. Metal loads from quarry sites have been consistently relatively low and either remained fairly constant or decreased with time. The decrease in metal loading is attributed to a reduction of reactive surface as reactants are consumed and coatings form on mineral surfaces.
