**INACTIVE PRODUCTION ROCK SITES AND QUARRIES  
2009 ANNUAL REPORT**

**Hecla Greens Creek Mining Company**

**April 15, 2010**

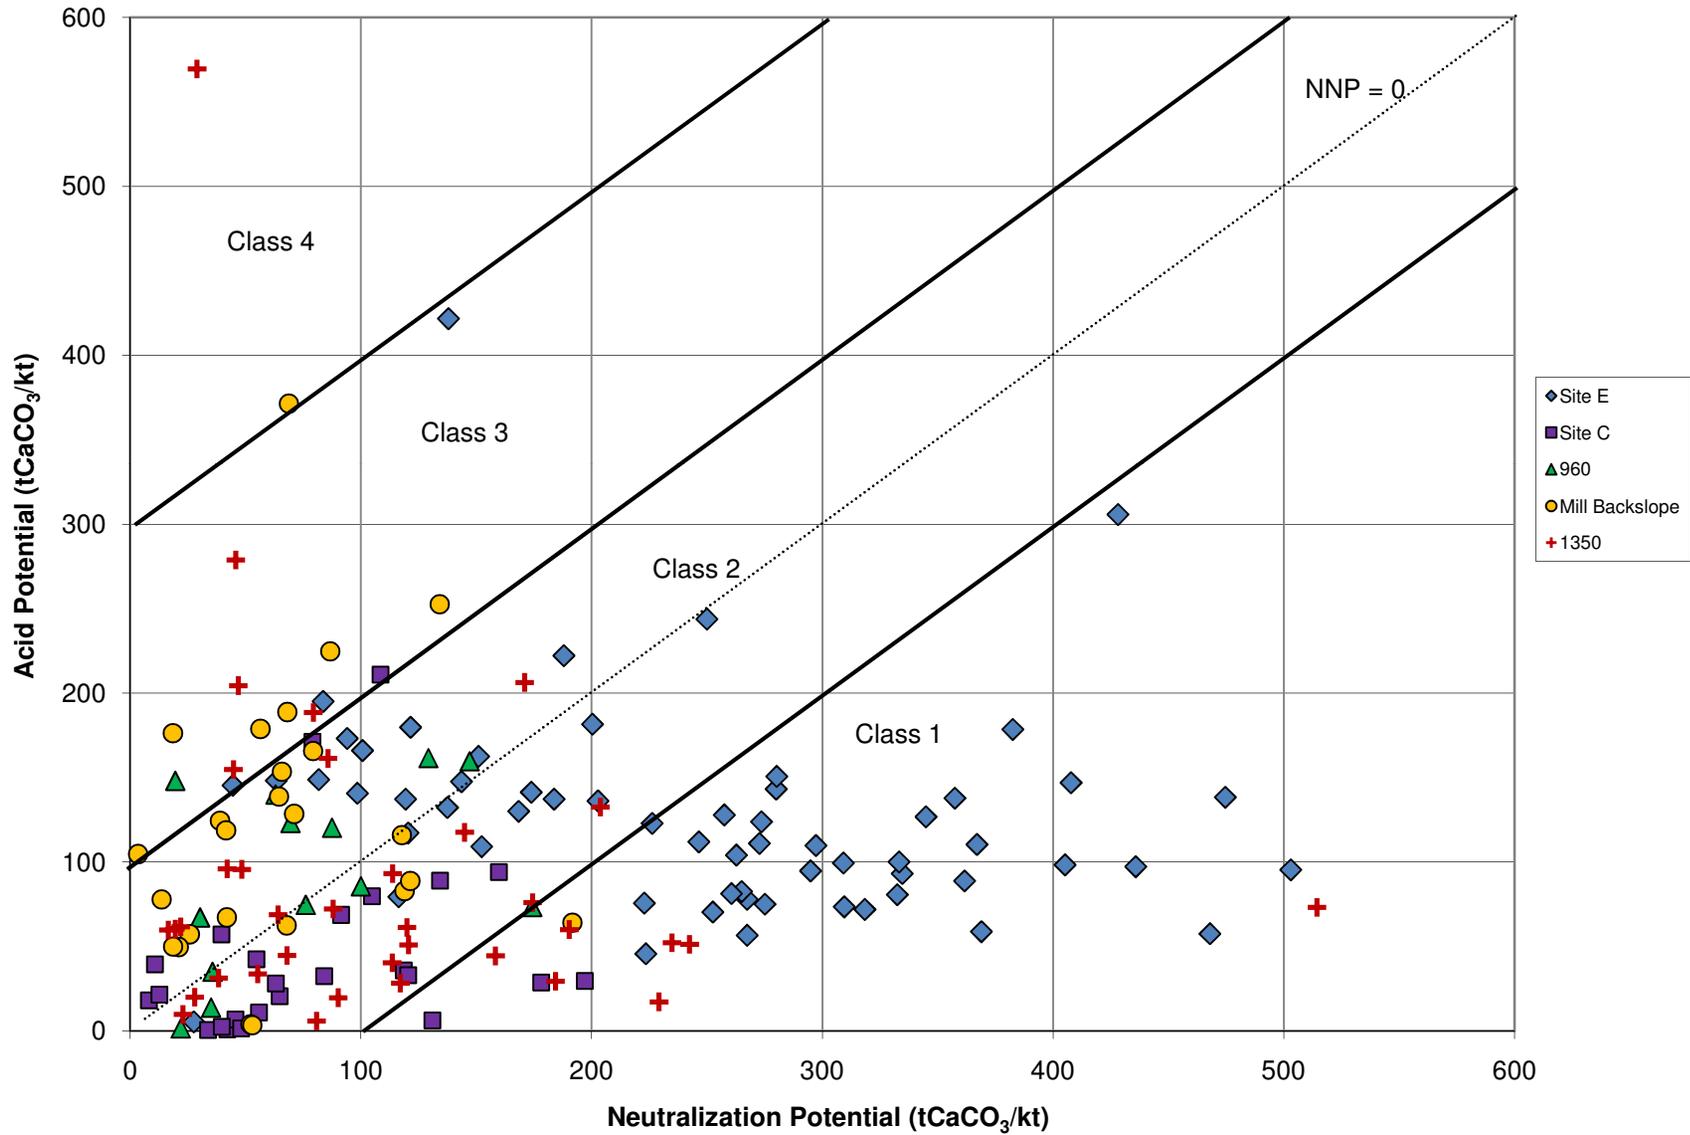
FIGURE 2.3a 2002-2008 INACTIVE SITE ABA DATA

Figure 2.3a compares acid potential (AP) with neutralization potential (NP) for 2002 to 2008 surface grid samples for the inactive sites. The inactive sites were constructed prior to development of the classification protocol that HGCMC currently uses. At the time the inactive piles were constructed HGCMC did not classify or segregate its production rock. Symbols in

Figure 2.3a represent actual laboratory data points. Lines indicating the currently utilized production rock classes are shown on Figure 2.3a for reference only. Figure 2.3a shows the distribution of potentially acid generating (upper left half of figure) and potentially acid neutralizing (lower right half of figure) samples. Many samples from Site E have more neutralization potential than those from other sites, reflecting a greater proportion of argillite. Samples from the mill backslope and the 1350 site generally have a higher acid generation potential than those from the other sites. Reclamation activities at the 960, 1350 and Site E have removed significant quantities of potentially acid generating material from these sites.

Grid sampling of the Mill Backslope rock cover and access road (Figures 2.3a and 2.3b) indicate that this rock is acid generating, and shows the higher sulfide content and low carbonate content in the rock. The low carbonate content is likely a combination of deficient initial composition and depletion of carbonate from the fines fraction through weathering.

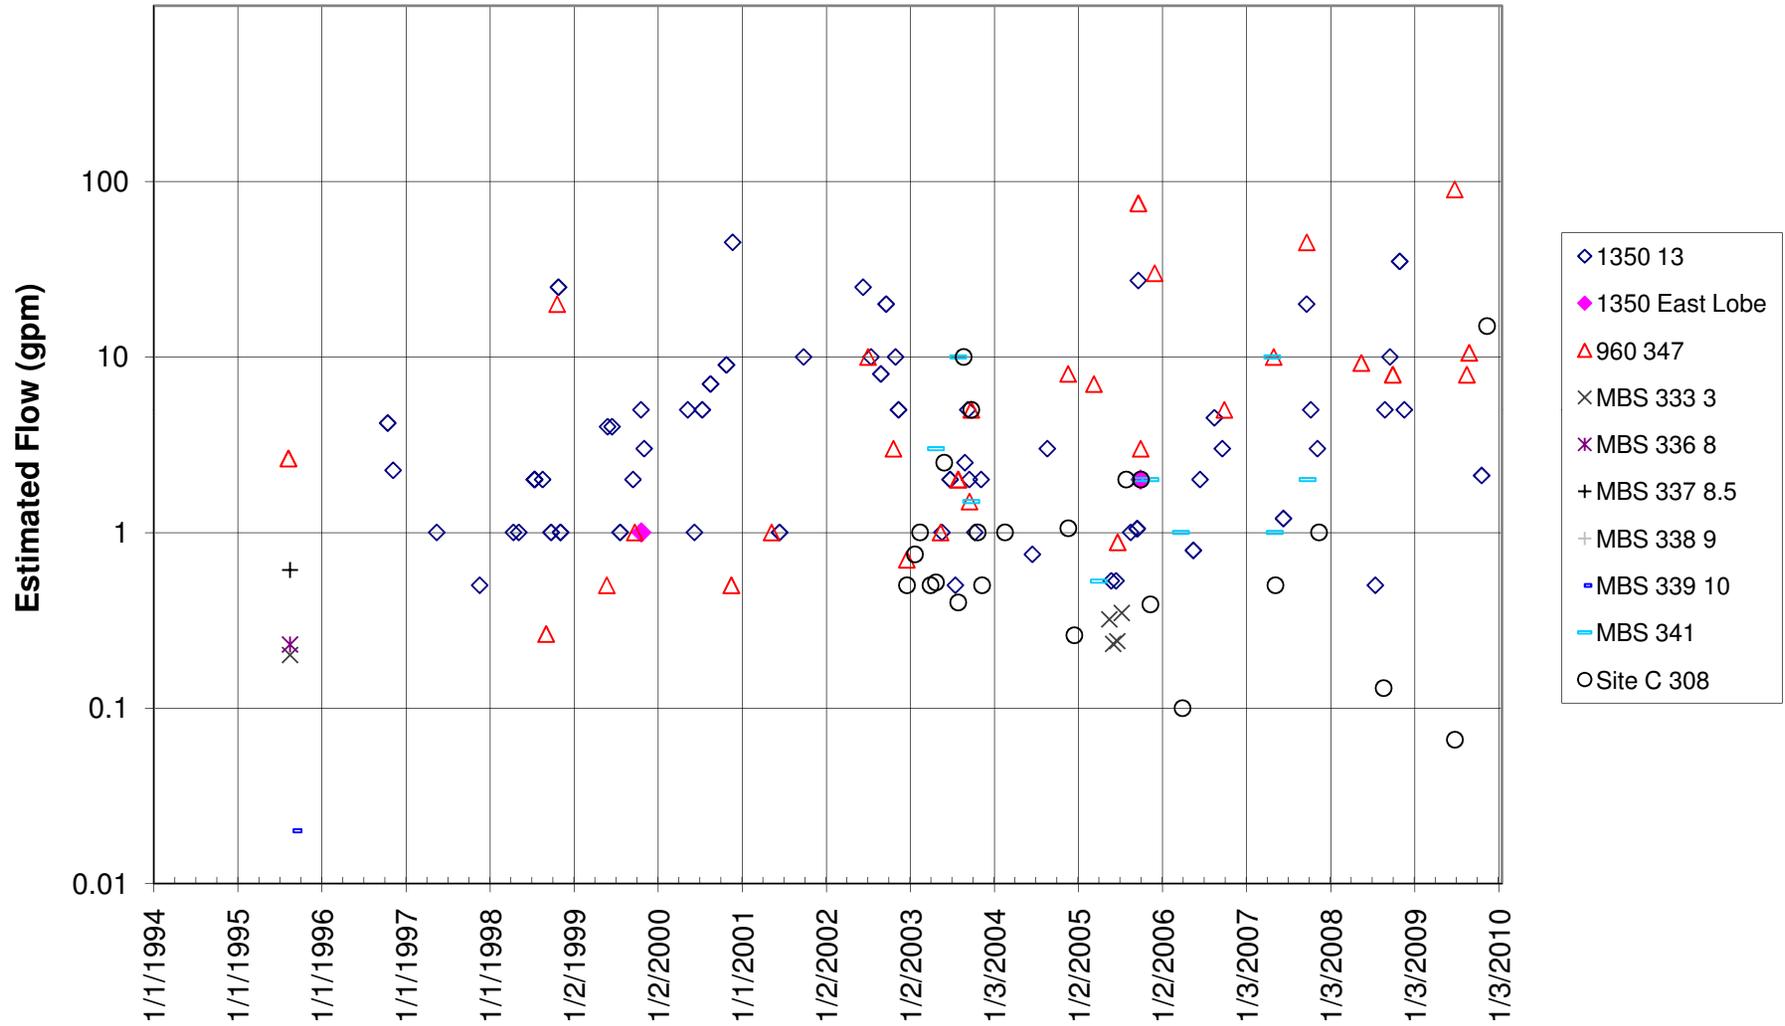
Figure 2.5 Inactive Production Rock Site Flow Data

Flow data presented in Figures 2.5 and 2.20 demonstrate that flows at most of the sample locations are generally low (less than 10 gpm) with the exception of Site E. Some of the flow data were collected as part of the NPDES stormwater monitoring program. Collected during or following storm events, flow data from these locations (e.g. Site E 356, 960 347) represent short-term maximum flow values in response to relatively large precipitation events. Lack of significant flow from inactive sites is a positive characteristic because it reflects minimization of potential off-site impacts.

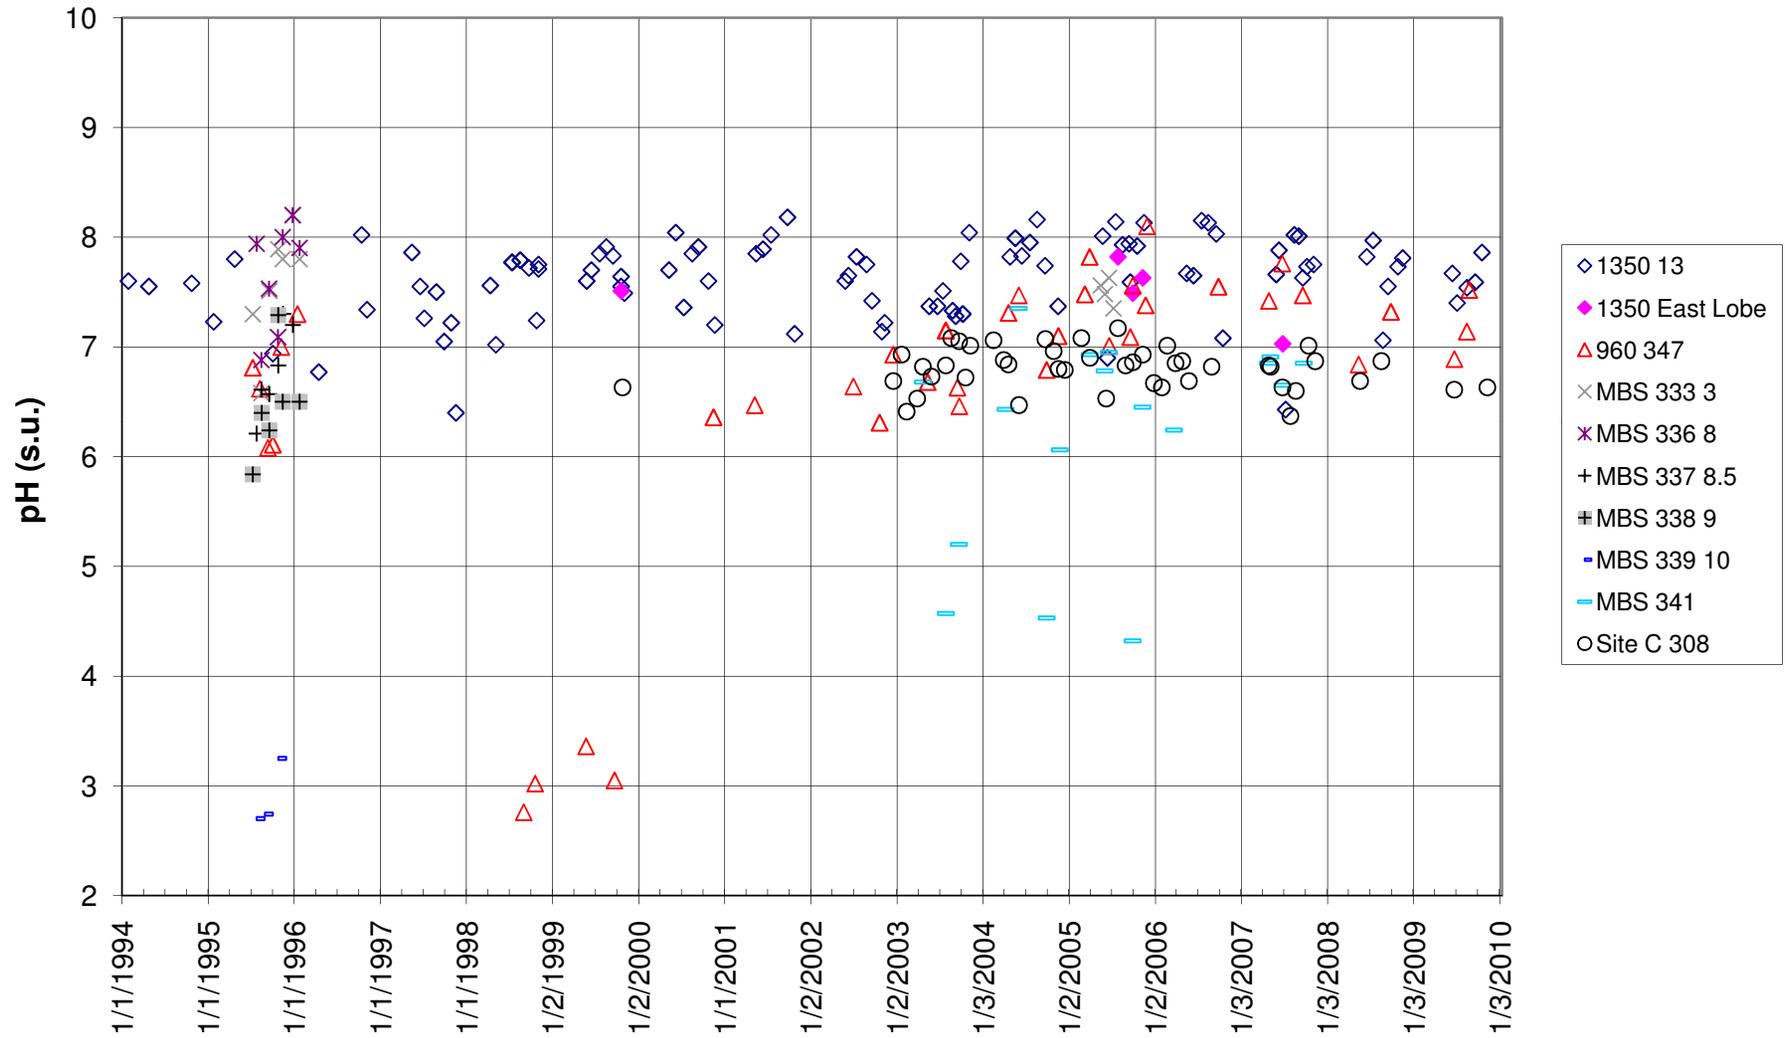
Figure 2.6 Inactive Production Rock Site pH Data

Figures 2.6 and 2.21 show pH data from inactive site sampling locations. Lower pH values can represent influences from pyrite oxidation and/or organic acids from muskeg and forest soils. The data show that the vast majority of the site drainage remains above pH 6.0. The sample from the Mill Backslope in 1995 was runoff collected from a bench containing zones of heavily pyritized rock. For a brief period in 1998 and 1999, acidic conditions began developing at the 960 (site 347). HGCMC applied lime and removed 1000 cubic yards of oxidized pyritic rock from the site in 2000. The pH of the drainage quickly rebounded and has remained near-neutral since 2000. Removal of additional Site 960 material in 2003, 2004 and 2005 is discussed below in Section 2.3. The material removal activities may also be responsible for the pH of 8.0 measured at the 960 site in 2005. This is the highest recorded for this site. The reason for the elevated pH is likely due to the removal of pyritic rock that had consumed much of its readily available buffering capacity. Fresh carbonate mineral surfaces exposed during the excavation and the placement of the toe buttress may have contributed to the higher pH values observed. Alkalinity data presented in Figures 2.7 and 2.22 are consistent with the pH results in Figures 2.6 and 2.21. Sample locations continued to maintain measurable alkalinity provided by dissolution of carbonate minerals.

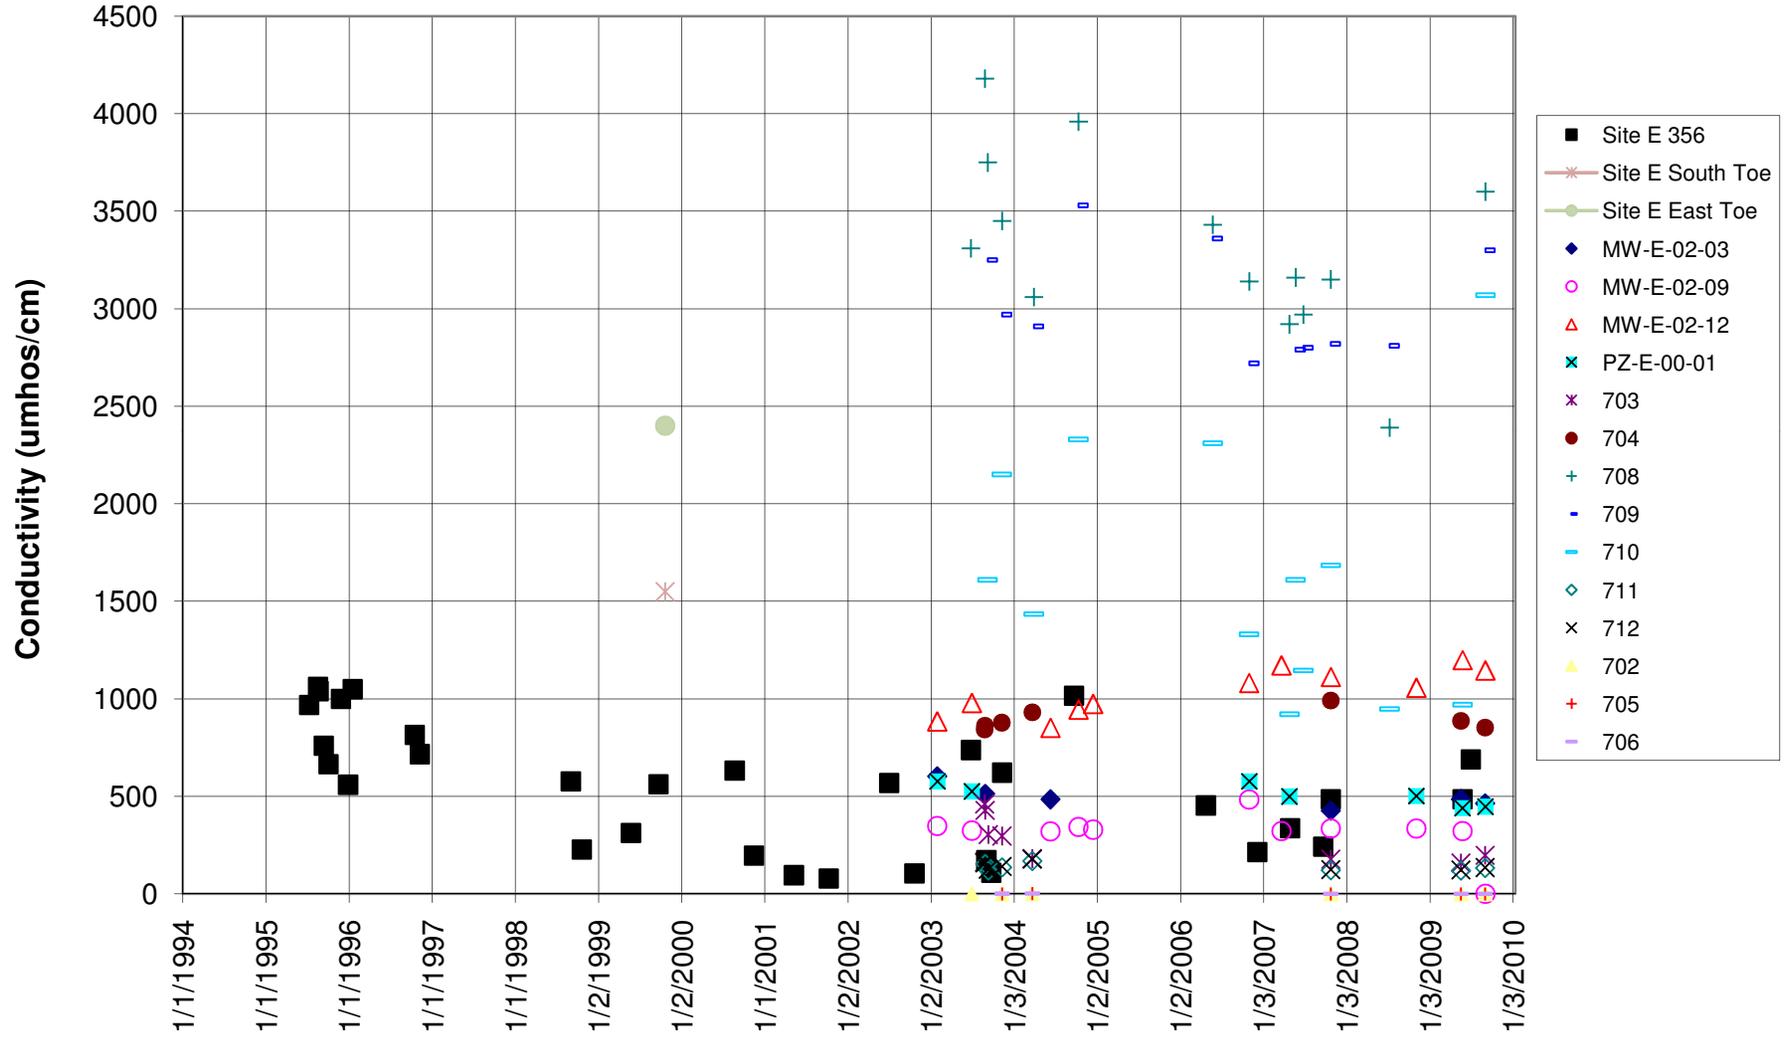
Figure 2.23 Inactive Production Rock Site E Conductivity Data

Conductivity data are shown in Figures 2.8 and 2.23. Conductivity indicates the amount of dissolved constituents in the water. HGCMC samples having higher conductivity values usually have higher sulfate, calcium and magnesium (hardness) concentrations, reflecting influences from sulfide oxidation and carbonate mineral dissolution. Water that has contacted production rock is expected to have higher conductivity values than background waters. The 960 (Site 347) shows an overall decreasing trend in conductivity, while the Site 1350 data remains unchanged. The combined drainage from the Mill Backslope area (Site 341) showed a lower average for the

dissolved load in 2007. The decreasing trends apparent in Figures 2.8 and 2.23 are the result of decreasing reactive surface area available for oxidation and dissolution. The reactive surface area decreases as reactants are consumed and mineral surfaces become coated with oxidation products. The results for sulfate, magnesium and hardness, shown in Figures 2.9 and 2.24, 2.10 and 2.25, and 2.11 and 2.26, respectively, correlate with conductivity results and are consistent with the concept of generally decreasing or static reactive surface area.

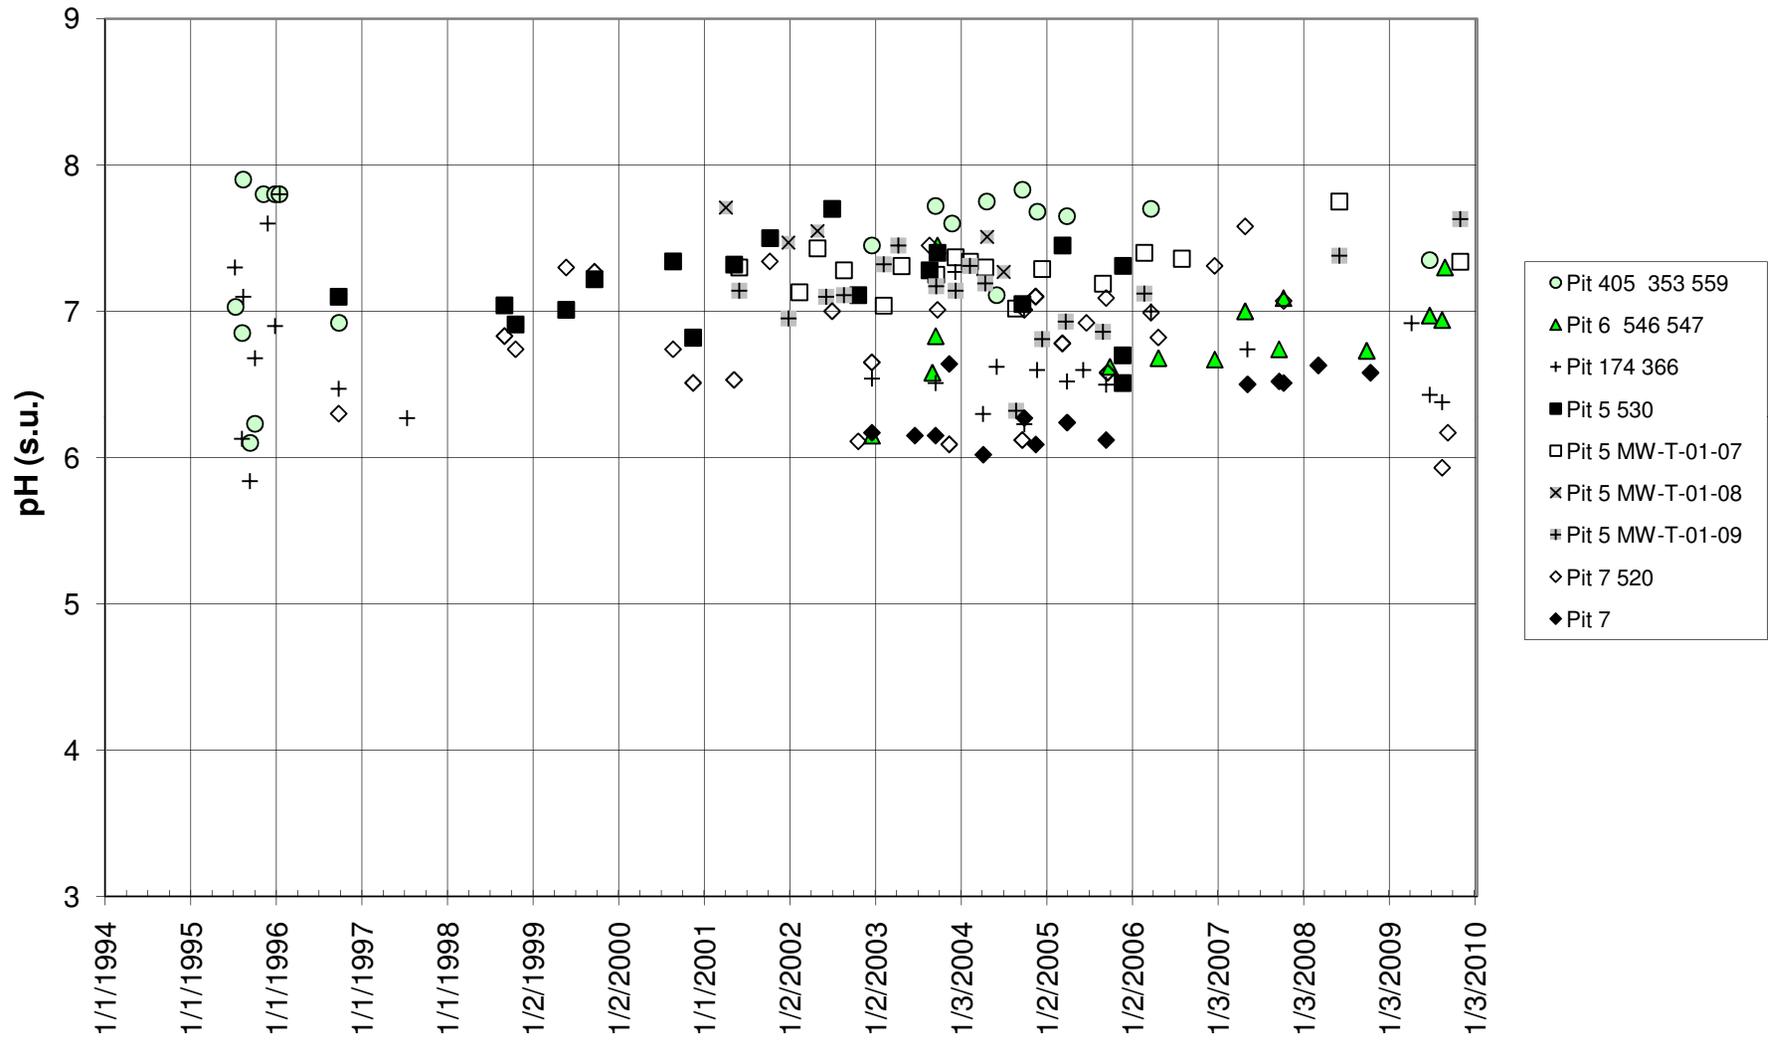
Figure 3.2 Quarry Site pH Data

Figure 3.2 shows pH data from the quarry site sampling locations. Since 1995 all but two of 180 samples have had a pH between 6.0 and 8.0. A pH of 5.8 was recorded from Pit 174; however,

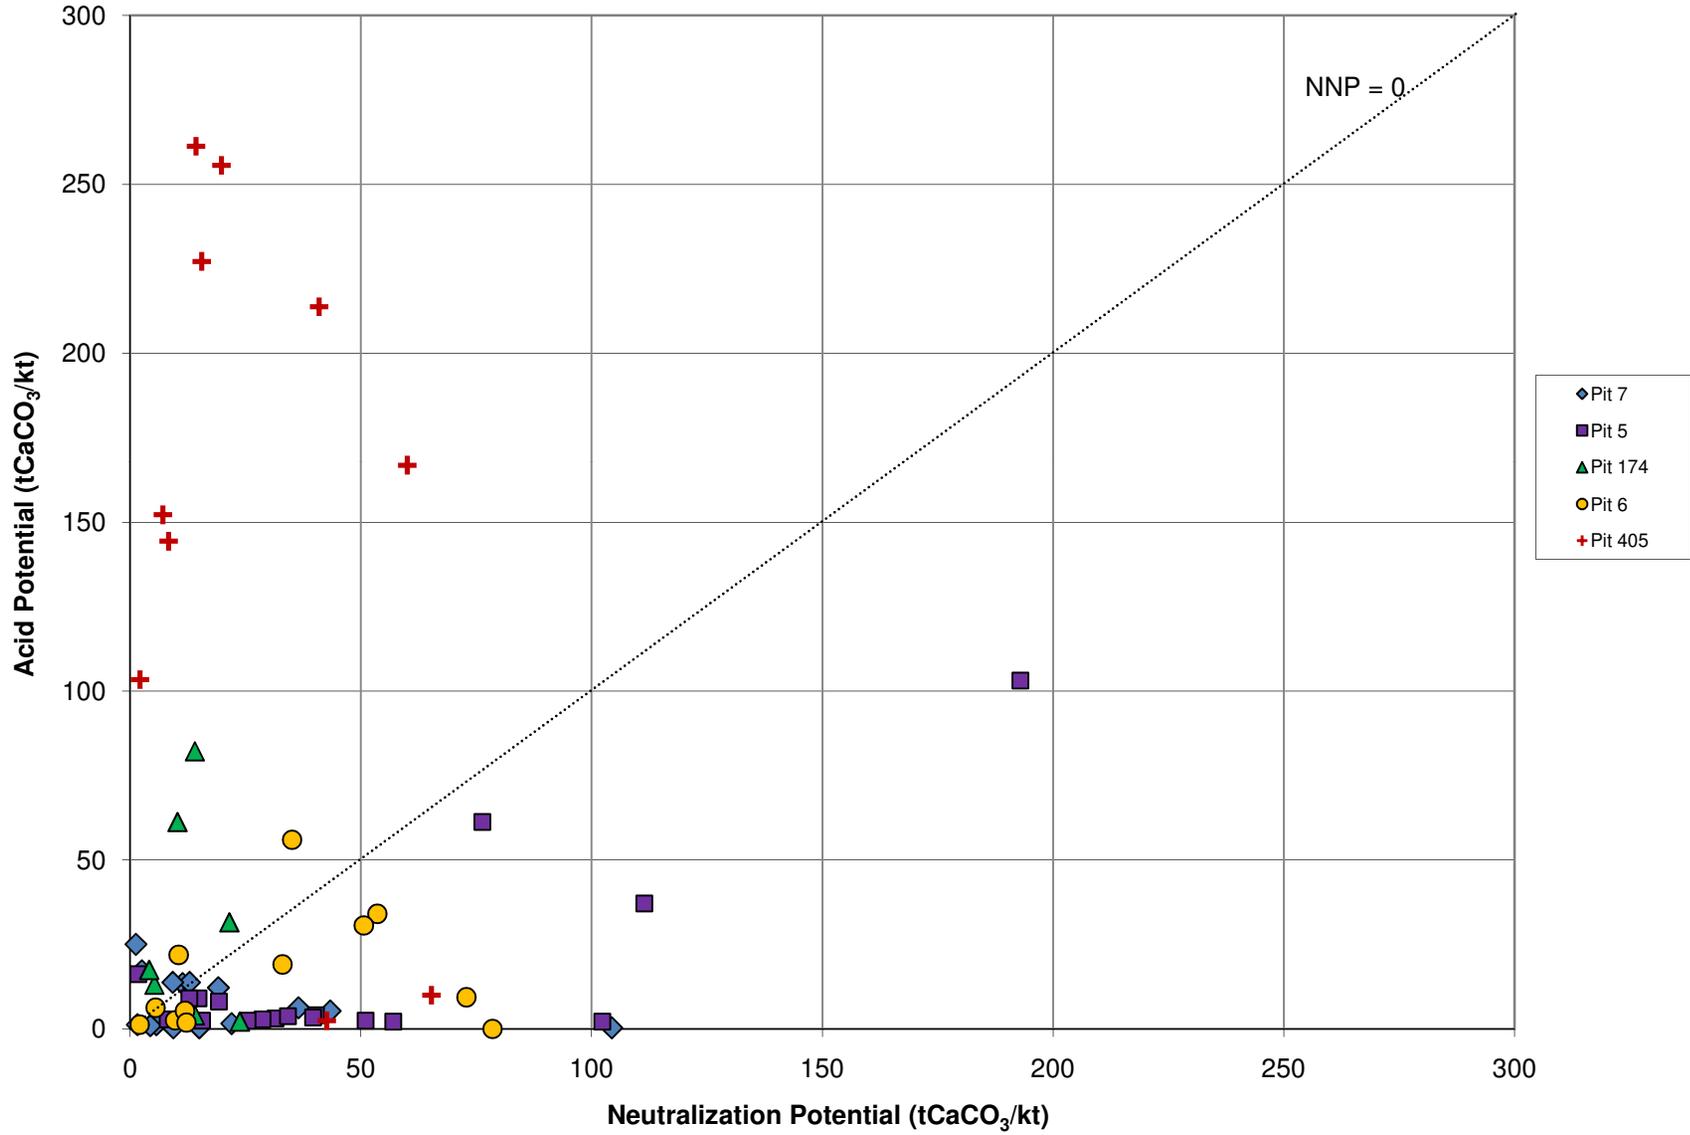
FIGURE 3.16a 2002-2008 QUARRY SITE ABA DATA

Acid Base Accounting data collected from 2002 to 2008 are summarized in Figures 3.16a and 3.16b. Pit 405 and Pit 174 have significant exposures of potentially acid generating rock and produced several samples with acidic rinse pH. Pit 6 and Pit 7 produced samples showing a broad distribution of NNP and rinse pH, and Pit 5 generally produced acid neutralizing samples with alkaline rinse pH. Buildup of oxidation products (salts) on overhanging quarry walls was noted at each of the five quarry sites and may have contributed to the lower rinse pH readings for several samples.
