**Mitigation Plan  
for  
Hecla Greens Creek Mining Company  
Greens Creek Mine Stage 3 Expansion**

**March 2014**

Ecological Land Services  
1157 3<sup>rd</sup> Avenue, Suite 220  
Longview, WA 98632  
(360) 578-1371

ELS Project Number 2039.01

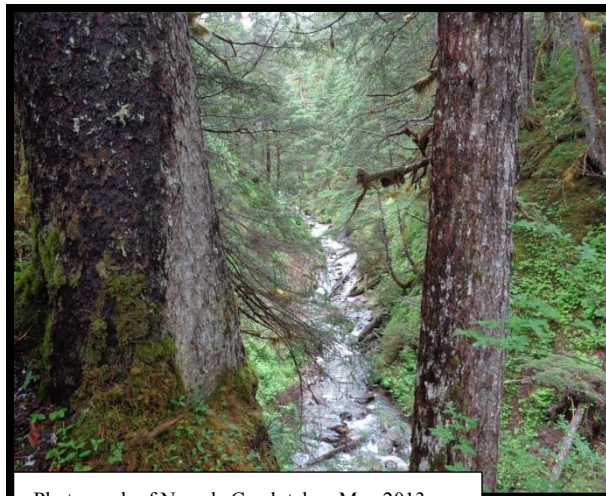
Photograph of Nevada Creek taken May 2013.

The proposed Nevada Creek Mitigation Site is located on southeast Douglas Island where metamorphosed slates, schists, and phyllites generally occur. The mitigation site is situated on a wide glaciomarine terrace with an eastern aspect that ranges in elevation from approximately 150- to 250-feet above Gastineau Channel before gently sloping down to sea-level at the channel's shore.

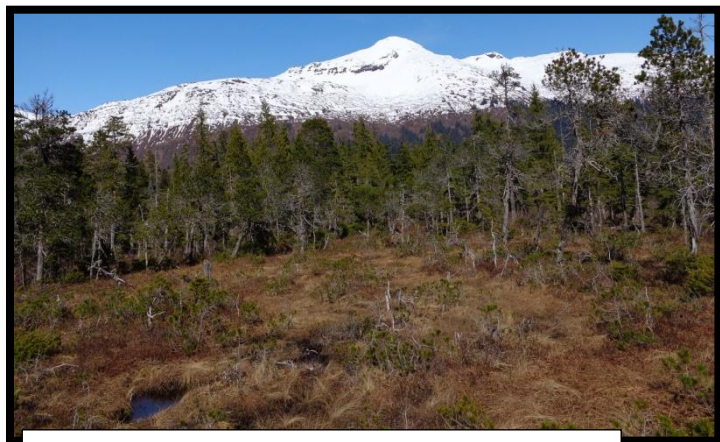
Photograph of Bog fringed by Bog Woodland taken May 2013.

National Wetlands Inventory (NWI) mapping generally captures the full extent of the Bog/Bog Woodland comprised of bogs with emergent and scrub-shrub Cowardin vegetation classes. However, the areas mapped by the NWI as PFO4B coincide with a

larger extent of scrub-shrub bog (PSS4B) as the area mapped as PFO4B is dominated by acid tolerant *Vaccinium* species and stunted trees that generally do not reach heights over 20 feet (Sheet 13; Appendix C).

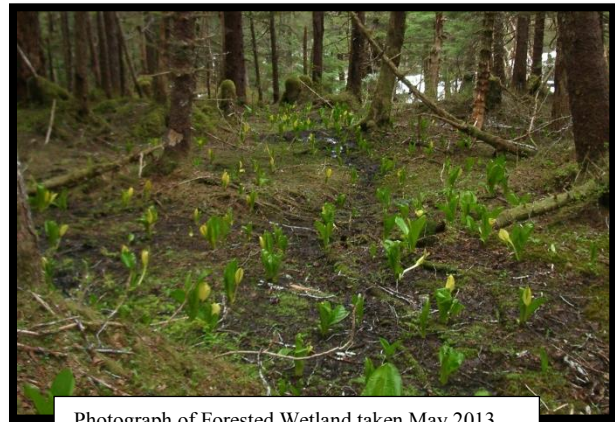
Photograph of Forested Wetland taken May 2013.

The Forested Wetlands are comprised of slope and toe-slope fen wetlands. National Wetlands Inventory (NWI) mapping generally captures the occurrence of the toe-slope fen wetlands. However, the NWI does not capture the forested slope wetlands that occur on the slopes above the wide glaciomarine terrace perched above Gastineau Channel (Sheet 13; Appendix C).

The Forested slope wetland community is comprised of the facultative species western hemlock (*Tsuga heterophylla*, FAC) dominant in the overstory, and Alaska blueberry (*Vaccinium alaskaense*, FAC) and the facultative upland species false azalea (*Menziesia ferruginea*, FACU) dominant in the sparse understory, and obligate wetland species such as American skunk cabbage (*Lysichiton americanus*, OBL) dominant within the herbaceous stratum (Appendix D). The Forested Wetland toe-slope fen community is comprised of facultative species such as red alder (*Alnus rubra*, FAC) dominant in the overstory, with lady fern (*Athyrium filix-femina*, NI) and skunk cabbage dominant in the herbaceous stratum.
