RE: 2002 Tailings and Production Rock Site 23/D Annual Report  
Alaska Waste Disposal Permit 0111-BA001

Attached please find two copies of the Kennecott Greens Creek Mining Company (KGCMC) 2002 Annual Report for the Tailings and Production Rock Site 23/D. This second KGCMC Annual Report is submitted in satisfaction of Sections 3.6.7, 4.1.2.4, and 6.2 of the above referenced KGCMC Waste Disposal Permit. Waste Disposal Permit 0111-BA001 was issued during this report year on 16 August 2002 to KGCMC by the Alaska Department of Environmental Conservation – Solid Waste Program, replacing the previous permit 9911-BA006.

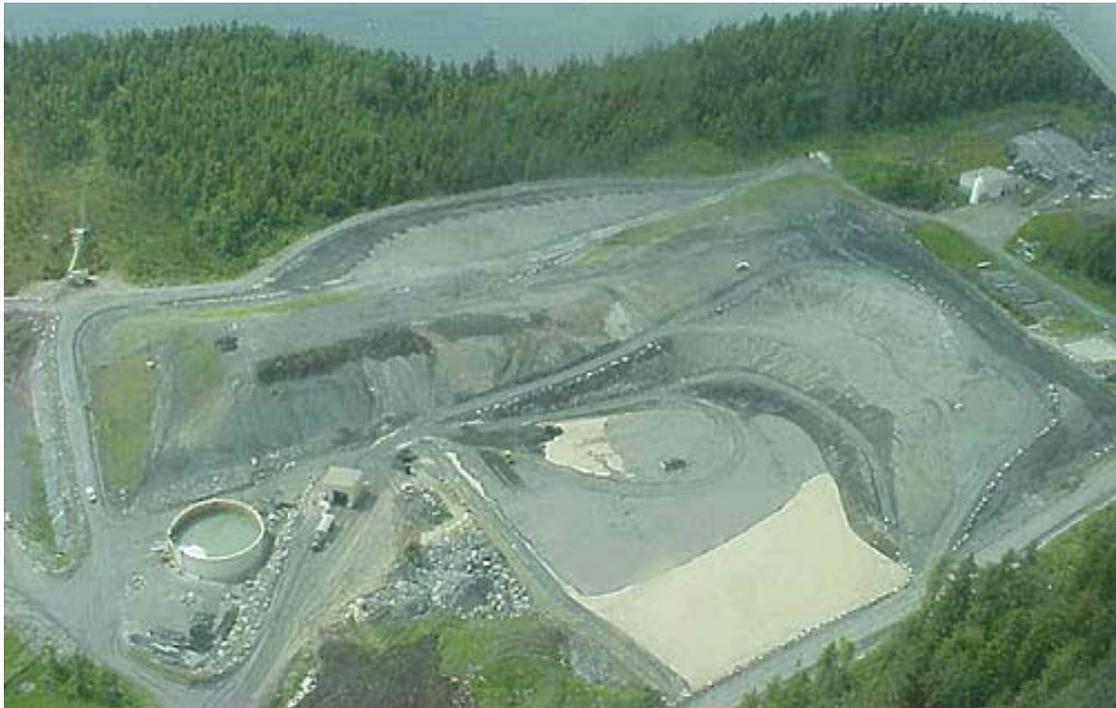
Figure 2.33 Aerial Photograph of Tailings Facility – June 2002

Aerial view of the Tailings Facility showing the new construction area SE Liner (light color area, east, middle bottom), West Buttress (west, top), Pit 5 water treatment facility (north, right), East Tailings placement area and B Road (east, bottom right), Tank 6 (bottom left, south), and NPDES outfall pipeline (upper left, west)

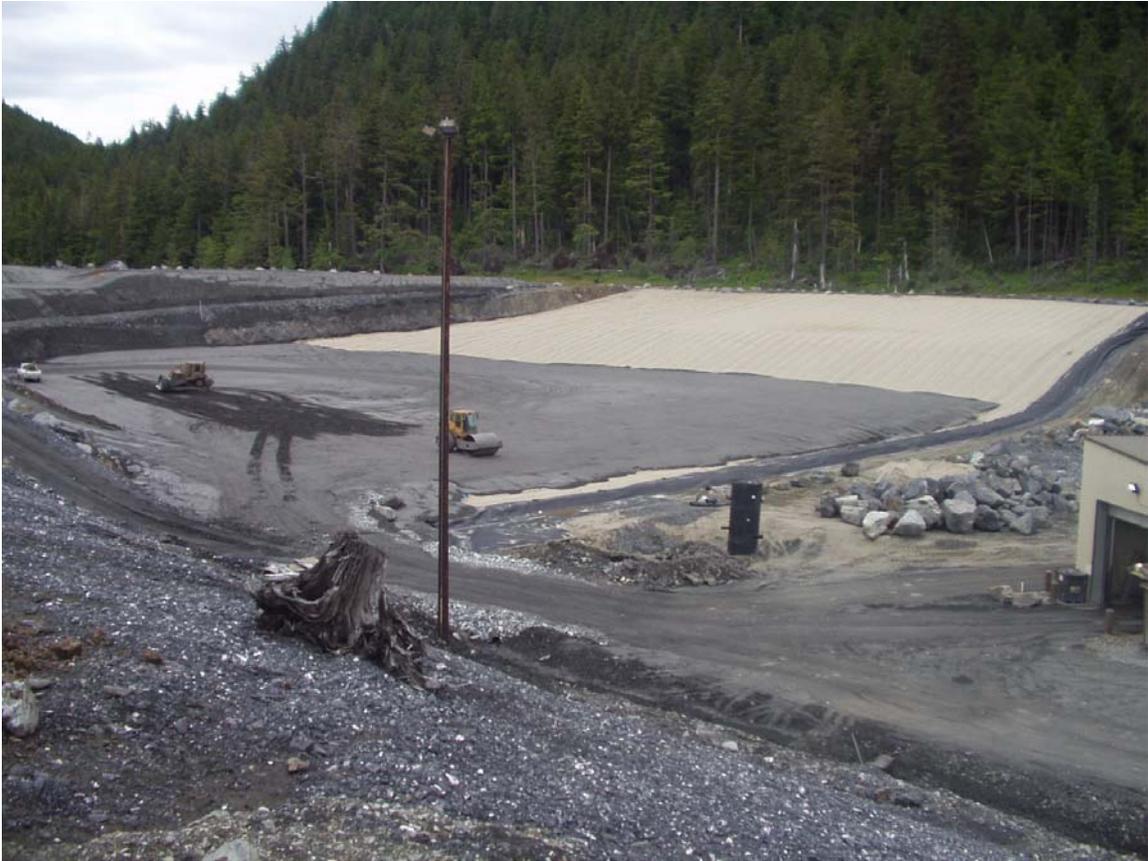
Figure 2.34 Photograph of Southeast Tailings Placement Area – July 2002

Initial tailings placement in the Southeast Liner Tailings placement area. Tailings are spread in thin lifts with a bulldozer (left) and compacted with a vibratory roller (middle). Ramps (center) provide access to the wheel wash located near Tank 6 (Figure 2.33).

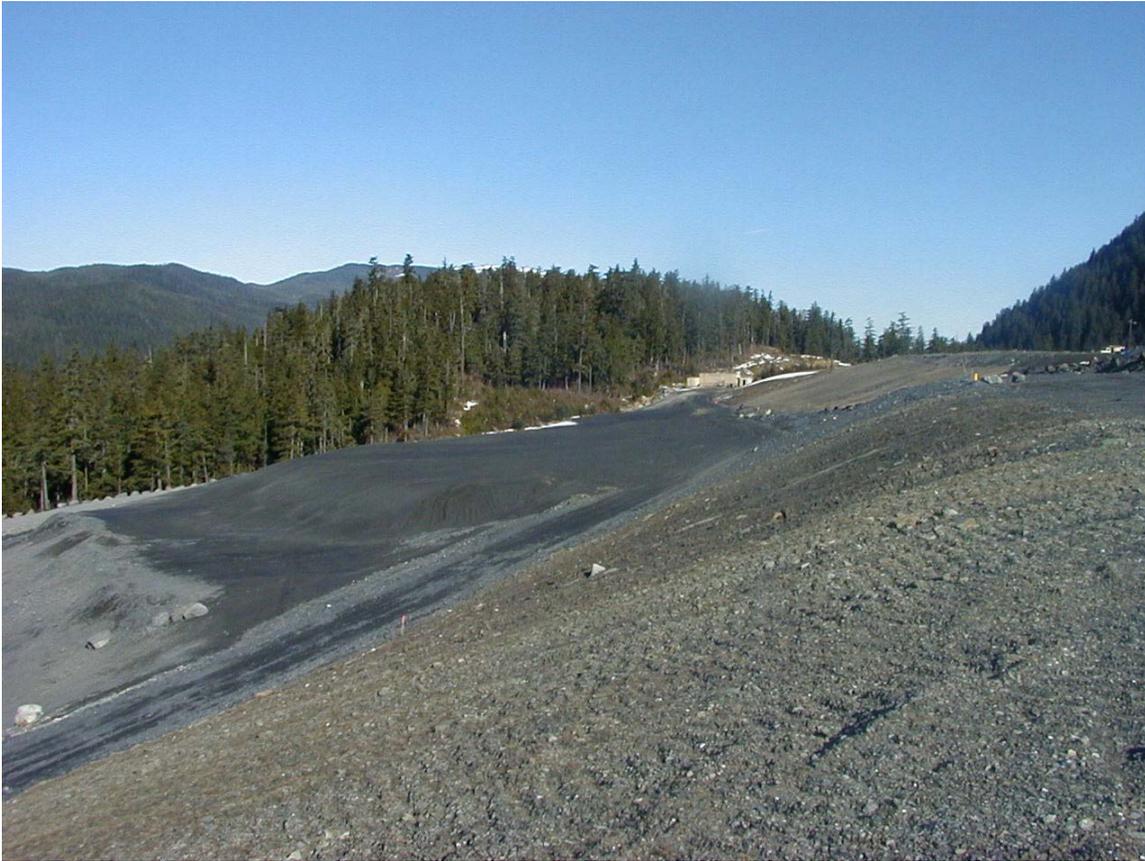
Figure 2.35 Photograph of West Buttress Tailings Placement Area - April 2002

This photograph is a view of the West Buttress placement looking north. Tailings are placed in cells and the 3H:1V outer slope is covered with Class 1 production rock or native materials to minimize erosion.

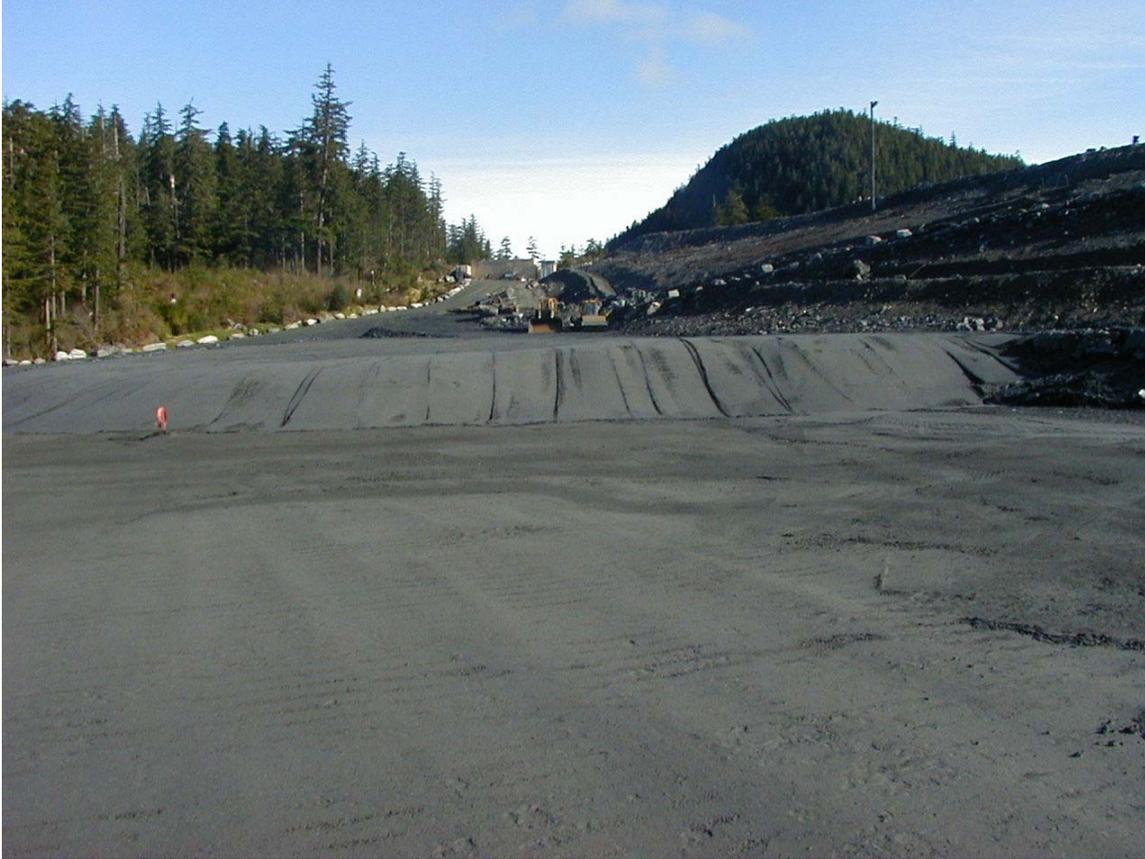
Figure 2.36 Photograph of Compacted West Buttress Tailings

View of compacted tailings in the West Buttress placement area. The tailings are spread and compacted in thin, inclined lifts in a cell that has an overall thickness of approximately five feet. This promotes drainage and dissipation of pore pressures that rise as the material is compacted. 12% of the overall placed tails for 2002 were put into West Buttress.

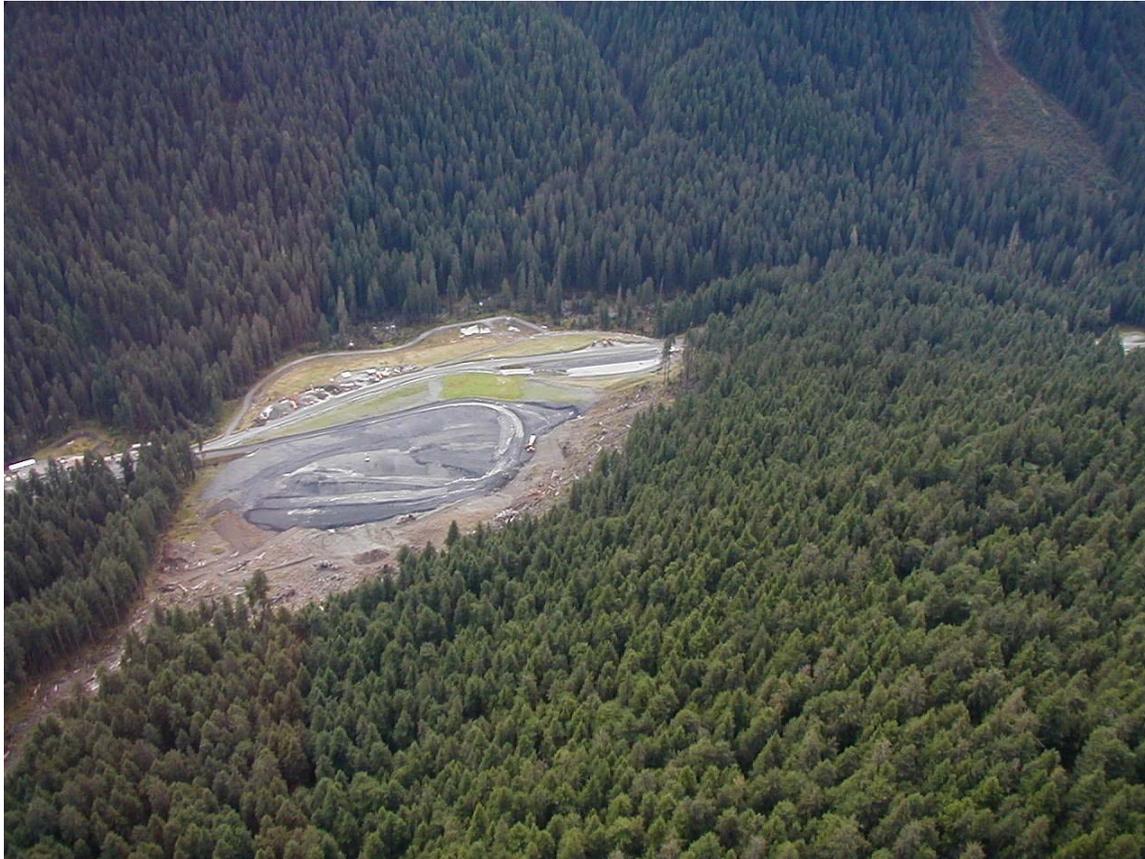
Figure 3.29 Aerial Photograph of Site 23/D

This photograph shows Site 23 (foreground) and Site D (separated from Site 23 by the B Road). The composite soil cover plot (green) is visible on the lower slope of Site 23. Pond 23 and Pond D are visible on the southwest (right) perimeters of their respective sites. Reclamation materials have been removed from the slope above Site 23 (below tree line, foreground).

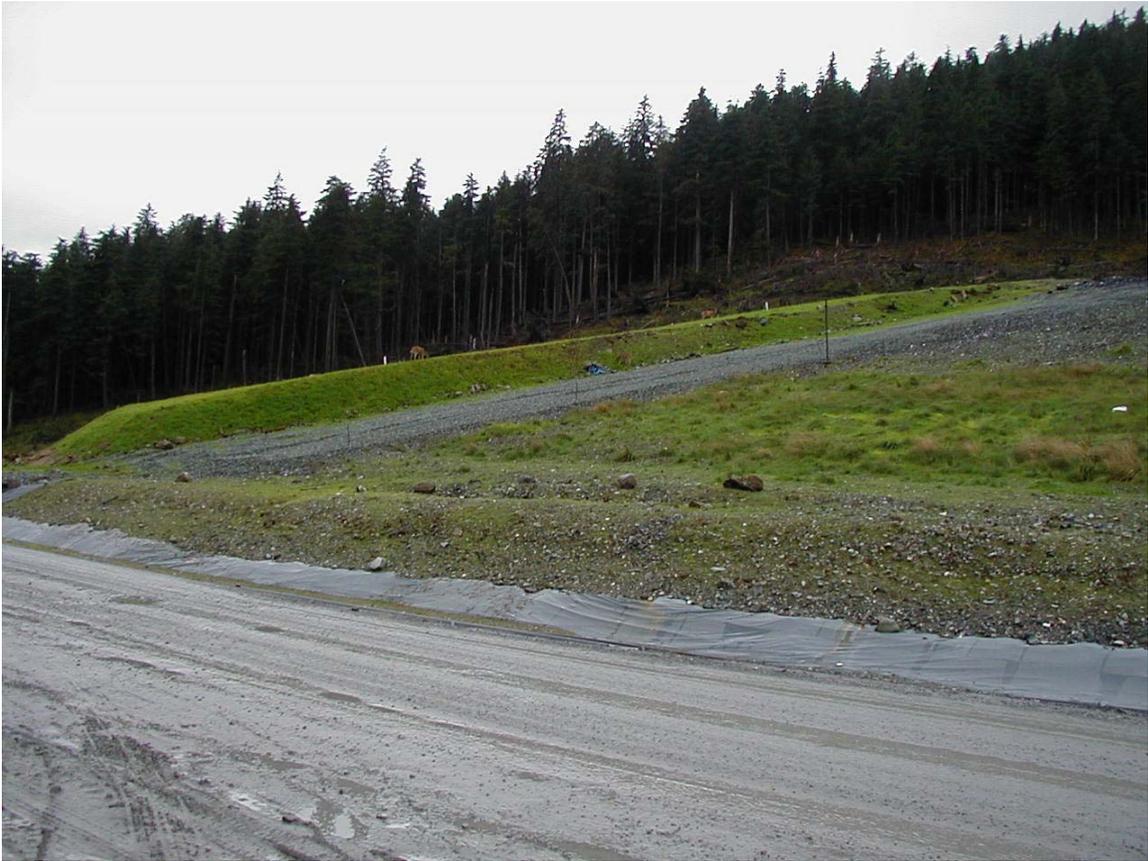
Figure 3.30 Photograph of Site 23 Composite Soil Cover Plot

The photograph shows the recently seeded composite soil cover placed on the lower slope of Site 23. A portion of the lower capillary break is visible below the seeded growth layer. The B Road and lined ditch that brings surface waters to Pond 23 are visible in the foreground.

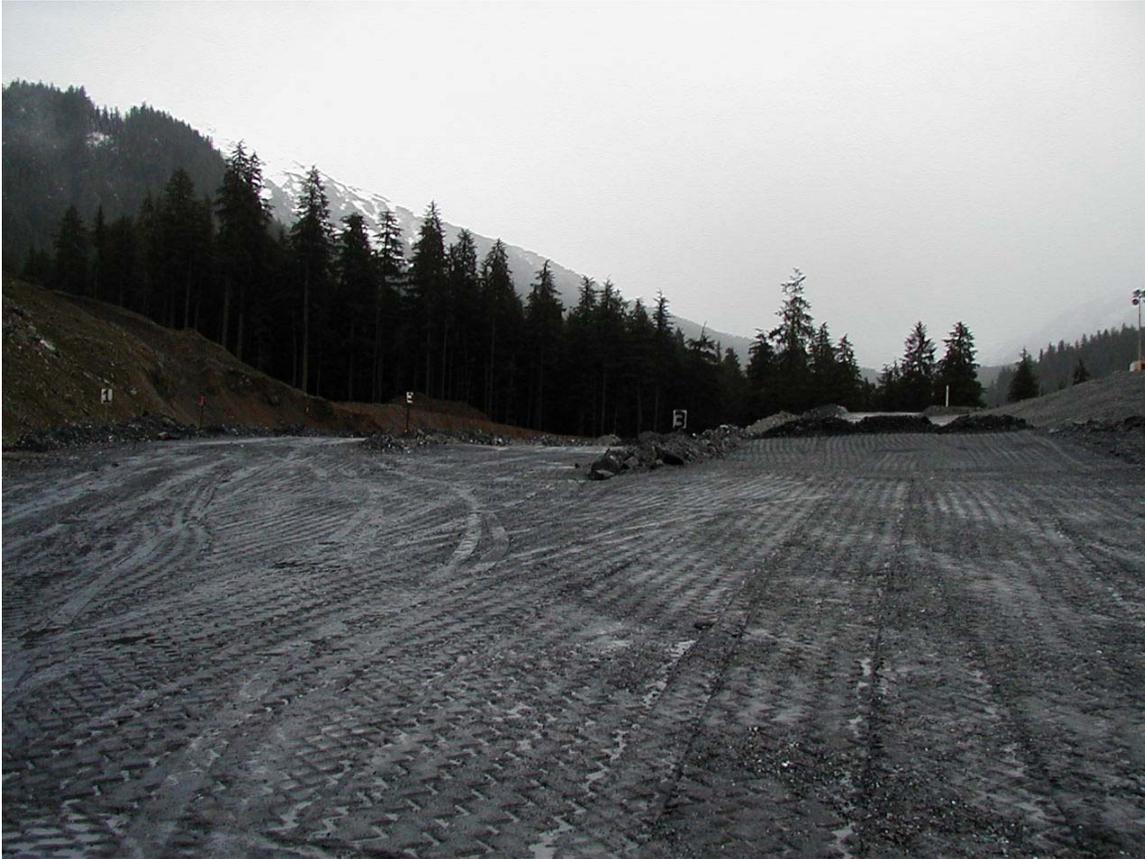
Figure 3.31 Photograph of Site 23 Designated Placement Zones

The photograph shows the designated placement zones (Class 1, left; Class 2, center; Class 3, right). Marks from the grid roller are visible on the recently spread and compacted production rock surface. The view is looking east.

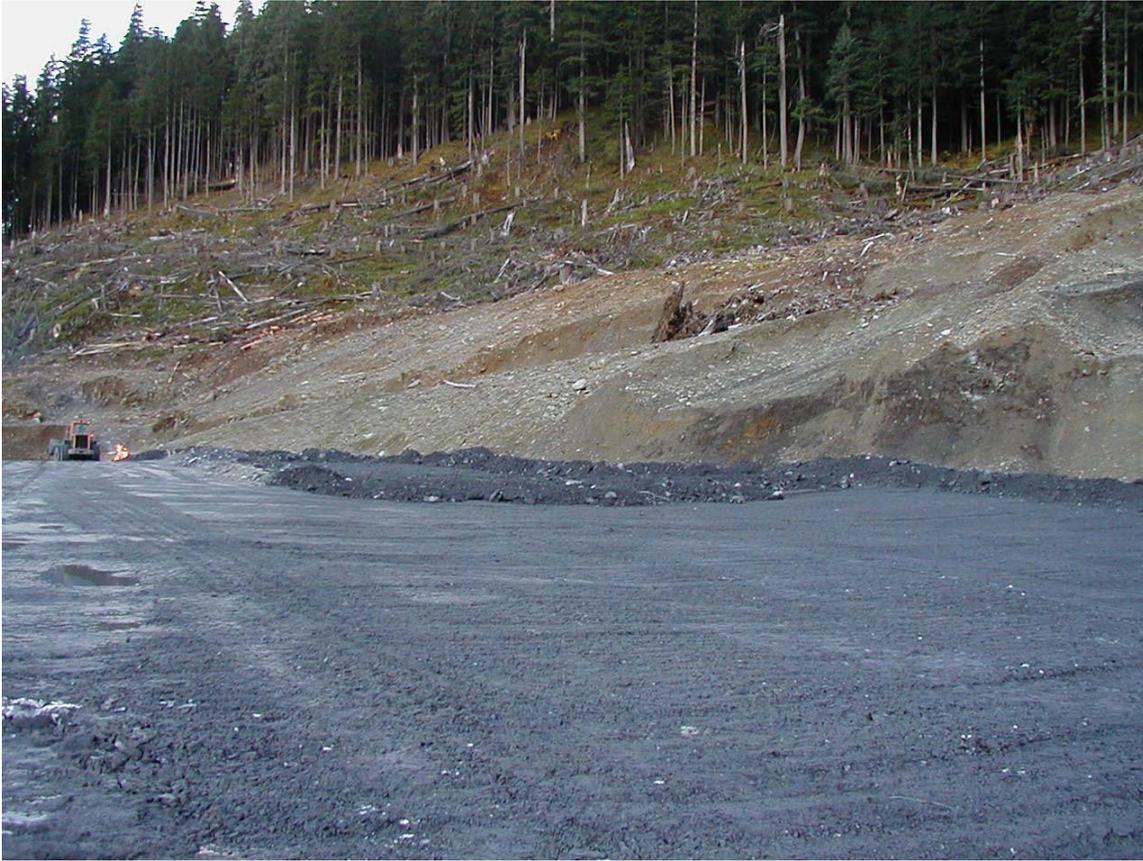
Figure 3.32 Photograph of Site 23 Foundation Preparation

This photograph shows construction of the pile base. Native rock and sediments are removed from the back slope and stockpiled for use in future reclamation projects. Continuation of finger drains (not visible) extend over the prepared surface and a five-foot thickness of Class 1 production rock is placed prior to placement of other classes.

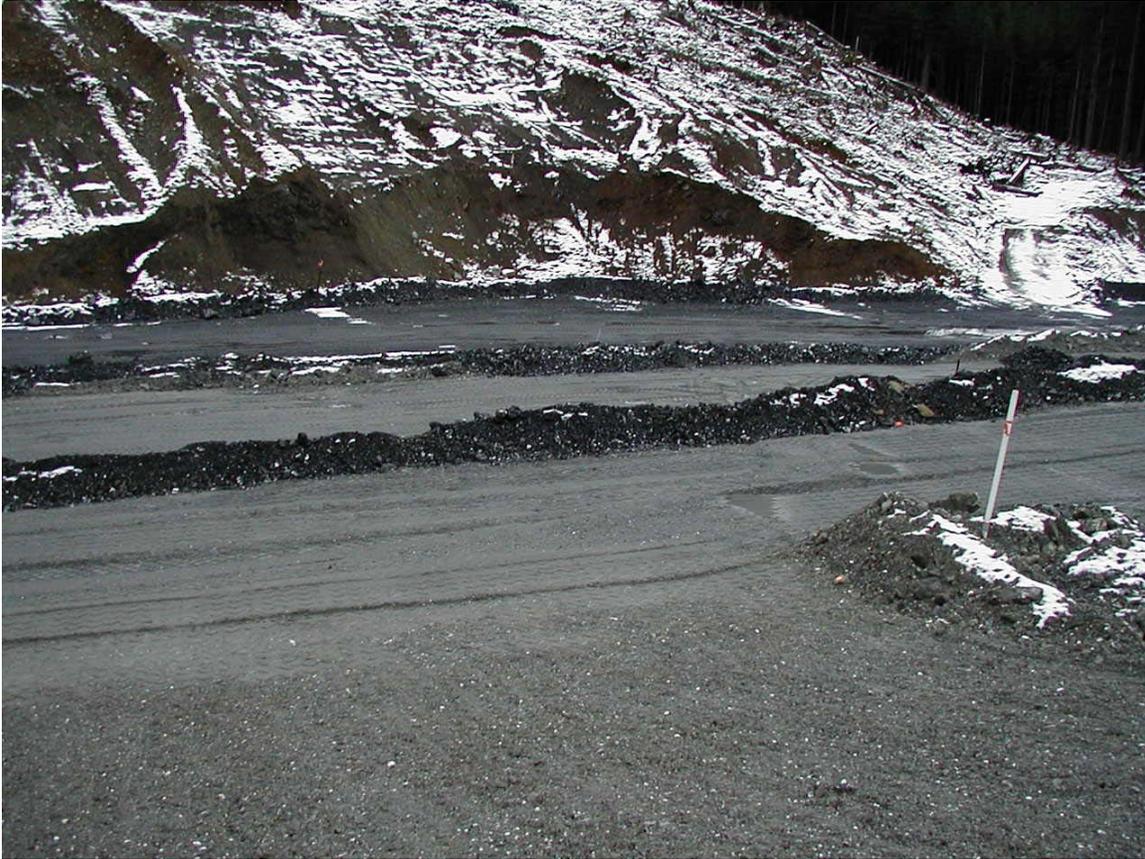
Figure 3.33 Photograph of Site 23 Backslope and Designated Placement Zones

The three designated placement zones are visible in the lower half of the photograph. Class 3 in the foreground, Class 2 at center and Class 1 at base of backslope. Safety berms are left between the placement zones. Excavated material from the backslope (upper half of photo) will be used for site reclamation. Monitoring well MW-23-98-01 is visible in the foreground (right). The view is oriented north.
