# MEMORANDUM

State of Alaska  
Department of Fish and Game  
Habitat Section

SUBJECT: Johnson River Fish Survey

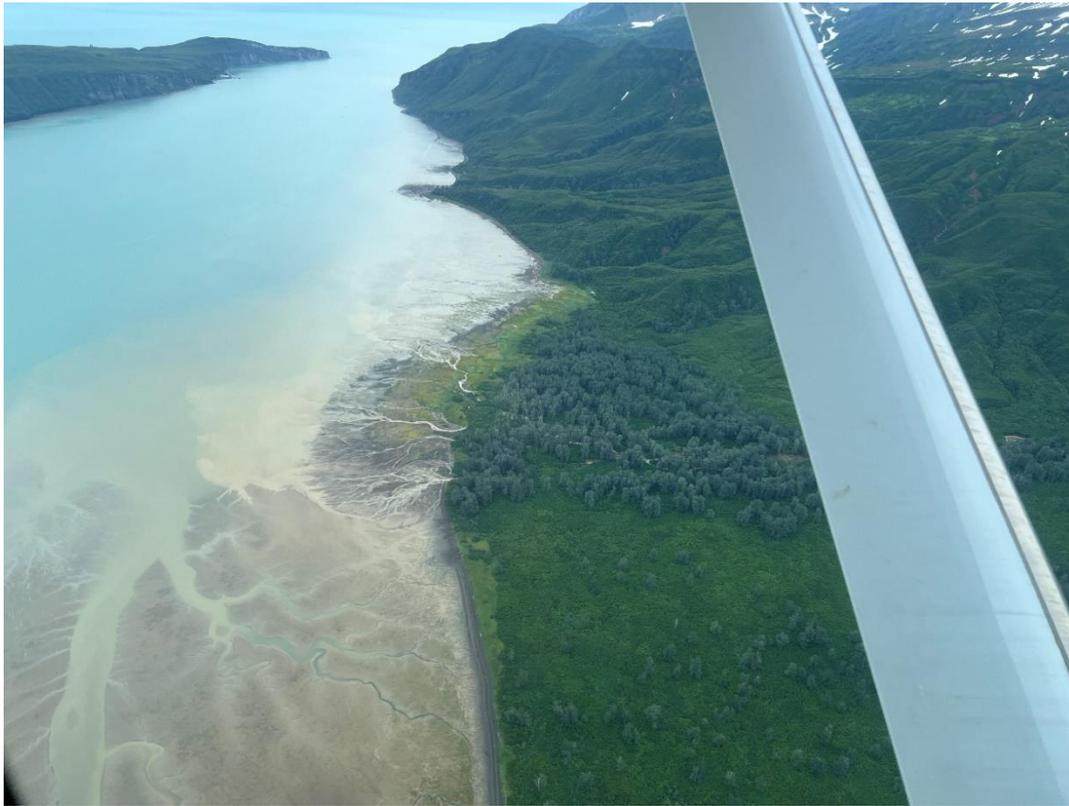
Photograph 1 – Mouth of Little Bear Creek (directly south of Bear Creek) and sediment plume in Tuxedni Channel from recent high water, August 12, 2024.

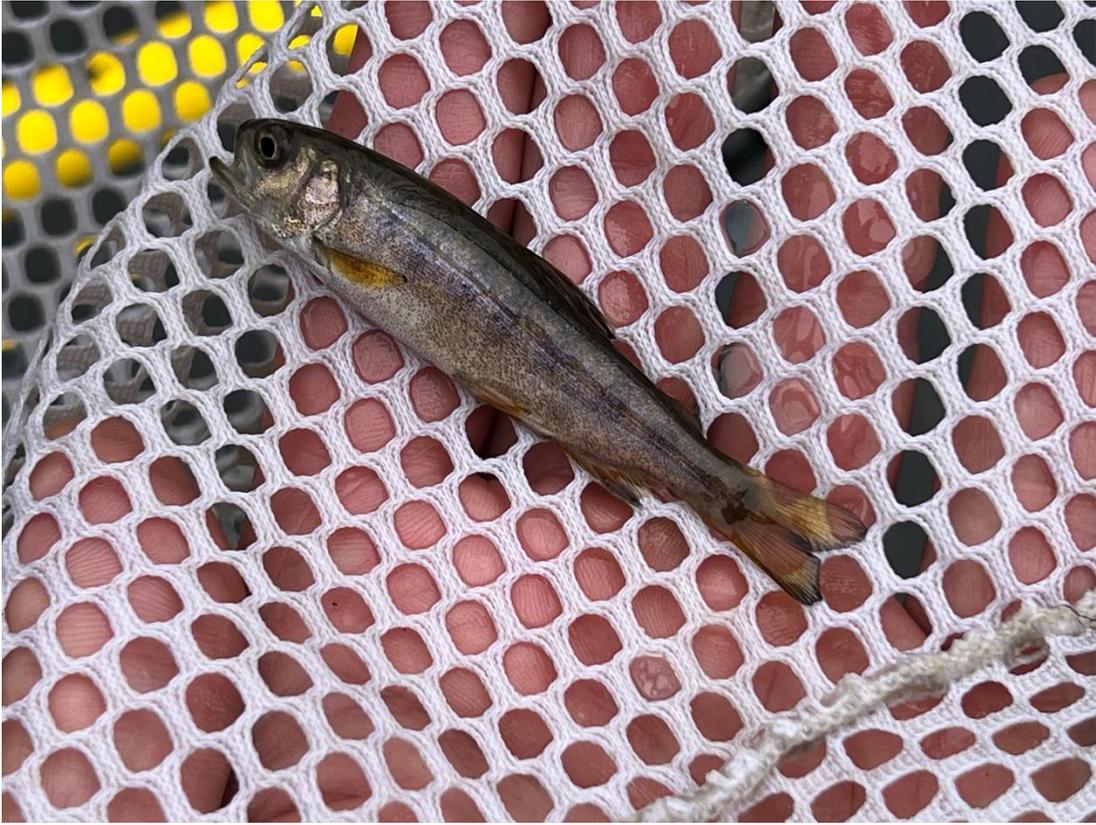
Photograph 3 – Juvenile coho salmon captured at RWY Beaver site (stream crossed by airport extension), August 12, 2024.

ADF&G Waypoint	Crossing/Culvert ID	Latitude	Longitude	Fish Obs. (species and fork lengths (mm))	Notes
149	RWY-Beaver	60.092047	-152.909884	CO - 54, 58, 59 DV - 60, 58, 56, 55, 63, 62, 56	Large substrate, series of small beaver ponds held with small (1-2 feet high) beaver dams, clear water, overhanging vegetation of willow and alder
150	RWY-Beaver	60.091541	-152.910057	DV - 88	Same stream as above – survey upstream of beaver dam in pond
151	RWY-Beaver	60.091409	-152.910008	DV - 100	Same stream as above – survey upstream of beaver dam impoundment (flowing water)
152	RWY-Reverse Creek	60.091462	-152.906489	no fish	scant flow of water, sand/silt substrate, 2-3' wide channel/path, overhanging vegetation
171	C01-002	60.091086	-152.922216	no fish	no water, channel path (swale) but well vegetated
172	added site	60.093265	-152.932048	no effort, sampled upstream	braided channel (multiple channels), gravel/sand substrate, variable width, 2 to 20' wide in places, recently drained beaver pond area

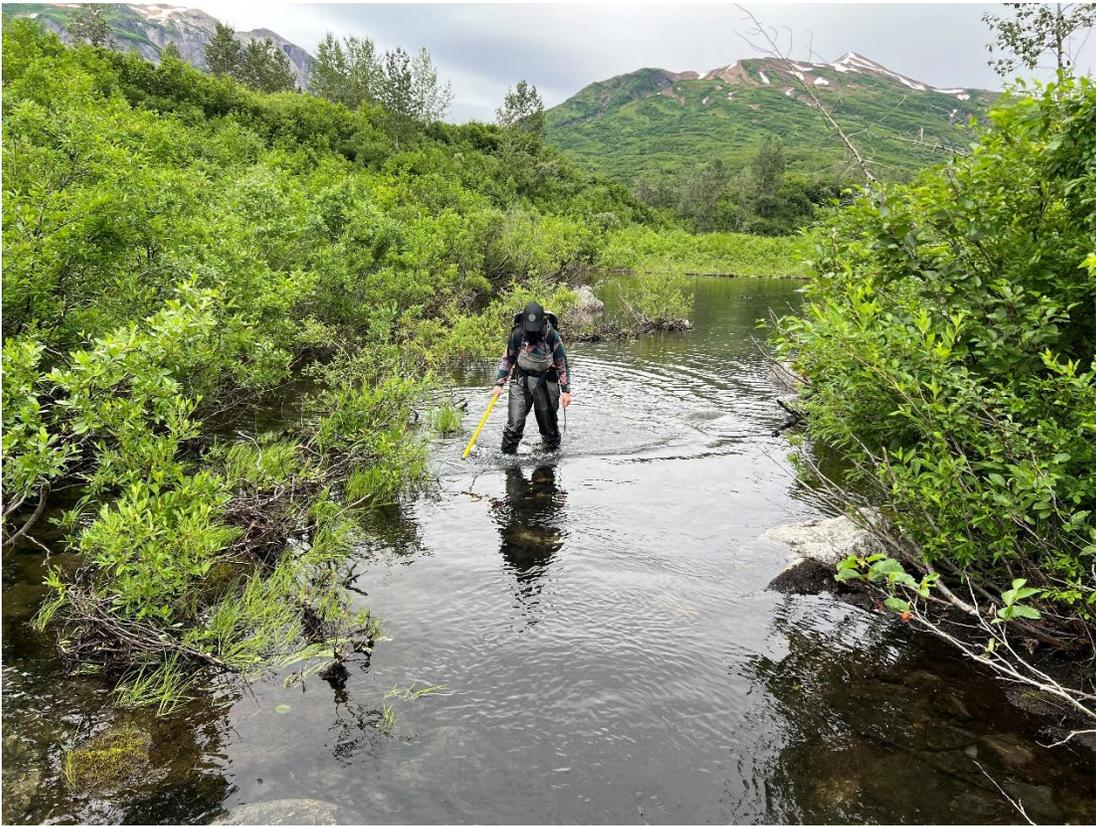
Photograph 4 – RWY Beaver site looking upstream, August 12, 2024.

Points 149-151 are in the same stream.

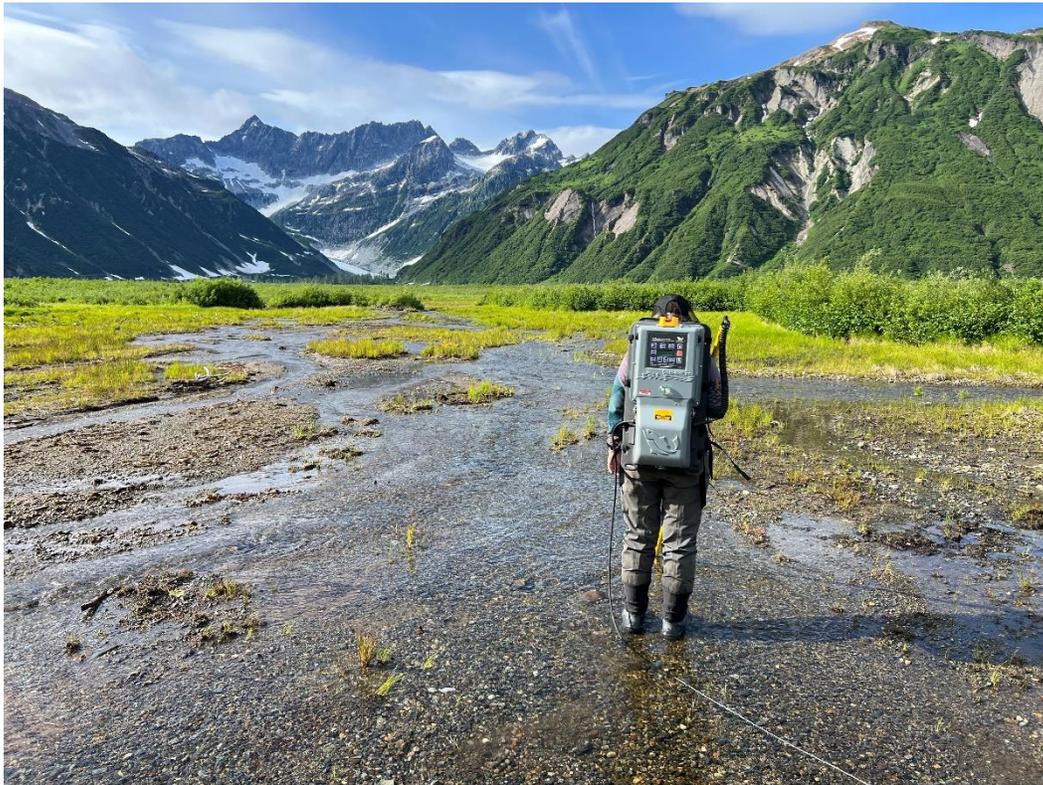
Photograph 5 – Proposed road corridor stream crossings. Several fish-bearing (Dolly Varden) streams converge in a broad area (former beaver pond) just west of existing runway.

173	added site	60.093169	-152.931964	DV - 42, 35, 56, 63	multiple channels in area/former beaver pond
174	added site	60.093188	-152.931516	DV - 116	multiple channels in area/former beaver pond
175	added site	60.093121	-152.932211	DV - 42, 40	multiple channels in area/former beaver pond
176	added site	60.093214	-152.932408	DV - 48	multiple channels in area/former beaver pond
177	added site	60.093282	-152.932910	DV - 38	multiple channels in area/former beaver pond
178	added site	60.093441	-152.934050	no effort, sample upstream	small channel (3-4' wide) with clear water
179	added site	60.093388	-152.934140	DV - 30, 46	small channel (3-4' wide) with clear water
180	added site	60.093548	-152.934248	DV - 72	small channel (4' wide), overhanging vegetation (alders)
191	C10-100	60.092061	-152.947791	no fish	intermittent water in pools/depressions, obvious flow path, large substrate (cobble to sand), mostly dry, thickly vegetated with alder and willow, likely sees water during higher flow periods

Points 172-180 are in streams that coalesce into one stream in a formerly ponded area (beaver).

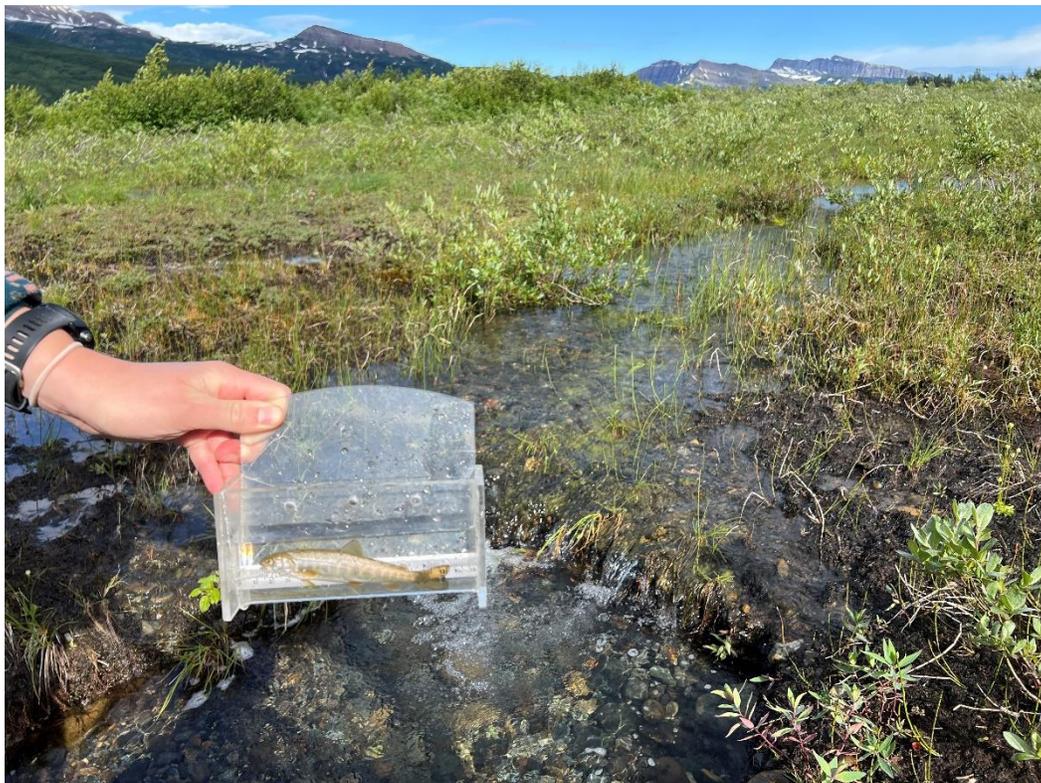
Photograph 6 – Dolly Varden and stream habitat just west of existing runway along proposed road corridor, August 12, 2024.

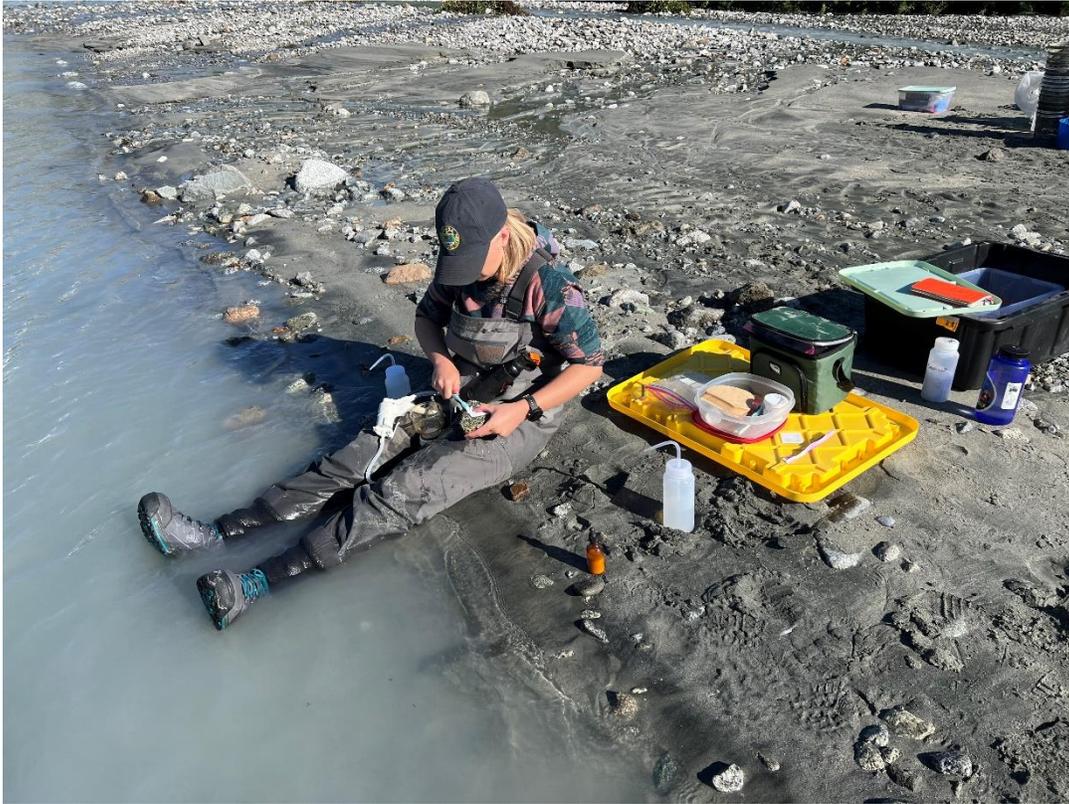
Photograph 7 – Collecting periphyton samples in the Johnson River, August 13, 2024.

Periphyton, aquatic benthic macroinvertebrate, sediment, and whole fish (Dolly Varden) samples were collected at both aquatic studies sites. Periphyton samples were collected using methods described in Parker (2017). Macroinvertebrates samples were collected using a Hess Sampler (diameter of 33.1 cm and 243 µm mesh size). Five (5) replicate samples were collected from riffle habitat at each site. A sediment sample was collected at each site by scooping fine sediments from pool habitat. Dolly Varden were collected at each site using baited minnow traps. Fifteen (15) Dolly Varden were collected and retained from the Johnson River site and ten fish were collected and retained from the Kona Creek site. All samples were collected on the same day (August 13) except for the Dolly Varden which were collected over a two day period (August 13 and 14). All samples have been shipped and received at their respective analysis locations.

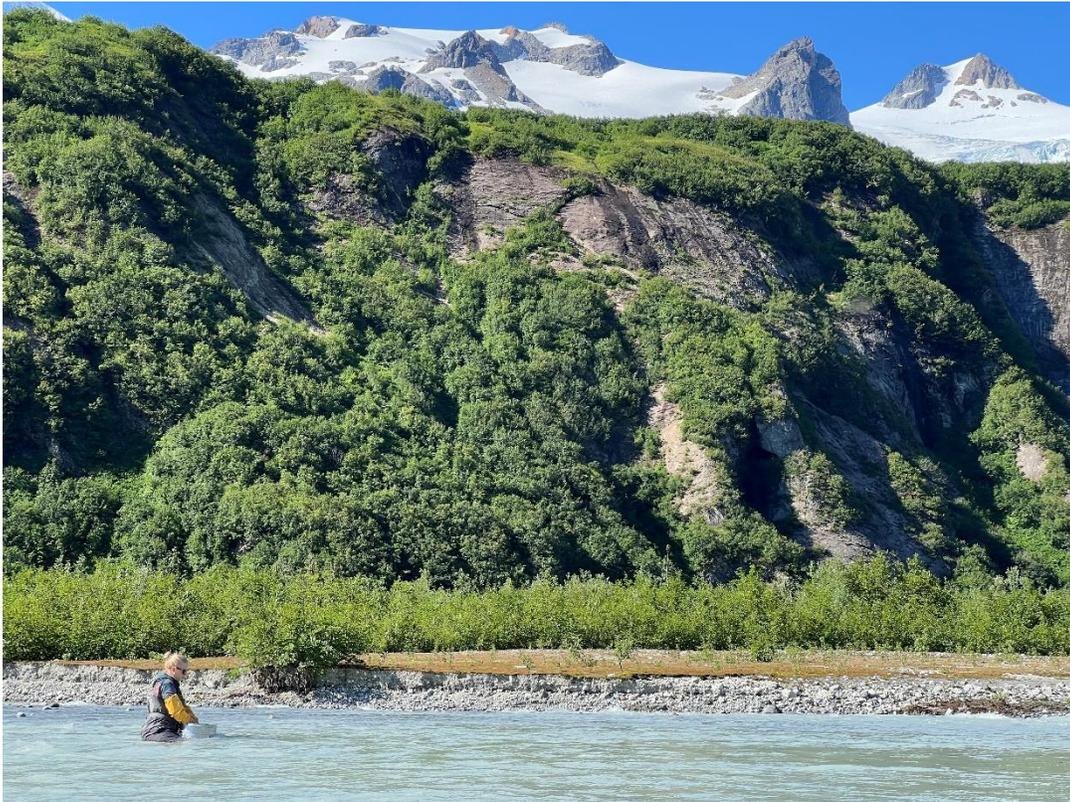
Photograph 8 – Collecting macroinvertebrate samples in the Johnson River with Hess Sampler, August 13, 2024.

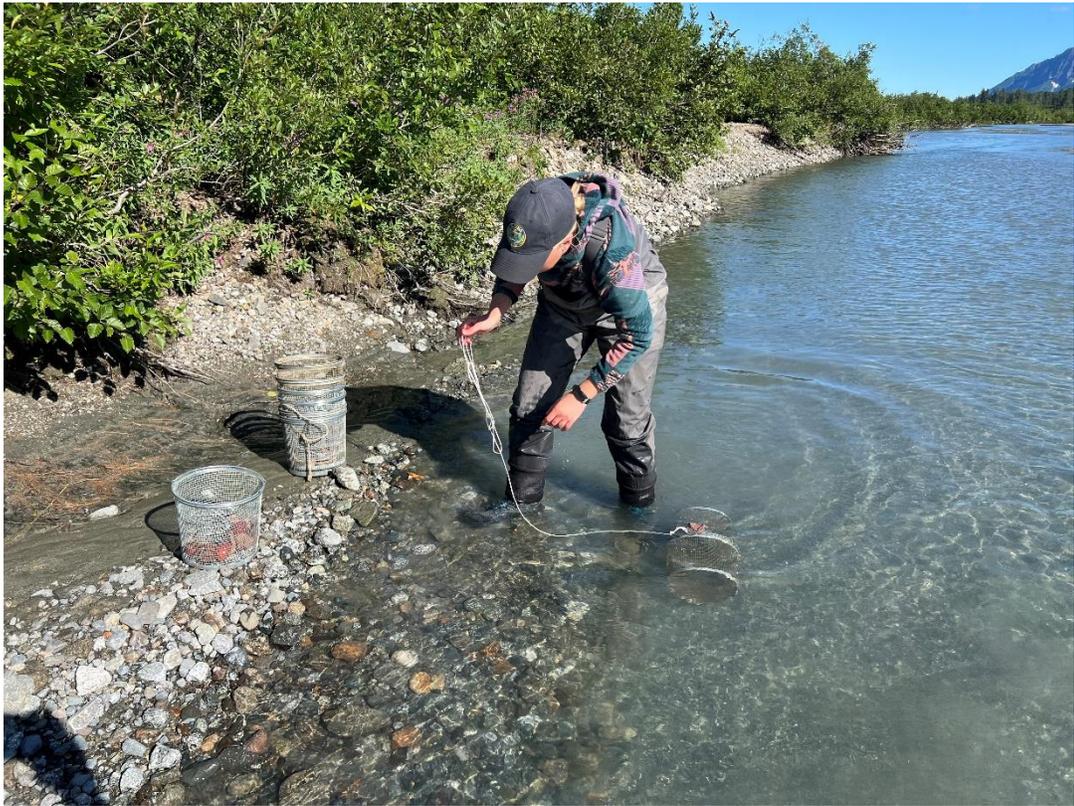
Photograph 9 – Setting minnow traps in the Johnson River, August 13, 2024.

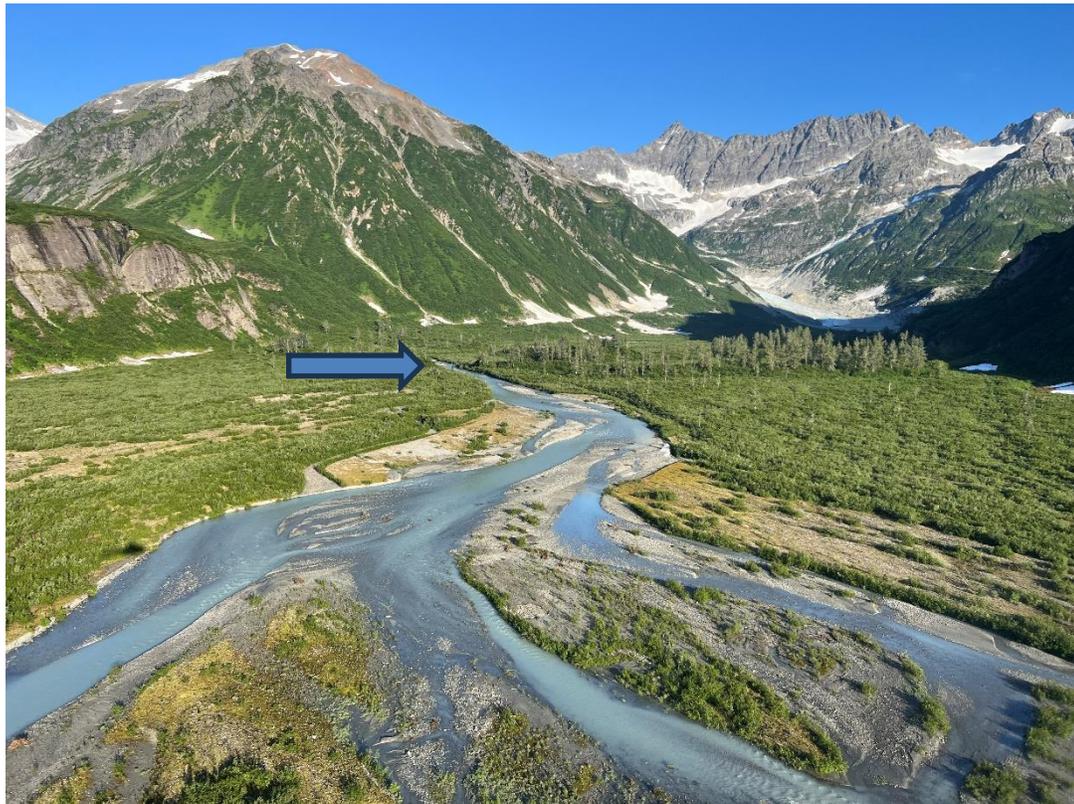
Photograph 10 – Upper Johnson River showing proposed bridge crossing location, looking upstream, August 14, 2024.

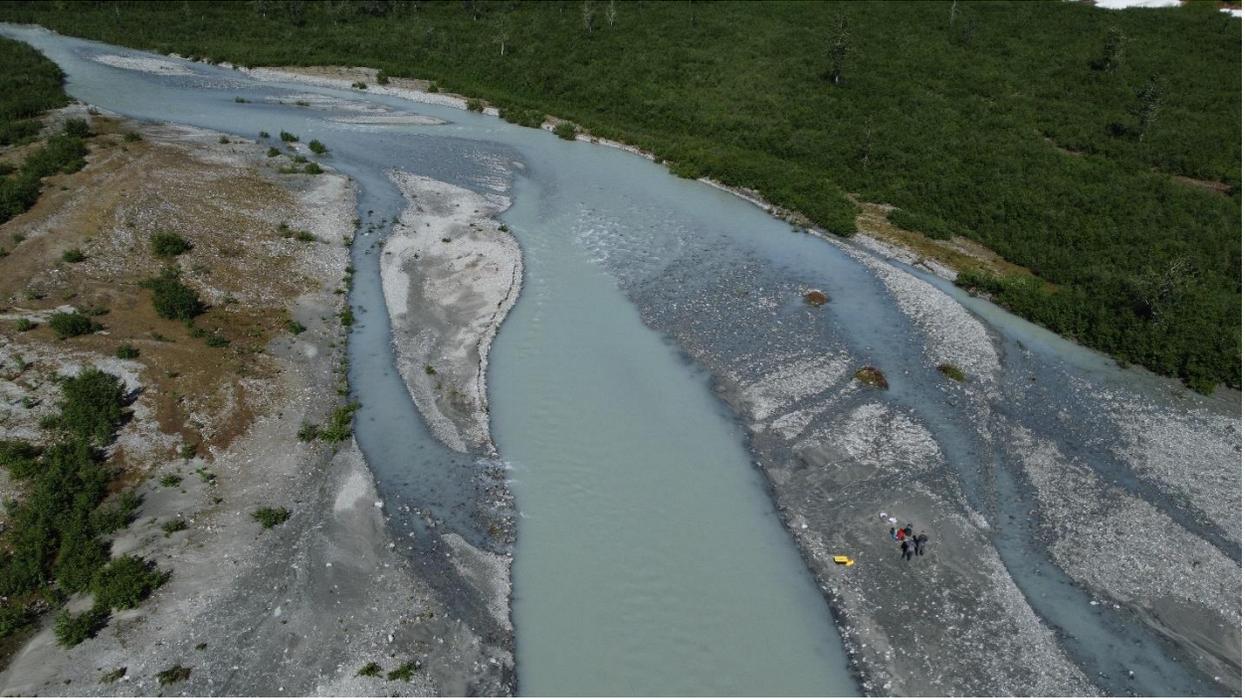
Photograph 11 – Johnson River aquatic studies site, August 13, 2024.

Two aquatic study sites were established in the Johnson River watershed in 2023, one in the mainstem Johnson River and one in Kona Creek (tributary to Johnson River). These sites were revisited, and replicate samples and water quality data were collected using the same methods as used in 2023. Water quality data (2023 and 2024) from the aquatic studies sites is shown in Table 2.

Site	Temperature (°C)	Conductivity (mS/cm <sup>2</sup> )	Dissolved Oxygen (mg/L)	pH	Turbidity (NTU)
2023					
Johnson River	2.27	36	14.5	6.82	58.8
Kona Creek	7.45	47	12.76	7.16	7.25
2024					
Johnson River	2.23	33	11.72	6.55	93.12
Kona Creek	6.41	34	11.35	6.86	3.51

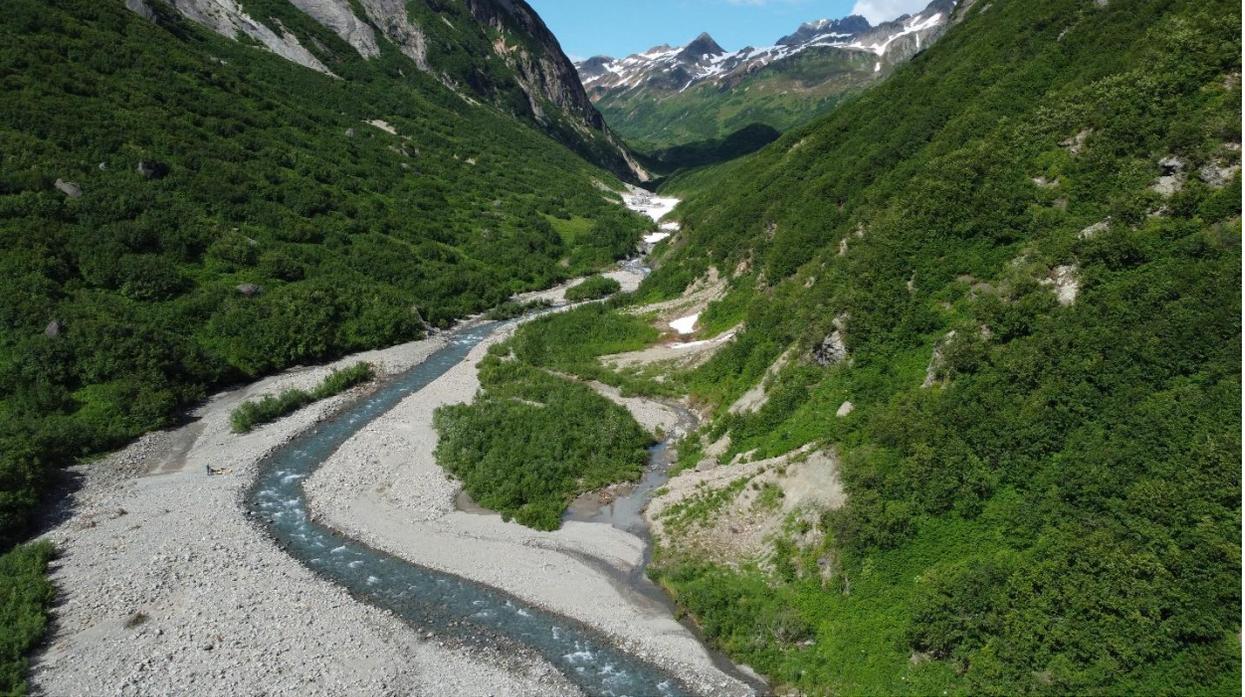
Photograph 12 – Kona Creek aquatic studies site, August 13, 2024.
