NIXON FORK MINE
QUARTERLY MONITORING REPORT
Fourth Quarter

ANNUAL REPORT 2012

Fire River Gold Corporation, Mystery Creek Resources, Inc.
340-1200 West 73rd Avenue
Vancouver, BC, Canada V6P-6G5

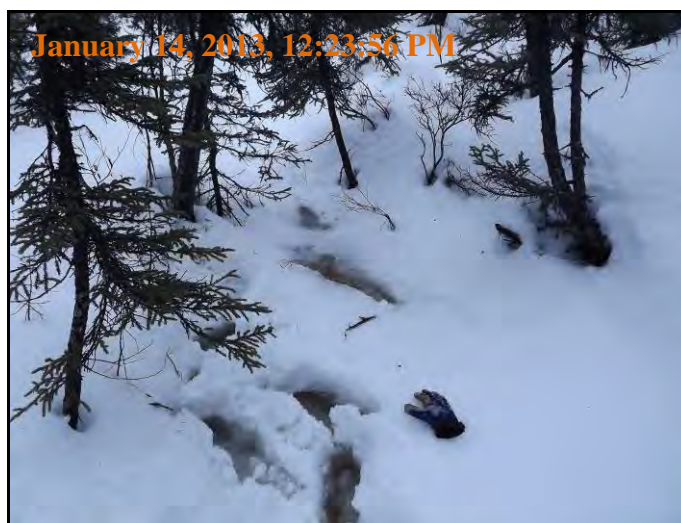
Photograph 1- RC-1

Due to influence of the historic mining activities, Ruby Creek samples have consistently high Mercury results. Photograph 1 below, shows the RC-1 sample site on January 14, 2013.

Sample location RC-1 is the downstream location along Ruby Creek. For the Fourth Quarter of 2012, a sample was collected on January 14, 2013. The sample collected exceeded water quality standards for the Ruby Creek drainage for the following parameters shown in the table below.

Parameter	Water Quality Standard for Ruby Creek	RC-1
Copper	4.51/3.89 µg/L	22.4 µg/L
Alkalinity	Minimum of 20	10.0 U

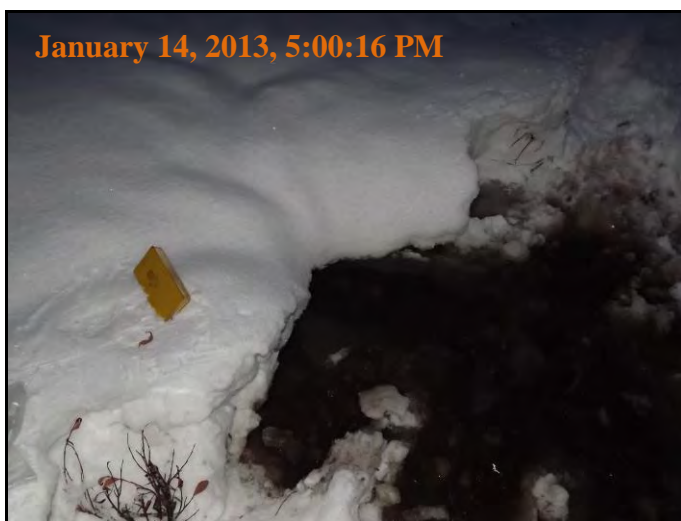
Photograph 2- MC-1

The Fourth Quarter 2012 sample collected at MC-1 exceeded water quality standards for arsenic, with a concentration of arsenic of 62.7 $\mu\text{g/L}$. The Alaska water quality standard for arsenic is based on the allowable level from drinking water: 10 $\mu\text{g/L}$. The creek has naturally high levels of arsenic and has exceeded water quality standards in every sampling event.

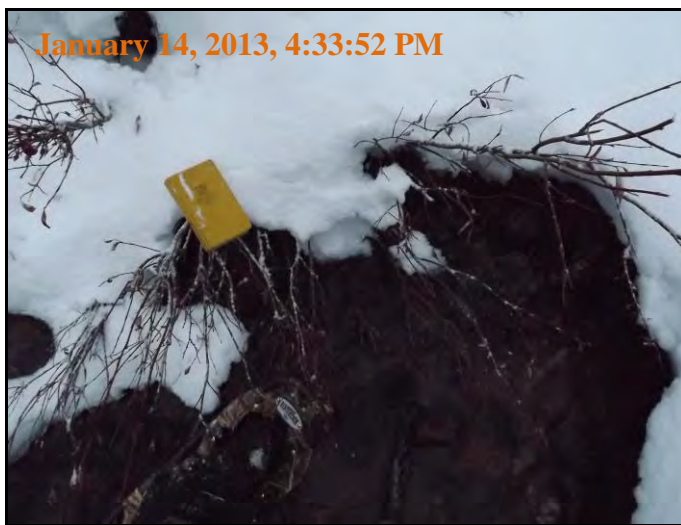
Photograph 3- MC-2

For the Fourth Quarter of 2012, samples (MC-2) and duplicates (MC-A) were collected at this location. Mystery Creek is narrow and deeply incised (approximately four feet deep during high-water flow) at the sampling location. The sample collected at MC-2 exceeded water quality standards for arsenic and aluminum, and the MC-A sample for copper. The Alaska water quality standard for arsenic is based on the allowable level from drinking water: 10 µg/L. The potential regulatory limit for aluminum and copper is 87.0 µg/L and 3.05 µg/L, respectively (based on the calculated hardness for the Ruby Creek drainage). The creek has naturally high levels of arsenic and has exceeded water quality standards in every sampling event. This sampling event the average concentration of arsenic was 64.2 µg/L. The average concentration of aluminum was 151.0 µg/L and the MC-A concentration for copper was 3.86 µg/L. The MC-2 concentration of copper was below the potential regulatory limit at 1.27 µg/L

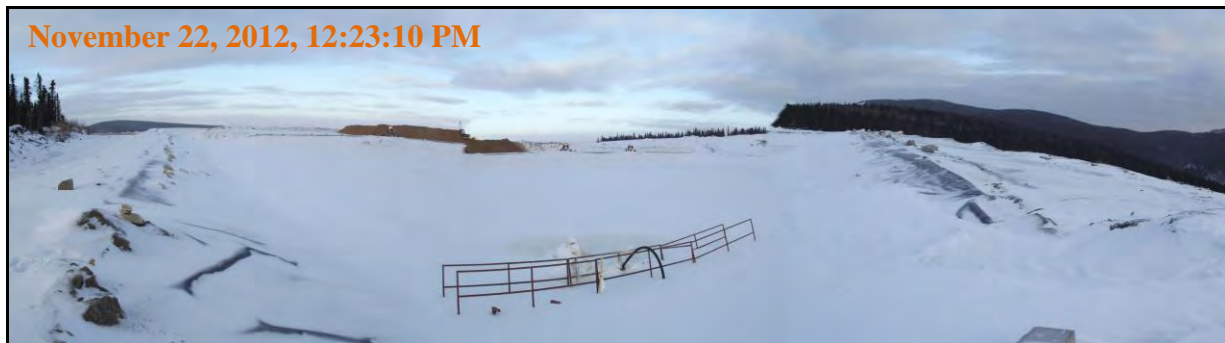
Photograph 4- FTDS Retention Pond

With storm-water entering the FTDS retention pond after CN-contacted tailings were placed into the facility, geochemical monitoring was followed as outlined in section 3.6.1 of the 2011 Monitoring Plan. Photograph 4 shows the FTDS retention pond on November 22, 2012. There were two samples taken from the FTDS retention pond at two different times. The analysis results indicated that the water exceeded the following strictest water quality standards:

Sample Same	FTDS 1	FTDS 2
Date	11/11/2012	1/16/2013
Total Dissolved Solids 500 mg/L	1560 mg/L	184 mg/L
Turbidity 5 NTU	-	50 NTU
Sulfate < 250 mg/L	-	1,060 mg/L
Total Nitrite/Nitrate 10 mg/L	15.9 mg/L	19.56 mg/L
WAD CN 0.0052 mg/L	1.6 mg/L	1.6 mg/L
Aluminum 87 ug/L	1,700 ug/L	1,210 ug/L
Arsenic 10 ug/L	33.1 ug/L	33.9 ug/L
Copper 3.05 ug/L	3,030 ug/L	4,220 ug/L
Lead 0.62 ug/L	8.57 ug/L	7.2 ug/L
Manganese 50 ug/L	134.0 ug/L	113.0 ug/L
Silver 0.39 ug/L	19.7 ug/L	31.5 ug/L
Mercury 50 ng/L	-	1,390 ng/L

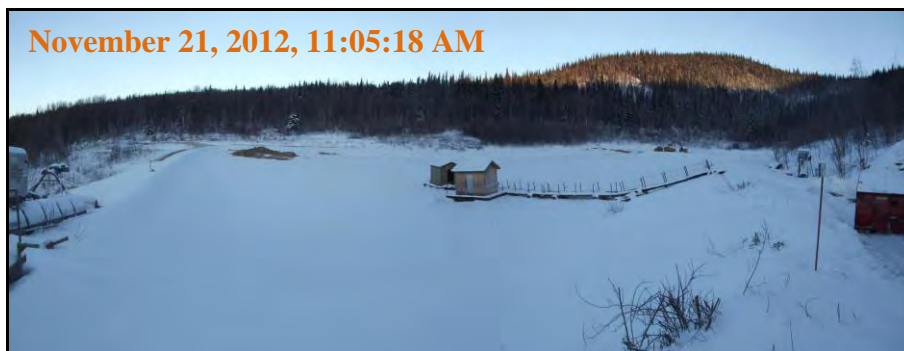
Photograph 5- TSF

No sample was taken during the Fourth Quarter. Due to low water-levels leading into winter, the water in the pond was frozen solid. Photo 5 shows the condition of the TSF on November 21, 2012.
