2010 ANNUAL ACTIVITY AND MONITORING REPORT

SUMITOMO METAL MINING POGO LLC

March 3, 2011

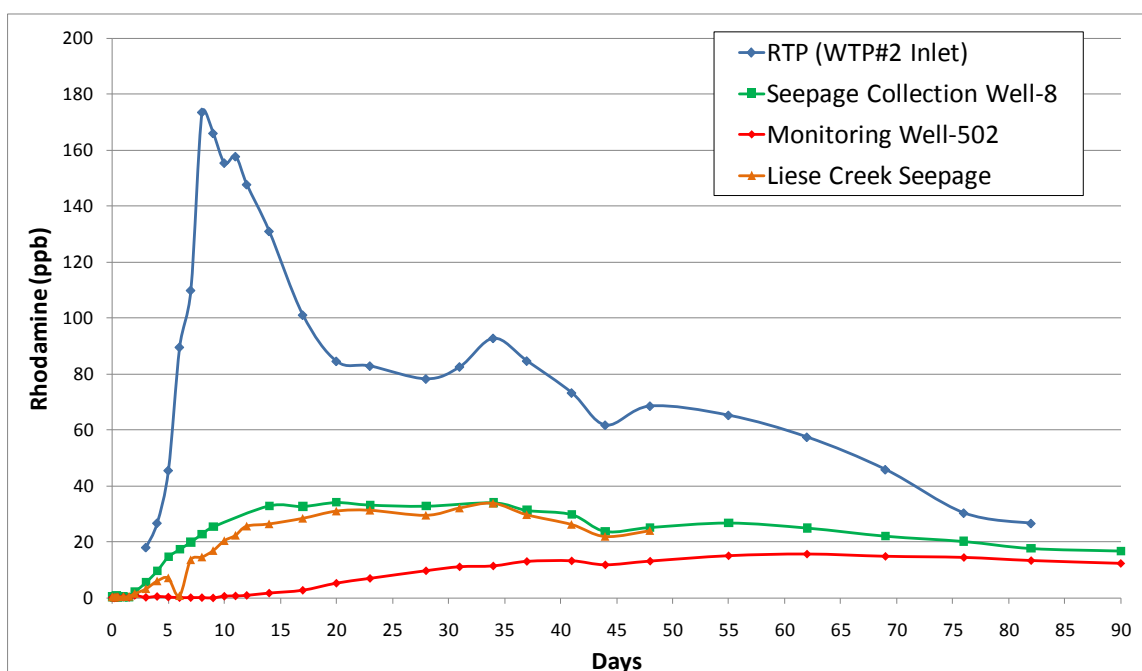
Chart 3 Tracer Test - Rhodamine Concentrations

Rhodamine was poured into the RTP on September 14, 2010. Water samples were collected at various locations upstream and downstream of RTP to analyze the Rhodamine levels for 90 days. **Chart 3** shows the Rhodamine concentration at RTP, Seepage Collection Well #8, Seepage into Liese Creek, and Monitoring Well MW-502. It shows that:

- Rhodamine at RTP reached 173 ppb then dropped down because of inflow of runoff water into RTP and discharging of RTP water to ORTW;
- Rhodamine was detected at Seepage Collection Well No. 8 at Day 3 for the first

- Rhodamine concentration at the seepage into Liese Creek downstream of Seepage Collection Wells was quite similar to that of Seepage Collection Wells;
- Rhodamine was detected at Monitoring Well MW-502 at Day 17 for the first time. The concentration reached 15 ppb in maximum and remained steadily.

Pogo intends to conduct a hydro-geophysical survey in the spring of 2011 in order to identify the major flow path of seepage from RTP. Appropriate mitigation measures will then be proposed by Pogo.

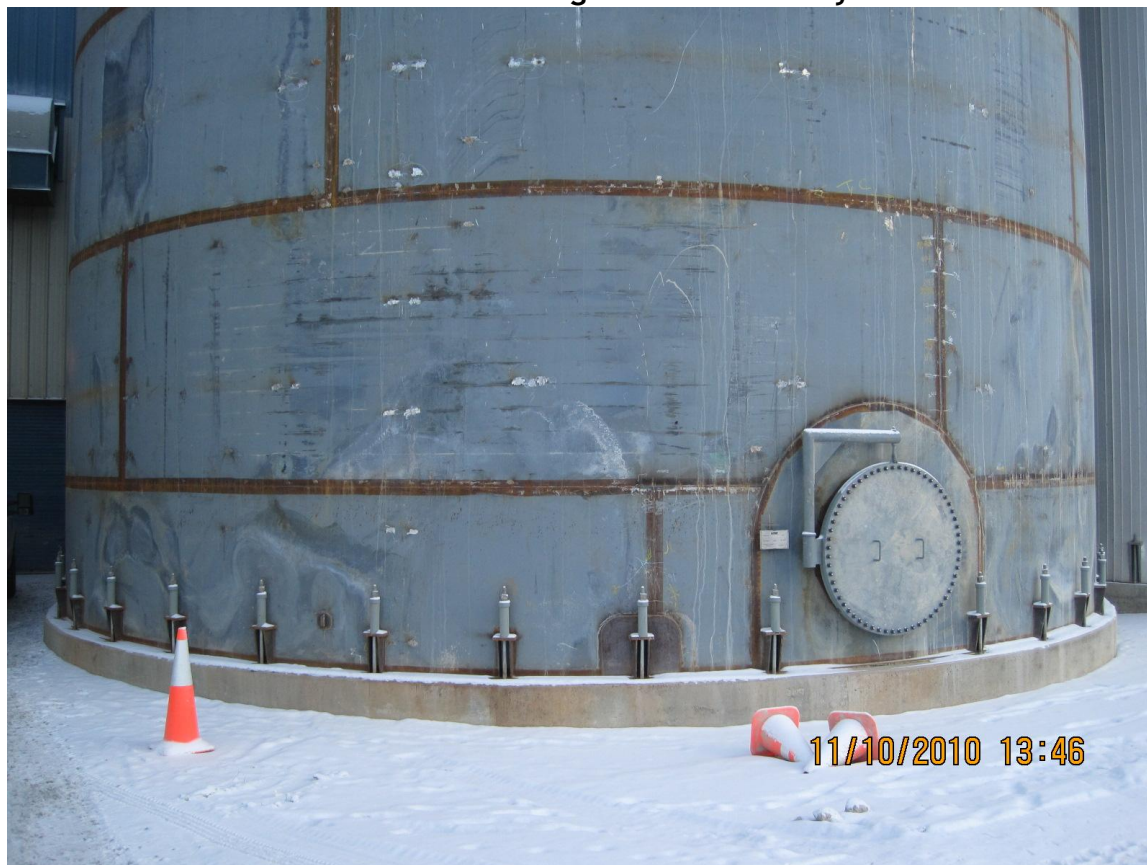
Photo A - CIP Tails Storage Tank Secondary Containment

The 2008 Environmental Audit was conducted by Golder Associates. The July 2009 Audit Report, Section 4.9 identified a need for the following improvements: 1) The construction of secondary containments for Carbon-in-Pulp (CIP) Tailings Storage Tank and Backfill Dilution Water Tank (refer to **Photo A**); 2) Secondary containment for the Paste Line between CV-02 splice shack and the 1690 Portal (refer to **Photo B**); and 3) Secondary containment for the CIP Tailings Slurry and Backfill Dilution Water pipelines between Mill Plant and Paste Plant (refer to **Photo C**). The work was completed in 2010 which is why an update is provided in the Annual Report.
