Re: **Sumitomo Metal Mining Pogo LLC 2014 Annual Activity and Monitoring Report**

2014 ANNUAL ACTIVITY AND MONITORING REPORT

SUMITOMO METAL MINING POGO LLC

March 1, 2015

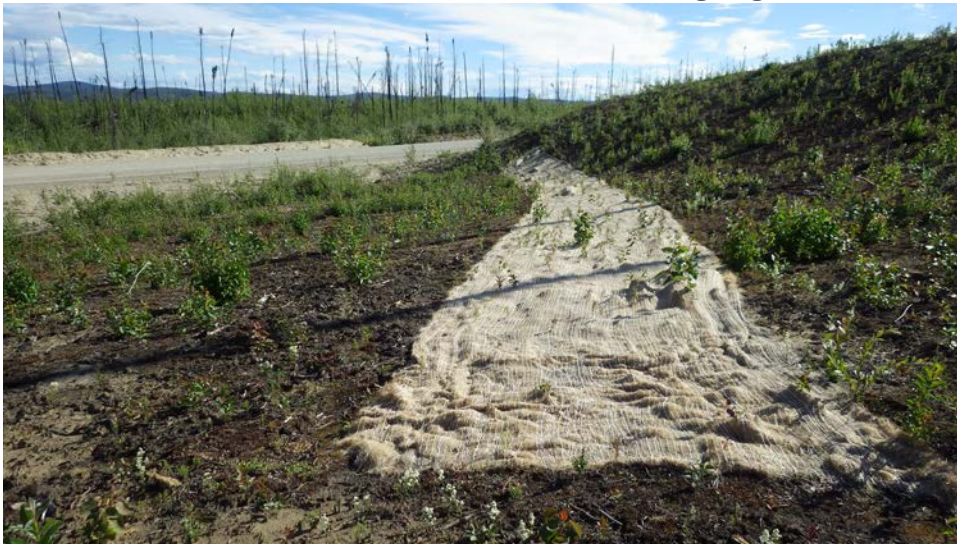
Photo 1: Erosion control under transmission line along Pogo Access Road

Photo 1 and **Photo 2** show erosion control measures implemented near Mile 20 of the Pogo Access Road on July 12, 2014.

Pogo is taking proactive measures to insure no environmentally sensitive areas are disturbed while fire prevention clearing occurs along the transmission line. In 2015 Pogo will:

- Brief equipment operators as to the amount, type, and locations of brush clearing activities allowed along the transmission line.
- Flag and delineate boundaries of all clearing activities to prevent disturbing any environmentally sensitive areas.

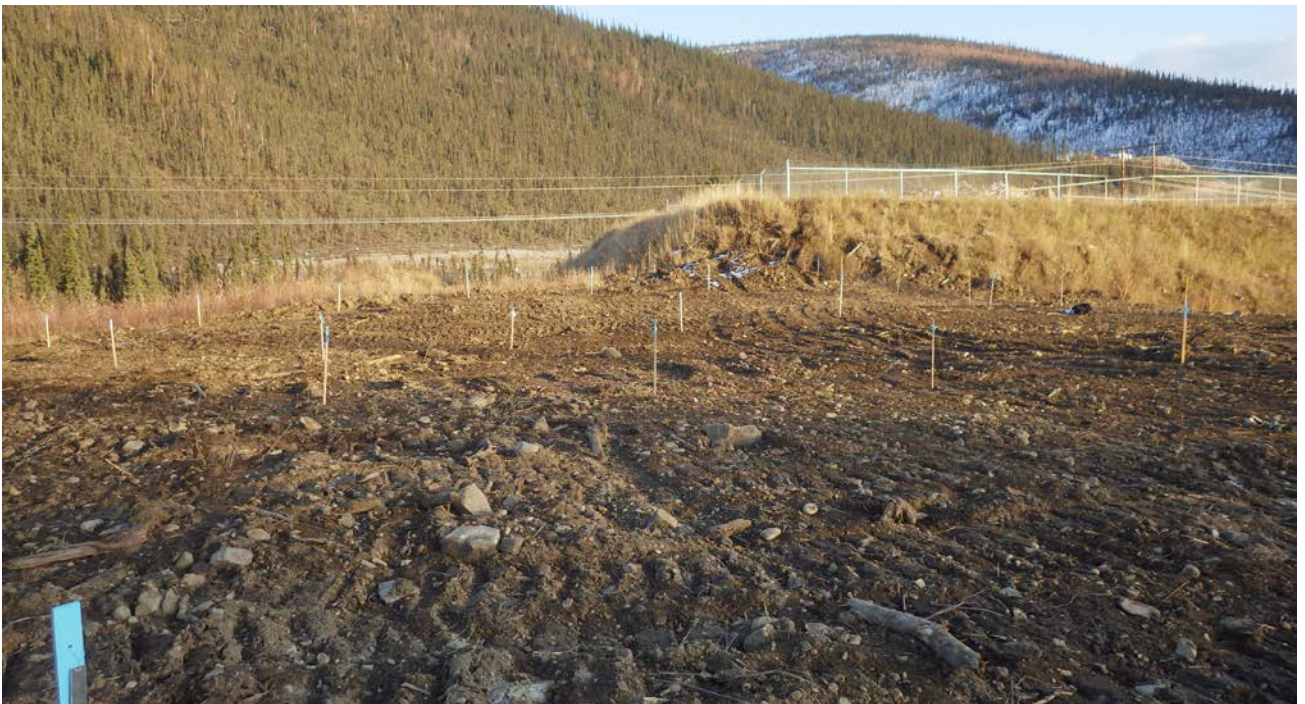
Photo 3: Alluvial Shrub Trial Plots

Test plots were established for alluvial shrubs and wetlands revegetation between the Pogo gravel pond and burn pit, in an area previously disturbed during construction (see **Figure 3a Appendix A**). As-built plot plans were recorded, as well as a photo record of each plot and plot label. The seed mix described in the plan was adhered to, with Feltleaf Willow seed as the major willow species. Seeds were weighed out for each plot into labeled bags and were then hand-broadcast after test plots were measured, staked and labeled. However, because seeding took place just before freeze up, no fertilizer was applied. Fertilizer, and agrotain will be applied in the spring. Willow cuttings will be collected and planted in the wetland trial plots as well.

Photo 3 shows a large portion of the alluvial shrub trial plots with burn pit fence and 1525 portal road in the background.

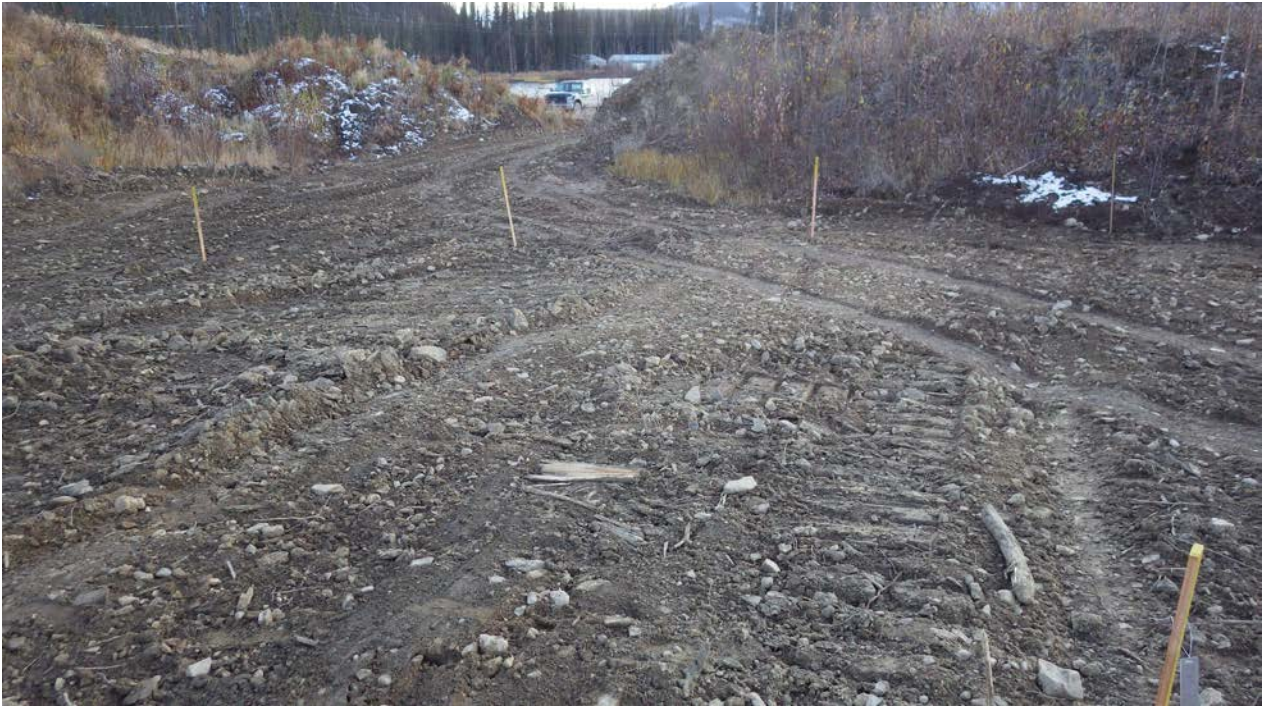
Photo 4: Wetland Trial Plots

Photo 4 shows the lower, wetter, portion of trial plot area next to gravel pond,

where wetland test plots are located.

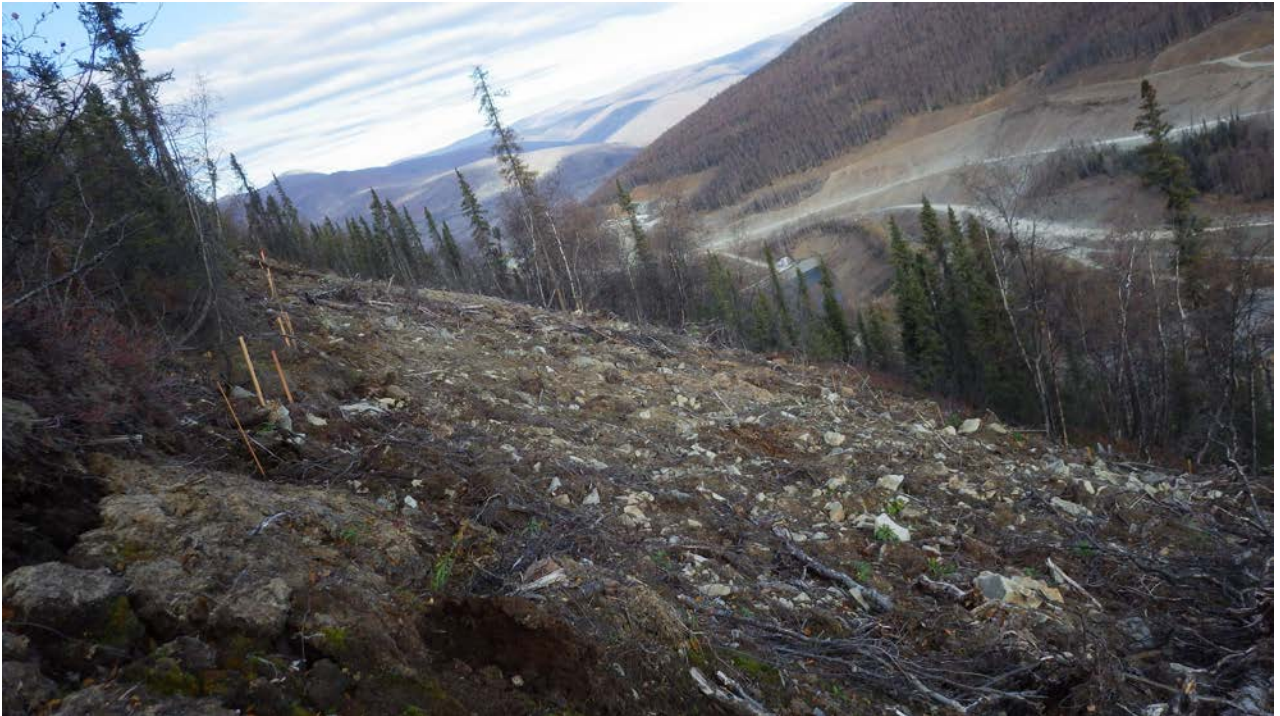
Photo 5: Broadleaf Forest Trial Plots

Test plots for the broadleaf forest revegetation were constructed above the south diversion ditch in an area disturbed by the drystack expansion project (see **Figure 3d, Appendix A**). Plots were measured, staked and labeled in the fall of 2014. Several large areas of woody debris were left in place and will be included in the trial. An as-built plot plan was recorded, photos of each plot and plot label were collected. However, due to an early snowfall, seeding and fertilizing will be delayed until spring of 2015.

Photo 5 shows the Broadleaf Forest trial plots, located at the end of the south diversion ditch road, where a road cut is in the process of being reclaimed.

In the late summer of 2015 percent cover and species data will be collected, and a photographic record kept for every trial plot established in 2014. Two more test plots, one for mesic and one for xeric, alpine meadow establishment, are scheduled to be developed in the summer of 2015 on, or near, the DSTF. Native seeds will be collected late summer and fall of 2015 as well.
