2015 ANNUAL ACTIVITY AND MONITORING REPORT

SUMITOMO METAL MINING POGO LLC

March 1, 2016

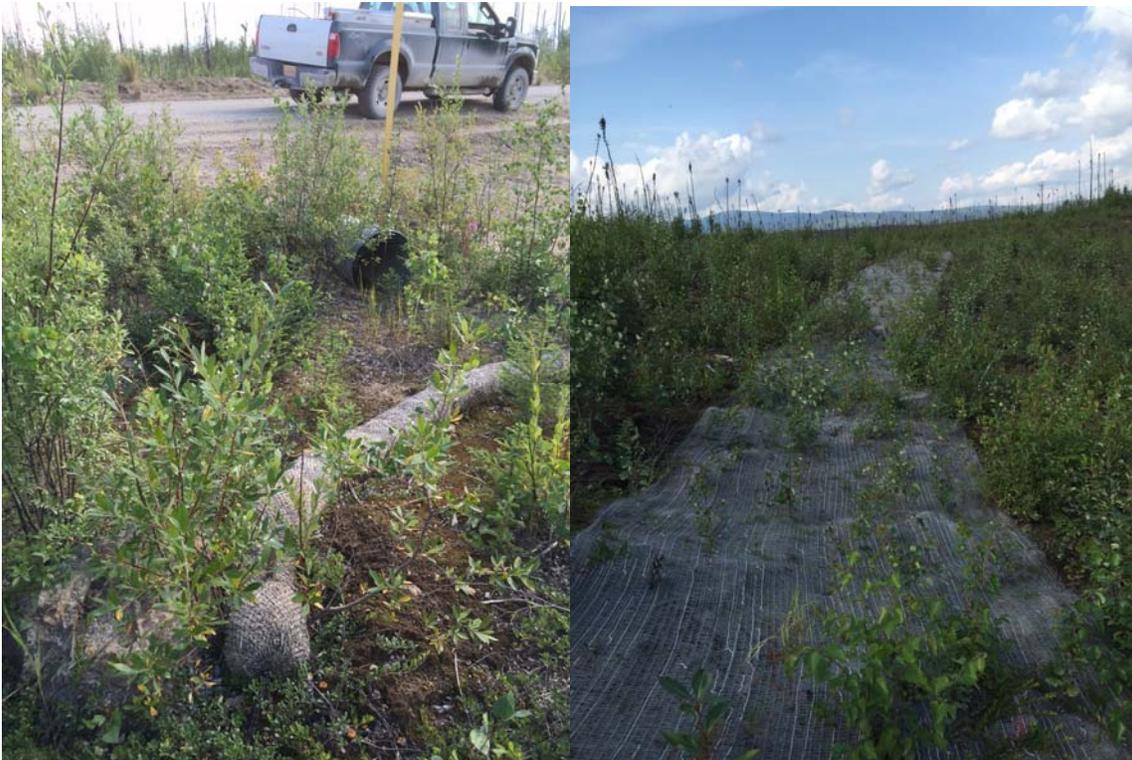
Photo 1 through **4** show erosion control measures implemented near Mile 20 of the Pogo Access Road on August 10, 2015.

Photo 1 & 2: Erosion control under transmission line along Pogo Access Road

In 2014 clearing activity along the Transmission Line Easement to meet Fire Prevention Protection Liability stipulation in its Early Entry Authorization occurred before sensitive areas were identified. SHPO approved Pogo's proposed mitigation plan and BMPs were installed by April 30, 2014. Below are the erosion control measures, performing effectively, during the summer of 2015.

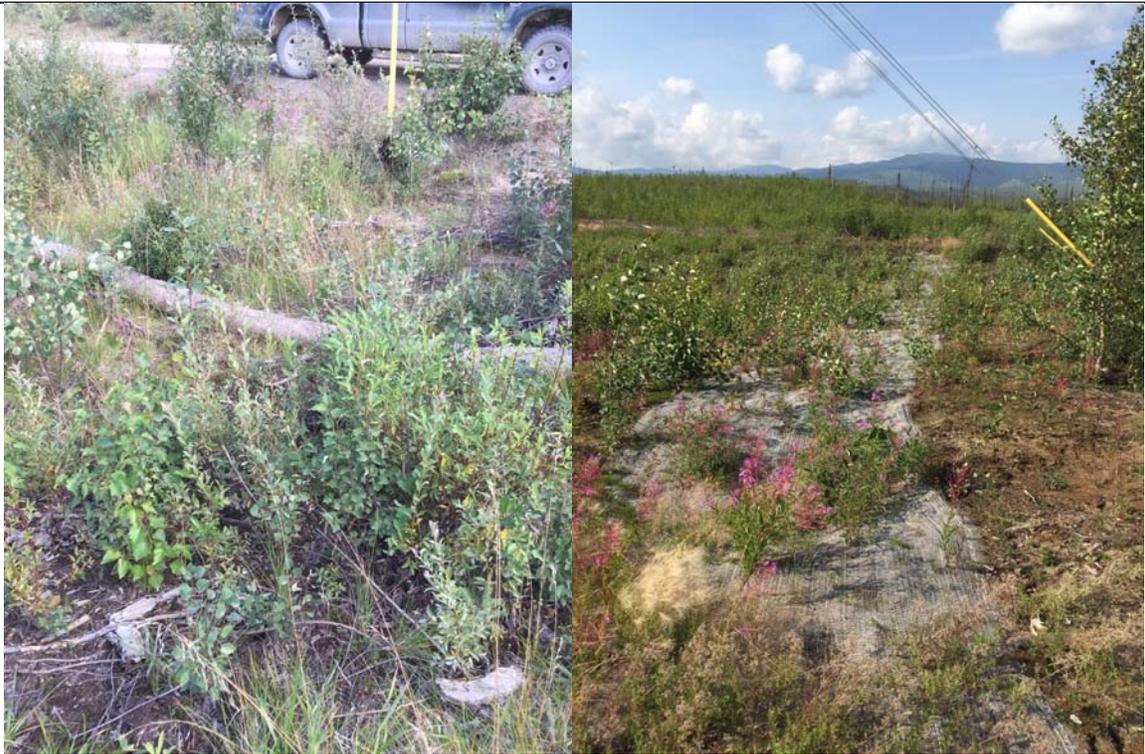
Photo 3 & 4: Erosion control under transmission line along Pogo Access Road

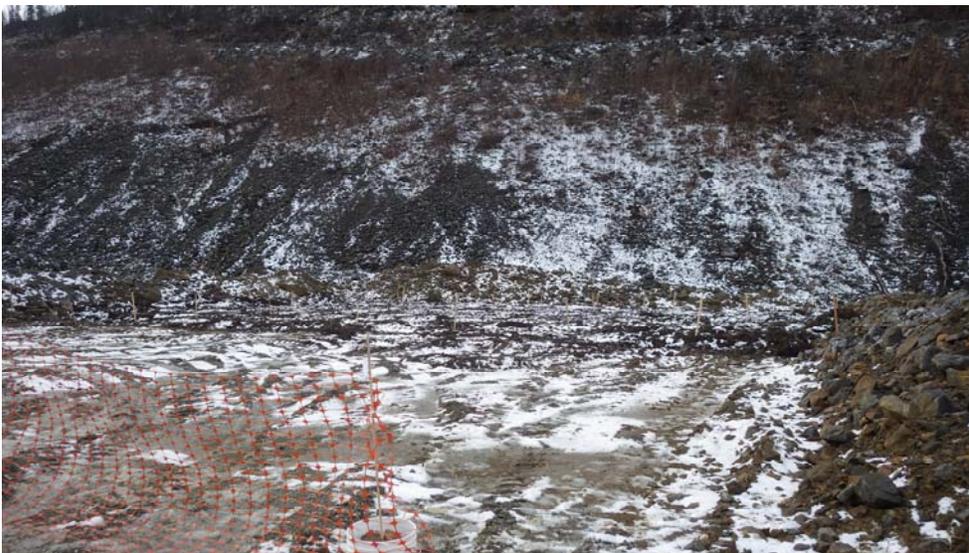
Photo 5: Alpine Meadow Trial Plots September 27, 2015 newly seeded.

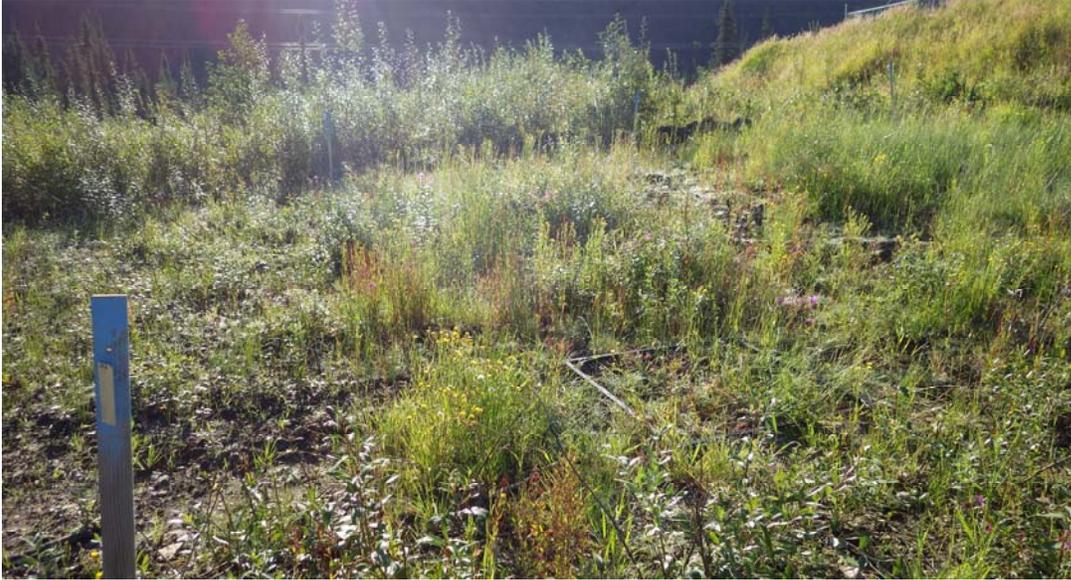
Test plots were monitored and percent cover and plant species was documented and photographed. Willow cuttings will be collected and planted in these plots and the wetland trial plots in spring of 2016. **Photo 6** shows a large portion of the alluvial shrub

trial plots with burn pit fence in the upper right. **Photo 7** a close up measuring percent cover.

Photo 6: Alluvial Shrub Trial Plots 2015

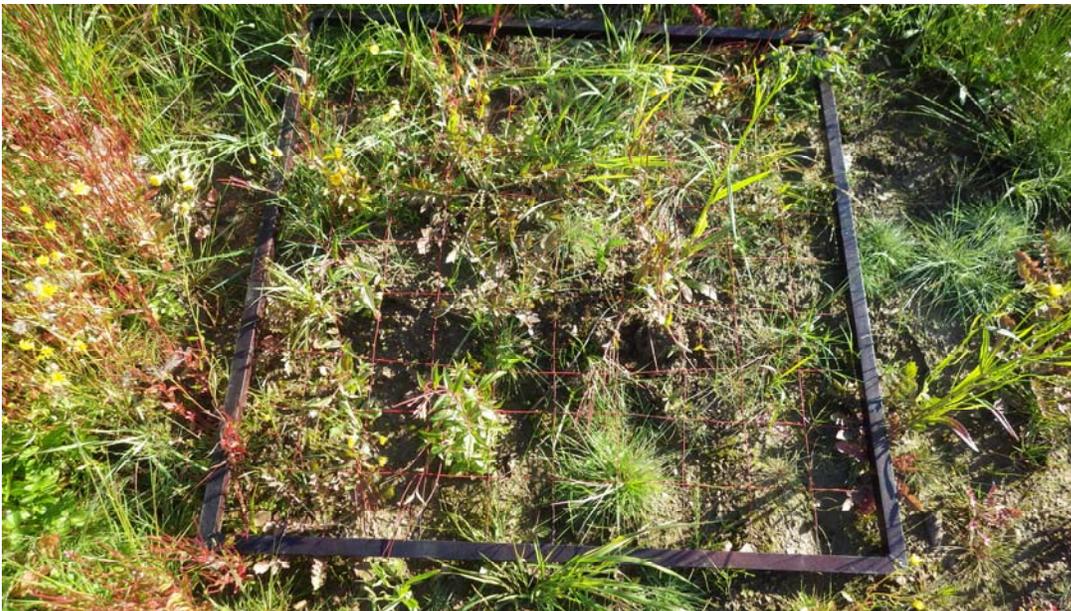
Photo 7: Alluvial Shrub Trial Plots 2015, %Cover Measurement

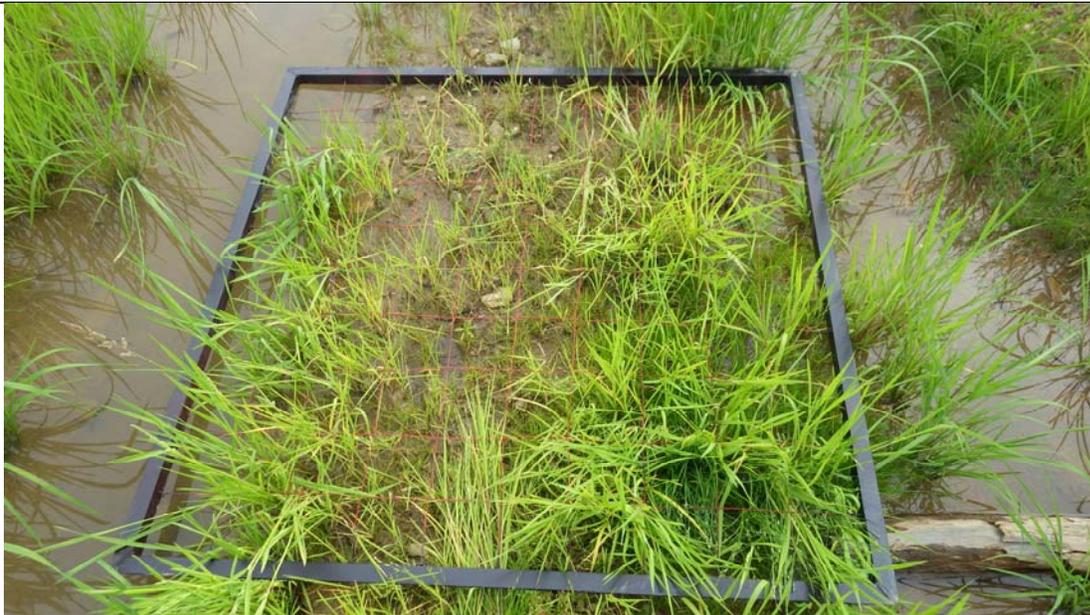
Photo 8: Wetland Trial Plots, %Cover Measurement

Photo 8 shows the establishment of Egan Slough grass, Wild Iris and Northwest Territory Sedge in a Wetland trial plot.

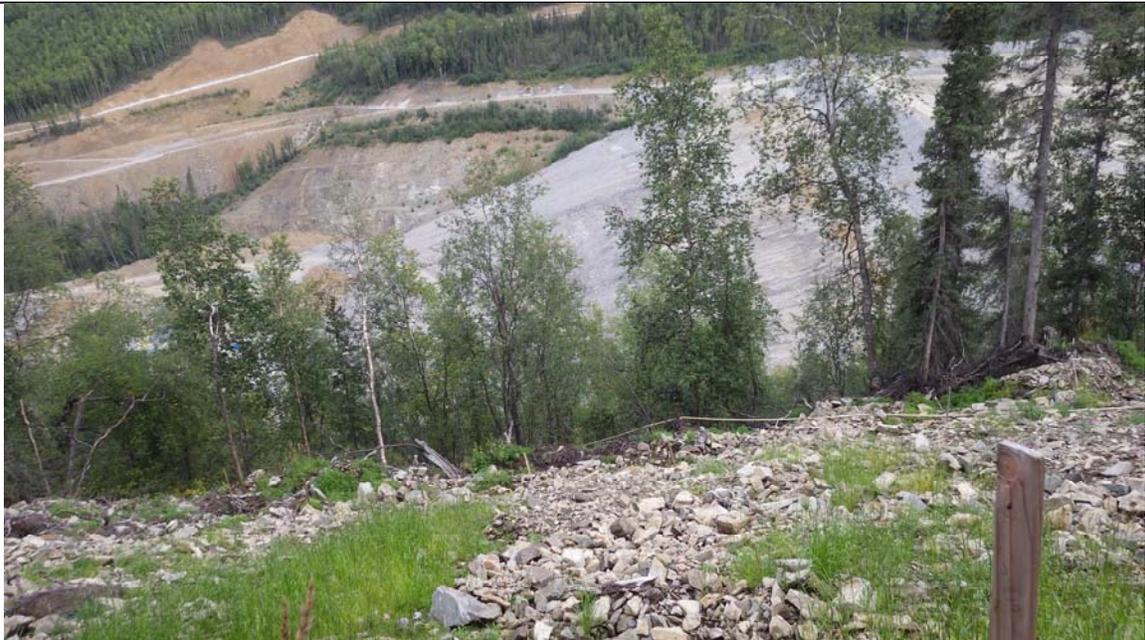
Photo 9 shows the Broadleaf Forest trial plots, located at the end of the south diversion ditch road, where a road cut is in the process of being reclaimed.

Photo 9: Broadleaf Forest Trial Plots 2015
