# Pogo Mine

## Environmental Audit

Sumitomo Metal Mining Pogo LLC

December 19, 2016

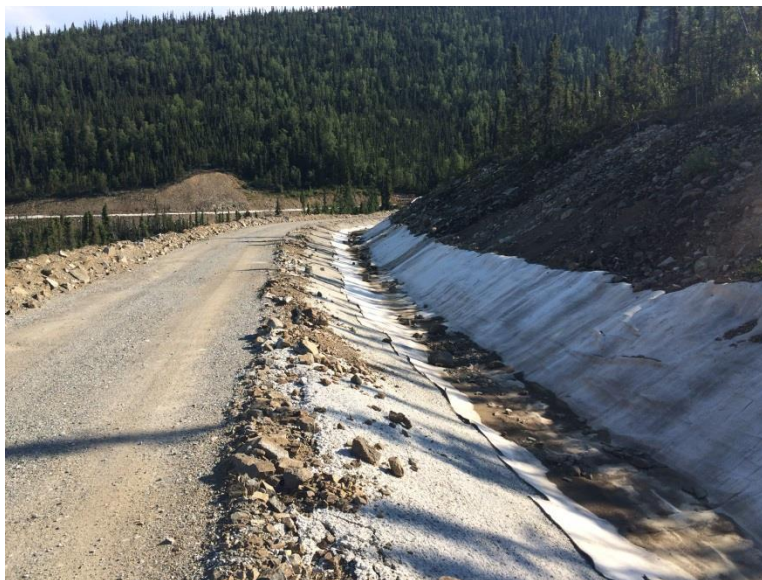
**Photo 2. Diversion ditches carrying offsite flows around mine facilities, discharging to Liese Creek. Ditches are free from sediment or blockages, and Pogo is addressing erosion of slopes upgradient from the ditches.**

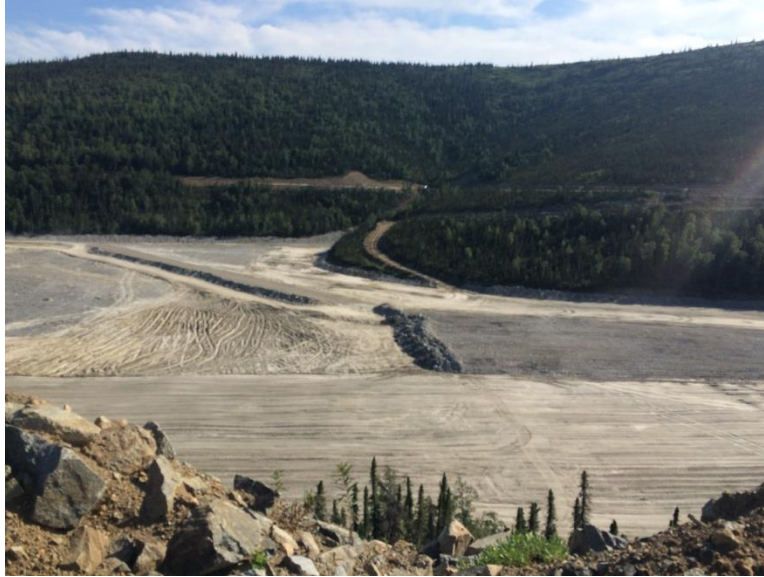
**Photo 3. DSTF tailings compaction surrounding the mineralized rock disposal in the center of the facility. Non-mineralized rock disposal along margins of the facility.**

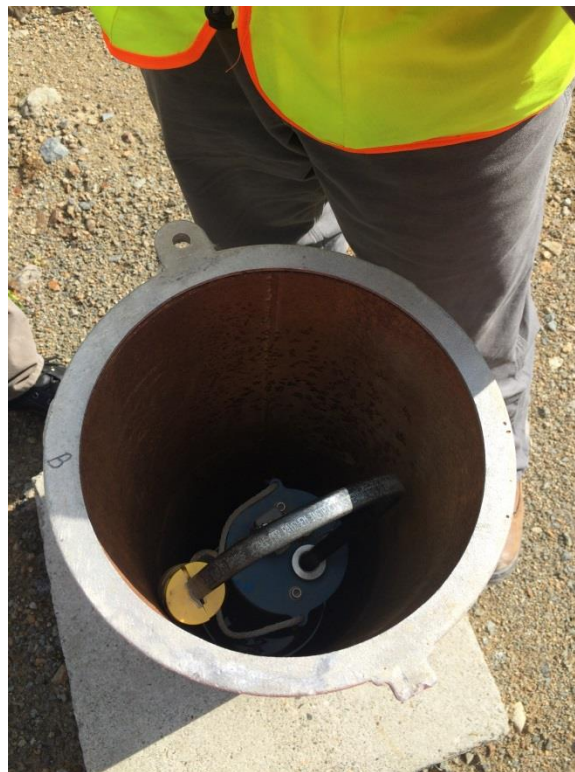
**Photo 4. Monitoring wells were intact and well-labeled, protected with berms, and dedicated pumps installed.**

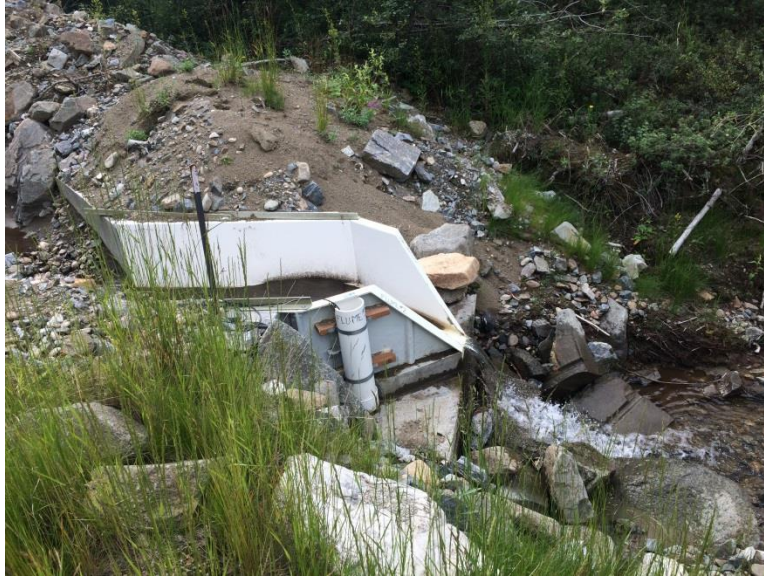
**Photo 5. Flumes were intact and maintained free of debris or sediment.**

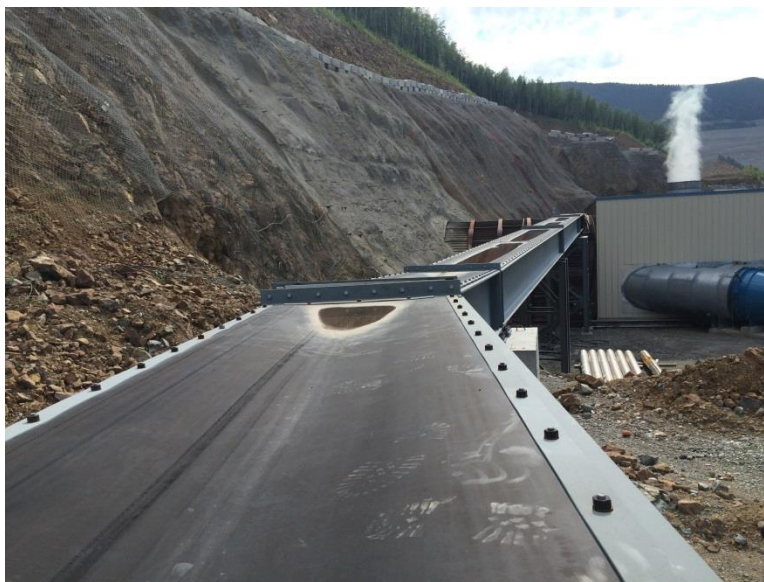
**Photo 6. Secondary containment of newly installed paste pipe to 2150 portal.**

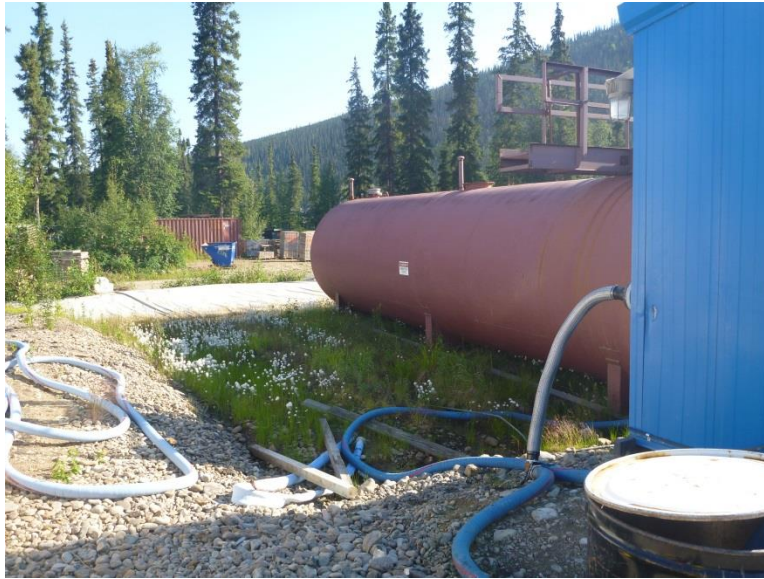
For most of the exterior secondary containment dikes, it is Pogo practice to fill in the secondary containment bottoms with gravel. In some cases, vegetation was observed growing in the gravel (Photo 7, Appendix C). The Audit Team's concerns with filling in the dikes with gravel are:

- It can be more difficult to remove accumulated stormwater
- It creates greater generated waste materials in the event of a spill (requires removing impacted gravel for disposal, versus just pumping out the spill liquid)
- The gravel takes up storage containment space
- It is not possible to visually observe the condition of the secondary containment impervious surface, as required in the SPCC Plan (e.g., liner tear).

**Photo 7. Fuel secondary containment system with fill material and vegetation.**

If the dike bottoms are HDPE or concrete, then it is recommended Pogo remove gravel from within the dike bottoms (unless the gravel is used to support vehicle traffic). If the bottoms are PVC, then the gravel should be retained as cover to protect from UV light if roof structures are not installed.

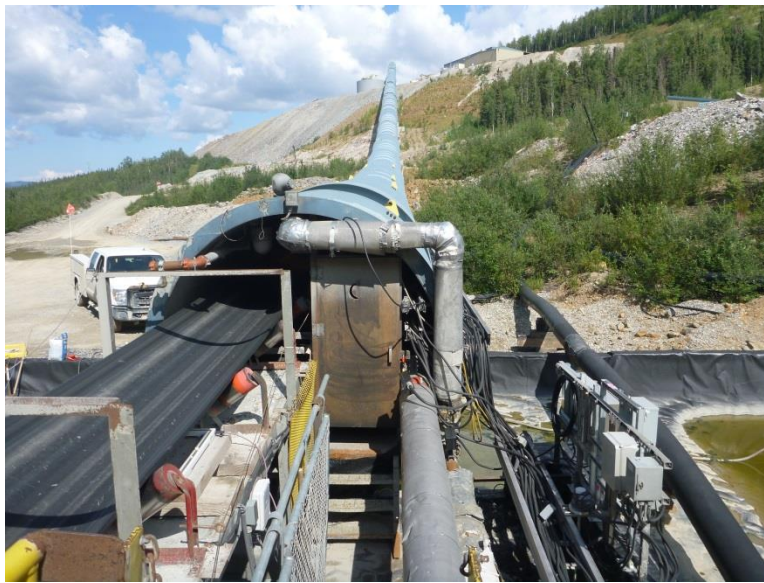
- On May 7, 2015, Pogo witnessed a release of paste outside the splice house (CV002) near the 1690 Portal. Approximately 90,000 gallons of paste was released; no surface water was impacted as the viscous paste material did not flow far from the release point. While secondary containment was in place for the paste line (blue tube), the splice house itself did not have sufficient storage capacity to contain the paste when the pipeline failed. The Audit Team reviewed the corrective action taken by Pogo, which included removal of the splice house and construction of a secondary containment dike system below the blue tube, where the pipeline leaves secondary containment piping and enters the portal (Photo 8, Appendix C). The Audit Team reviewed the calculations supporting the size of the secondary containment, which are adequate, and Pogo has increased the frequency of line inspections. The corrective action appears sufficient to manage any future spills.

**Photo 8. Former Splice House area where paste spill occurred. Plastic liner is part of new secondary containment system. Pipe coming out of blue tube is the paste line that enters into the 1690 portal.**

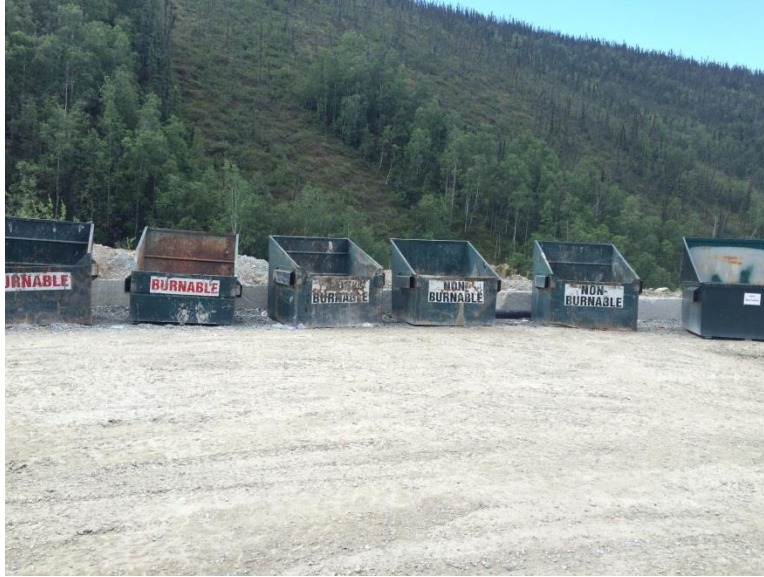
**Photo 9. Best management practice - separation of waste for disposal to on-site incinerator or transported to off-site landfill.**

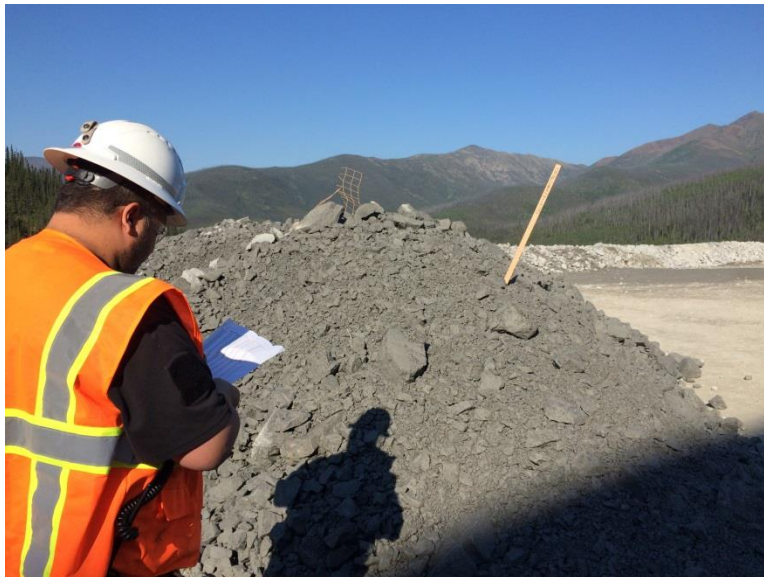
**Photo 10. Waste rock outside of portal labeled with the survey lath and waiting for laboratory results for flagging before ultimate disposal.**

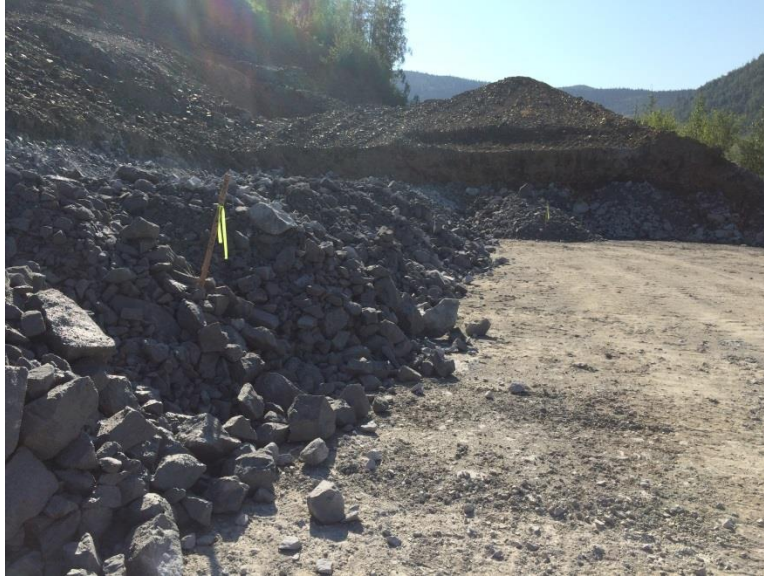
**Photo 11. Non-mineralized rock segregation with flagging outside of portal.**

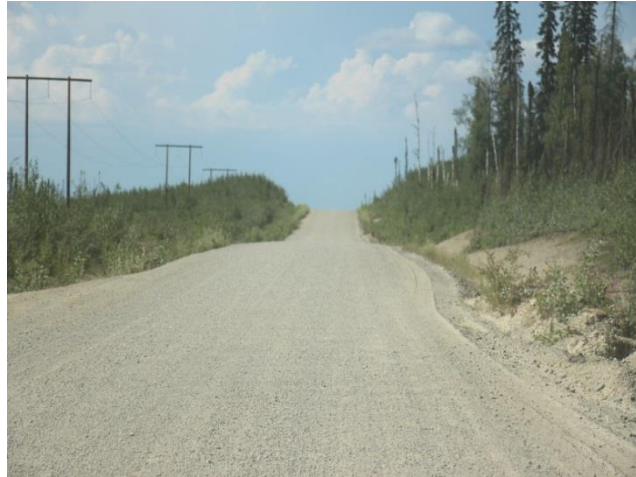
Overall, the Shaw Creek Access Road is in good condition and is routinely maintained to provide safe year-round access to the mine. The driving surface of the road is well maintained with adequate gravel thickness and good drainage and there is little to no wash-boarding, corrugating, or pot-holing. At the time of the inspection, a water truck was on the road performing dust control and a road-grader and roller were conducting routine preventative maintenance.

**Photo 13. Typical Driving Surface on the Shaw Creek Access Road**

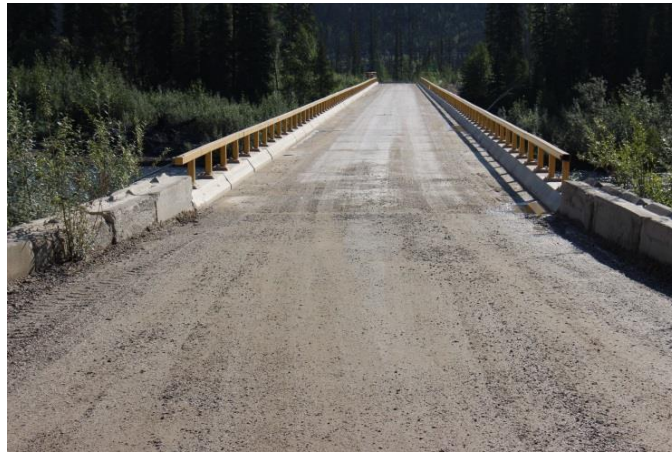
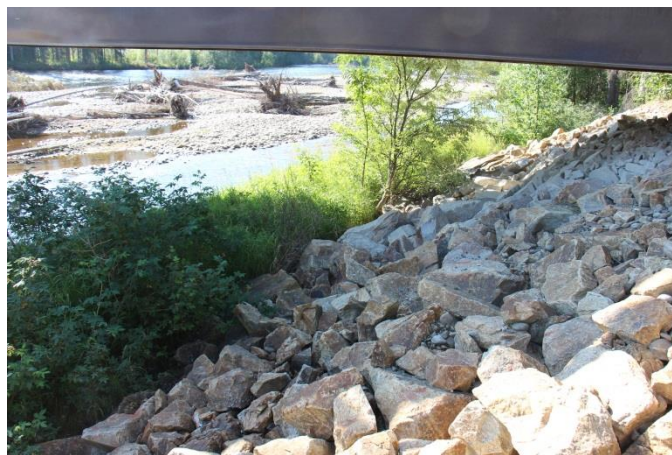
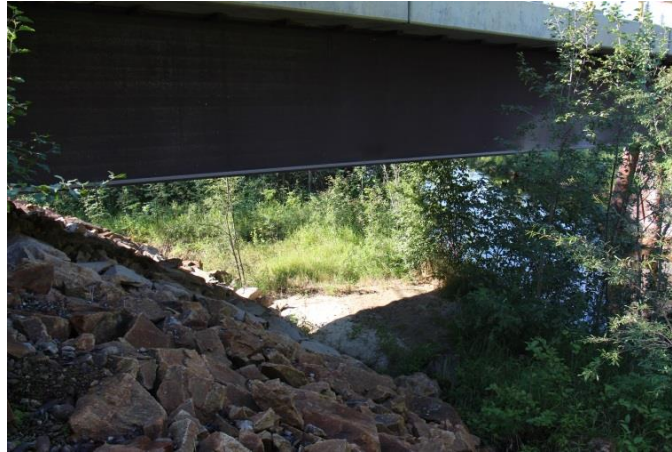
- **Goodpaster River Bridge** – The Goodpaster River Bridge (FHP No. FH03-III-0331) is the longest bridge on the access road (390 feet) and is supported by six bridge spans and three in-water piers. The driving surface of the bridge is concrete and was in good condition at the time of the inspection. Deck drains were clear and there were no obvious signs of distress (i.e., cracking or spalling). Some large woody debris has accumulated on each of the three bridge piers but at the time of inspection was not causing water flow problems beneath the bridge. Scour protection at both abutments was in good condition with no signs of scour and there was mature vegetation between the toe of the scour protection and the river bank.

**Photo 14. Goodpaster River Bridge, Bridge Deck**

**Photo 15. Goodpaster River Bridge Scour Protection, West Bank**

**Photo 16. Goodpaster River Bridge Scour Protection, East Bank**

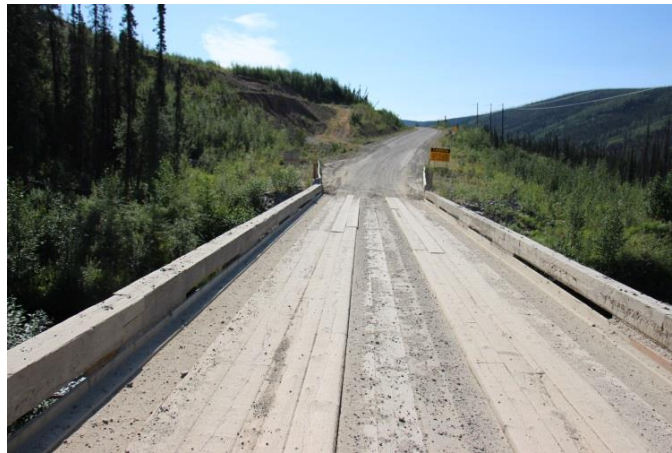
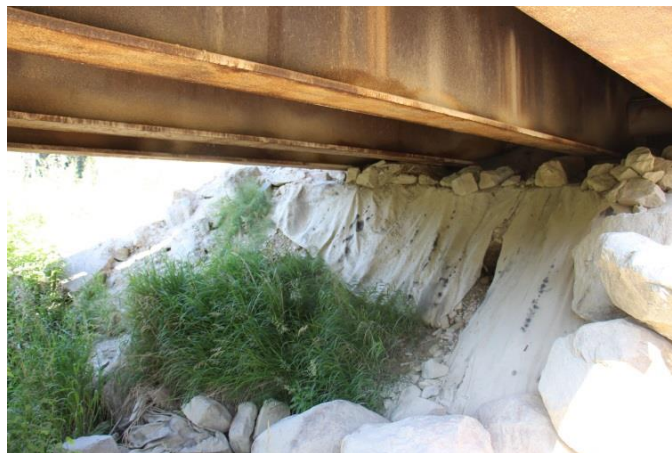
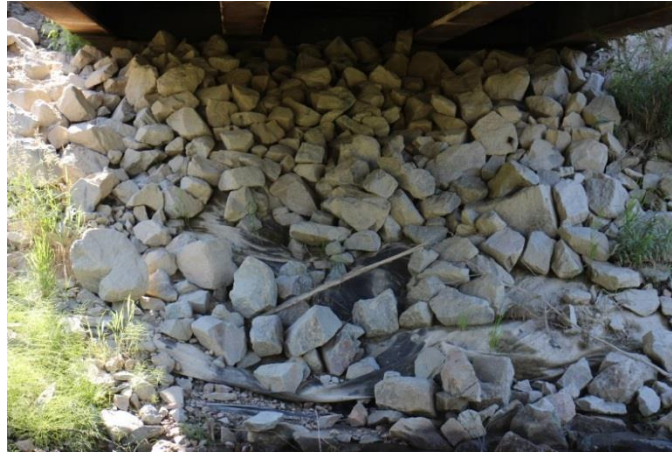
some bridges had obvious signs of erosion near the abutments and in one instance at Shaw Creek the scour protection for one of the bridge abutments was completely washed out and in need of repair.

- **Shaw Creek Bridge** – The Shaw Creek Bridge (FHP No. FH03-III-0335) is a wood decked clear span bridge. The driving surface of the bridge was in fair condition and bridge rails were in good condition at the time of the inspection. A small amount of sedimentation has been washing off of the road and depositing on the flanks of the bridge abutments, though none appeared to be reaching Shaw Creek. The scour protection on the west (i.e., downstream right) bridge abutment was heavily degraded and has been almost completely washed away. The geotextile material at the abutment was exposed across the face. Scour protection at the east abutment was also impacted and had exposed geotextile and obvious signs of erosion, though it was not as degraded. Scour protection at the Shaw Creek Bridge abutments is recommended for repair as soon as possible to avoid potentially dangerous degradation of the bridge abutments and road grade during the next major flood event. It is noted that according to ADFG Division of Habitat Trip Report from September 20, 2016, the riprap had been repaired under the Shaw Creek Bridge.

**Photo 17. Shaw Creek Bridge, Bridge Deck and Rails**

**Photo 18. Shaw Creek Bridge, Degraded Scour Protection**

**Photo 19. Shaw Creek Bridge, Degraded Scour Protection**

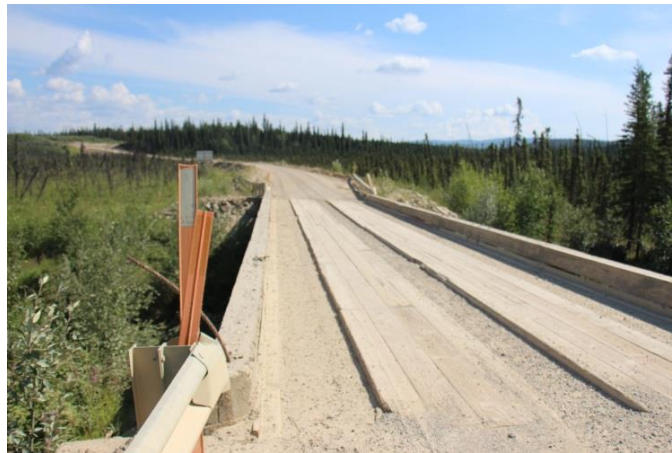
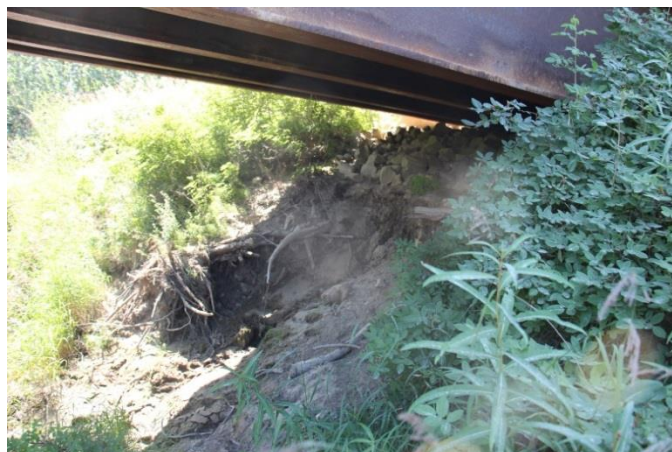
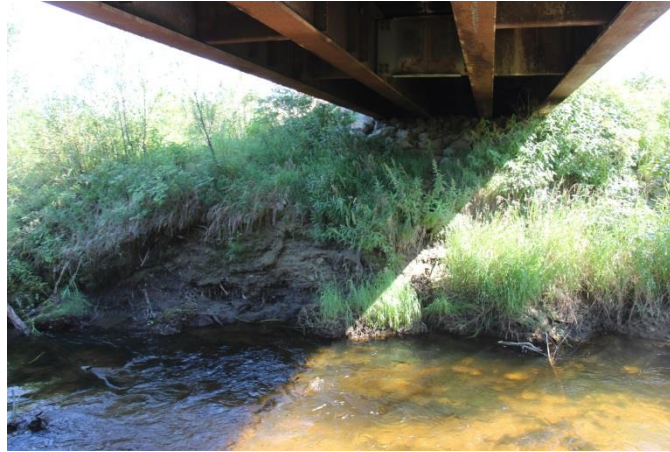
- **Gilles Creek Bridge** - The Gilles Creek Bridge (FHP No. FH03-III-0332) is a wood decked clear span bridge. The driving surface of the bridge was in fair condition and bridge rails were in good condition at the time of the inspection. A minor amount of scour was occurring at the stream bank adjacent to both bridge abutments, but it has not reached the bridge abutments. There was minimal scour protection under the Gilles Creek Bridge, and as the Audit Team observed no immediate need for repairs. However, consideration should be given to proactively preventing additional erosion at the bridge abutments.

**Photo 20. Gilles Creek Bridge, Bridge Deck and Rails**

**Photo 21. Gilles Creek Bridge, Abutment Scour, West Bank**

**Photo 22. Gilles Creek Bridge, Abutment Scour, East Bank**

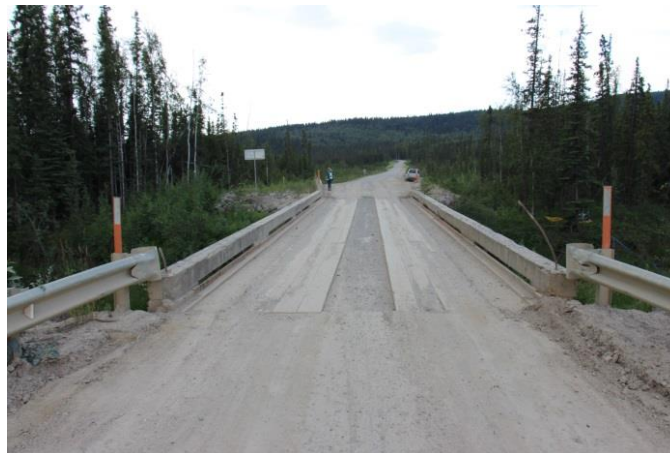
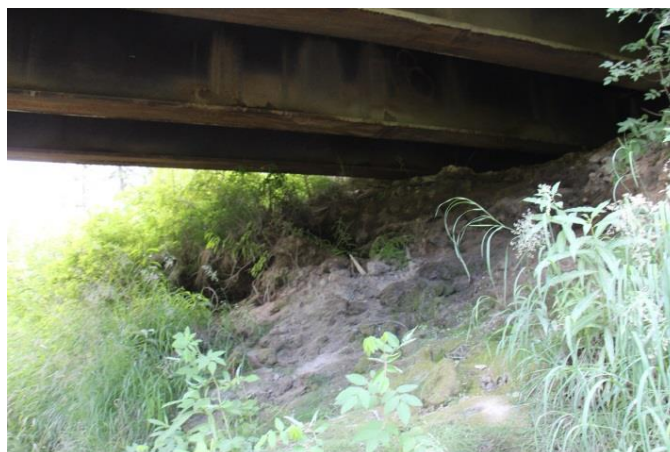
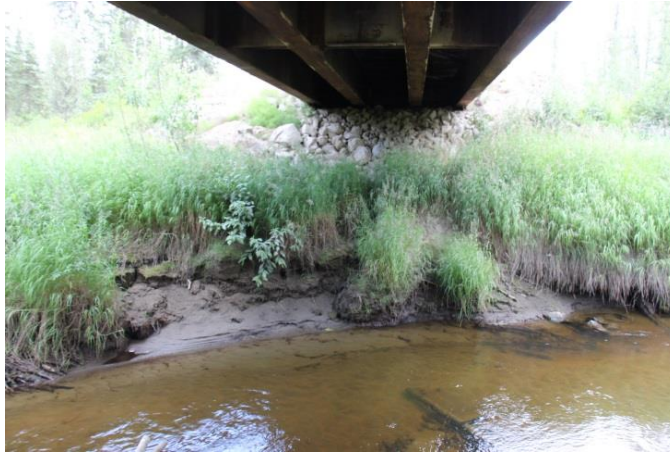
- **Caribou Creek** - The Caribou Creek Bridge (FHP No. FH03-III-0333) is a wood decked clear span bridge. The driving surface of the bridge was in fair condition and bridge rails were in good condition at the time of the inspection. Erosion at the bridge abutments was minimal, with some minor amounts of scour and erosion occurring at the stream bank under the bridge. No immediate concerns were observed by the Audit Team at the Caribou Creek Bridge.

**Photo 23. Caribou Creek Bridge, Bridge Deck and Rails**

**Photo 24. Caribou Creek Bridge, West Bank Abutment, No Scour Protection**

**Photo 25. Caribou Creek Bridge, East Bank Abutment Scour Protection**

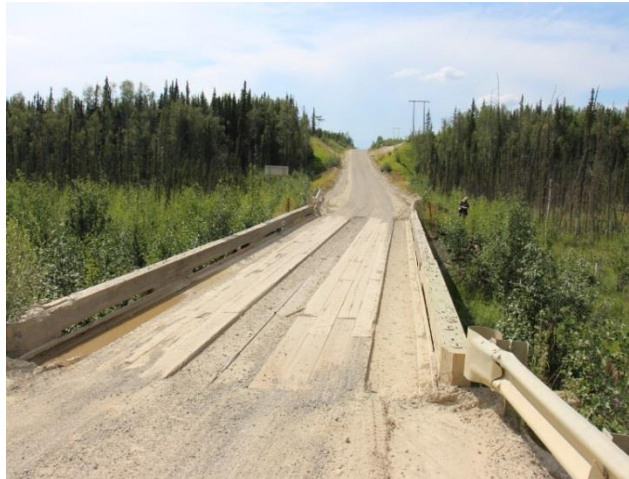
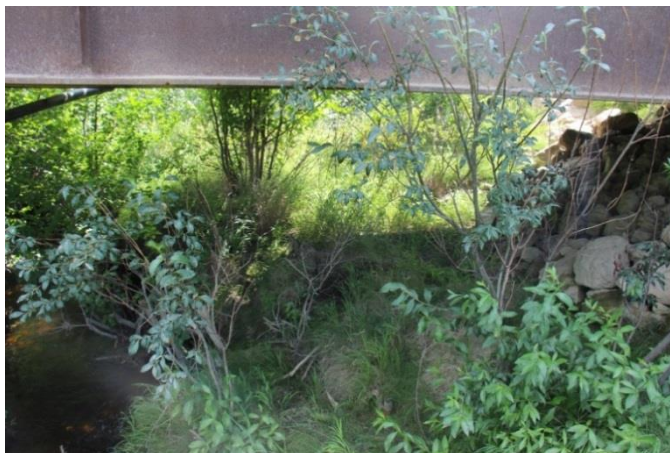
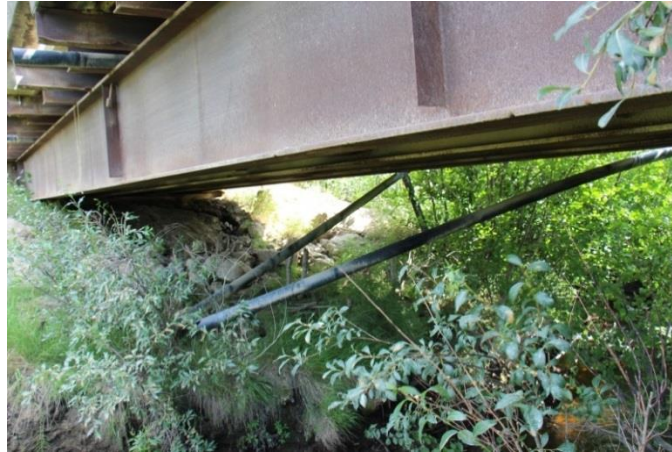
- **West Keystone Creek Bridge** - The West Keystone Creek Bridge (FHP No. FH03-III-0334) is a wood decked clear span bridge. The driving surface of the bridge was in fair condition and bridge rails were in good condition at the time of the inspection. Erosion at the west bridge abutment was minimal. Some scour and erosion is occurring at the east abutment though it was not clear if rip-rap simply sloughed off the face of abutment from a slope failure or was washed off by a high flow event. However, the east side abutment had a minimal amount of rip-rap scour protection. The stream bank was stable had an abundance of vegetation. The Audit Team observed no immediate need for repairs. However, consideration should be given to proactively preventing additional erosion at the bridge abutments.

**Photo 26. West Keystone Creek Bridge, Bridge Deck and Rails**

**Photo 27. West Keystone Creek Bridge, West Bank Scour Protection**

**Photo 28. West Keystone Creek Bridge, East Bank Scour Protection**

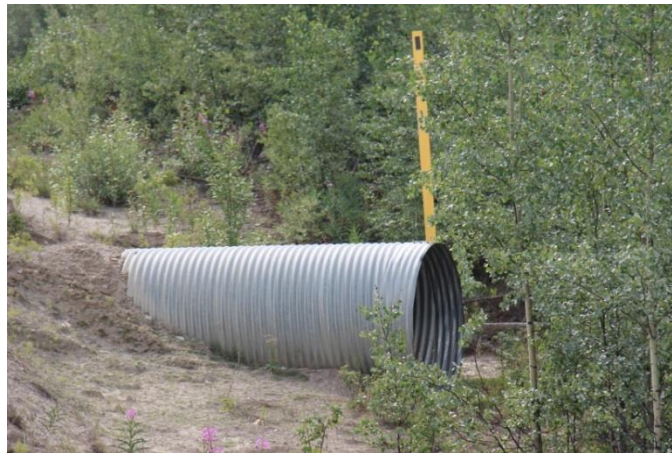
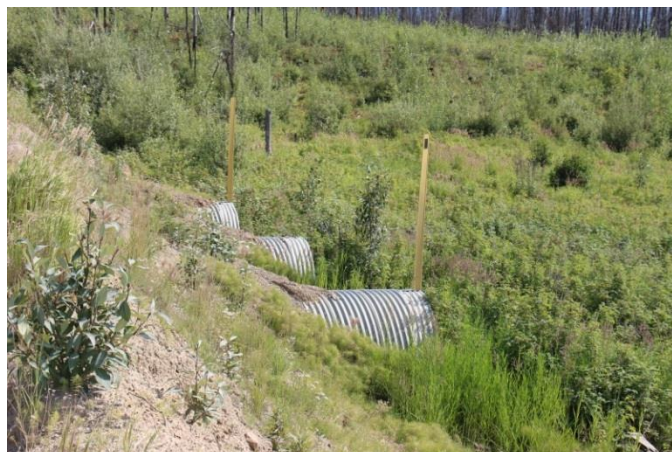
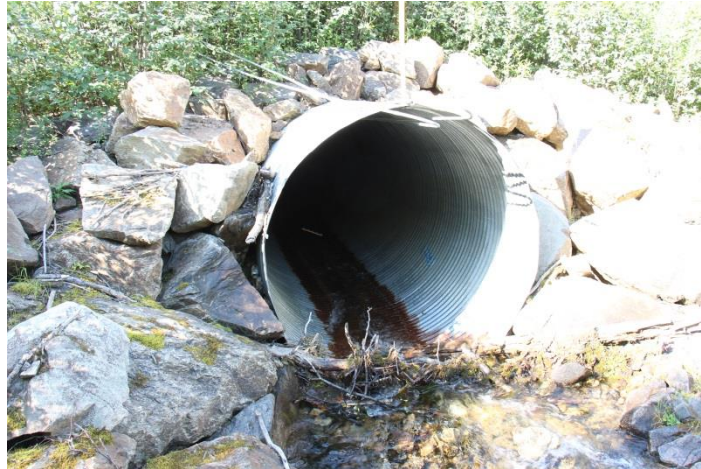
Many locations throughout the road corridor contain cross drainage culverts. A majority of the culverts were dry at the time of the inspection. Photographs of drainage culverts visited during the audit are included in Appendix C. The only culvert observed with active flow was at Wolverine Creek and water flow was low at the time of the inspection. All of the culverts were in good condition with no obvious signs of corrosion, overtopping, or scour.

**Photo 29. Typical Drainage Culvert**

**Photo 30. Three Pipe Gulch**

**Photo 31. Wolverine Creek Culvert**

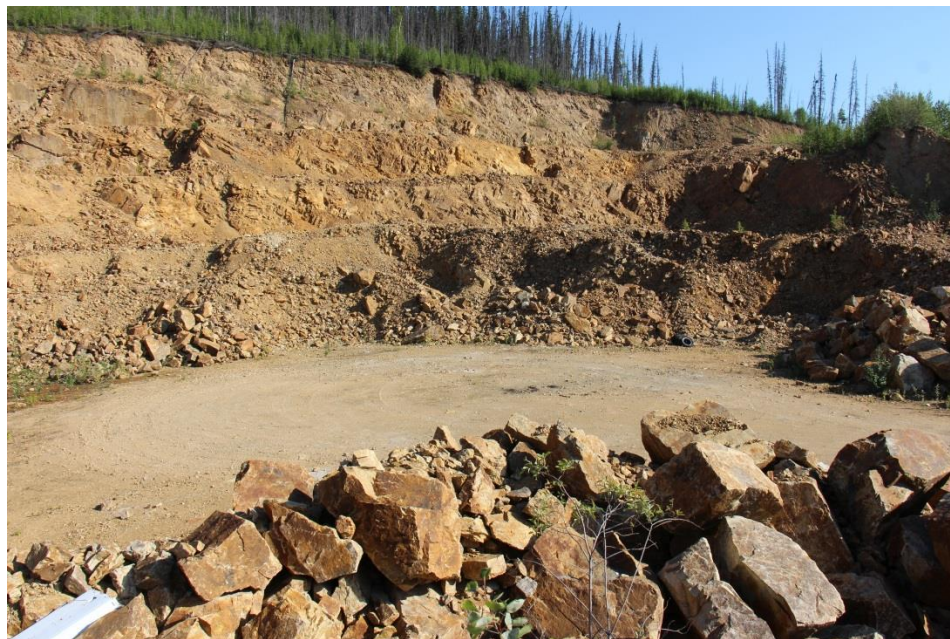
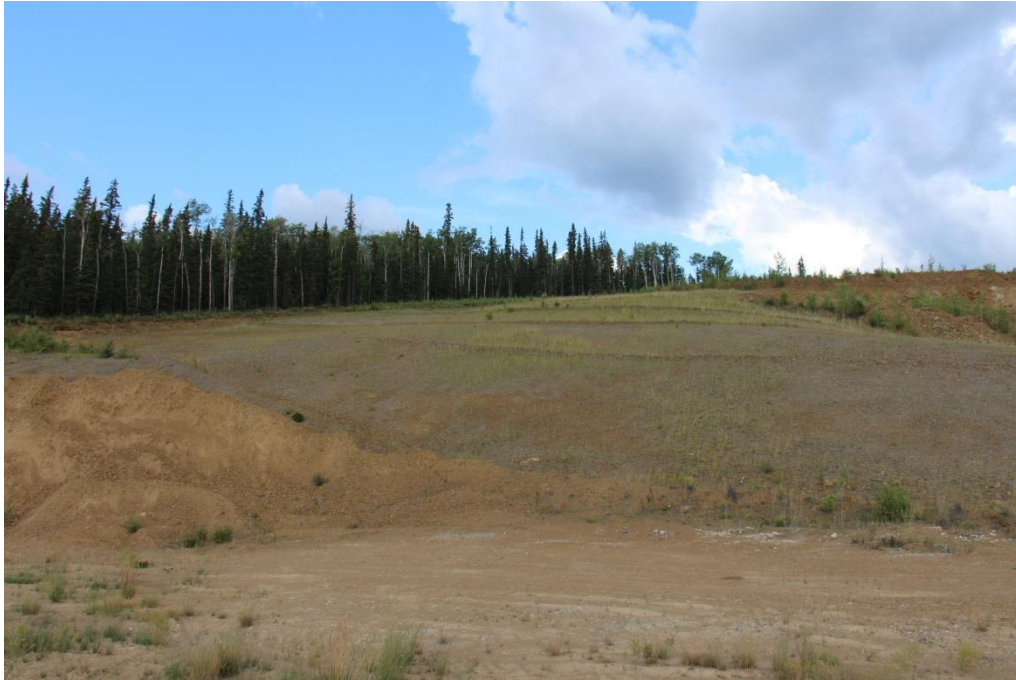
Roadside material sites were inspected, none of which were active at the time of the inspection and no issues were observed.

**Photo 32. Material Site near the West Bank of the Goodpaster River Bridge**

**Photo 33. Material Site Located Between Caribou Creek and W. Keystone Creek**

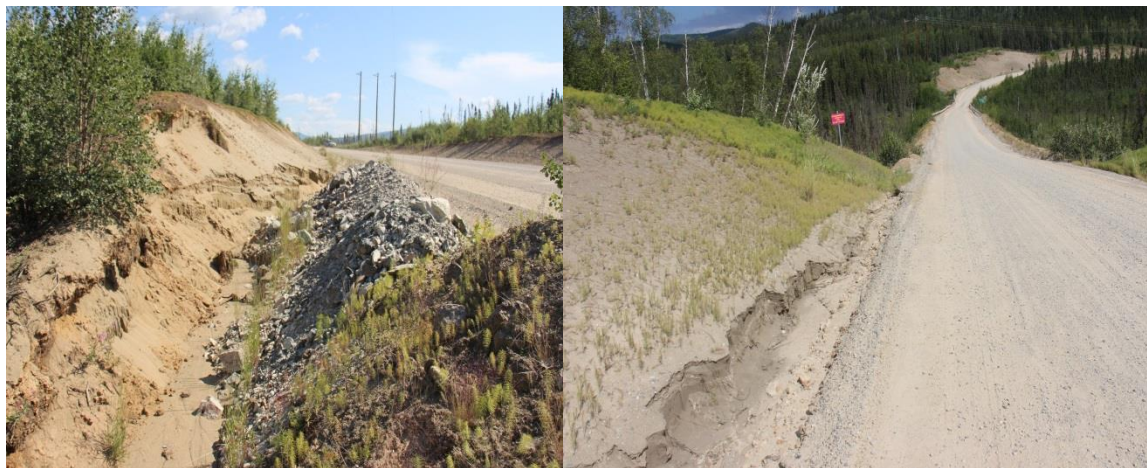
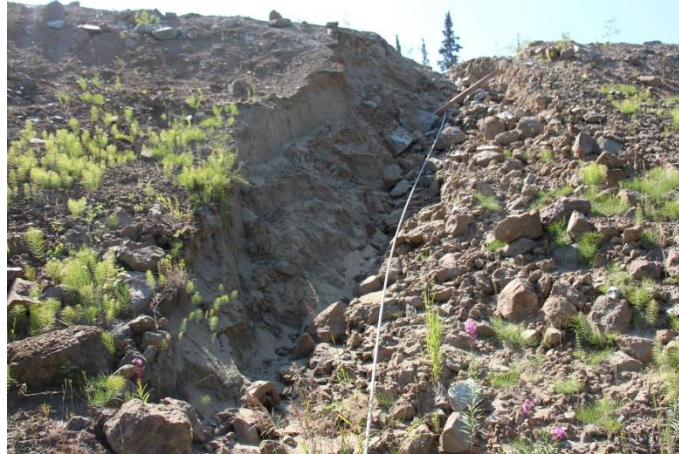
The Audit Team observed erosion and sedimentation at several localized areas within the road corridor. The soils along the road corridor are largely composed of sand, which is highly erodible. Areas where the road transitions from a cut to fill are experiencing the greatest levels of erosion and sedimentation. Additionally, barriers placed along the road are also contributing to localized erosion along the edge of the driving surface. The barriers cause water to accumulate alongside of the road surface, which then runs to a low spot causing erosion at the road surface and fill embankment, as well as sedimentation at the base of the road embankment. At least one location, at Gold Hub Creek, heavy erosion of the road bank that needs immediate attention was observed, see photos in Appendix C.

**Photo 34. Erodible Soil (Sand) on Road Cut**

**Photo 35. Road Bank Erosion at Gold Creek Gulch**

Because most of the problems are localized and relatively small in scale, best management practices for runoff, erosion, and sediment control could be employed to address these conditions.

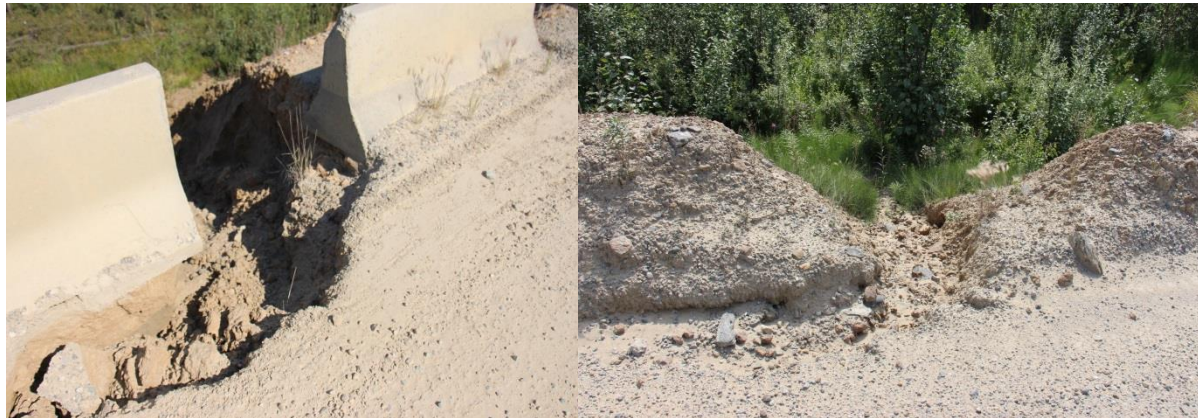
The western approach to the Gilles Creek Bridge is also experiencing erosion on the shoulder of the road. Shoulder erosion is being caused by Jersey Barriers here and at other locations throughout the road corridor. The barriers direct runoff along the edge of the road to low spots, which results in erosion. This type of erosion could be addressed at problem locations using best management practices for stormwater erosion and sediment control.

**Photo 36. Erosion Caused by Roadside Barriers**

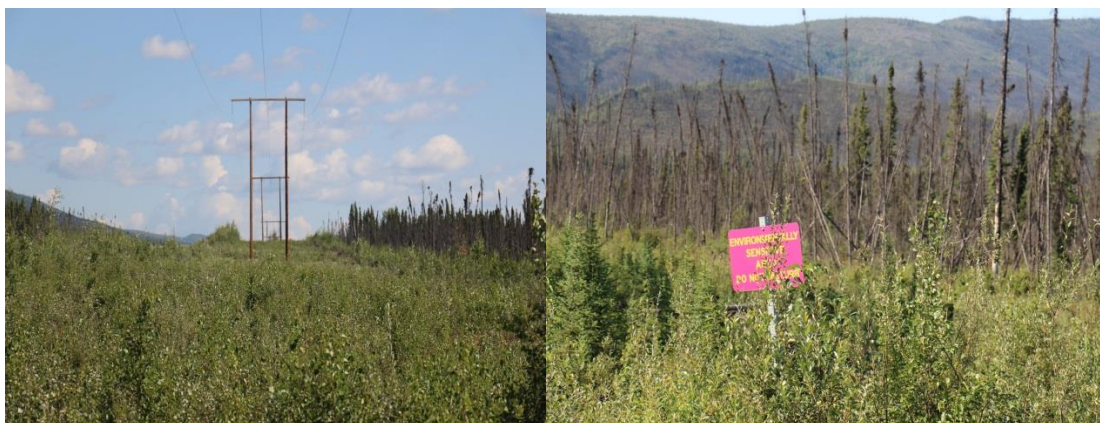
The transmission line is carried by wooden H-Frame poles which are spaced approximately 1,000 feet apart. Vegetation in the right-of-way is cleared near ground level to keep the power lines clear of vegetation and to help protect it from wildfires. Vehicles and clearing equipment that operate within the right-of-way must prevent ground disturbances that will expose mineral soil to thermal degradation and erosion.

**Photo 37. Typical Conditions for Transmission Line and Environmentally Sensitive Area Sign Alaska Road and Transmission Line Corridor**
