## DEPARTMENT OF NATURAL RESOURCES

### INSPECTION REPORT POGO PROJECT

**Inspection Date:** May 19, 1999  
**Report Date:** May 24, 1999  
**Weather:** sunny, temperature in the 60's, wind 0-5 mph down river  
**Operator Contact:** Jason Morrison, Teck; Denise Herzog, Teck; Ed Grozik, EBA  
**Agency Personnel:** Steve McGroarty, DMWM  
**Inspection Objectives:** Inspect waste rock storage facility liner and over-liner material placement.

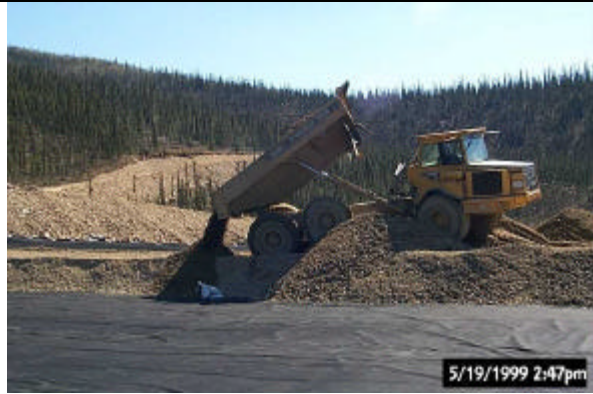
**Non-Mineralized Waste Rock Storage Facility:** Installation of the geotextile on top to the liner had been completed and 4' thick access road had been constructed with 2" minus over-liner material up the center of the non-mineralized waste rock storage facility. A haul truck was end-dumping additional 2" minus material along the edges of this roadway and this material was being spread with a Cat D-7 dozer (Figure 1 & 2). Jason Morrison removed several pieces of "root material" that was present in the 2" material coming from the gravel pit. I requested that Ed Grozik (EBA) ensure that no woody debris that could represent a threat to the integrity of the liner be incorporated into the over-liner material.

**Figure 1.** End dumping two-inch minus over-liner.

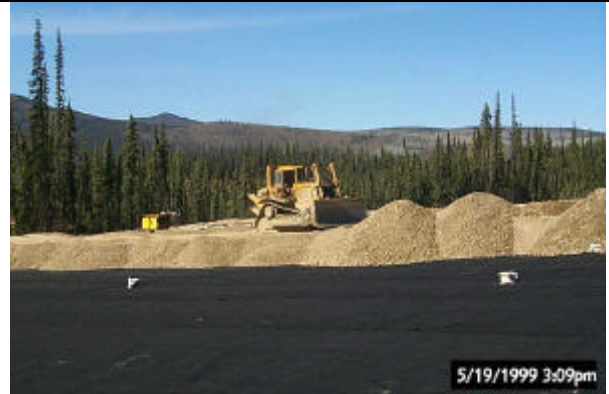
**Figure 2.** D-7 dozer spreading over-liner.

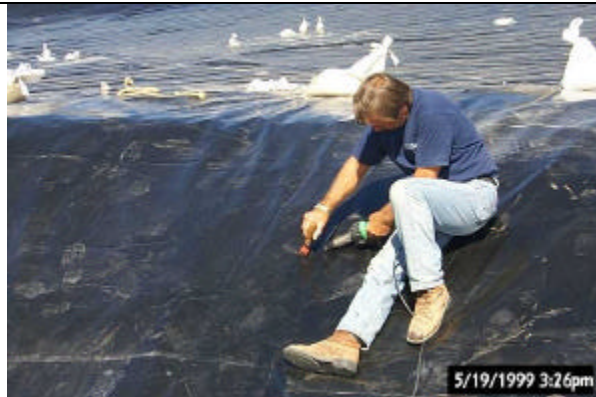
**Mineralized Waste Rock Storage Facility:** Liner installation was essentially complete with final seam work and vacuum testing of seams occurring in the ditch along the bottom the mineralized waste rock storage area (Figure 3 & 4).

**Figure 3.** Lystering liner seam in ditch.

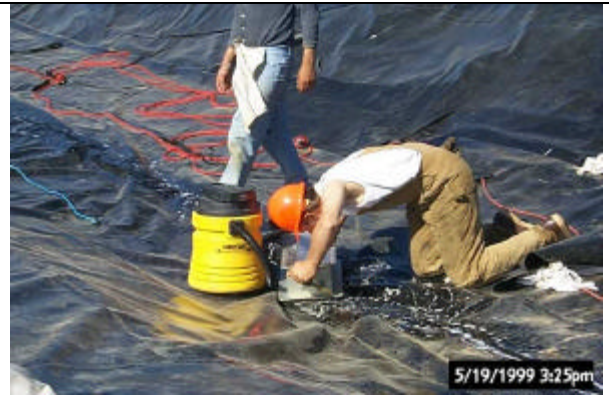
**Figure 4.** Vacuum testing of welded liner seam in ditch.
