# TRIP REPORT

**State of Alaska  
Department of Fish and Game**

*Location(s):* **Red Dog Mine / Anarraaq Prospect**

*Objective(s):* Periphyton, aquatic invertebrate, and sediment sampling

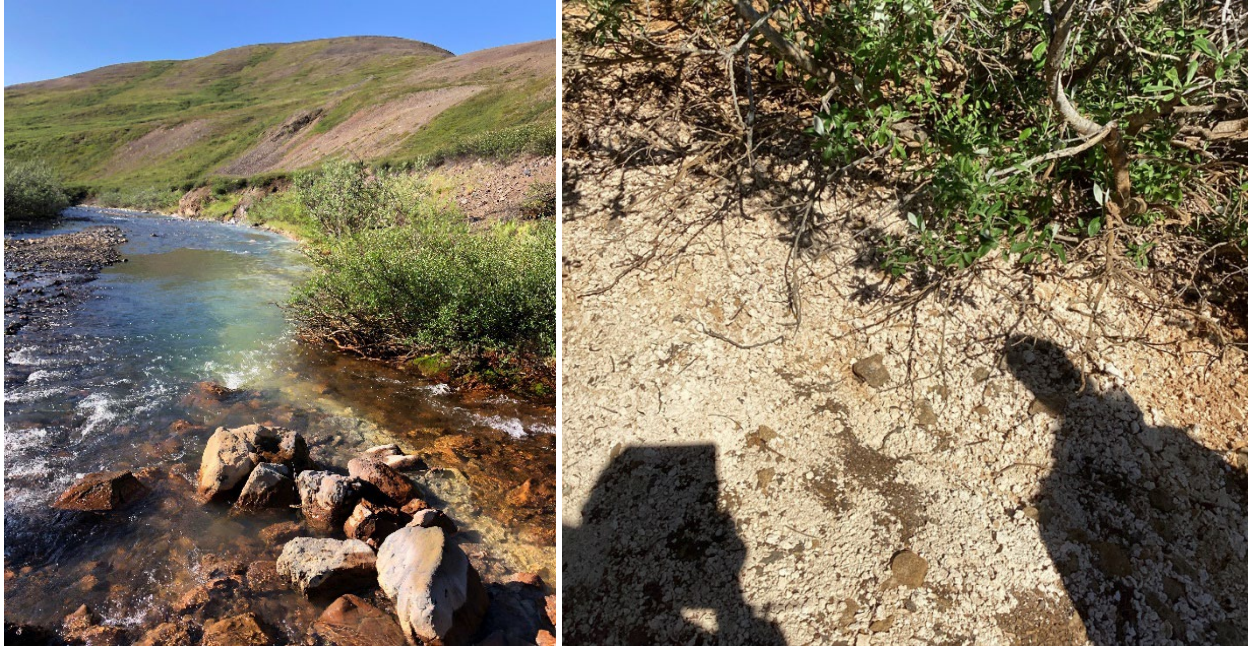
**Figure 2.** West Fork Ikalukrok Creek (left) mixing with Ikalukrok Creek forming a white solid precipitate and milky waters. Solid white sediment/precipitate found at the mouth of Noa Creek (right).

New to Red Dog sampling parameters in July 2022, water quality was recorded at each site with a multiparameter YSI unit. Water chemistry parameters such as pH were highly variable among sites- for example, pH was as low as 3.65 and 3.66 at Moil and Warf Creek, and as high as 8.32 at Buddy Creek below the falls (Table 2). Low pH values often coincided with many of the metal-heavy, red-stained, smaller creeks. Solid precipitate (often white in color) was found at

several sample sites (Figure 2), and was previously observed in the July 2020 trip report at the confluence of West Fork Ikalukrok Creek. Solid precipitate forms as low pH waters mix with circumneutral waters, potentially explaining our sightings.

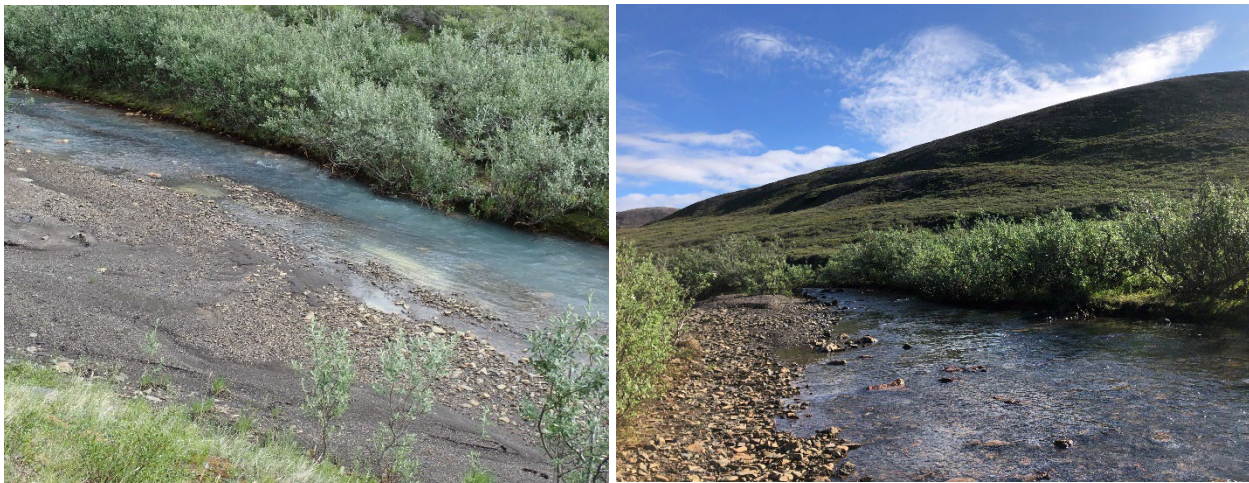
**Figure 3.** Ikalukrok Creek upstream of the West Fork Ikalukrok Creek mouth in July 2020 (left) and July 2022 (right).

Turbidity has been a concern at many of the creeks, and this year we observed similar water conditions as in July 2020 and July 2021. Notably, Ikalukrok Creek downstream of Dudd Creek and Mainstem Red Dog Creek appeared to be less milky than previous years. Ikalukrok Creek upstream of the West Fork confluence was reported clear this year which differs from the past two years of milky/blueish water, especially when stream levels were lower in July 2020 (Figure 3). This year we used a portable turbidity meter which may prove useful in the future for quantifying comparisons of turbidity measurements.

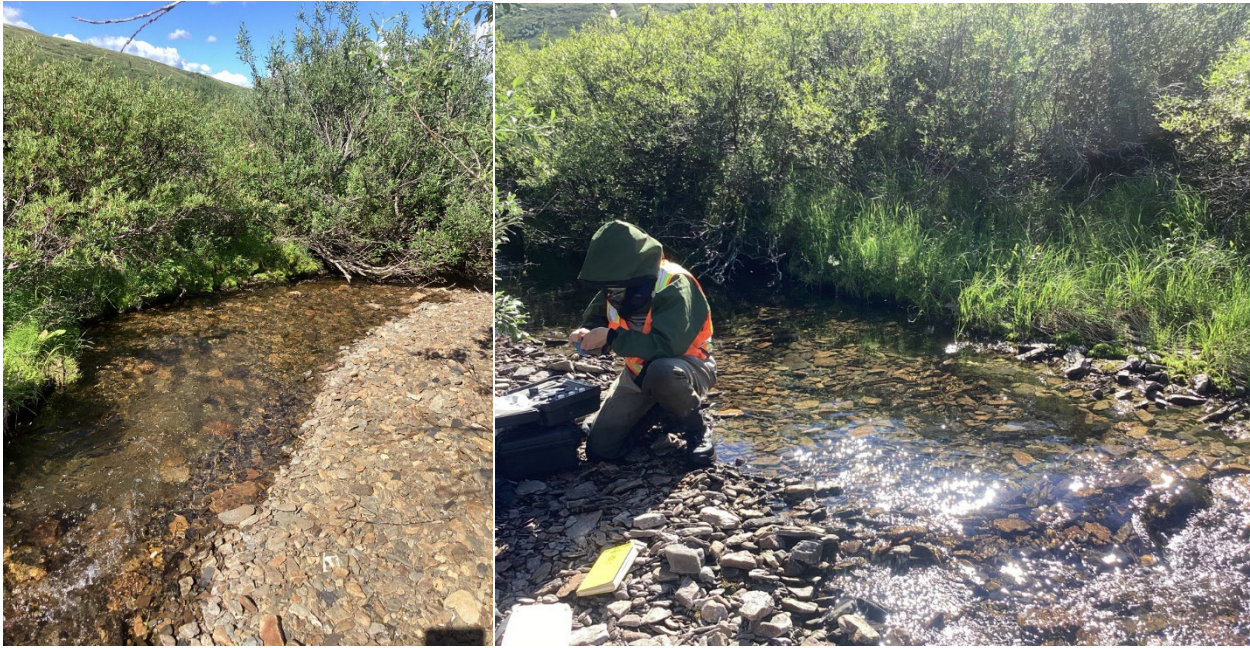
**Figure 4.** Upper North Fork Red Dog 1 downstream (left) and upstream (right).

Three additional sites in the upper North Fork Red Dog (NFRD), Grayling Junior, and Volcano creeks were visited. NFRD 1 and Grayling Jr 1 were minnow trapped in August 2021. Upper NFRD 1 had similar habitat characteristics as Upper NFRD with clear water, but appeared to be a slightly higher gradient (Figure 4). One Dolly Varden was observed at Upper NFRD 1 while collecting invertebrates and periphyton. Grayling Jr 1 was upstream of a tributary that was

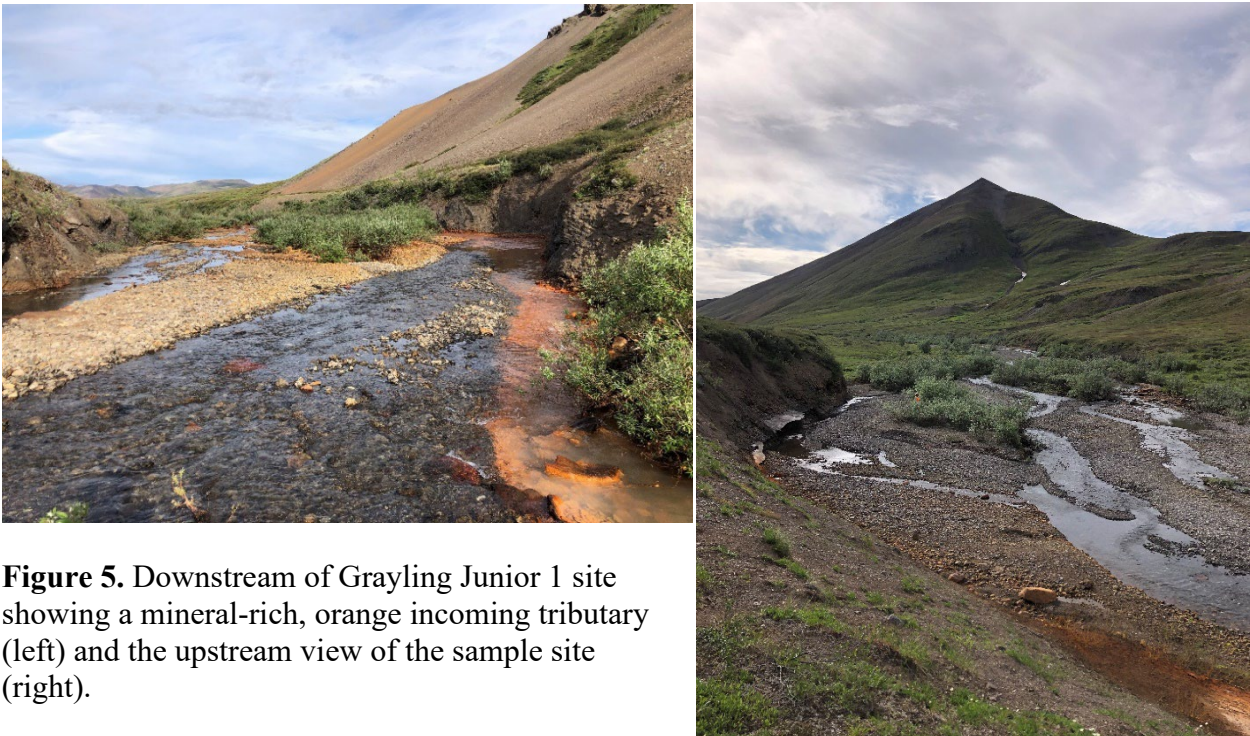
**Figure 5.** Downstream of Grayling Junior 1 site showing a mineral-rich, orange incoming tributary (left) and the upstream view of the sample site (right).

stained orange (Figure 5). Orange staining occurred all over the narrow riparian area on the incoming tributary. There was also orange stained aufeis near our sample site, shown in the bottom corner of Figure 5. Grayling Jr 1 had meandering channels along gravel bars with clear water. Upper Volcano Creek site had a steeper gradient with large moss-covered boulders (Figure 6).

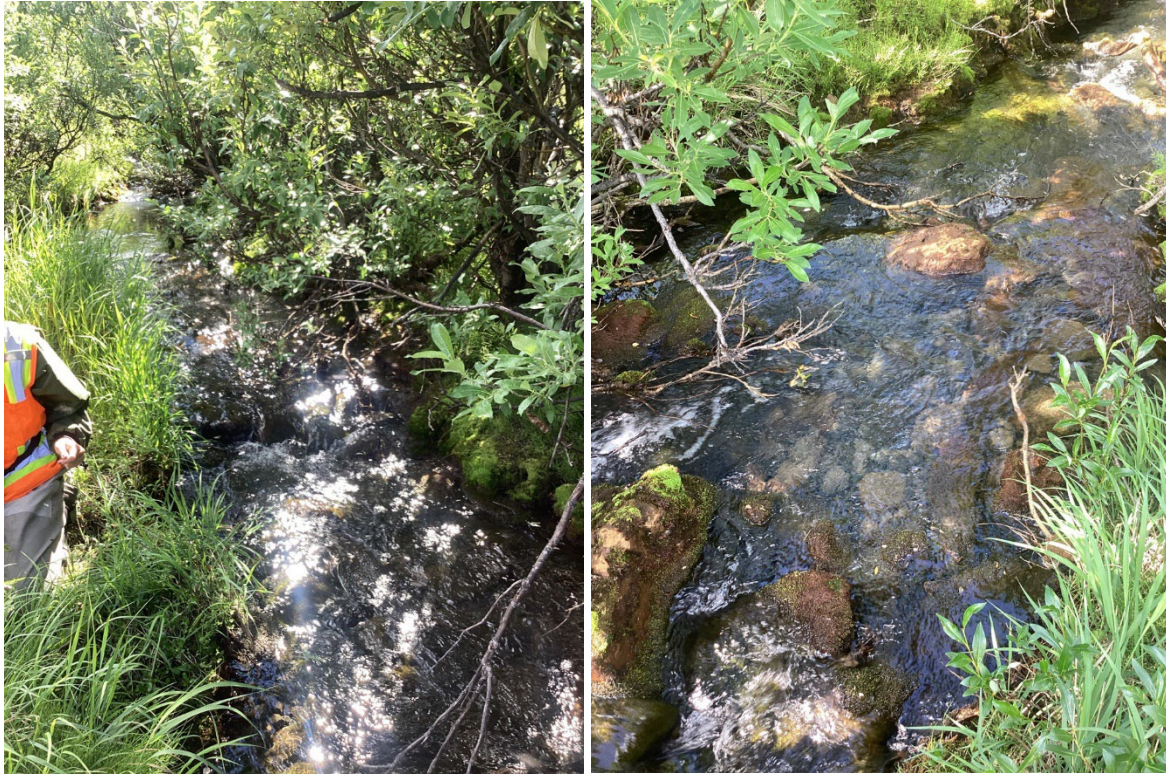
**Figure 6.** Dense shrubbery along Upper Volcano Creek (left) and moss-covered boulders and large cobble (right).
