Red Dog Operations

**4th Quarter Report & Annual
Waste Management Permit 2021DB0001
Reclamation Plan Approval F20219958**

February 28, 2022

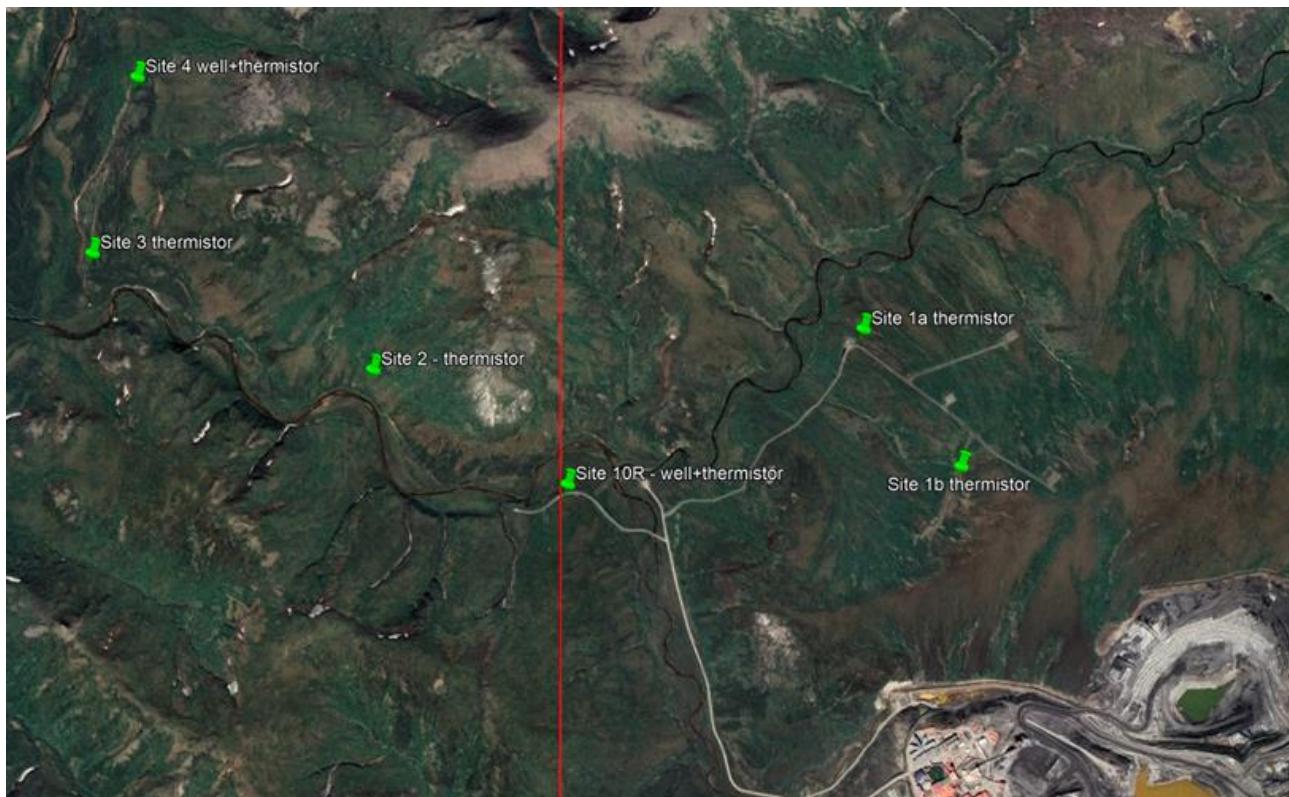
Figure 1 - Shallow Active Layer Thermistor Well Locations

In April 2021, six shallow thermistor and monitoring wells were installed in various locations within the Red Dog Creek and Ikalukrok Creek valleys. Figure 1- Shallow Active Layer Thermistor Locations depicts their locations. The installations were initially part of an internal investigation by Red Dog Operations to access changing permafrost conditions observed in the area and to help determine the source and cause of high Total Dissolved Solids (TDS) observed in Red Dog Creek and Ikalukrok Creek.

The source of the high TDS water is hypothesized to be shallow groundwater from melting permafrost. The purpose of installing thermistors and monitoring wells in undisturbed areas away from Red Dog Operations is to monitor shallow ground temperature, potential permafrost thaw, and groundwater presence and water quality that may be caused by the long-term warming trends observed in the area. Additional shallow monitoring well installations are being reviewed for the 2022 year.

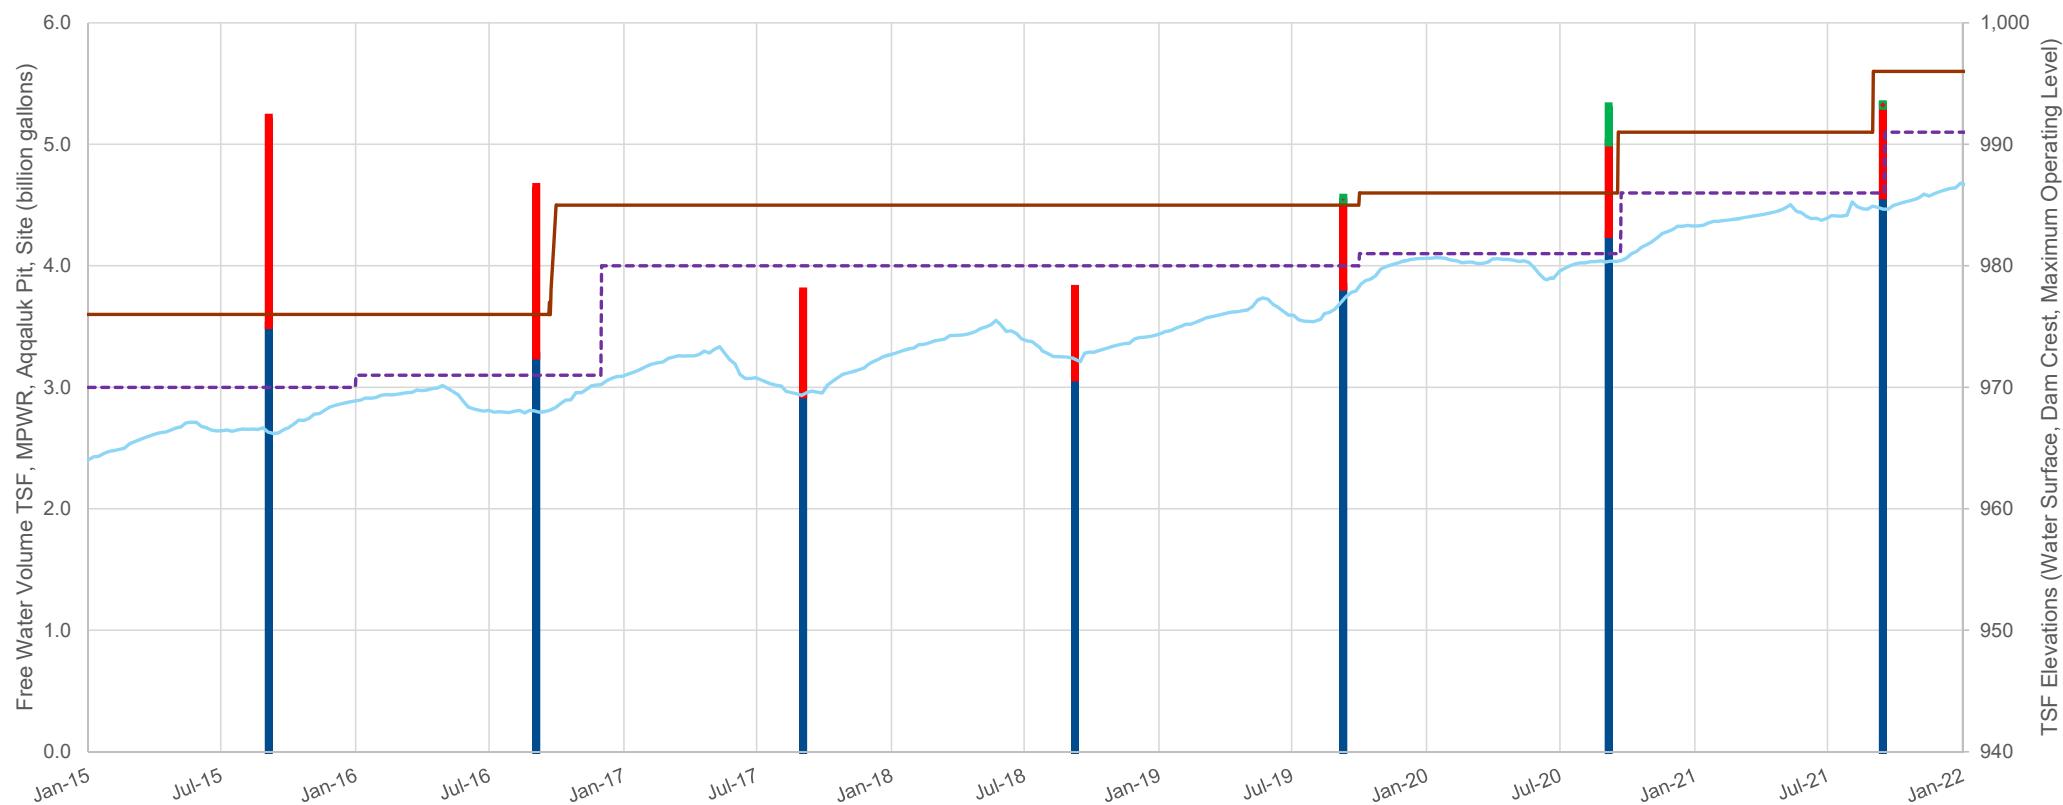
Figure 2 Water Balance & Tailing Storage Facility Water Surface Elevation

A mine water balance computer simulation program is maintained using GoldSim software. The GoldSim simulation generated a water balance projection for Life of Mine (LOM) by predicting surface water elevation in the Tailings Storage Facility. Figure 1 depicts simulated Tailings Storage Facility elevation based on current operations. A free water inventory chart is provided in Figure 2 which represents historic trends through 2021 and includes water volumes for the Tailings Storage Facility, Main Pit Water Reservoir and Aqqaluk Pit.

Current Volume (Mgal) (as of Dec 28 th YR2021)
Aqqaluk	2
MPWR	529
TSF	5,020
Total	5,551

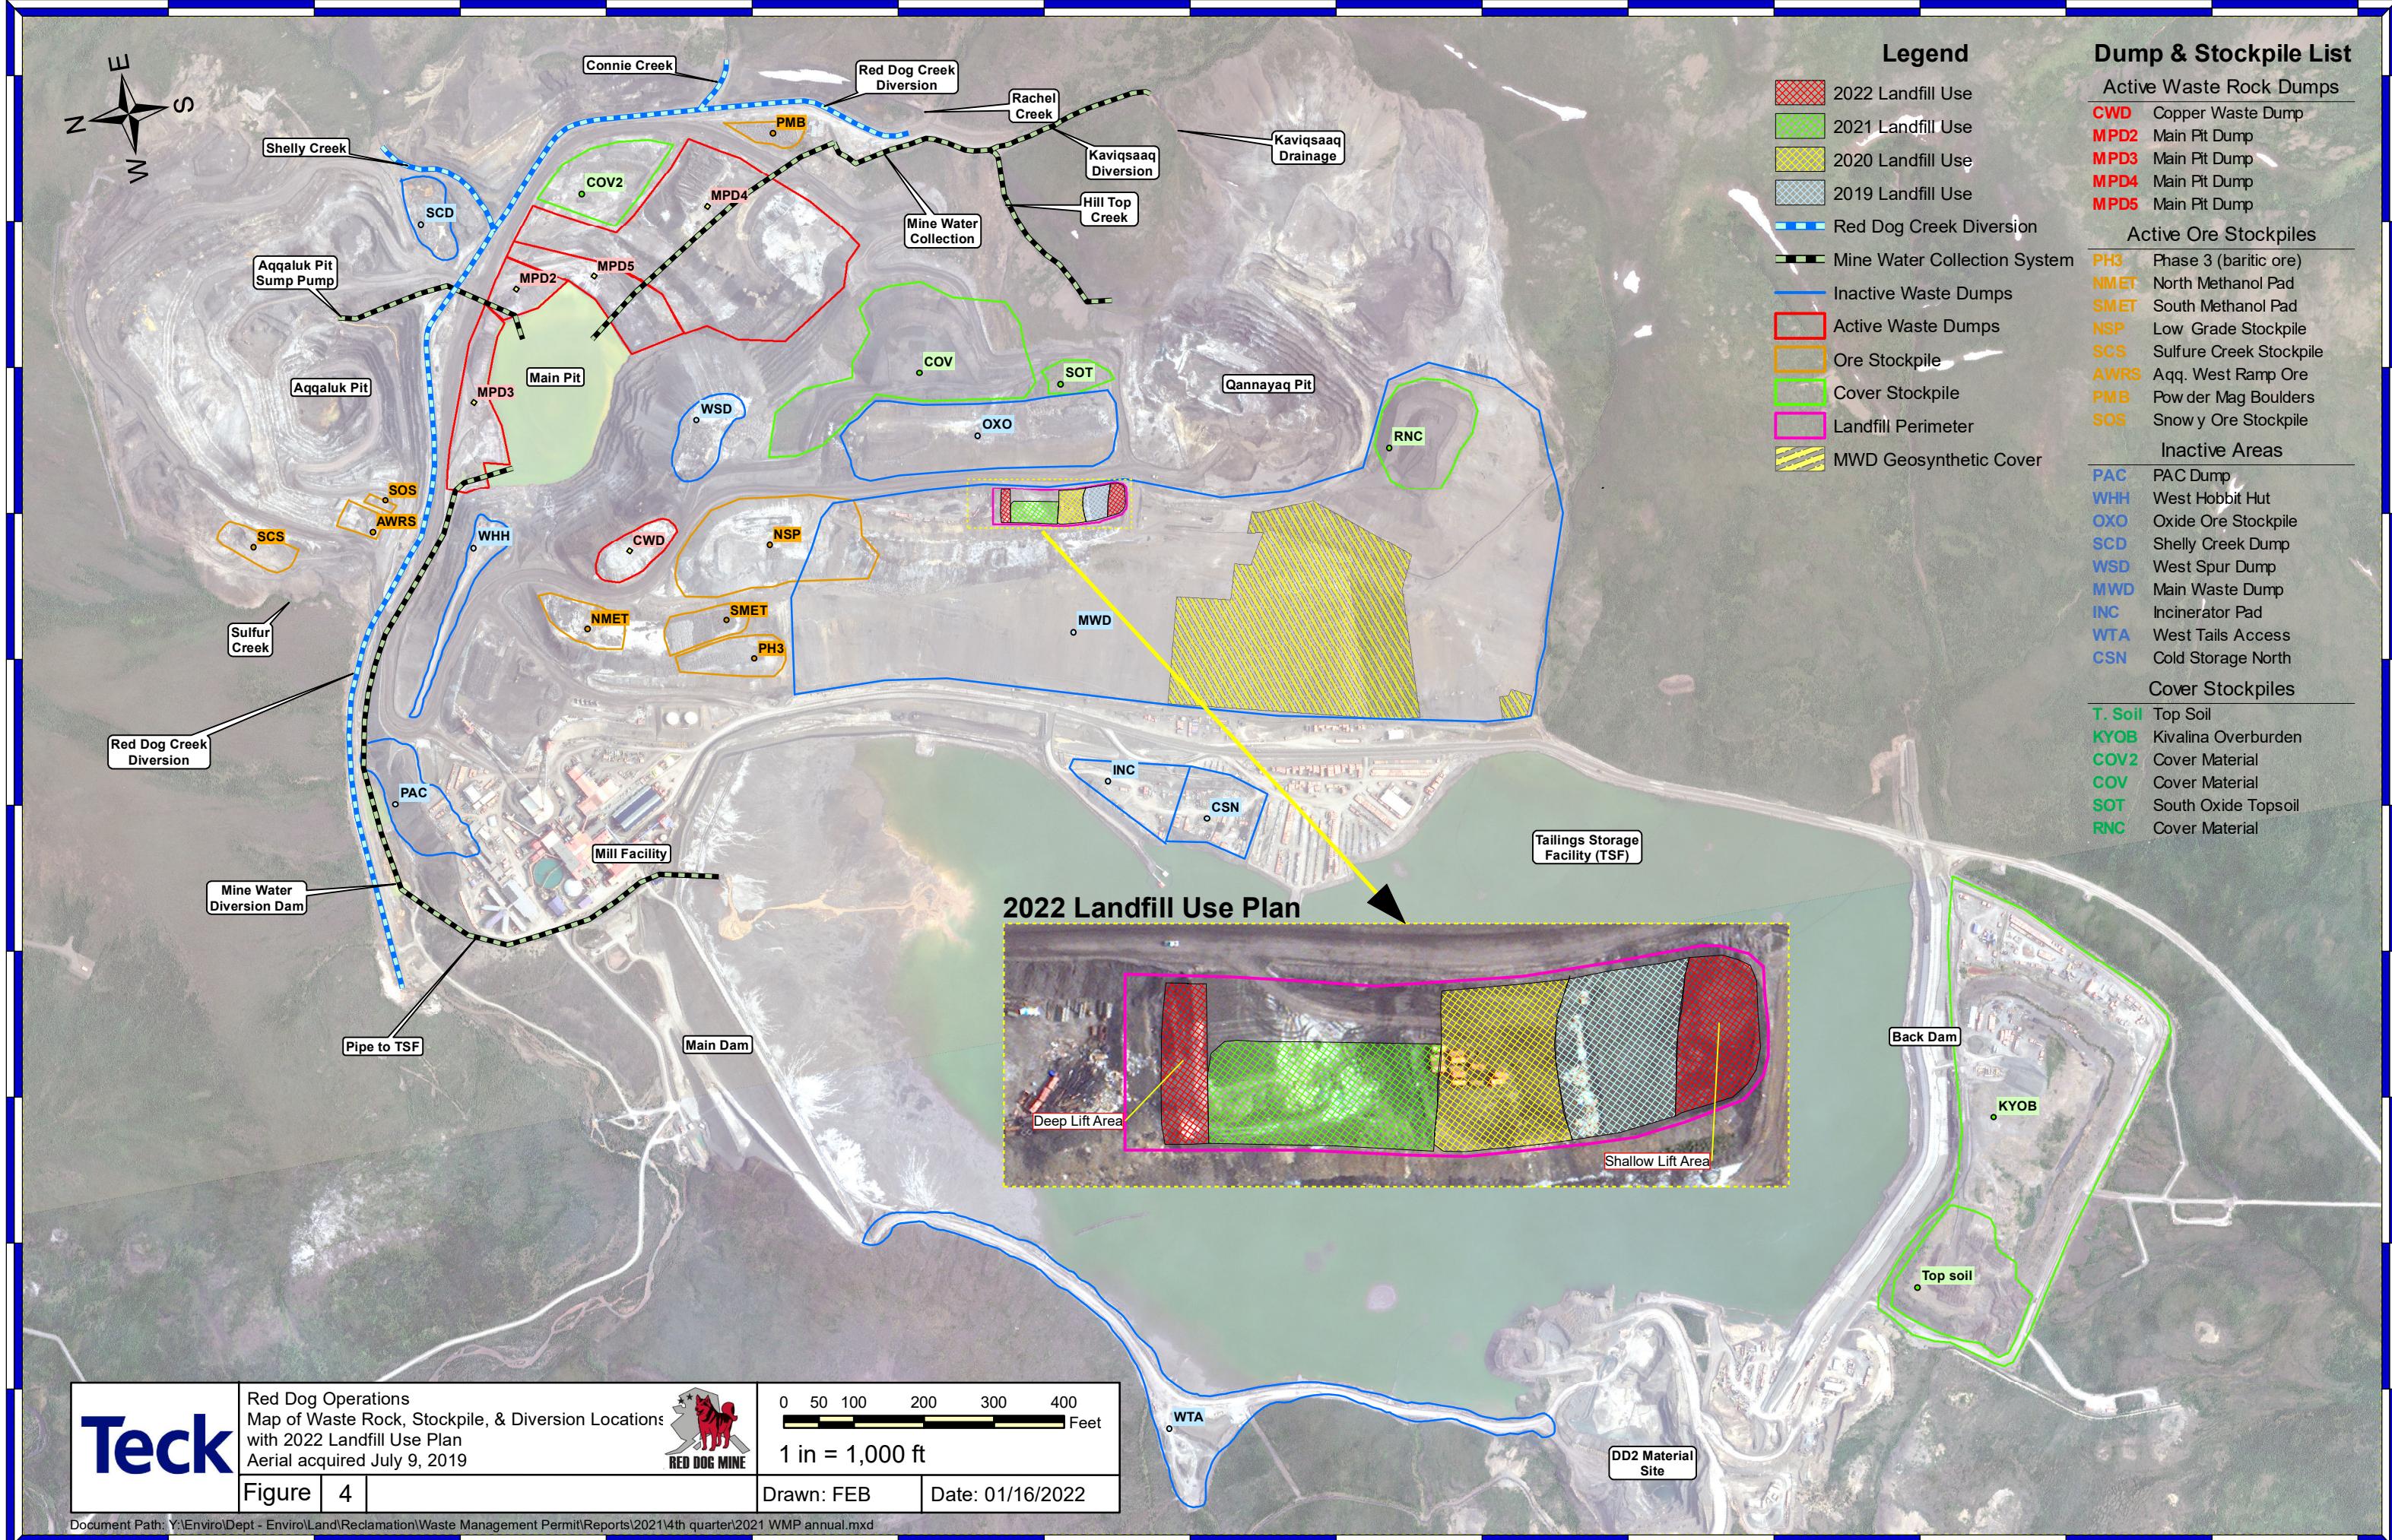
While not waste rock a new cover material stockpile was added during the 2021 year and named the Cover 2 (COV2) stockpile. The new stockpile area is depicted on Figure 4 – *Map of Waste Rock, Stockpile & Diversion Locations*.

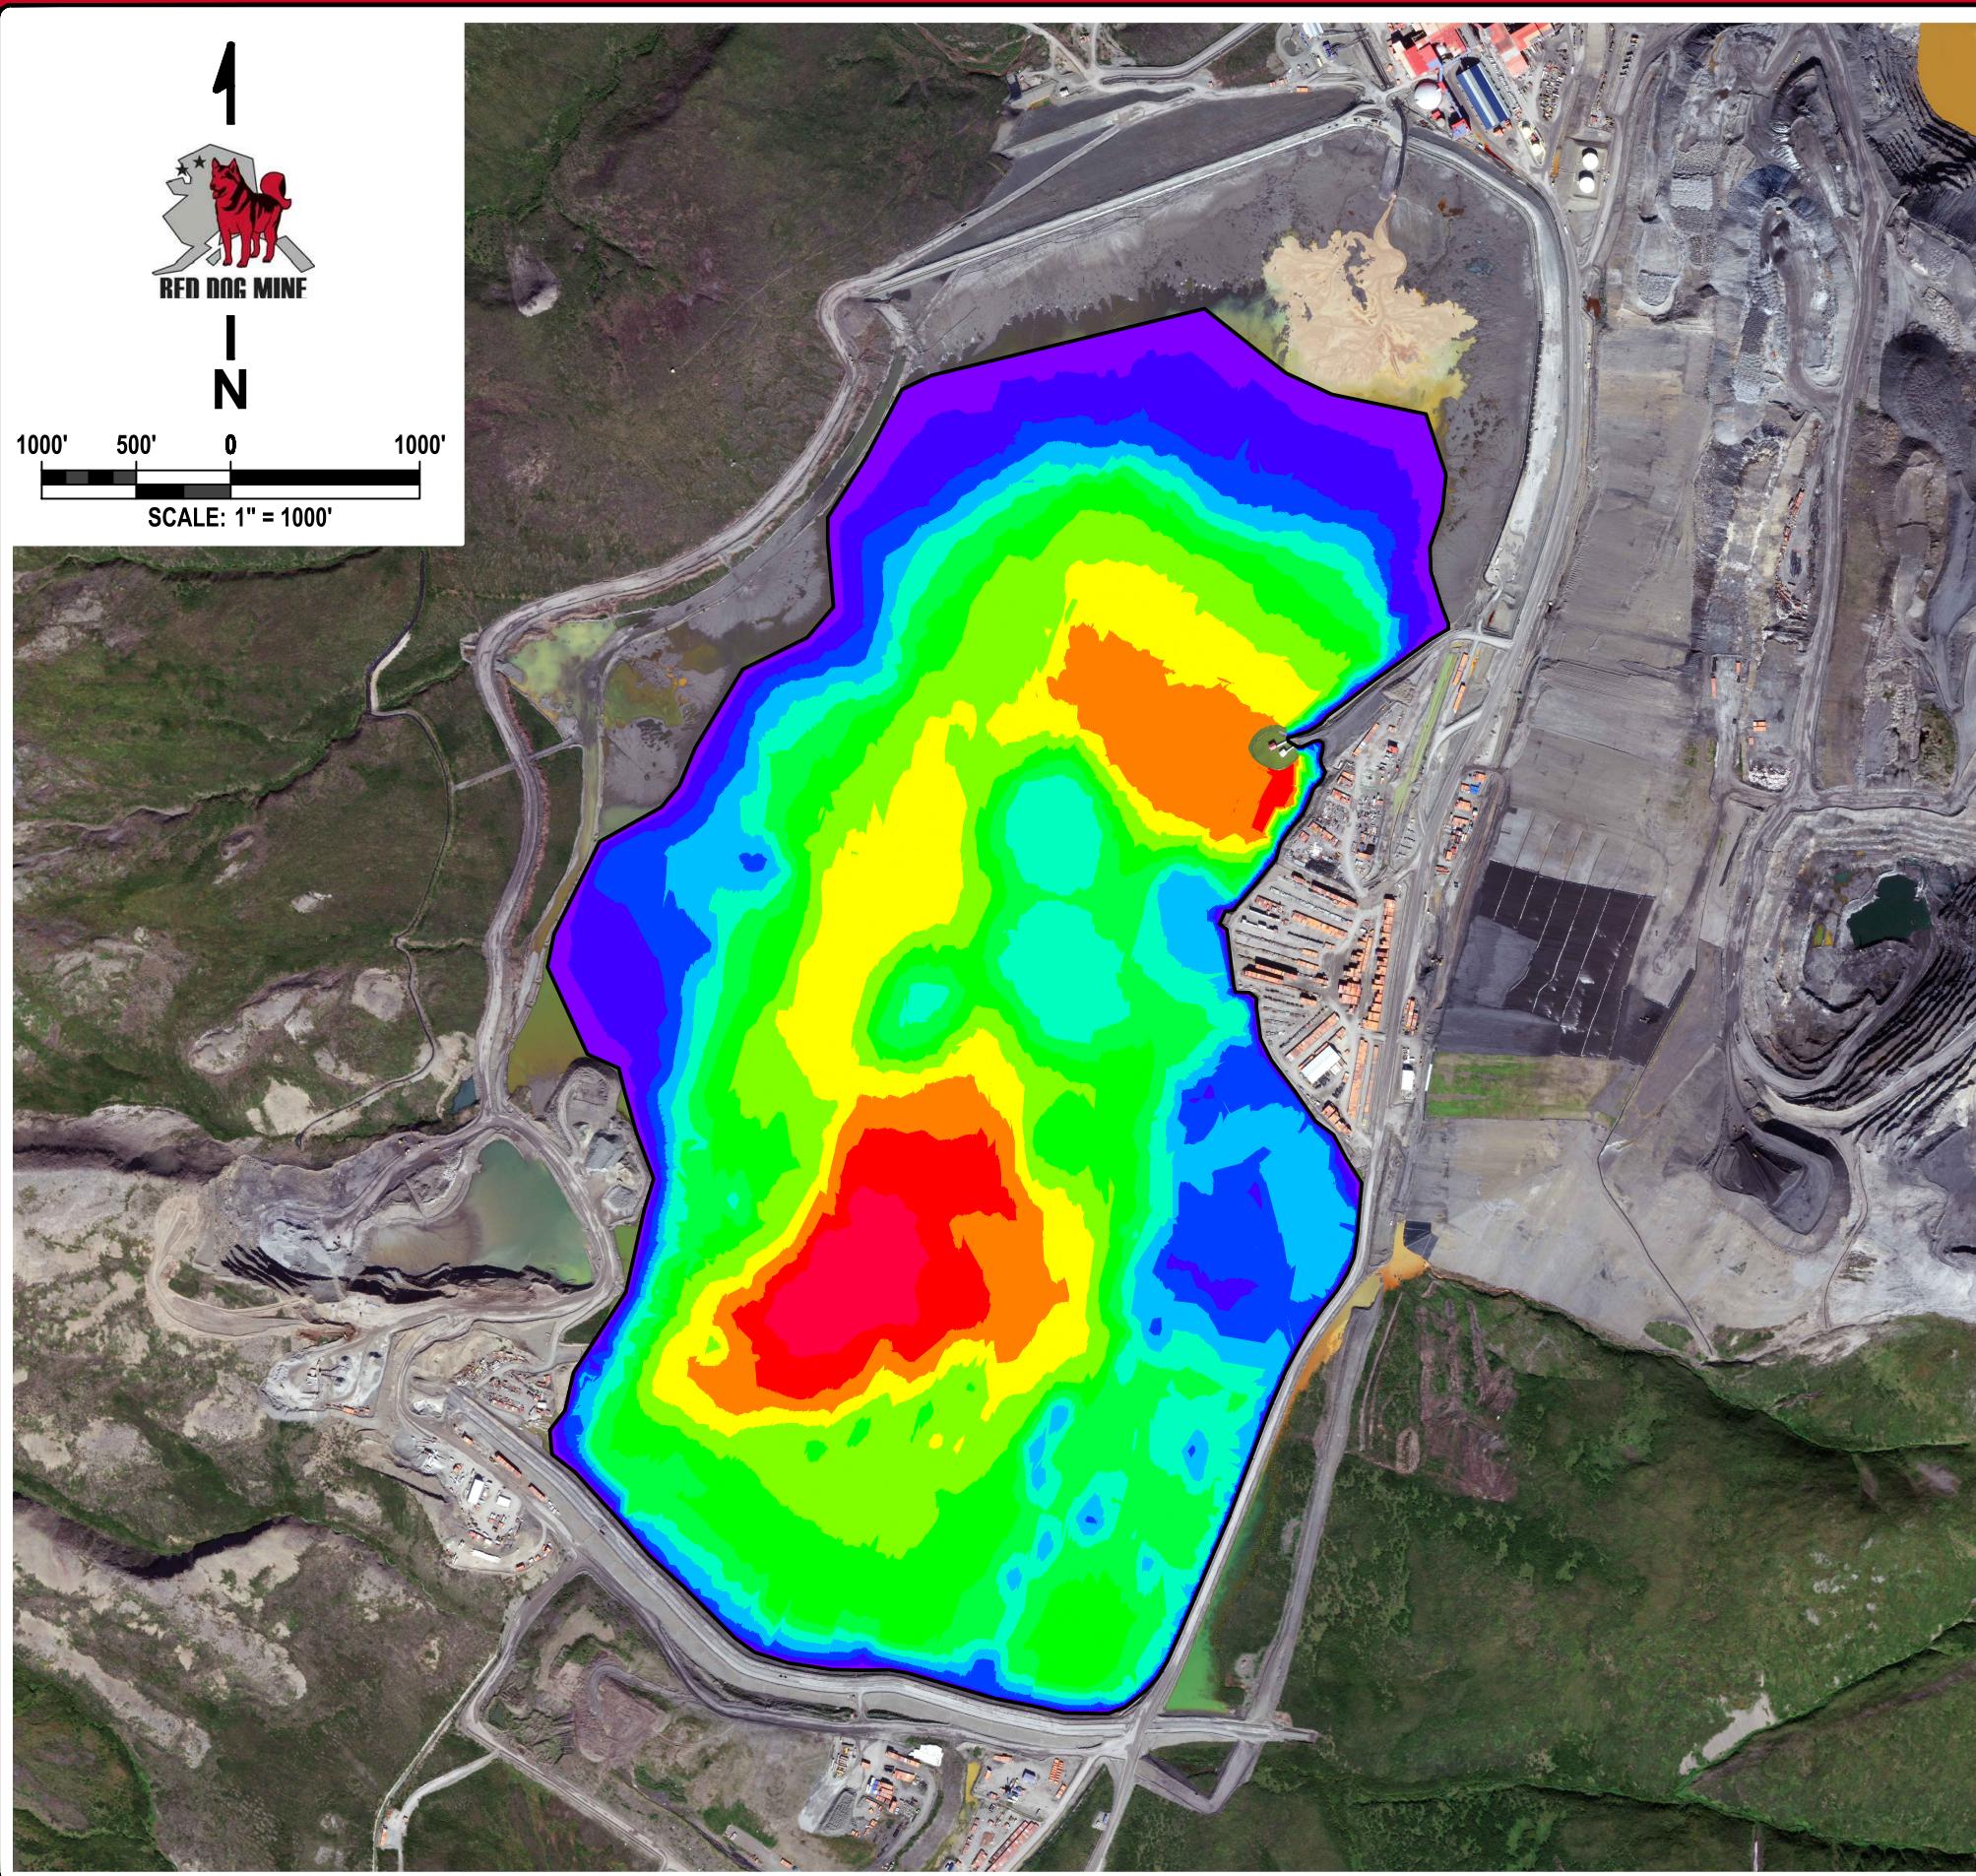
The Tailings Storage Facility and Main Pit Water Reservoir bathymetry surveys were completed during the 2nd quarter and are presented in Figures 5 and 6.

BATHYMETRY DATE: SEPTEMBER 21, 2021
IMAGERY DATE: AUGUST 2021
TSF WATER ELEVATION: 984.5
TSF AREA: 23,562,036 Sq. Ft. 541.910 Acres
FREE WATER VOLUME: 4,579.757 M Gal

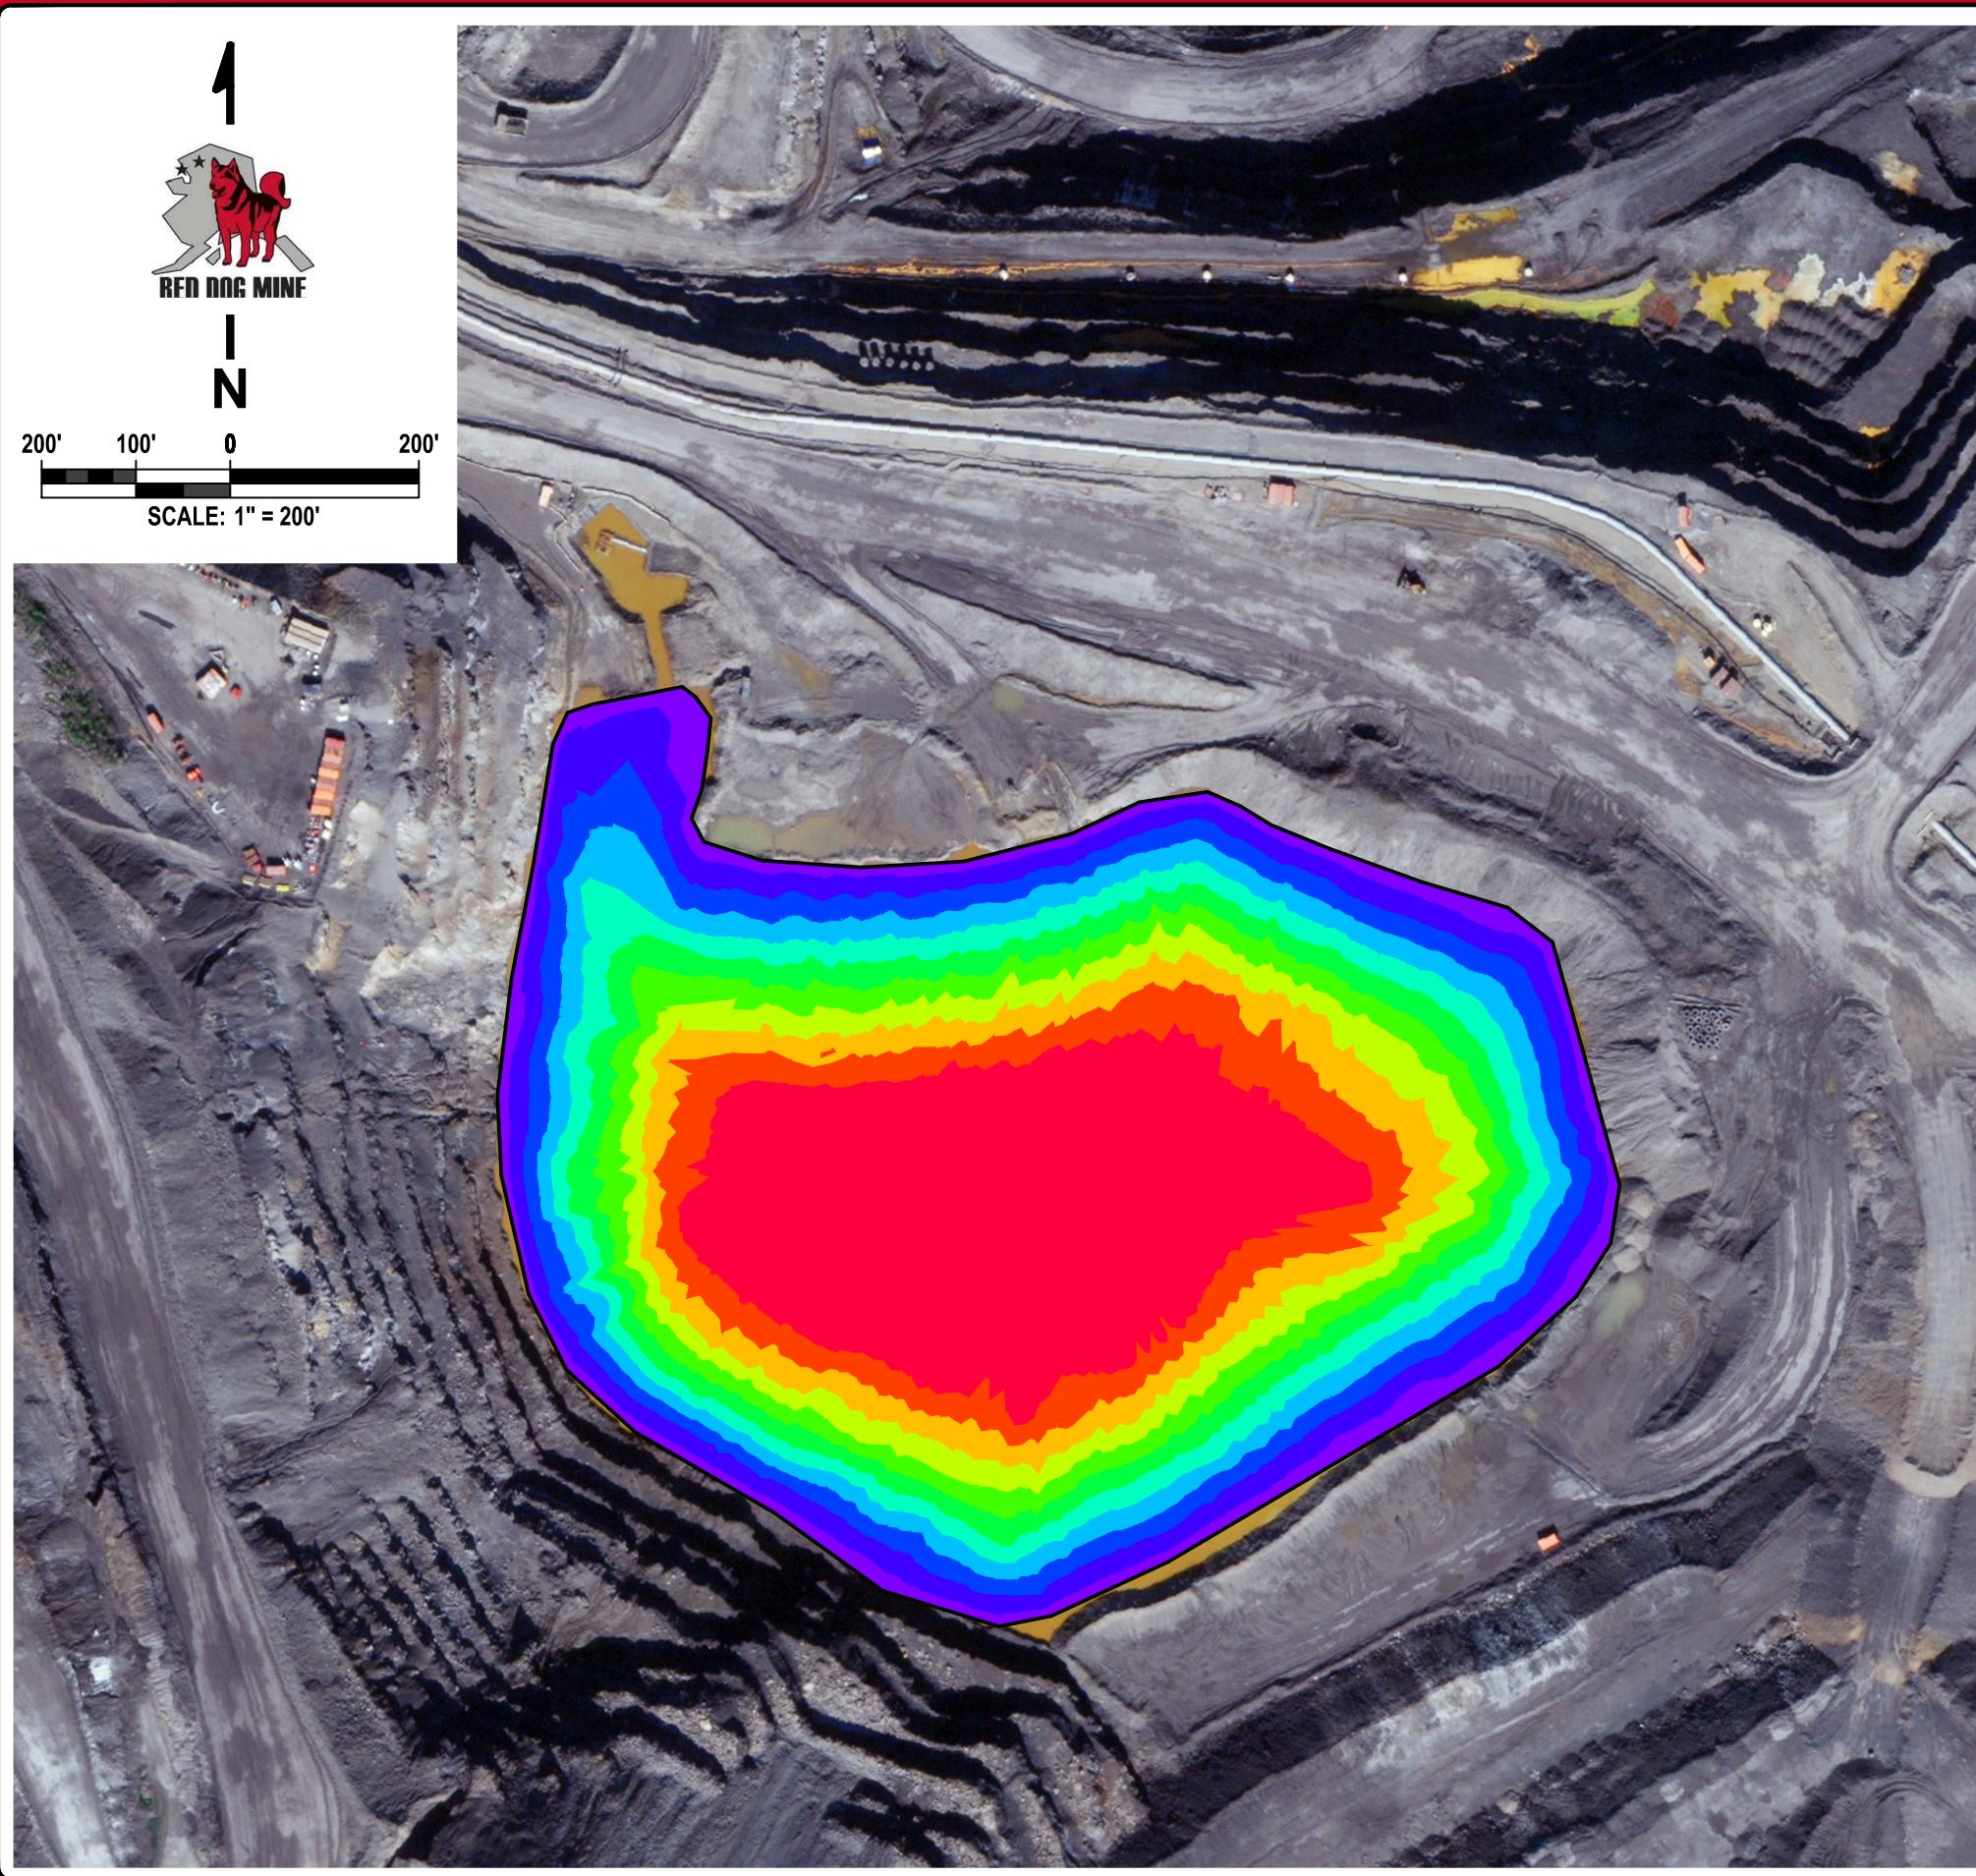
2021 MPWR BATHYMETRIC MAP

BATHYMETRY DATE: SEPTEMBER 20, 2021
IMAGERY DATE: AUGUST 2021
TSF WATER ELEVATION: 845.3
TSF AREA: 793,453 Sq. Ft. 18.215 Acres
FREE WATER VOLUME: 526.188 M Gal

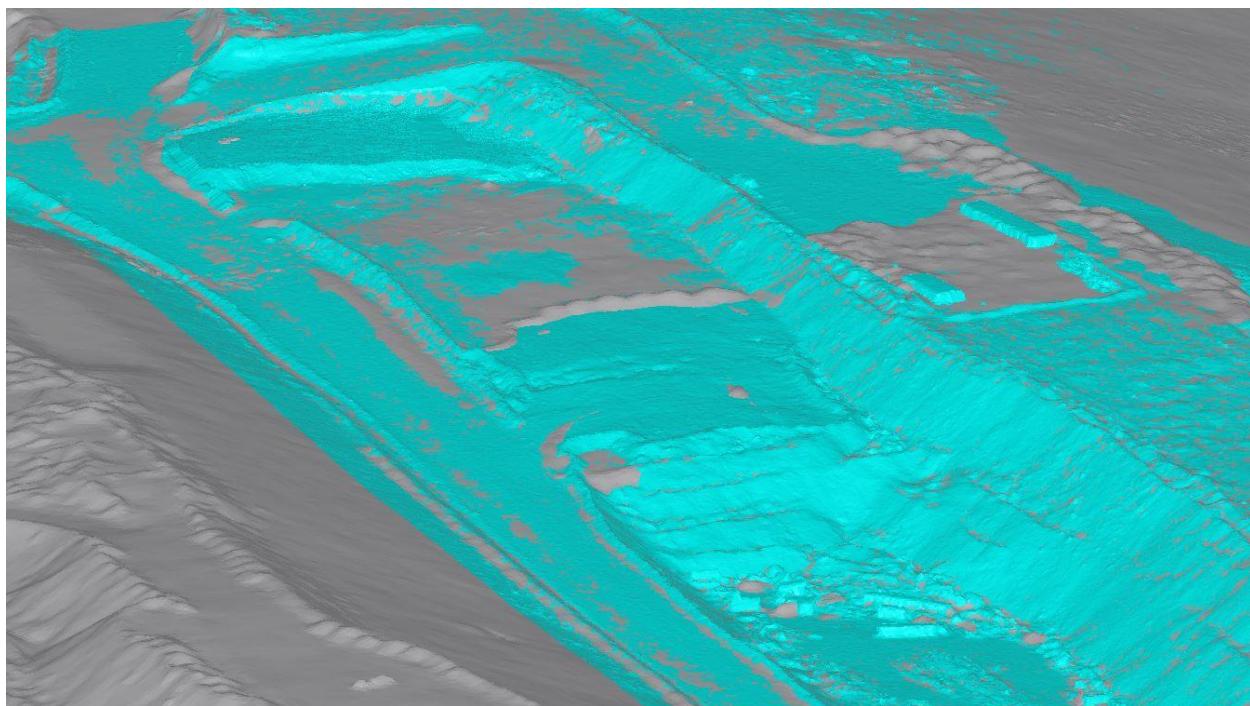
Figure 7 - Landfill LiDAR image looking south

Figure 7 – 2021 *Landfill LiDAR image looking south* depicts the difference between the operating years 2021 and 2020. The difference in volumes was taken as a volumetric calculation between surfaces utilizing MineSight.

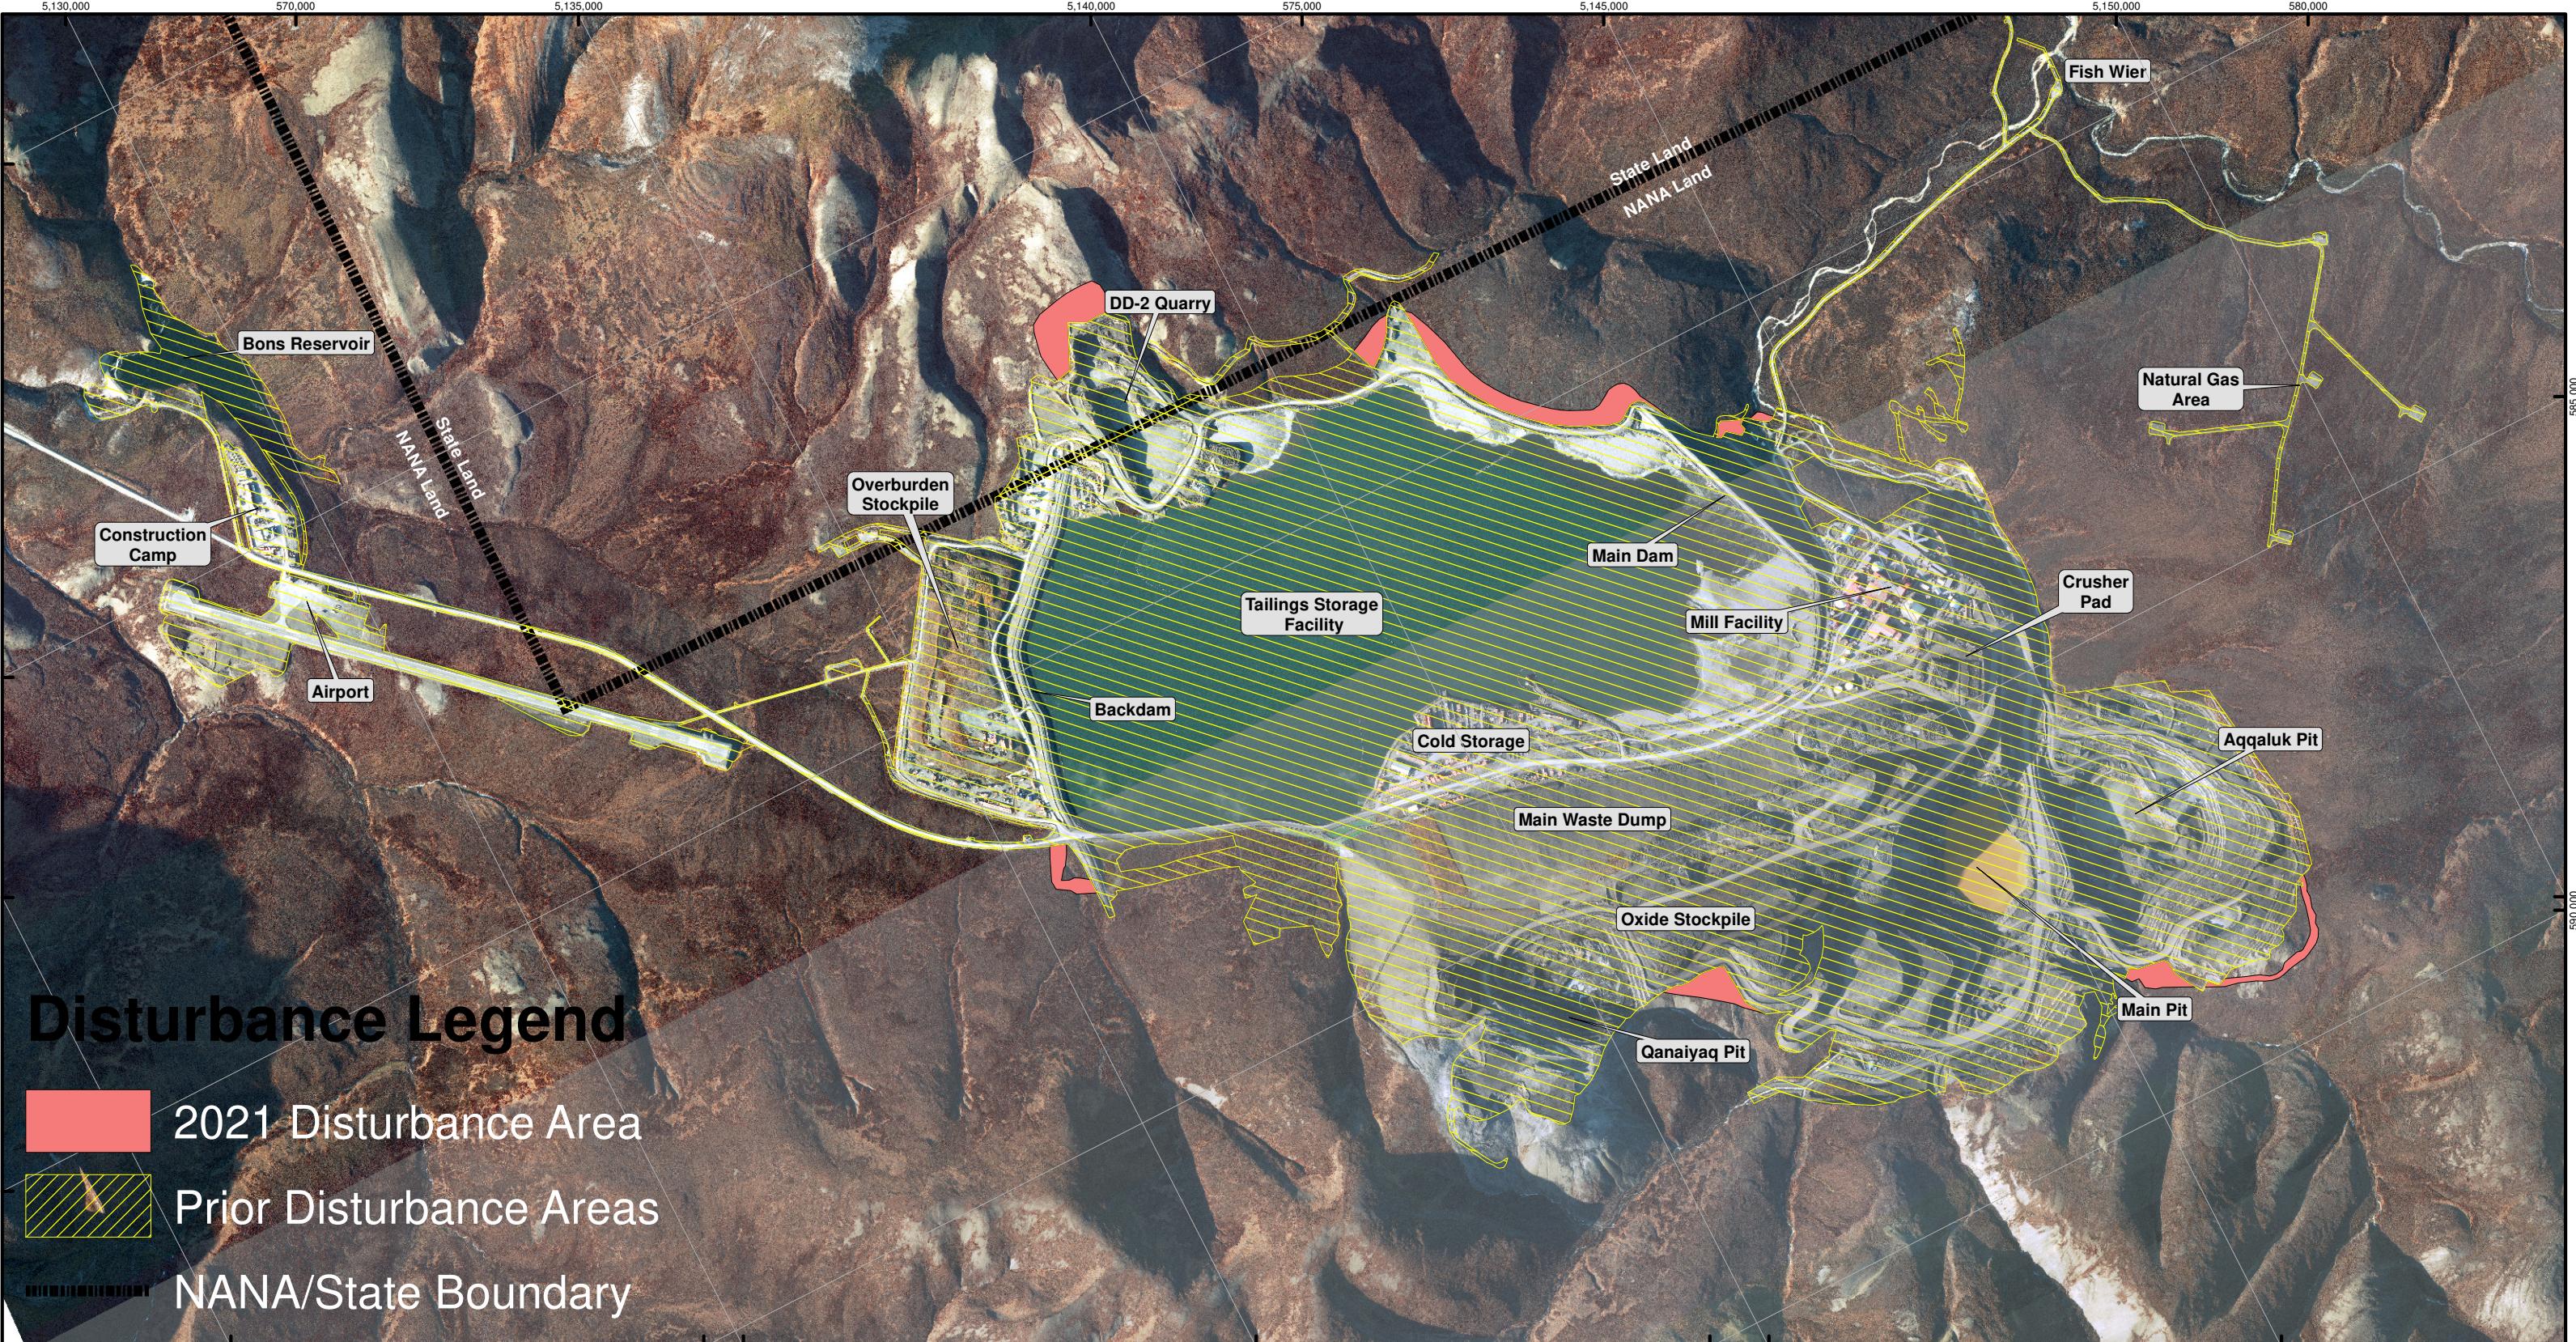
ITEM	2021 ACRES	CHANGE	COMMENTS
2020 Total	2110.3		
Aqqaluk Communications Road	6.3	6.3	For pit network upgrade.
West Tails Road Relocation	15.7	15.7	Necessary because of rising water in TSF.
Main Dam Seepage	1.4	1.4	For preparation of Main Dam raise.
Transportation Corridor - Phase 2	2.7	2.7	Necessary because of rising water in TSF.
East Oxide Road Relocation	4.4	4.4	For additional cover stockpile capacity.
DD2 Development (State land)	9.4	9.4	For pushback of DD2 to support Main Dam construction.
Total 2021 Land Disturbance (State + NANA)	2,150.3	40.0	
Total 2021 Land Disturbance (NANA)		30.6
