Teck Alaska, Inc. - Red Dog Mine
4th Quarter & Annual Report 2016
Waste Management Permit No. 2016DB0002
Reclamation Plan Approval F20169958
February 11th, 2017

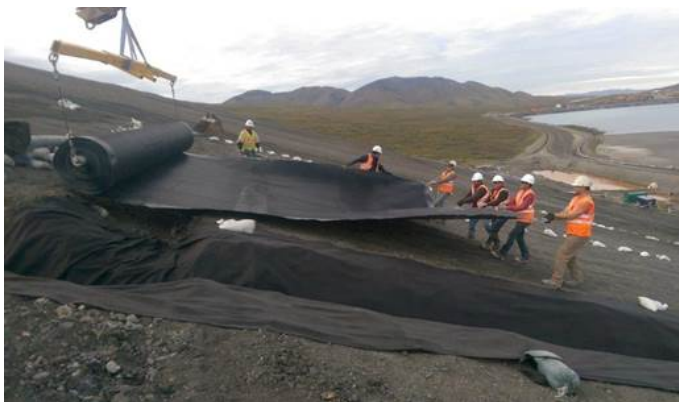
Photo 1 - Two acre test, Looking south, near south end of MWD. Placing double textured LLDPE on MWD surface.

A two acre geosynthetic cover test on the southern limit of the west facing slope and top deck of the main waste dump was completed mid-October. The cover test was installed with no deviations from the submitted work plan design. Monitoring for stability of the cover rock material placed above the geosynthetic will be measured after snow melt and continue throughout the year. Infiltration performance will be evaluated during snow melt and continue throughout the year.

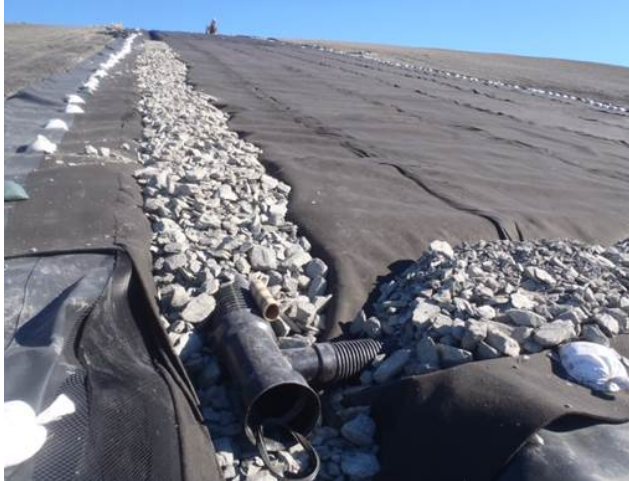
Photo 2 - Two acre test, MWD toe, west face looking east, final placement of drainage mat over LLDPE, prior to placing 2 feet of cover rock on top.

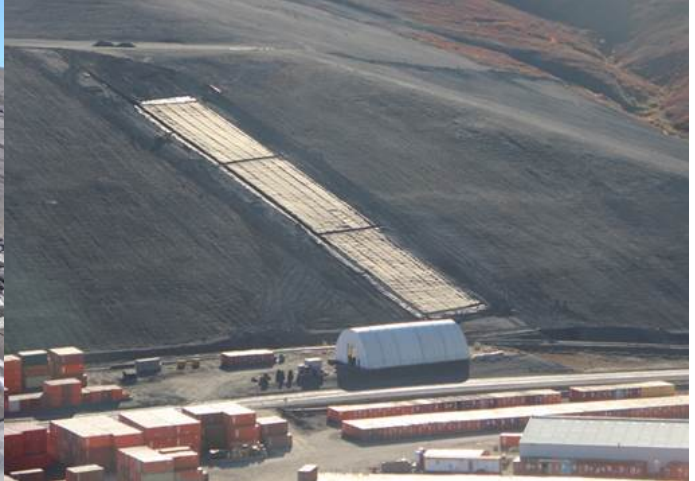
Photo 3 - Two acre test, aerial of cover construction

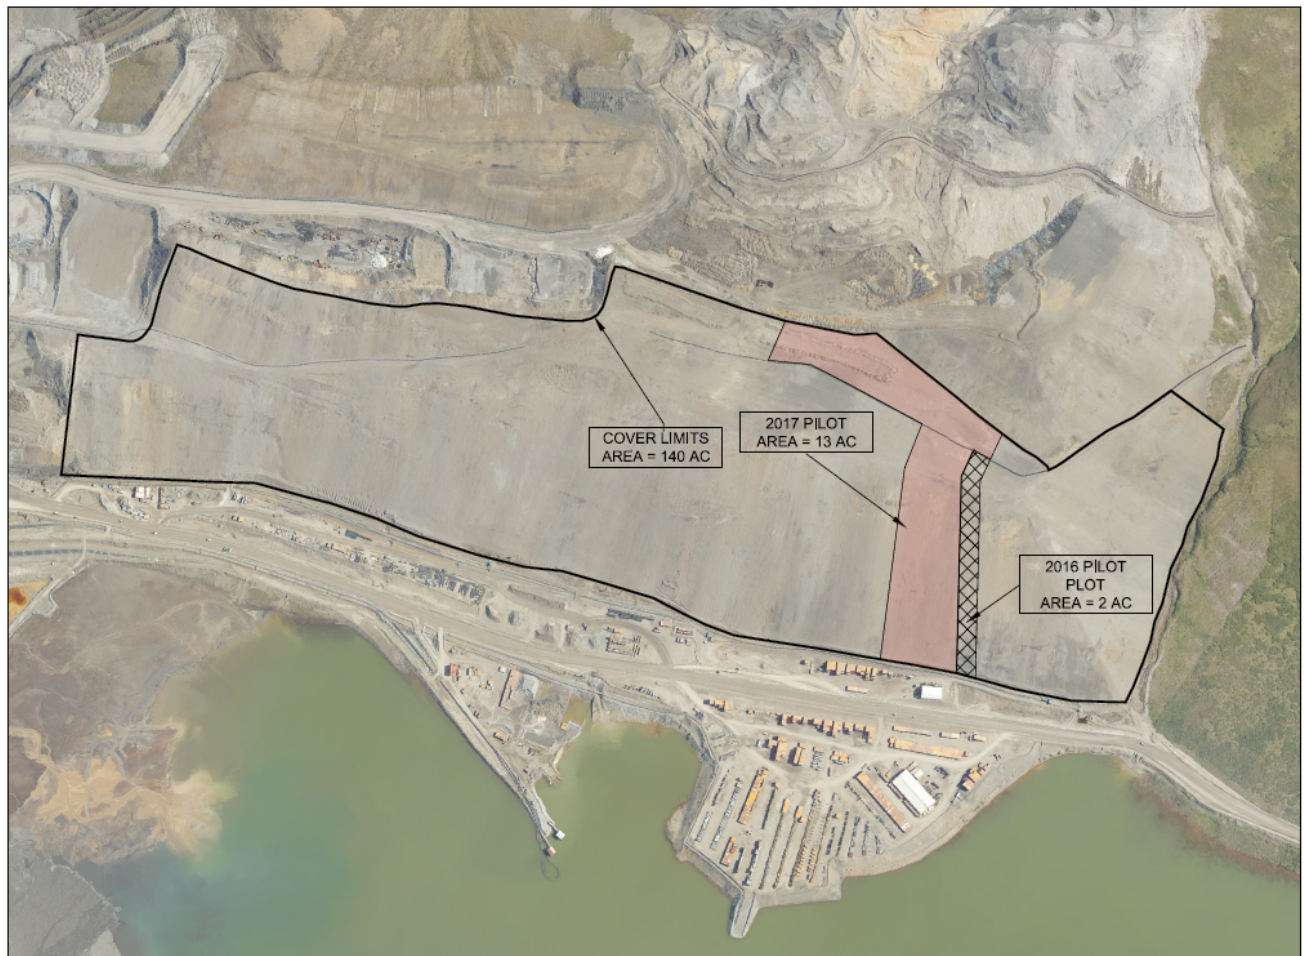
Figure 1 - Proposed 13 Acre Geosynthetic Cover Test Layout

An additional 13 acre geosynthetic cover test is proposed for the 2017 year. The purpose of the larger test to gain a more thorough understanding of constructability and costs. The test will incorporate similar geosynthetic materials (double textured LLDPE, woven geonet) as utilized for the two acre test. Two feet of uncompacted waste rock cover will be placed over the geosynthetic. No moisture instrumentation will be utilized for the test. Figure 1 depicts the location of the 13 acre geosynthetic layout.

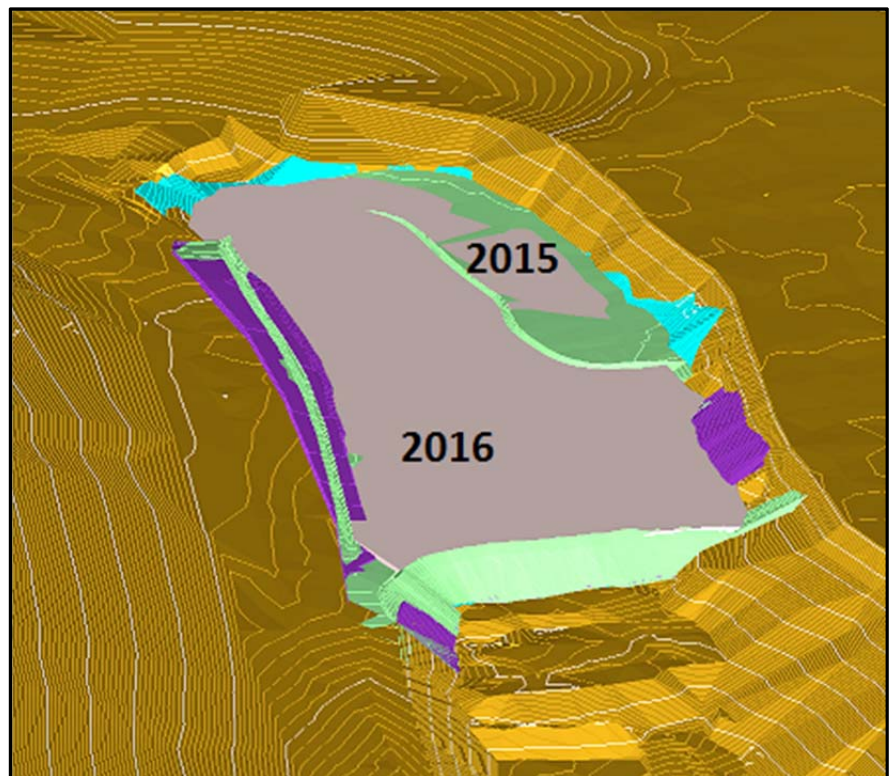
Figure 4 - Landfill Development and Use Plans

During the latter part of the 2016 year the entire cell was graded and compacted using additional rock material from the western slope wall side. For the 2017 year, refuse will be placed starting in the southern most end of the cell creating a new lift. Based on historical volumes the 2017 lift is expected to cover half of the existing dump cell. The 2016 and 2017 Landfill Use Plans are depicted in Figure 4.

Inert Solid Waste Landfill – Main Waste Dump

2015 Fill Area
Volume 14,407 cubic yards

2016 Fill Area
Volume 17,558 cubic yards
