Teck Alaska, Inc. - Red Dog Mine  
4<sup>th</sup> Quarter & Annual Report 2017  
Waste Management Permit No. 2016DB0002  
Reclamation Plan Approval F20169958  
March 1<sup>st</sup>, 2018

This report has been prepared to fulfill the 4<sup>th</sup> quarter and annual reporting requirements of Teck Alaska Incorporated's (TAK) obligations under the State of Alaska Waste Management Permit No. 2016DB0002 and the Red Dog Mine Reclamation Plan Approval F20169958.

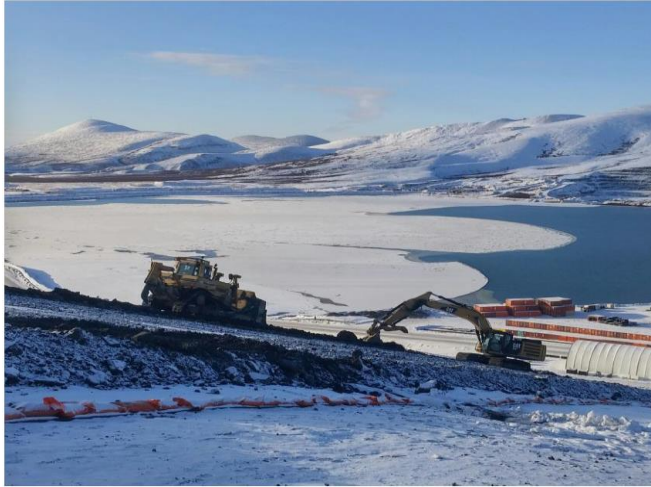
**Figure 1 - Photos of MWD Synthetic Cover Project**

Photo 1 – Looking west off MWD. Placing cover rock over the geocomposite.

- The Main Waste Dump cover test plot construction was completed 10/23/18. A total of 15 acres of synthetic liner and cover material has been installed. Monitoring of cover performance will be ongoing over the next 18 months.

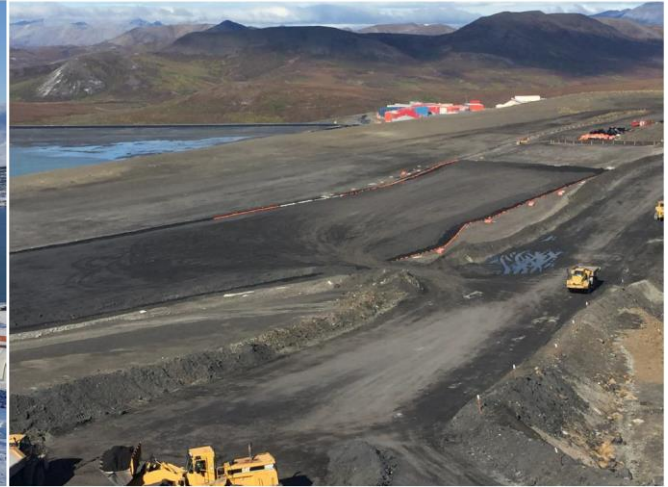
Photo 2 – Looking northwest at the top of the MWD.

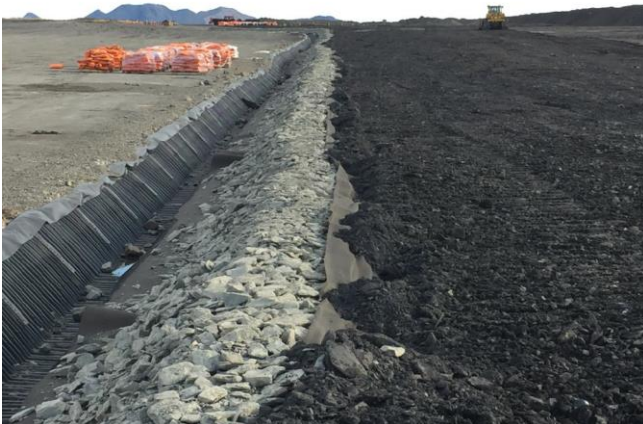
Photo 3 – Looking north, on upper surface of MWD. Drainage channel to the left.

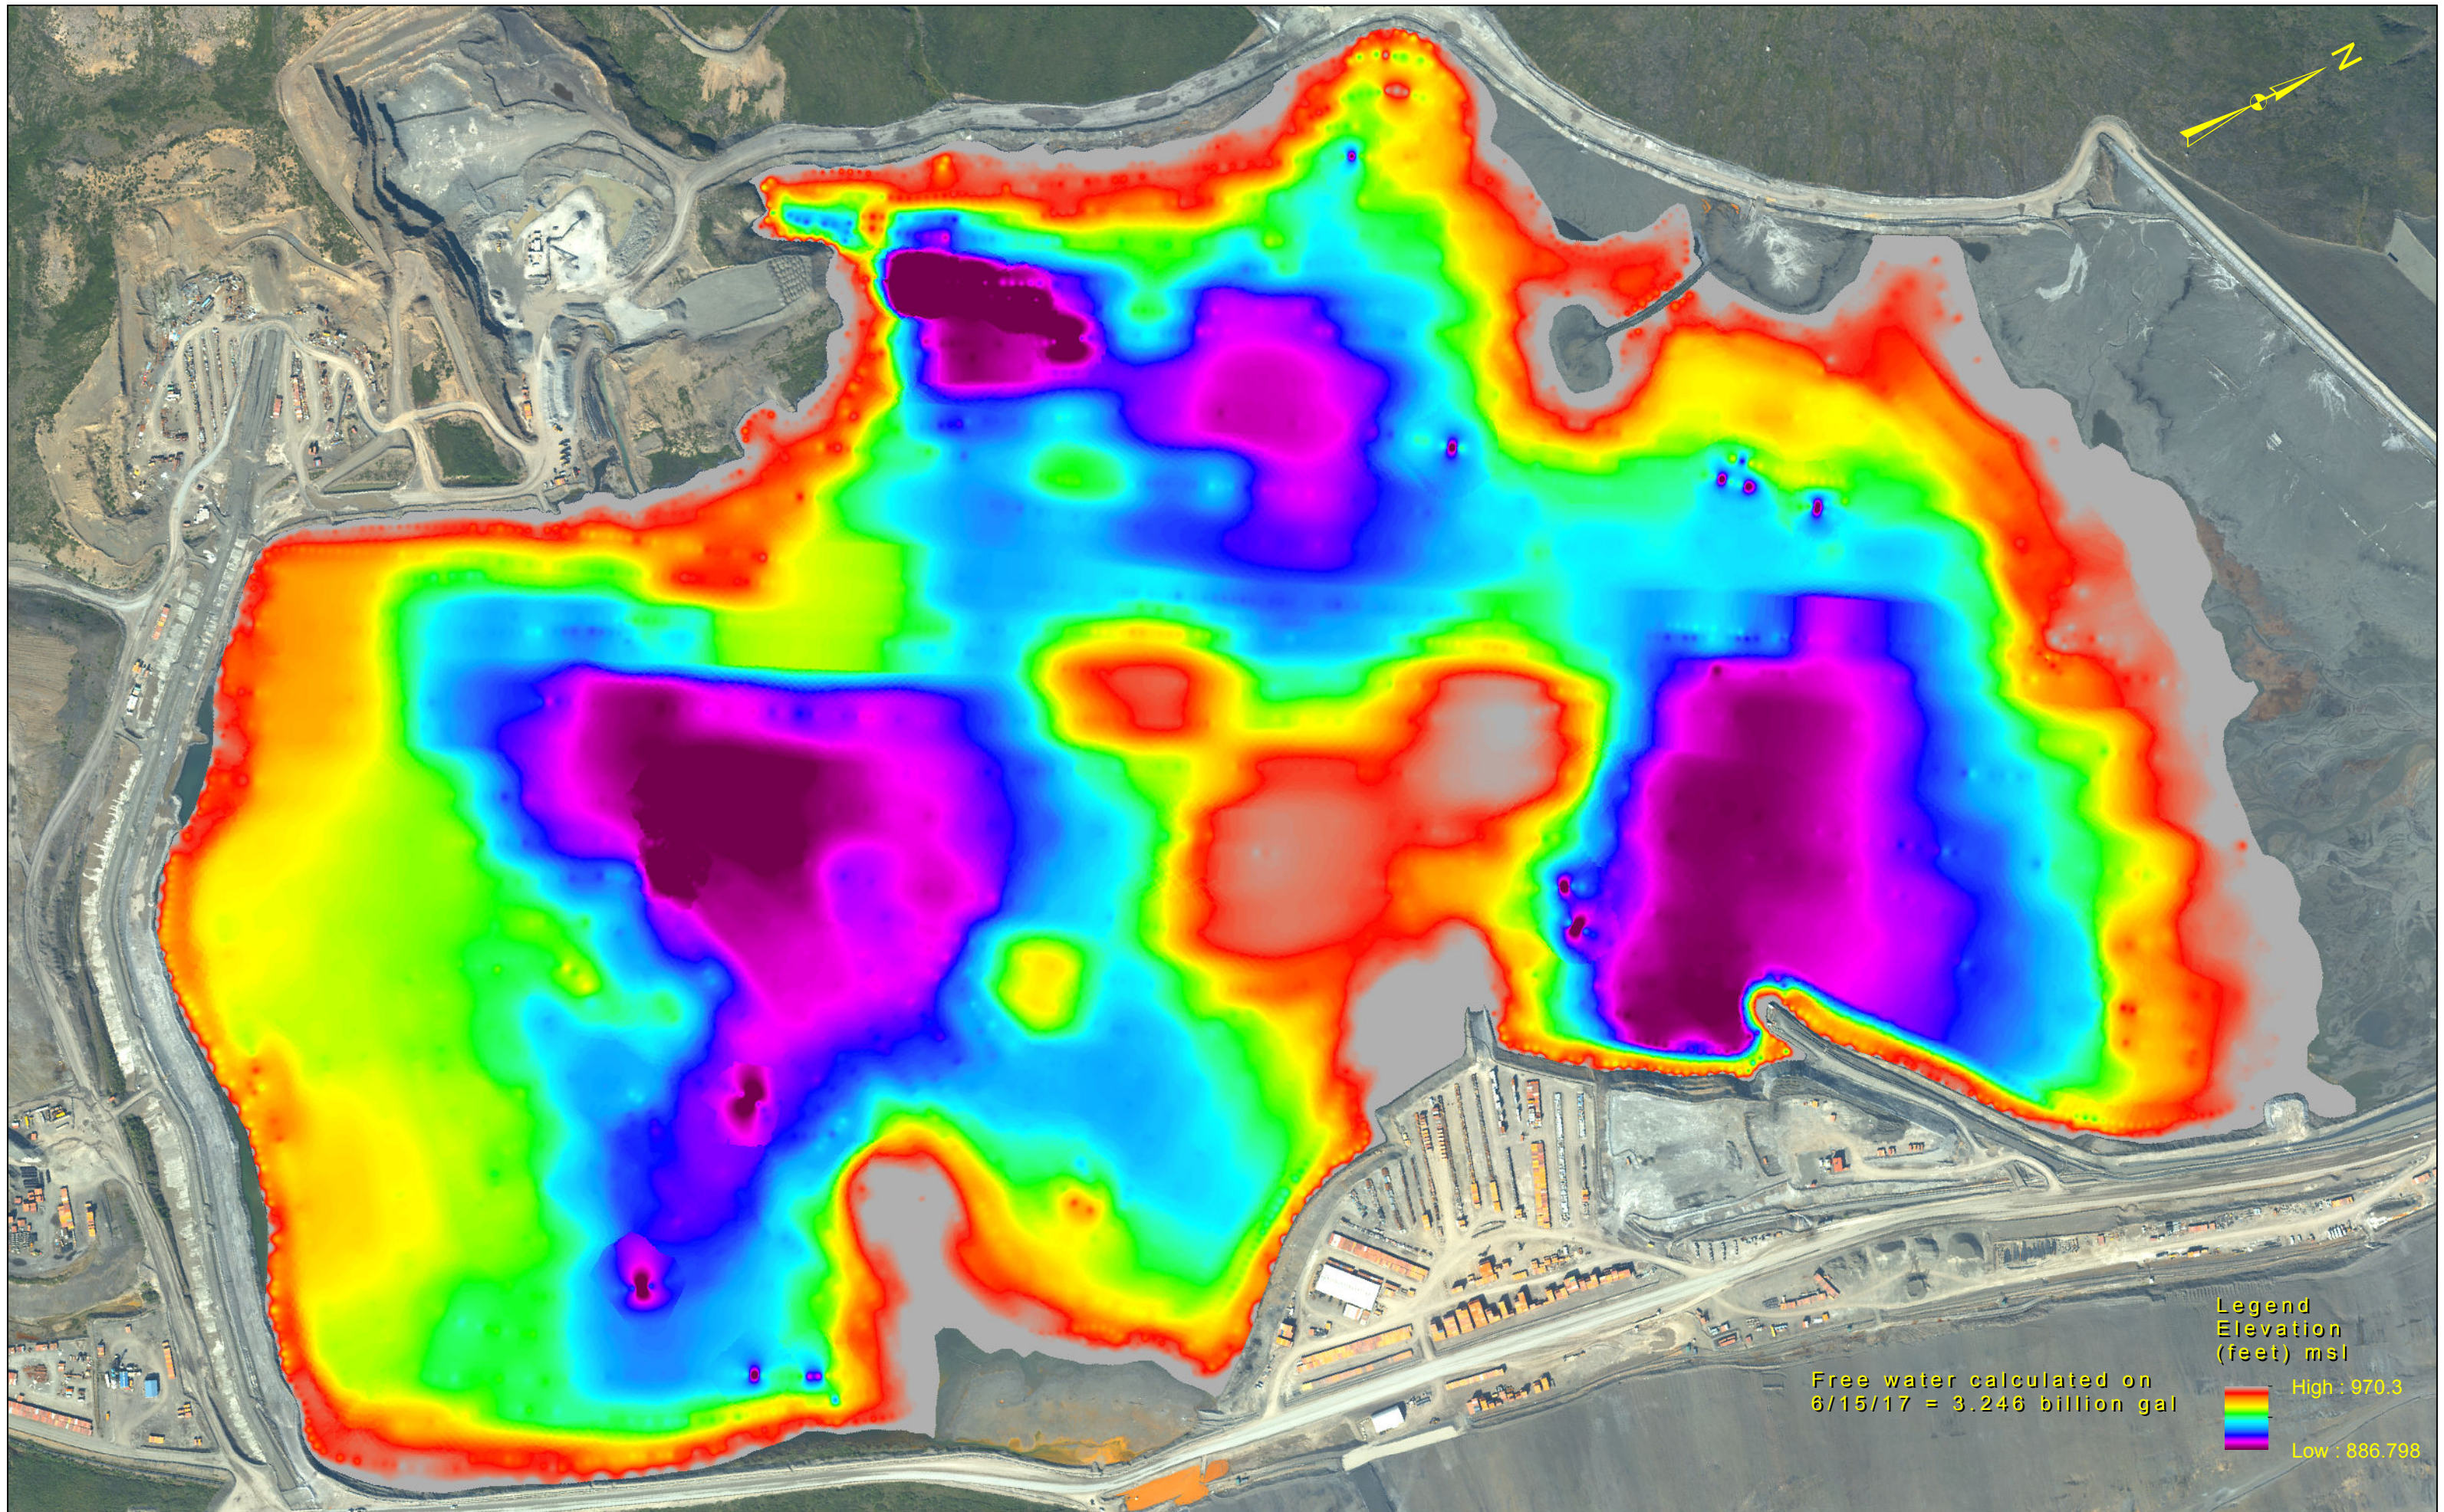
Legend  
 Elevation  
 (feet) msl  
 High : 970.3  
 Low : 886.798

Free water calculated on  
 6/15/17 = 3.246 billion gal

Bathymetry surveys were completed June 15, 2017 for both the Tailings Storage Facility and the Main Pit. A bathymetry map for each area was generated and depicted in Figures 2 and 3.

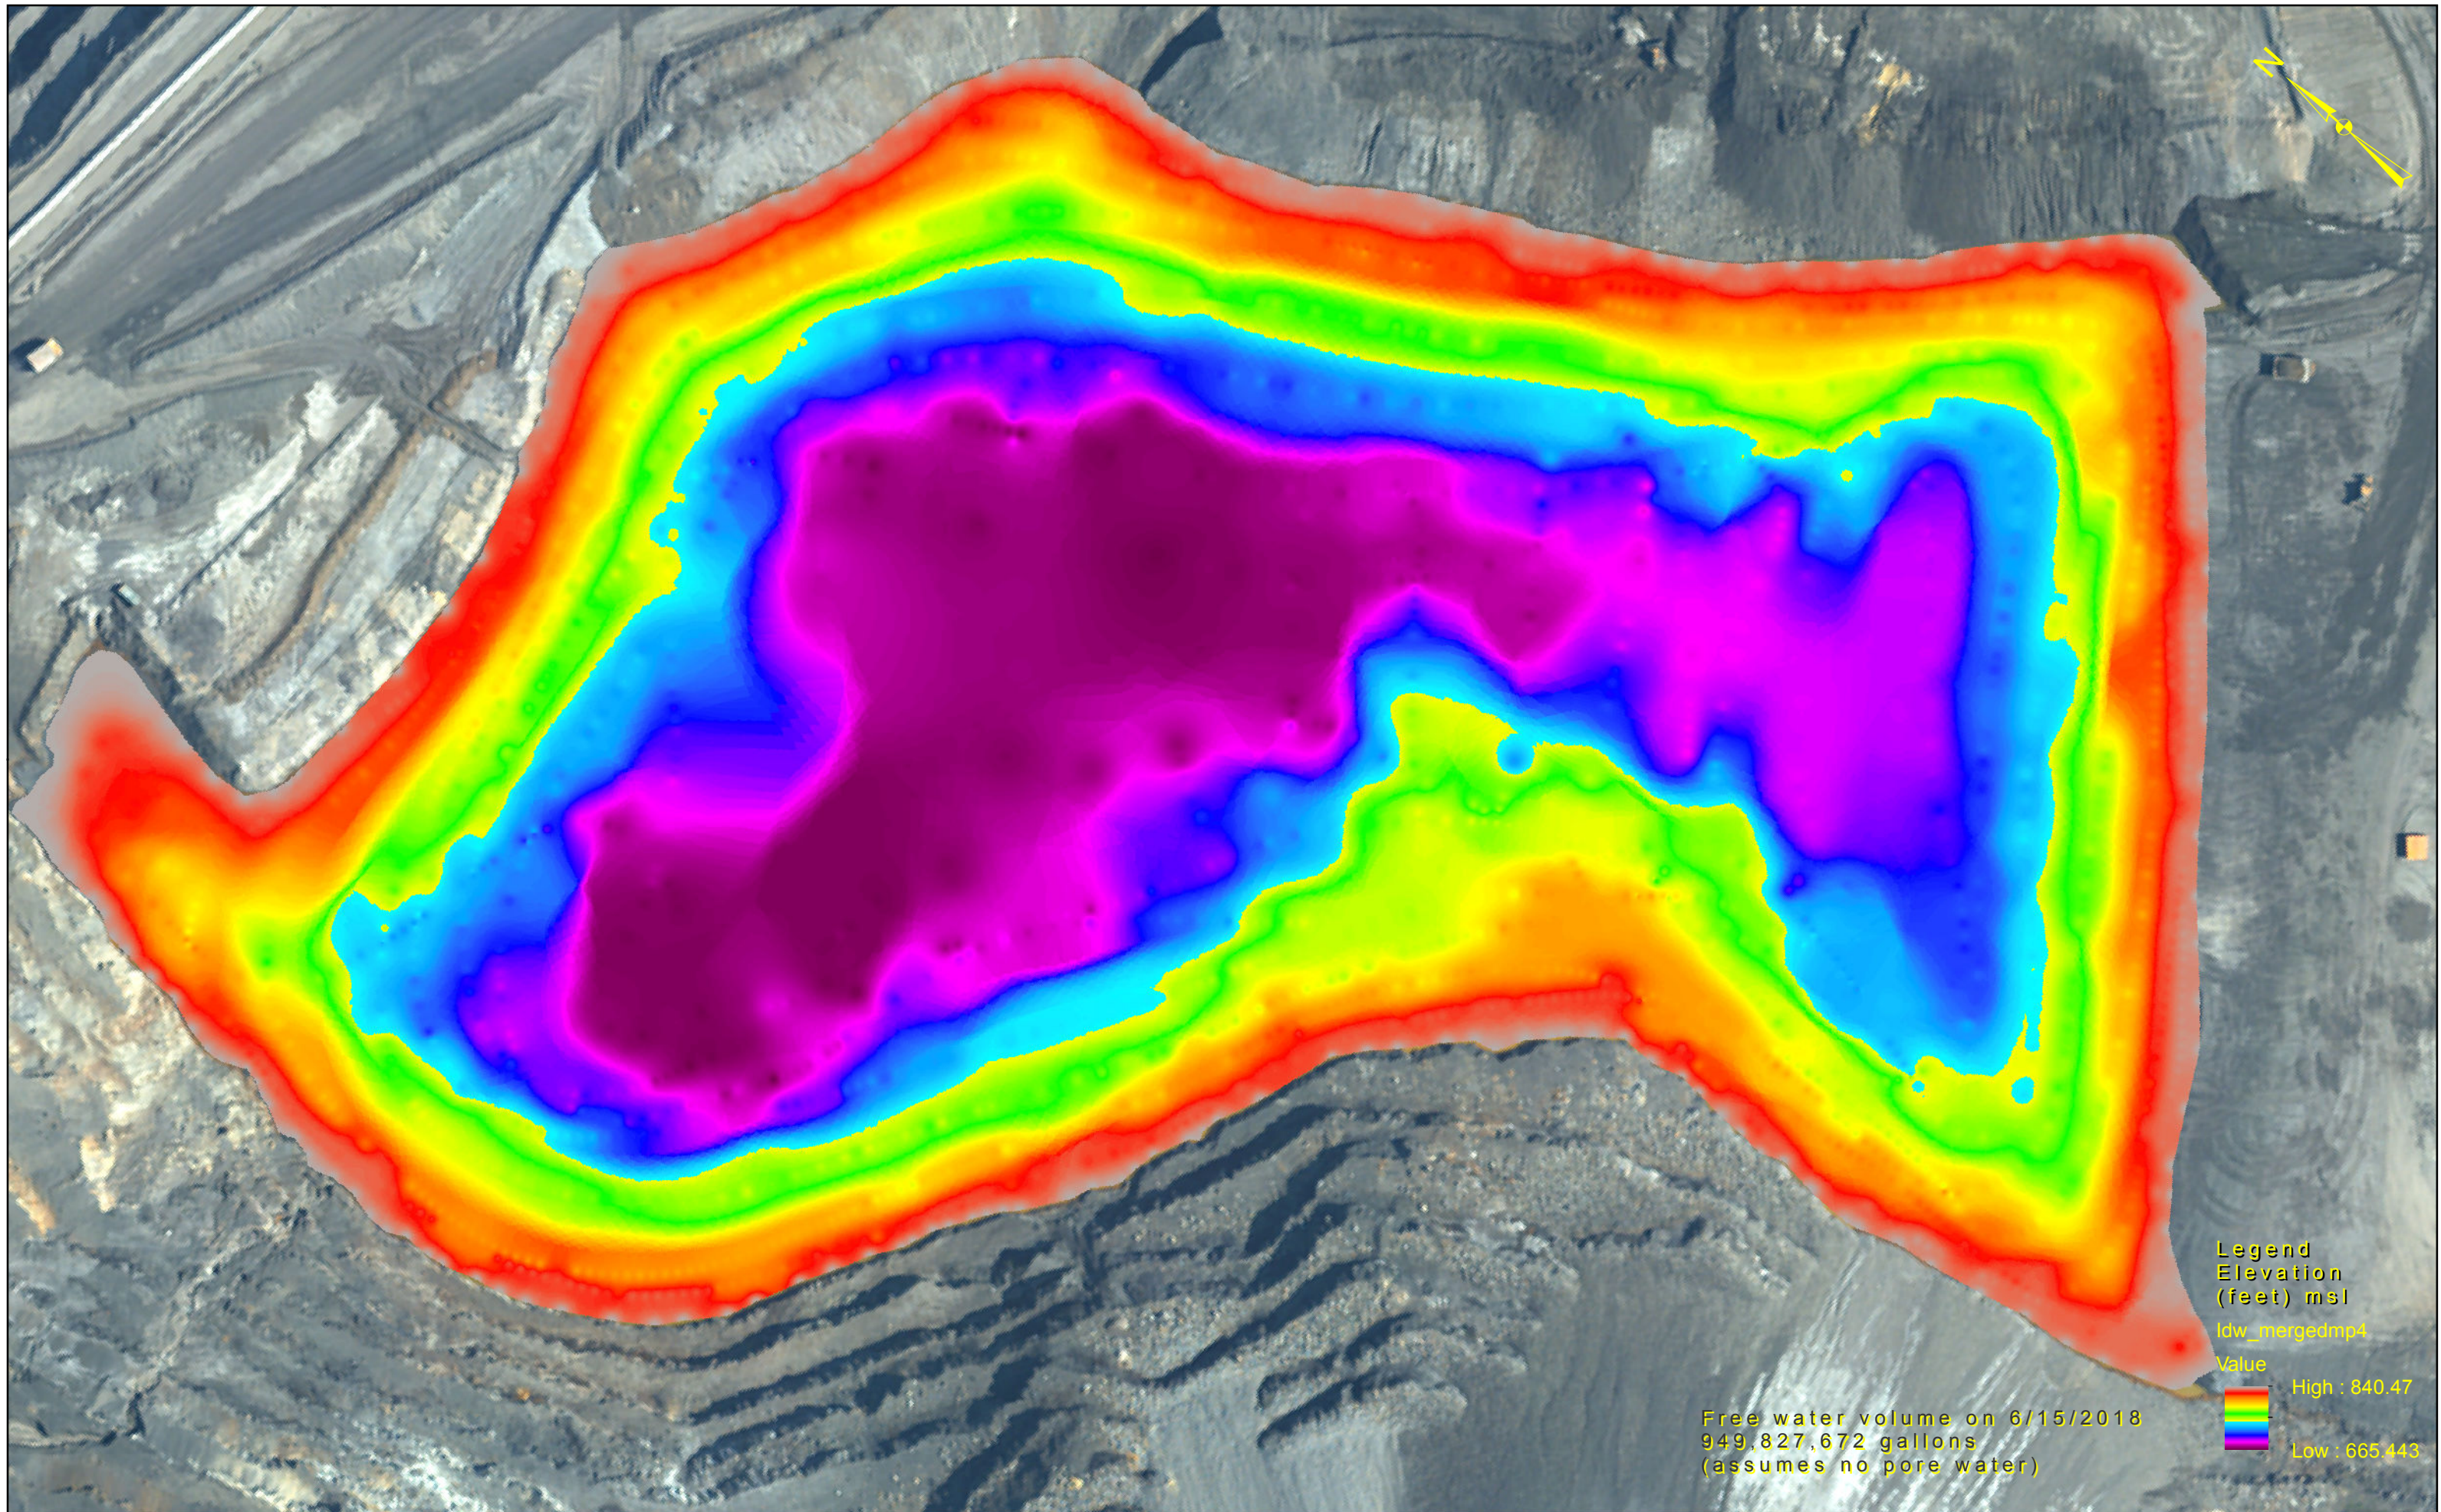
Legend  
 Elevation  
 (feet) msl  
 ldw\_mergedmp4  
 Value  
 High : 840.47  
 Low : 665.443

Free water volume on 6/15/2018  
 949,827,672 gallons  
 (assumes no pore water)
