Subject: Reconsideration of the Navigability Report Dated June 29, 1983, Regarding the West Fork of the Dennison Fork and the Dennison Fork of the Fortymile River in the Upper Yukon Region, Alaska

Maps of West Fork Dennison and Dennison Fork of the Fortymile River

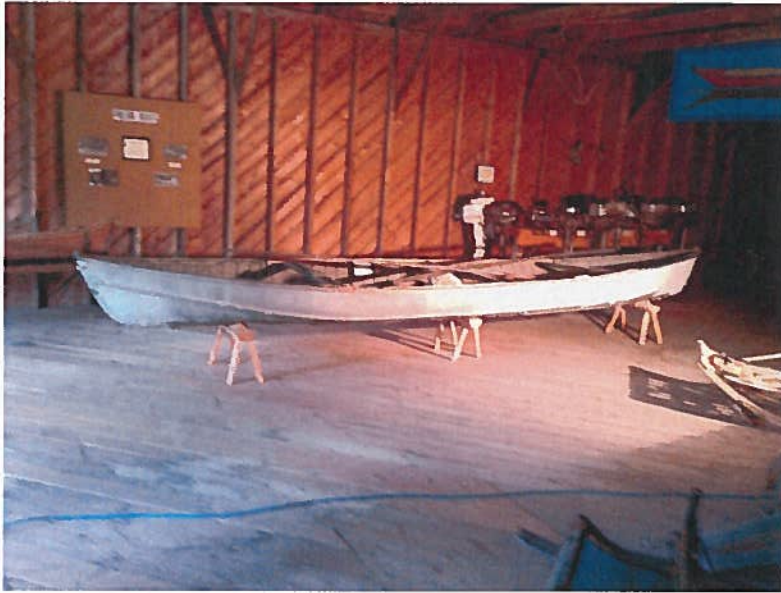
Picture 1- An example of a pole boat (approximately 20' long by 4.5' wide) used in the Fortymile Region located at Fort Egbert, in Eagle, Alaska. Photograph taken by Jack Frost, BLM, July 2018.

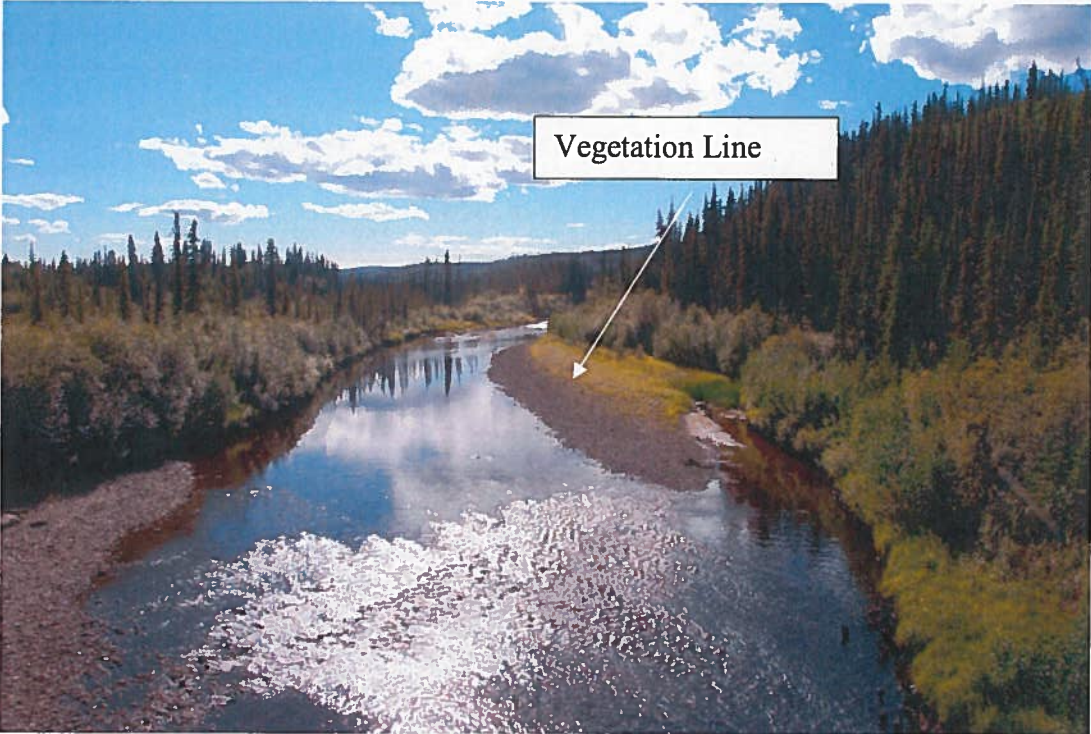
Figure 1a. Upstream view of West Fork Dennison channel at low flow, stream gage water level = 4.6 feet. Taylor Highway Bridge MP49, 1715 hours, July 29, 2018.

Figure	Date	Flow Condition	Water Surface Elevation (feet)	Discharge (cfs)	River Travel Rating
Figure 1	July 29, 2018	Low	4.6 feet	26	Very Difficult
Figure 2*	July 14, 2018	Moderate	5.7 feet	265	Fair
Figure 3	August 22, 2018	High	7.7 feet	1750	Good
		Flood	Overbank		Very Difficult

Vegetation features on gravel bars upstream and downstream of the bridge are annotated in Figures 1-3 to provide additional visual reference for changes in water surface elevation.

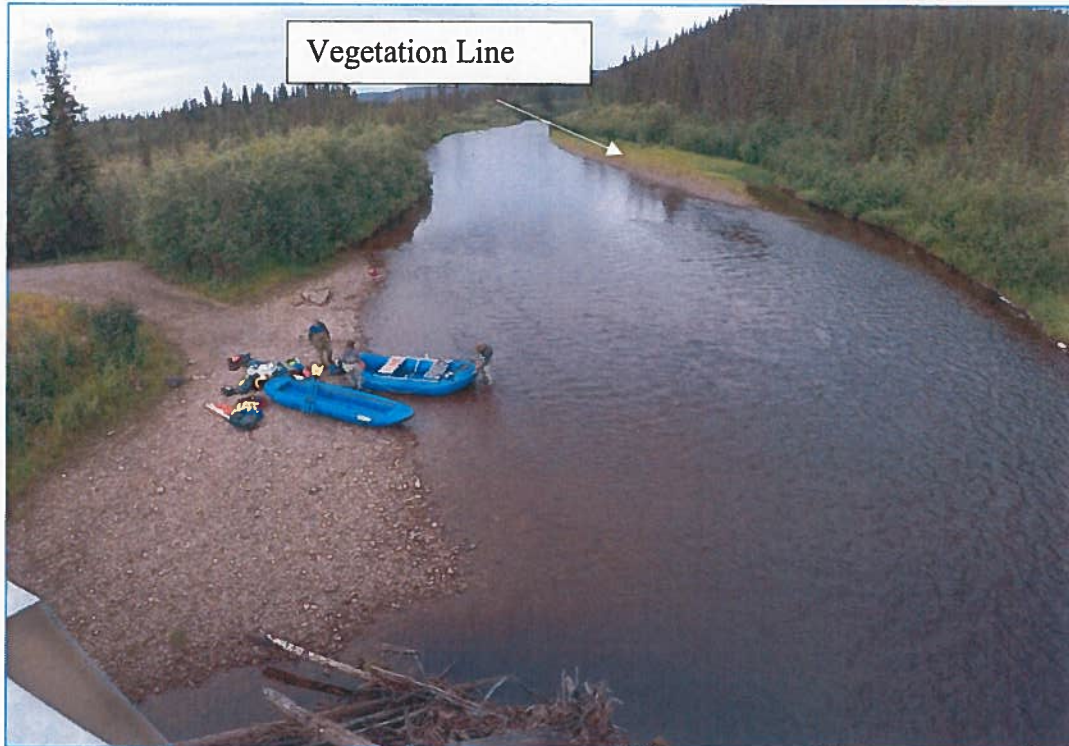
Figure 2a. Upstream view of West Fork Dennison channel at moderate flow, stream gage water level = 5.7 feet. BLM navigability float trip, Taylor Highway MP49, 1000 hours, July 14, 2018.

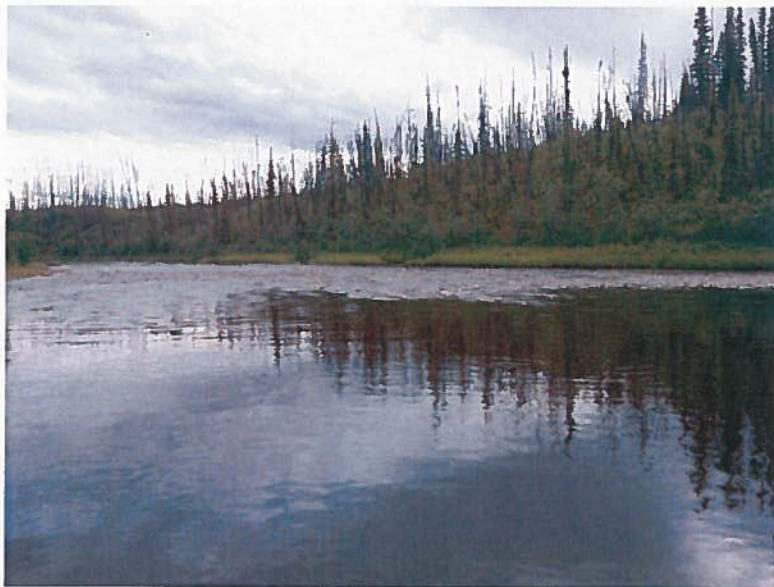
Picture 4- The first minor riffle we encountered on the West Fork about one mile downstream from the Taylor Highway Bridge.

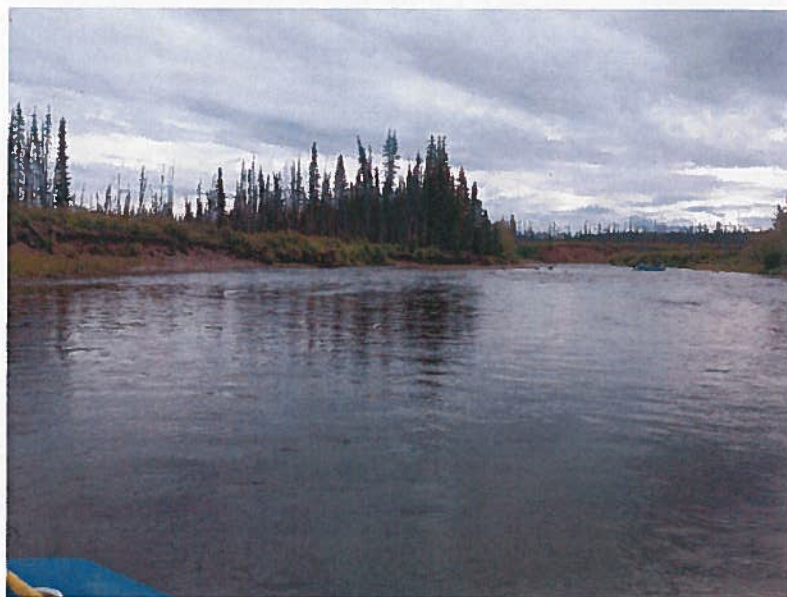
Picture 5- A riffle that required dragging through. See boat in upper right.

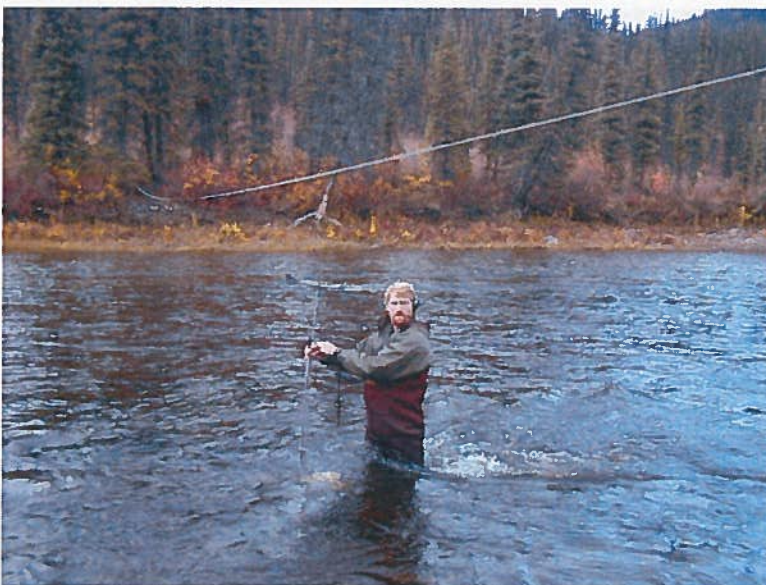
Fig. 1. A BLM field technician surveys the streamflow on the North Fork of the Fortymile River. Most rivers were surveyed by wading the cross section.

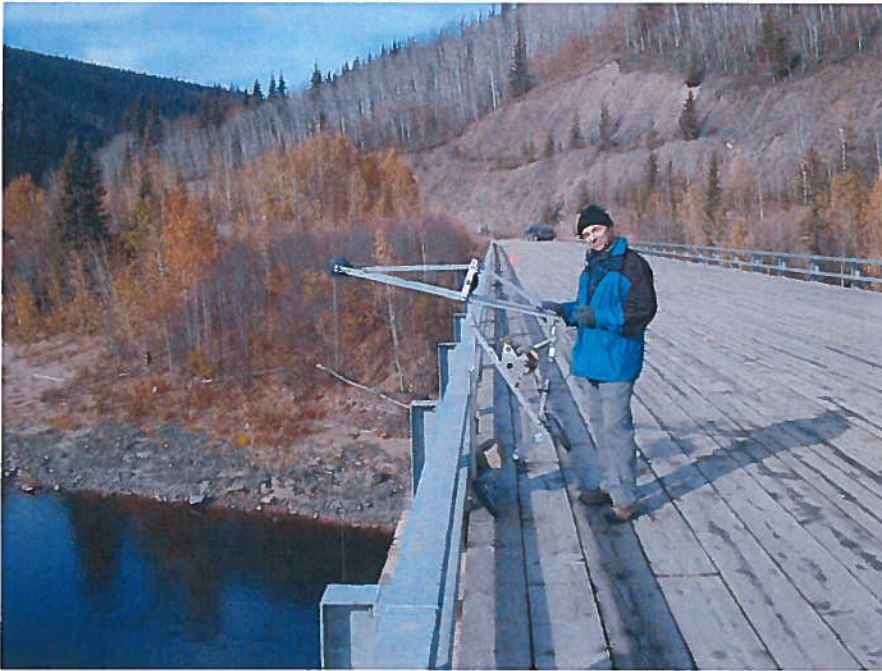
Fig. 2. Where the river was too deep to wade, such as the Fortymile River at the Taylor Highway Bridge, a flow meter and sounding weight were suspended by a cable and reel system to survey the river.

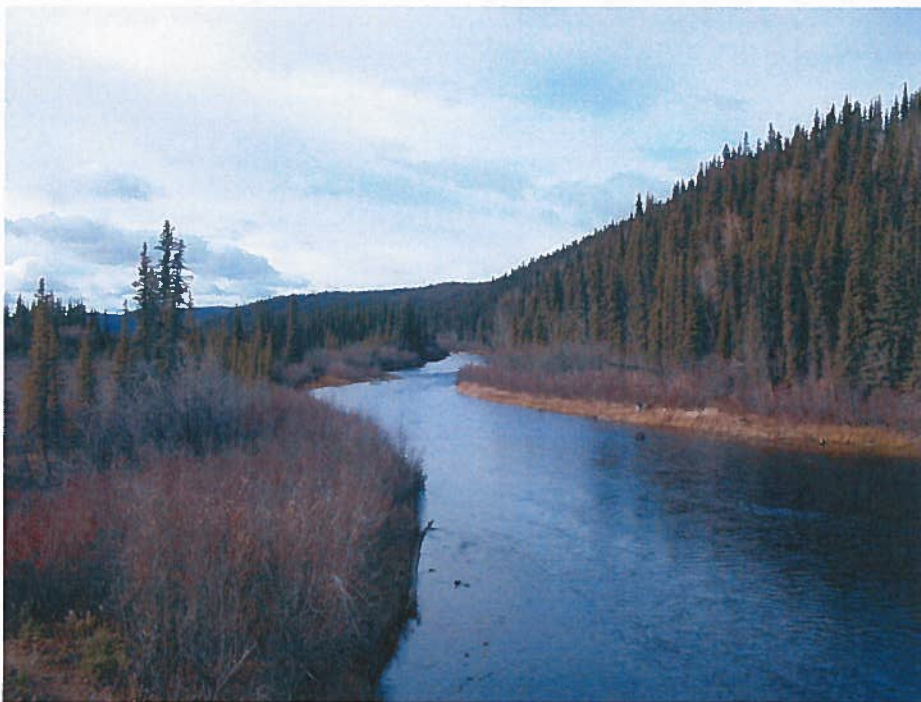
Fig. 3. The channel is relatively straight upstream of the bridge with few riffles or obstructions. The stream is confined by a low ridge to the north with a lower bank and wide floodplain to the south

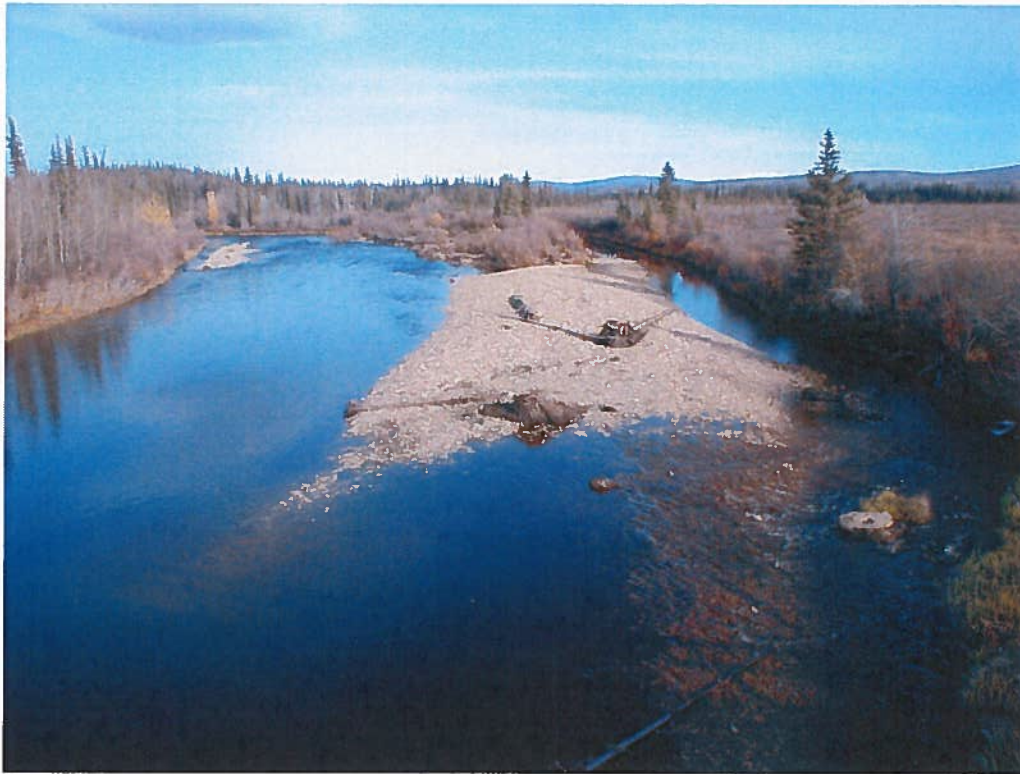
Fig. 4. Downstream of the bridge, the channel is wider, shallower, and has more obstructions from islands and boulders (rock gardens), than upstream of the bridge

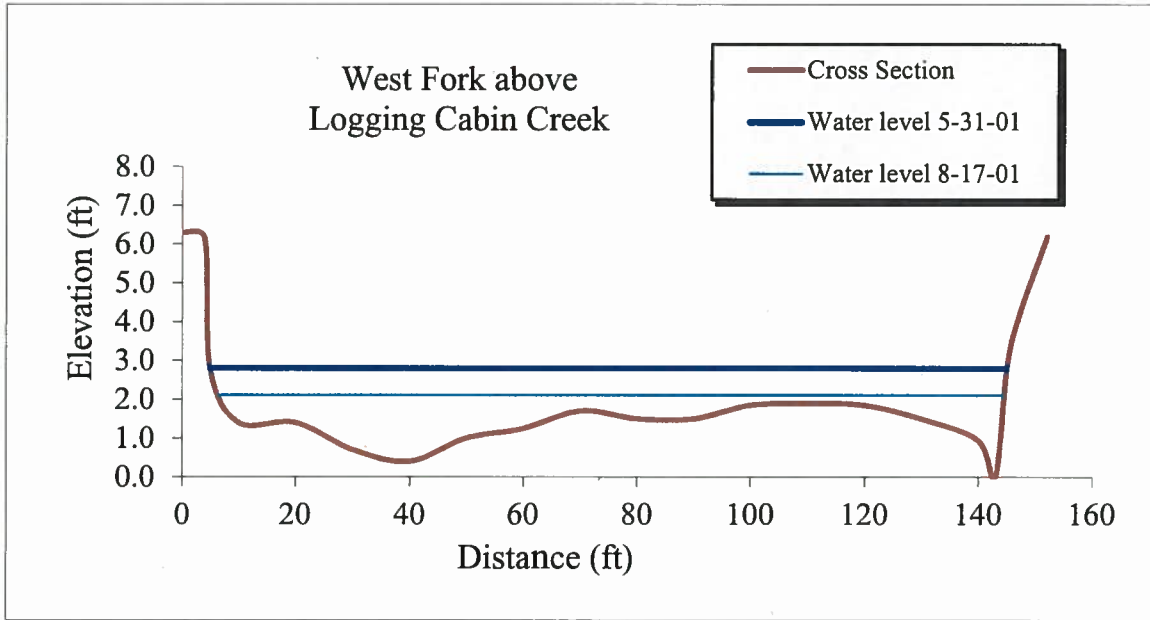
Fig. 7 Cross Section of West Fork Fortymile River above Logging Cabin Creek

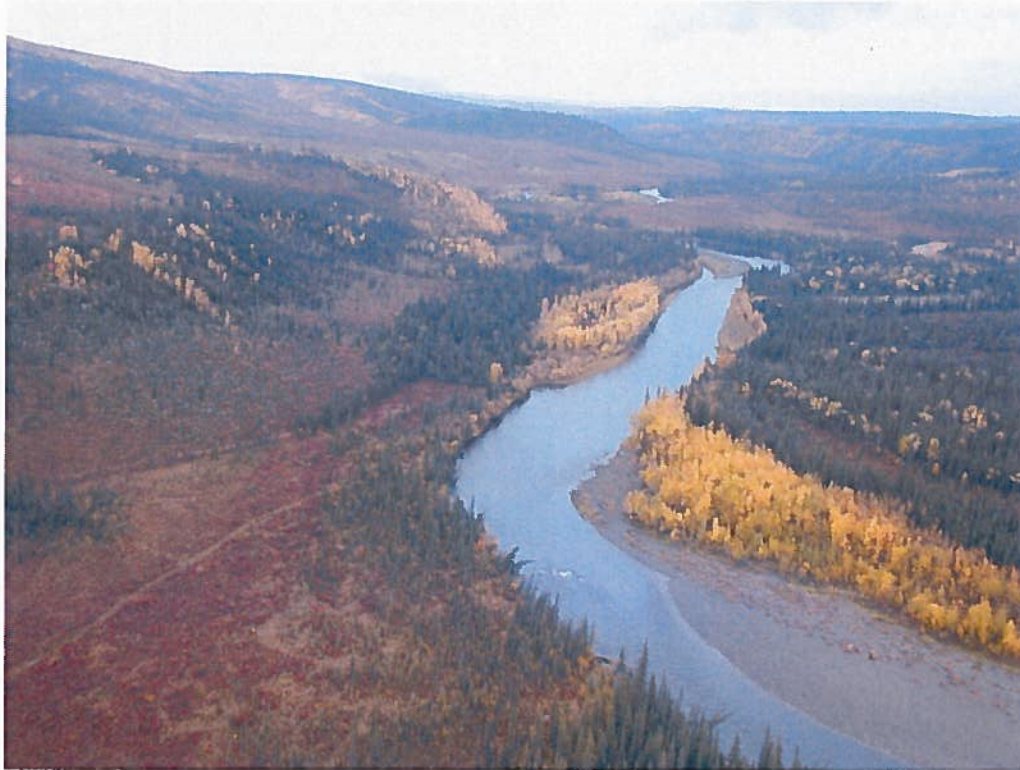
Fig. 8 Dennison Fork of the Fortymile River looking upstream of the mouth. The channel is relatively wide and braids out into two channels at low water. The 1991 cross section is the straight reach near the center of the center photo

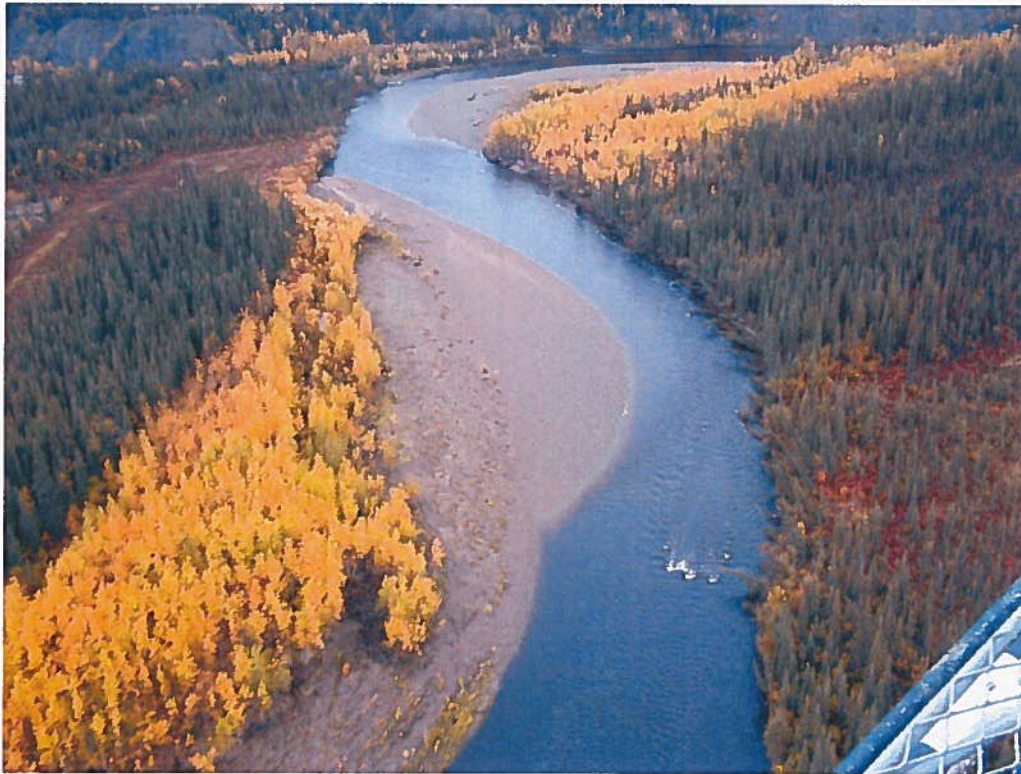
Fig. 9 Dennison Fork looking downstream to the mouth. Most streamflow measurements were near the center of the photo, where there was a single low water channel

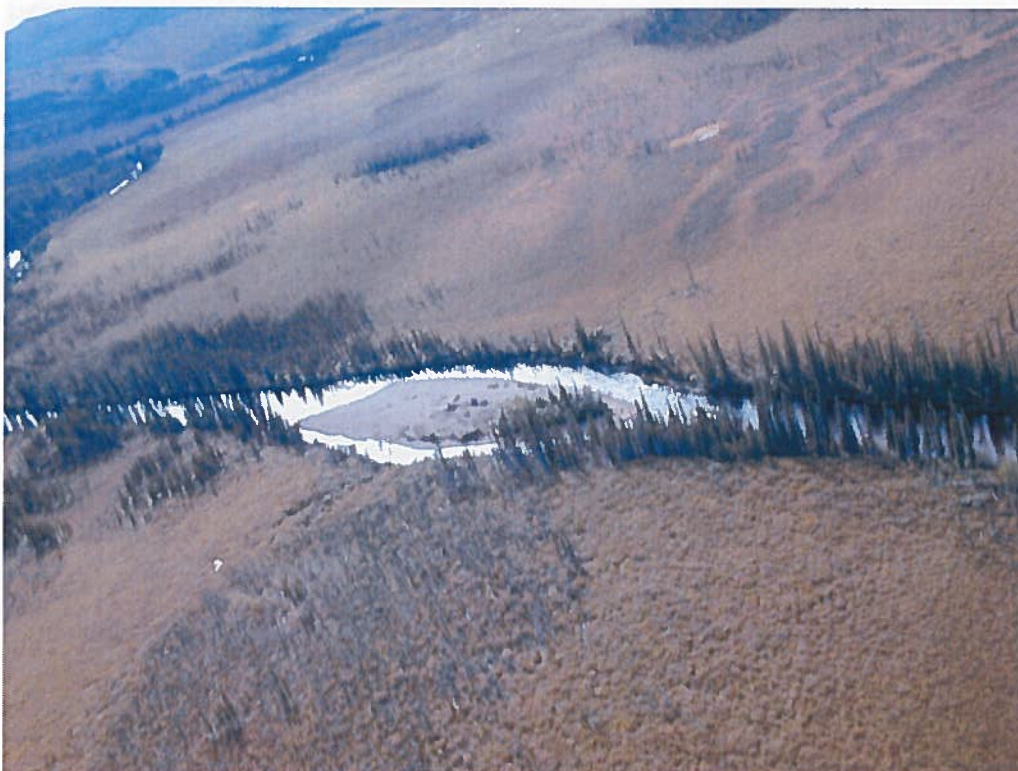
Fig. 11 Dennison Fork above West Fork, streamflow is from left to right. The surveyed cross section is to the left (upstream) of the island

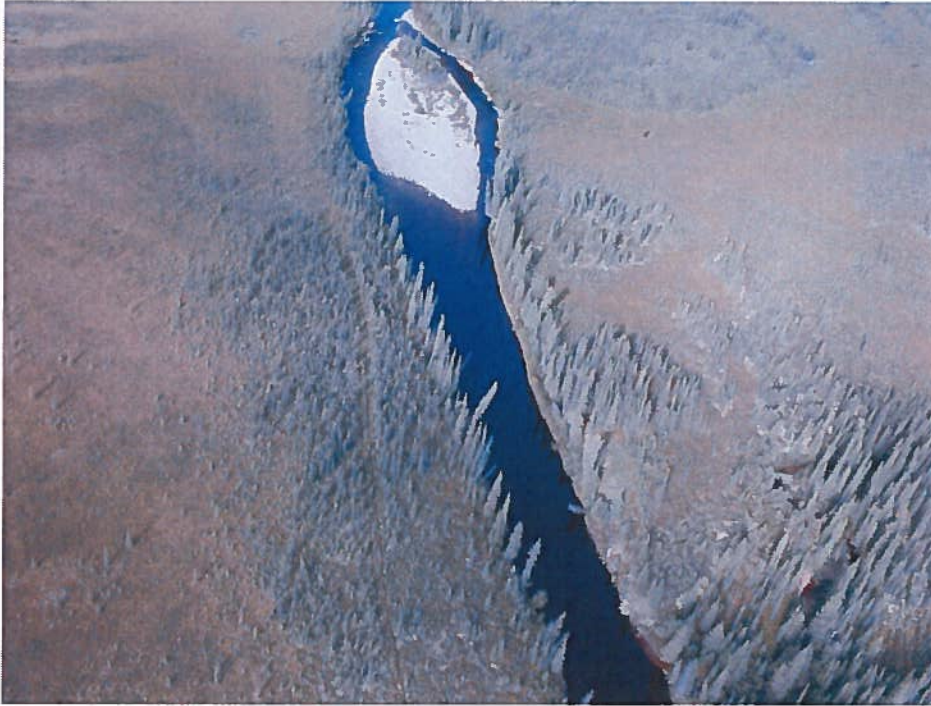
Fig. 12 Dennison Fork above West Fork looking downstream. The surveyed cross section is upstream of the island. The channel is fairly uniform, deep and slow in this reach.

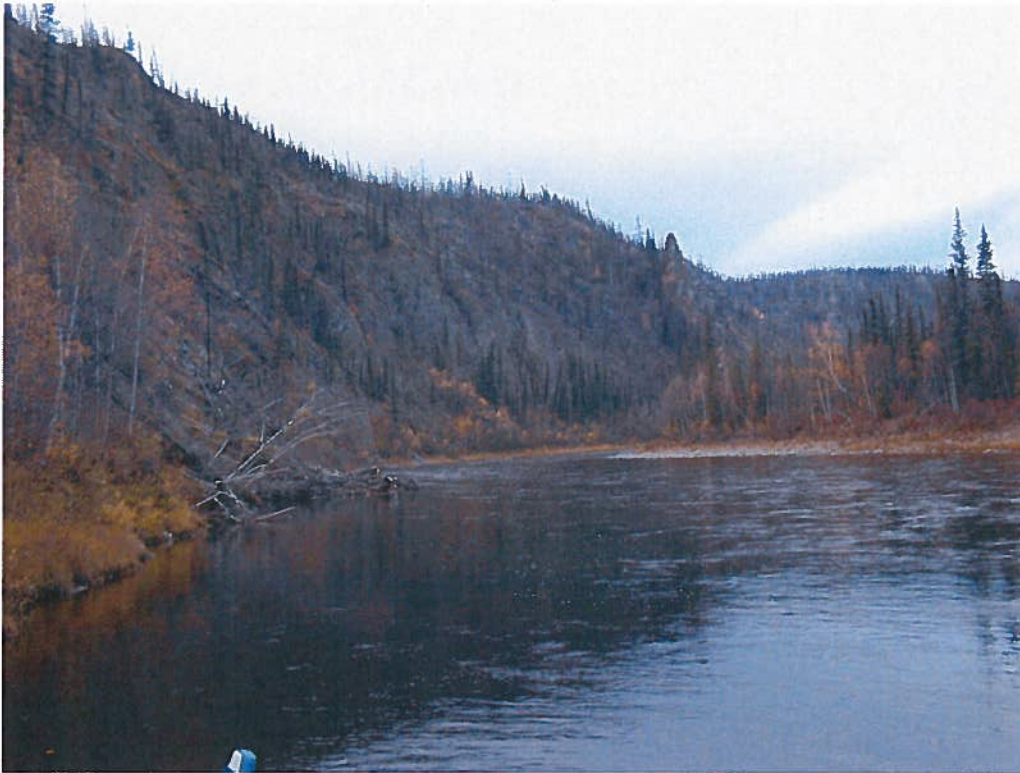
Fig. 14 North Fork at South Fork looking upstream. The surveyed cross section is just downstream. The channel is very uniform, deep and moderately fast in this reach

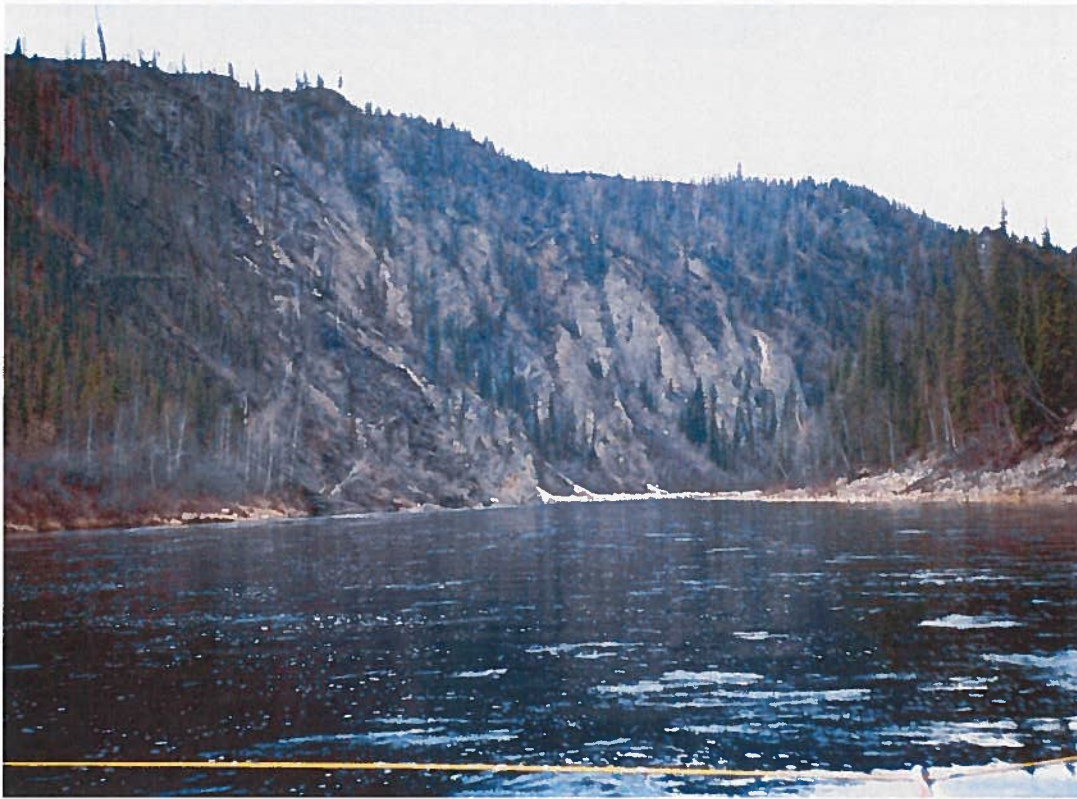
Fig. 15 North Fork at South Fork looking upstream at the cross section. The channel steepens, shallows, and becomes quite fast as the river approaches the confluence with the South Fork

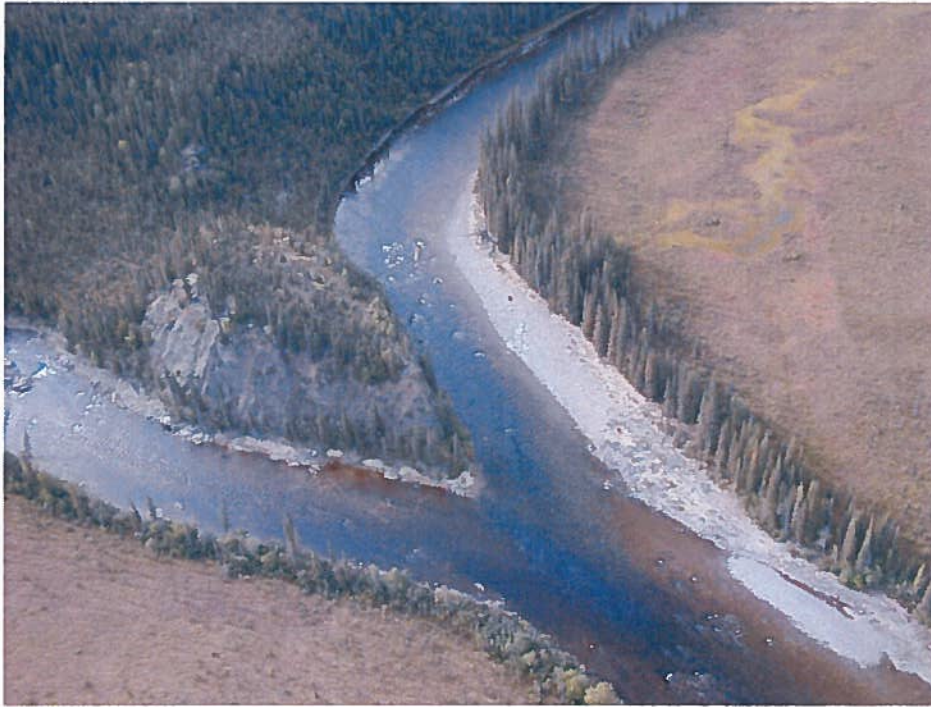
Fig. 21 The North Fork Fortymile River at Middle Fork looking upstream, with the Middle Fork on the left and North Fork on the right. There is a series of boulder bed rapids (rock gardens) just upstream and class III rapids downstream of the confluence

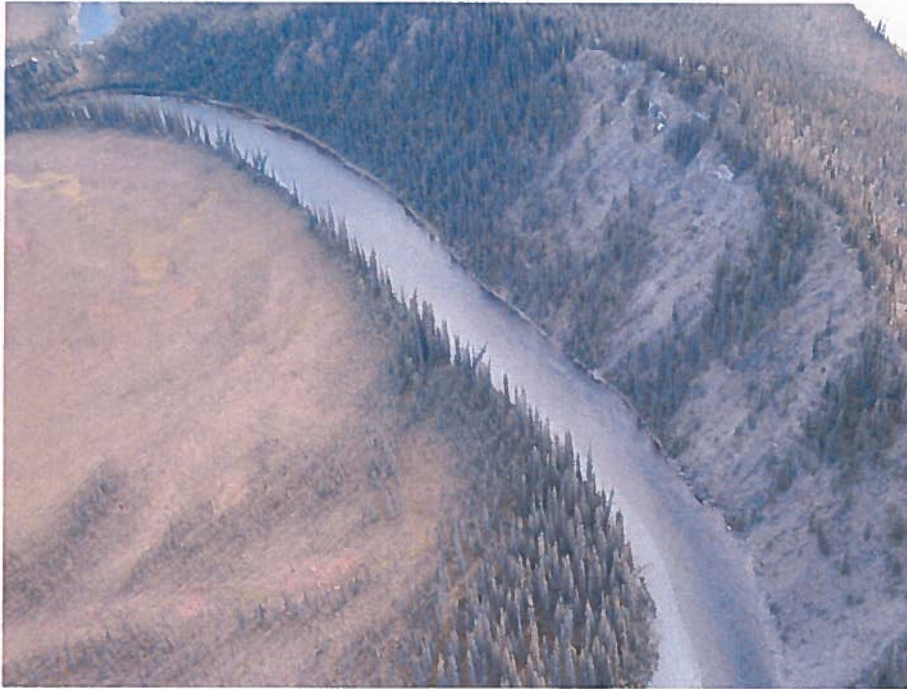
Fig. 22 The North Fork Fortymile River at Middle Fork looking downstream is a fairly straight, uniform reach with no obstructions or constricted areas

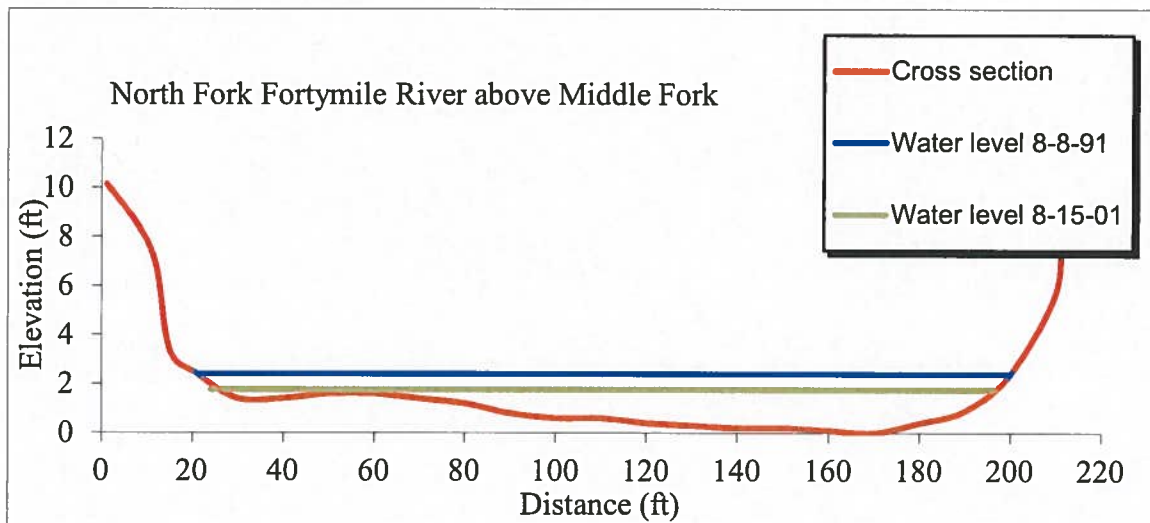
Fig. 23 The surveyed cross section on North Fork Fortymile River at Middle Fork

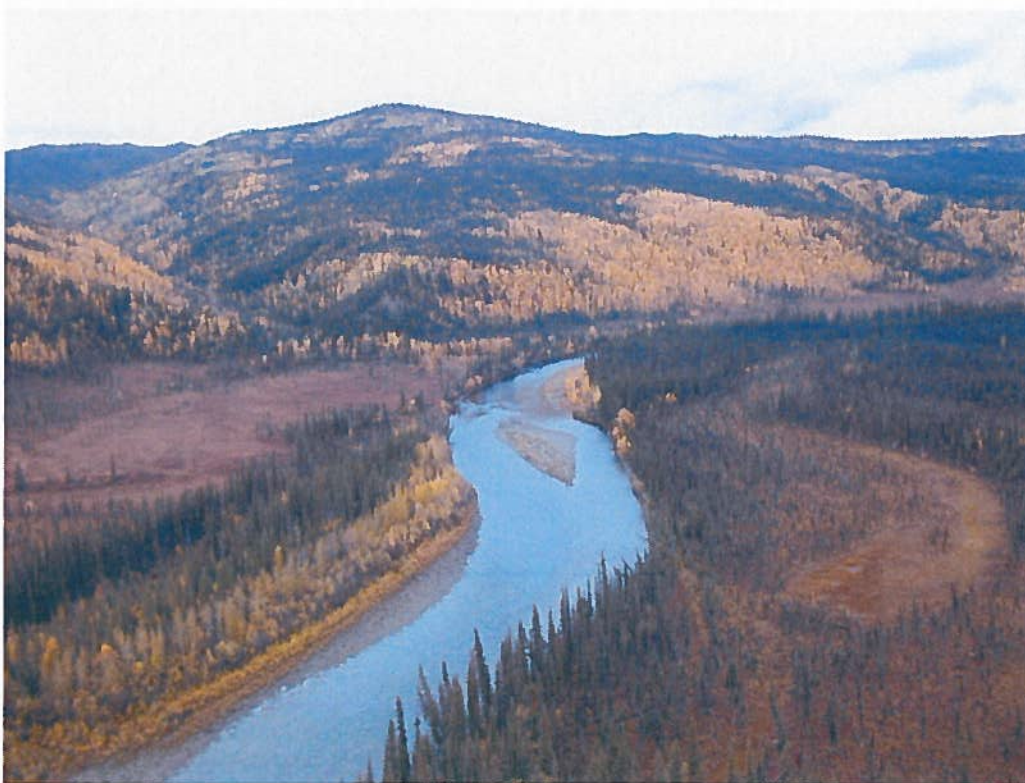
Fig. 24 North Fork Fortymile River above Champion Creek cross section is the relatively straight reach near the bottom of the photo

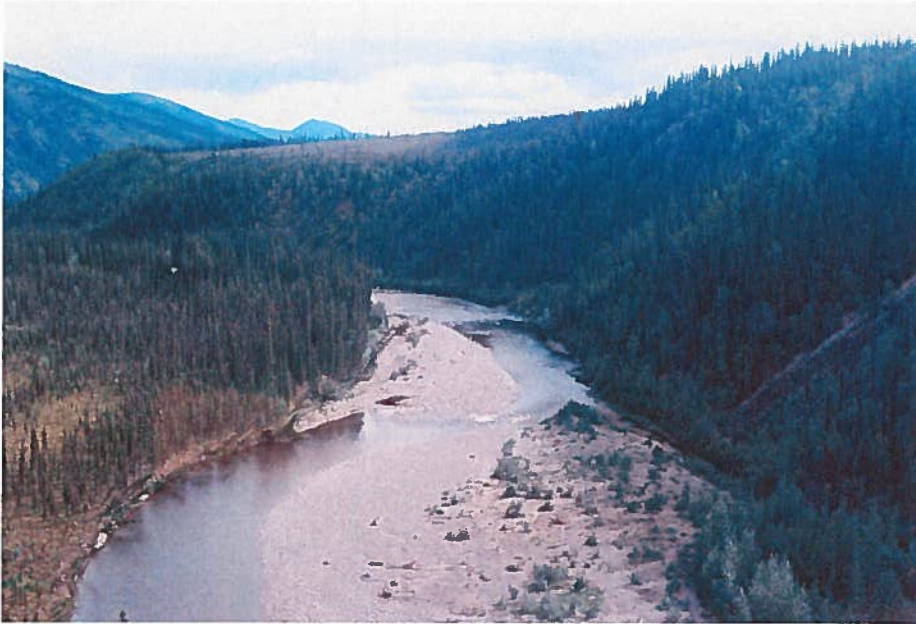
Fig. 25 North Fork Fortymile River above Champion Creek is a meandering stream with wide gravel bars and occasional islands

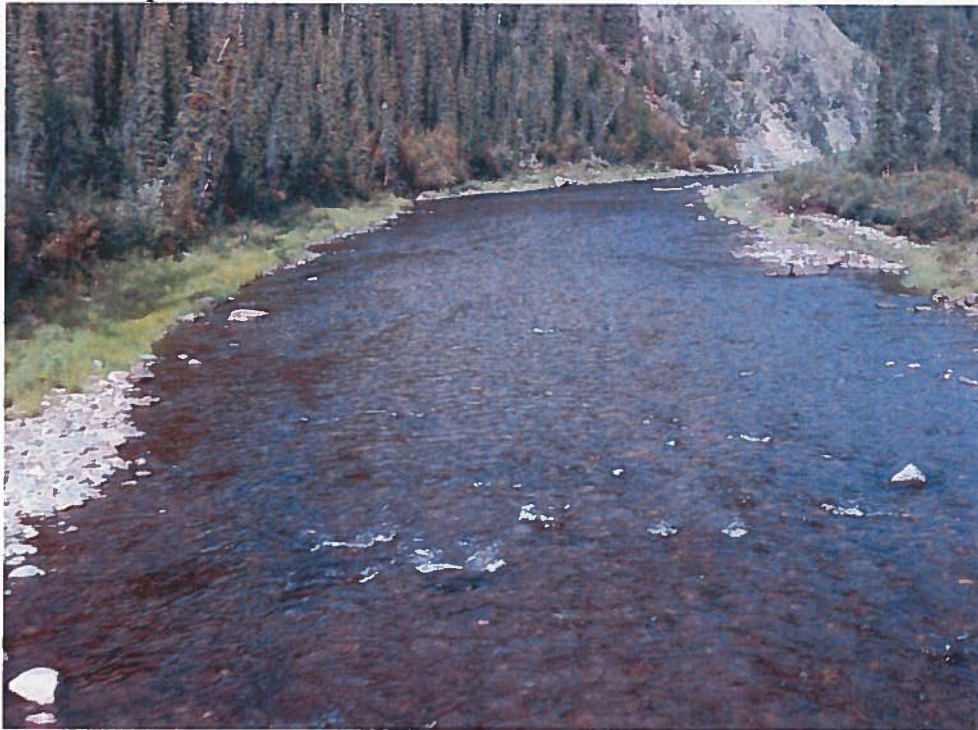
Fig. 27 North Fork Fortymile River above Little Bonanza Creek cross section #1 surveyed in 1992 is a shallow, uniform reach with a bed of cobbles and small boulders

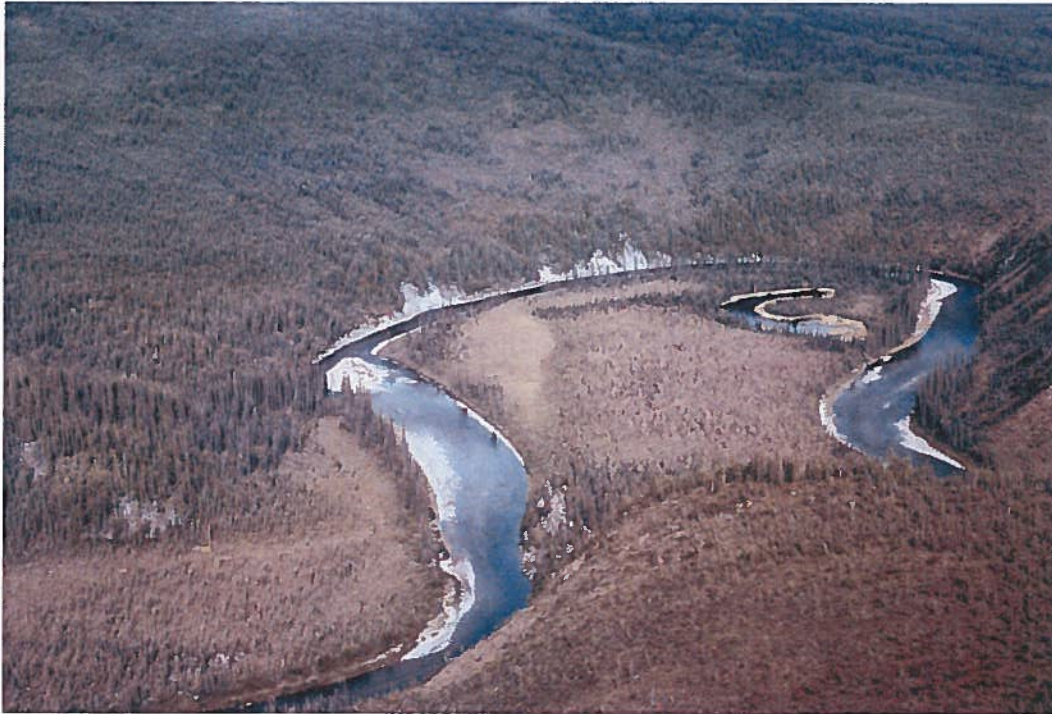
Fig. 28 North Fork Fortymile River above Little Bonanza Creek is a shallow stream with gravel bars and occasional constrictions at bends

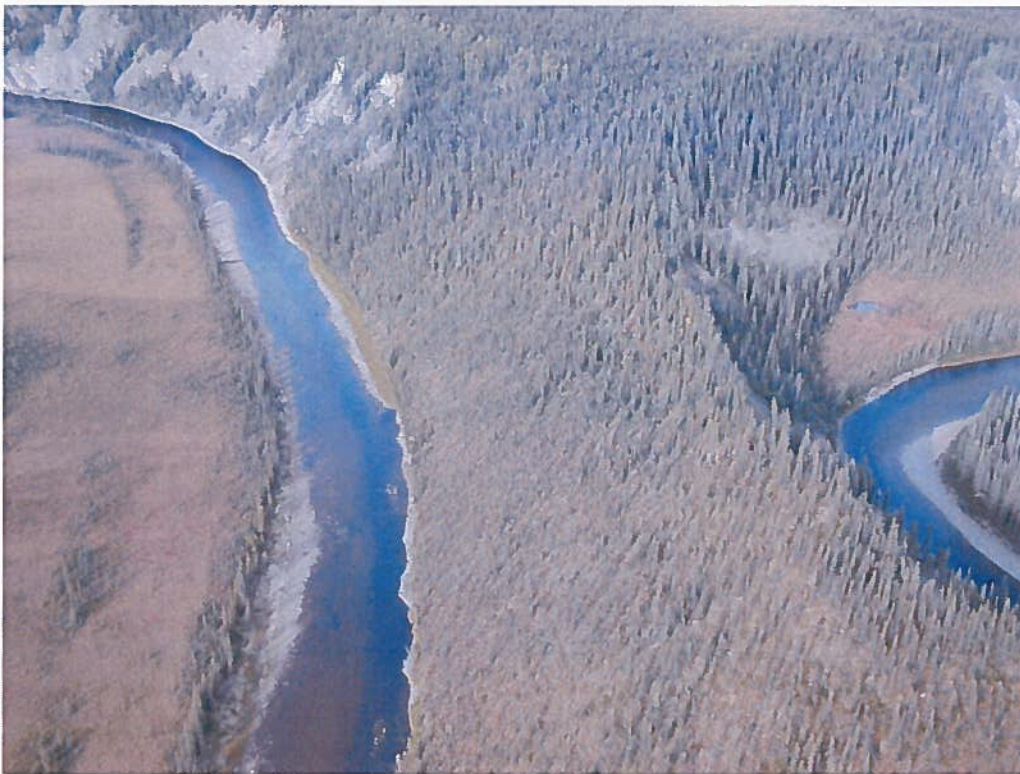
Fig. 30 Middle Fork Fortymile River (left) at North Fork (right) is a uniform, moderately deep channel with narrow gravel bars. Just downstream are the class II/III Eagle Rapids

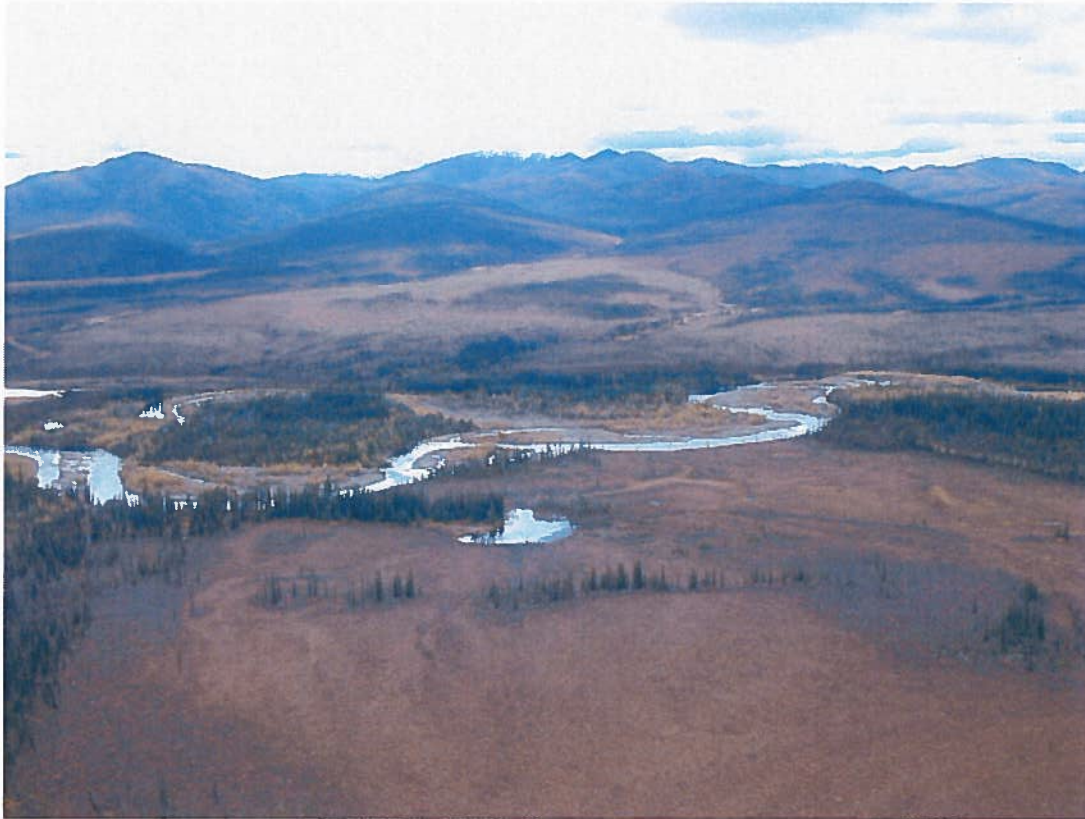
Fig. 32 Middle Fork Fortymile River downstream of Joseph airstrip is a moderately deep, meandering stream with sloughs and islands

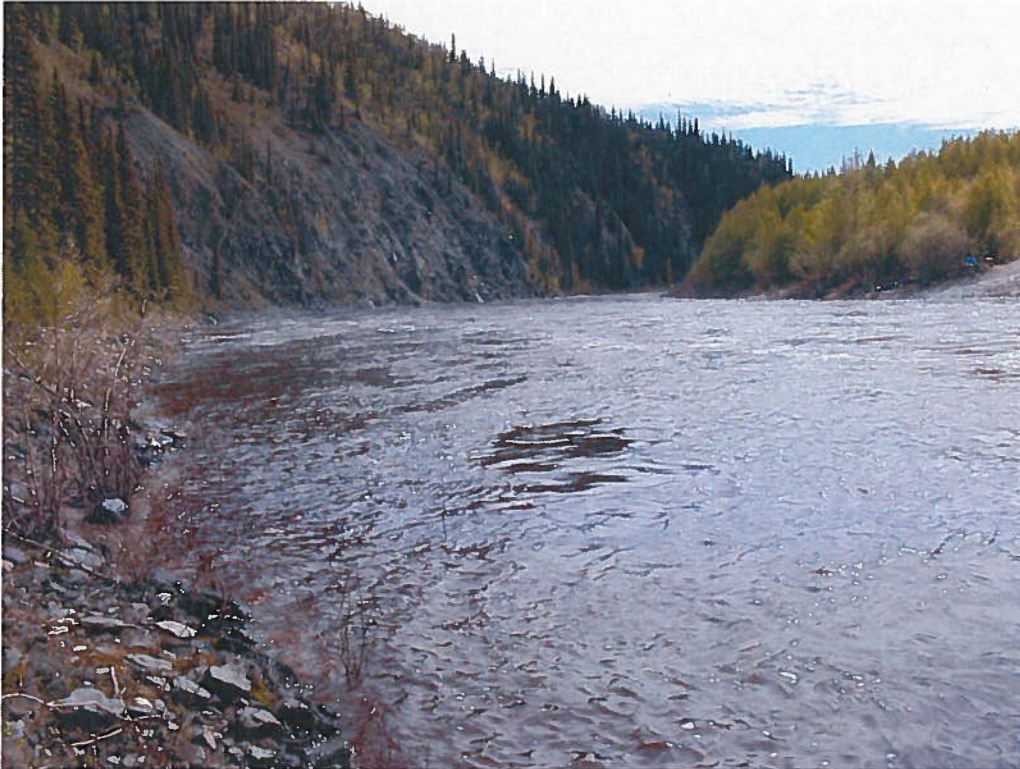
Fig. 34 The Fortymile River looking downstream of the bridge. The river is deep and fast in this reach, but widens out and is shallower and somewhat slower downstream of the bend

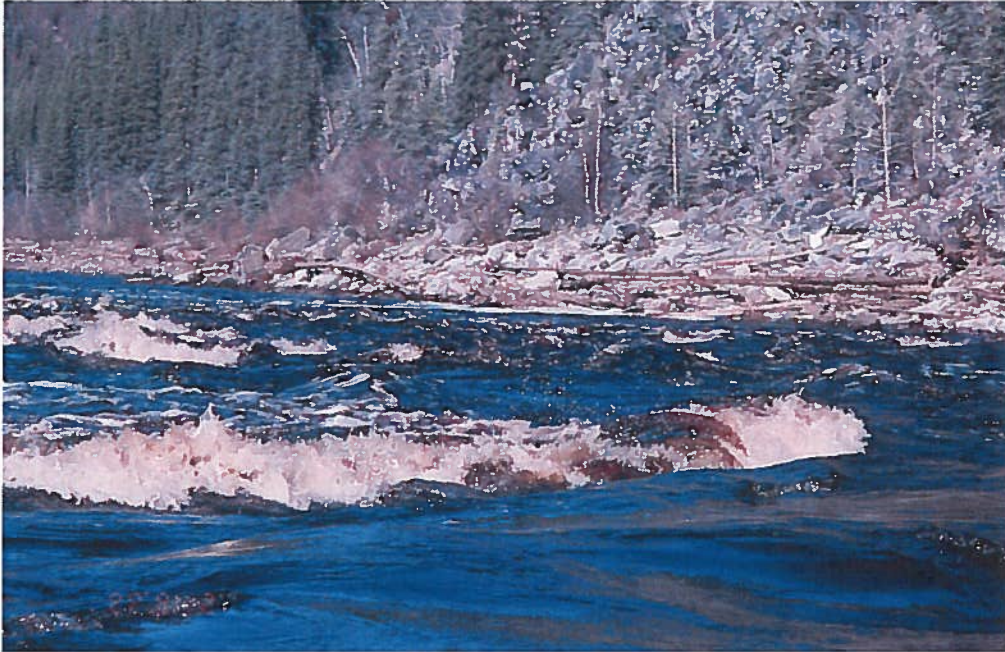
Fig. 35 The class II/III falls of the Fortymile River are about three miles upstream of the bridge
