HAZARDOUS BUILDING MATERIALS SURVEY
25951 and 26035 Williamson Lane
Former Fish Processing Facility and Associated Structures
Kasilof, Alaska 99610

July 8, 2016

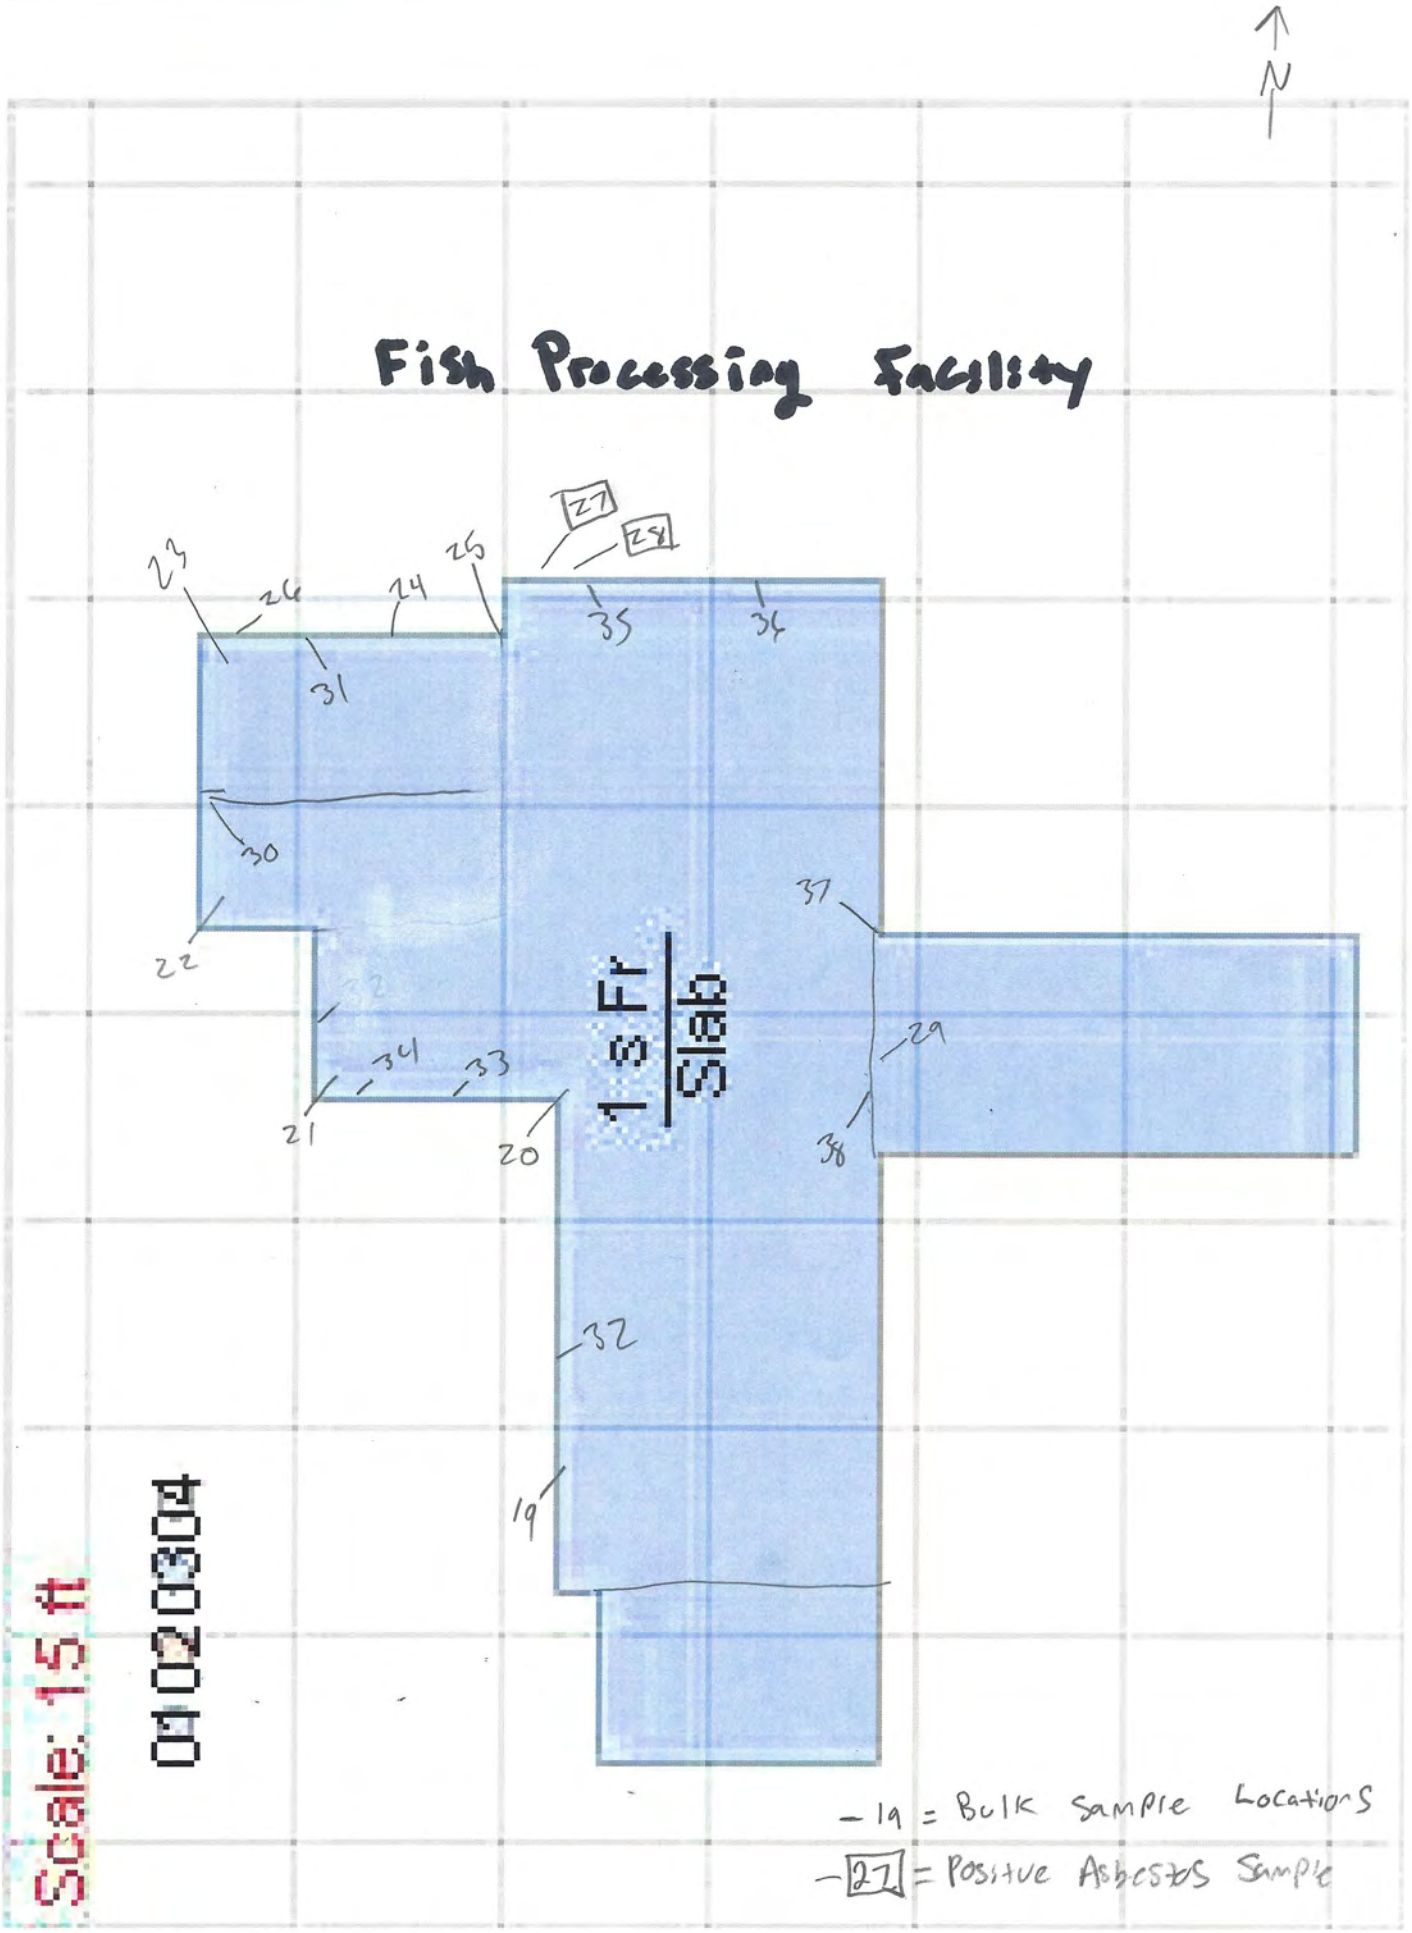
Figure 1A

Fish Processing Facility	Estimated Quantity of ACBM
• Grey/White Caulk (category II)	<1000 sq. ft.
• White/Clear Caulk (category II)	<1000 sq. ft.

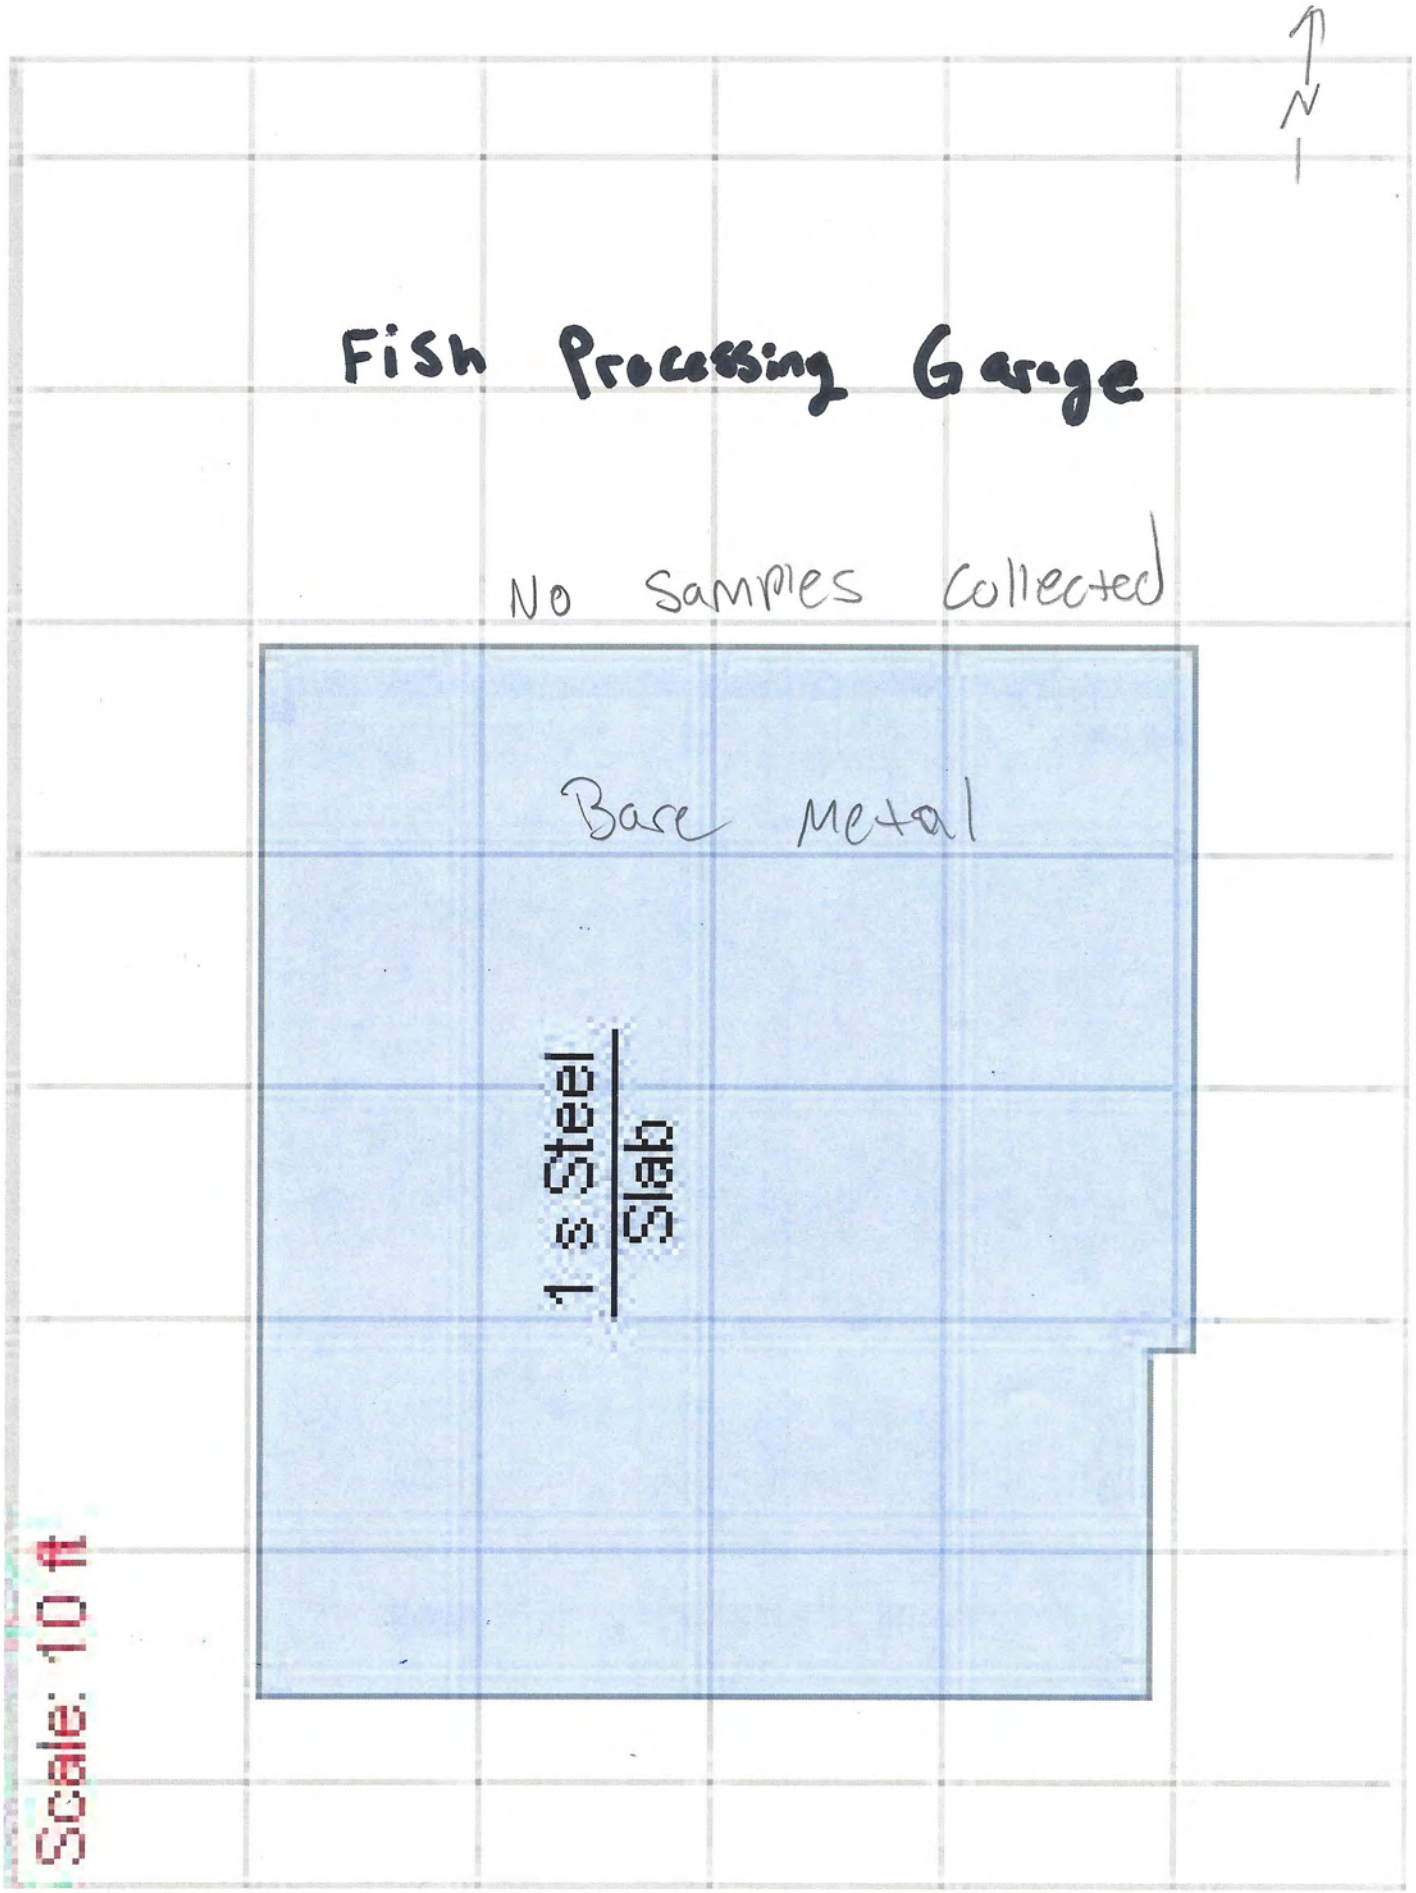
Figure 2

Scale: 10 ft
1 ≤ Steel Slab
Bare Metal
No samples collected
Fish Processing Garage
N

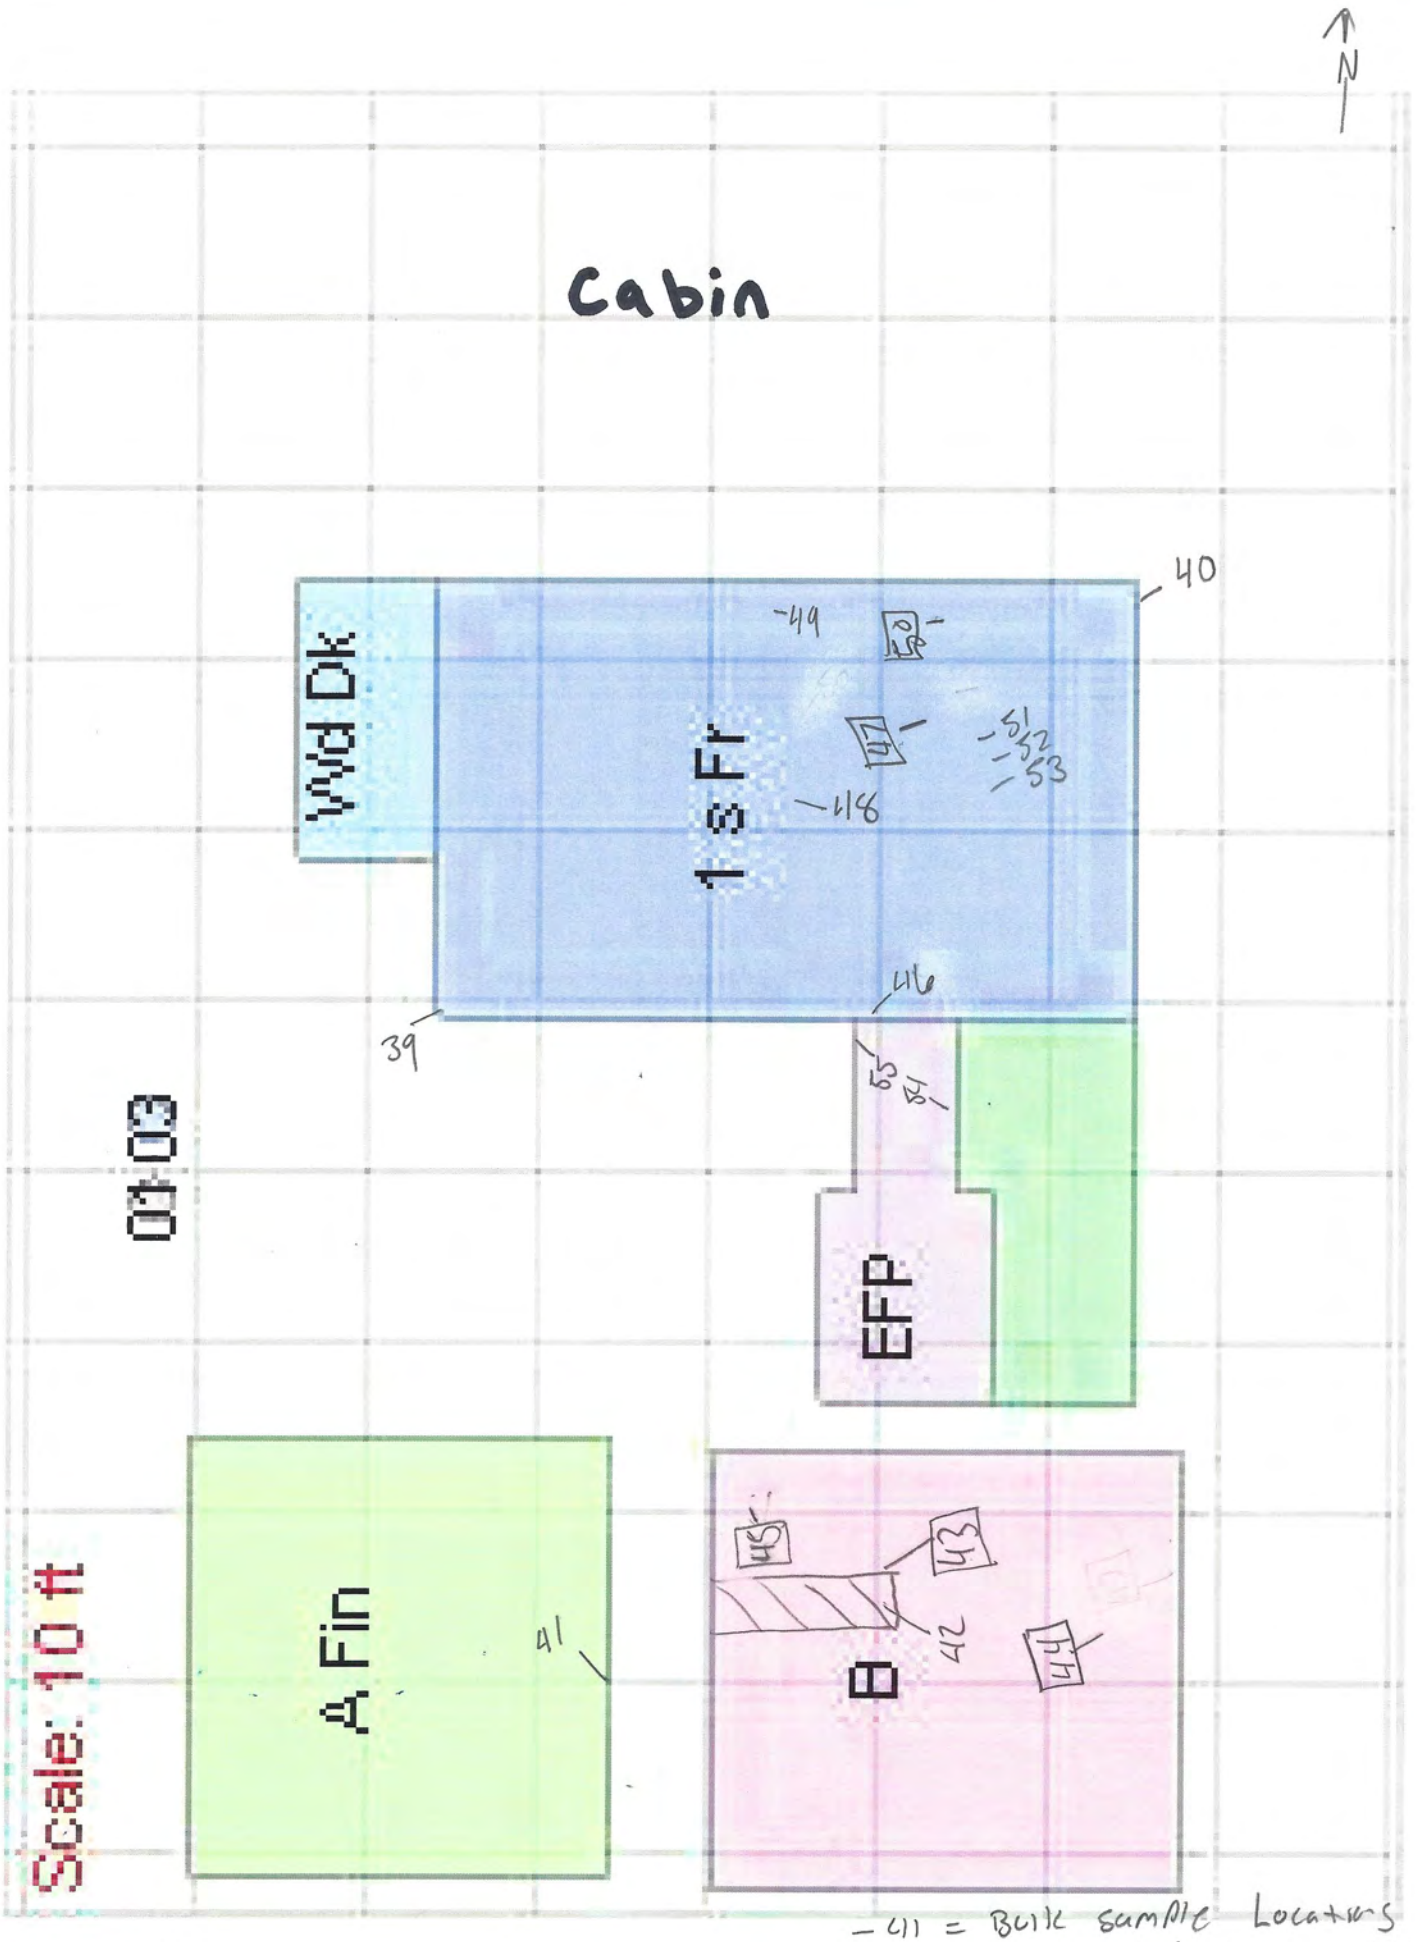
Figure 3A

Single Family Cabin	Estimated Quantity of ACBM
• White Joint Compound (category II)	<4000 sq. ft.
• Grey Insulation (RACM)	<100 sq. ft.
• Brown/Grey Vinyl Sheet Flooring(category II)	<500 sq. ft.
• Tan/Grey Vinyl Sheet Flooring (category II)	<500 sq. ft.

- 41 = Bulk sample Locations
- 44 = positive Asbestos sample
