TAILINGS AND PRODUCTION ROCK SITE
2006 ANNUAL REPORT

Kennecott Greens Creek Mining Company

April 2007

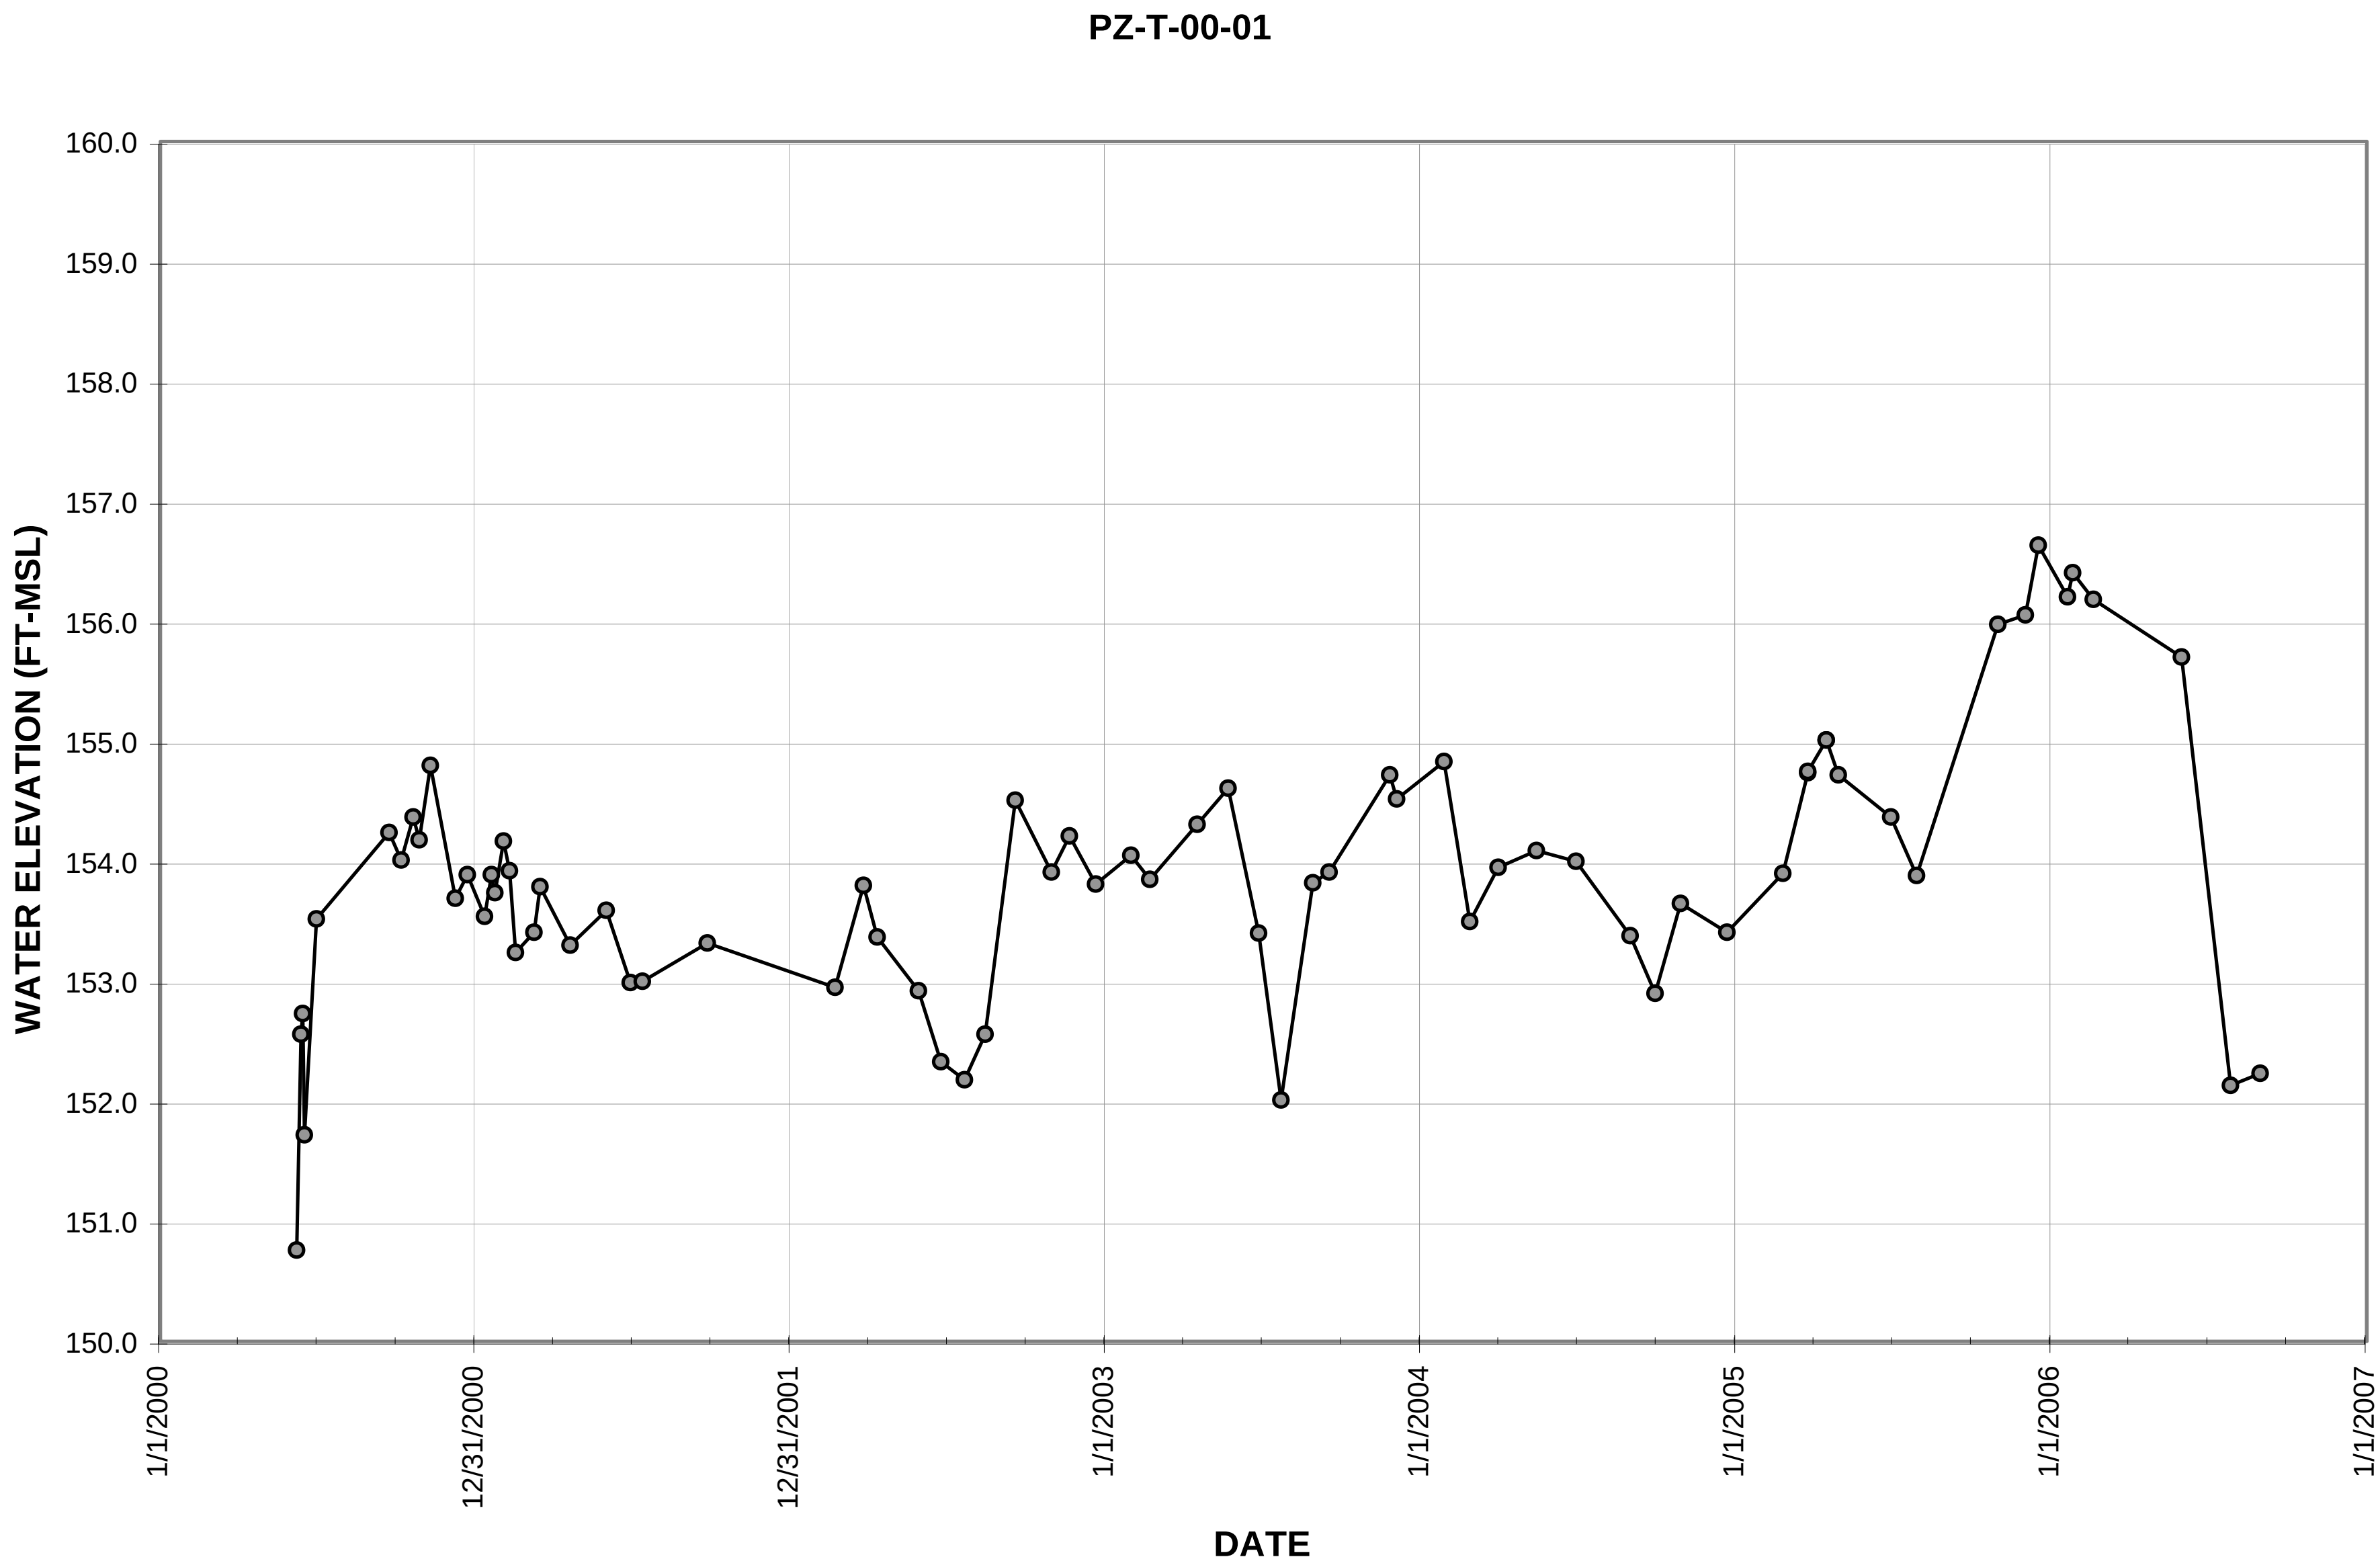
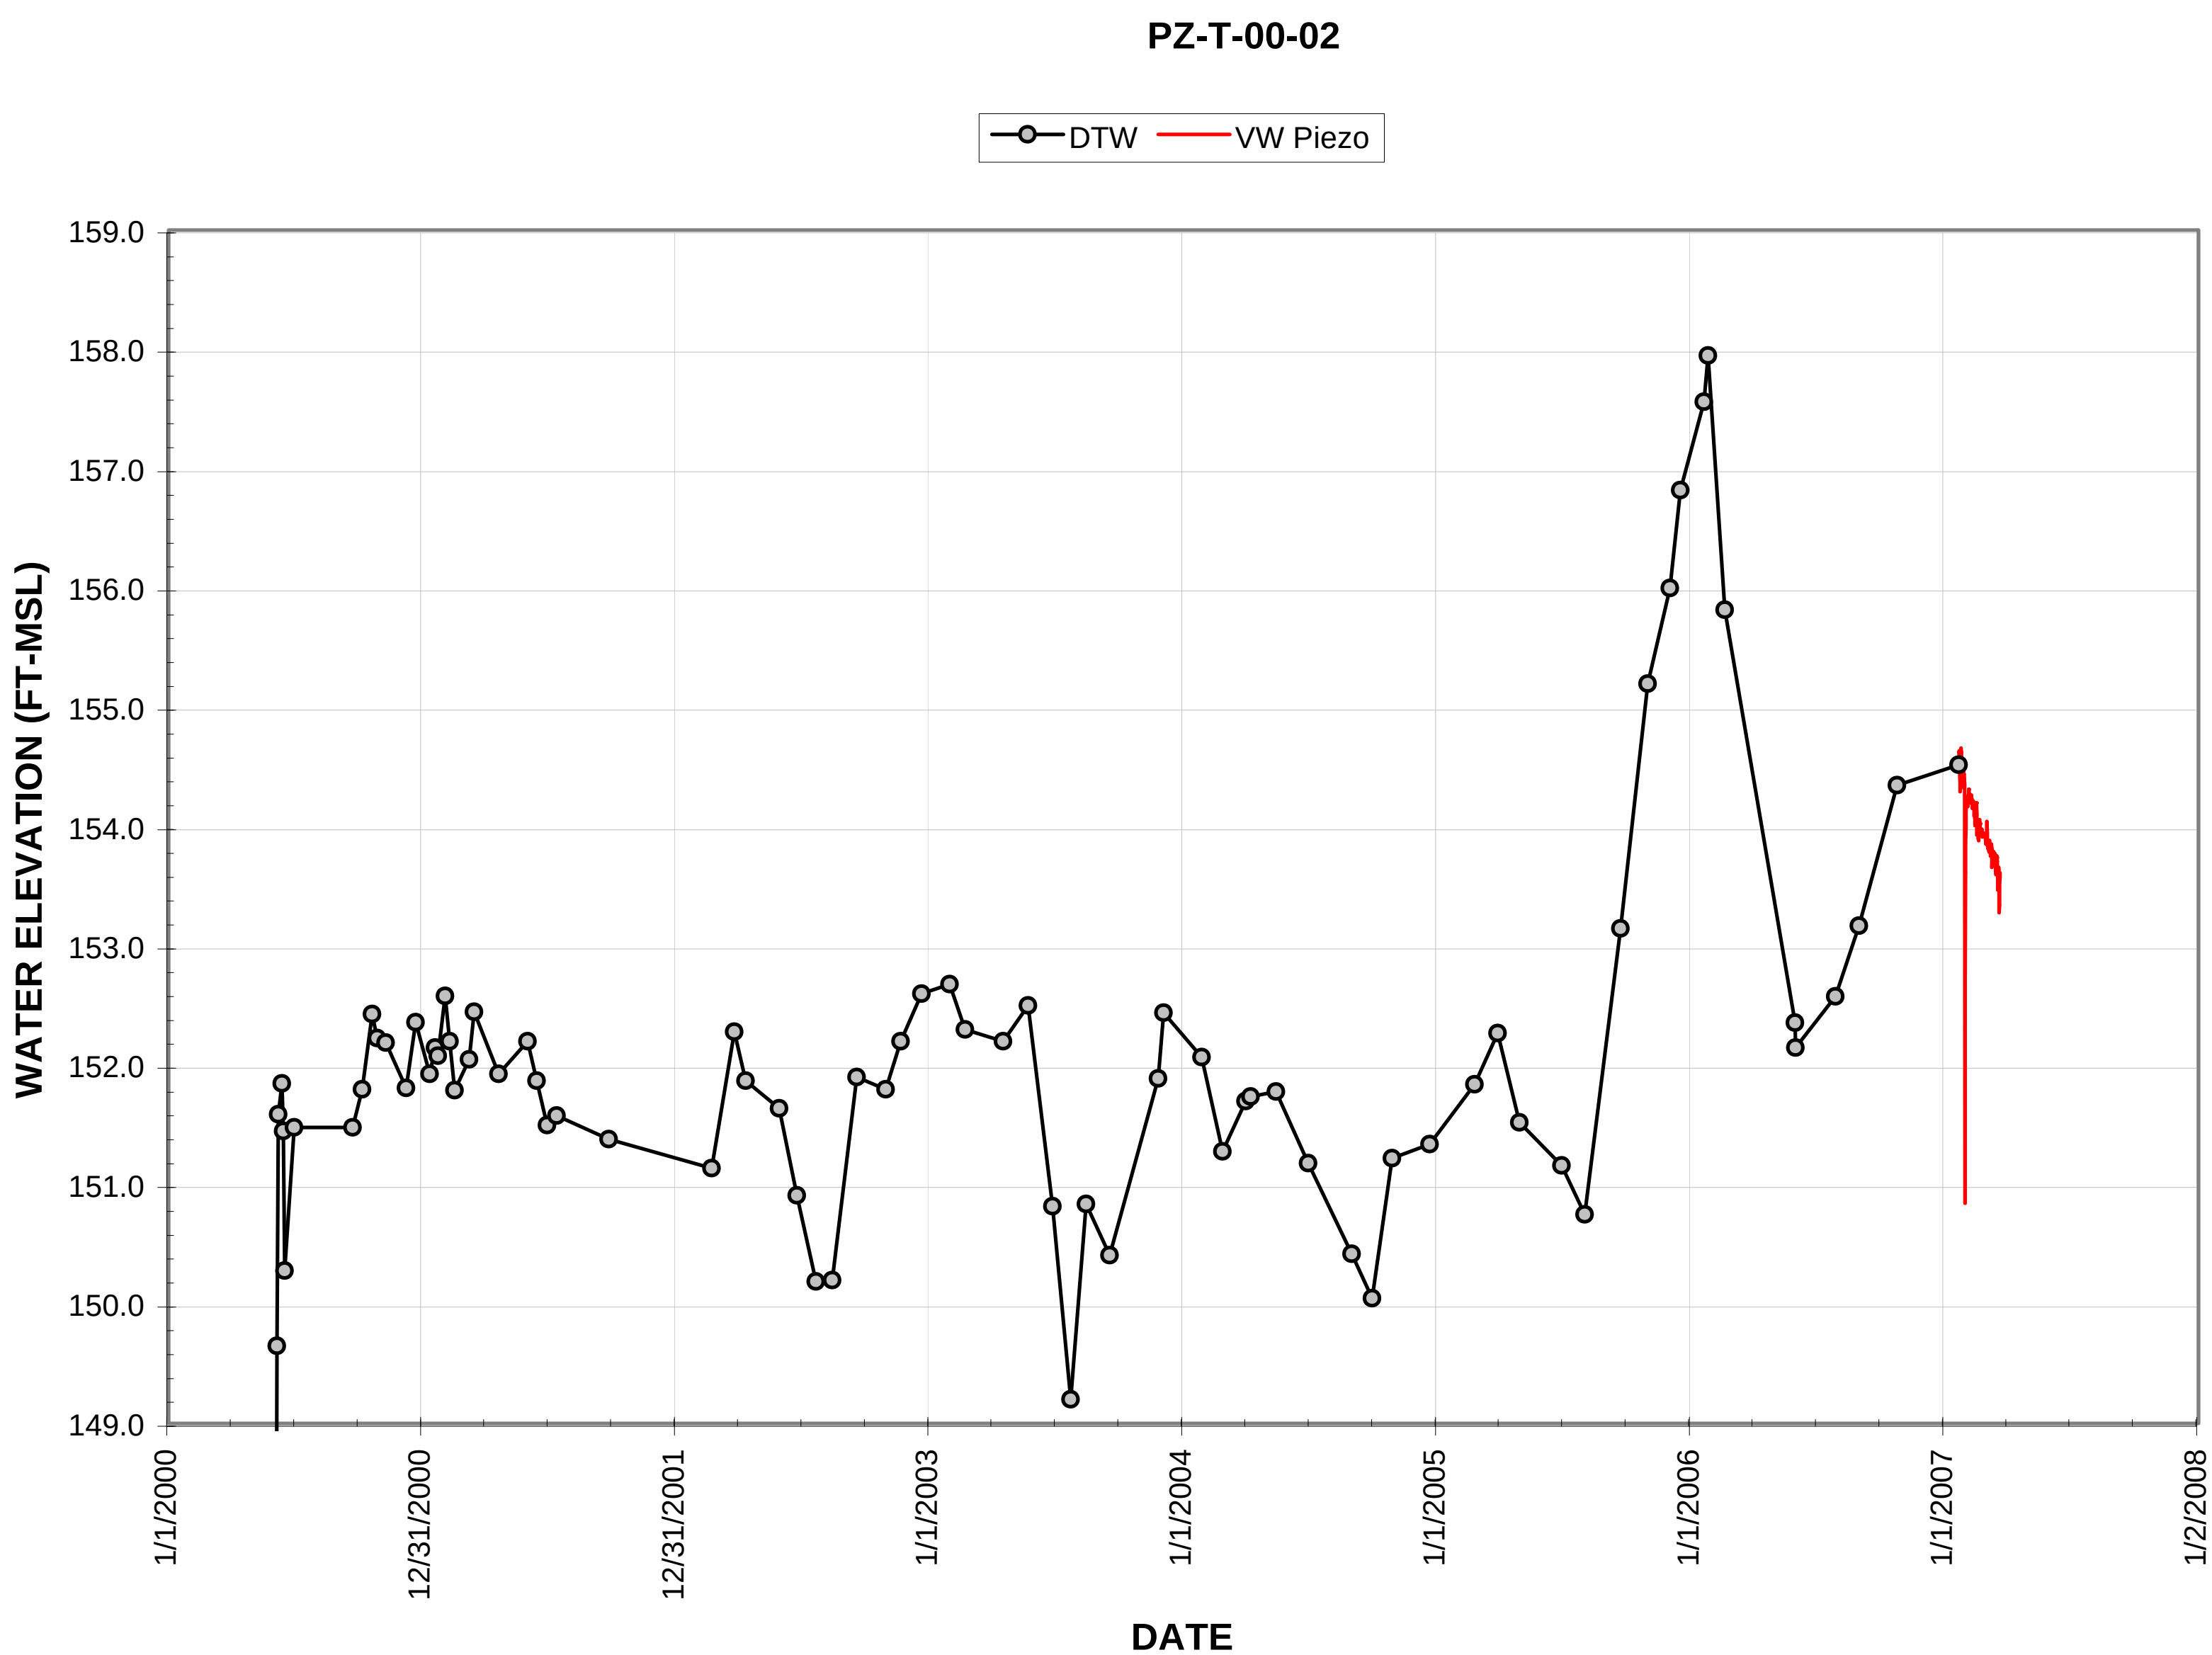
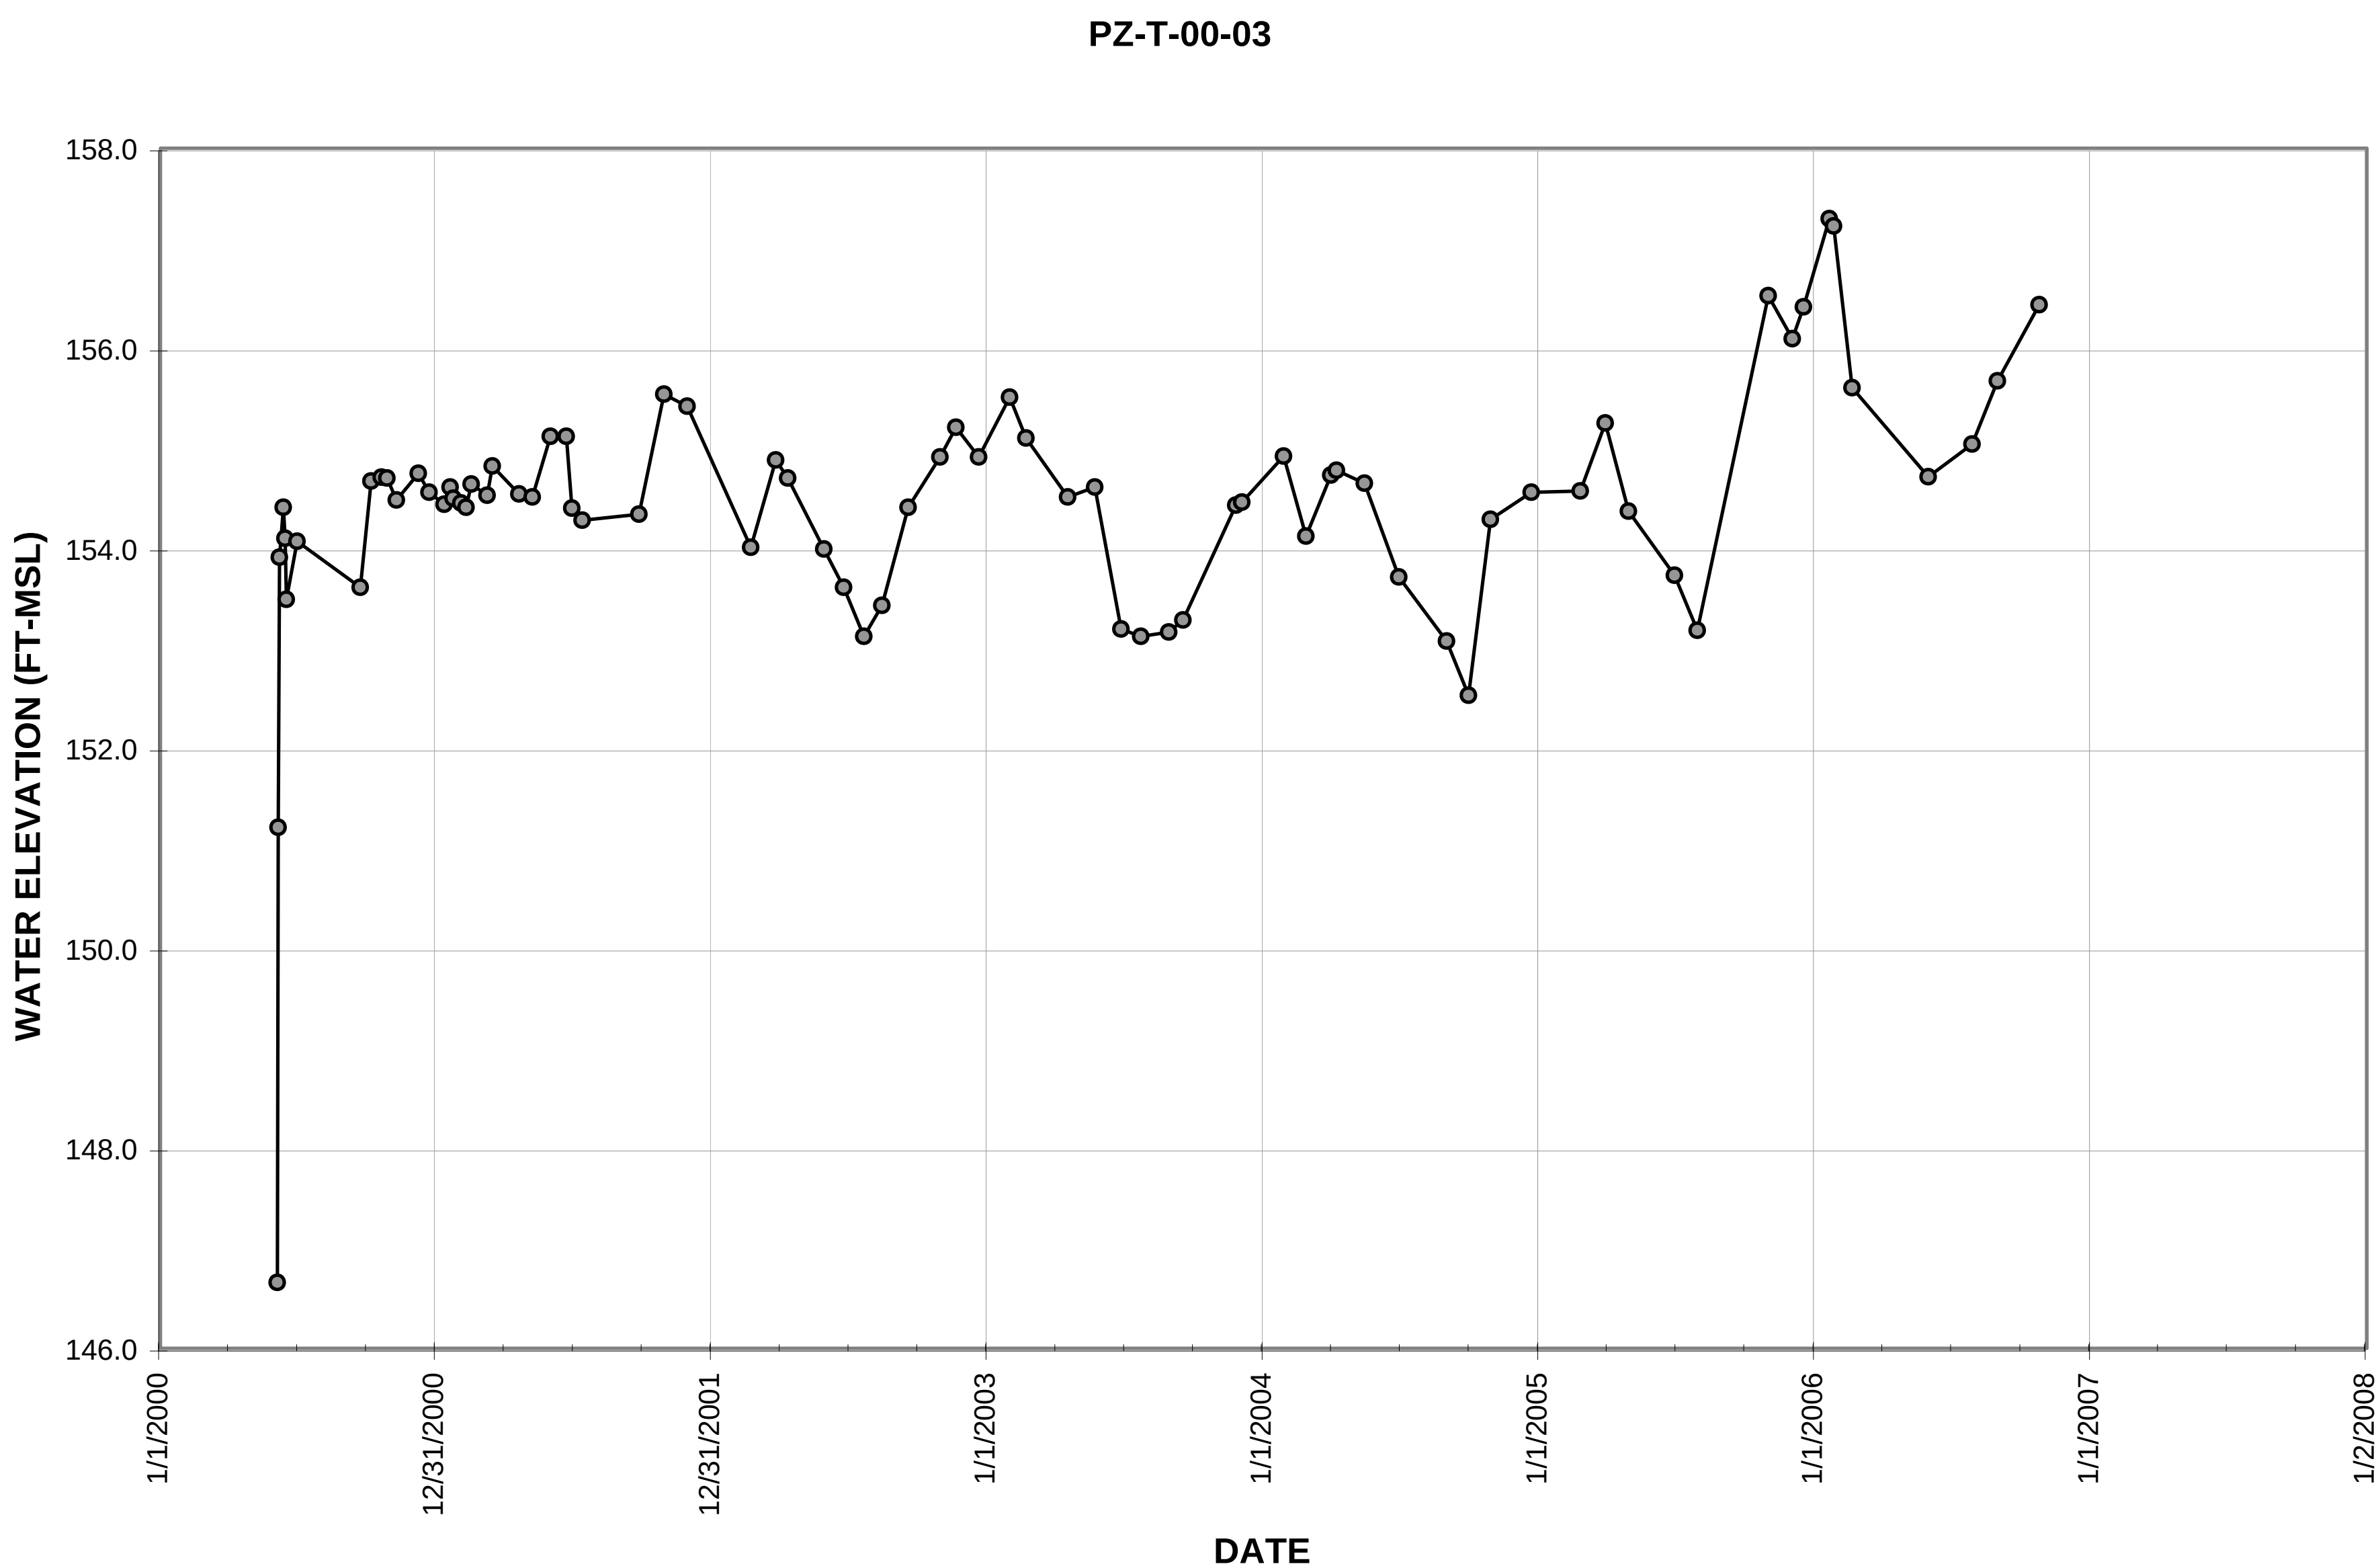
The data from standpipe piezometers completed above the blanket drain (PZ-T-00-01, PZ-T-00-02, PZ-T-00-03 in Figures 2.11, 2.12, 2.13) indicate that the water perches above the unsaturated underdrains to a thickness of approximately 12 feet. This is consistent with the low permeability of the tailings and the un-capped condition of the pile. Covering the pile will help minimize the saturated zone in the pile. This was demonstrated by the over 10 foot decrease in the water table that occurred from 1995 to 1997 when the pile was covered (see Figures 2.1 to 2.7). Water levels have rebounded to, and in some cases above, 1994 elevations in most areas. Areas where water levels exceed their 1994 values are areas where the pile is considerably thicker than it was in 1994.

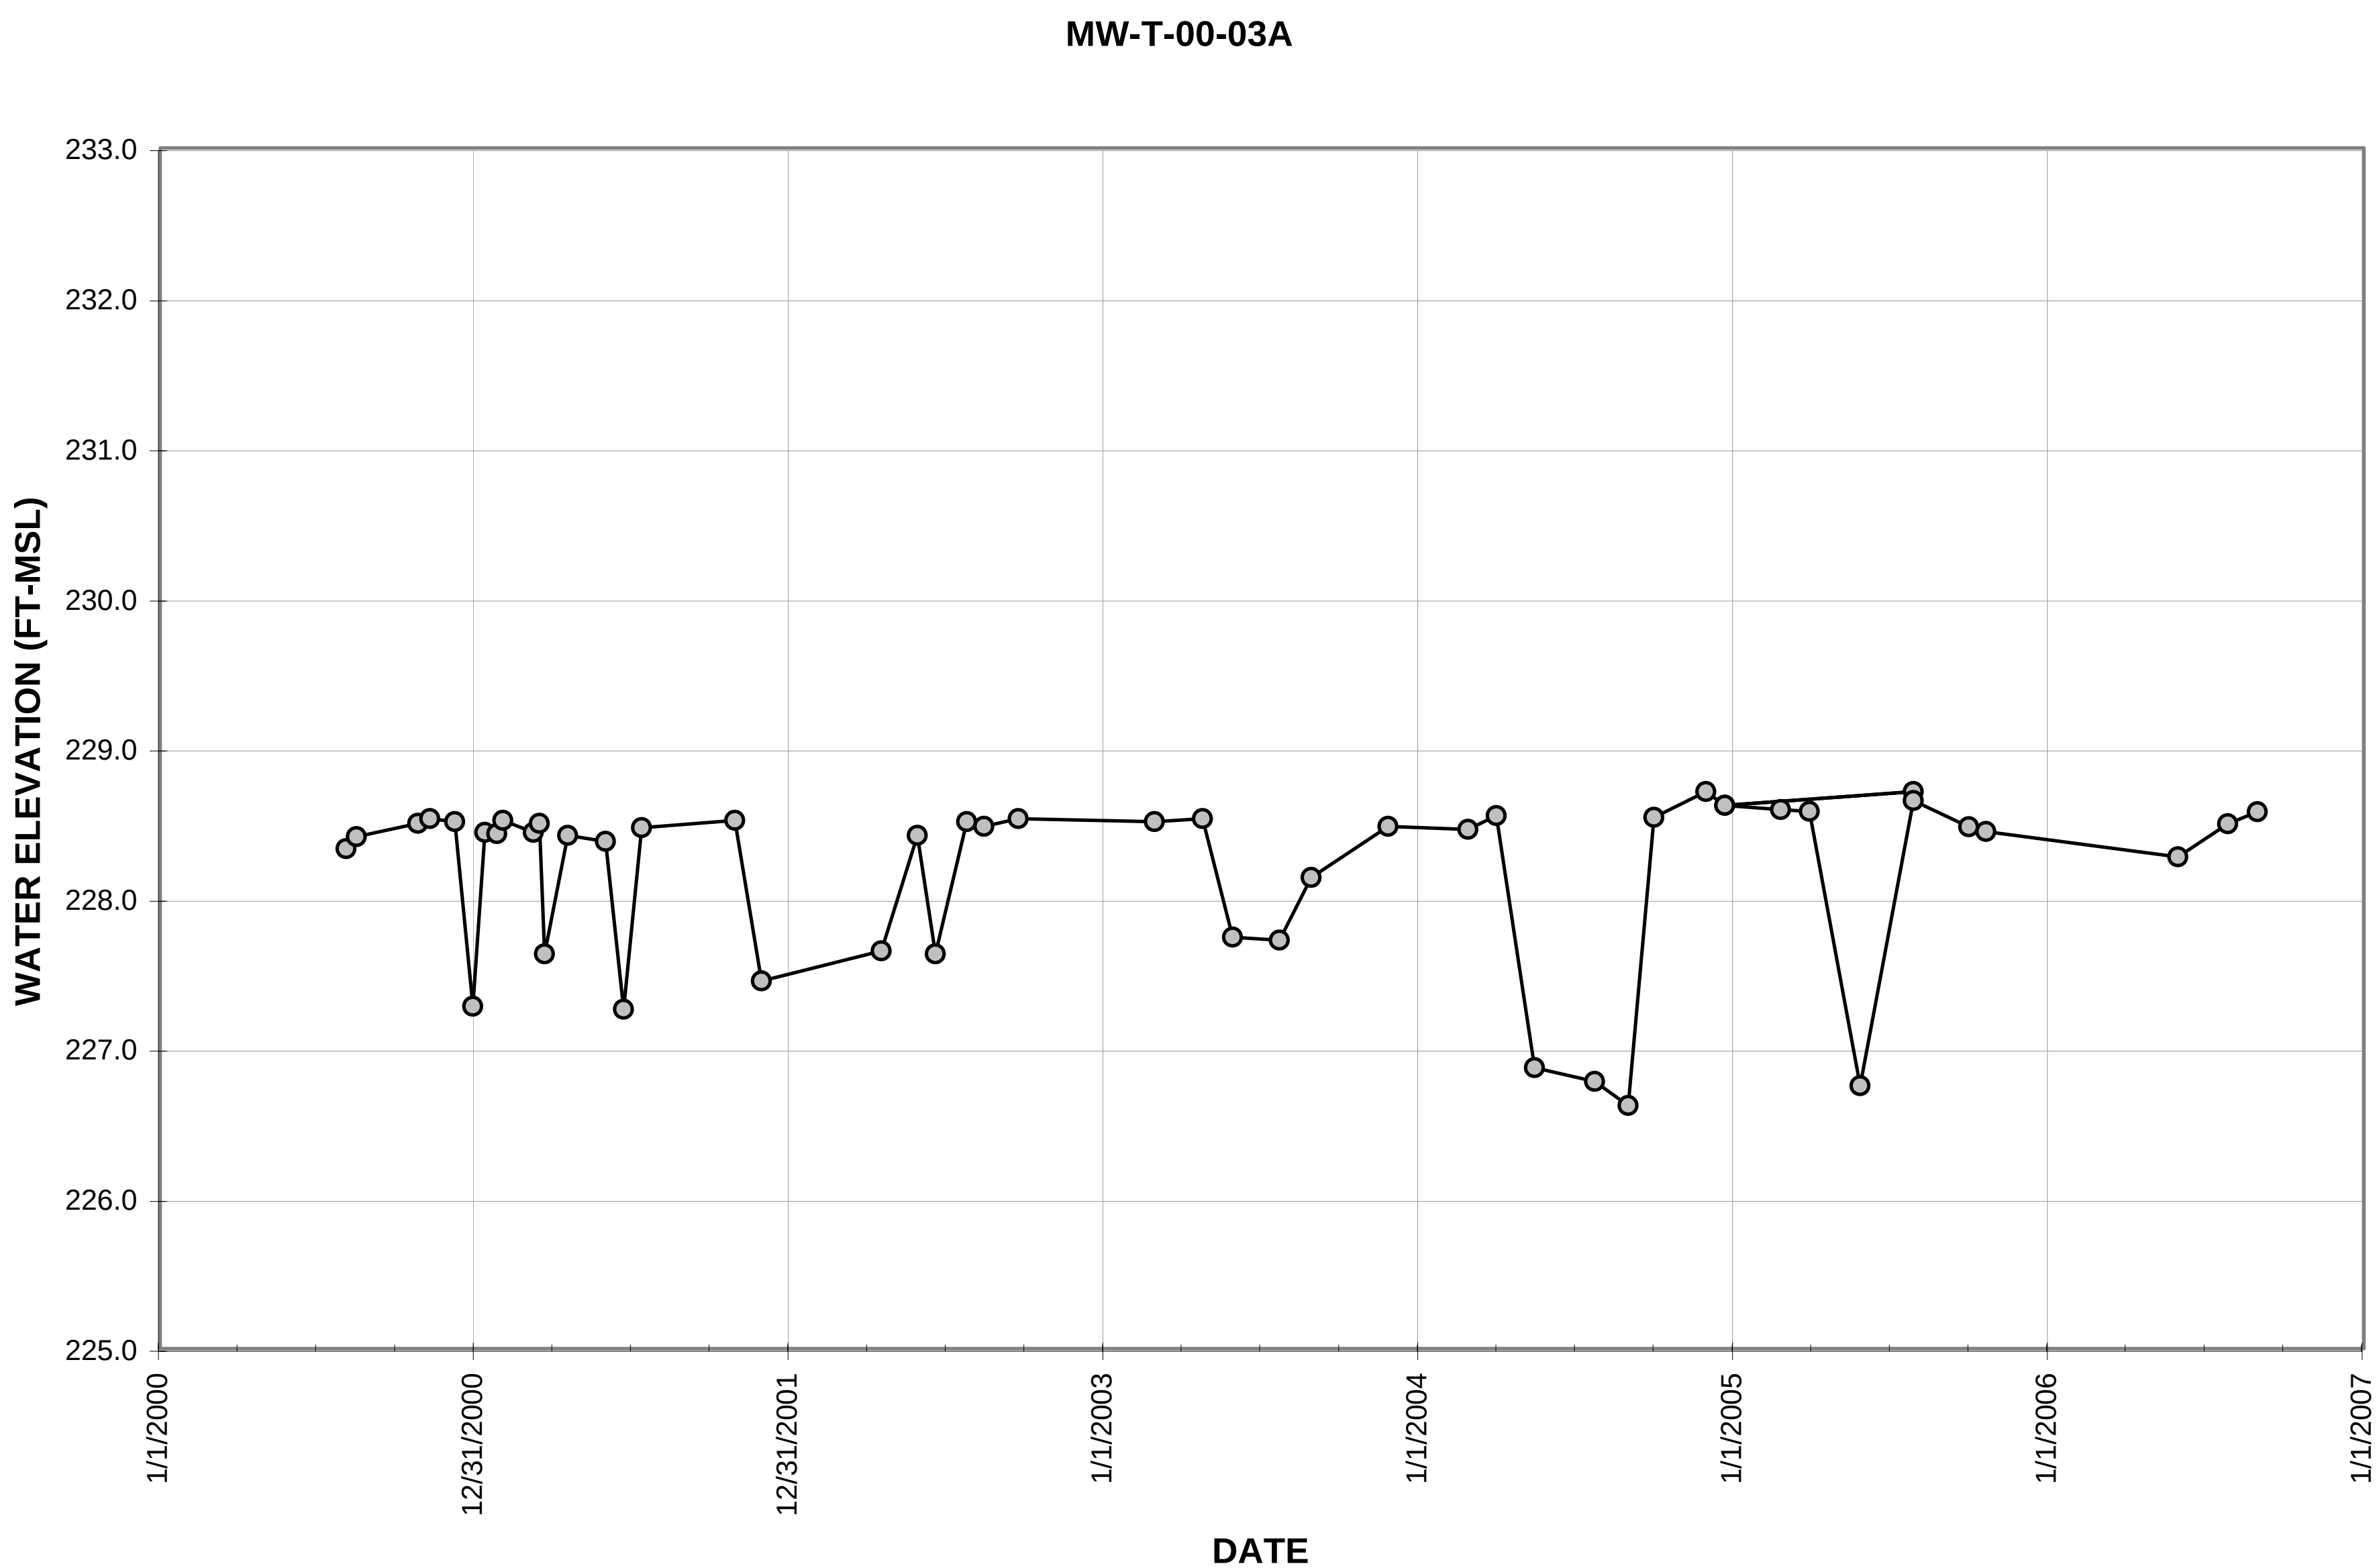
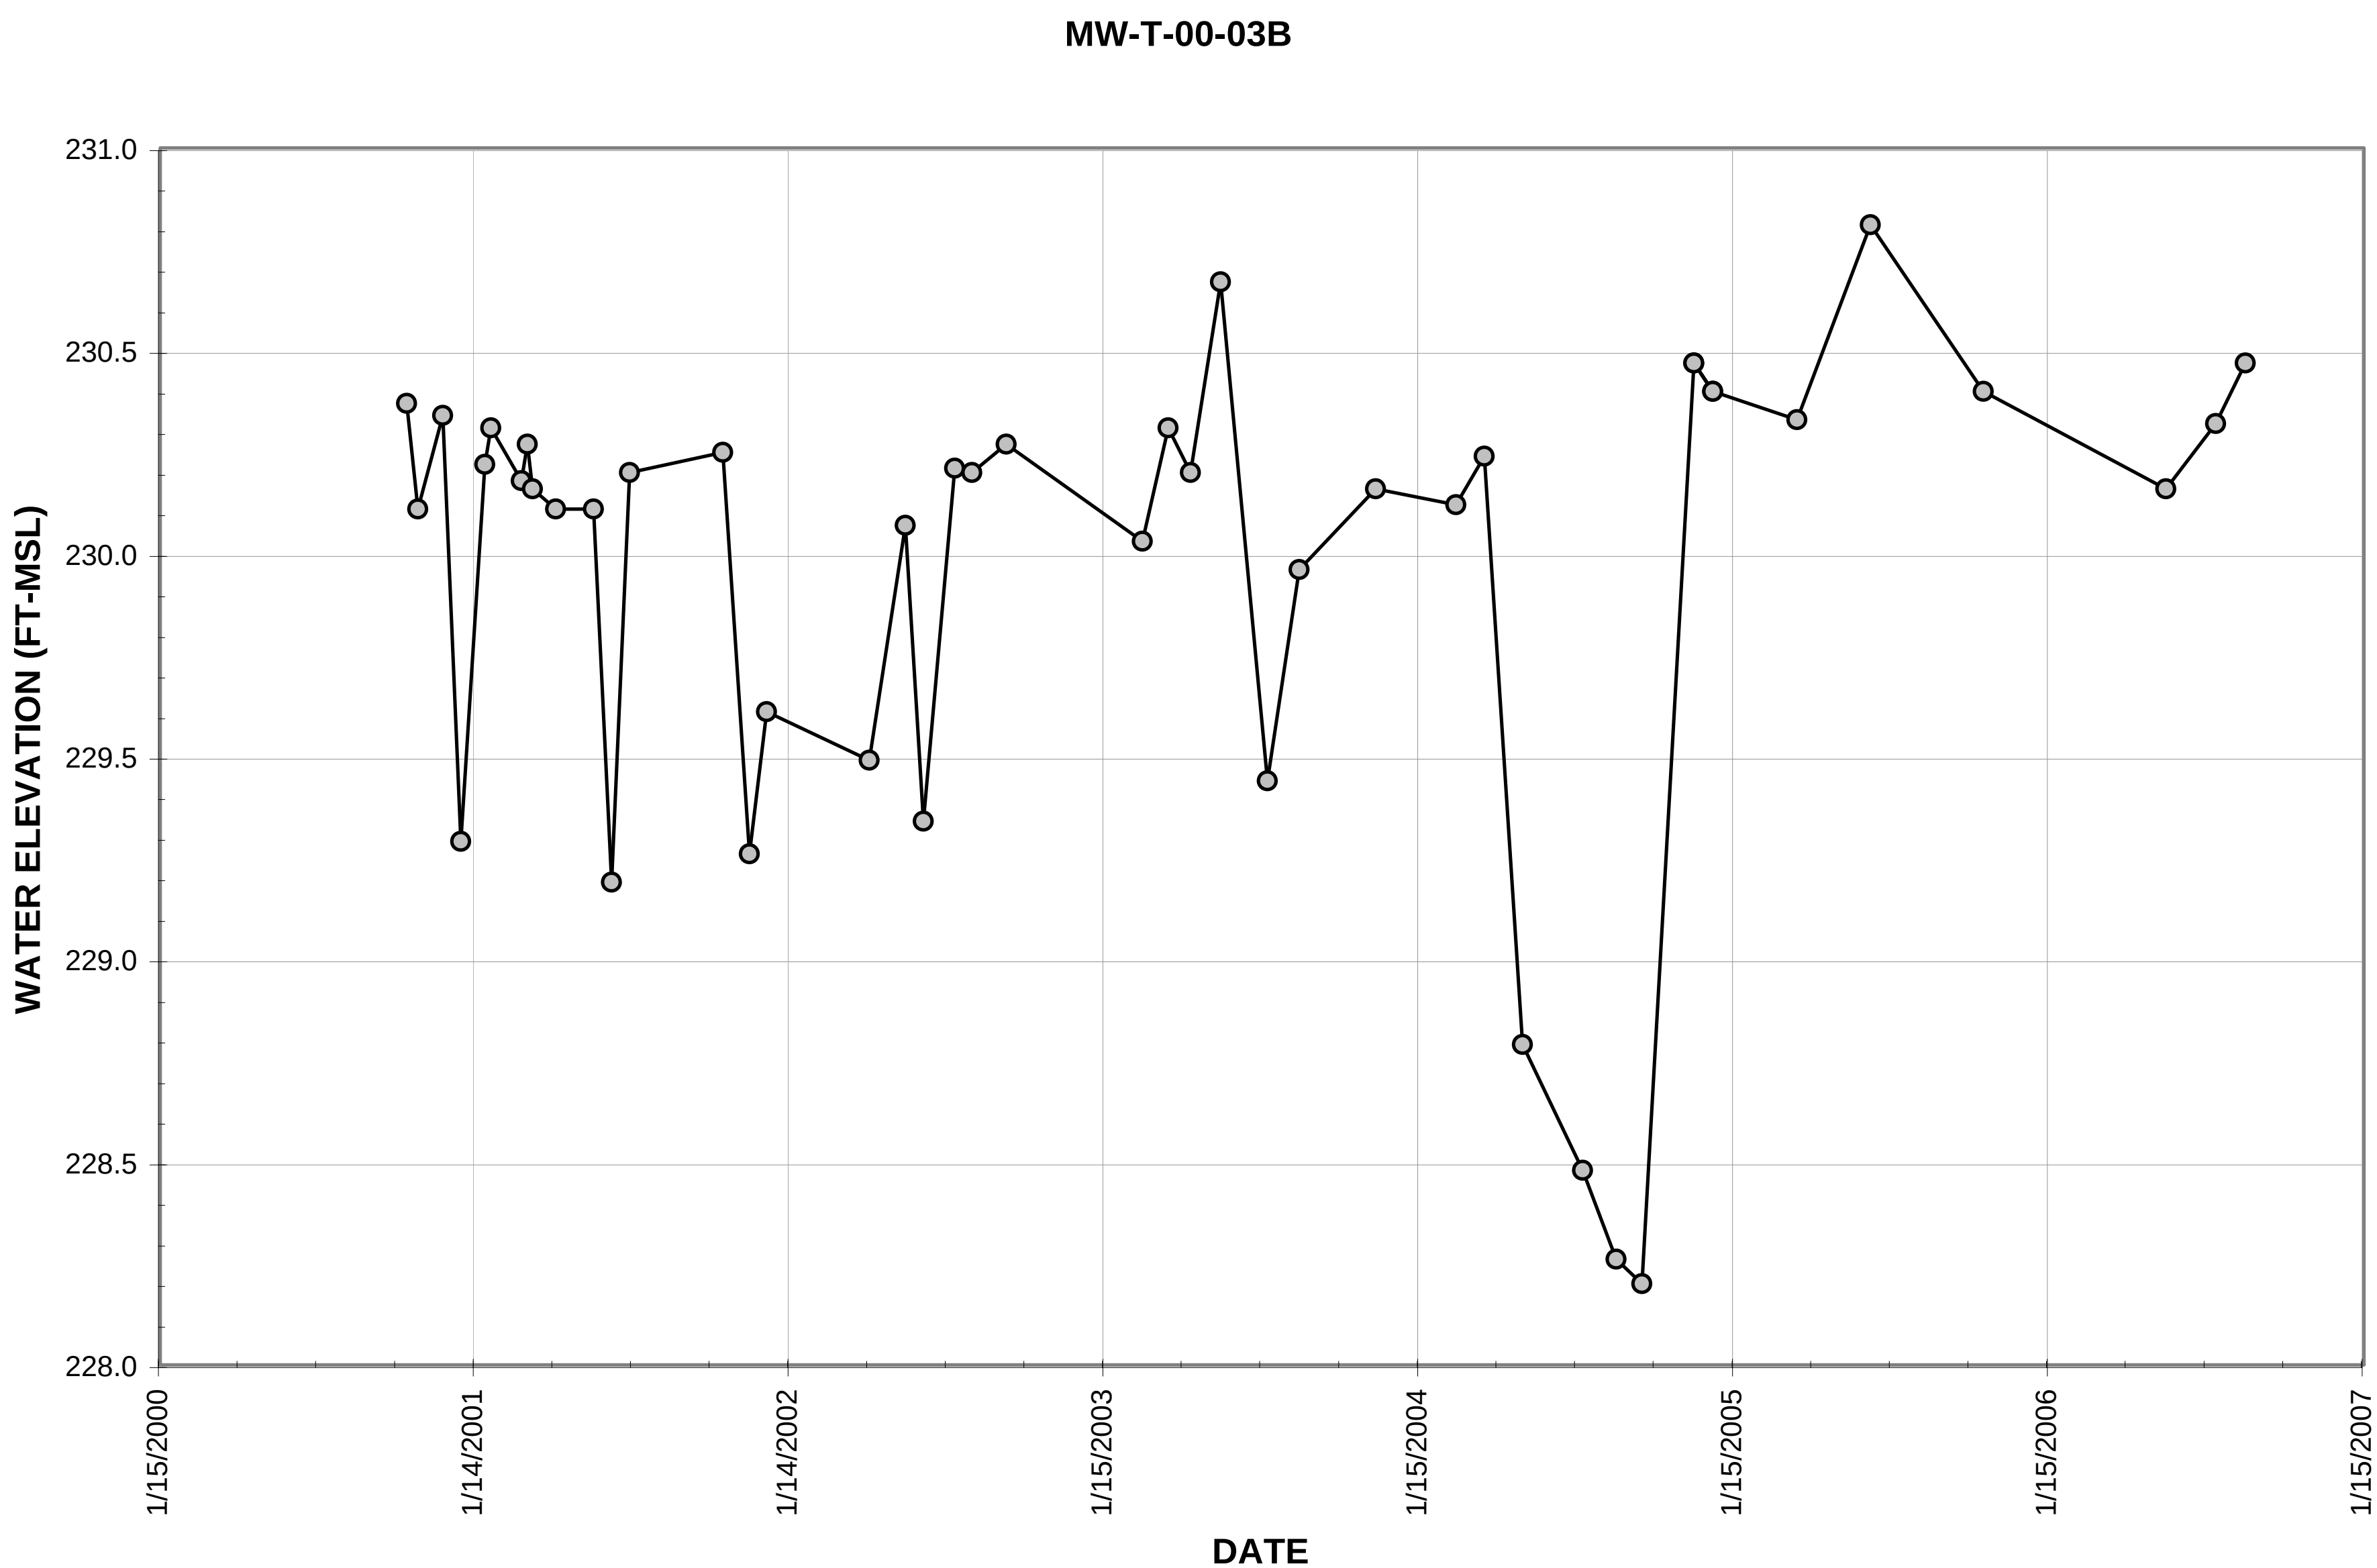
Water levels for four wells completed east and west of the pile are shown for comparison in Figures 2.15 to 2.18. The eastern wells, MW-T-00-03A (Figure 2.15) and MW-T-00-03B (Figure 2.16), are completed in the shallow sands 12 and 17 feet, respectively, below ground surface. The figures for these wells show that the water elevation in shallow completions in native materials can be readily influenced by abnormal weather conditions. Wells MW-T-01-03A and MW-T-01-03B are installed west of the pile. Their water levels are shown in Figures 2.17 and 2.18, respectively. MW-T-01-03A is completed in bedrock to a depth of 20 feet and MW-T-01-03B is completed in clayey silt to a depth of 12 feet. These wells show similar water level fluctuations with weather conditions as the two eastern wells. However, the water level in MW-T-01-03B shows a larger differential than MW-T-01-03A because silts and clays hold more water in tension, so a small increase in water content causes a large change in head. The ground surface elevation is 134 feet in the proximity of these two wells.

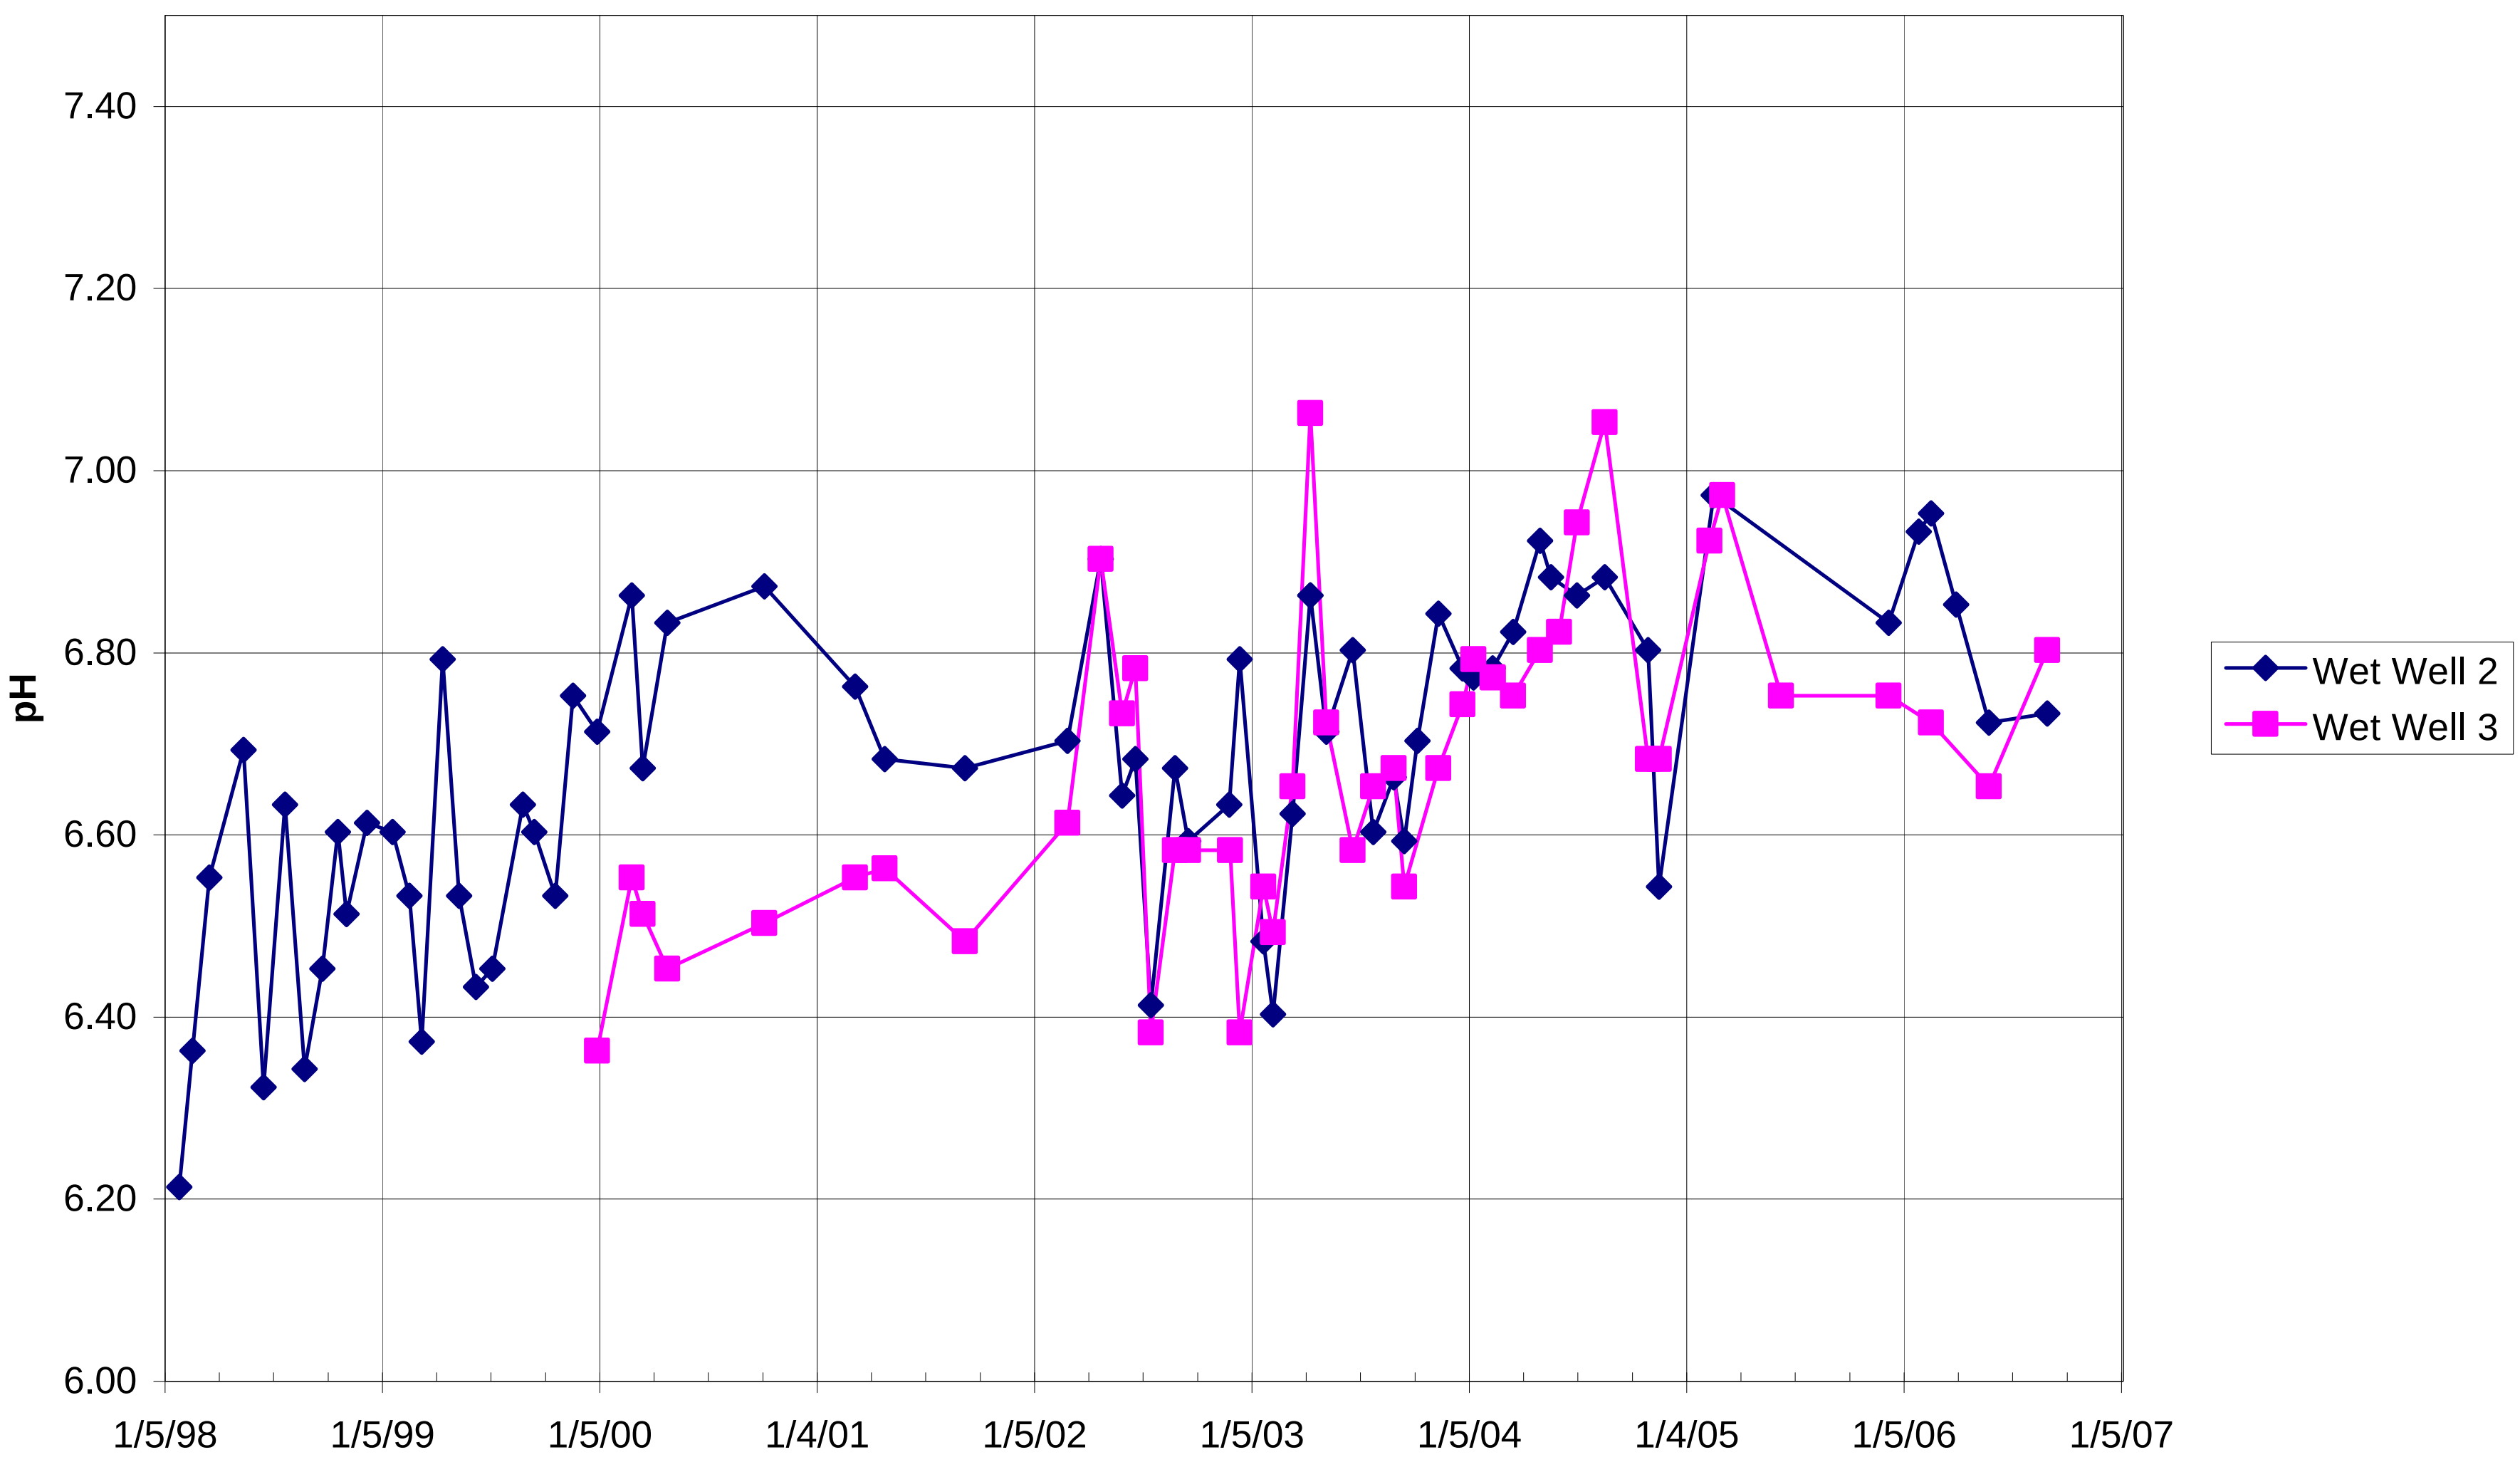
FIGURE 2.20a GREENS CREEK TAILINGS AREA INTERNAL MONITORING SITES: WET WELLS - pH DATA

Values of pH remained between 6 and 8.5 for all internal monitoring site samples in 2006 (Figure 2.20a, b and c), except for suction lysimeter SL-T-02-06, which showed a pH of 8.87. PZ-T-00-01, PZ-T-00-2 and PZ-T-00-3, which screen the lower ten feet of tailings pile, have the highest pH of the internal monitoring sites. This is likely a result of microbial sulfate reduction and equilibration with carbonate in the saturated zone of the pile. The wet wells produce water with slightly lower pH (generally between 6.5 and 7), reflecting minor influences from groundwater (organic acids) and oxidized surface waters (acidity from thiosalt, sulfide and iron oxidation). The suction lysimeters all have pH values between 6.87 and 8.87.
