TAILINGS AND PRODUCTION ROCK SITE
2006 ANNUAL REPORT

Kennecott Greens Creek Mining Company

April 2007

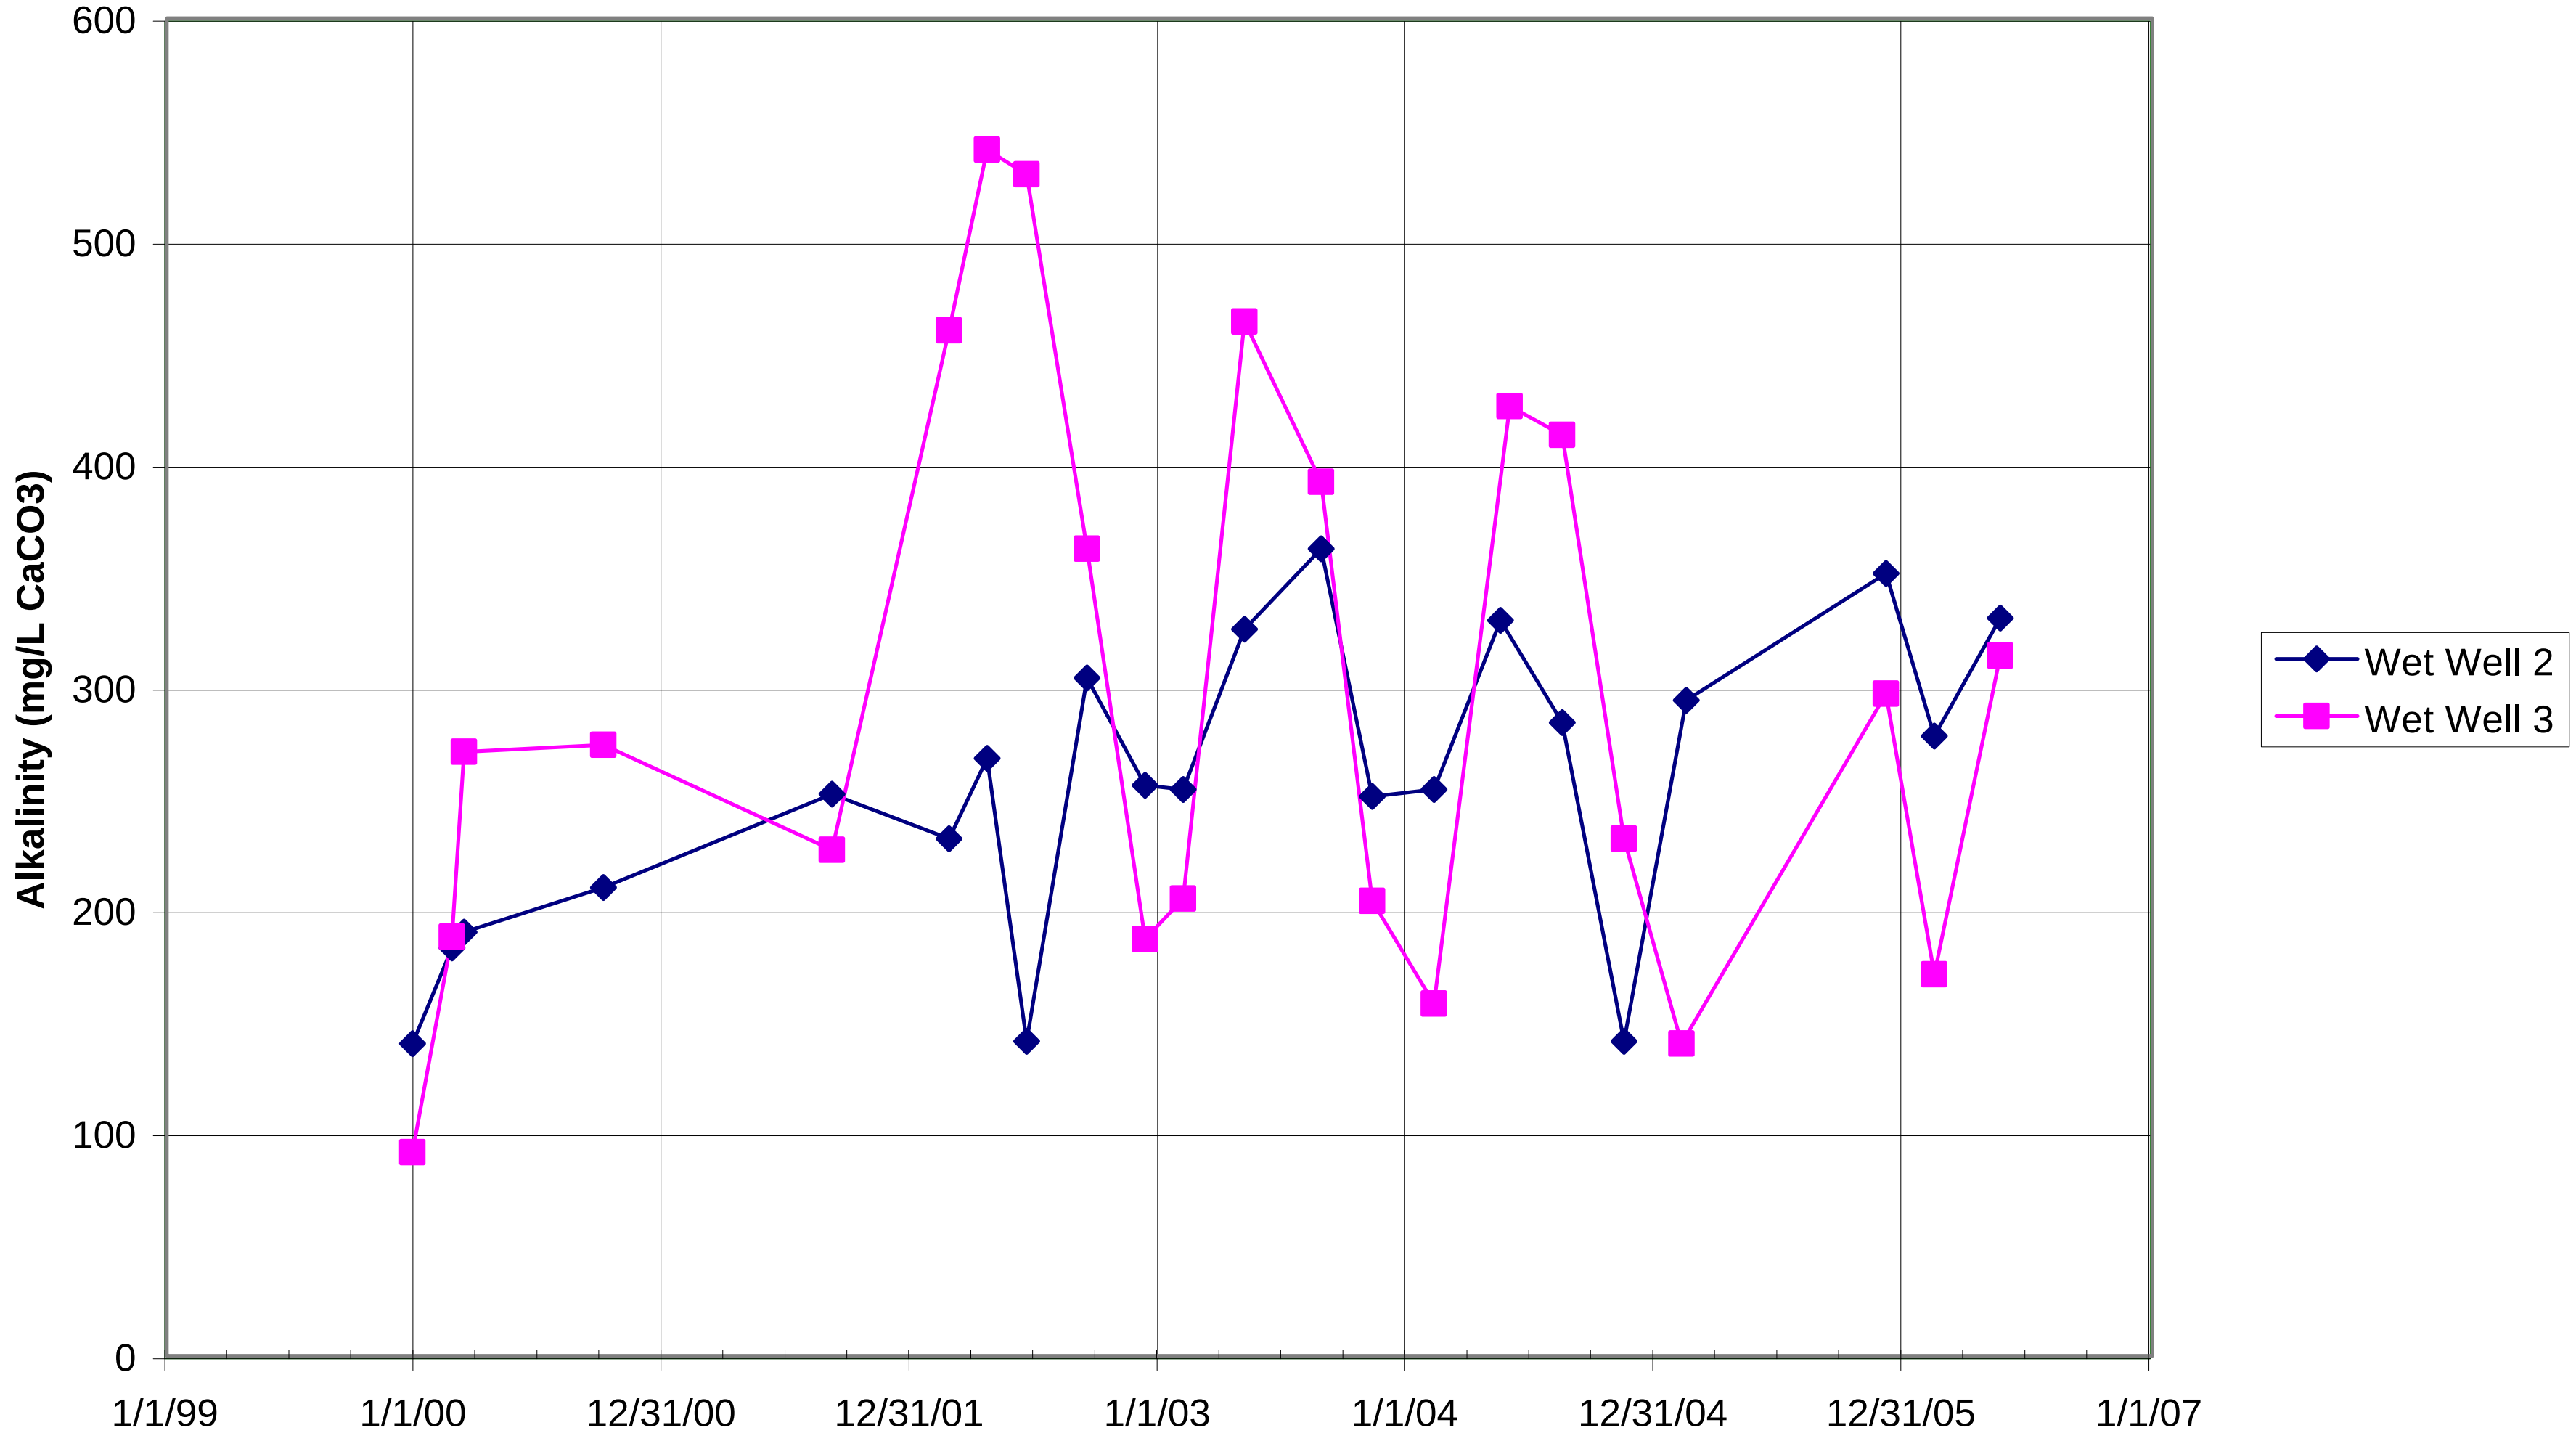
FIGURE 2.21a GREENS CREEK TAILINGS INTERNAL MONITORING SITES:
WET WELLS - ALKALINITY
(Non-detectable analyses plotted as zero)

Alkalinity data are presented in Figure 2.21a, b and c. Alkalinity generally ranges between 200 and 600 mg/l $CaCO_3$ within the tailings pile, consistent with buffering from carbonate minerals and the products of microbial sulfate reduction. The fact that these internal waters are near-neutral to alkaline and have substantial alkalinity indicates that the buffering capacity of the tailings is sufficient to prevent acidification of site drainage in the near-term (at least tens of years).

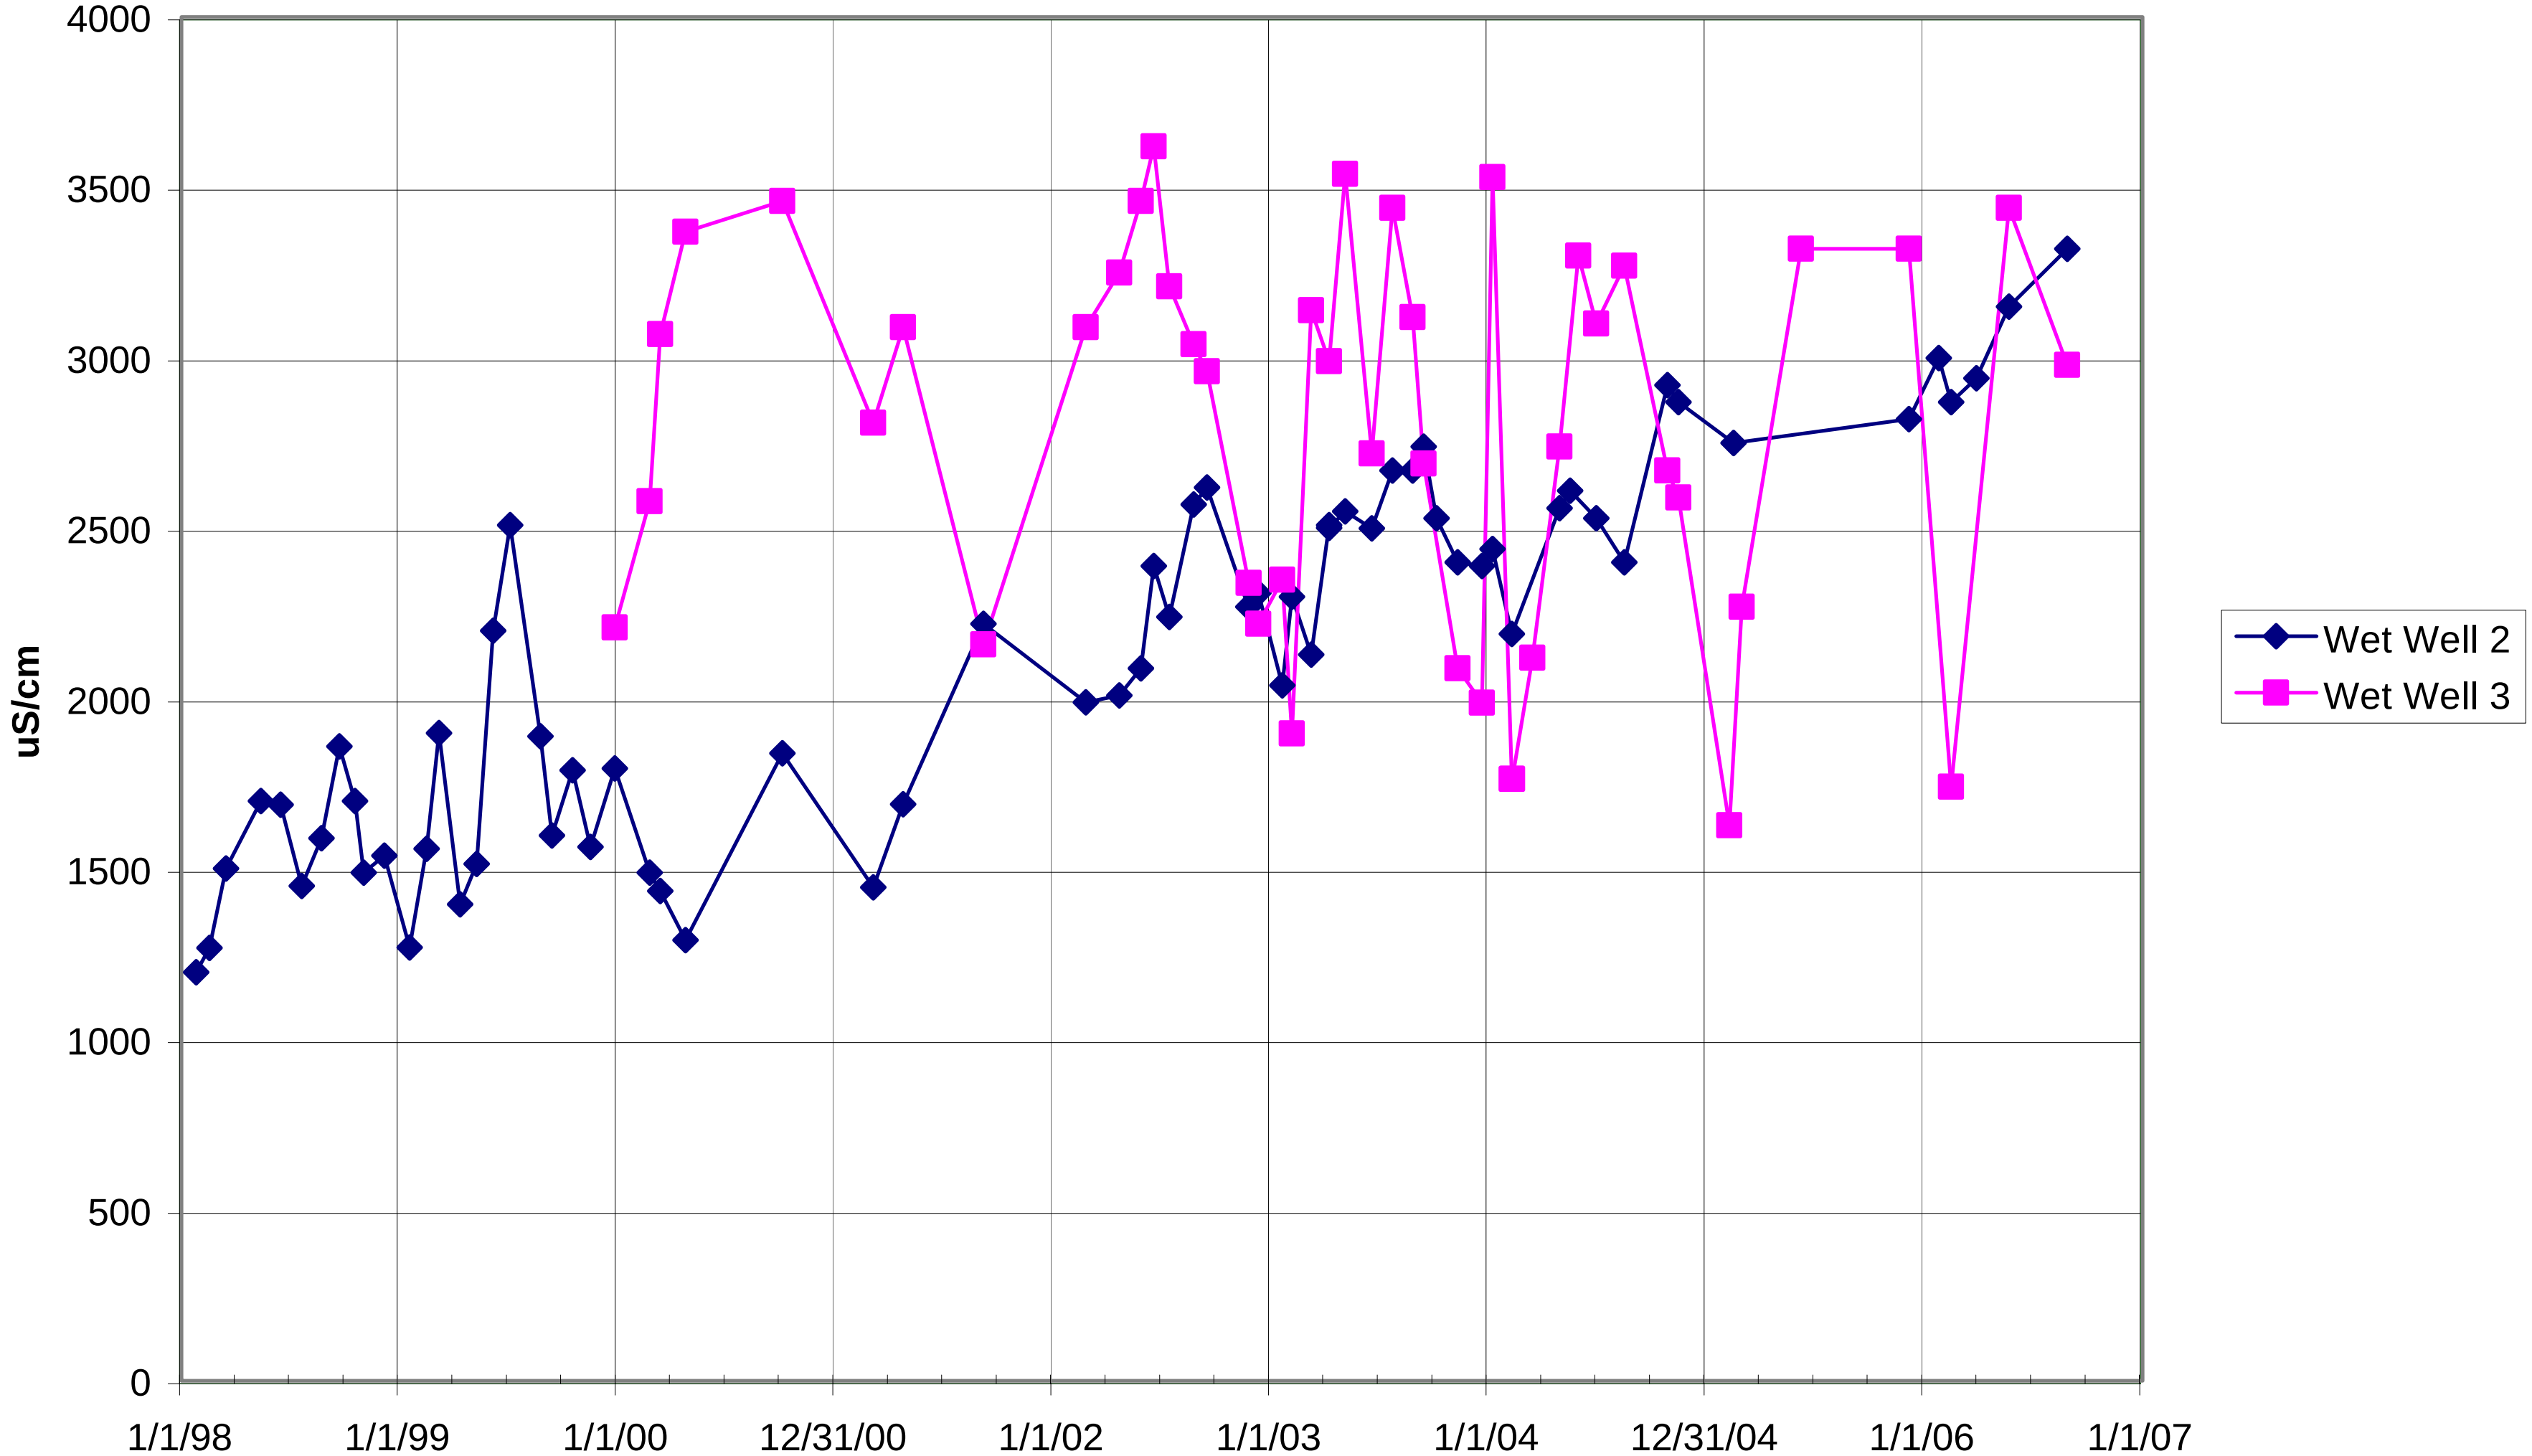
FIGURE 2.22a GREENS CREEK TAILINGS INTERNAL MONITORING SITES: WET WELLS - CONDUCTIVITY DATA

The conductivity results from internal monitoring site waters are presented in Figure 2.22a, b, and c. 2005 conductivity measurement were between 1742 (wet wells) and 7460 (suction lysimeters) µS/cm. The higher conductivity of the site contact waters reflects a larger dissolved load caused by weathering of the tailings. Pyrite oxidation and carbonate dissolution contribute dissolved ions such as sulfate, bicarbonate, calcium and magnesium to the contact waters, increasing their conductivity. Wet Well 3 has a different capture area than Wet Well 2 and shows a different pattern with respect to conductivity. The changes in conductivity observed in Wet Well 3 suggest changes in the relative contributions from runoff, addition of the Northwest Diversion Ditch flow, infiltration and groundwater as the West Buttress was constructed. The increase in conductivity seen in Wet Well 2 over the past several years likely reflects an increasing contribution from contact water in the drain system and an increase in the dissolved load from migration/remobilization of oxidation products in the pile. The suction lysimeters have 2006 conductivity values ranging from 5000 to 7460 µS/cm. Suction lysimeter samples are drawn from the smallest pore spaces of the unsaturated zone. Water held in these pores is often isolated from flow paths and thus has higher dissolved constituent concentrations than water from the saturated zone and foundation drains.

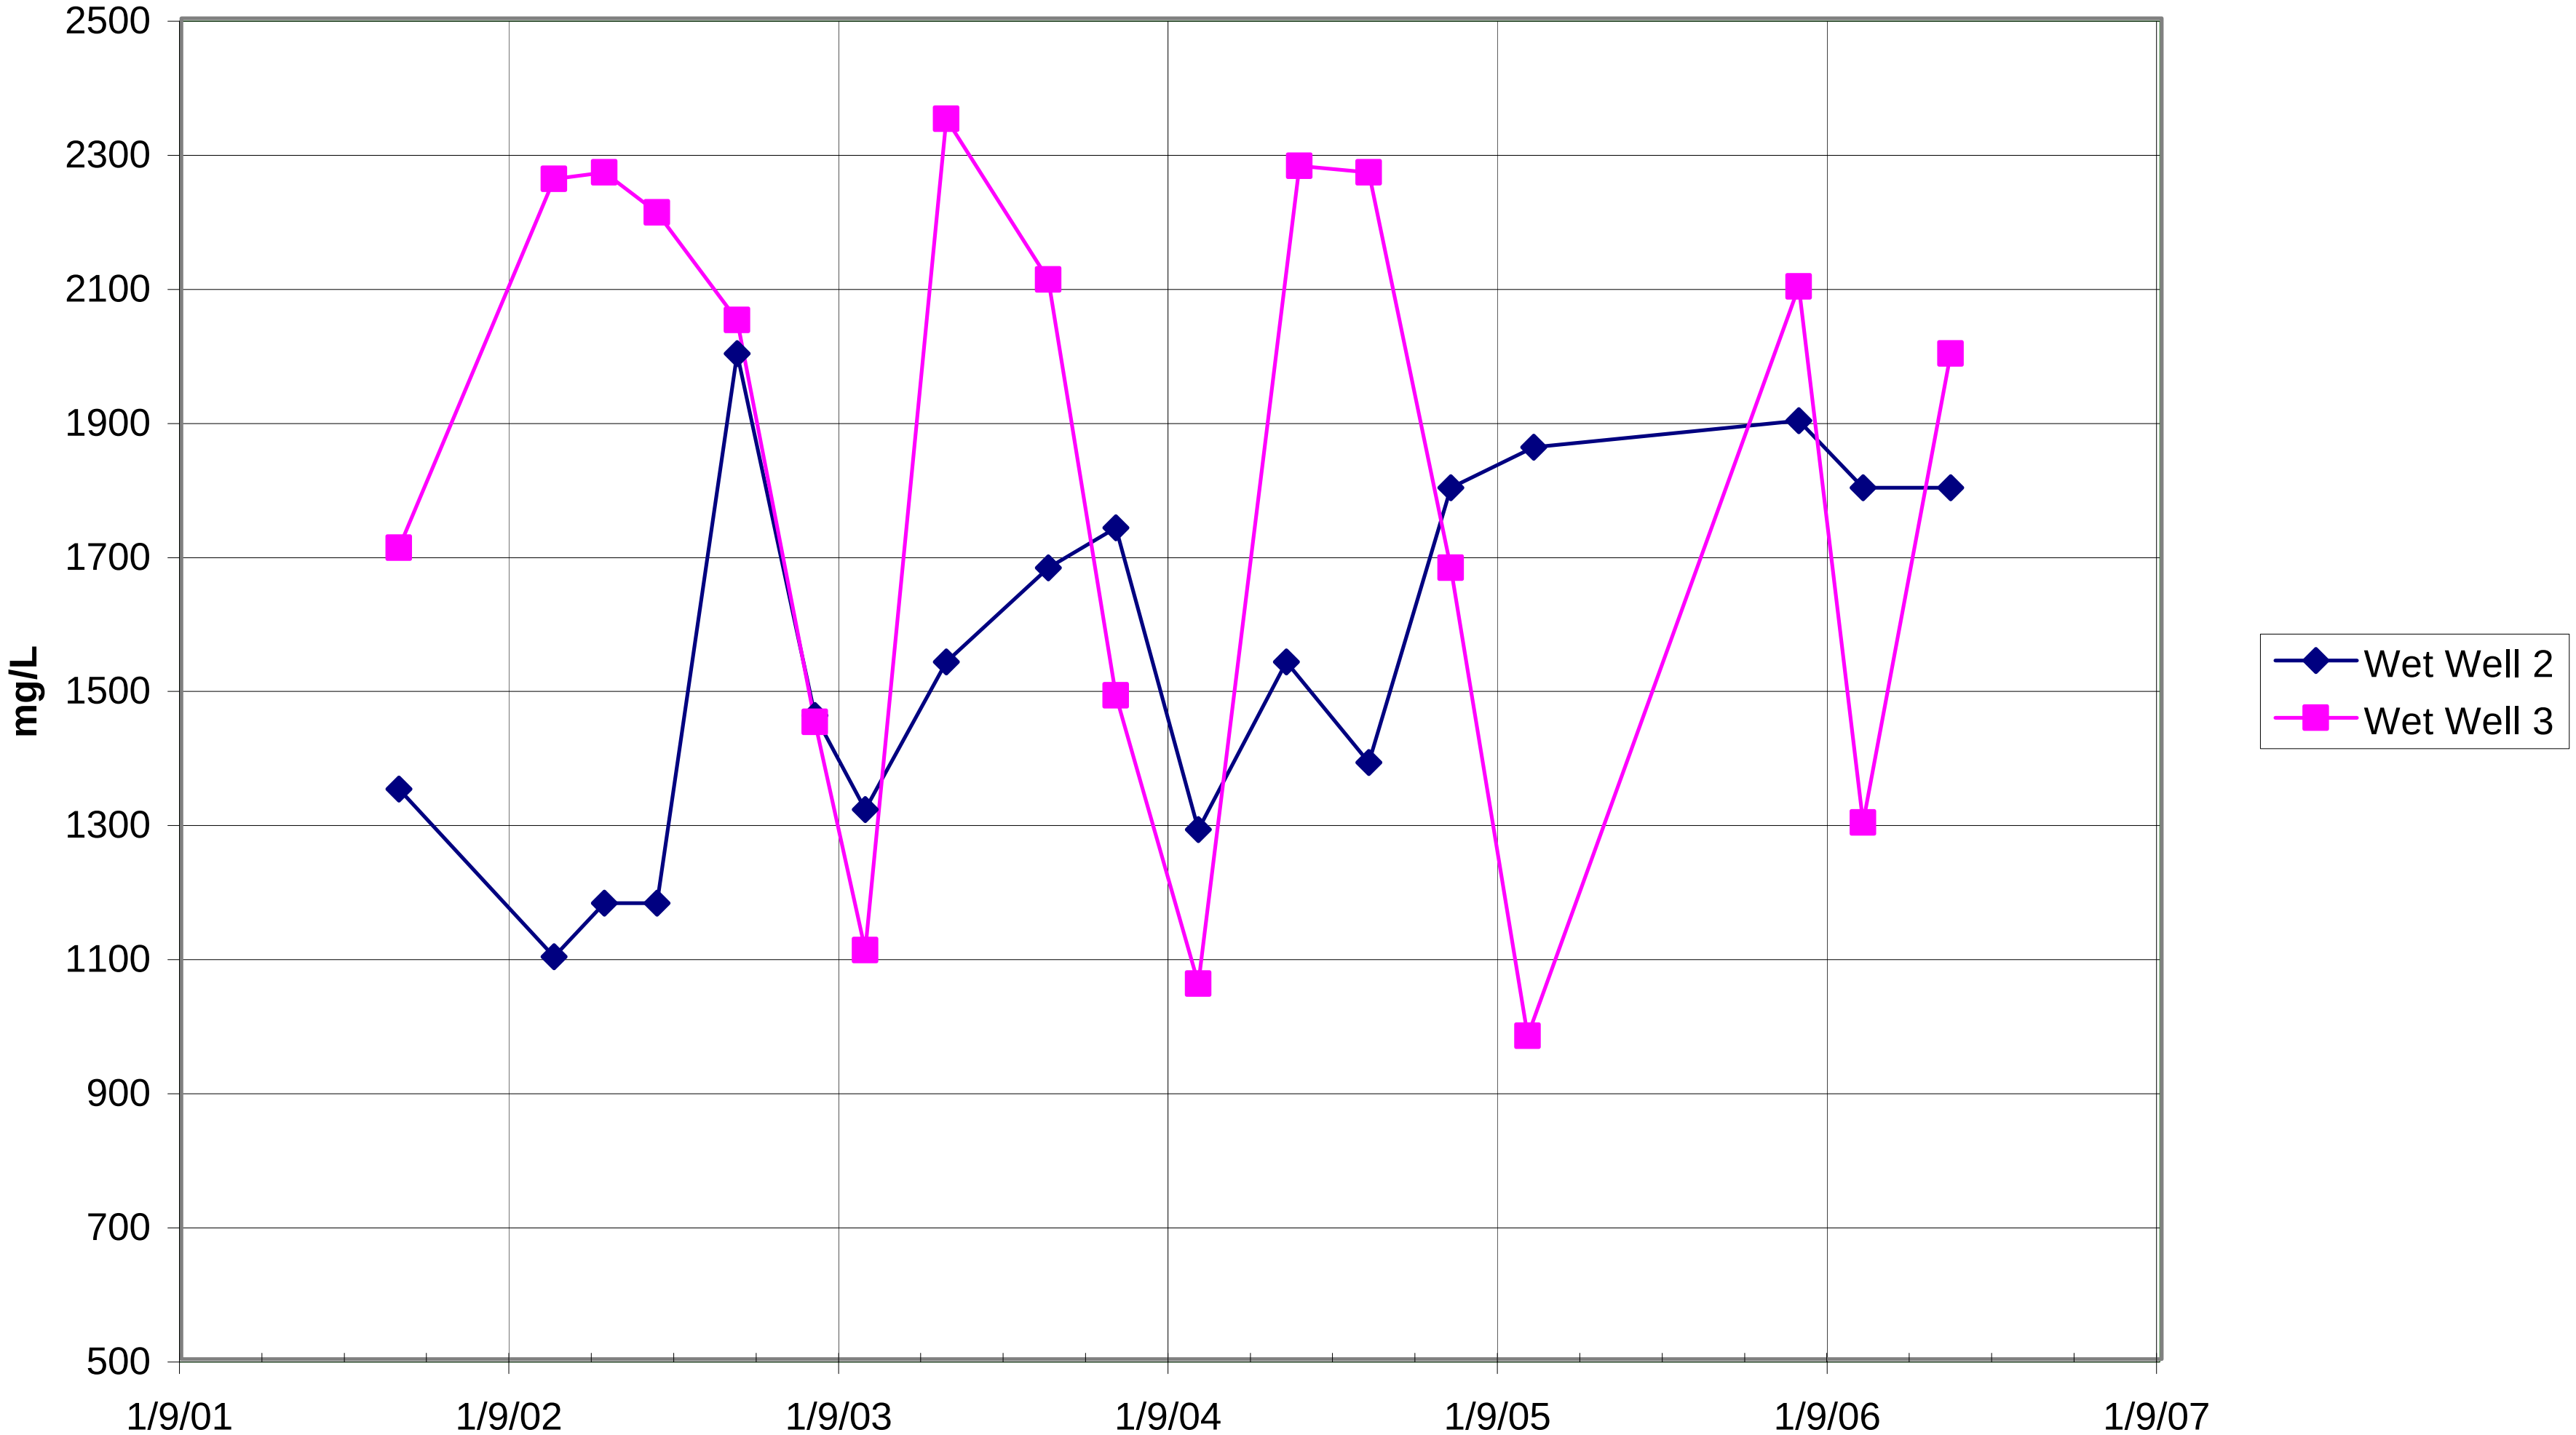
FIGURE 2.23a GREENS CREEK TAILINGS INTERNAL MONITORING SITES: WET WELLS - HARDNESS DATA (Non-detectable analyses plotted as zero)

Hardness and sulfate concentrations are consistent with the conductivity results. Calcium and magnesium are the primary contributors to hardness (Figure 2.23a and b) and reflect dissolution of carbonate minerals, such as calcite and dolomite. Carbonate dissolution neutralizes acidity formed by sulfide oxidation, which is also the source of sulfate shown in Figure 2.24a, b, and c. Sulfate concentrations range between 500 and 3200 mg/l in the tailings pile waters. The increase in sulfate and other constituents seen in PZ-T-00-03 likely reflects the replacement of interstitial process water with infiltrating surface water, which carries a higher dissolved load.

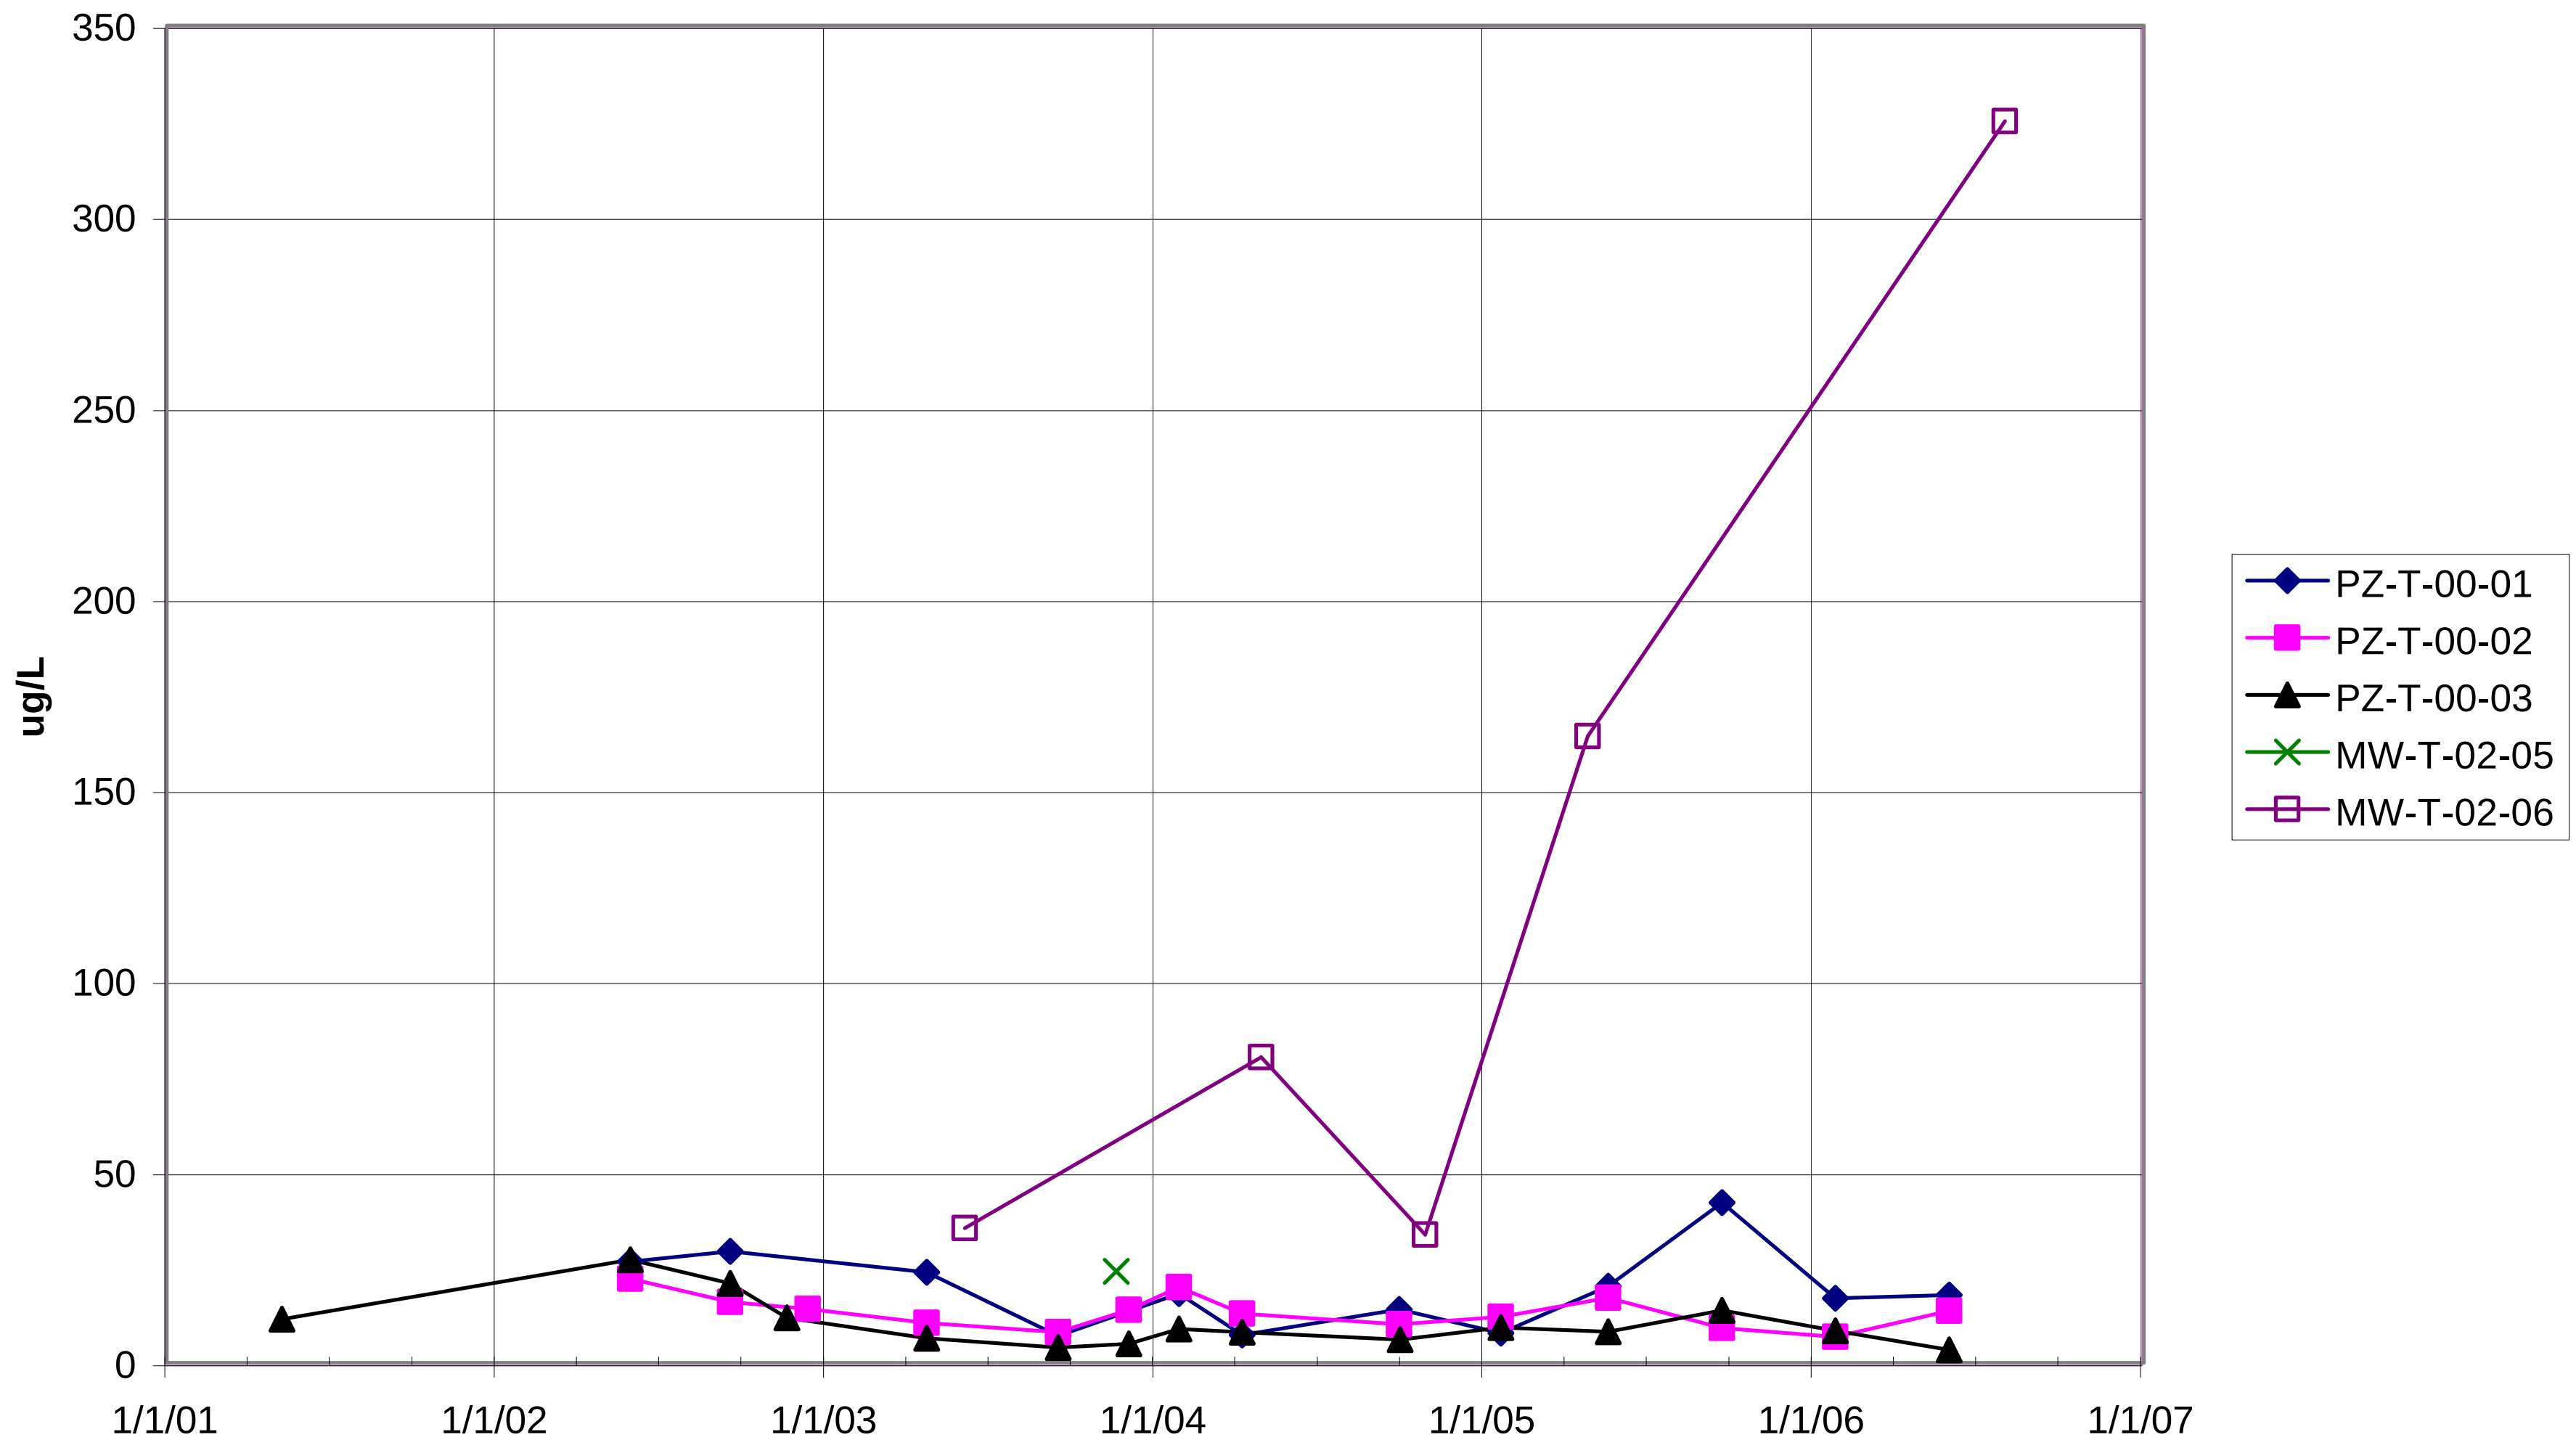
FIGURE 2.25b GREENS CREEK TAILINGS INTERNAL MONITORING SITES: TAILINGS COMPLETIONS - ARSENIC DATA (Non-detectable analyses plotted as zero)

Arsenic data are presented in Figures 2.25a, b and c. The arsenic in MW-T-02-06 doubled from 2005 to 2006 (164 µg/l in 2005 to 325 µg/l in 2006) and the data for Wet Well 2 also shows a distinct increasing trend. As arsenic-bearing minerals such as tetrahedrite/tennantite (and to a lesser extent pyrite) weather, the arsenic that is released is typically co-precipitated with iron oxy-hydroxides. As the pile grows, reducing conditions overtake areas that were once oxidizing. This was particularly true as the water table rose following removal of the temporary PVC cover that was placed on the pile in 1995 (removal began in 1997). Dissolution of oxyhydroxides (and possibly sulfates) is expected as the waters respond to the changing redox conditions. This will contribute arsenic and iron (Figures 2.30a, b and c) to the drainage water. Arsenic concentrations in the drainage will therefore decrease when redox conditions in the pile stabilize (e.g. with closure and capping of the pile). Sulfate reduction may also lower arsenic concentrations. This is apparent in the composition of waters from the saturated zone and in some of the SRMP test cells, which are discussed in more detail below.

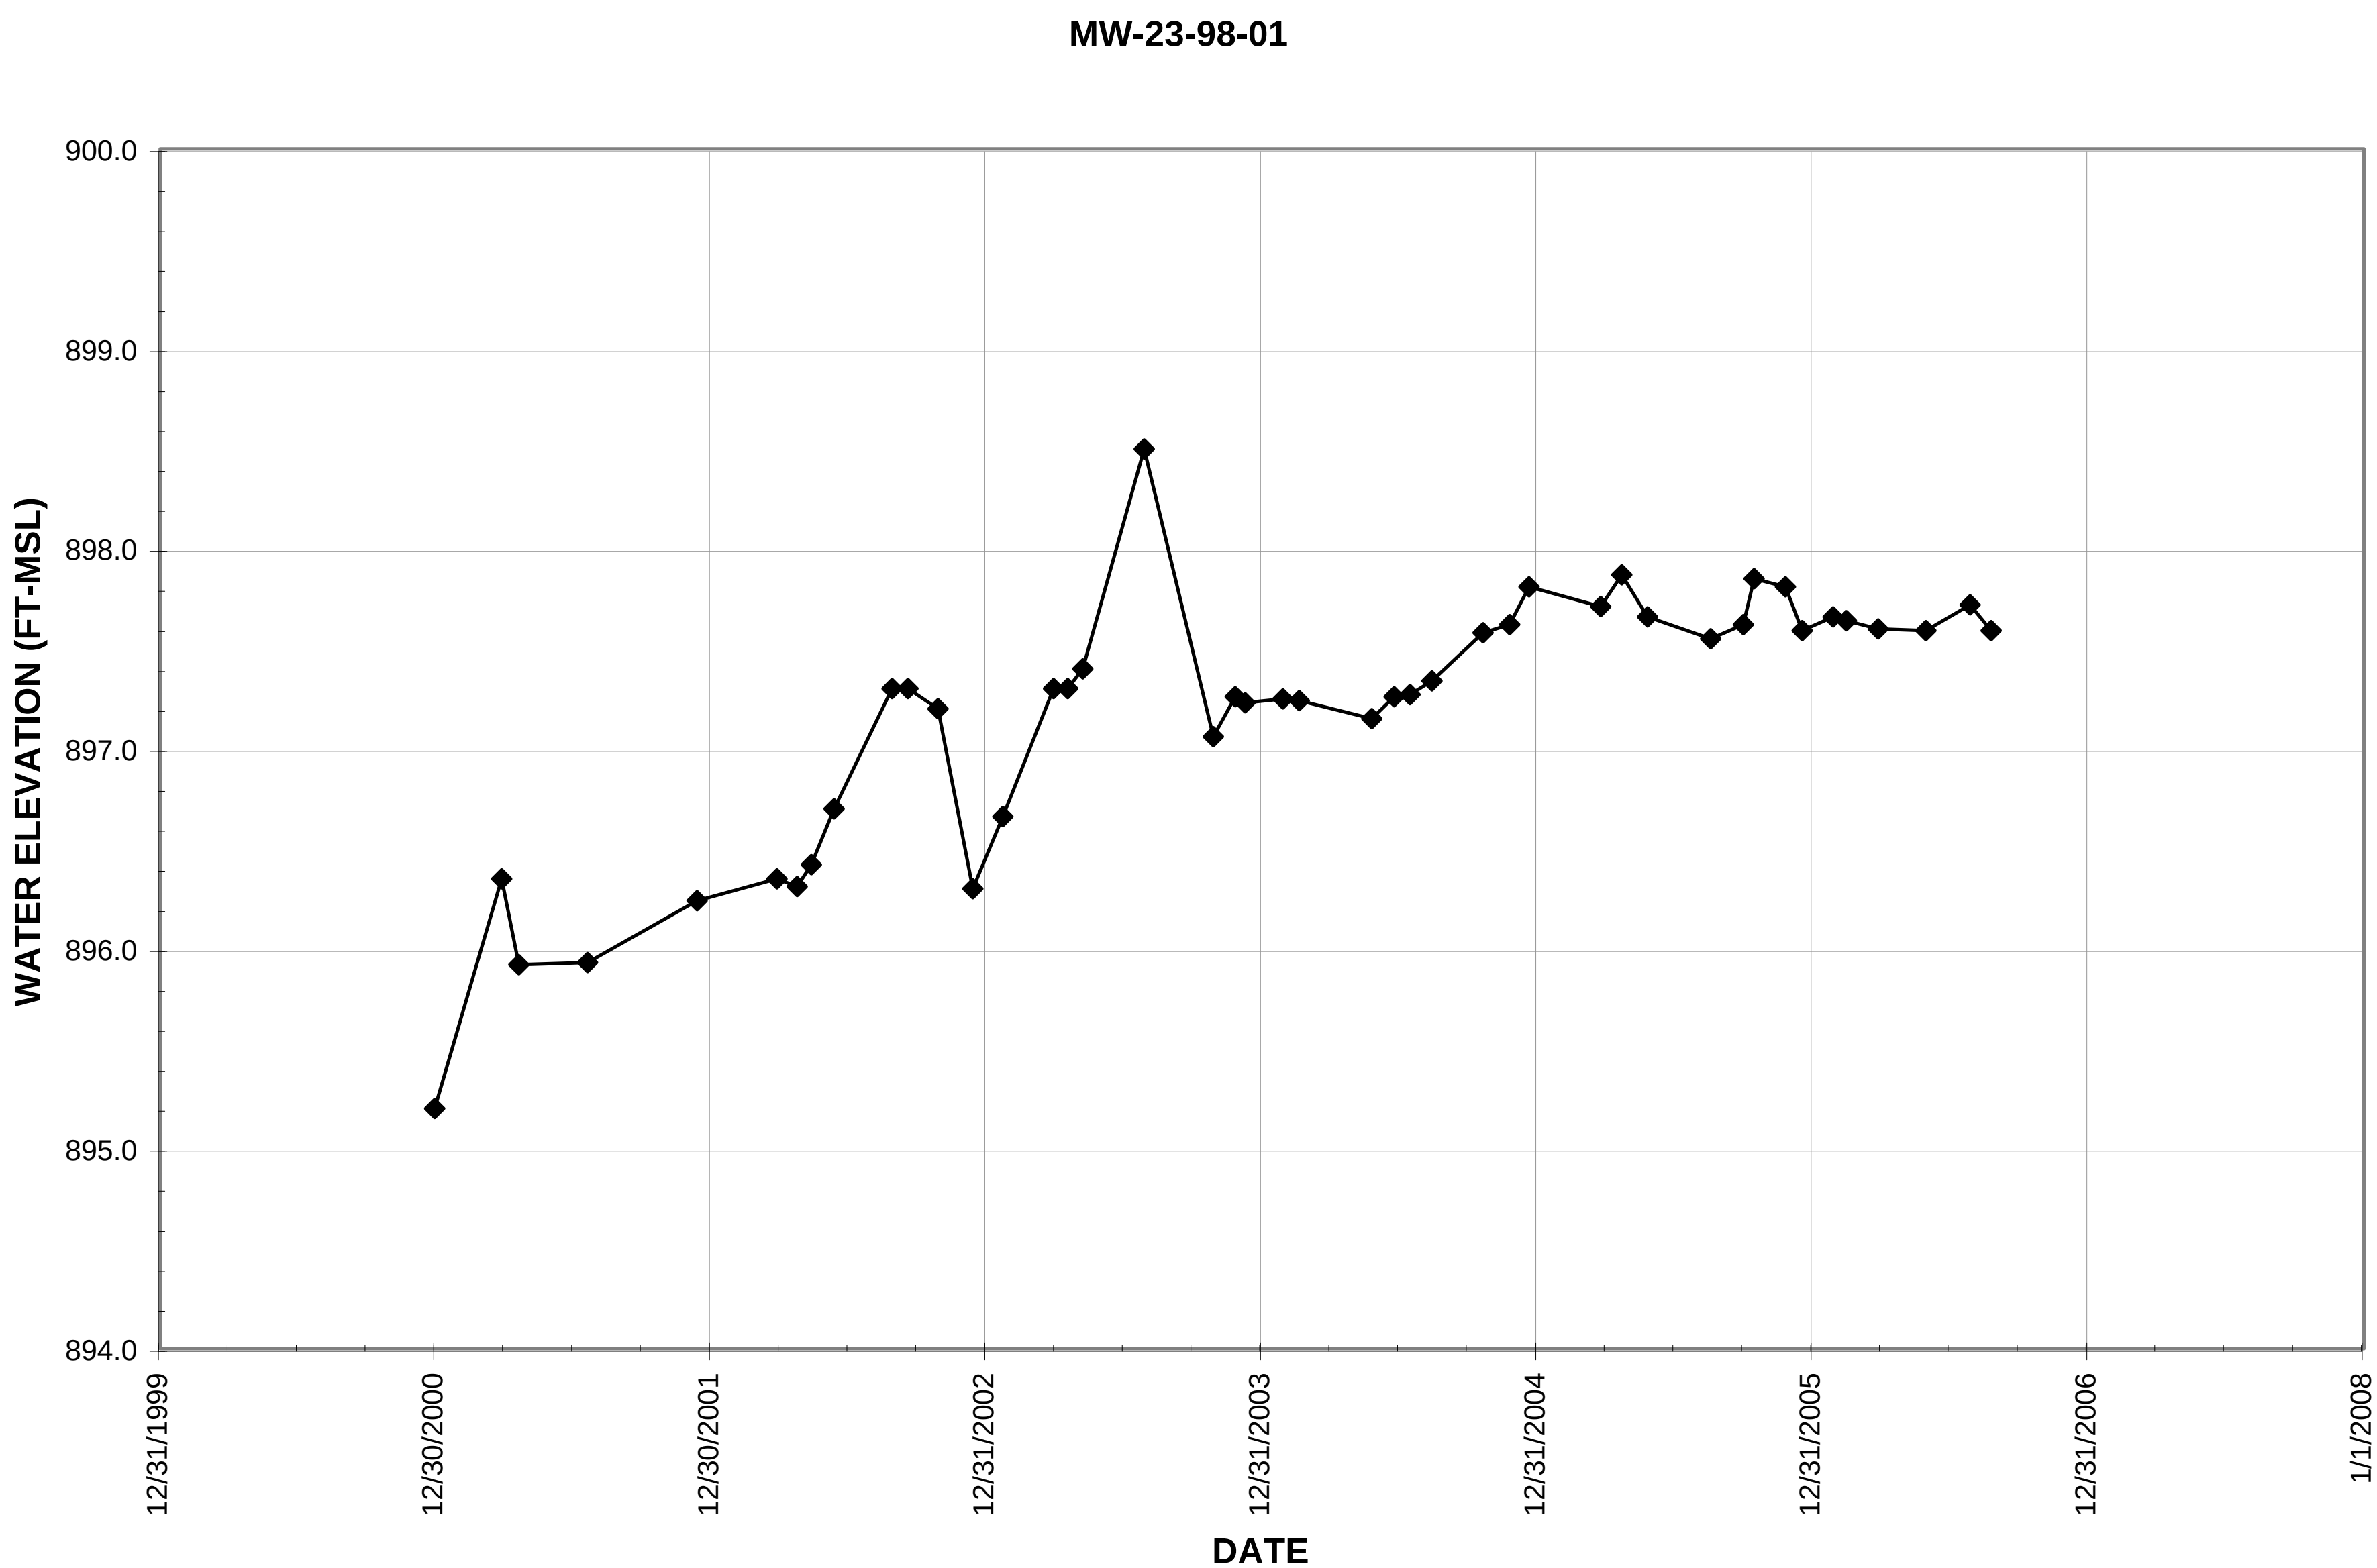
Figure 3.8 Water Level Data for Well MW-23-98-01

The silty/clay till that underlies the colluvial unit impedes downward flow and has an upward hydrologic gradient caused by confining the more permeable bedrock below it. MW-23-98-01 (Figure 3.8) is completed in the till unit and indicates a water table near the top of the till, which is approximately 100 feet below the existing topographic surface. Alluvial sands occur between the colluvial unit and the silt/clay till near the toe of Site 23 and under Site D. Data from MW-23-A4 and MW-D-94-D3 (Figures 3.9 and 3.11) indicate that the sands are saturated. A curtain drain installed in between Site D and Site 23 in 1994 collects water that flows at the base of the colluvial unit and the top of the alluvial sands (see as-built and Section CC for locations). This drain helps reduce pore pressures in the foundation of Site D, as well as capturing infiltration waters from Site 23.
