TAILINGS AND PRODUCTION ROCK SITE
2006 ANNUAL REPORT

Kennecott Greens Creek Mining Company

April 2007

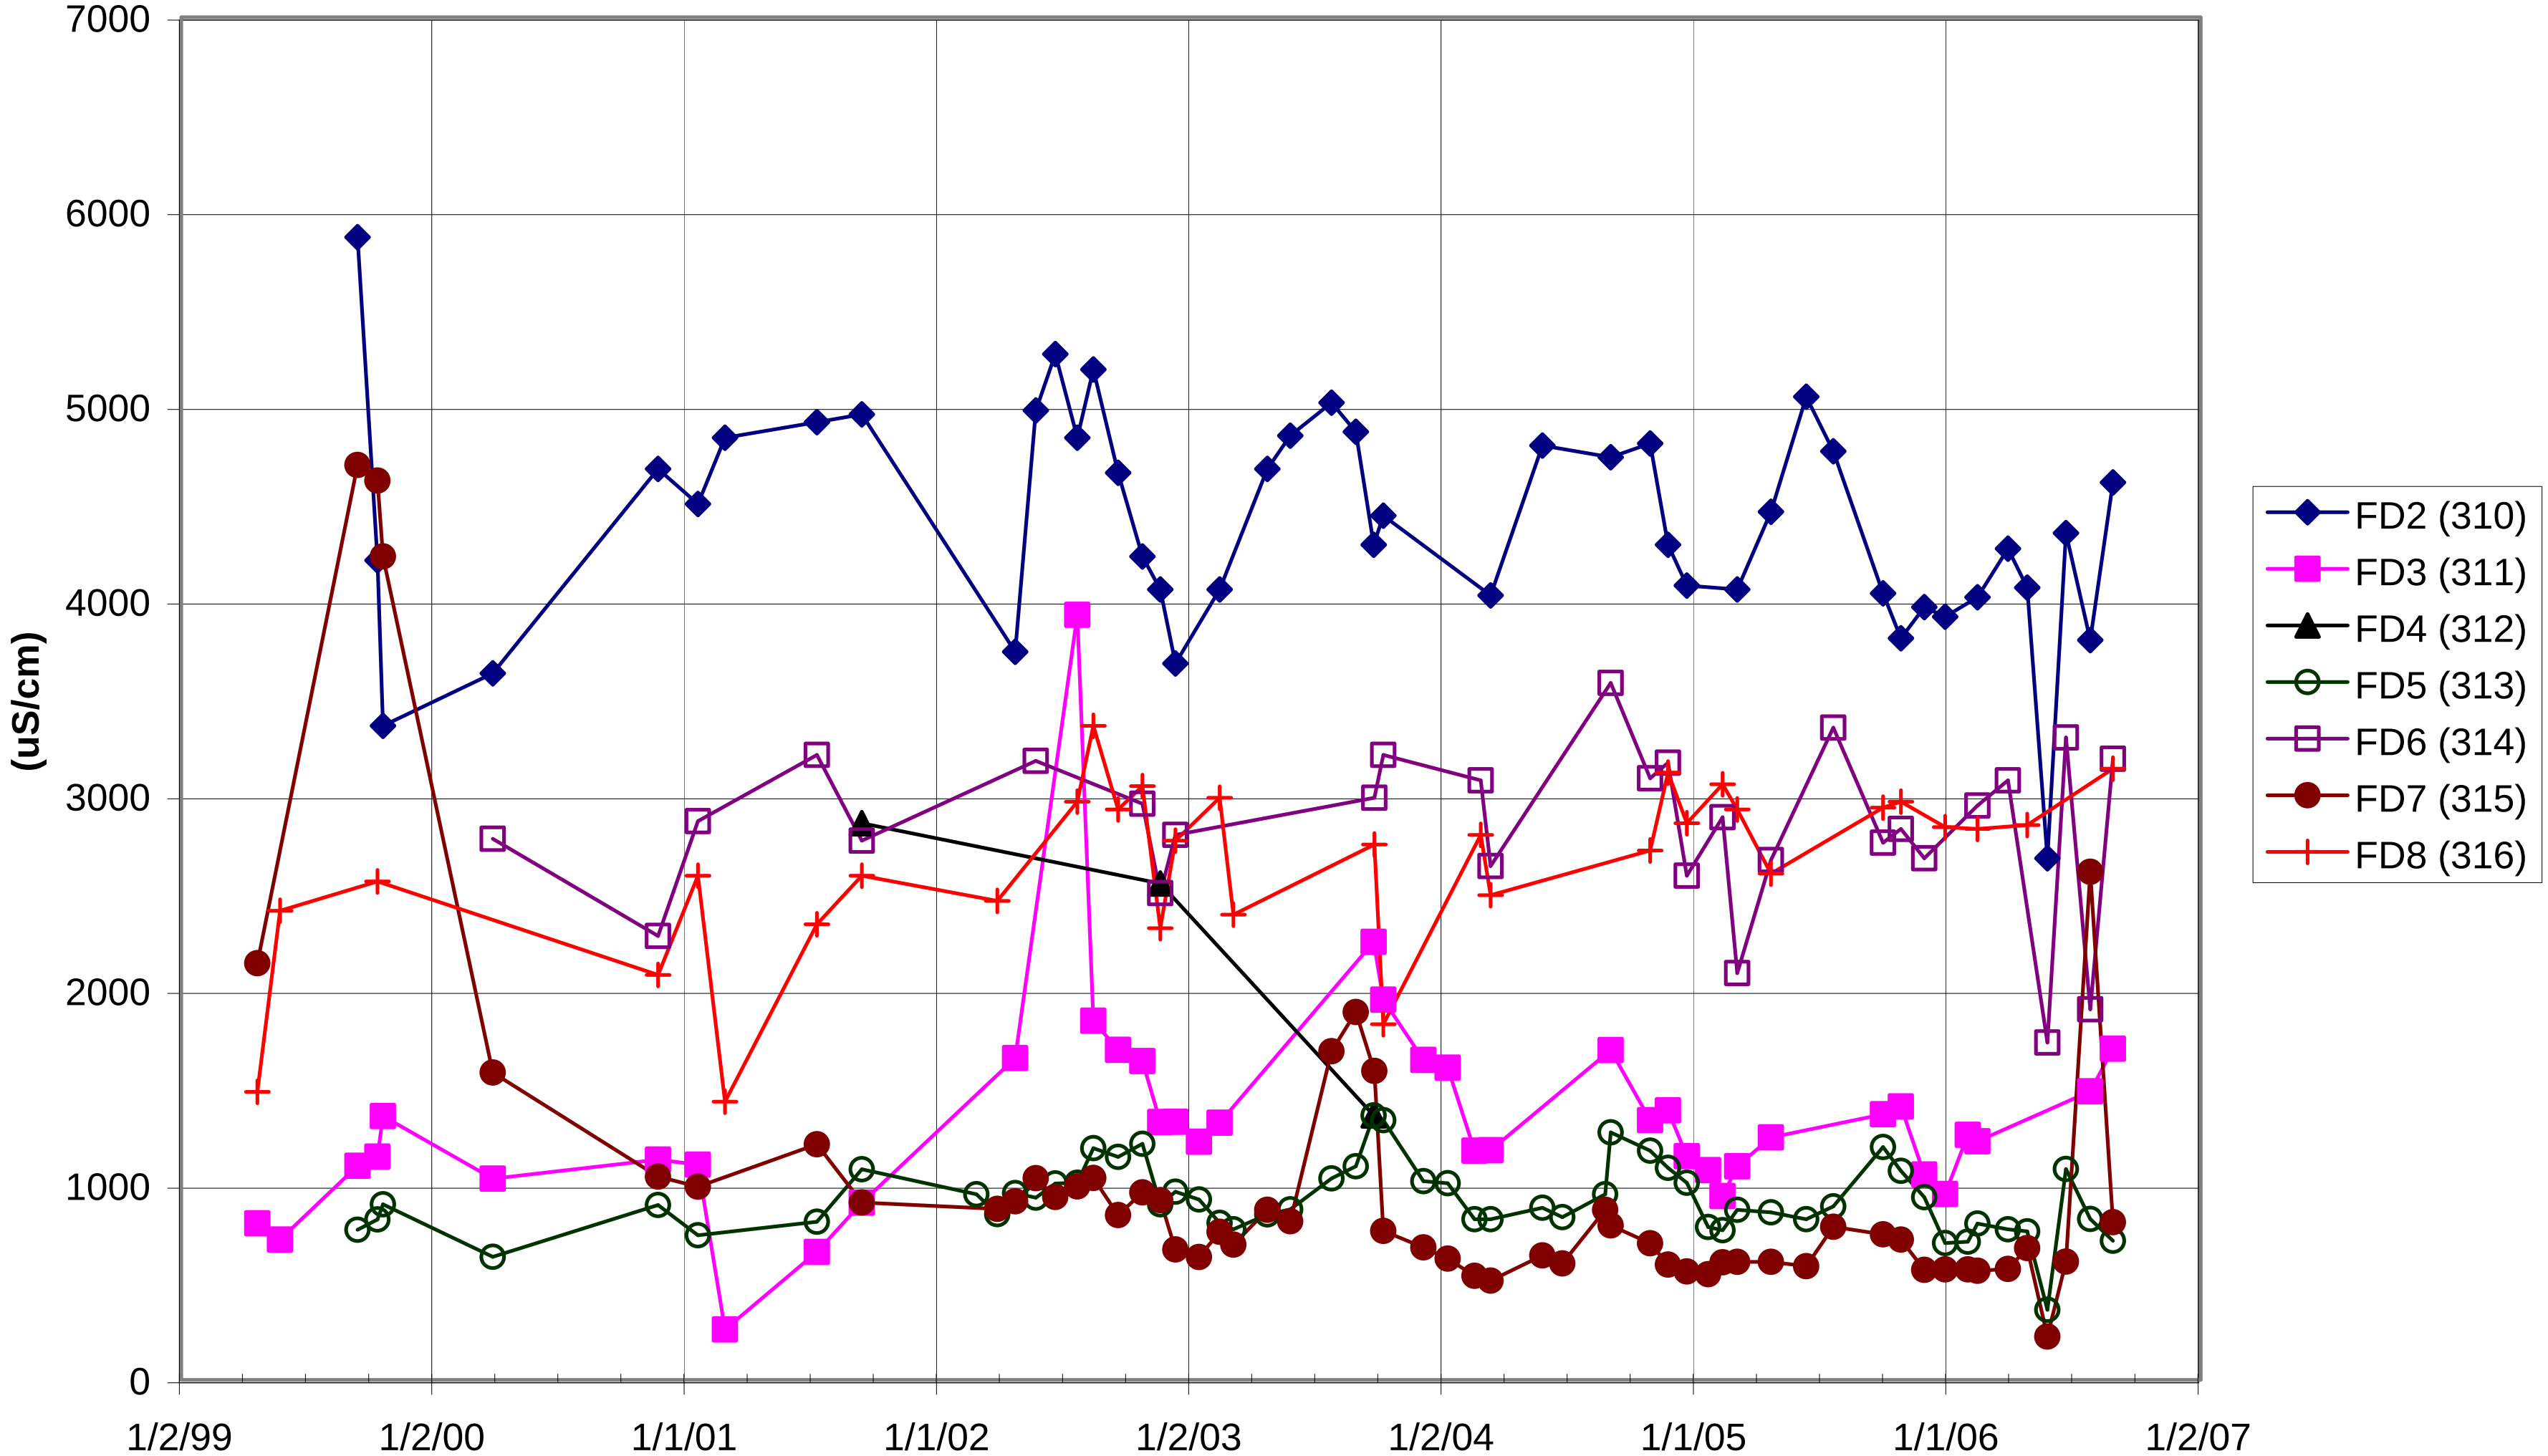
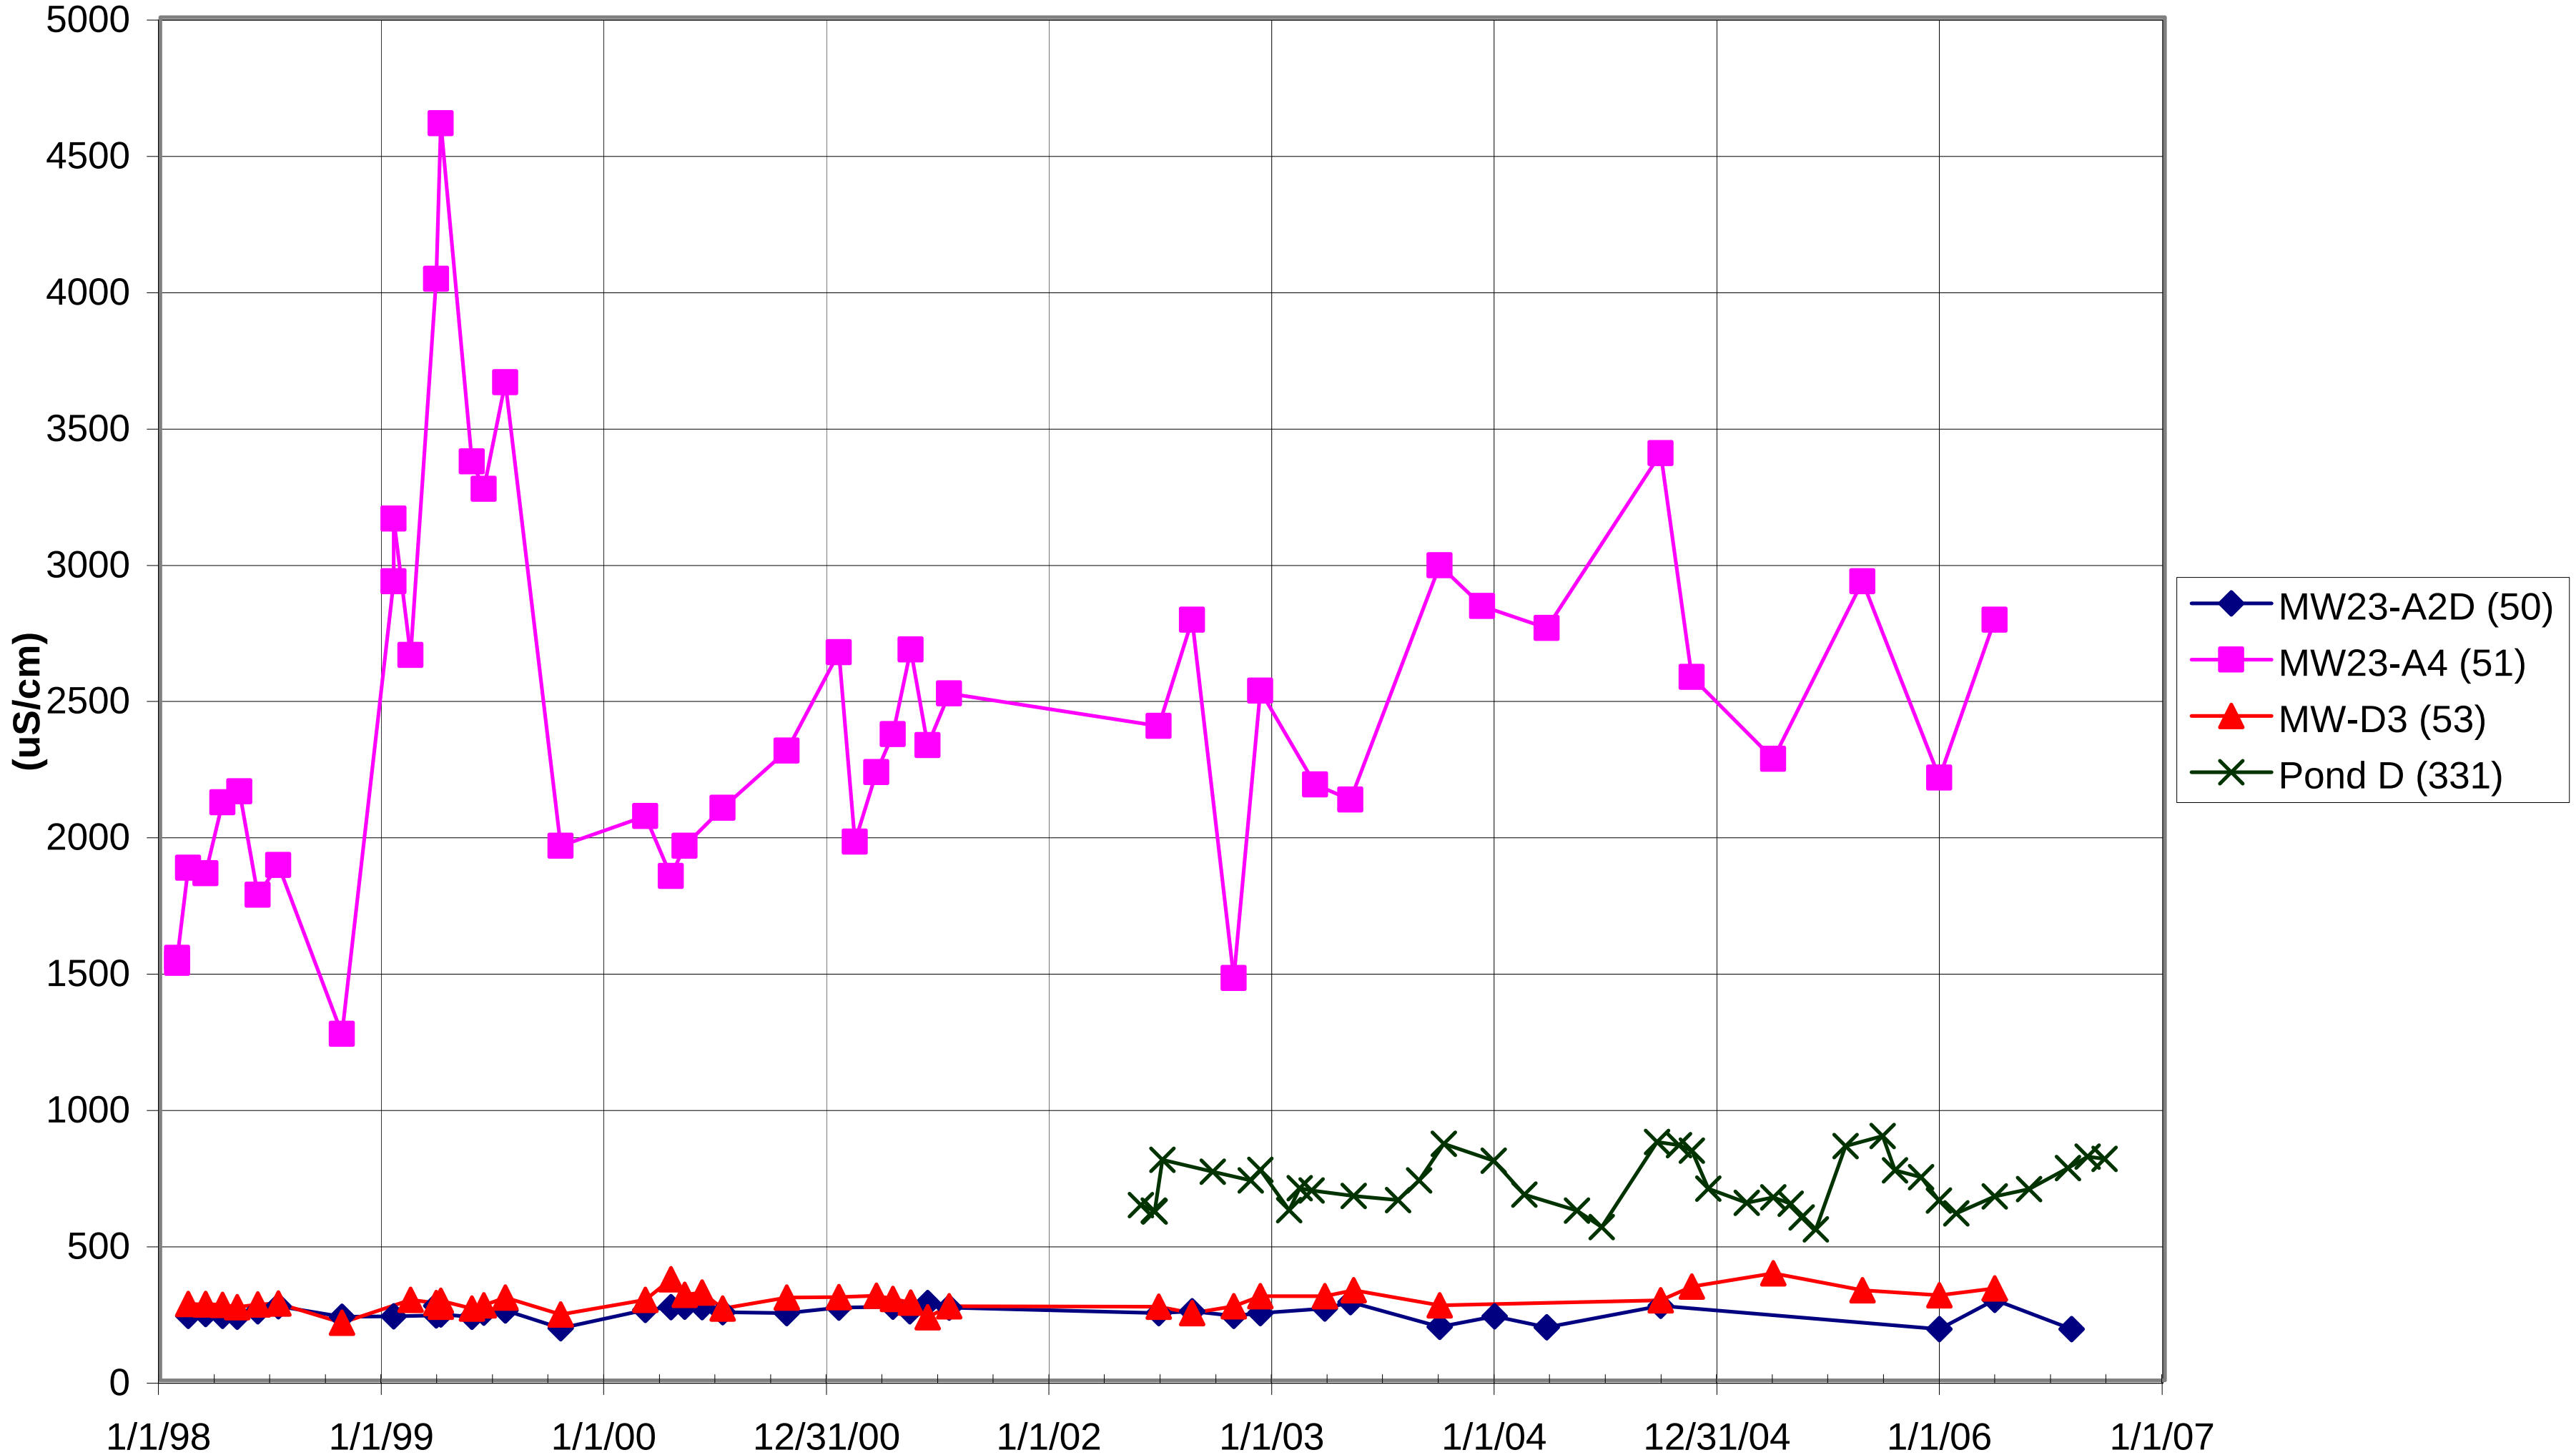
FIGURE 3.17a GREENS CREEK SITE 23/D INTERNAL MONITORING SITES: FINGER DRAINS - CONDUCTIVITY DATA

Conductivity results from internal monitoring site waters are presented in Figure 3.17a and b. 2005 conductivity measurements range up to 4,610 µS/cm. MW-23-A2D and MW-D3 have the lowest conductivity. MW-D3 is completed in alluvial sands below the fill placed at Site D. The finger drains with the highest flow (e.g. 23FD-5, which directly drains an excavated spring) generally have lower conductivities than the drains with lower flow. This reflects a larger contribution from groundwater to the high-flow drains relative to a higher proportion of site contact water in the other finger drains. The significant decrease in conductivity in 23FD-7 that occurred in 2000 is probably the result of incorporation of groundwater collected in the upper portion of the drain above the active placement area. The presence of contact water in the alluvial sand below Site 23 (as seen in MW-23-A4) is not surprising given the permeable nature of the colluvium that lies immediately beneath the site. A clay till layer underlies the colluvium and alluvial sands beneath the site. The clay till serves as a barrier to downward flow; however, as discussed earlier, it occurs well below the base of both piles.

The fact that MW-D3 does not show signs of a contribution from contact water suggests that an upward hydrologic gradient may exist beneath Site D. Finger Drain 23FD-2 has the highest conductivity but consistently low flow, suggesting no significant influence from groundwater. This drain may also be influenced by runoff that infiltrates along the access ramp to the site. The higher conductivity of the site contact waters reflects a larger dissolved load caused by weathering of the production rock. As with tailings, pyrite oxidation and carbonate dissolution contribute dissolved ions such as sulfate, bicarbonate, calcium and magnesium to the contact waters, increasing their conductivity. Sulfate concentrations for the finger drains and groundwater wells are plotted in Figures 3.18a and 3.18b and match closely the relative value patterns of conductivity.

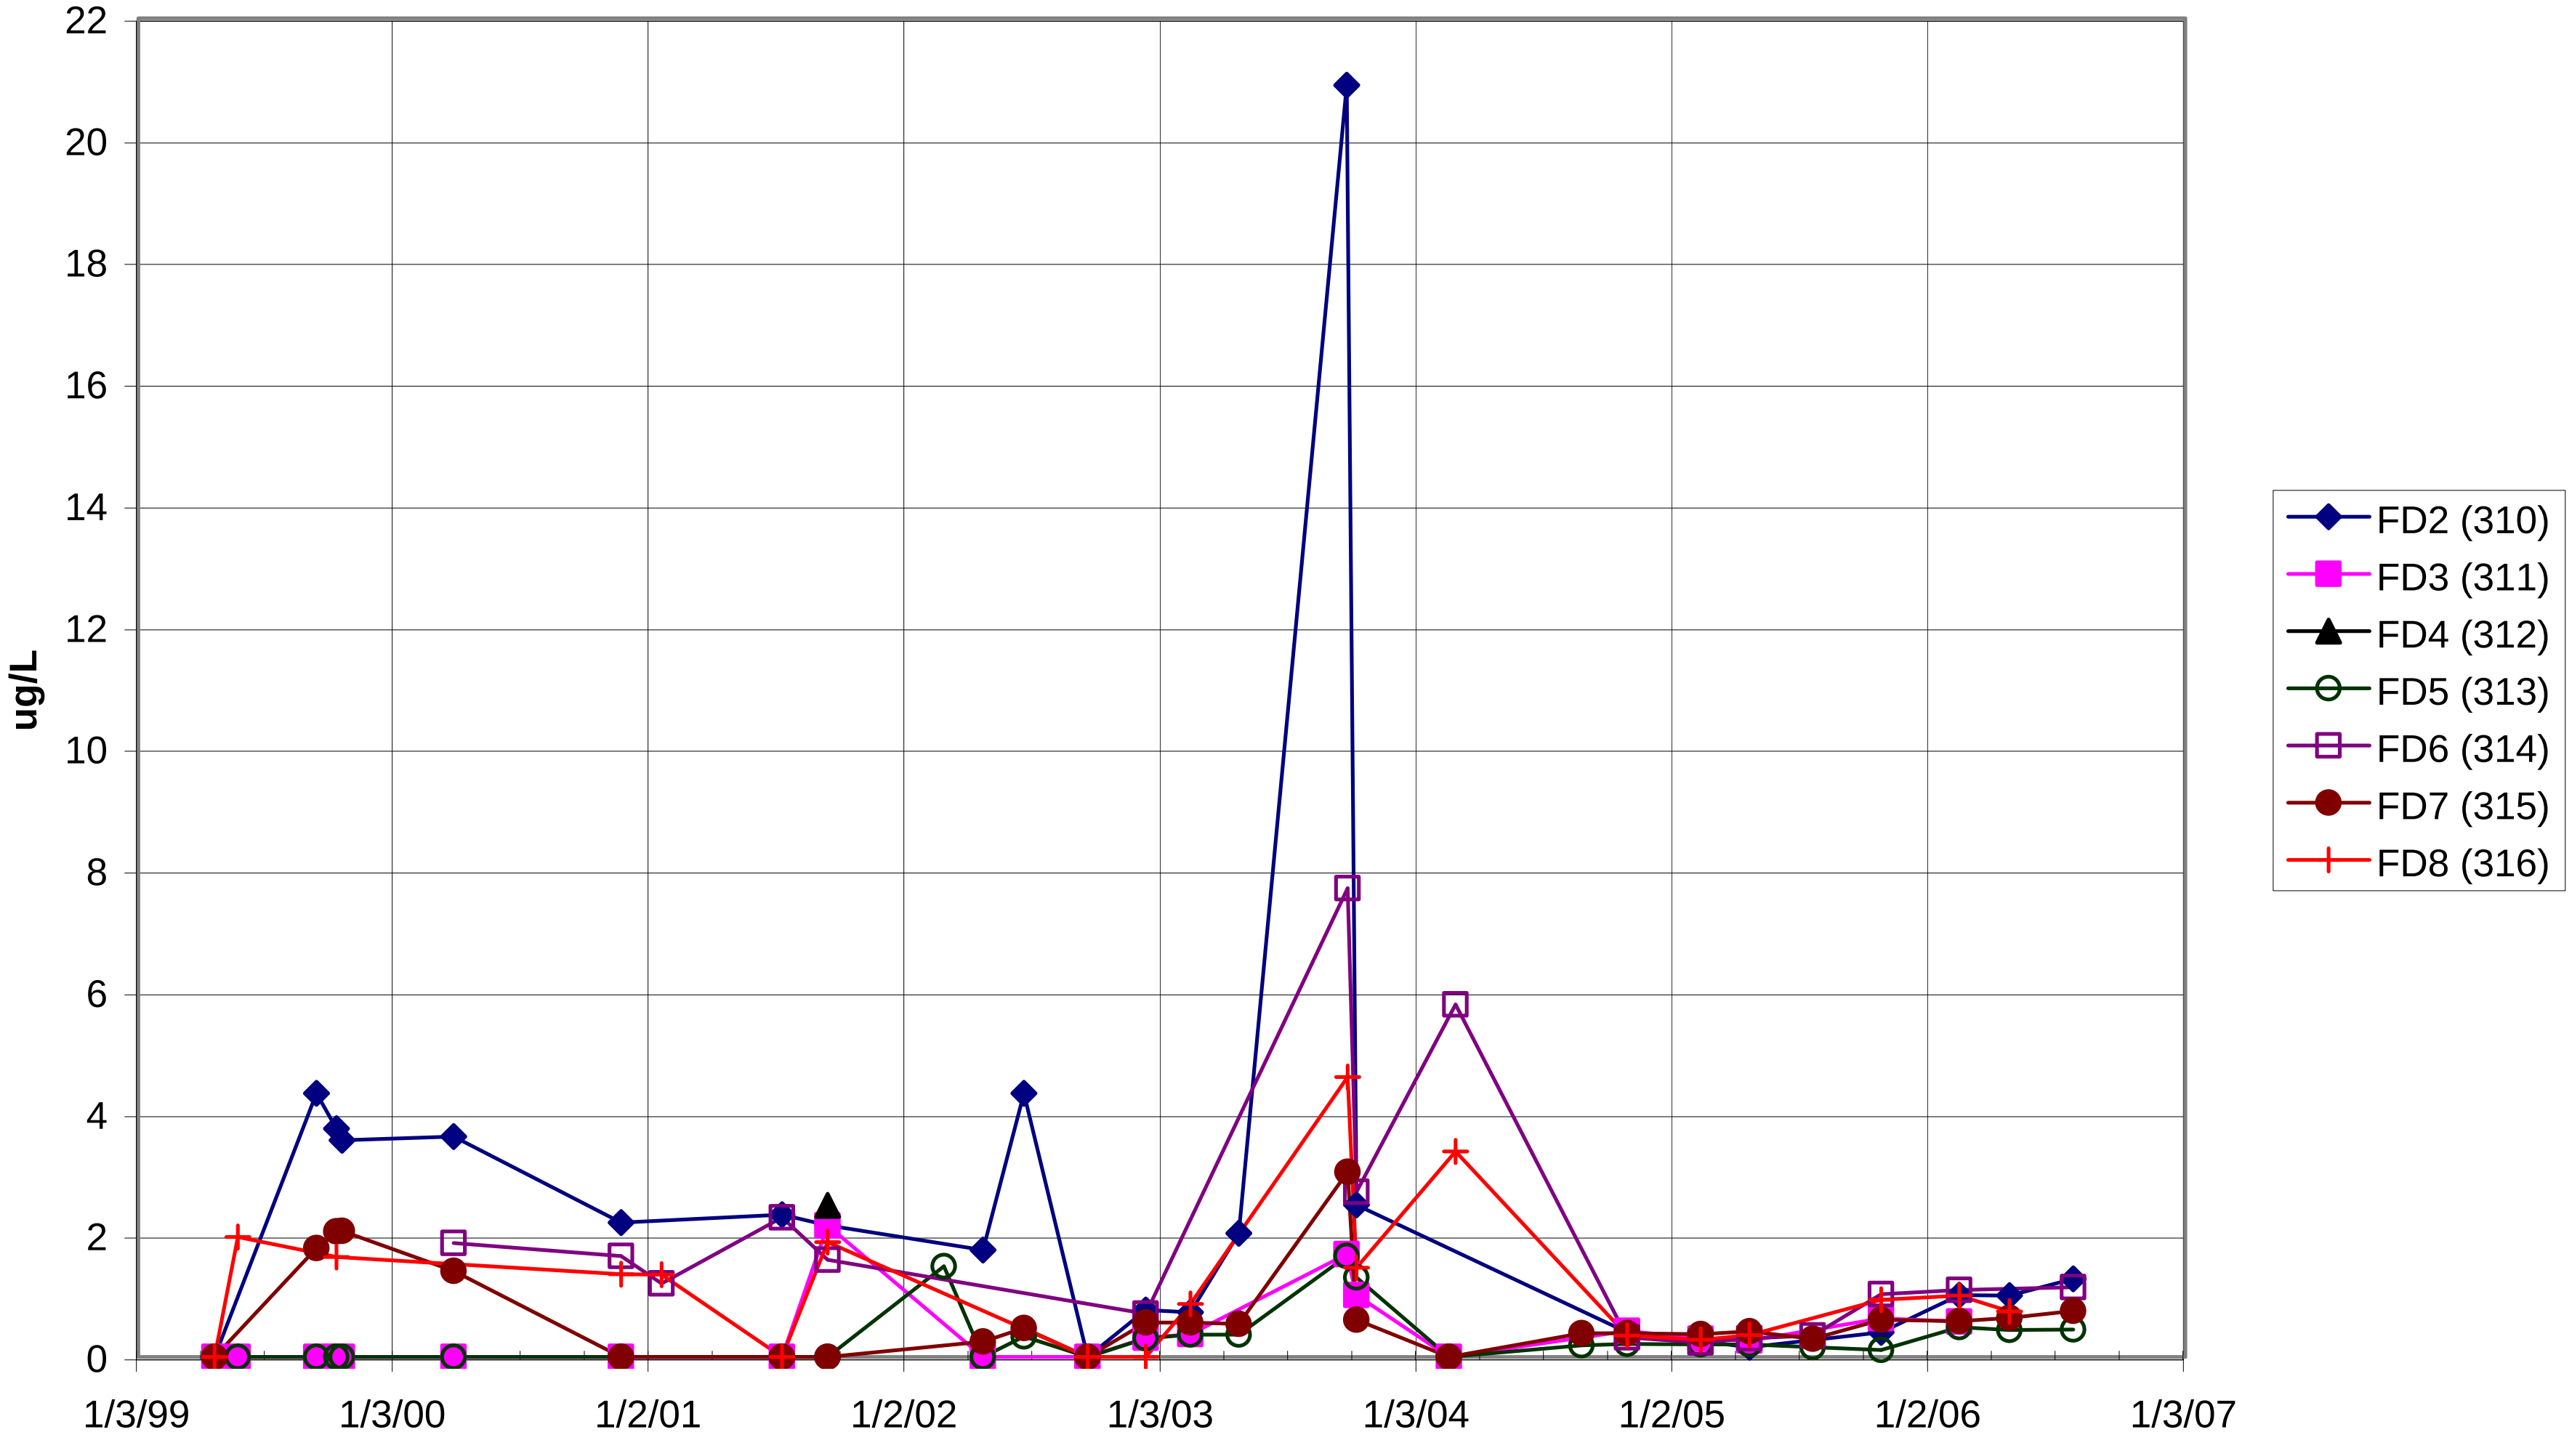
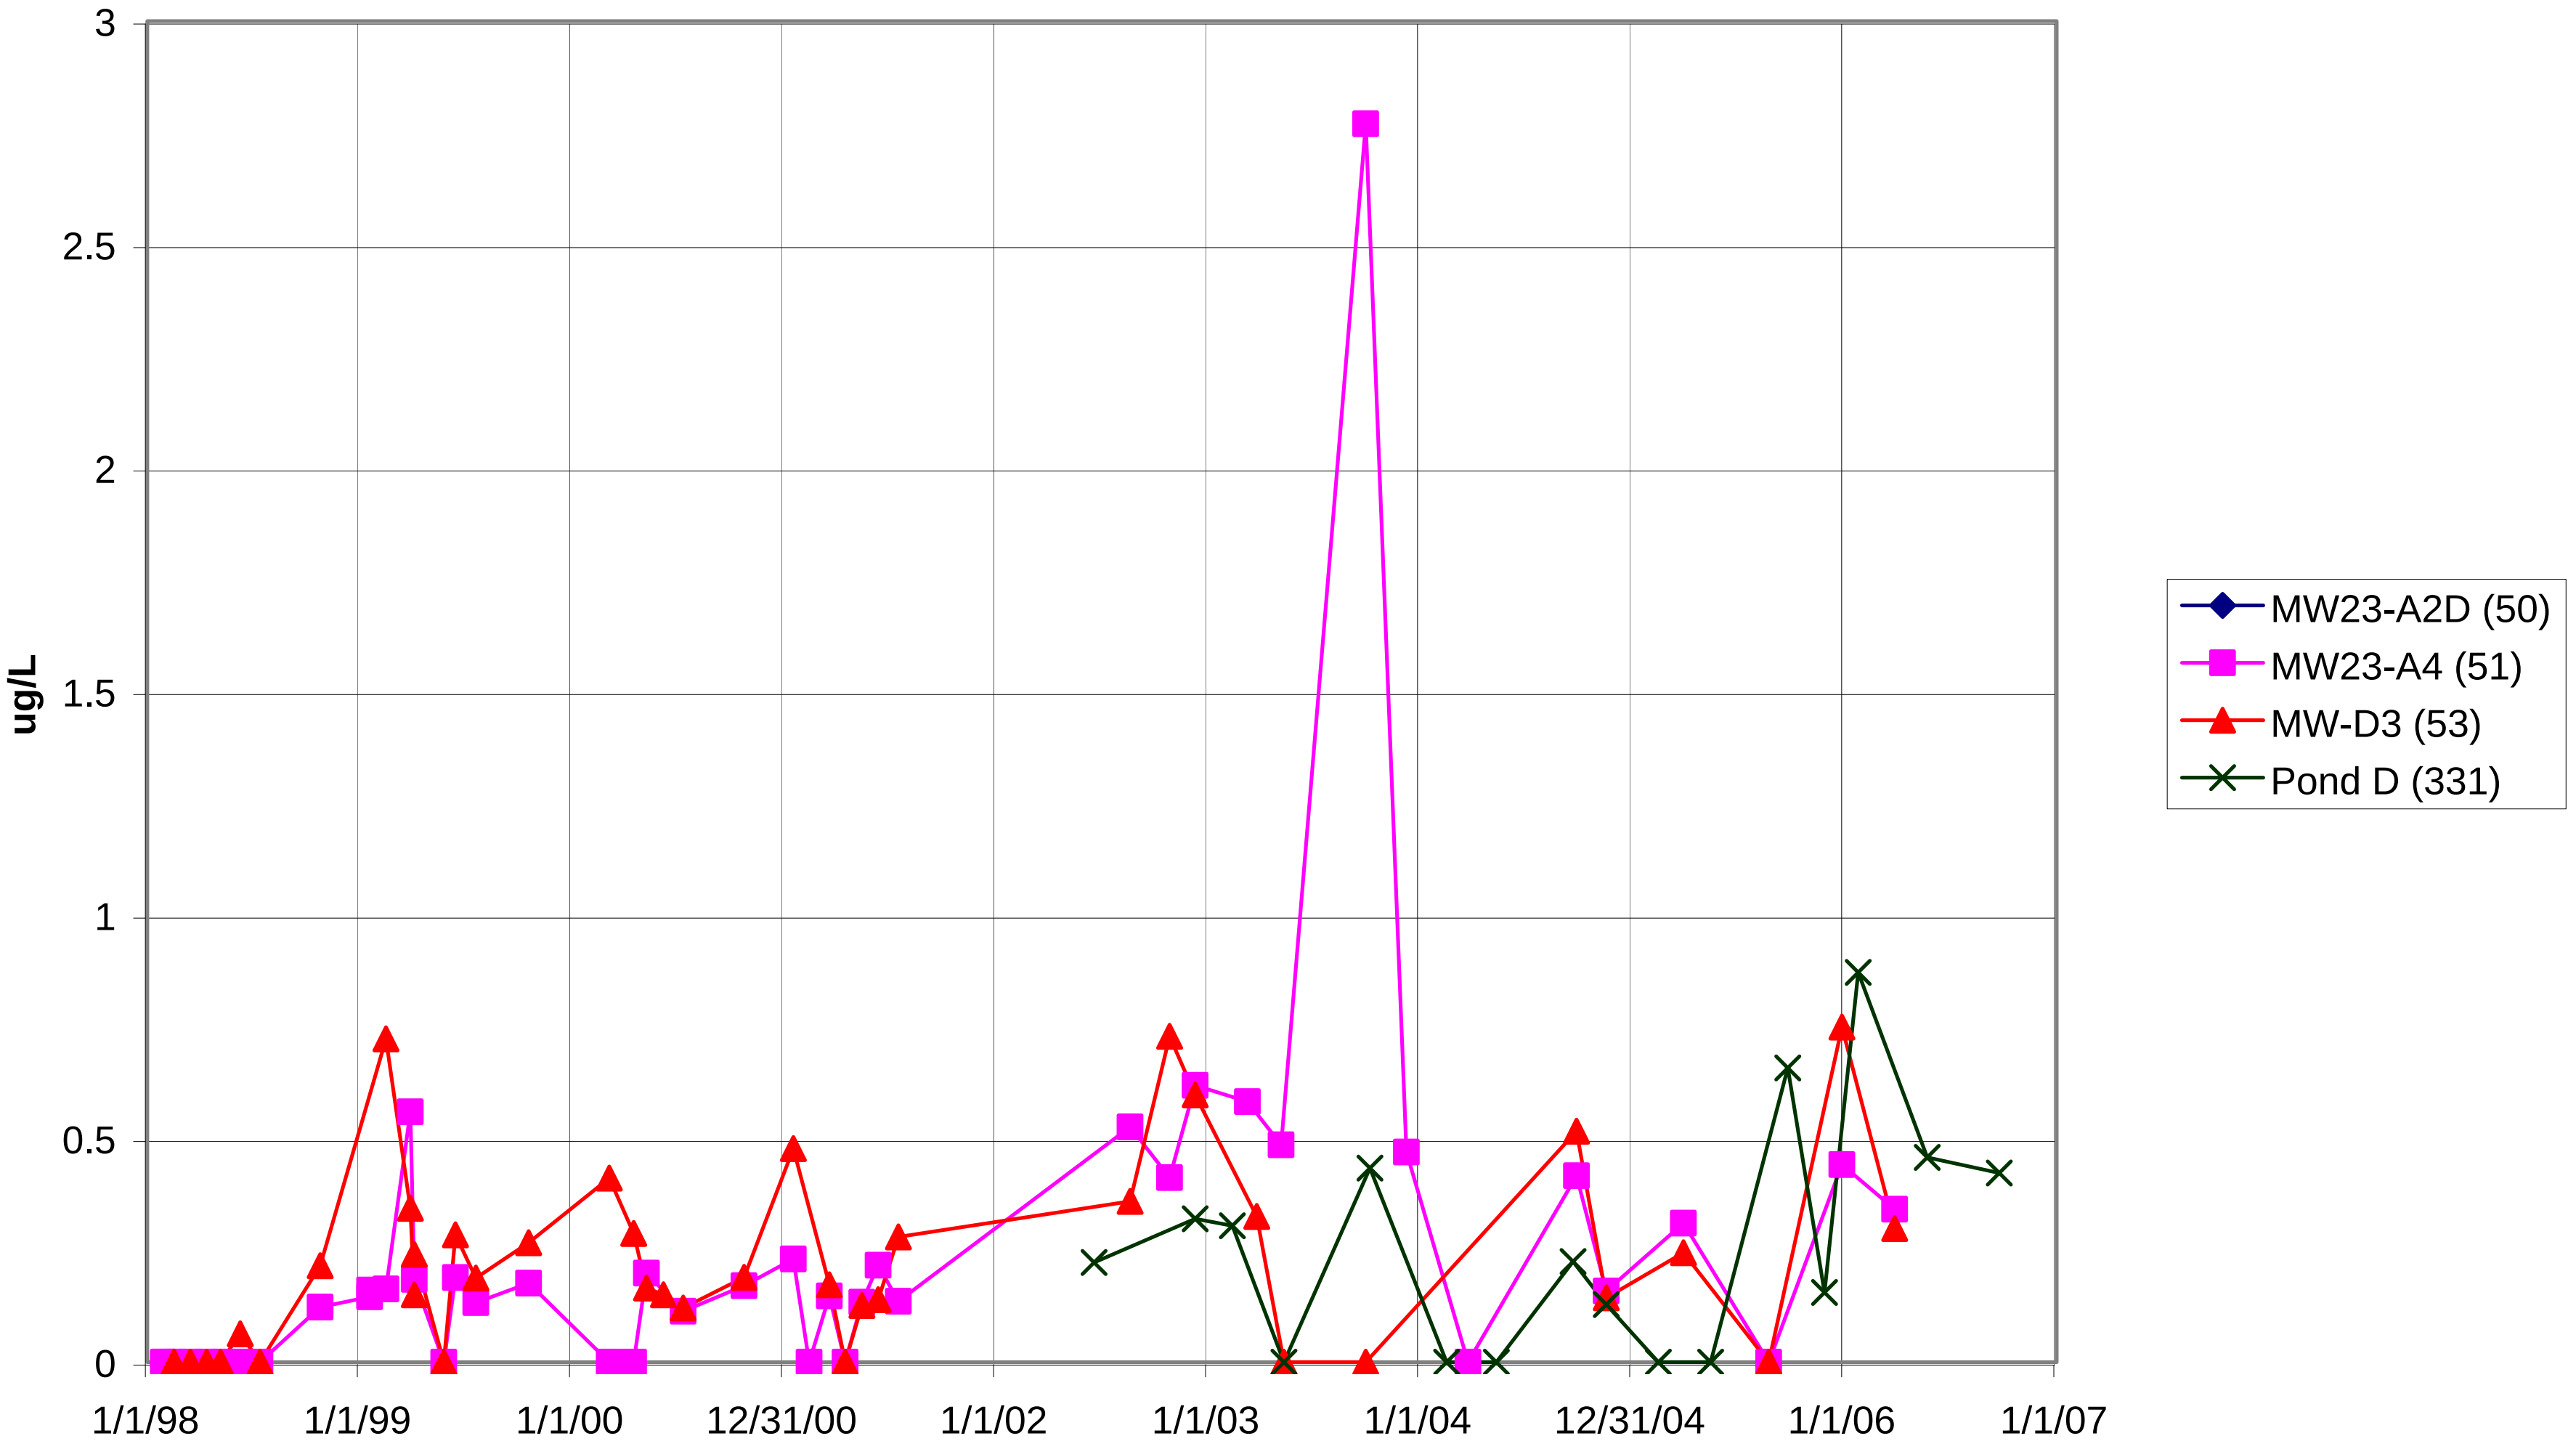
**FIGURE 3.19a GREENS CREEK SITE 23/D INTERNAL MONITORING SITES:
FINGER DRAINS - ARSENIC DATA
(Non-detectable analyses plotted as zero)**

Arsenic data are presented in Figure 3.19a and b and are generally quite low. All finger drains and MW-23-A4 experienced increases in their arsenic concentrations in September 2003, with subsequent decreases to historical levels in October. The flows in the finger drains positively correlate with these changes. Fluctuations in arsenic values in 23FD-2 can be attributed to changes in redox conditions. Low arsenic and iron (Figures 3.25 a and b) concentrations indicate that these metals are precipitating as oxyhydroxides on rock surfaces inside the pile.
