TAILINGS AND PRODUCTION ROCK SITE
2006 ANNUAL REPORT

Kennecott Greens Creek Mining Company

April 2007

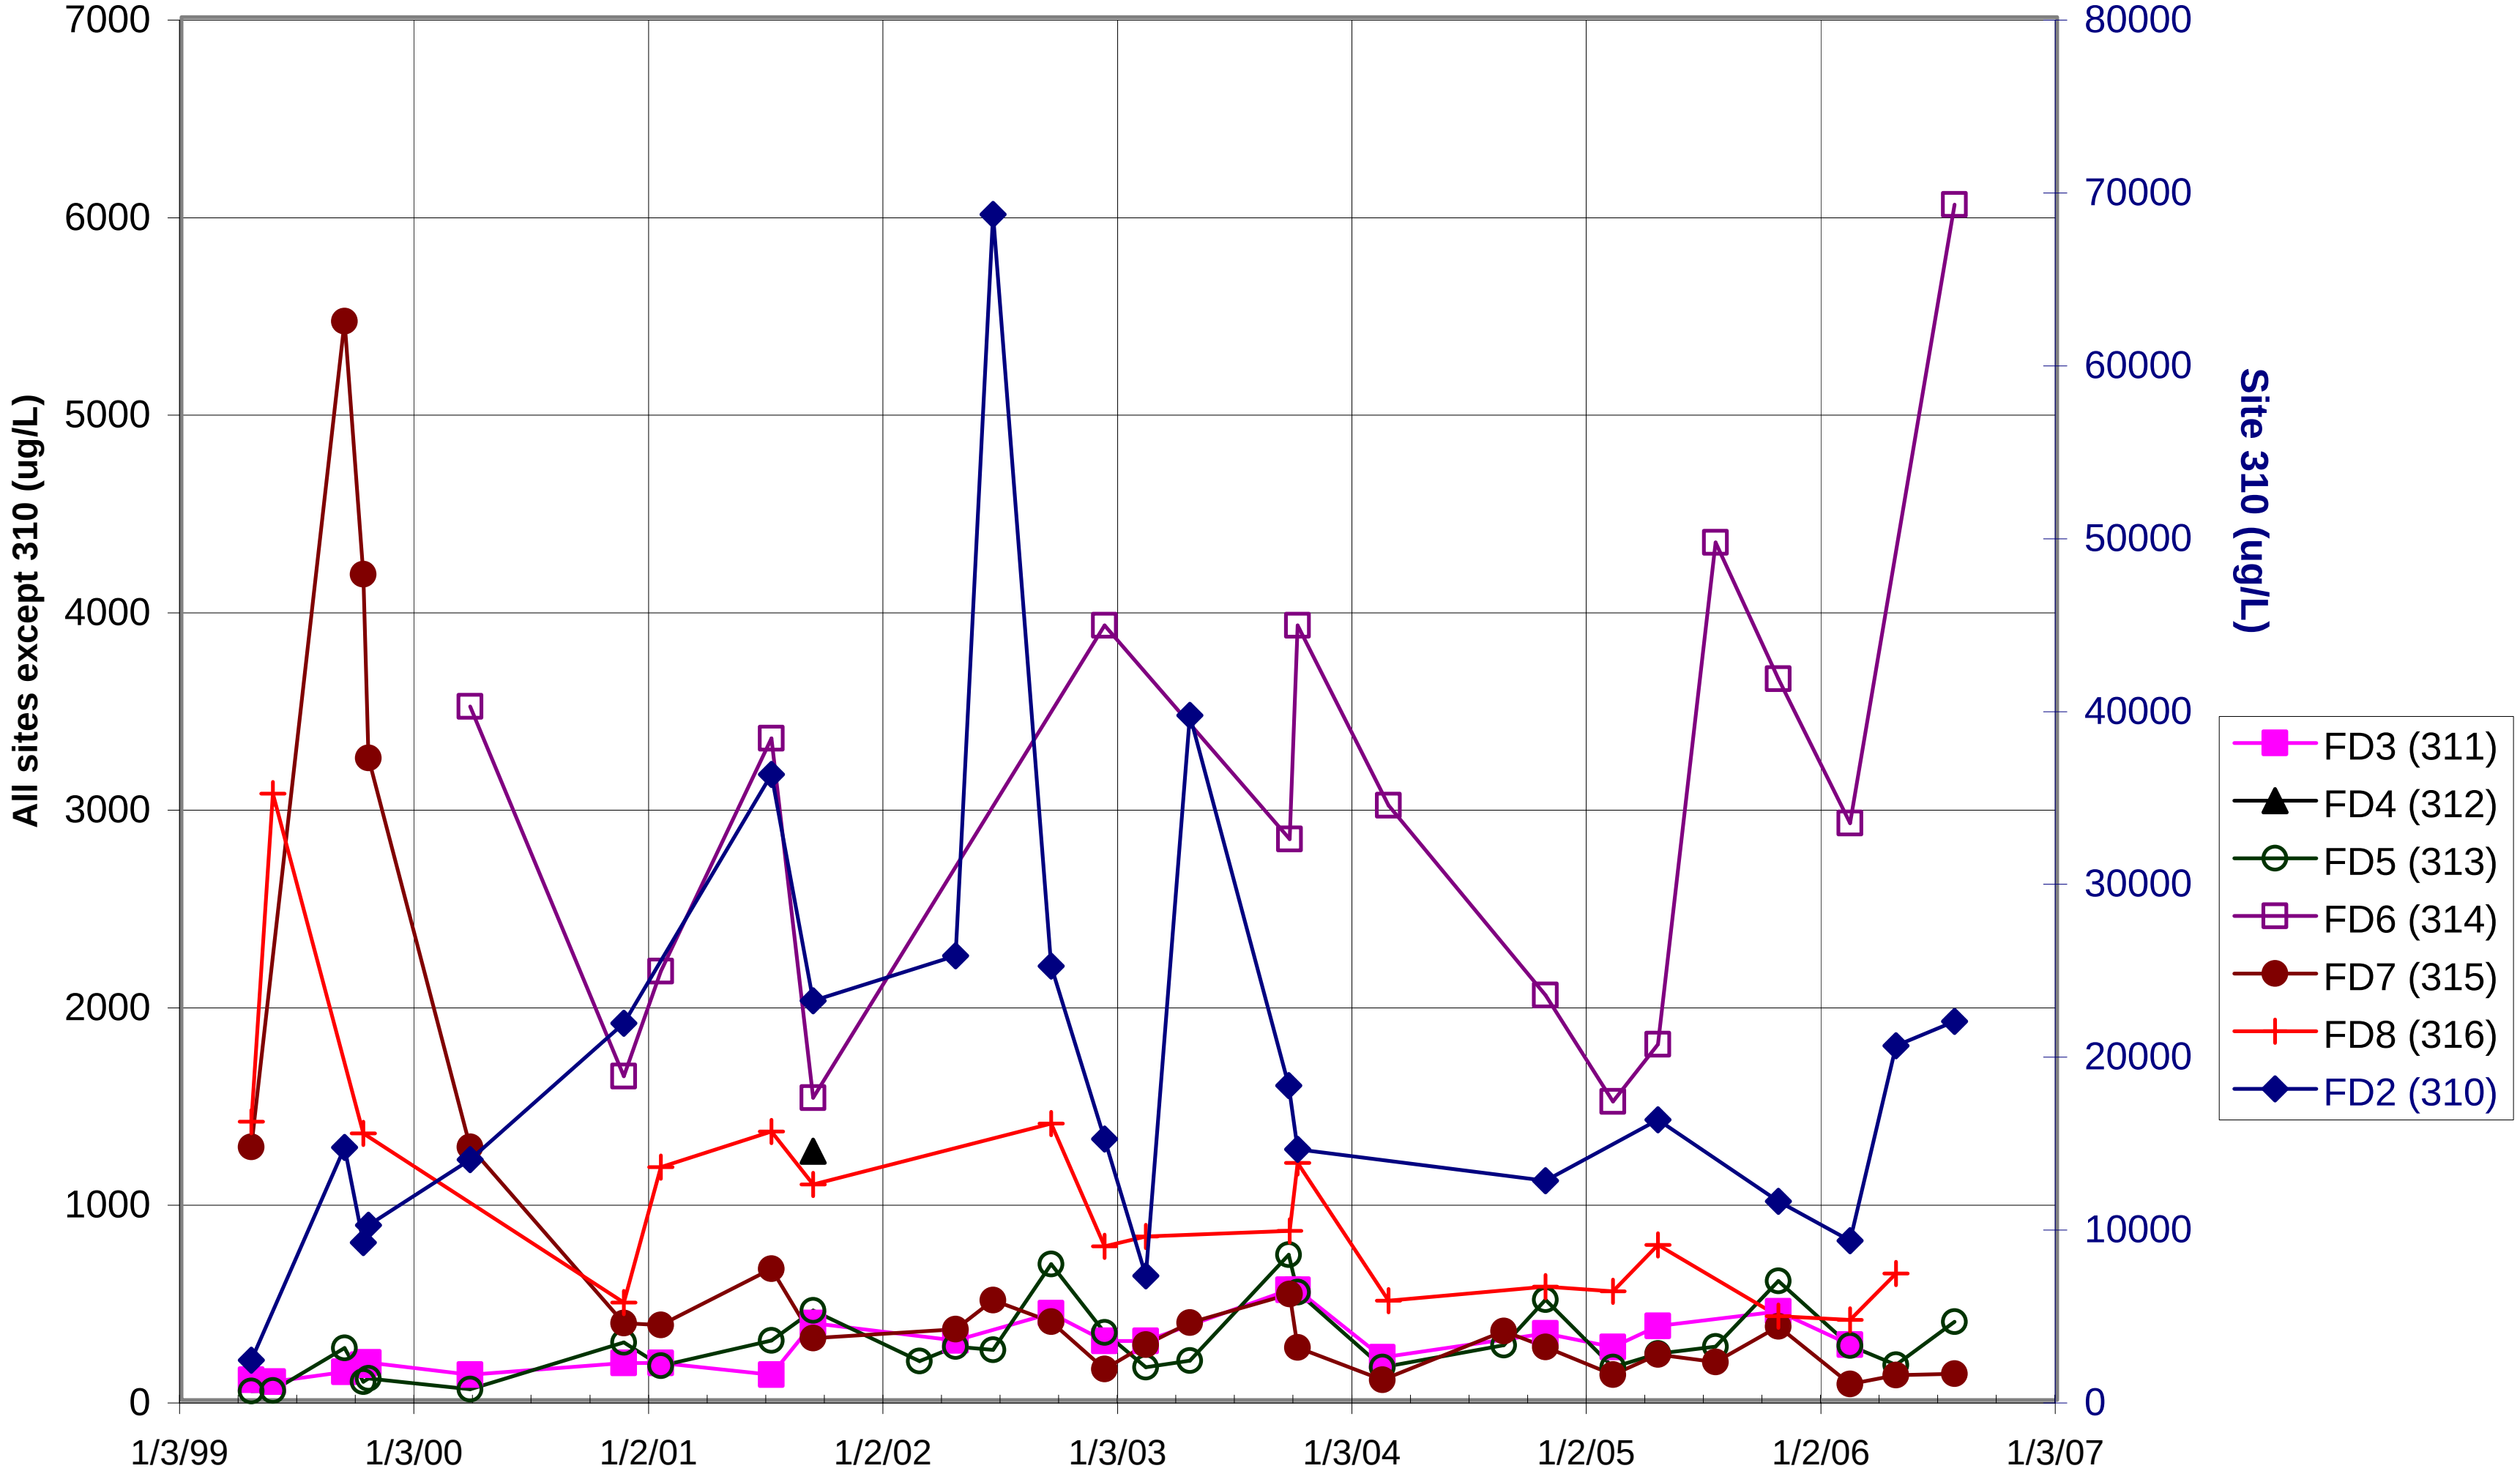
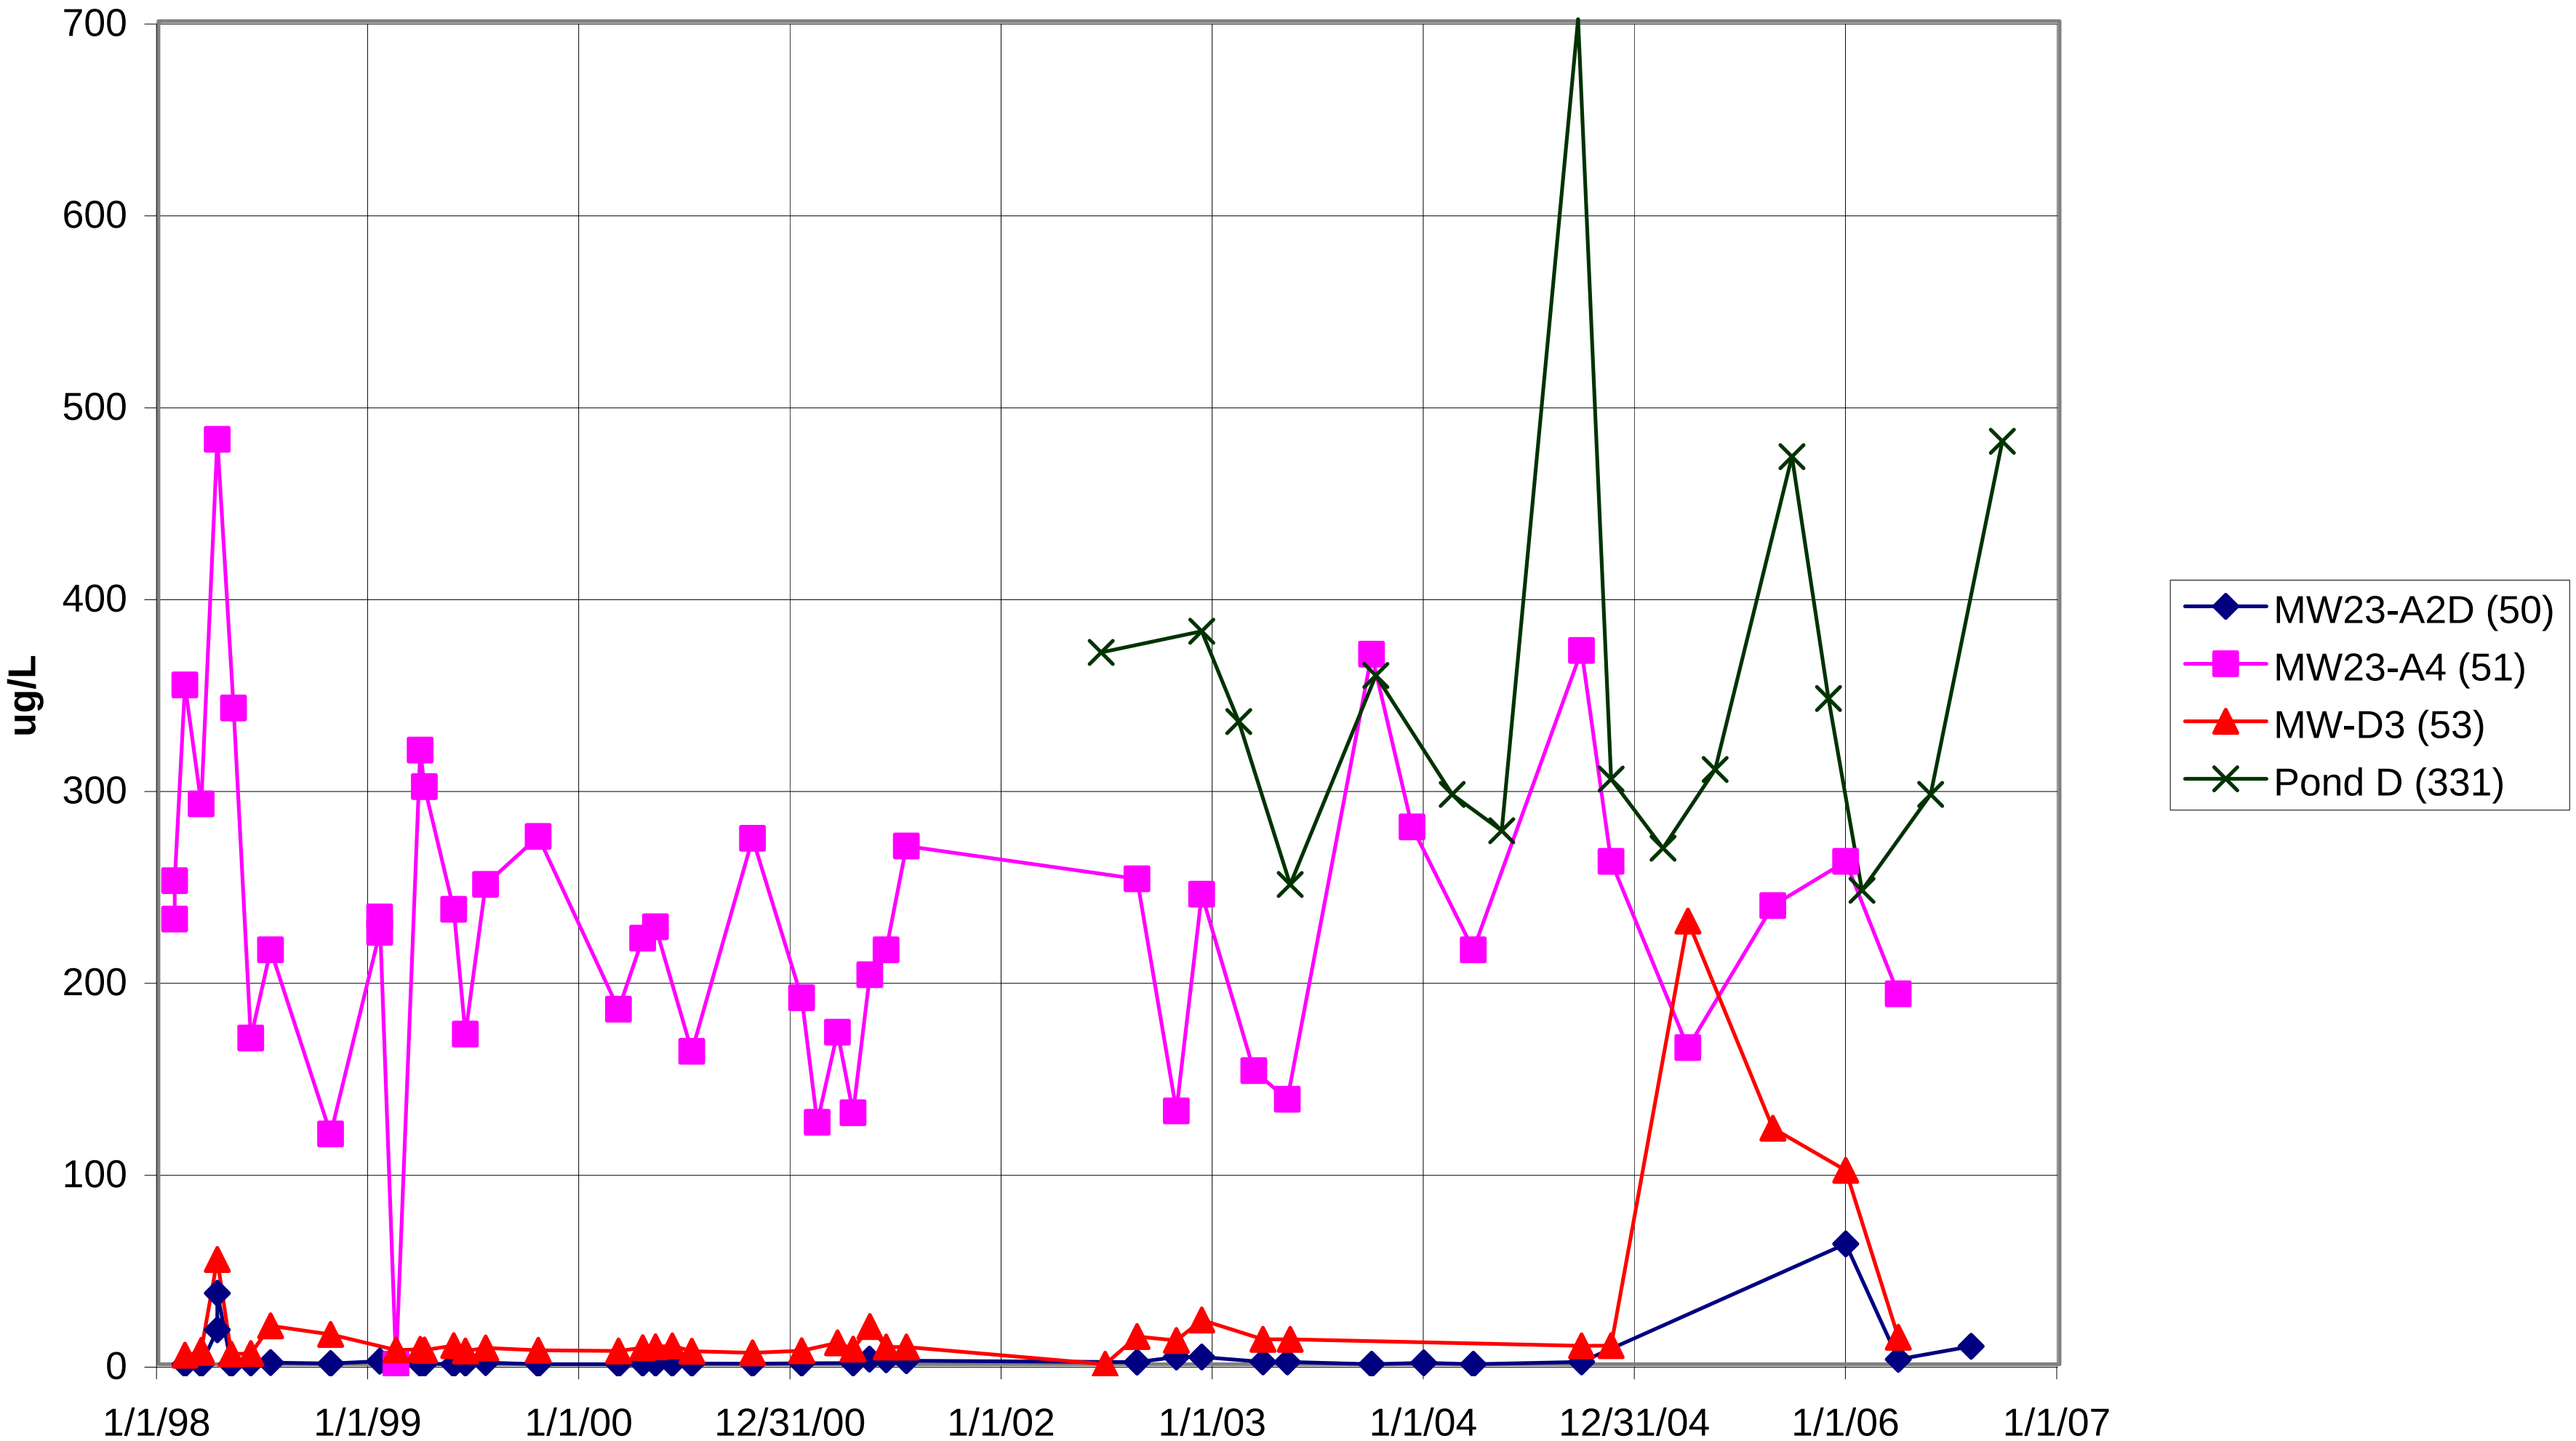
FIGURE 3.20a GREENS CREEK SITE 23/D INTERNAL MONITORING SITES: FINGER DRAINS - ZINC DATA
(Non-detectable analyses plotted as zero)

Figure 3.20a and b shows the concentration of zinc in the internal monitoring locations at Site 23/D. Zinc levels appear to be controlled by seasonal conditions. The changes in zinc concentrations mimic those for conductivity and sulfate. 23FD-2 had a zinc concentration of approximately 70 mg/l in June 2002. In 2003, the zinc concentration averaged 20 mg/l, and this average further decreased to approximately 14 mg/l in 2004 and 2005. However, in 2006, the average zinc concentration had increased to 17 mg/l. Zinc concentrations in the range of 20 to 70 mg/l are consistent with laboratory kinetic weathering tests performed on samples of argillite and serpentinite (Vos, 1993). The zinc concentrations recorded for Pond D are generally below 0.7 mg/l and reflect contributions from several source waters. Pond D receives water from Site D surface runoff, seeps on the slope and at the toe of the site and the effluent from the curtain drain that KGCMC installed between Site D and Site 23. MW-D3 showed elevated zinc concentrations in both 2005 samples: zinc levels rose from an average of 10 µg/l in 1998-2004 to an average of 177 µg/l in 2005. Average sulfate also increased by approximately 30 mg/l in 2005 compared to average values from 2002-2004. The zinc and sulfate returned to within historical limits in 2006. The cause for the increases in 2005 is not immediately apparent; however, if it was the arrival of a contact water front, a significant increase in conductivity, sulfate, calcium and magnesium should have preceded an increase in metals such as lead and zinc.

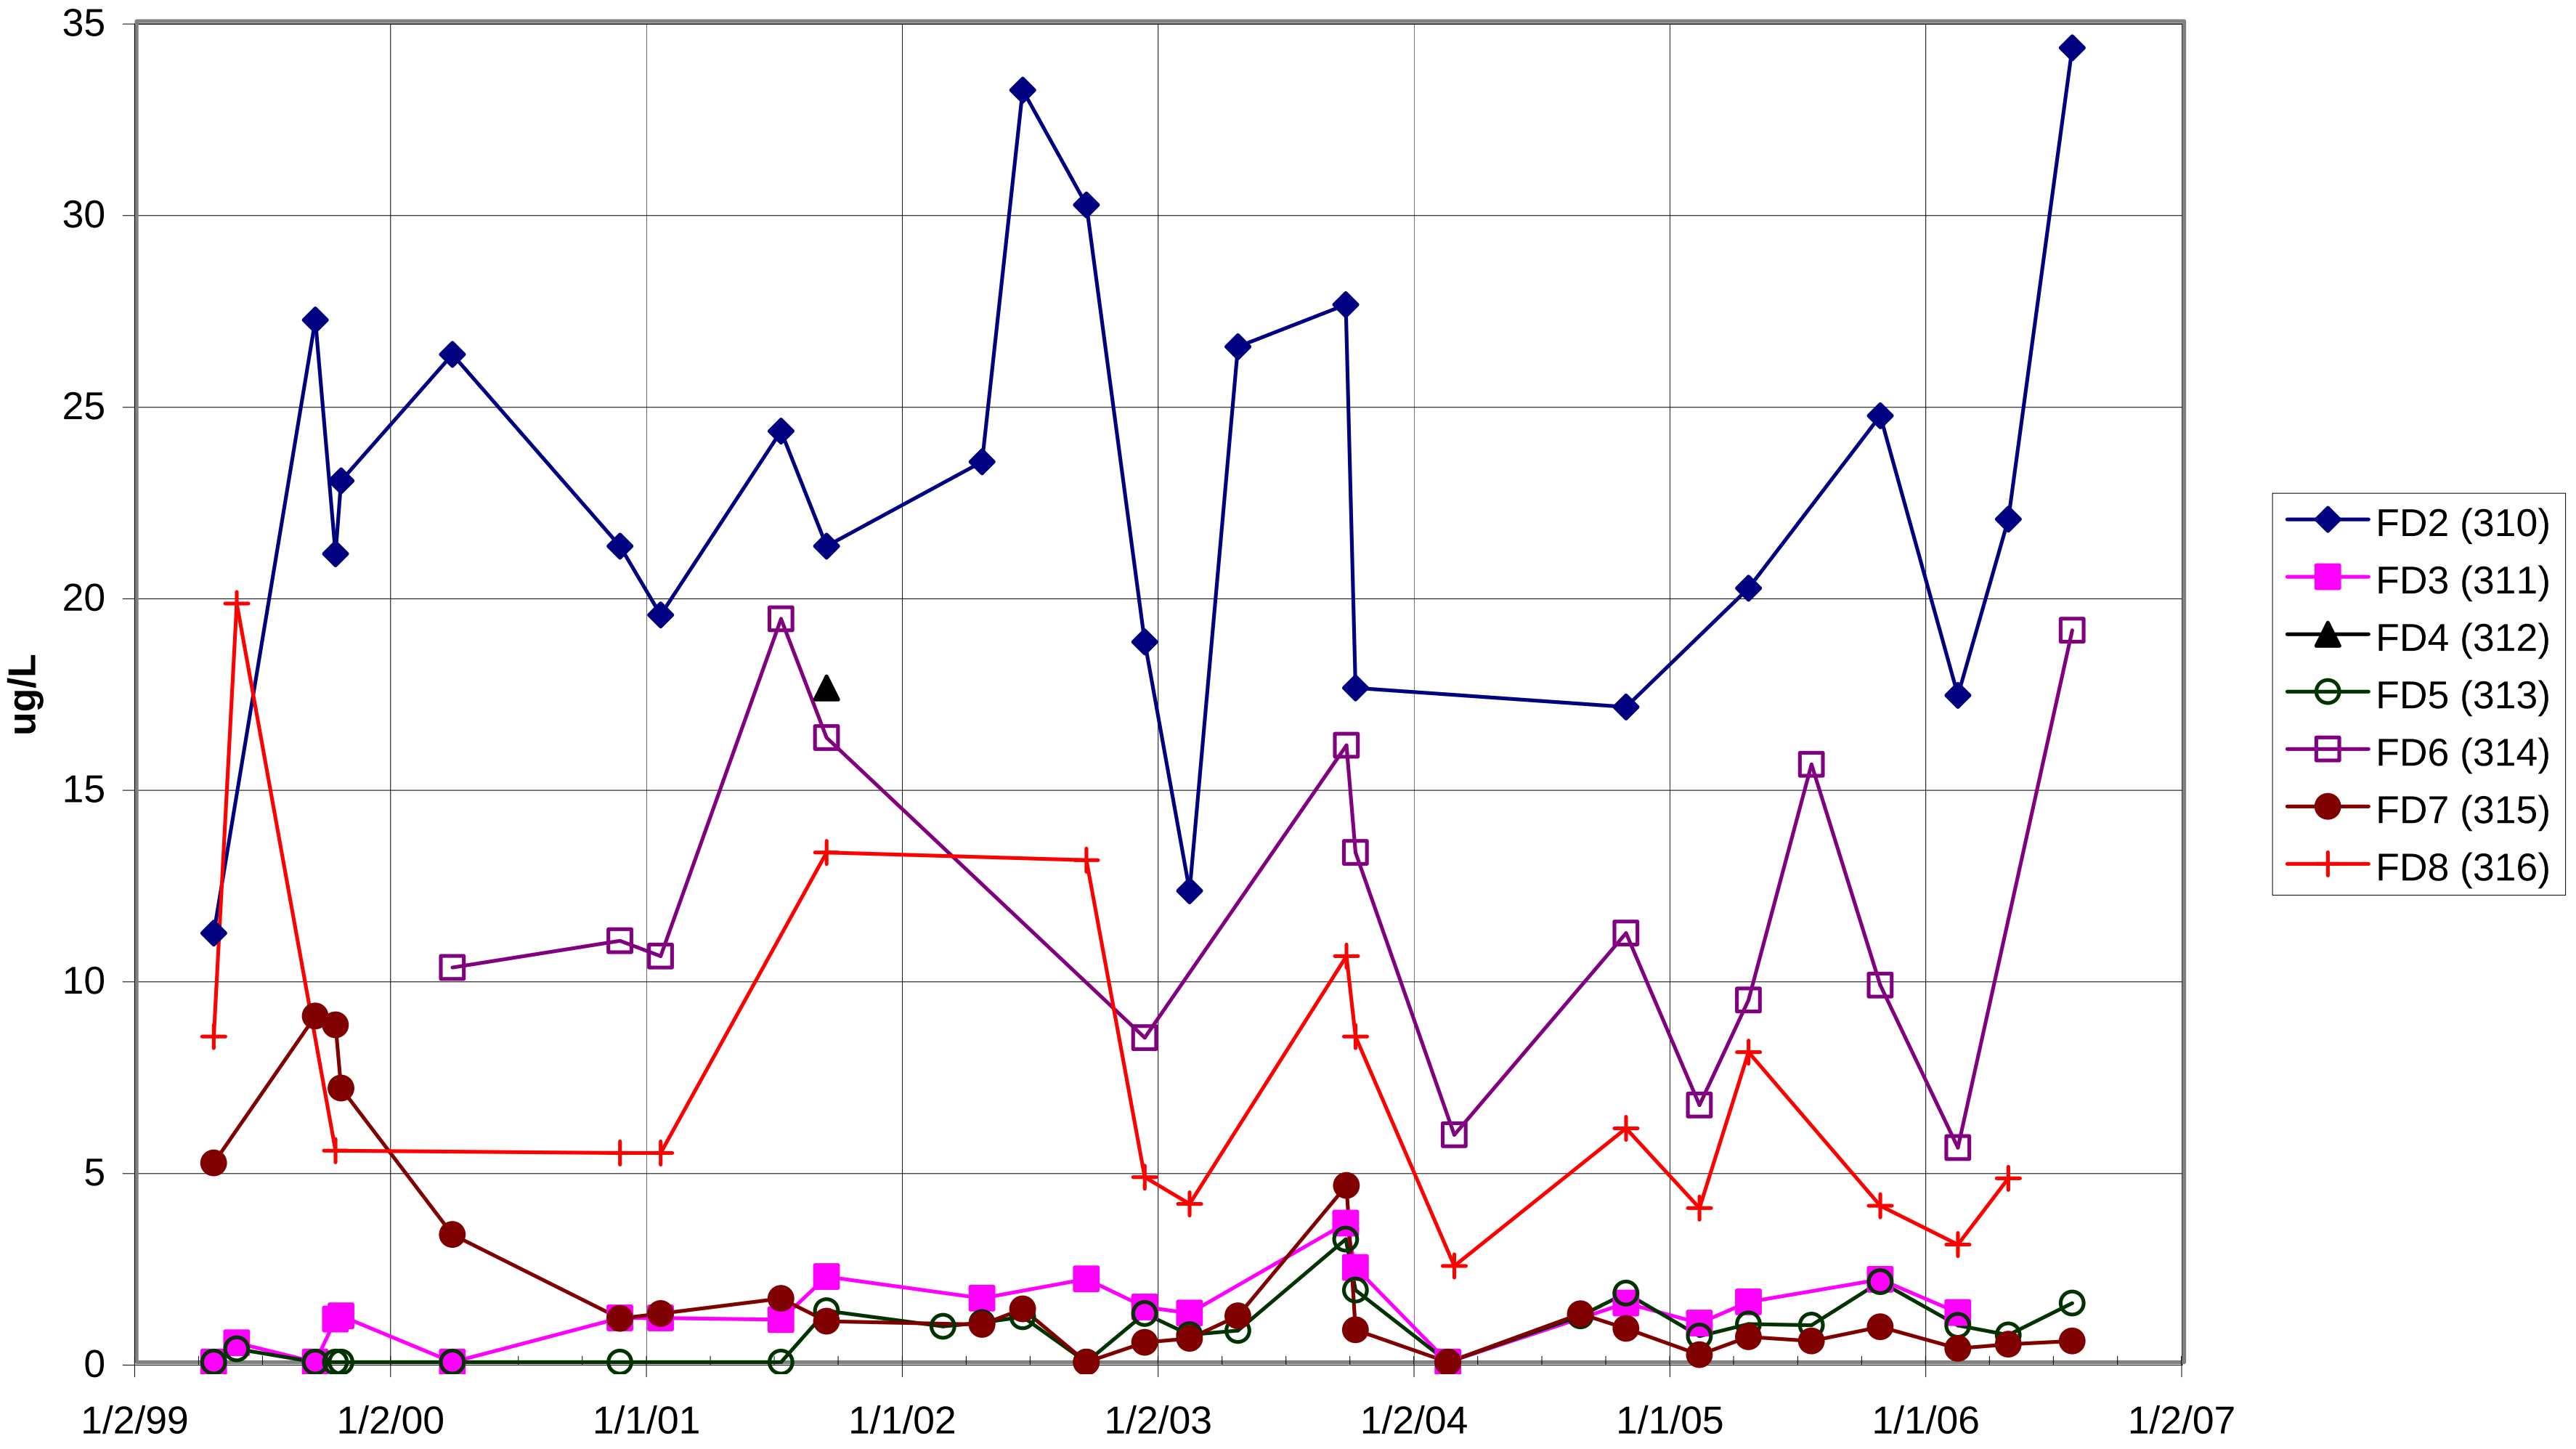
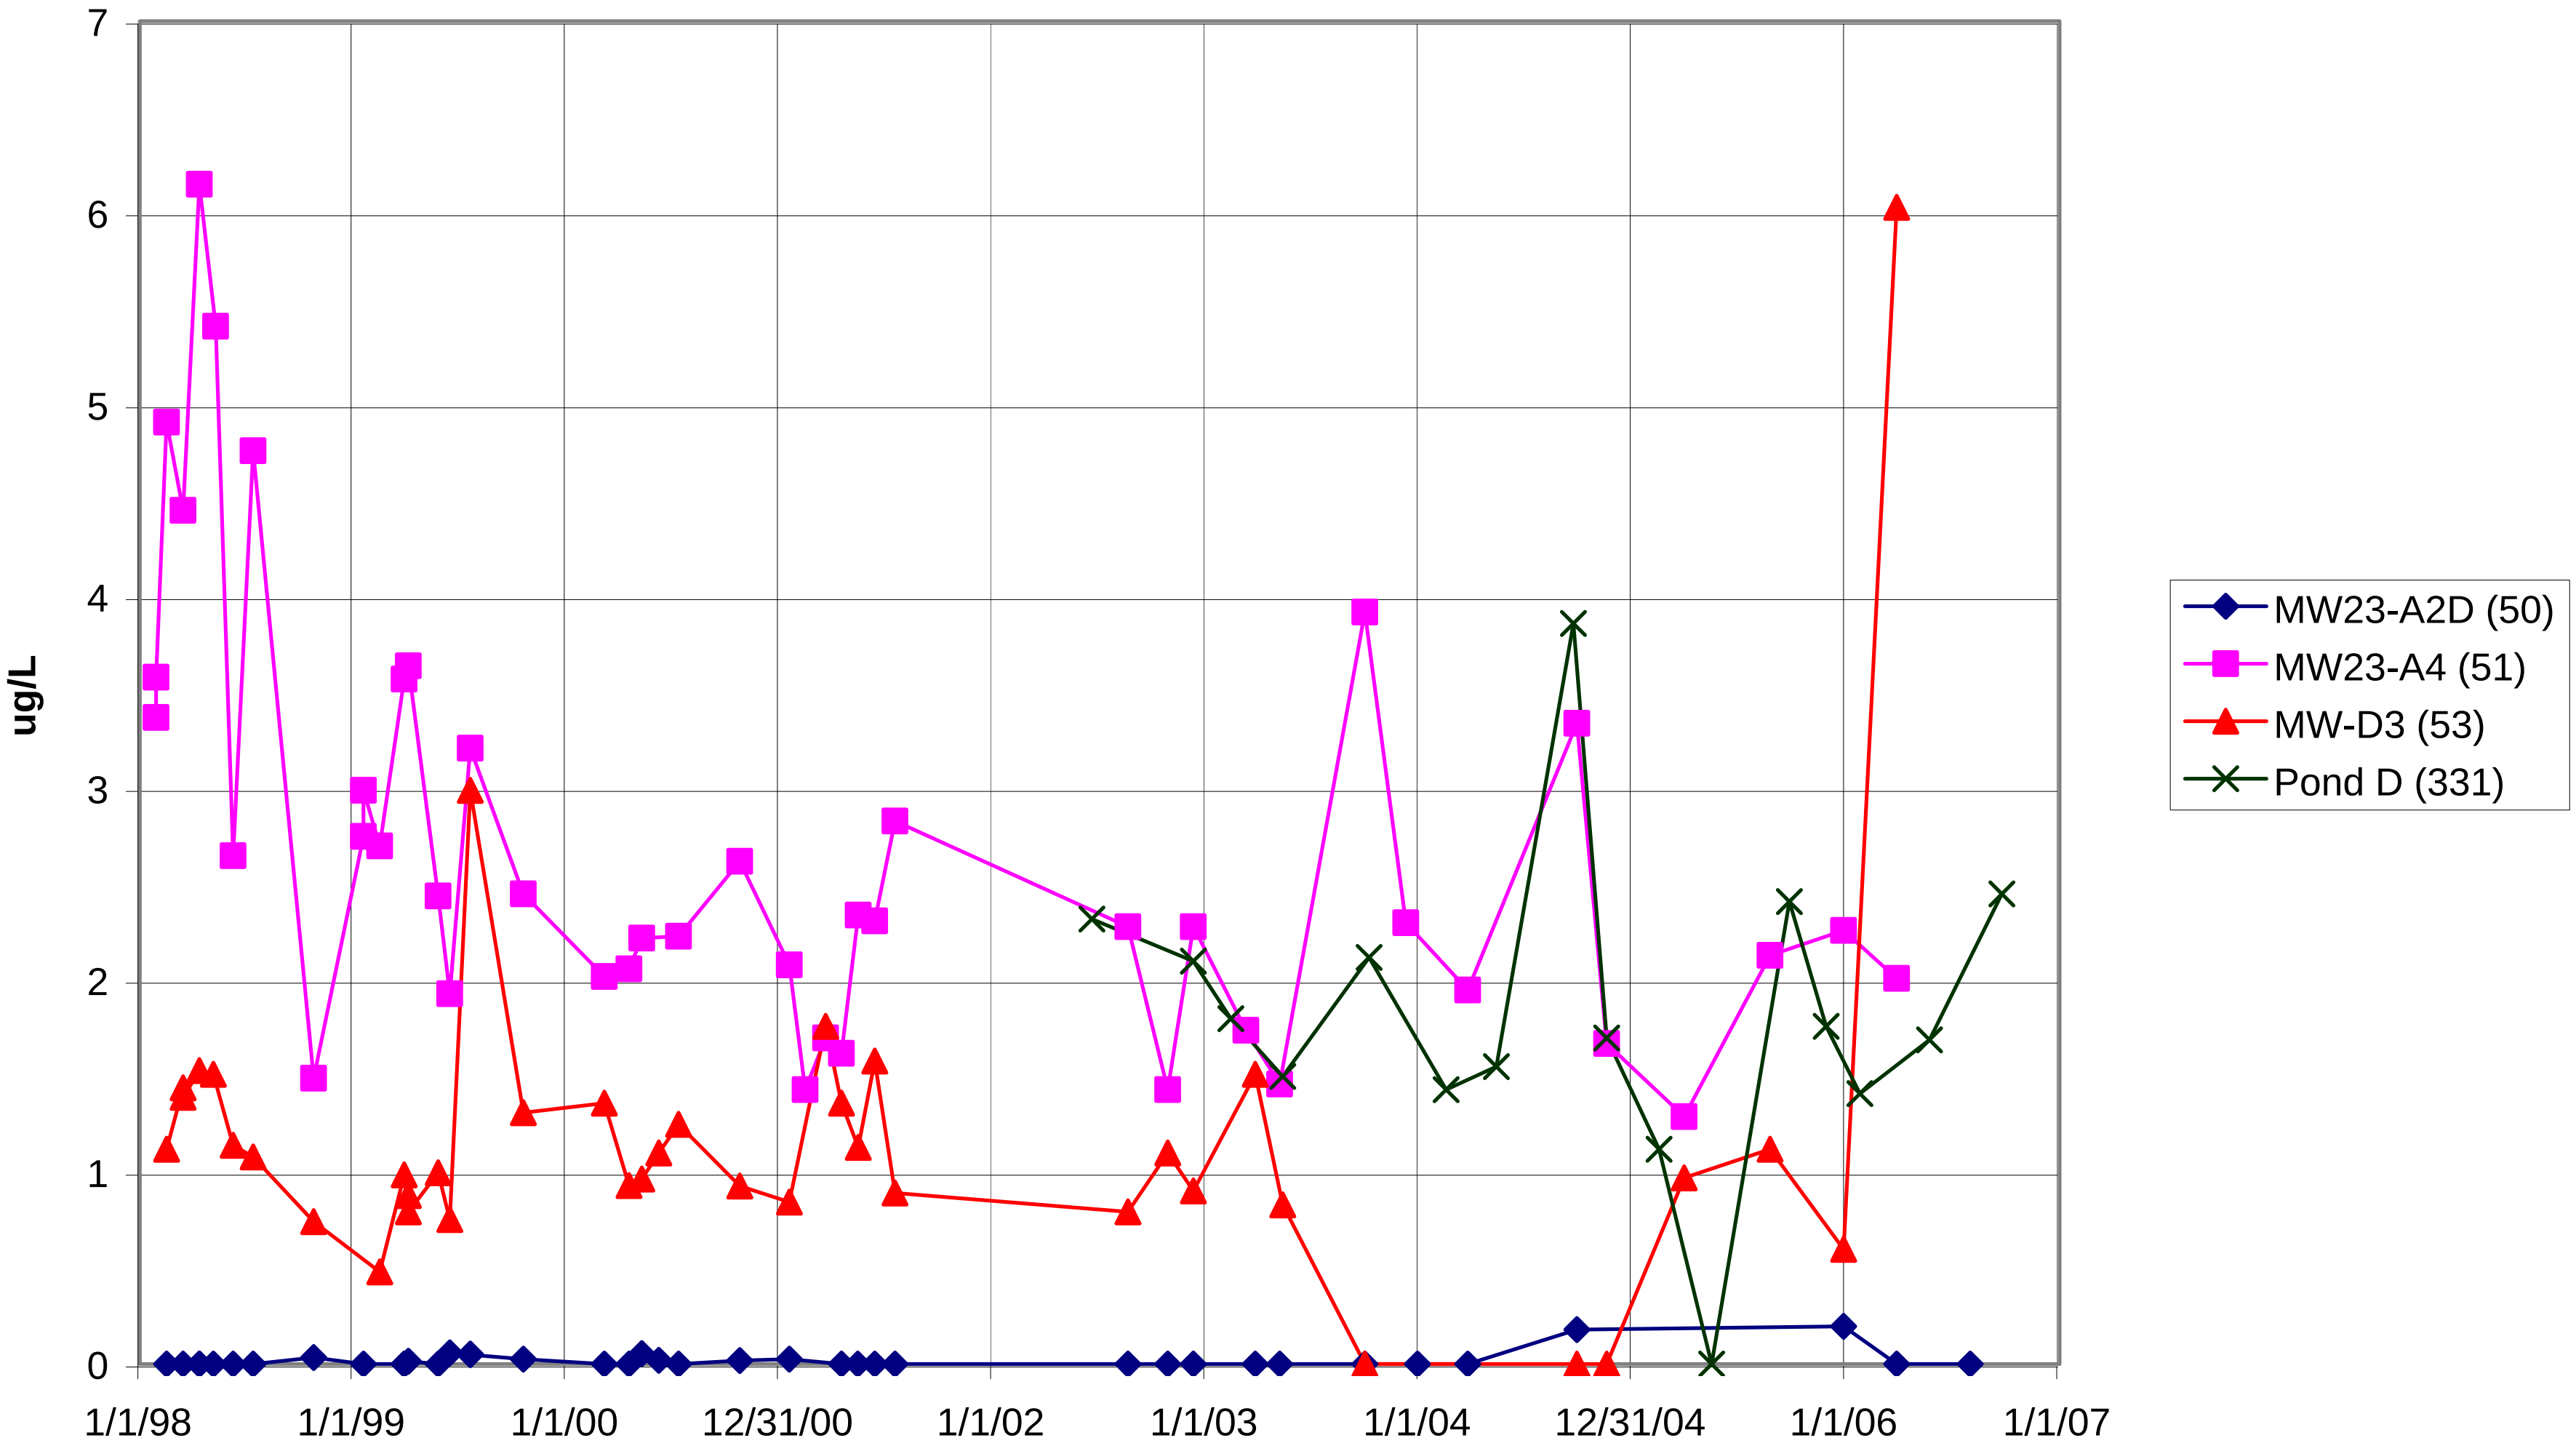
FIGURE 3.21a GREENS CREEK SITE 23/D INTERNAL MONITORING SITES:
FINGER DRAINS - CADMIUM DATA
(Non-detectable analyses plotted as zero)

Cadmium concentrations (Figure 3.21a and b) correlate well with those of zinc for the internal monitoring sites although at much lower values (0 to 35 µg/l).
