TAILINGS AND PRODUCTION ROCK SITE
2006 ANNUAL REPORT

Kennecott Greens Creek Mining Company

April 2007

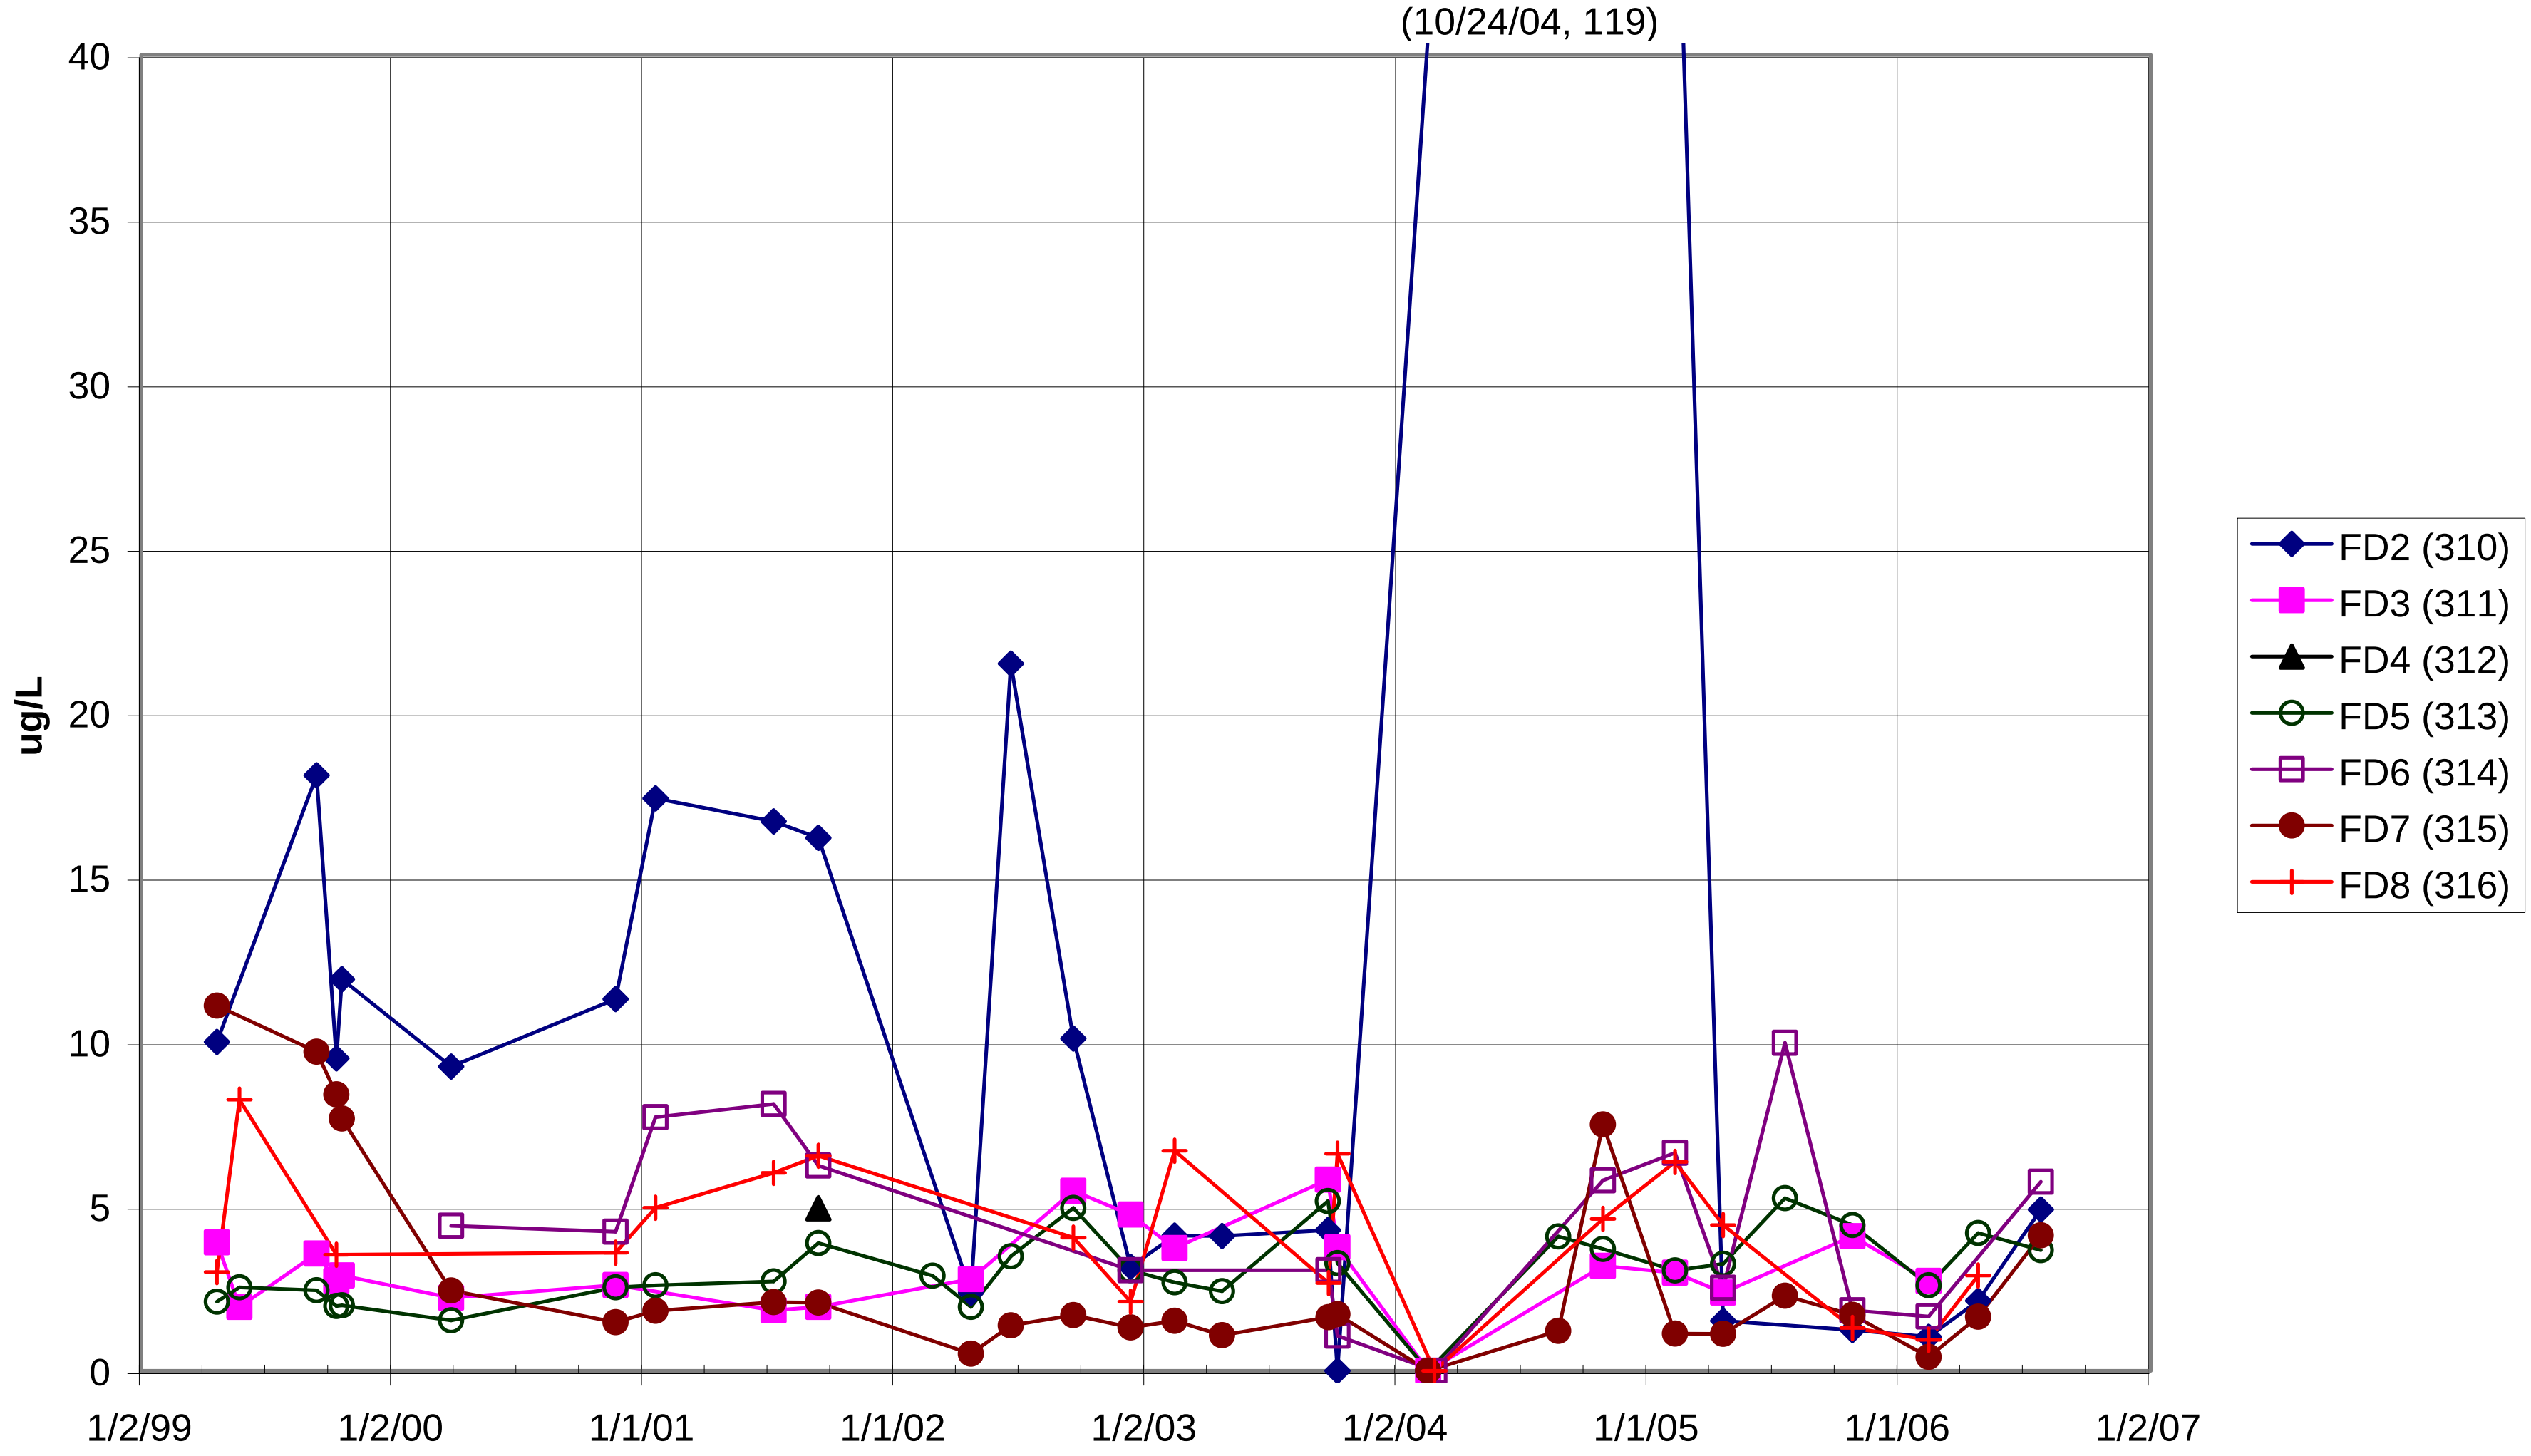
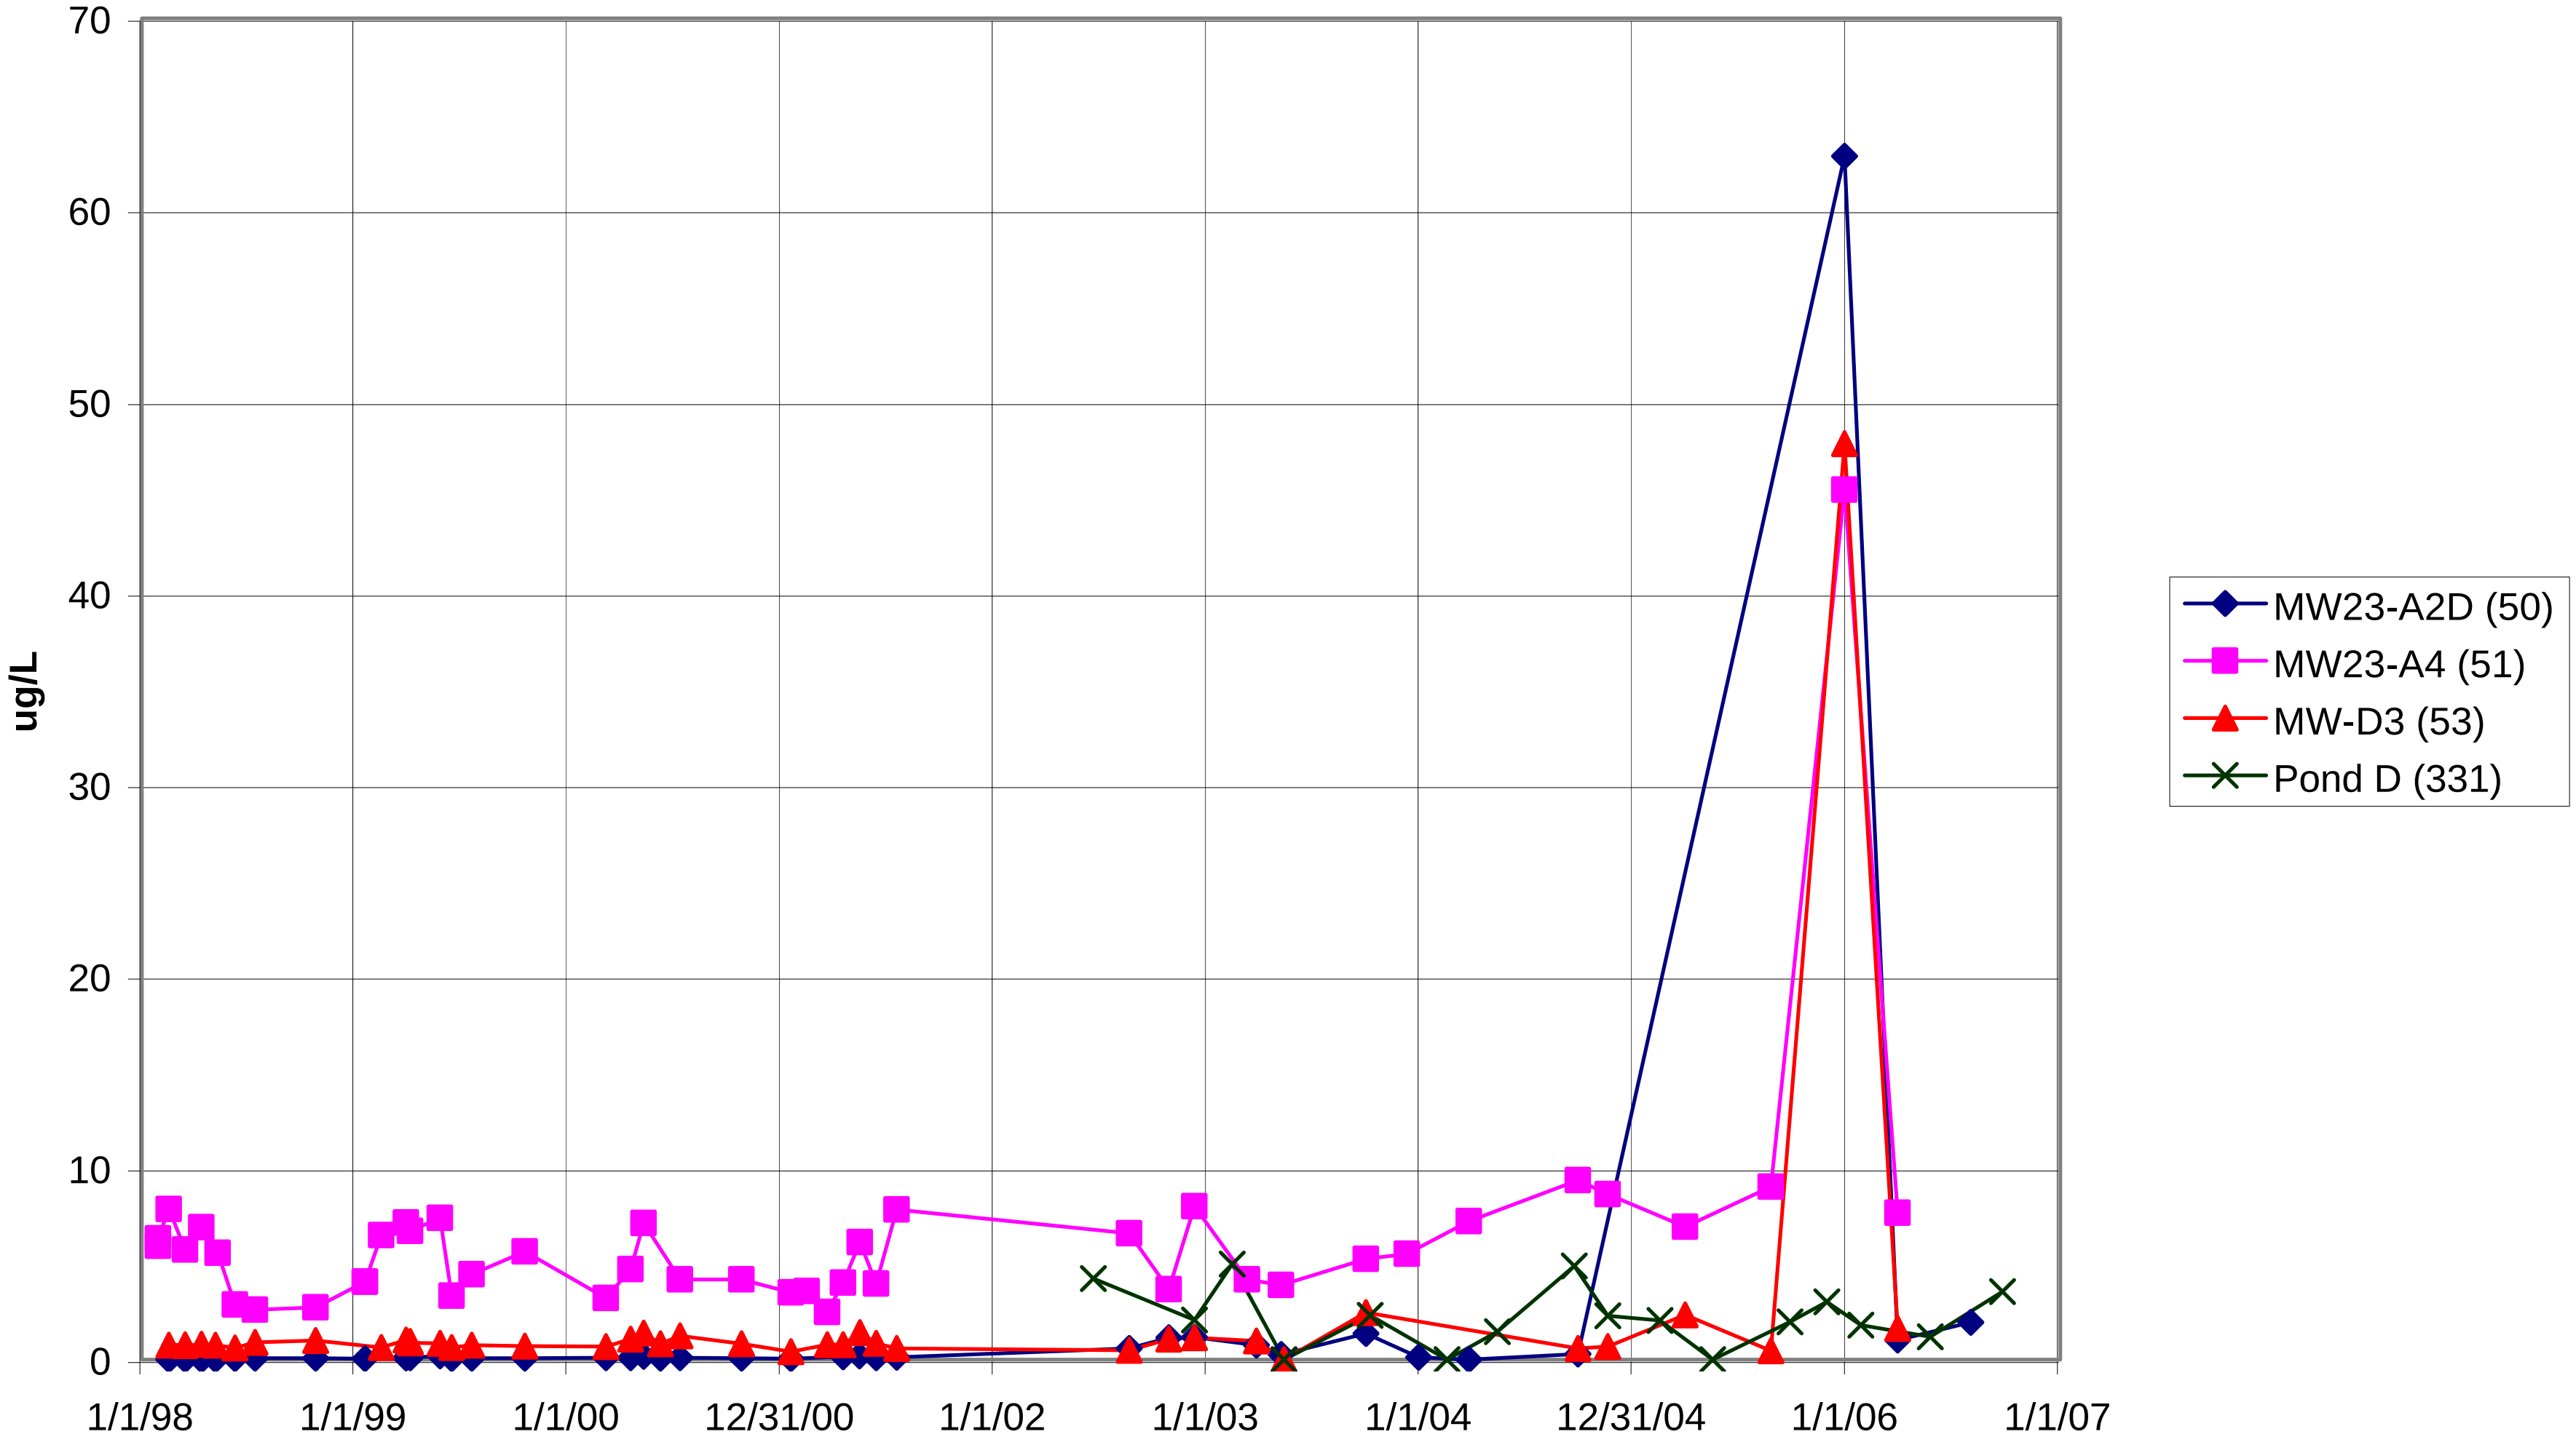
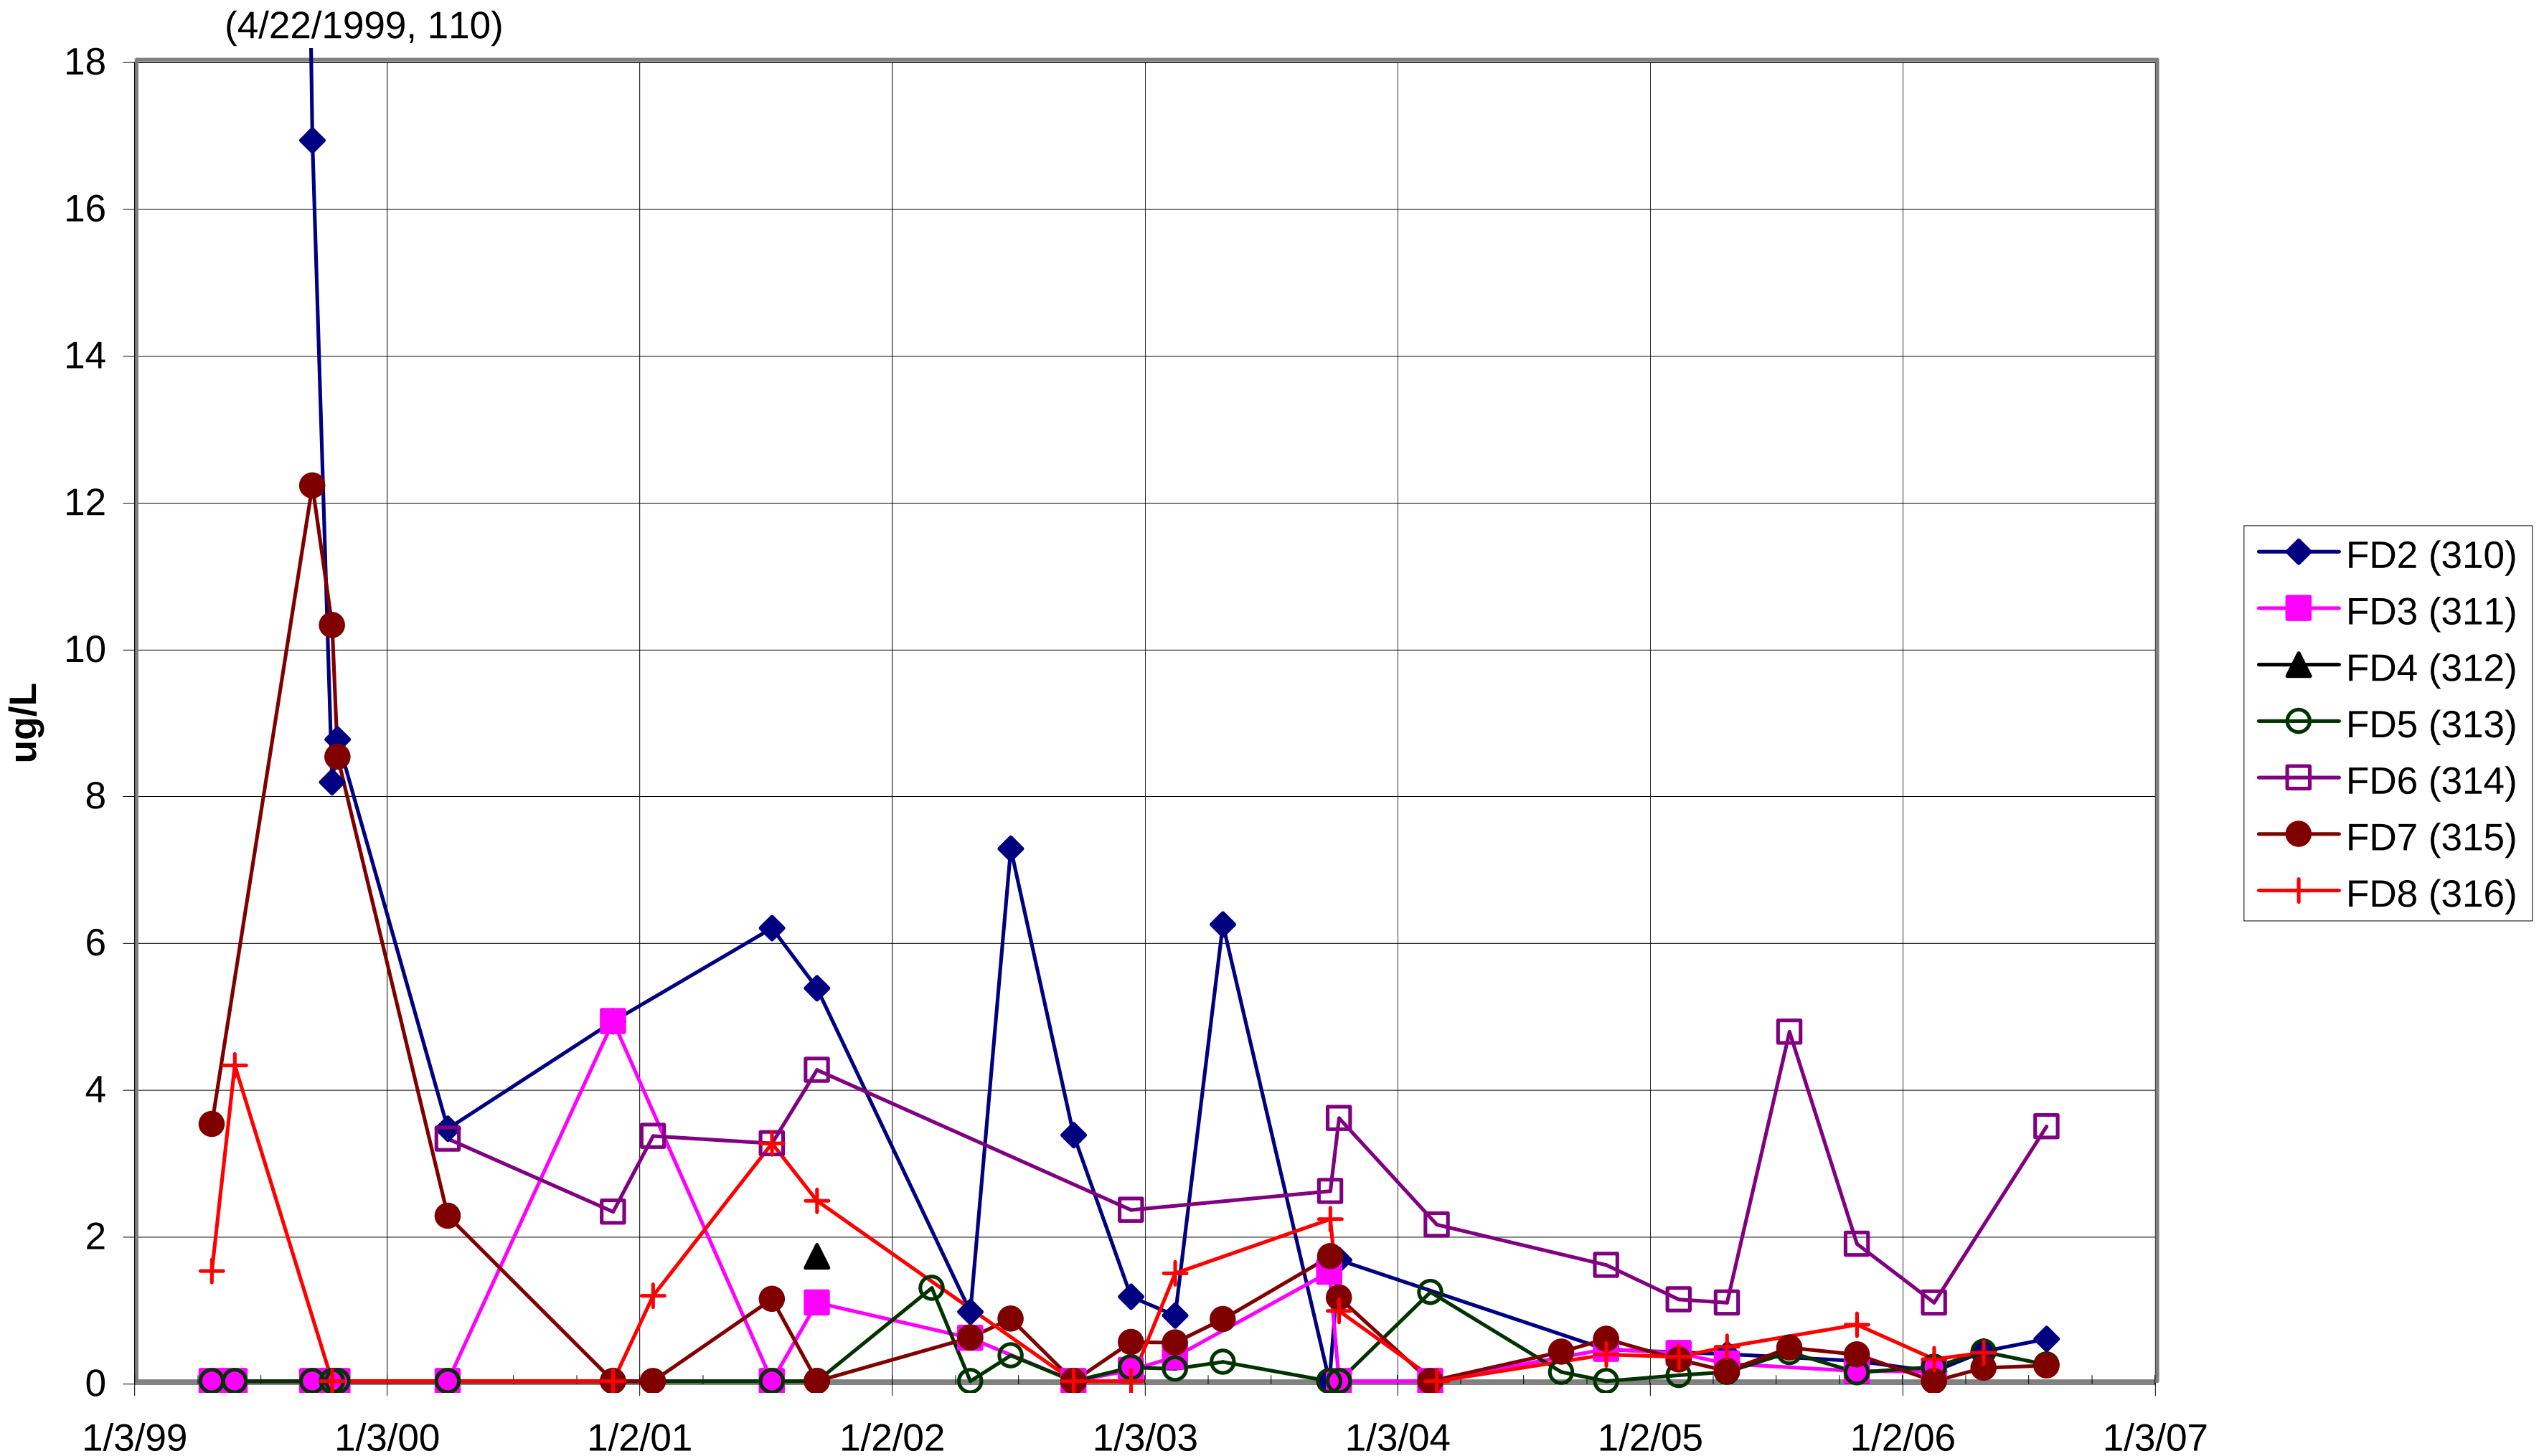
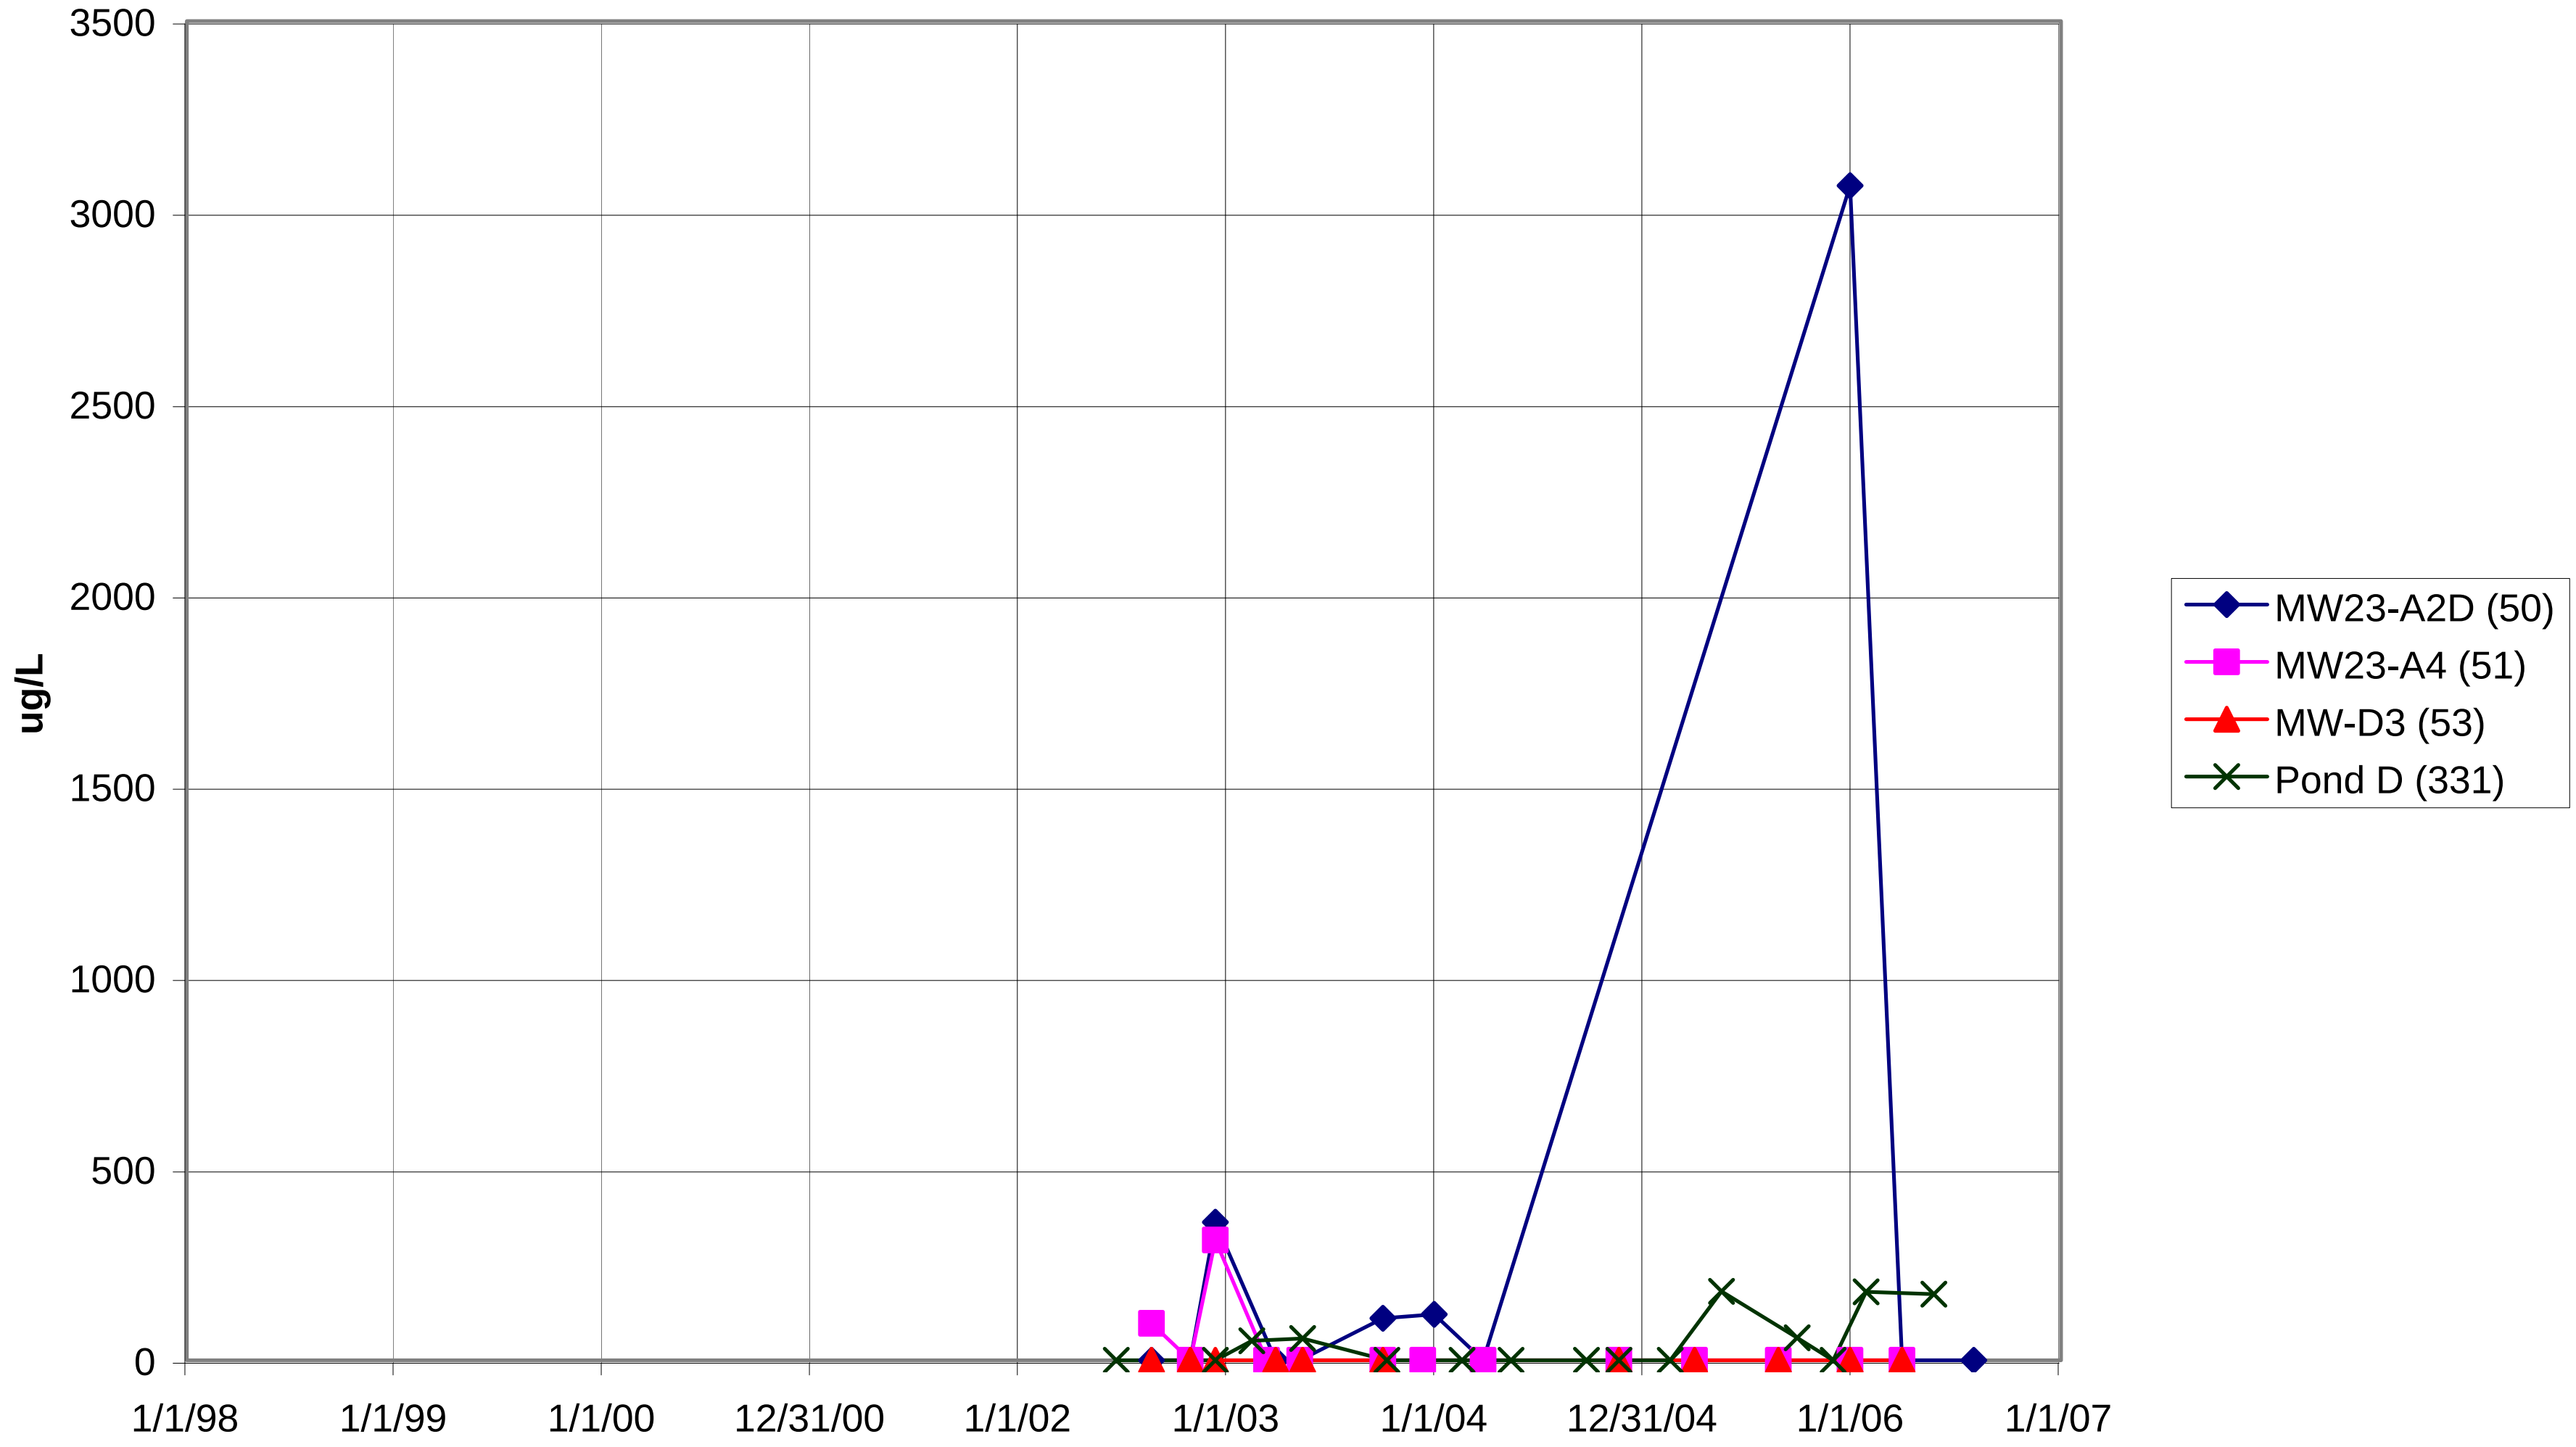
FIGURE 3.22a   GREENS CREEK SITE 23/D INTERNAL MONITORING SITES:
FINGER DRAINS - COPPER DATA
(Non-detectable analyses plotted as zero)

The concentrations of copper and lead (Figures 3.22a and b and 3.23a and b) are considerably lower than that of zinc in the Site 23/D internal monitoring sites. Both of these metals show the same general trends as zinc with the exception of one anomalous lead result in a sample from 23FD-2 in 1999. The nickel concentrations presented in Figure 3.24a and b support the observation that the drainage from 23FD-2 is different than that of other drainages. It is possible that the material that supplies water to this drain has a greater proportion of serpentinite, which was shown to produce higher zinc and nickel concentrations than other rock types such as argillite and phyllite (Vos, 1993). What appeared to be a linear increase in nickel concentrations in 23FD-2 prior to 2002 now appears to be decreasing or at least cyclical. The December 2005 sample from MW-23-A2D showed elevated metal concentrations; however, the 2006 metal concentrations for this site are within historical data values. Monitoring will continue to determine trends.

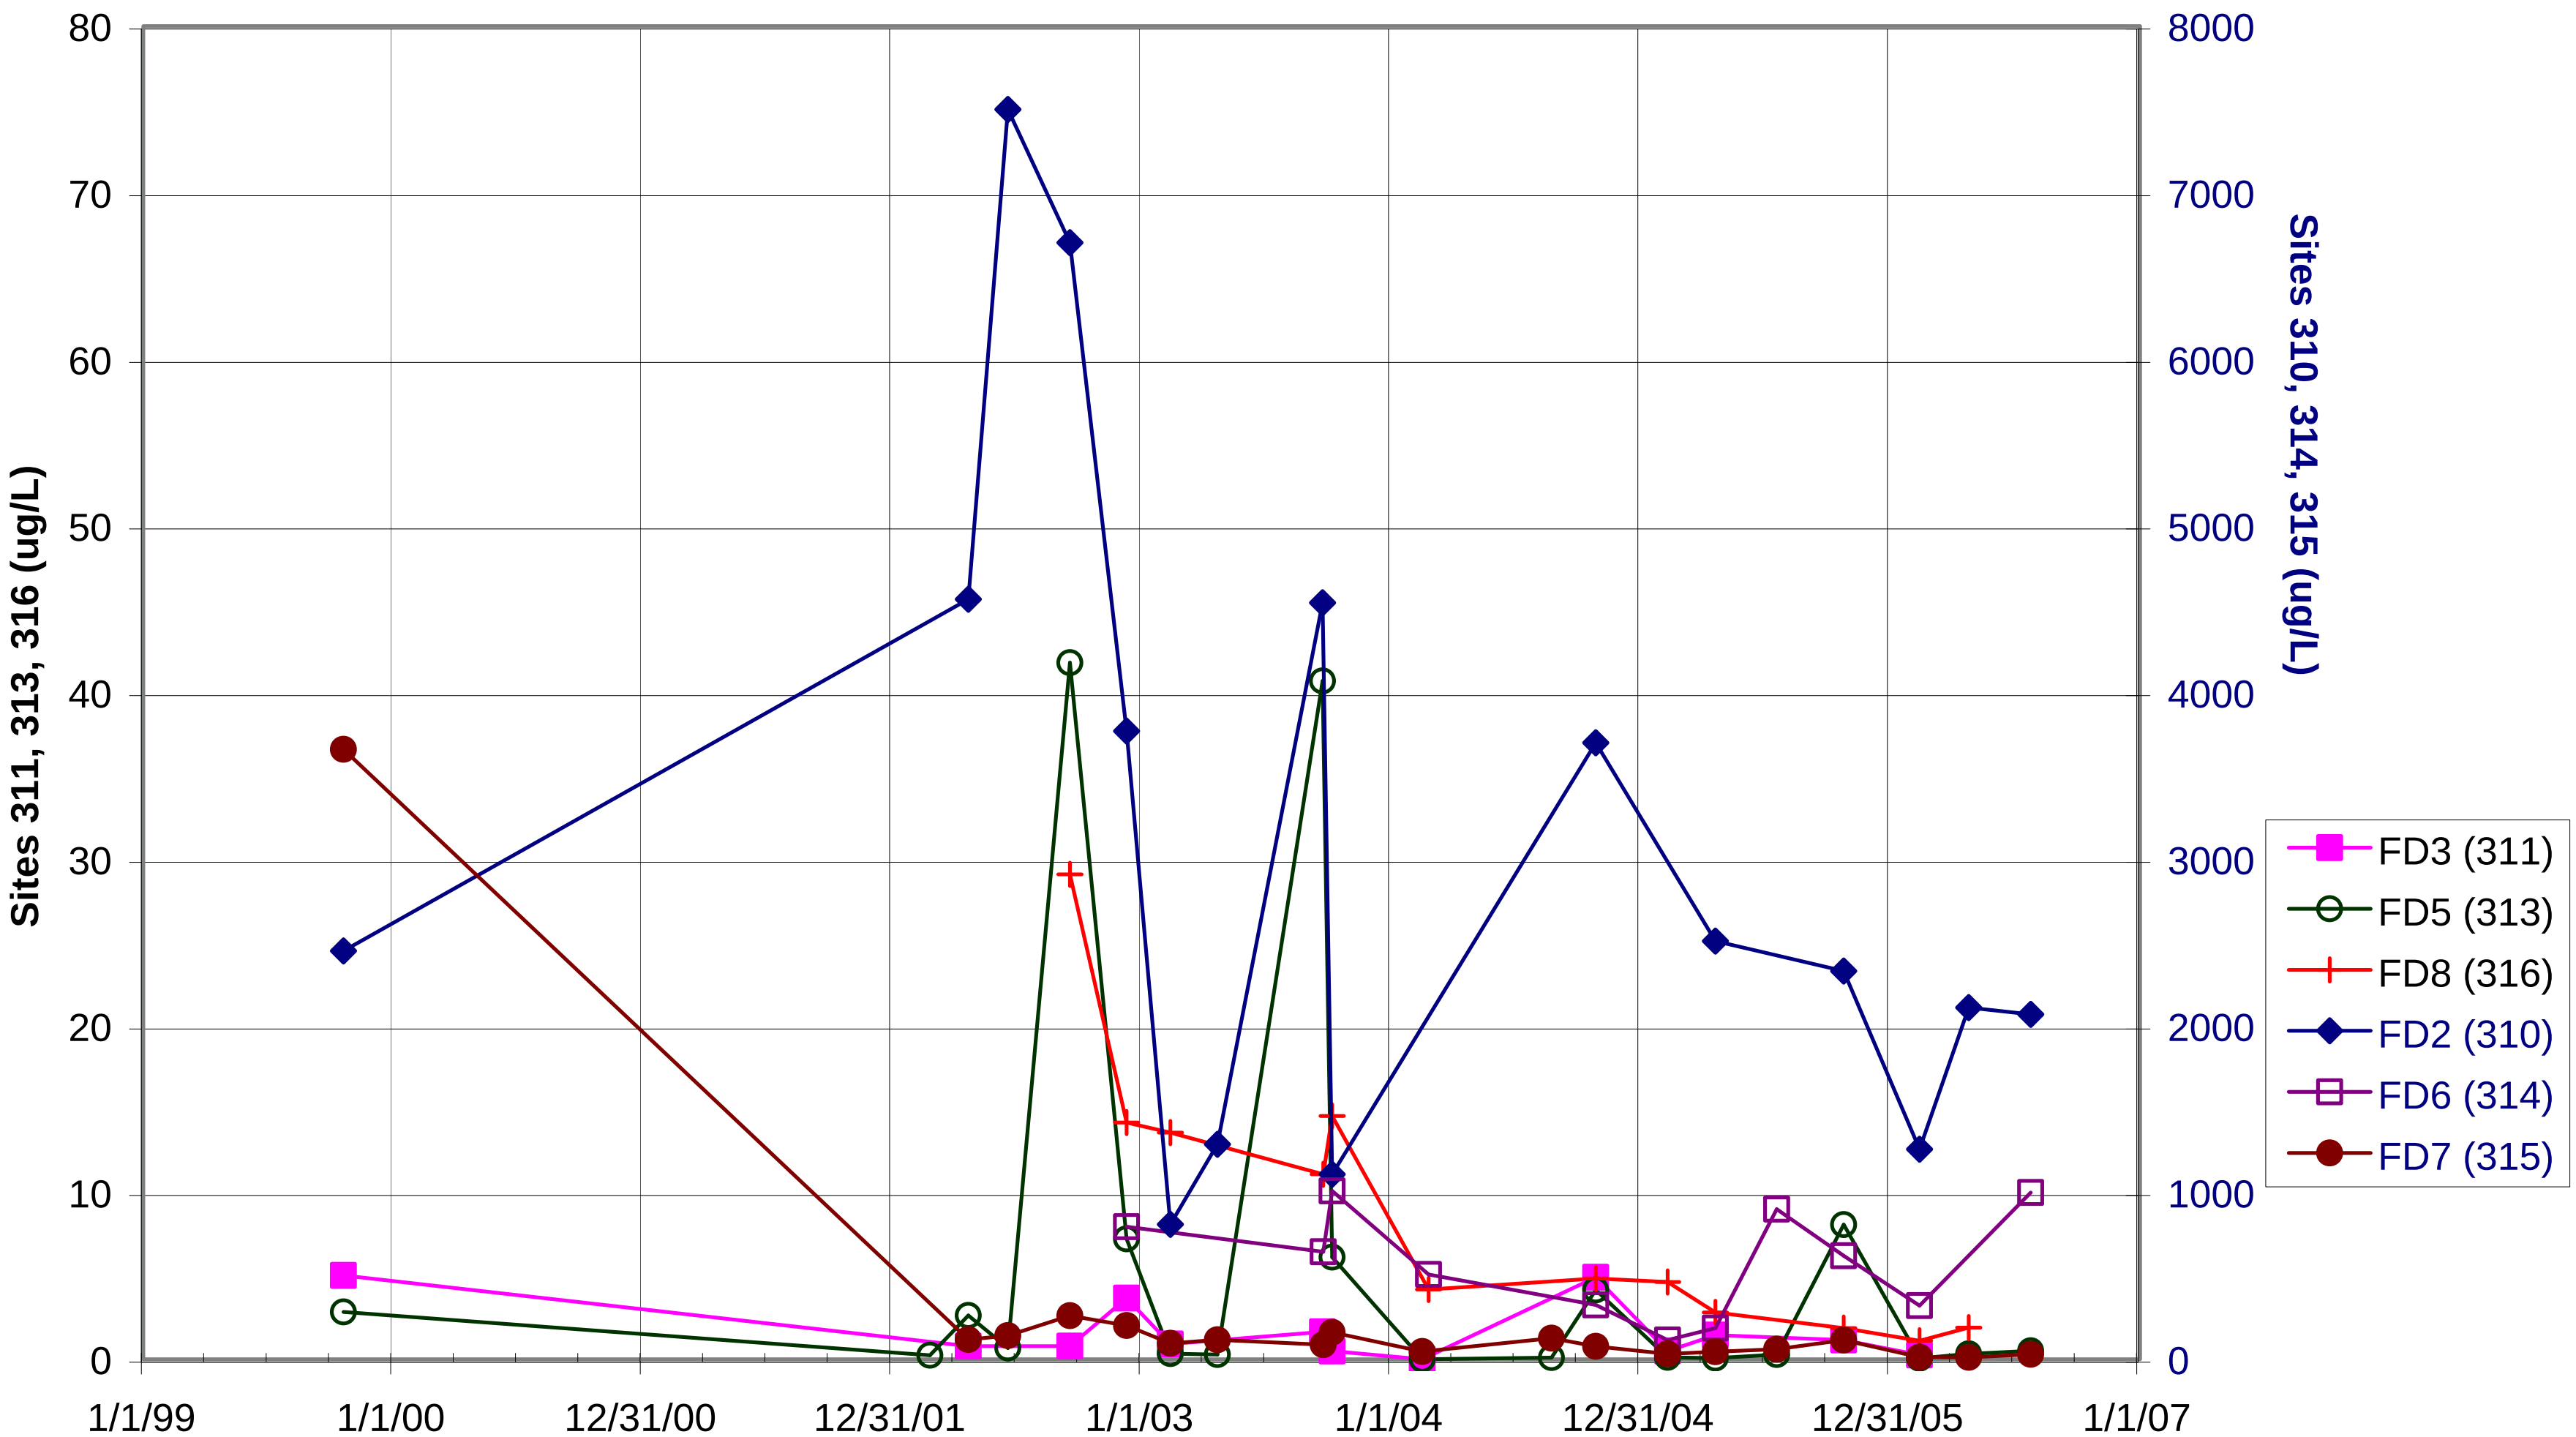
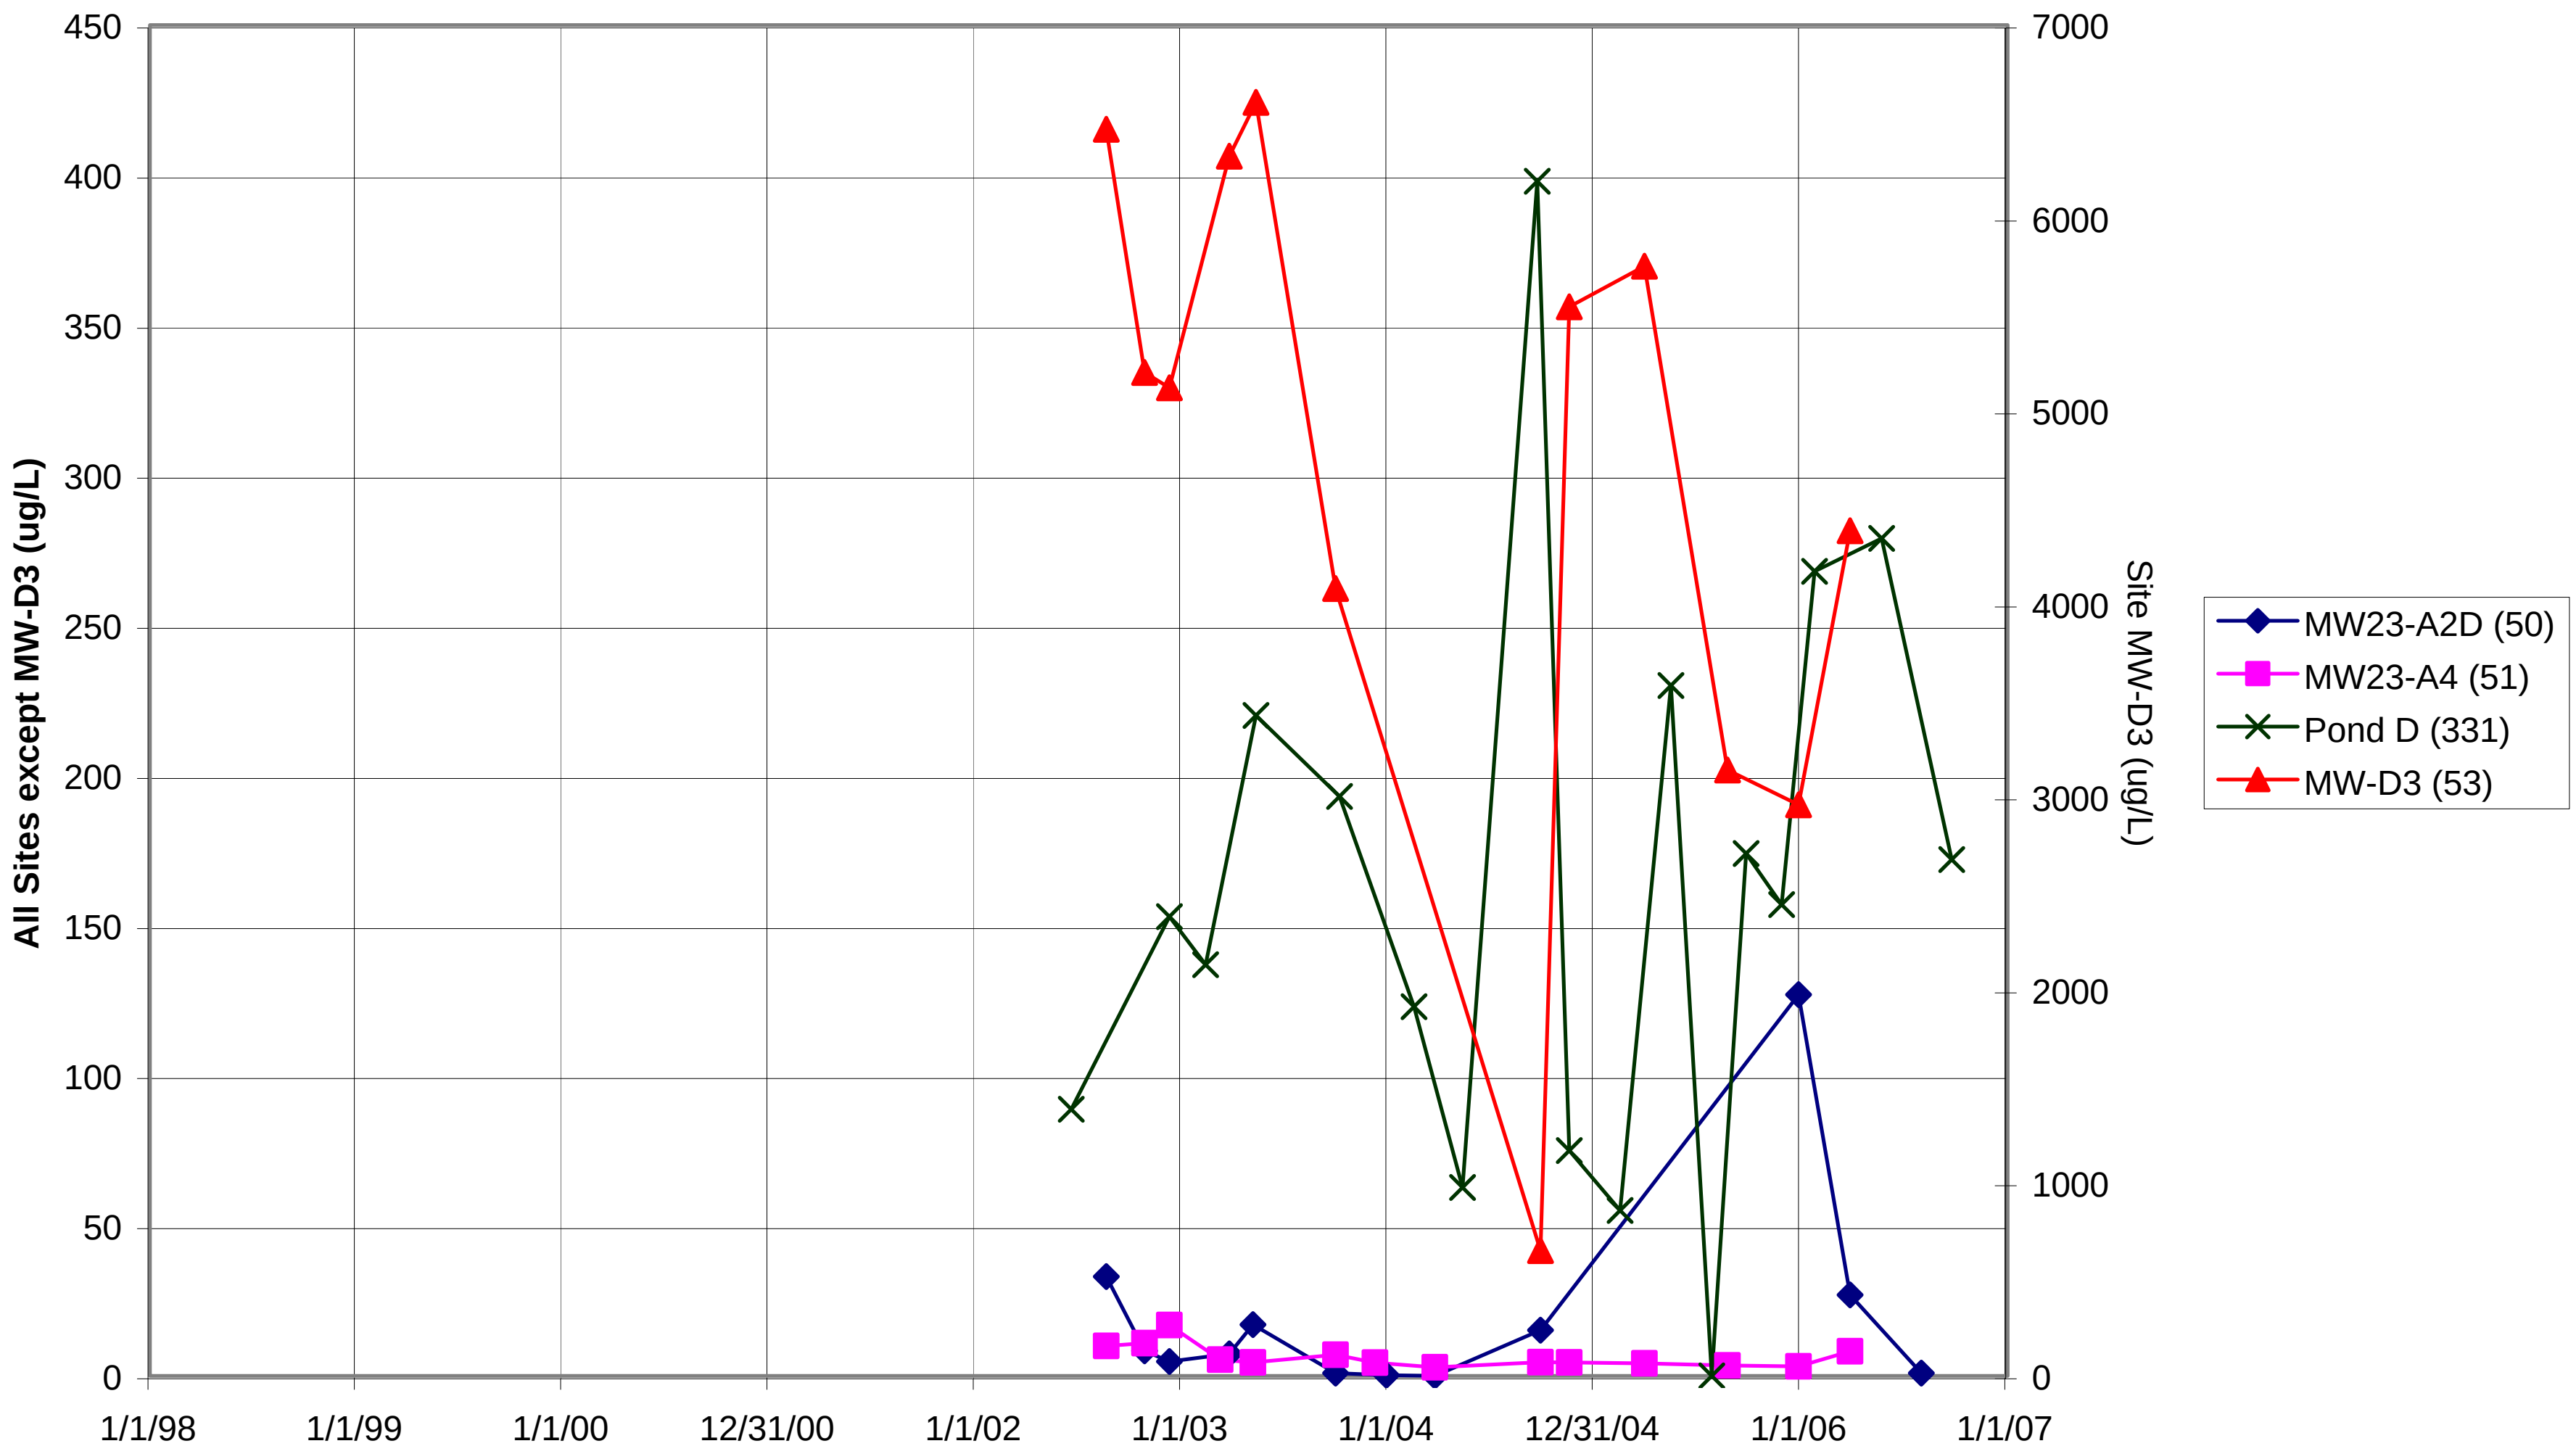
FIGURE 3.26a GREENS CREEK SITE 23/D INTERNAL MONITORING SITES:
FINGER DRAINS - MANGANESE DATA
(Non-detectable analyses plotted as zero)

Manganese concentrations (Figures 3.26a and b) are generally less than 50 µg/l for MW23-A2D, MW23-A4, and three of the finger drains (23FD-3, 23FD-5 and 23FD-8). The other three finger drains (23FD-2, 23FD-6 and 23FD-7) and MW-D3 and Pond D have elevated manganese concentrations, indicative of the different redox conditions. Precipitation/dissolution of iron oxyhydroxides and manganese oxides controls the concentrations of iron and manganese in these waters.
