TAILINGS AND PRODUCTION ROCK SITE
2006 ANNUAL REPORT

Kennecott Greens Creek Mining Company

April 2007

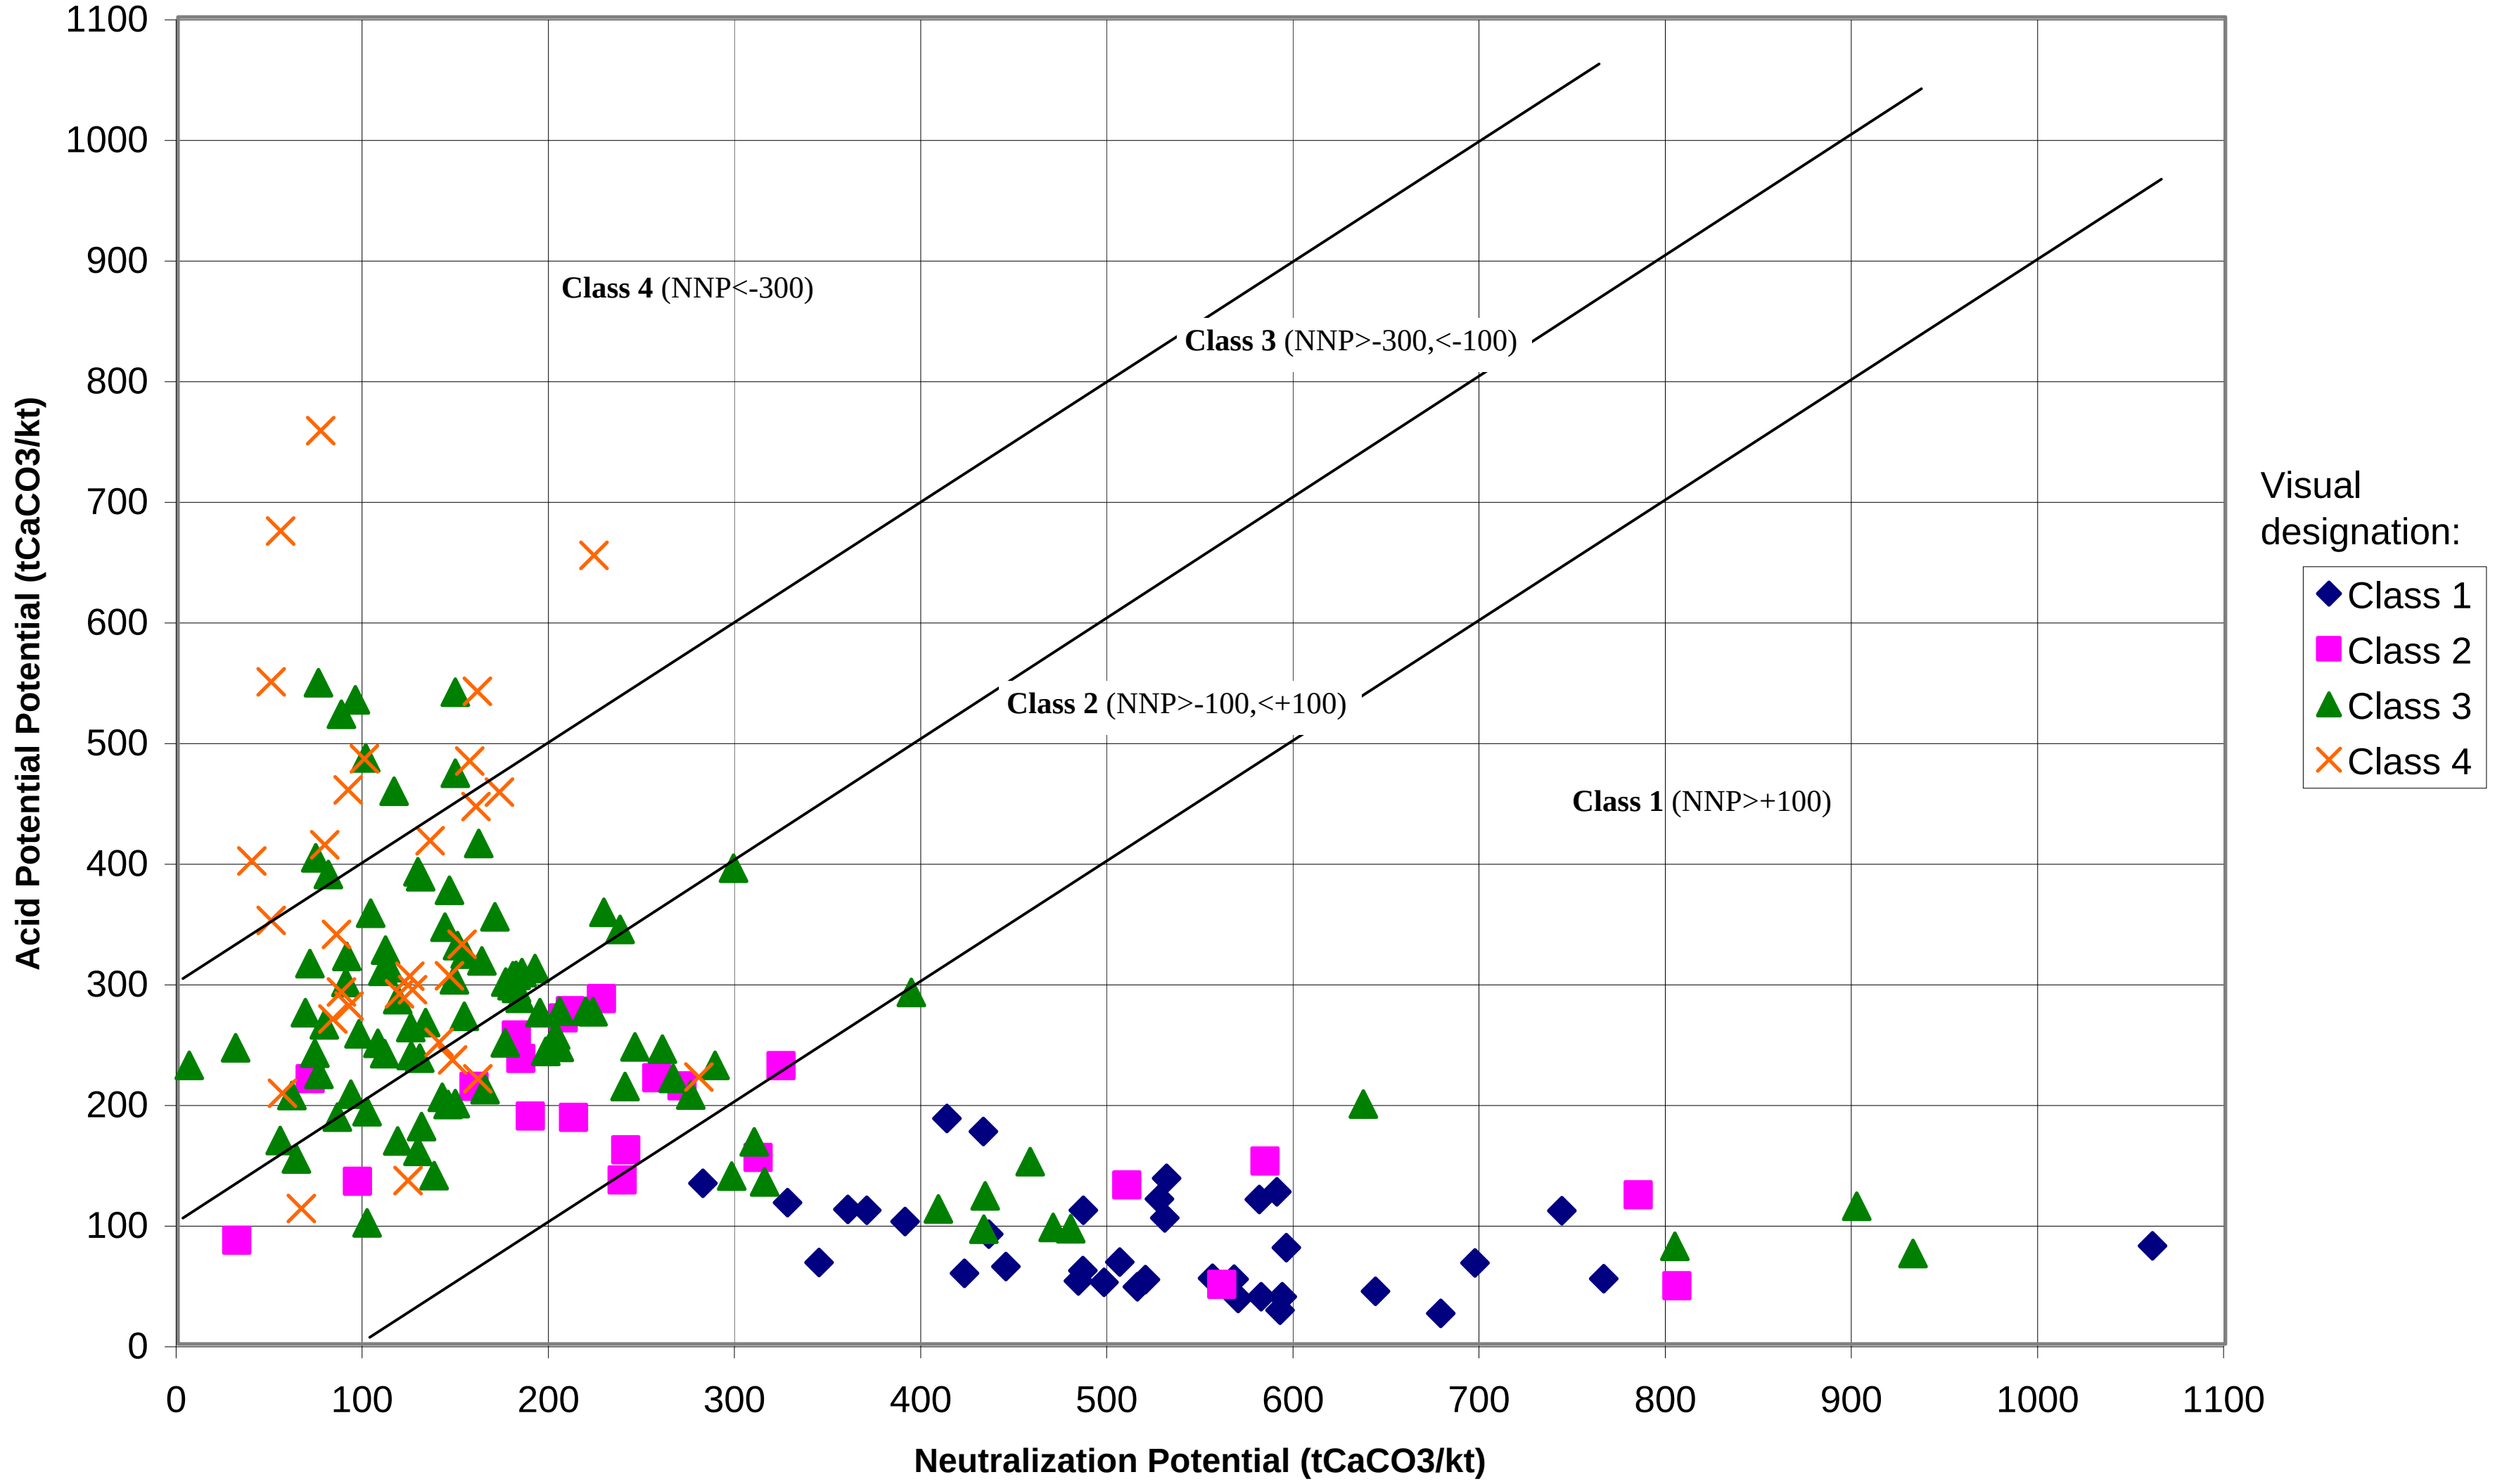
FIGURE 3.28 2006 ABA DATA FROM UNDERGROUND RIB SAMPLES

Acid base accounting (ABA) results from 183 underground rib composites collected in 2006 are presented in Table 3.3 and Figure 3.28. Class 1 rib samples had an average neutralization potential (NP) of 530 tons $CaCO_3$/1000t, which is equivalent to 53% carbonate. The Class 1 samples had an average acid potential (AP) of 99 tons$CaCO_3$/1000t, which produced an average net neutralization potential (NNP) of 431 tons $CaCO_3$/1000t. Class 1 production rock does not have the potential to generate acid rock drainage, however KGCMC recognizes the potential for metal mobility (primarily zinc) from argillite. KGCMC recognizes this characteristic of Class 1 production rock and handles the material accordingly by placing it in controlled facilities, such as Site 23 and the tailings area.

Figure 3.28 compares actual class designation based on ABA analyses to the results of visual designation use underground to classify the production rock. Of the 183 composites, visual classification assigned 5 sample (3%) to a lower, less conservative class. 111 (39%) of the composites were assigned to the appropriate class and 67 (58%) to a higher, more conservative class. These data represent a 97% success rate for the visual classification program.

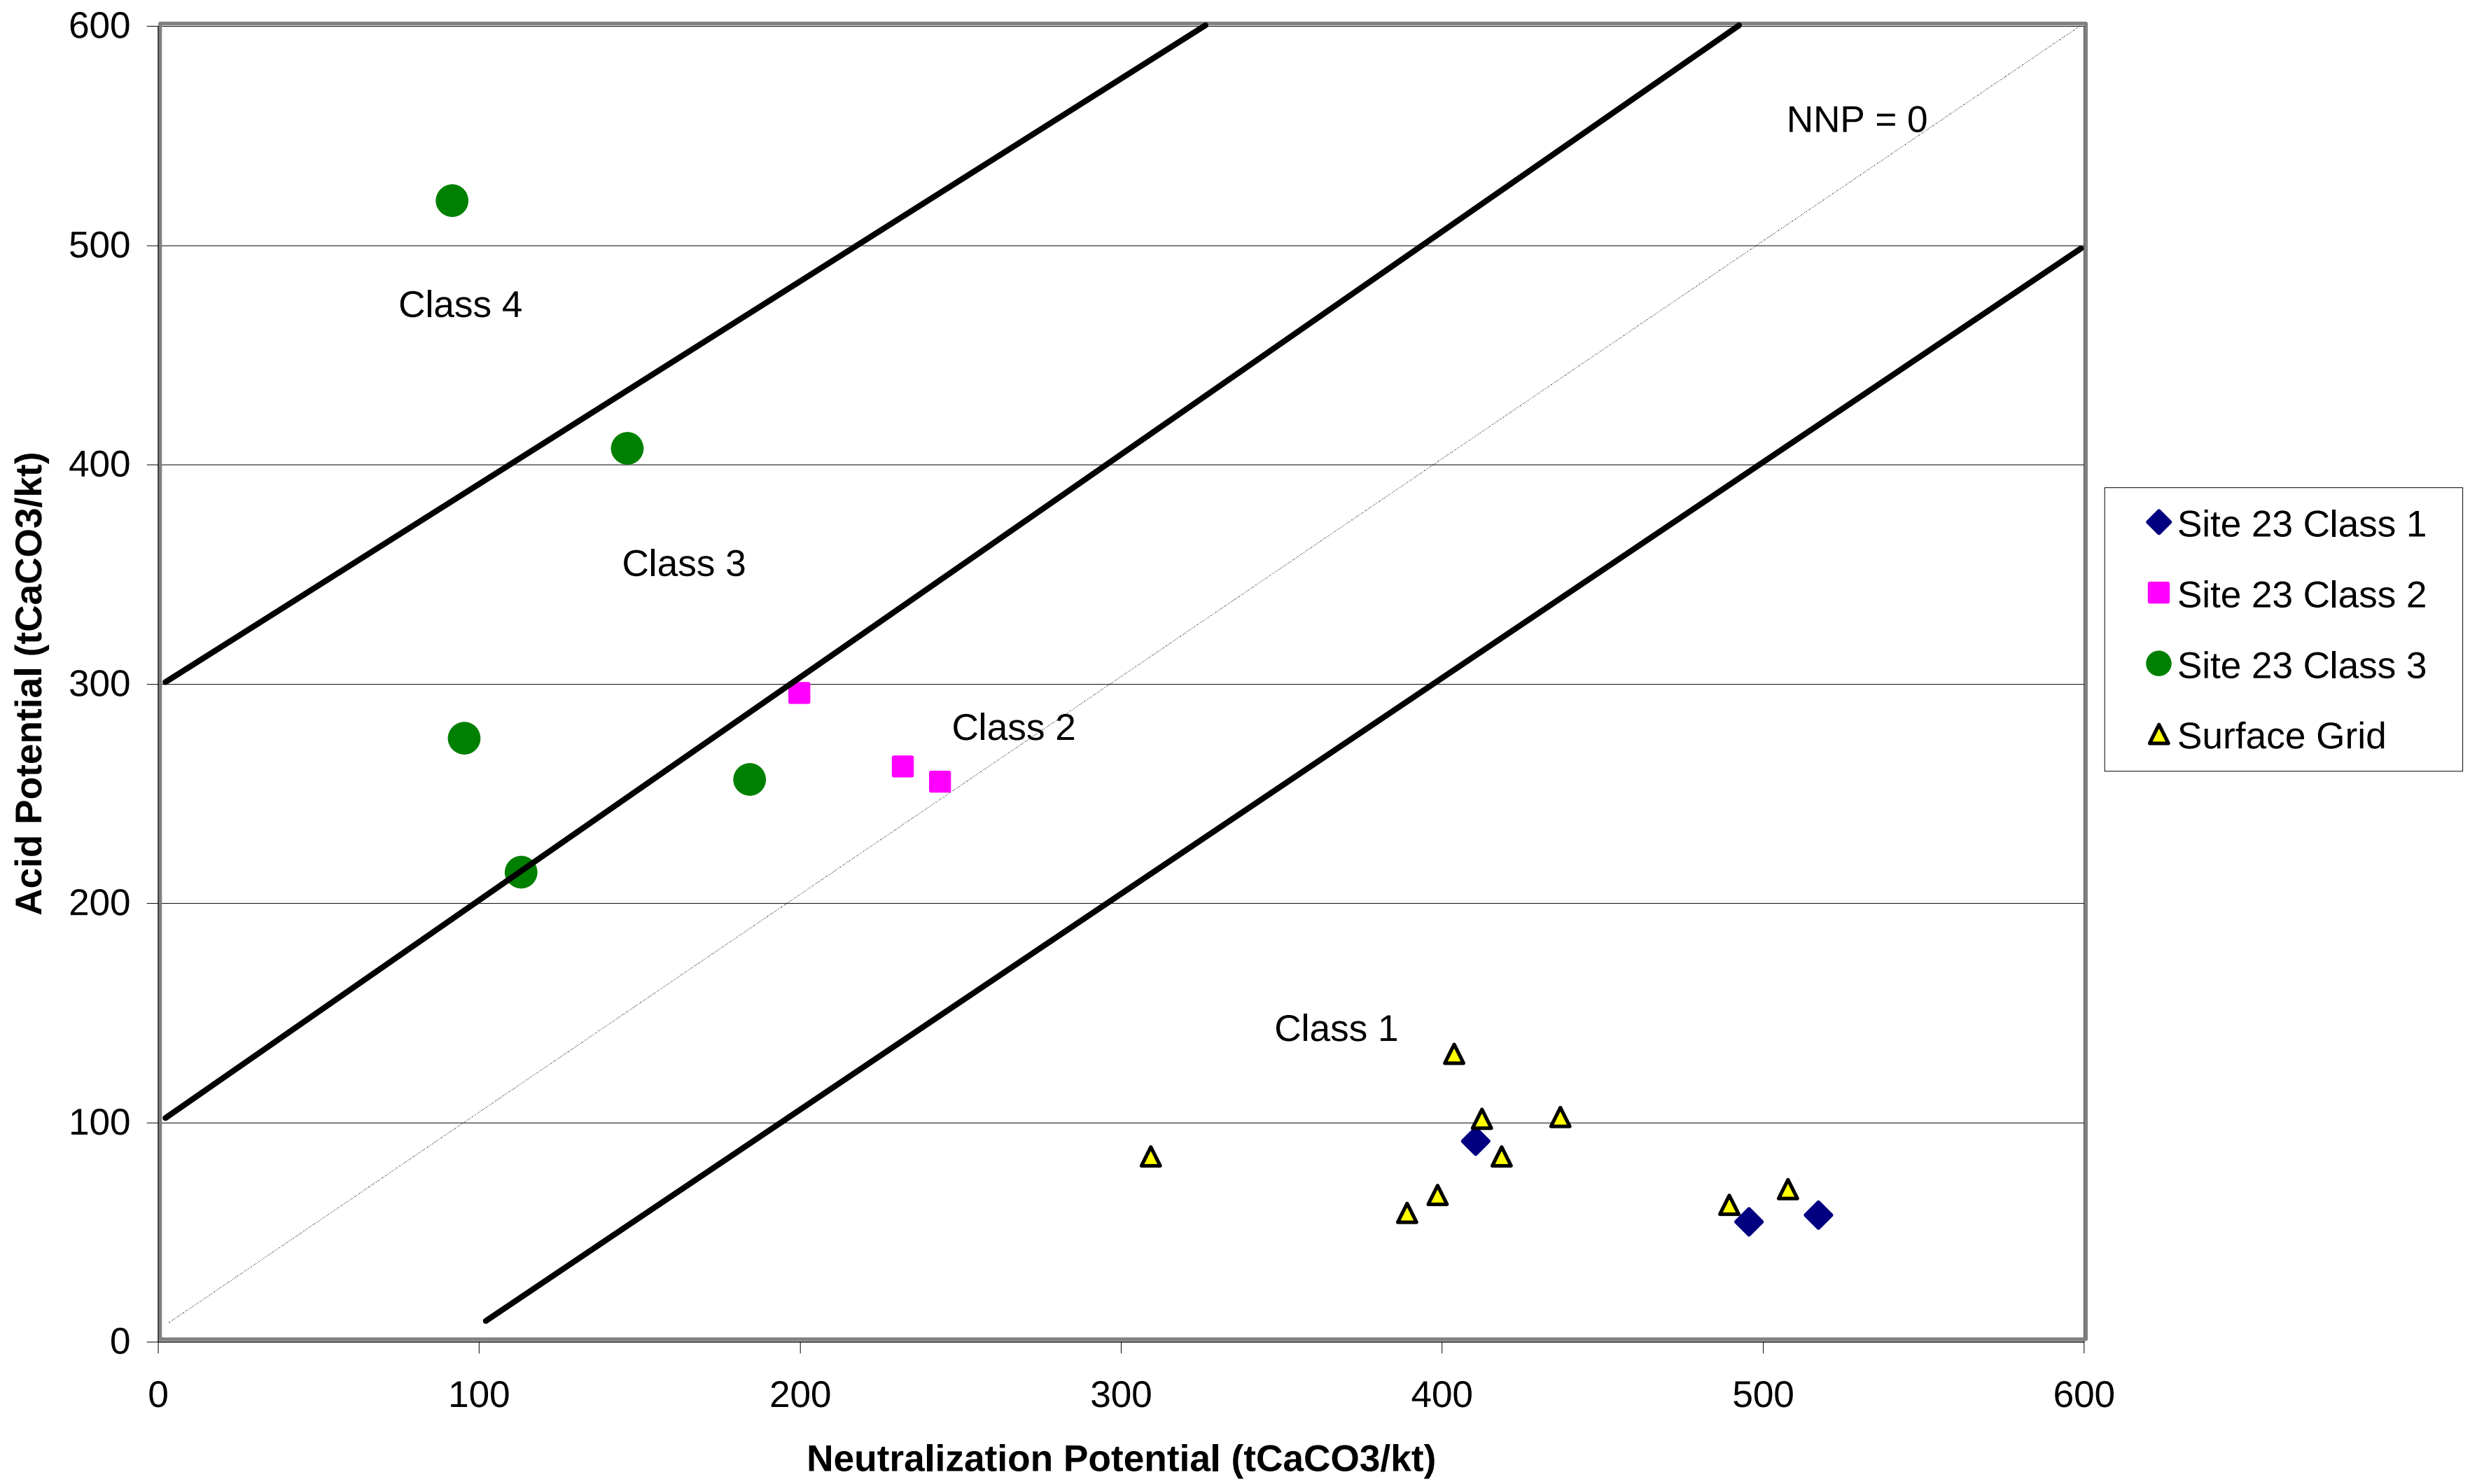
FIGURE 3.29 ACID-BASE ACCOUNTING DATA FOR SURFACE SITE 23

Table 3.3 and Figure 3.29 shows the ABA data from surface sampling at Site 23 in 2006. The AP to NP distribution in the Site 23 samples is similar to the underground rib samples. Many of the samples at Site 23 were taken near the boundaries of the classification areas, and may be more representative of a mixture of classes. Therefore some of the data points may not fall neatly into the classification areas on the graph. Currently drainage from the Site 23/D area is collected and pumped to the Pit 5 water treatment facility.
