Re: **Sumitomo Metal Mining Pogo LLC 2011 Annual Activity and Monitoring Report**

2011 ANNUAL ACTIVITY AND MONITORING REPORT

SUMITOMO METAL MINING POGO LLC

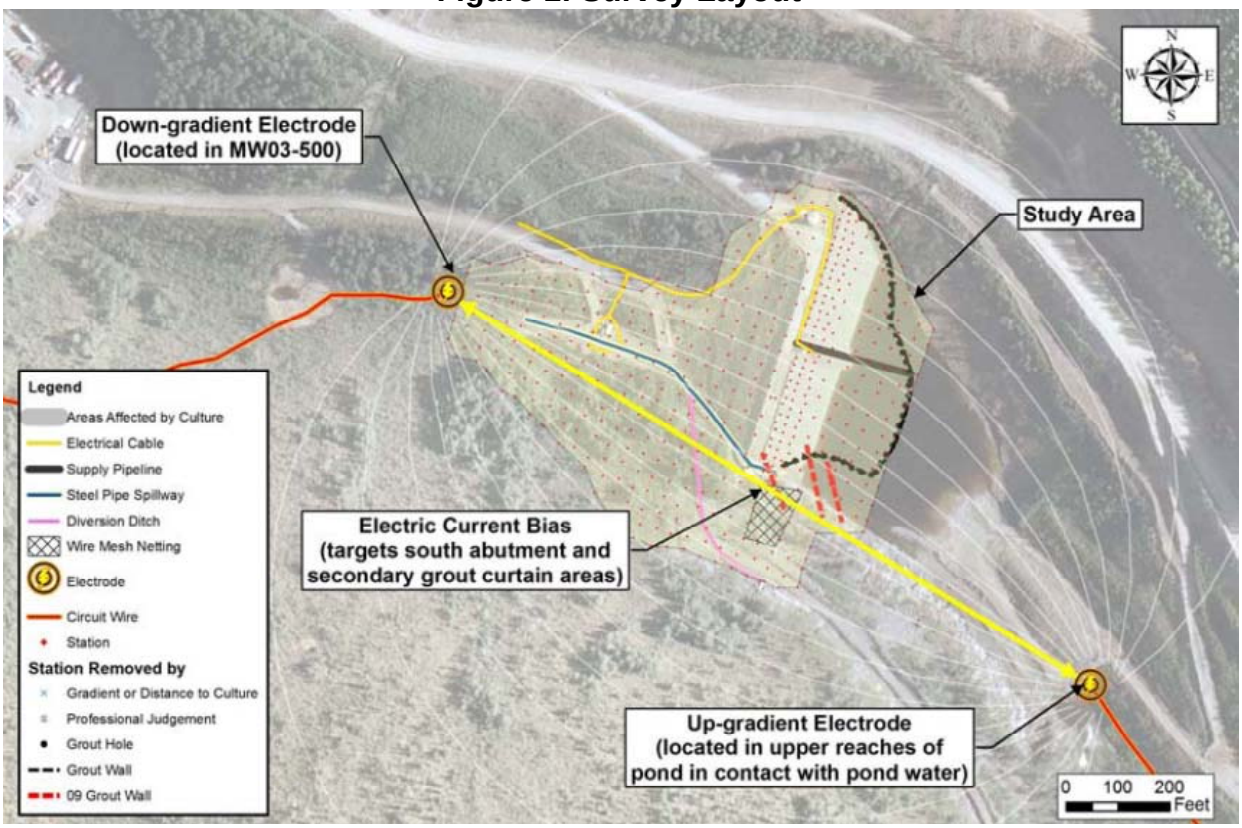
Figure 1: Survey Layout

Aspen Hydrologic Services, LLC (AHS) with Willowstick Technology (Willowstick) completed a geophysical survey of the RTP area in order to determine the location of seepage(s) and develop a mitigation plan. The Willowstick method uses an application of magneto-metric resistivity or MMR for groundwater mapping and modeling. The method is high-speed, accurate, minimally invasive, and cost effective. The technology utilizes the principle that groundwater increases the electric conductivity of soil and rock through which it flows in order to map hydraulic flow paths. The survey covered the RTP dam, pond area, north and south abutments and below the dam to the monitoring wells (MW-500 thru 502) (**Figure 1**).

The results of the survey show a potential flow pathway that flows from under the north abutment in the weathered diorite/paragneiss. When it contacts the gneiss bedrock, the seepage turns west and travels along the north-face of Pogo Ridge giving the appearance of continued seepage from the south abutment (Figure 2).

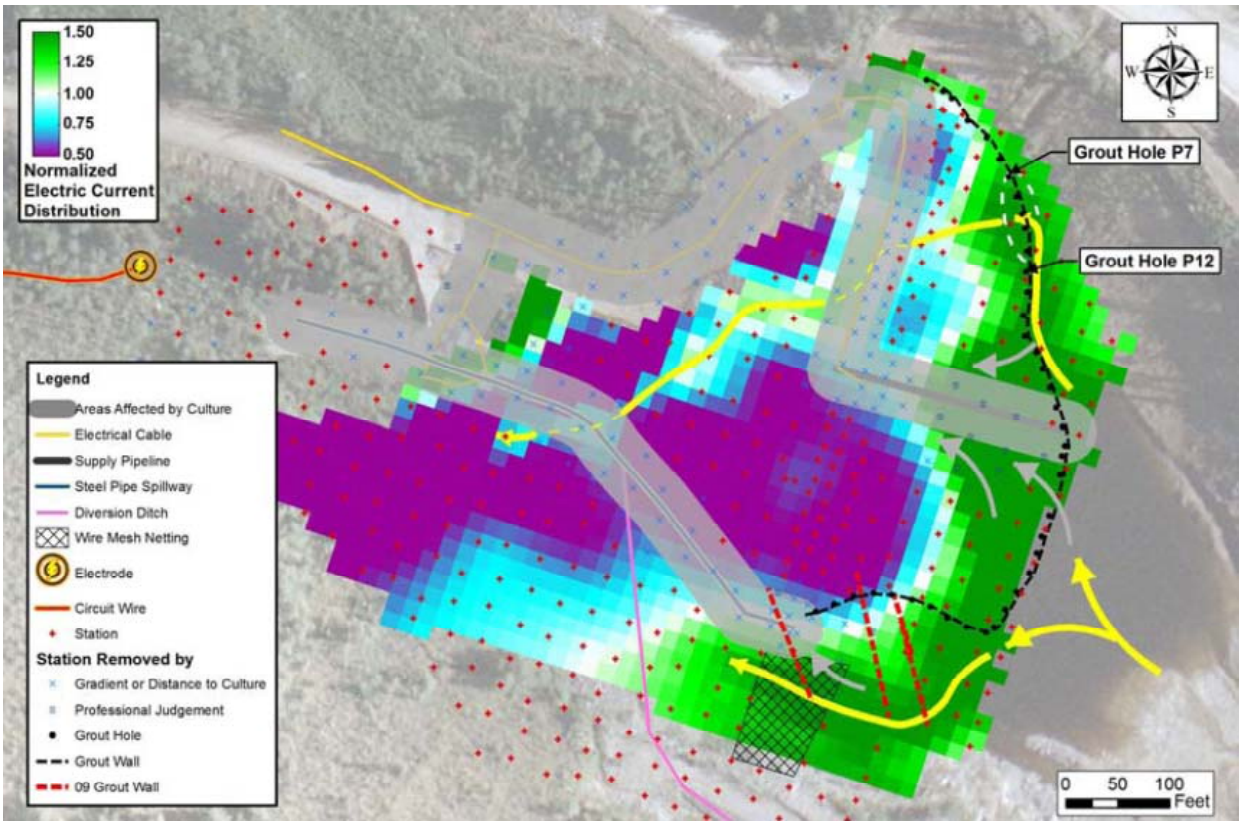
Figure 2. Preferential Seepage Flow beneath RTP Dam.

The survey also proved the success of the additional grouting of the south abutment (dashed red lines) in April 2009. AHS recommends dropping the water level of the RTP sufficiently for additional grouting of the north abutment of the dam from the 2075 ft elevation to the 2018 ft elevation to a depth of approximately 200 ft or several feet into competent bedrock. Pogo is currently working on a grouting plan. The complete ***Willowstick Geophysical Investigation*** report is attached as **Appendix E.**
