**ATIGUN PASS
REROUTE
REHABILITATION PROJECT
FINAL REPORT
1994**

**Prepared for
Alyeska Pipeline Service Company**

**Prepared by
Stoney J. Wright
Alaska Plant Materials Center**

January 25, 1995

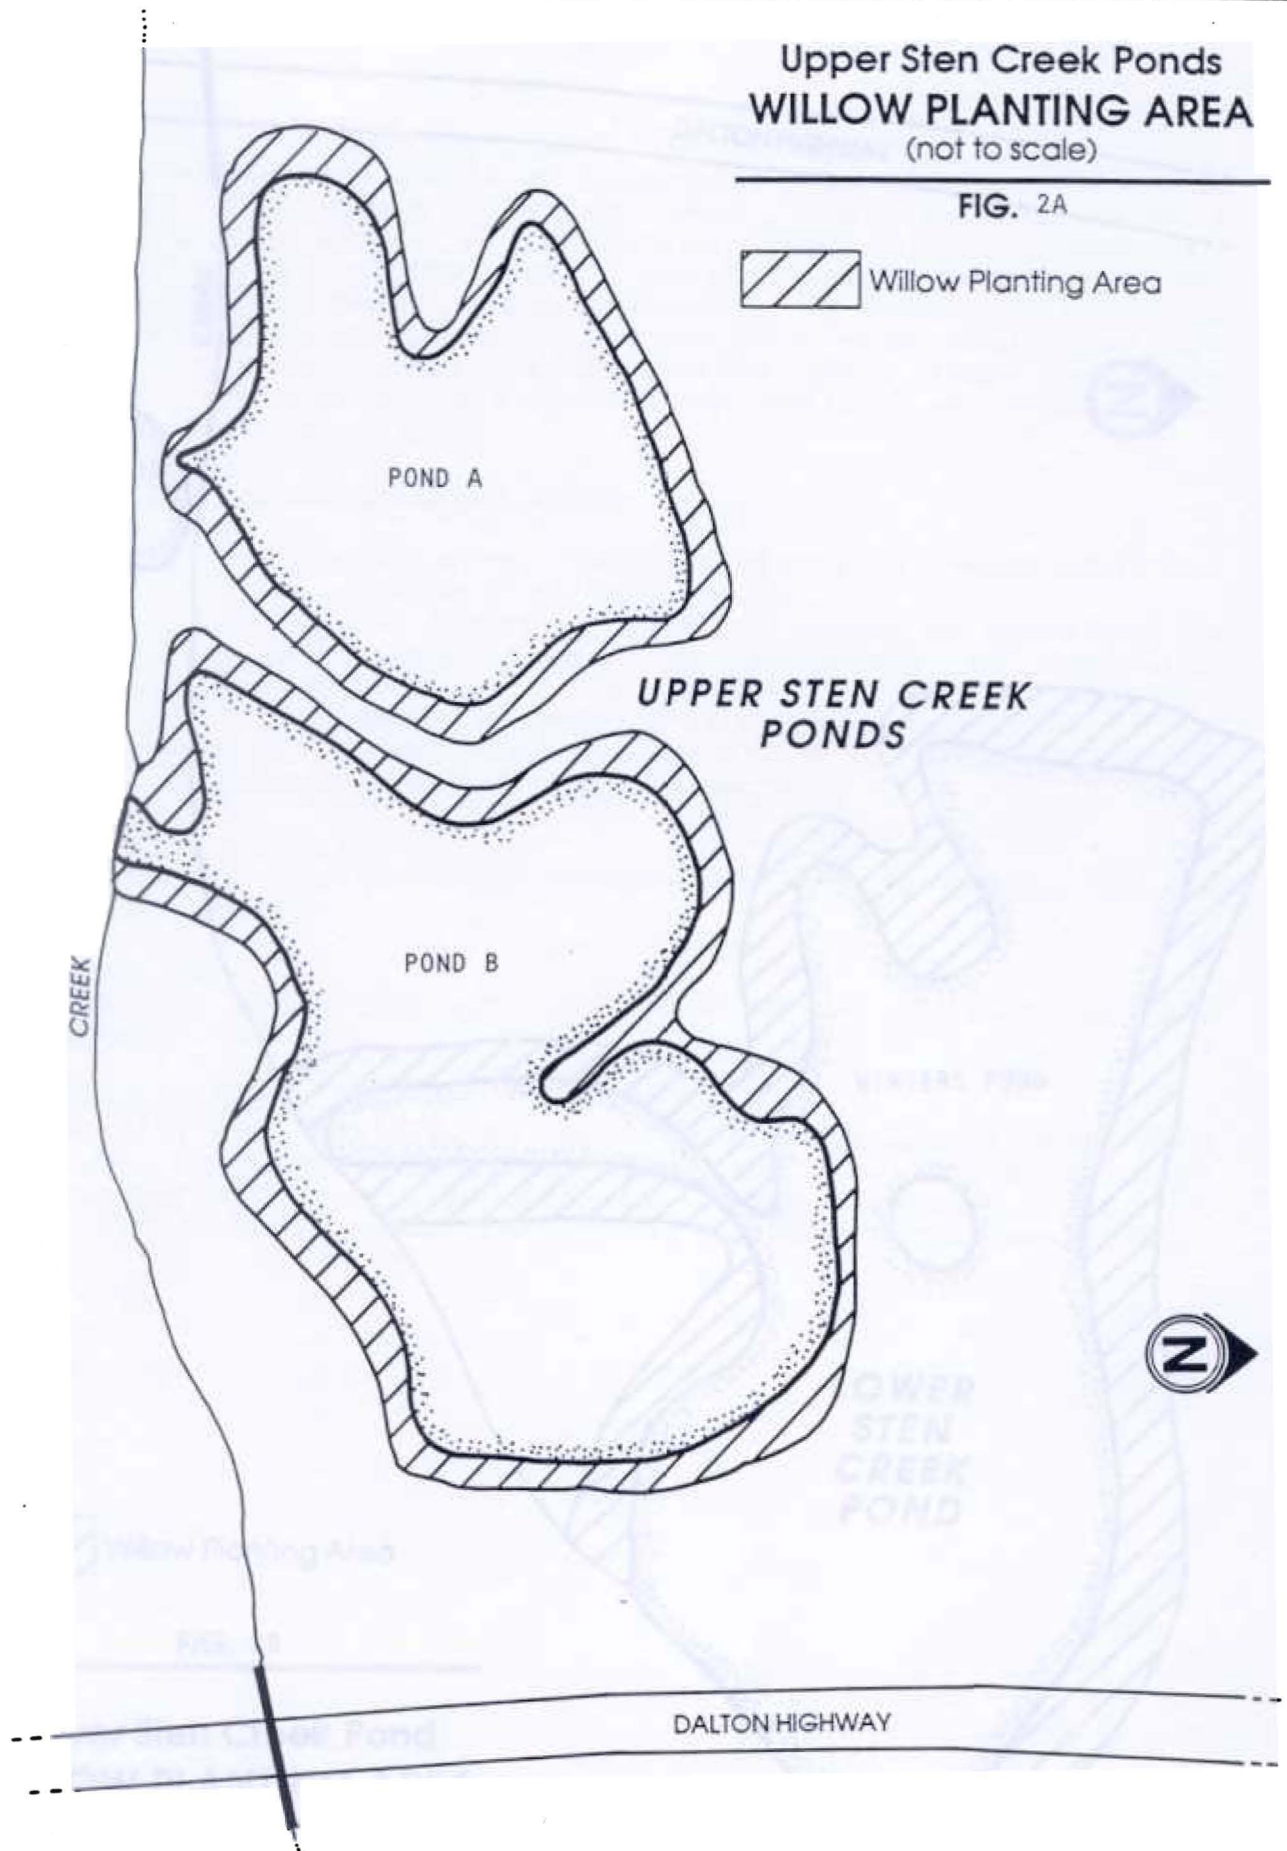
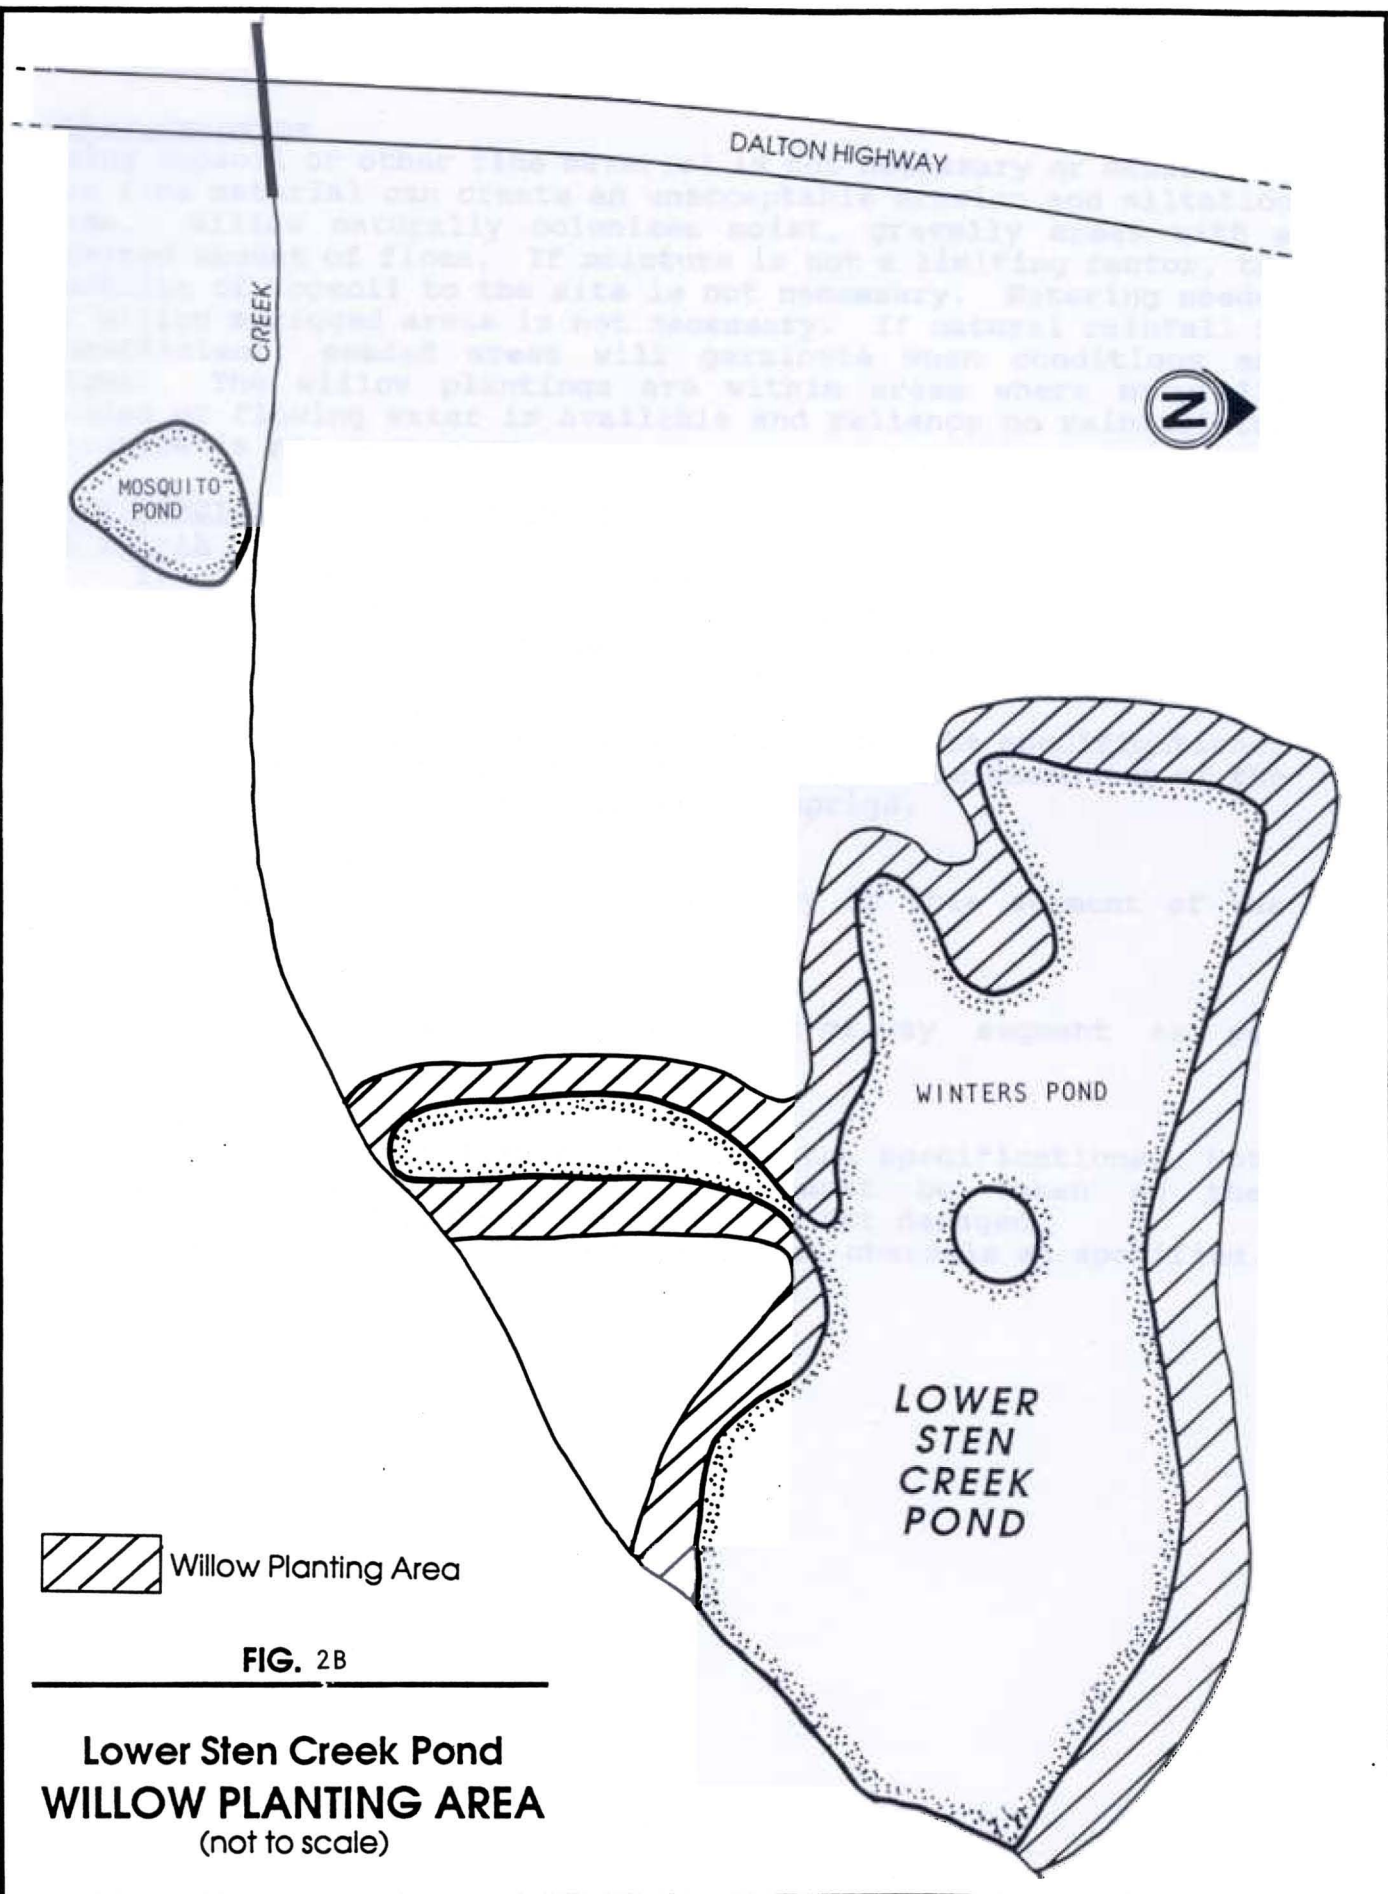
FIG. 2A

The willow sprigs planted adjacent to the Sten Creek Ponds will be placed in two rows from the ponds edge outward (figures 1 and 2). Spacing between rows will vary from two to three feet randomly to prevent the visual lines. Spacing between sprigs within rows will be approximately five feet. A total of approximately 1,900 willow sprigs will be planted in the Sten Creek Area.

Upper Sten Creek Ponds
WILLOW PLANTING AREA
(not to scale)

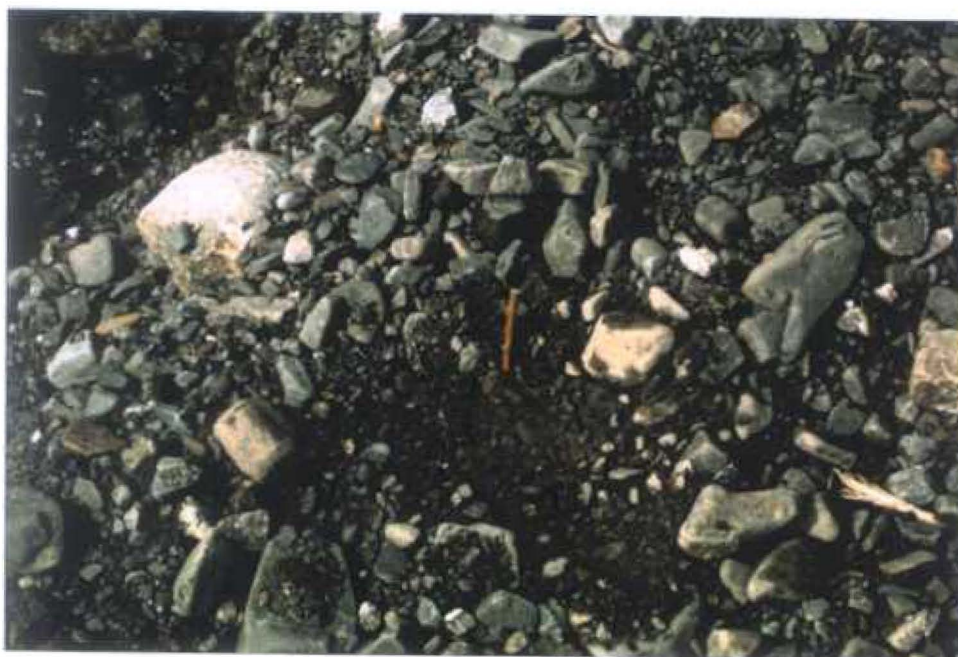
Figure 4. A typical willow sprig at planting.

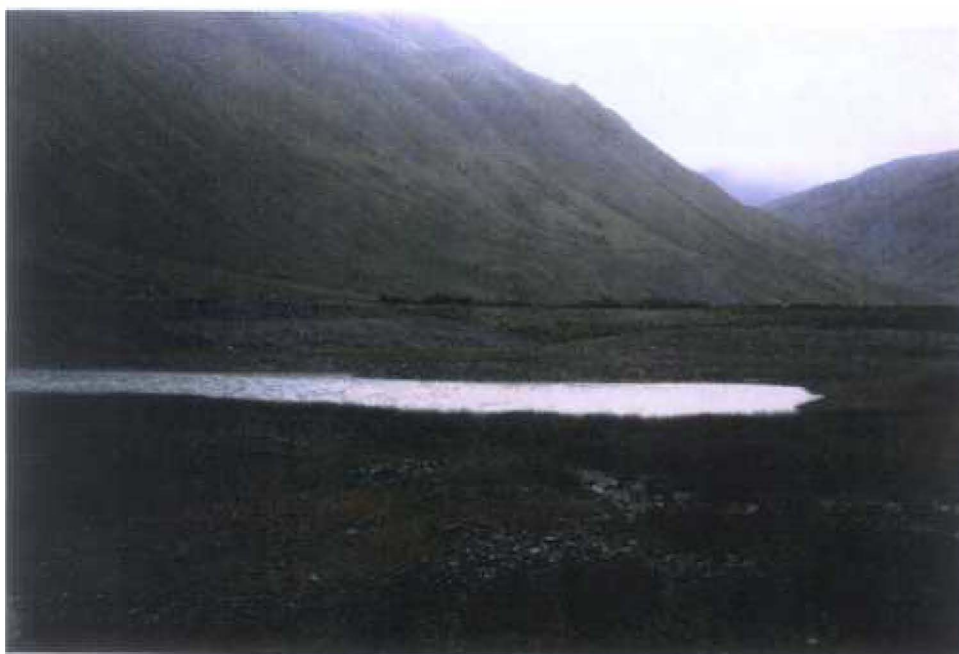
Plant cover for the seeded areas around the Sten Creek ponds, continued to increase. The upper pond complex supported approximately 40% cover in 1993. The vigor of the grass was rated good to excellent. The most vigorous growth occurred on the mound area west of Pond A (figures 12 and 13). The drier, gravelly sites had the poorest vigor and lowest ground cover.

Figure 13. Upper pond area, 1993.
