Landfill Restoration

On Adak Island

December 1999

LANDFILL RESTORATION ON ADAK ISLAND 1997 - 1999

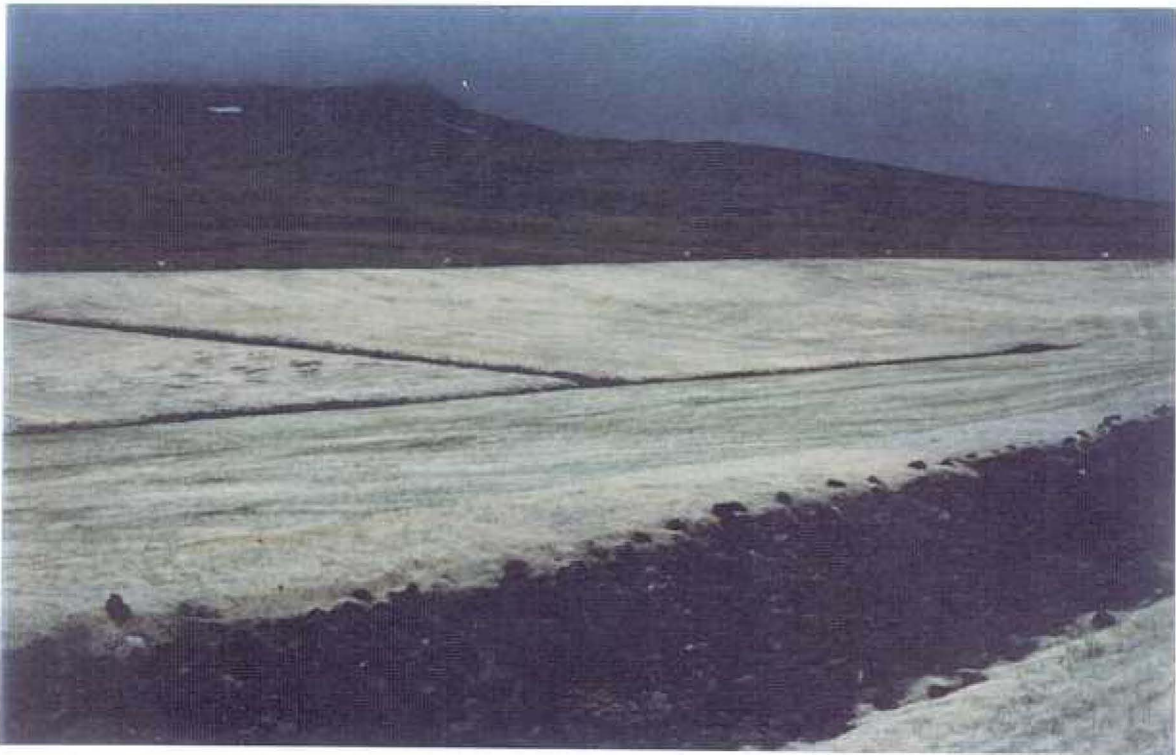
Figure 14. White Alice Landfill, 1997

Initial work began on the White Alice Landfill in 1996. Seeding occurred in 1997 (Figures 12 and 13). The design specified the same 60-35-5 (Hairgrass-Fescue-Annual ryegrass) mix called for on the other sites. The specifications did, however, allow for substitution to the mix without prior approval. Unfortunately, the species and cultivars used as substitutes were poor choices; they had been used previously and had not survived on Adak. The initial plant establishment was very poor and much poorer than stands found at other sites on Adak including the Metals and Palisades Landfills. Poor plant establishment probably occurred because inexpensive non-native substitutes were made to the seed mix.

In addition to this poor seed mix, the White Alice Landfill was heavily mulched with straw and then covered with excelsior blankets. Heavy mulching can slow the warming of the soils in Alaska. Also, excelsior blankets have the tendency to come apart, leaving plastic netting behind to be carried by the wind (Figures 17 and 18). The excelsior blankets did come apart at the White Alice Landfill creating an eyesore and potential trap for small animals and birds. This material is not recommended by the AKPMC for this reason. Straw also is not recommended because of possible weed seed content, cost of shipping and the potential for over-insulating the soil.
