**TAILINGS AND PRODUCTION ROCK SITE
2012 ANNUAL REPORT**

Hecla Green Creek Mining Company

April 15, 2013

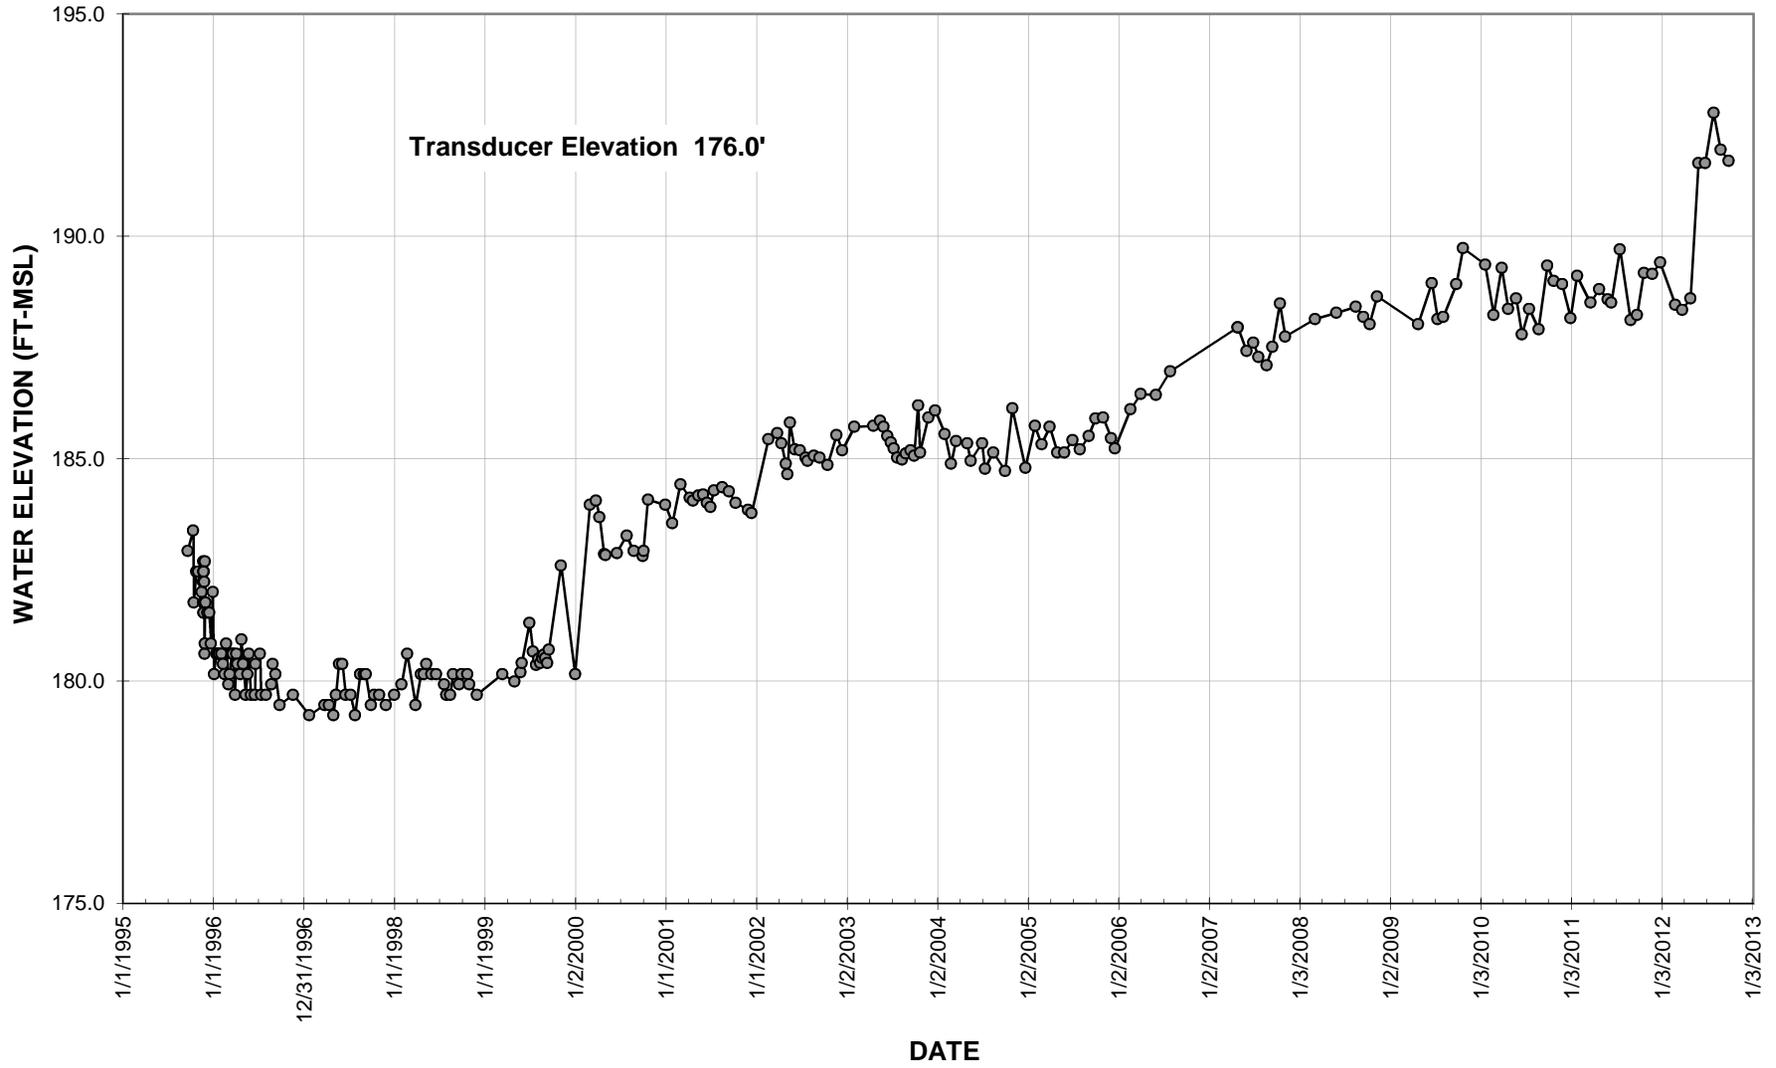
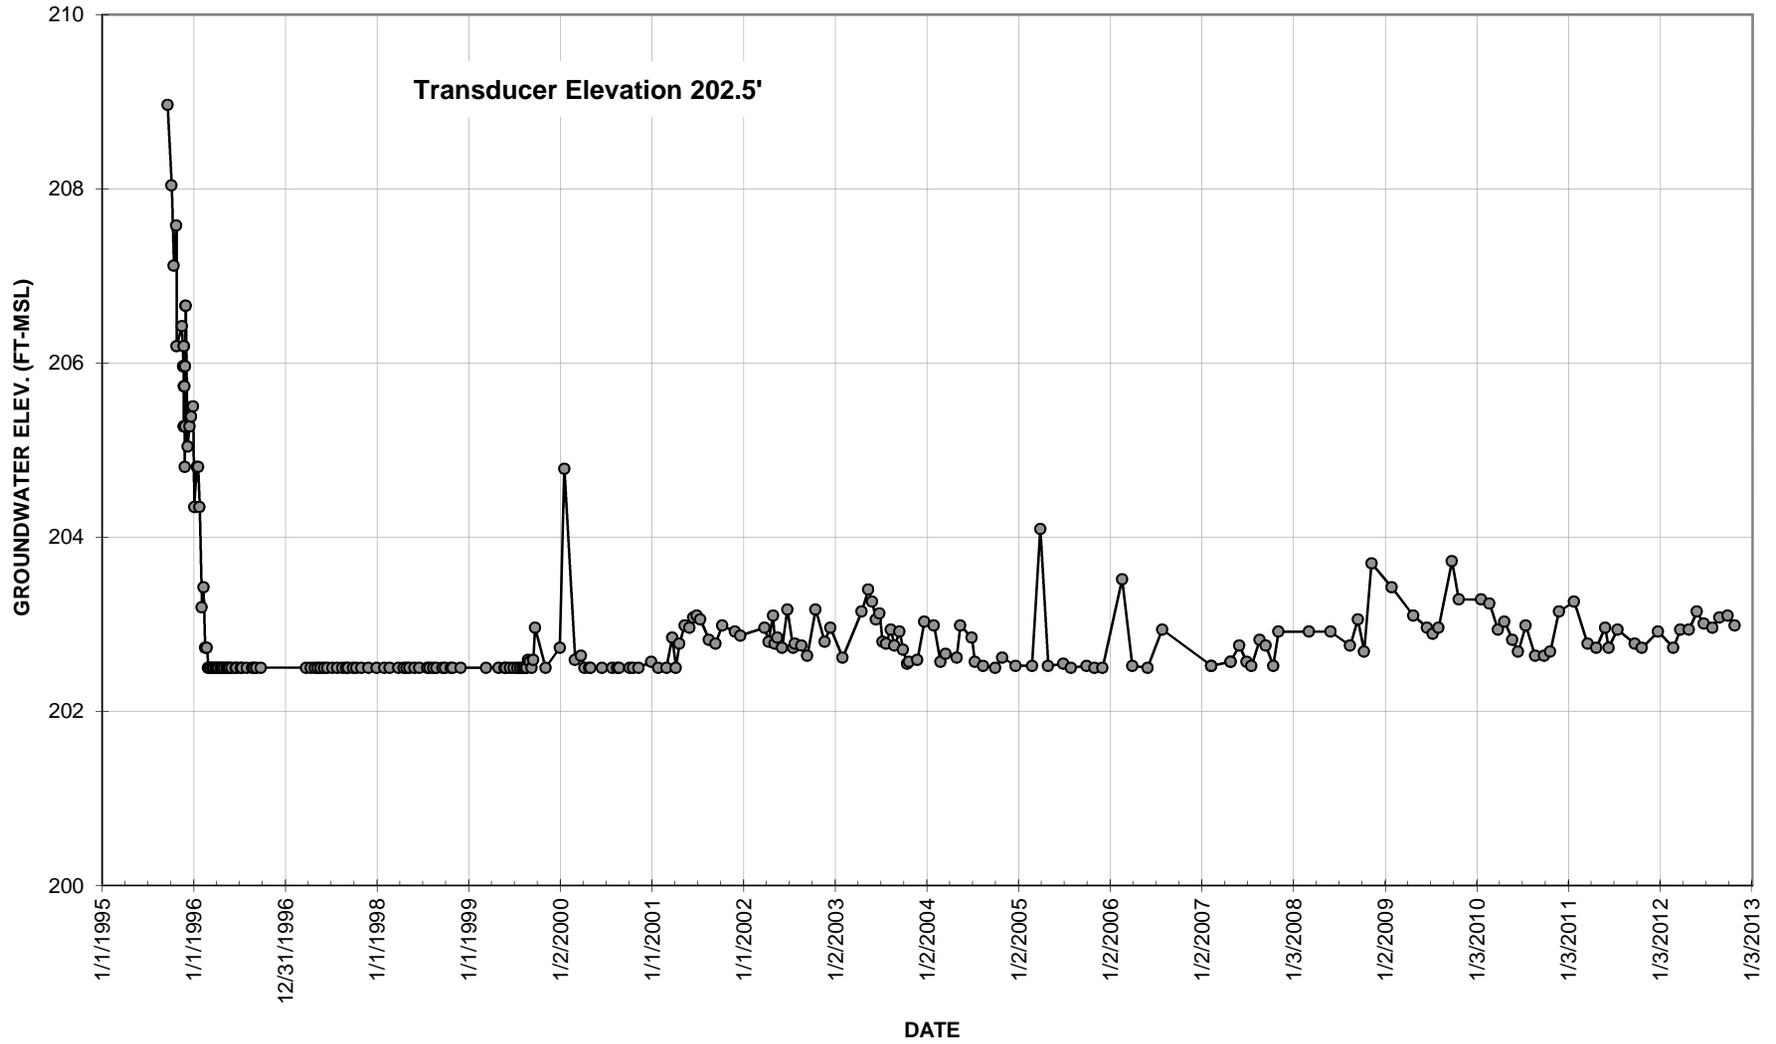
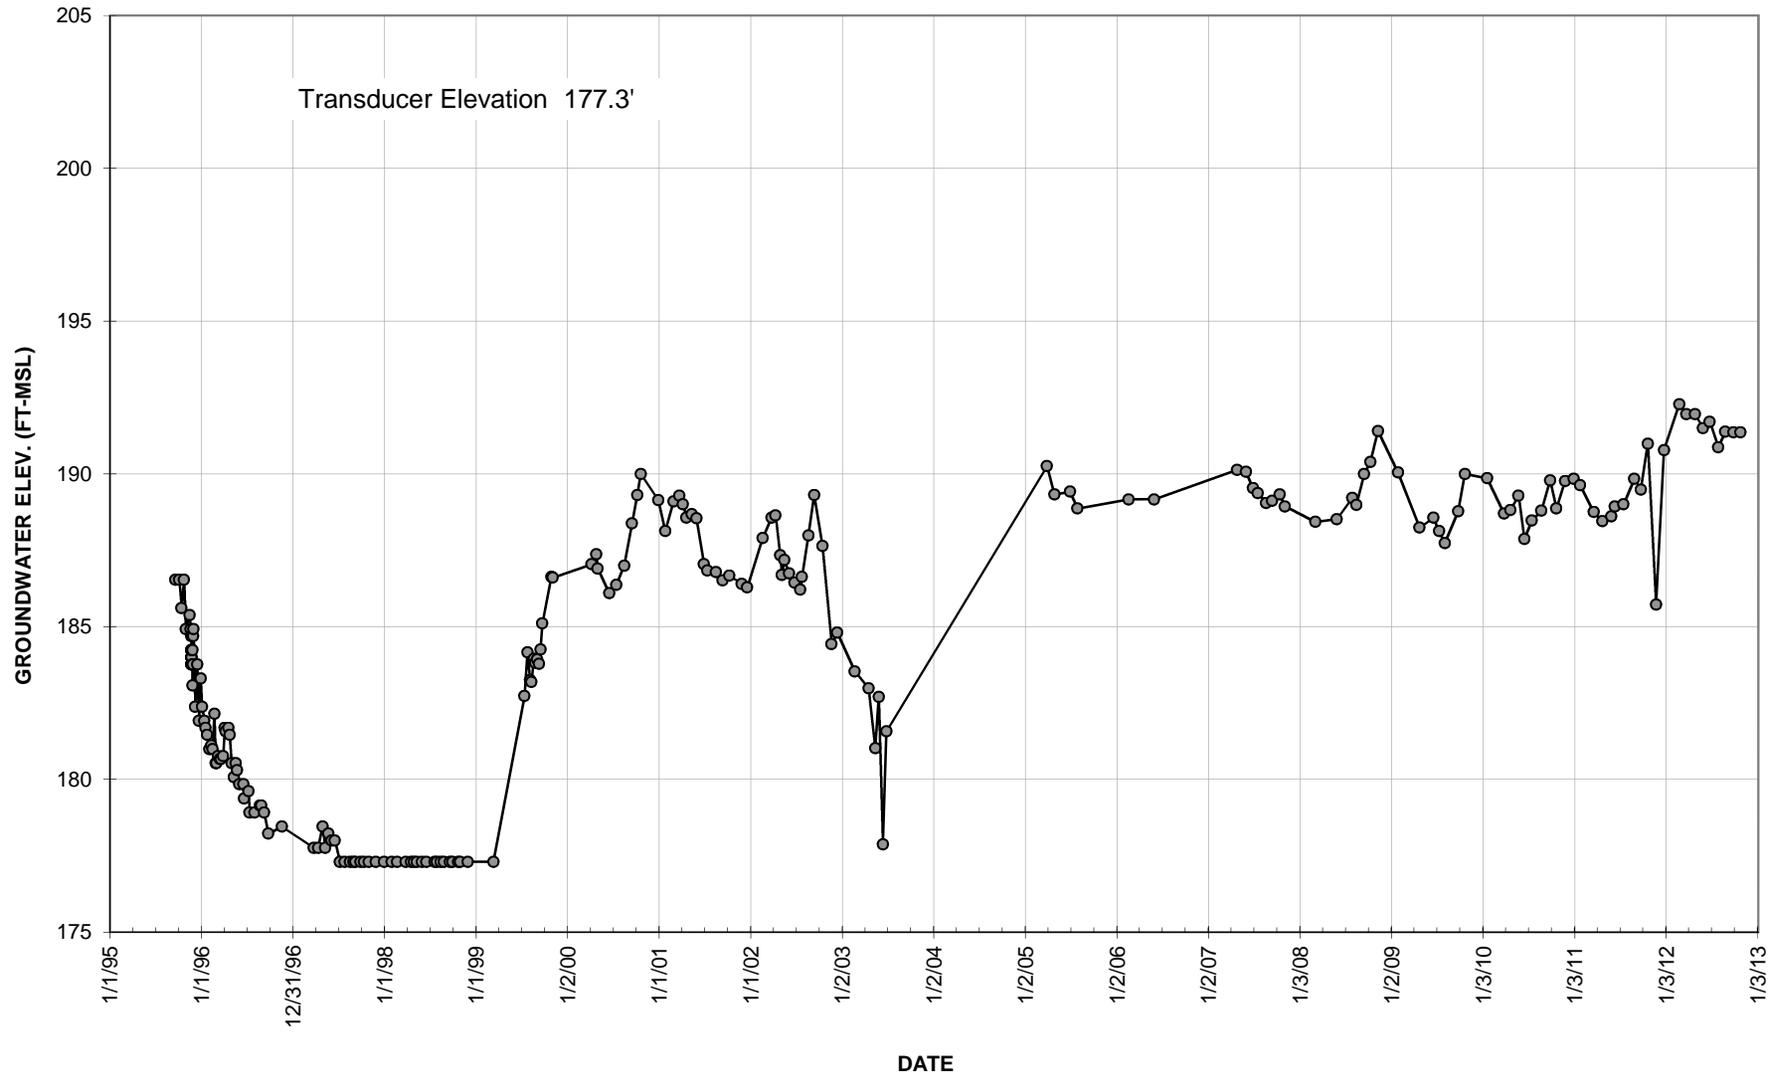
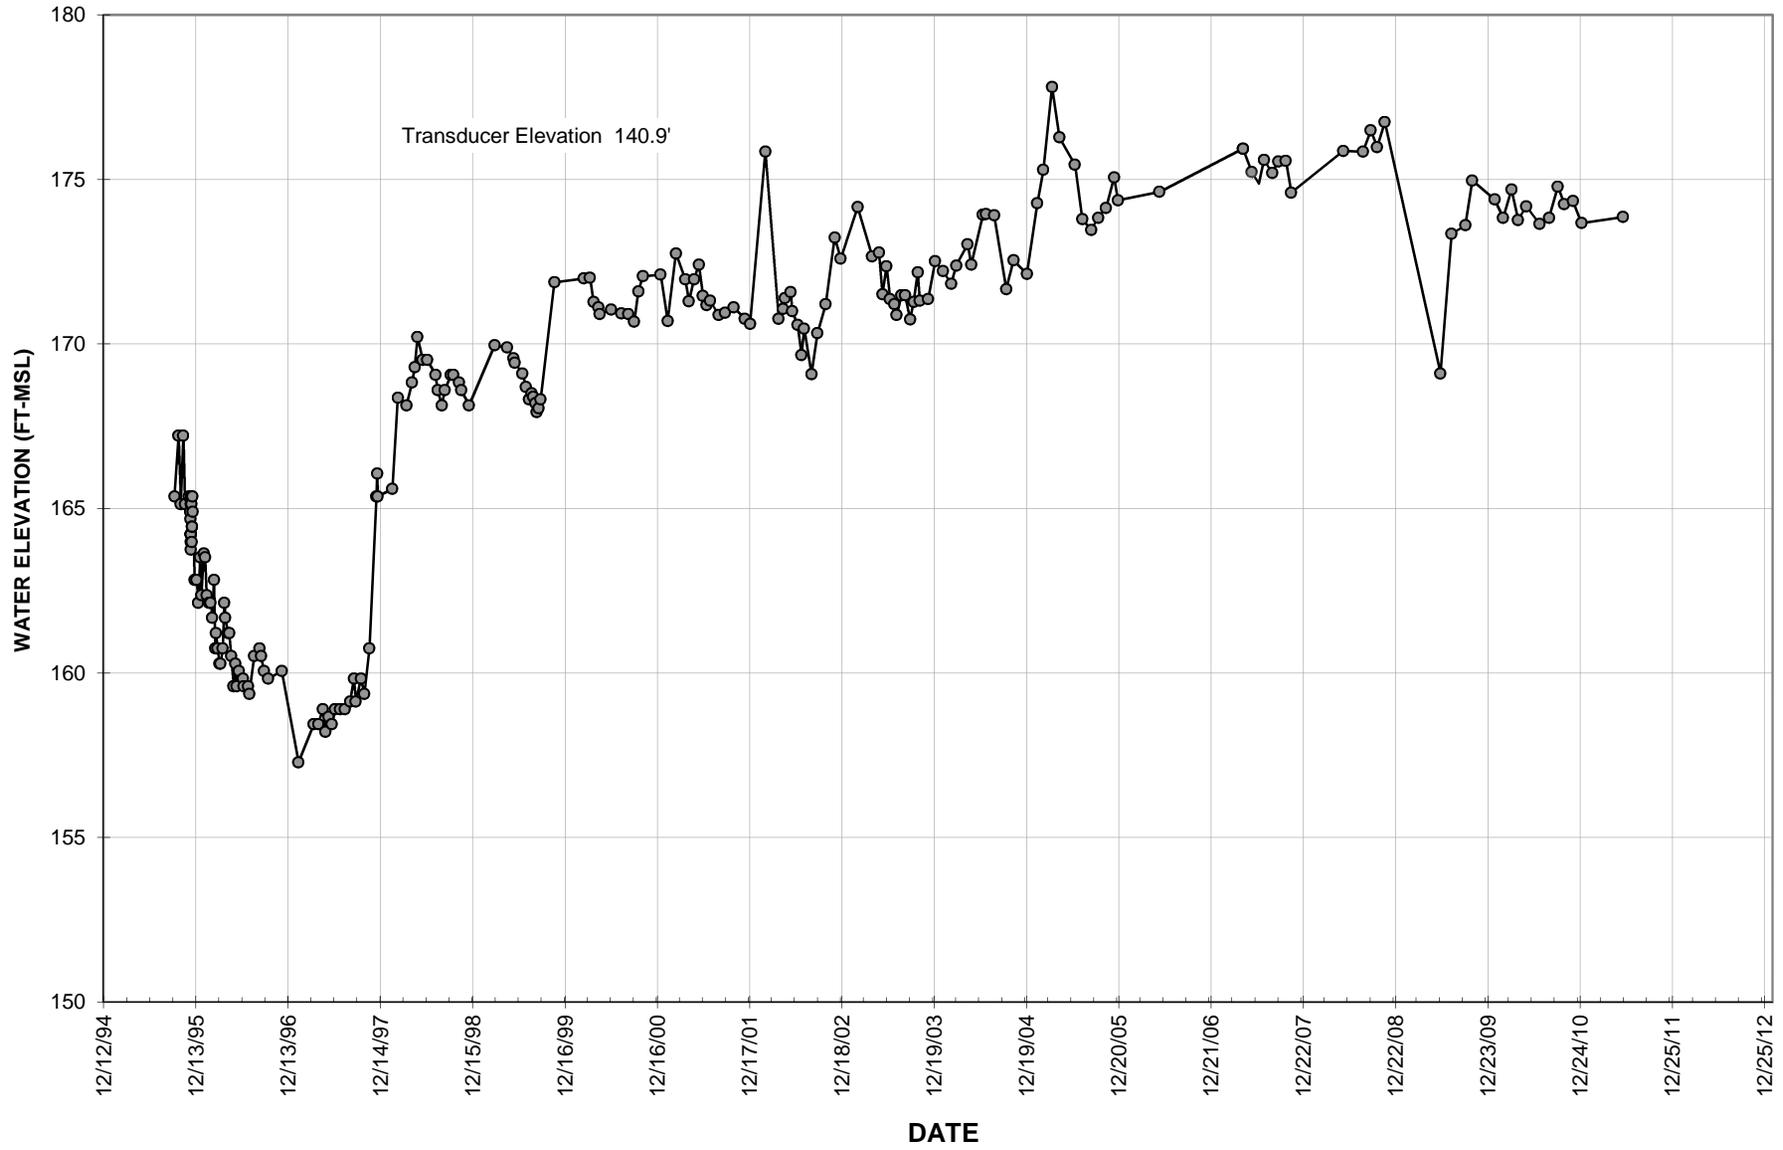
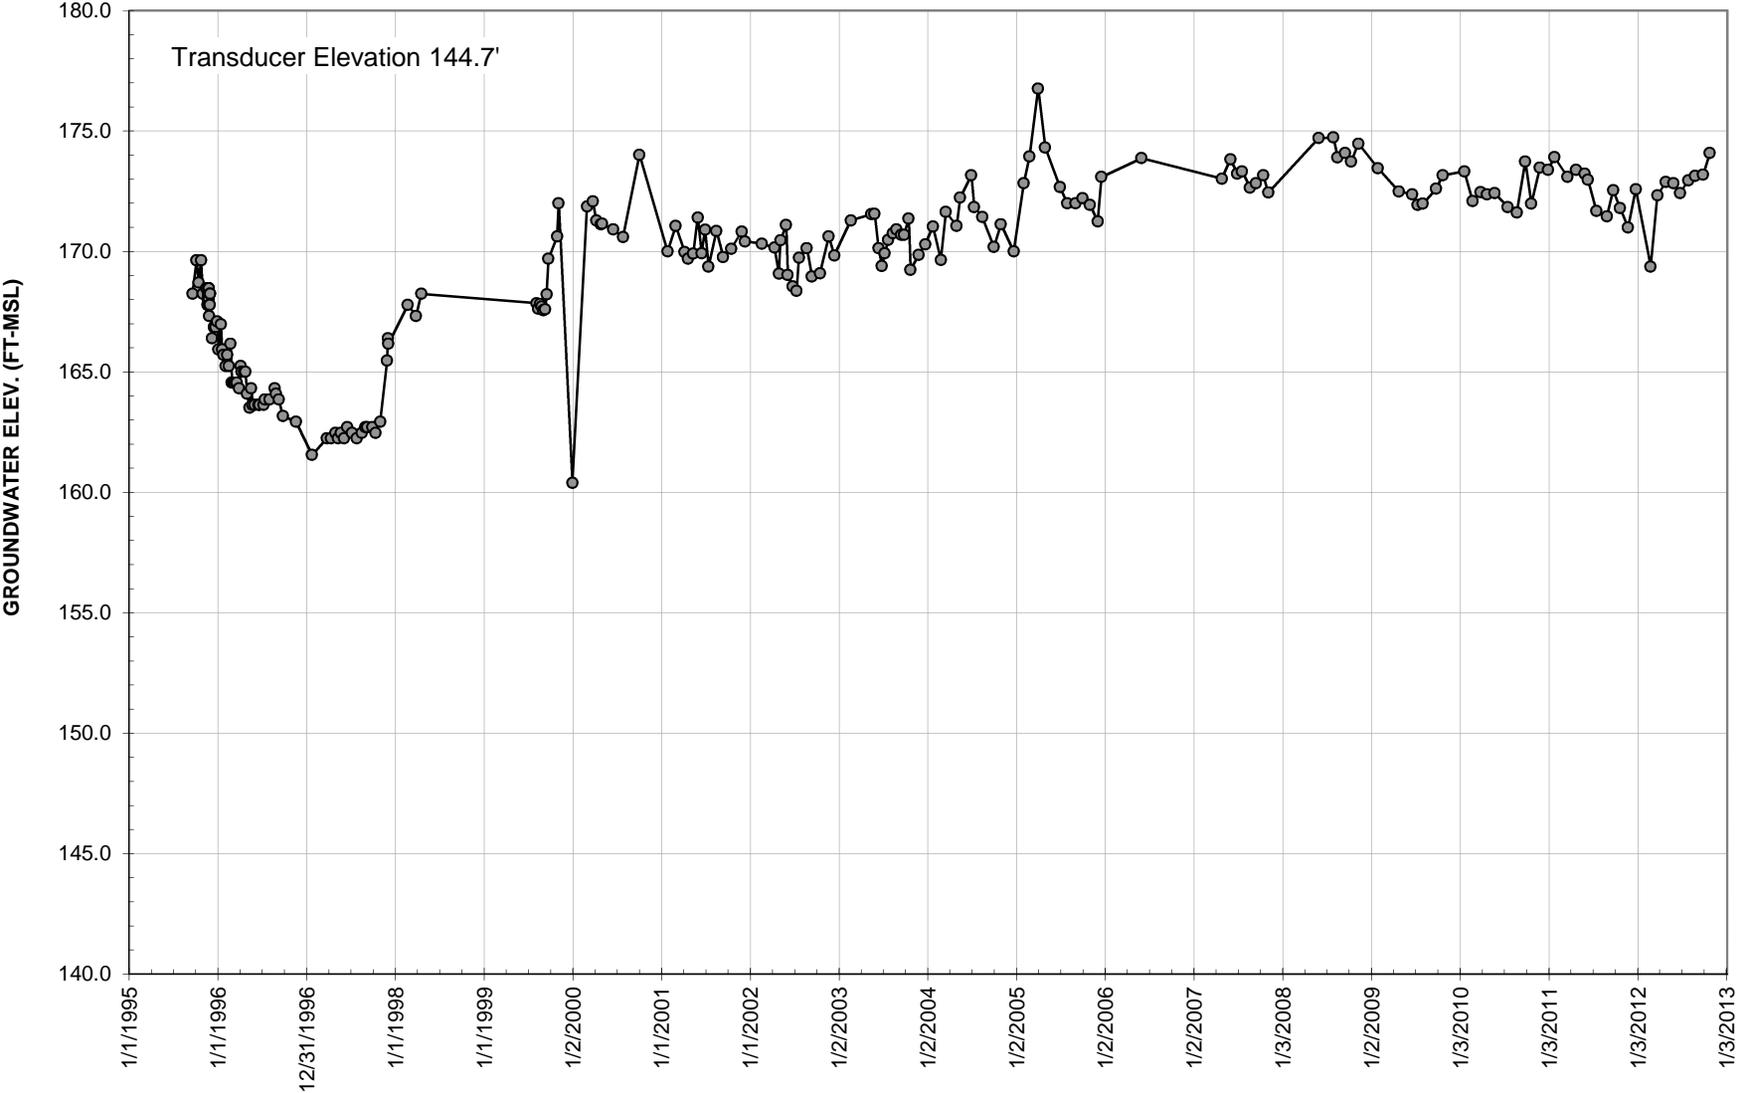
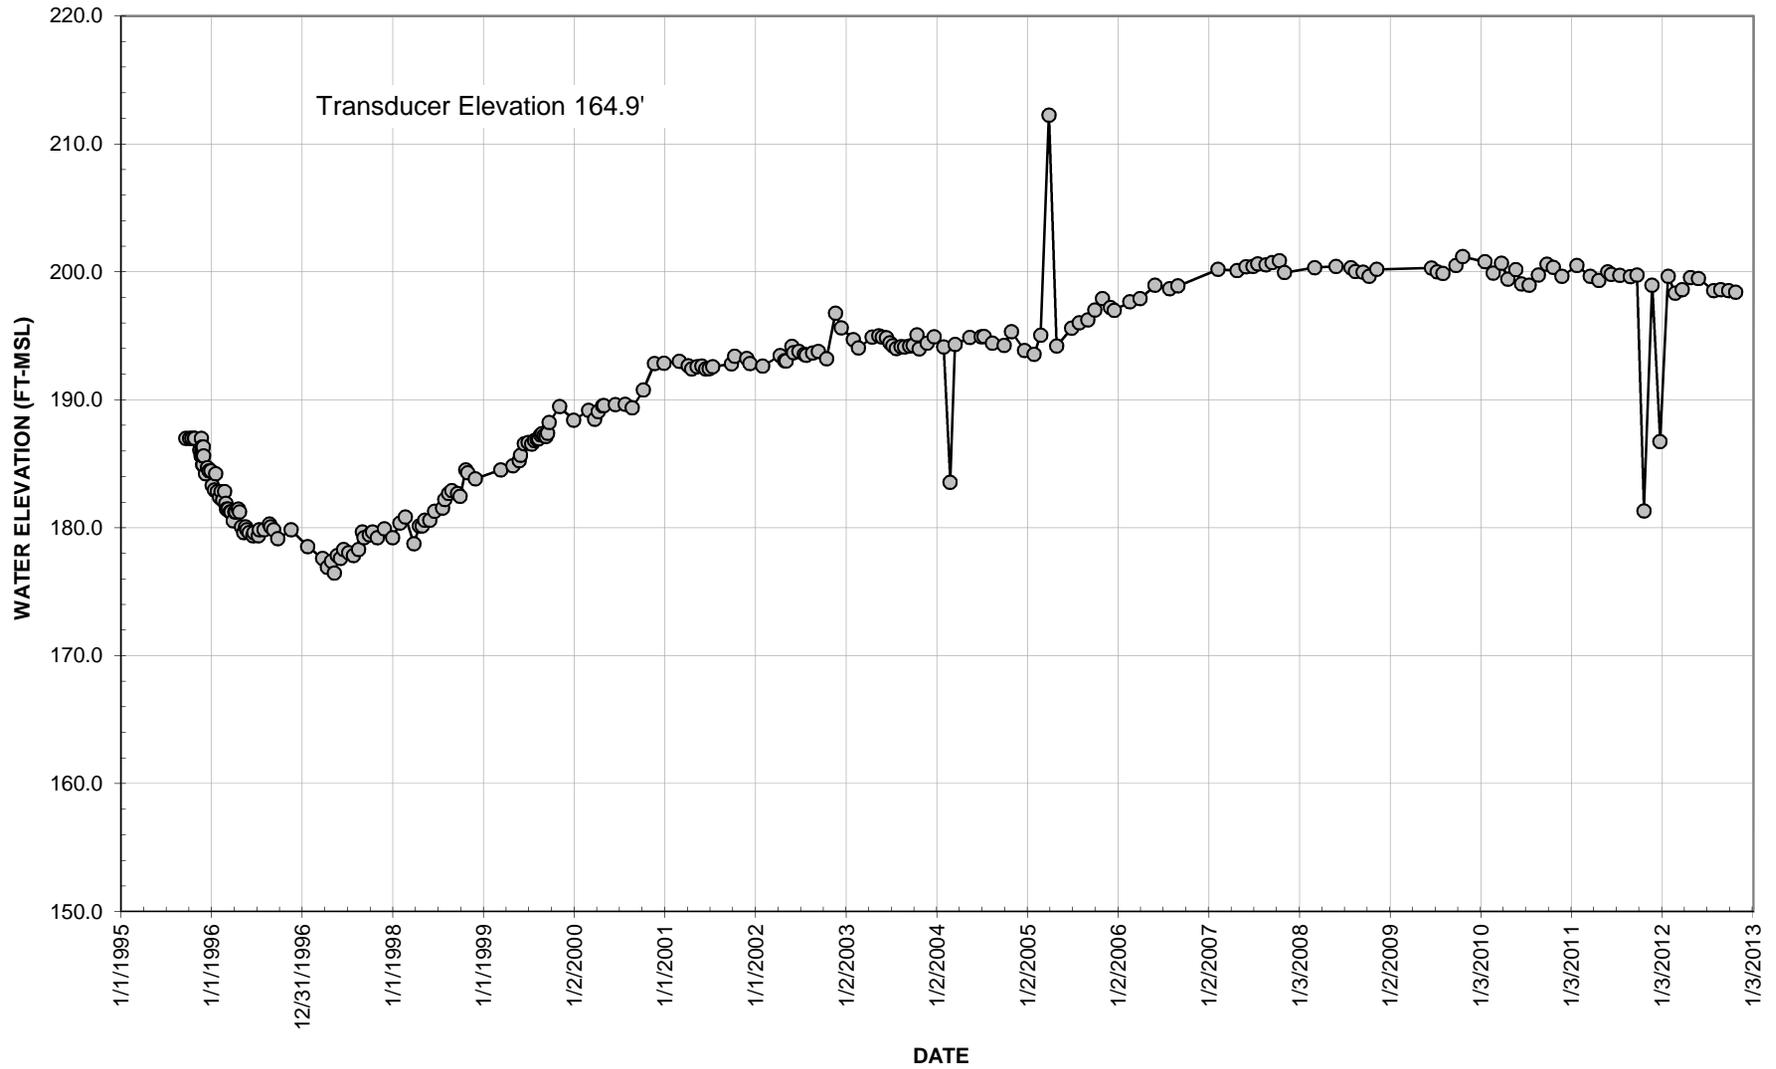
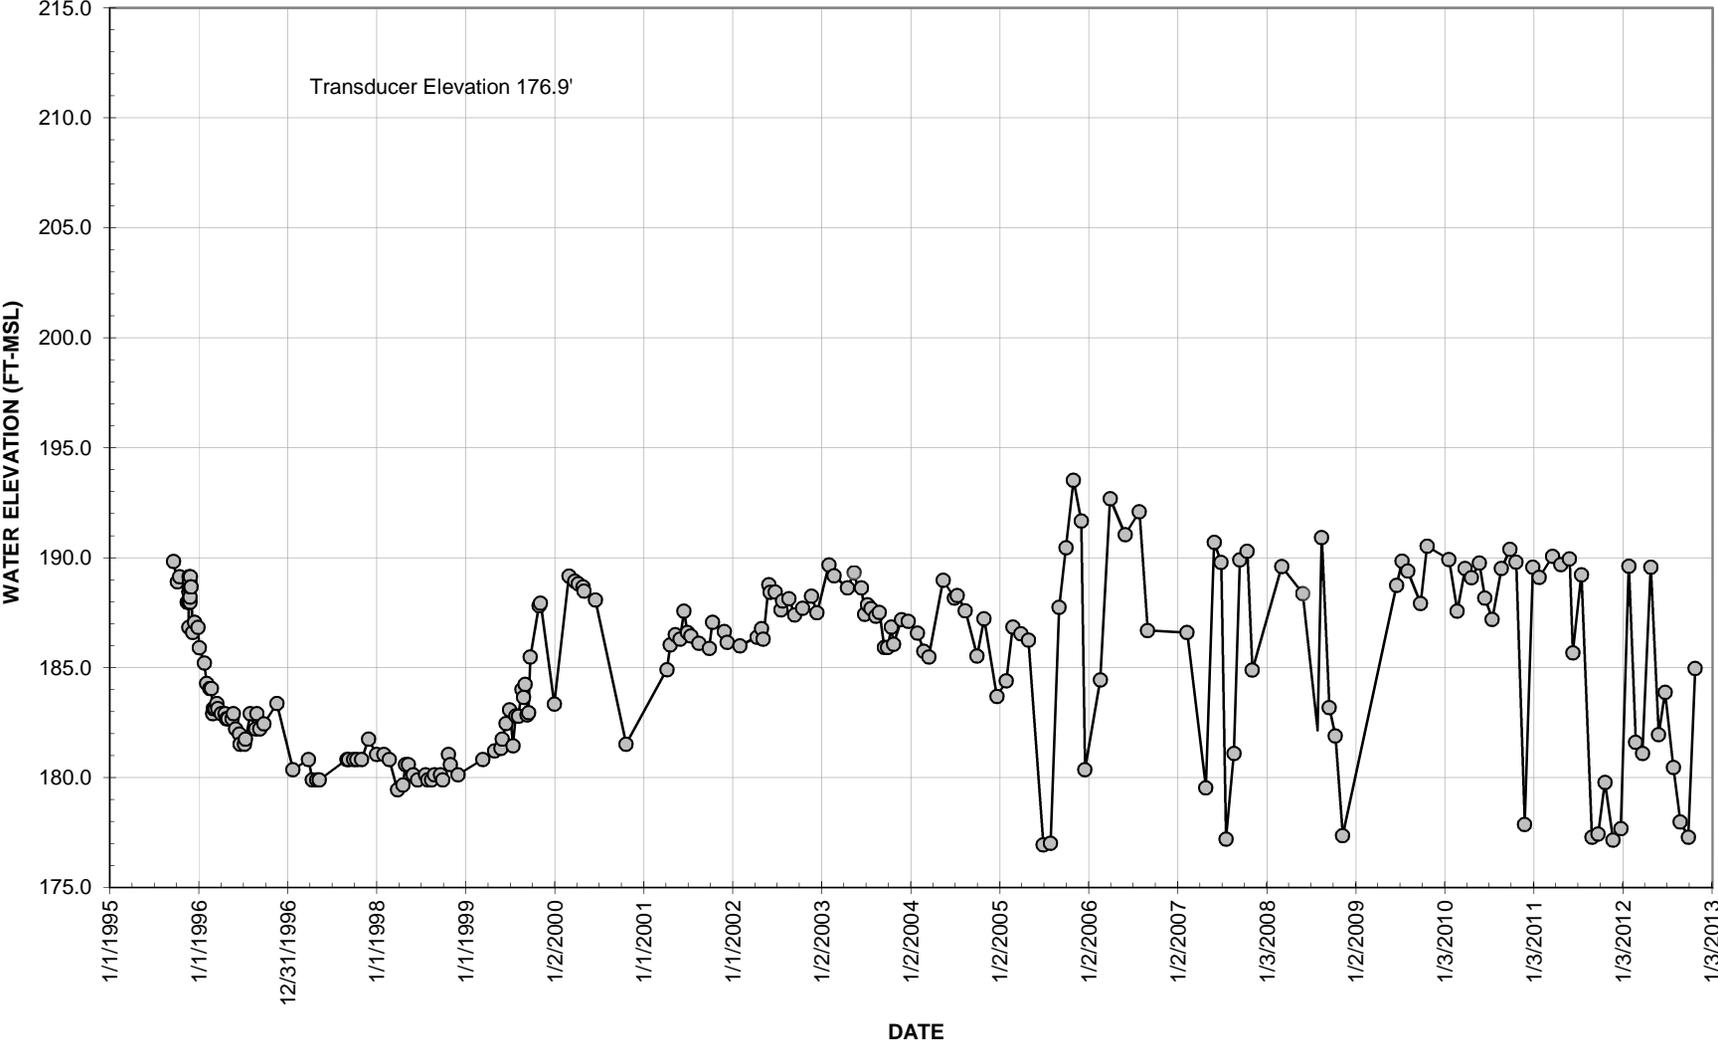
uncapped condition of the pile. Covering the pile will help minimize the saturated zone in the pile. This was demonstrated by the over 10 foot decrease in the water table that occurred from 1995 to 1997 when the pile was covered (see Figures 2.1 to 2.7). Water levels have rebounded to, and in some cases above, 1994 elevations in most areas. Areas where water levels exceed their 1994 values are areas where the pile is considerably thicker than it was in 1994. The increase in water levels observed in PZ-T-00-01 (and to a lesser extent in instruments nearby) from 2005 to 2007 is likely a result of new tailings placement in the area and staged decommissioning of Wet Well 2.

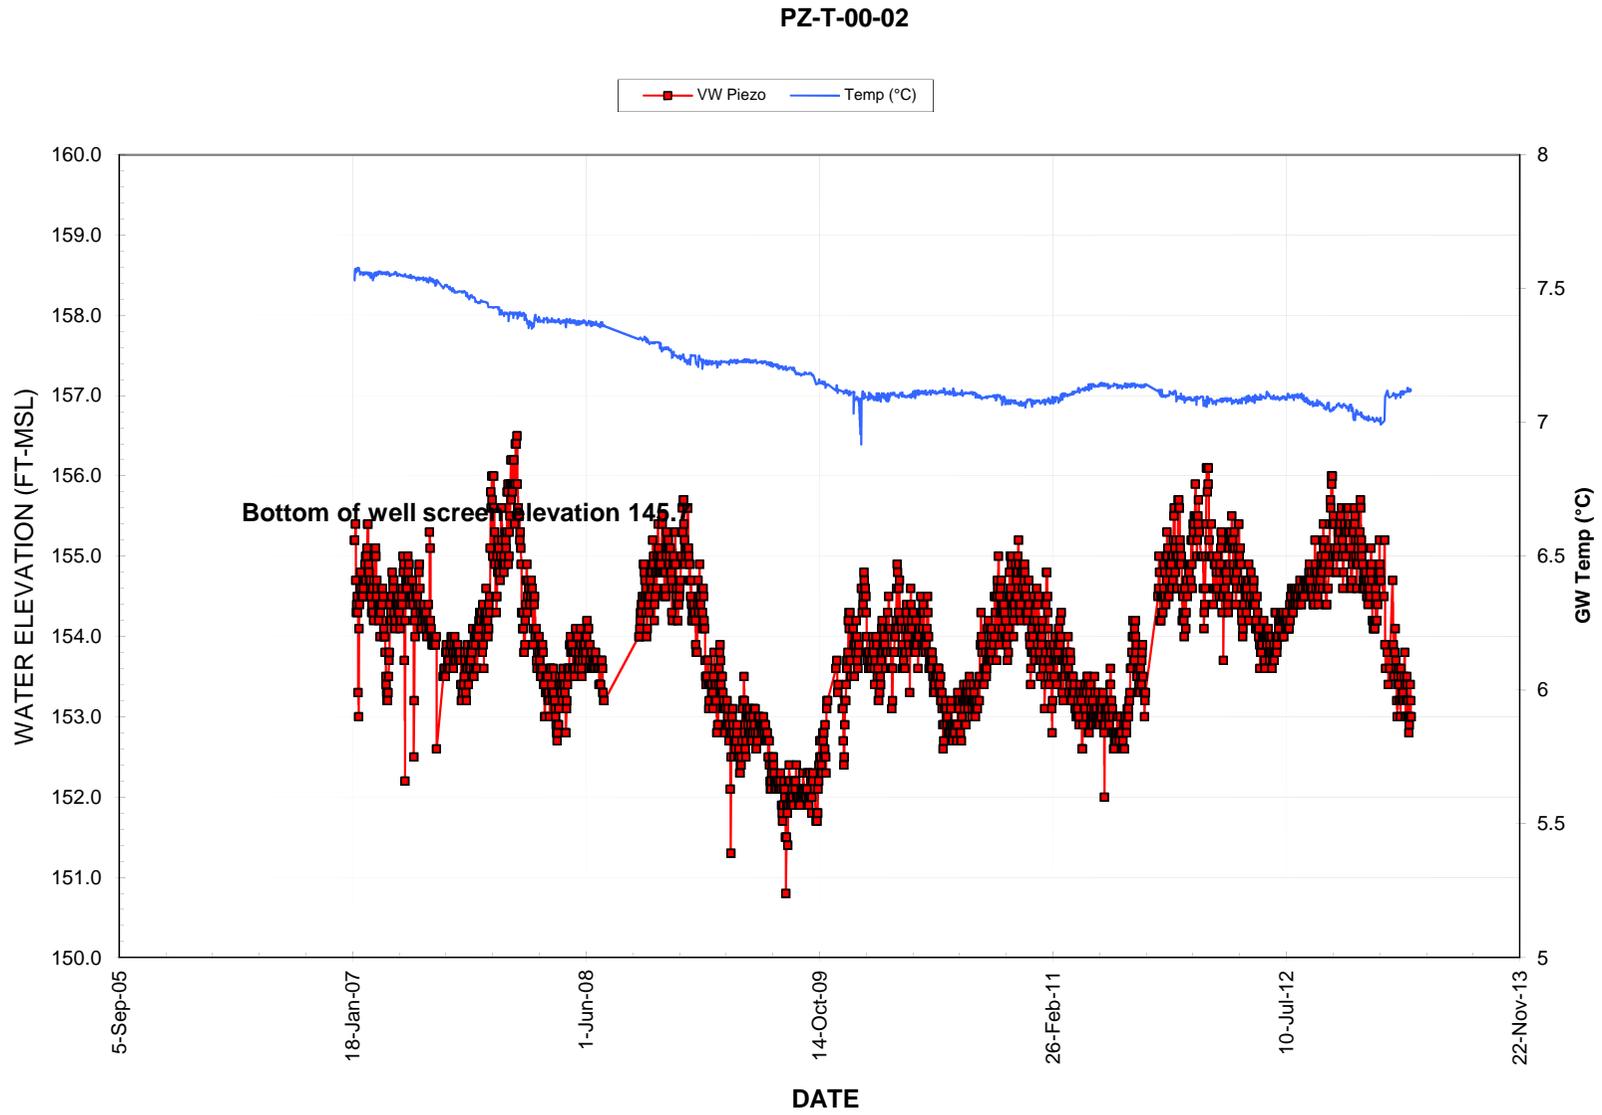
Figure 2.12 Water Level Data for Standpipe Piezometer PZ-T-00-02

The data from standpipe and pneumatic piezometers completed above the blanket drain (Piezometer 76, PZ-T-00-01, PZ-T-00-02, PZ-T-00-03 in Figures 2.10, 2.11, 2.12, 2.13) indicate that saturated conditions can develop above the unsaturated underdrains to a thickness of approximately 12 feet. This is consistent with the low permeability of the tailings and the

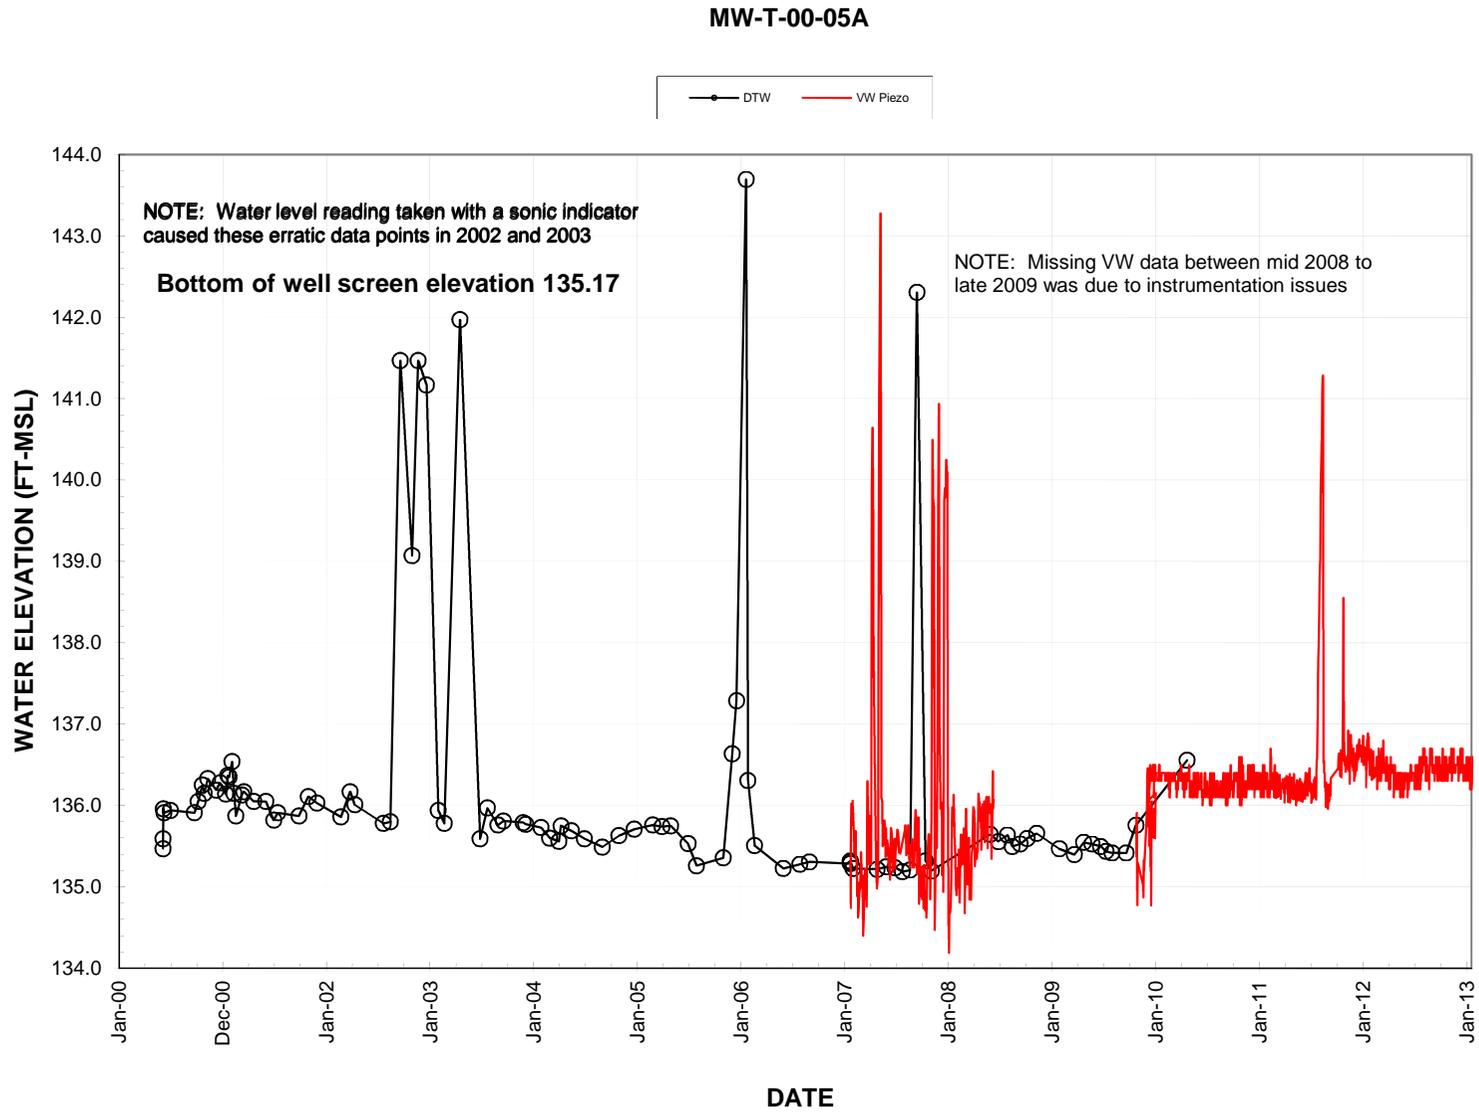
Figure 2.14 Water Level Data for Standpipe Piezometer MW-T-00-05A

Periodic spikes in water levels in the wells and piezometers are due to a variety of factors including extreme weather events (e.g. Fall/Winter 2005-2006), changes to water management infrastructure (e.g. decommissioning of Wet Well 2 from 2005-2008), damage to instrumentation (Piezometer 76 in 2004), and measurement errors (e.g. MW-T-00-05A in 2002-2003 and 2007).

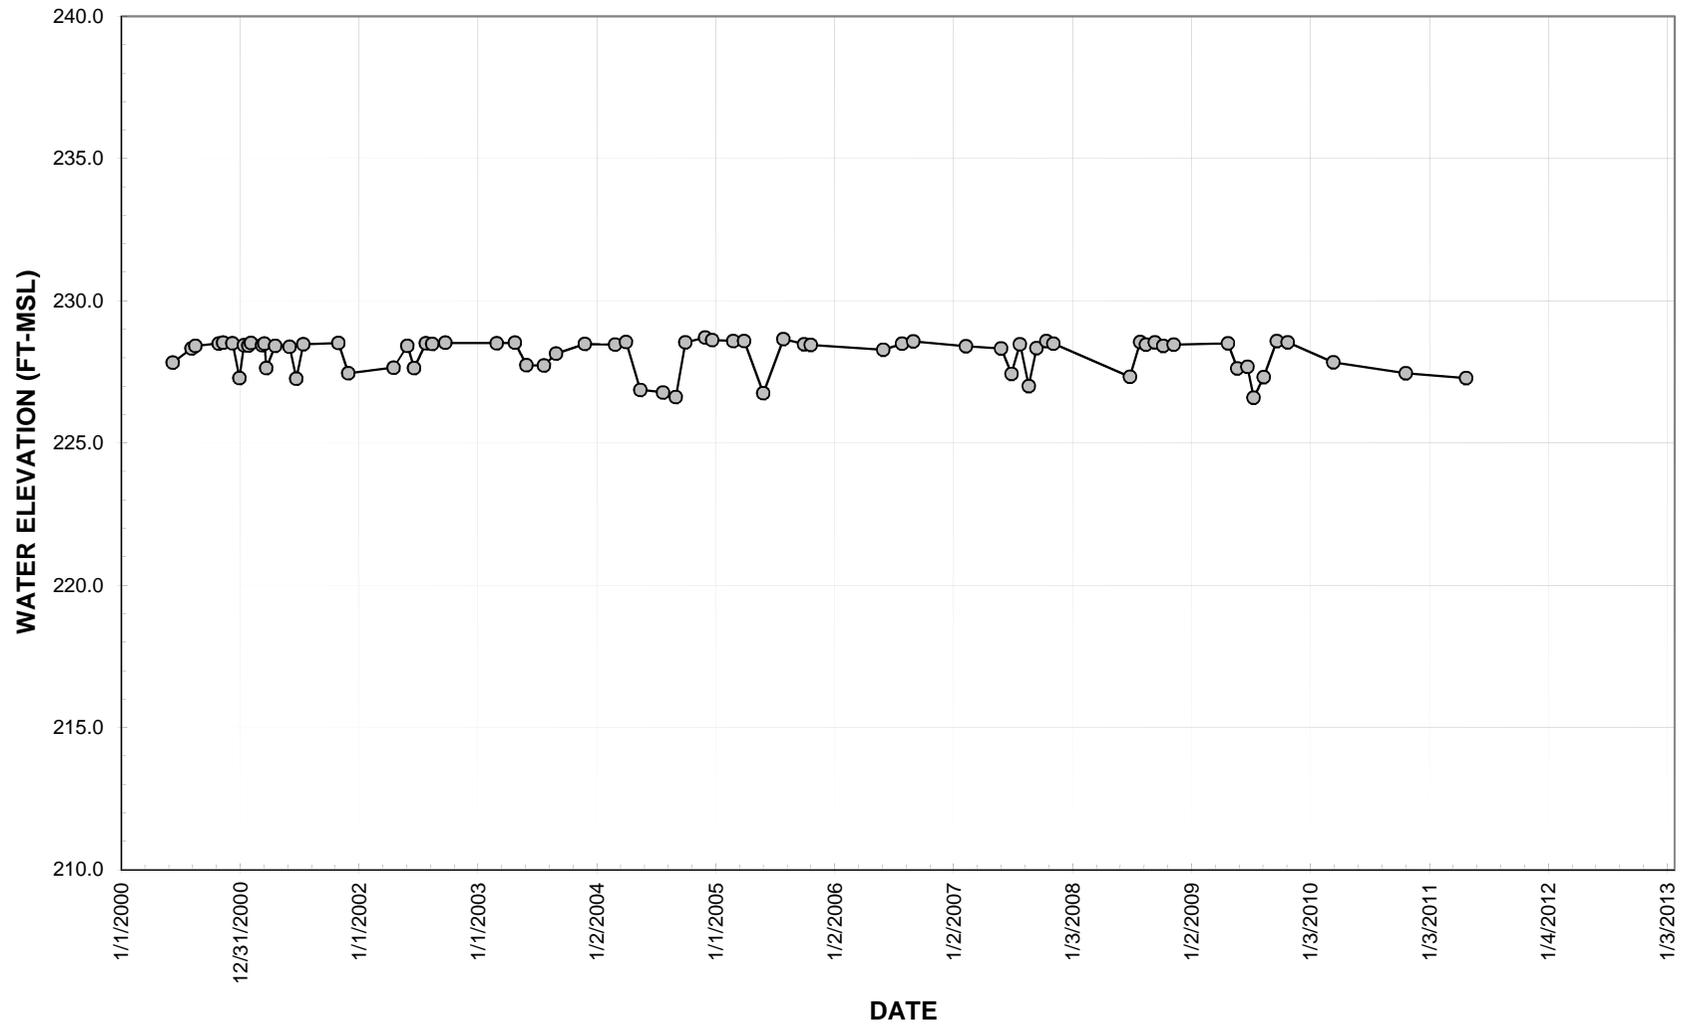
Figure 2.15 Water Level Data for for Well MW-T-00-03A

Water levels in four wells completed east and west of the pile are shown for comparison in Figures 2.15 to 2.18. The eastern wells, MW-T-00-03A (Figure 2.15) and MW-T-00-03B (Figure 2.16), are completed in the shallow sands 12 and 17 feet, respectively, below ground surface. The figures for these wells show that the water elevation in shallow completions in native materials can be readily influenced by abnormal weather conditions. Wells MW-T-01-03A and MW-T-01-03B are installed west of the pile. Their water levels are shown in Figures 2.17 and 2.18, respectively. MW-T-01-03A is completed in bedrock to a depth of 20 feet and MW-T-01-03B is completed in clayey silt to a depth of 12 feet. These wells show similar water level fluctuations with weather conditions as the two eastern wells. However, the water level in MW-T-01-03B shows a larger differential than MW-T-01-03A because silts and clays hold more water in tension, so a small increase in water content causes a large change in head. The ground surface elevation is 134 feet in the proximity of these two wells. Both MW-T-01-03A and MW-T-01-03B were damaged by bears in 2006 and attempts to recover them were not successful until 2010. A rapid decrease followed by a gradual increase to levels above recent historical values occurred in MW-T-01-03A in 2011. In 2012, the level decreased to levels seen in the past. The cause for the change is not known at this point, however this type of behavior has been documented in the companion well (MW-T-01-03B).

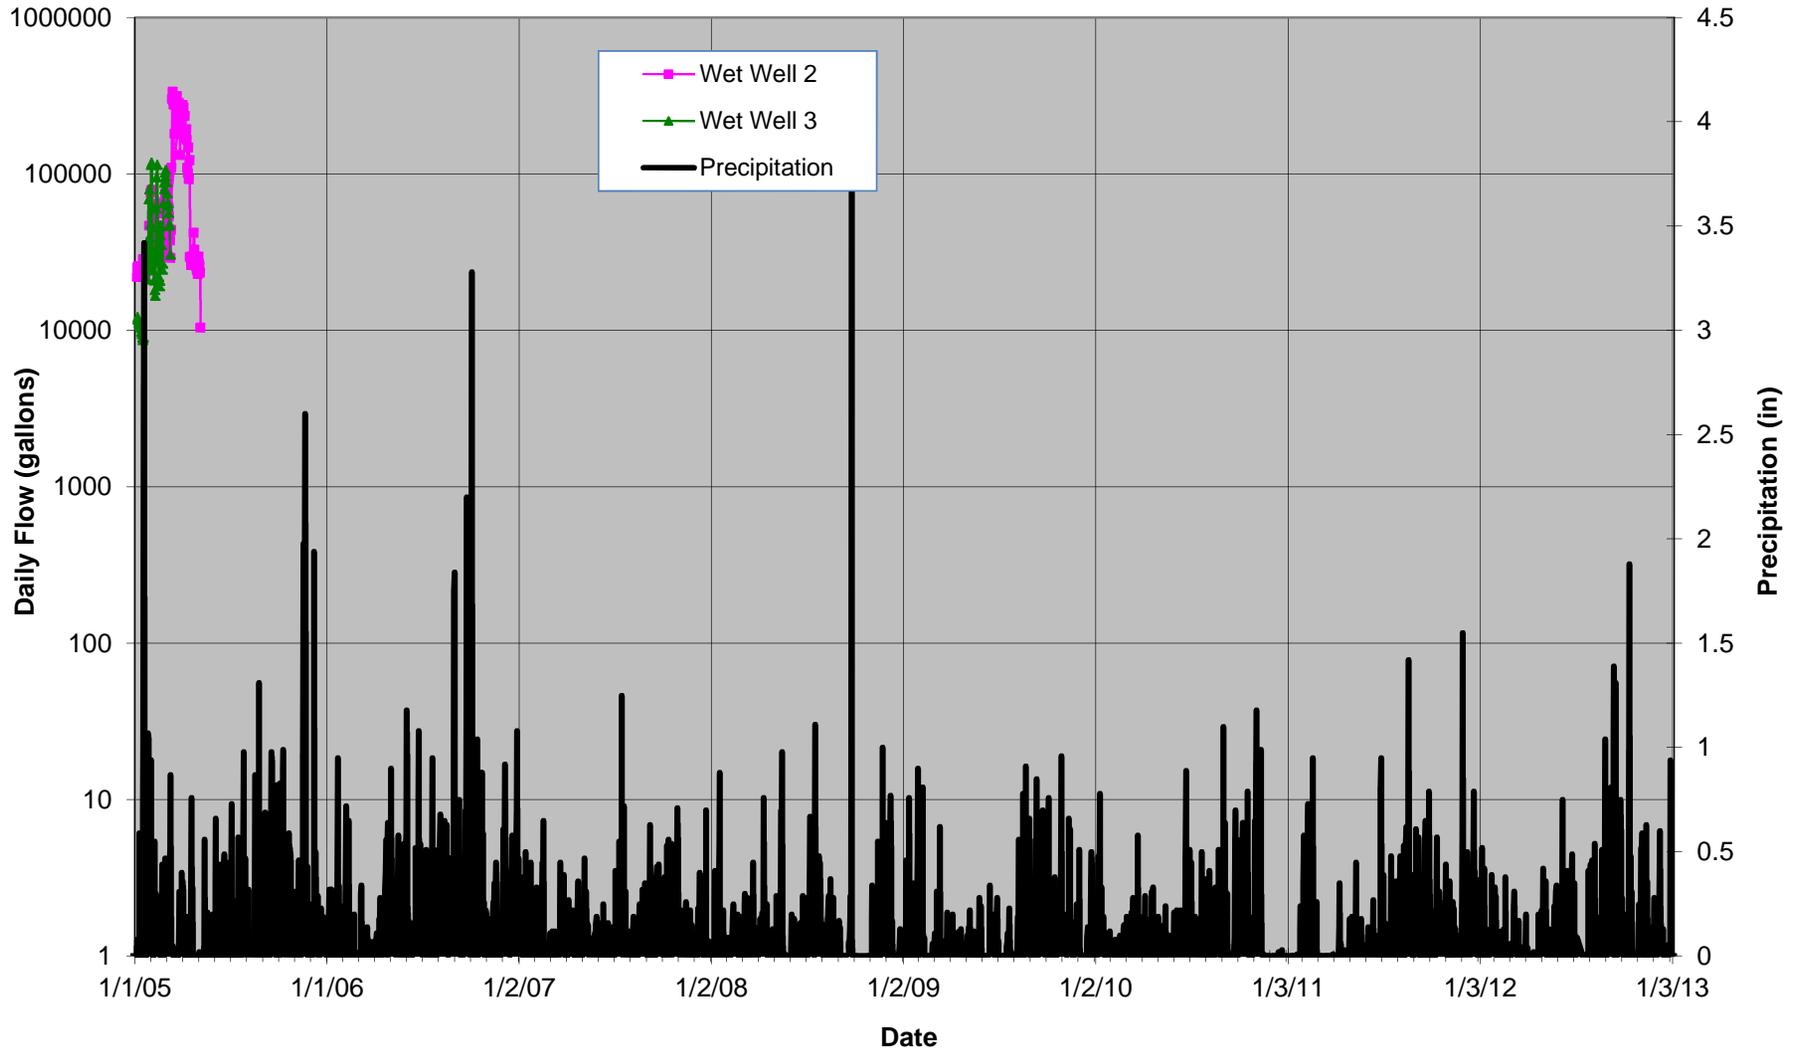
Figure 2.19 Tailings Area Wet Well Flow Data

Flow data from Wet Wells 2 and 3 are presented with the precipitation data for 2005 – 2012 in Figure 2.19. The wet well flows respond relatively quickly to precipitation events, demonstrating a significant contribution of surface water. The use of the wet well flow meters has been discontinued since 2005 as part of the tailings expansion activities.
