**TAILINGS AND PRODUCTION ROCK SITE
2012 ANNUAL REPORT**

Hecla Green Creek Mining Company

April 15, 2013

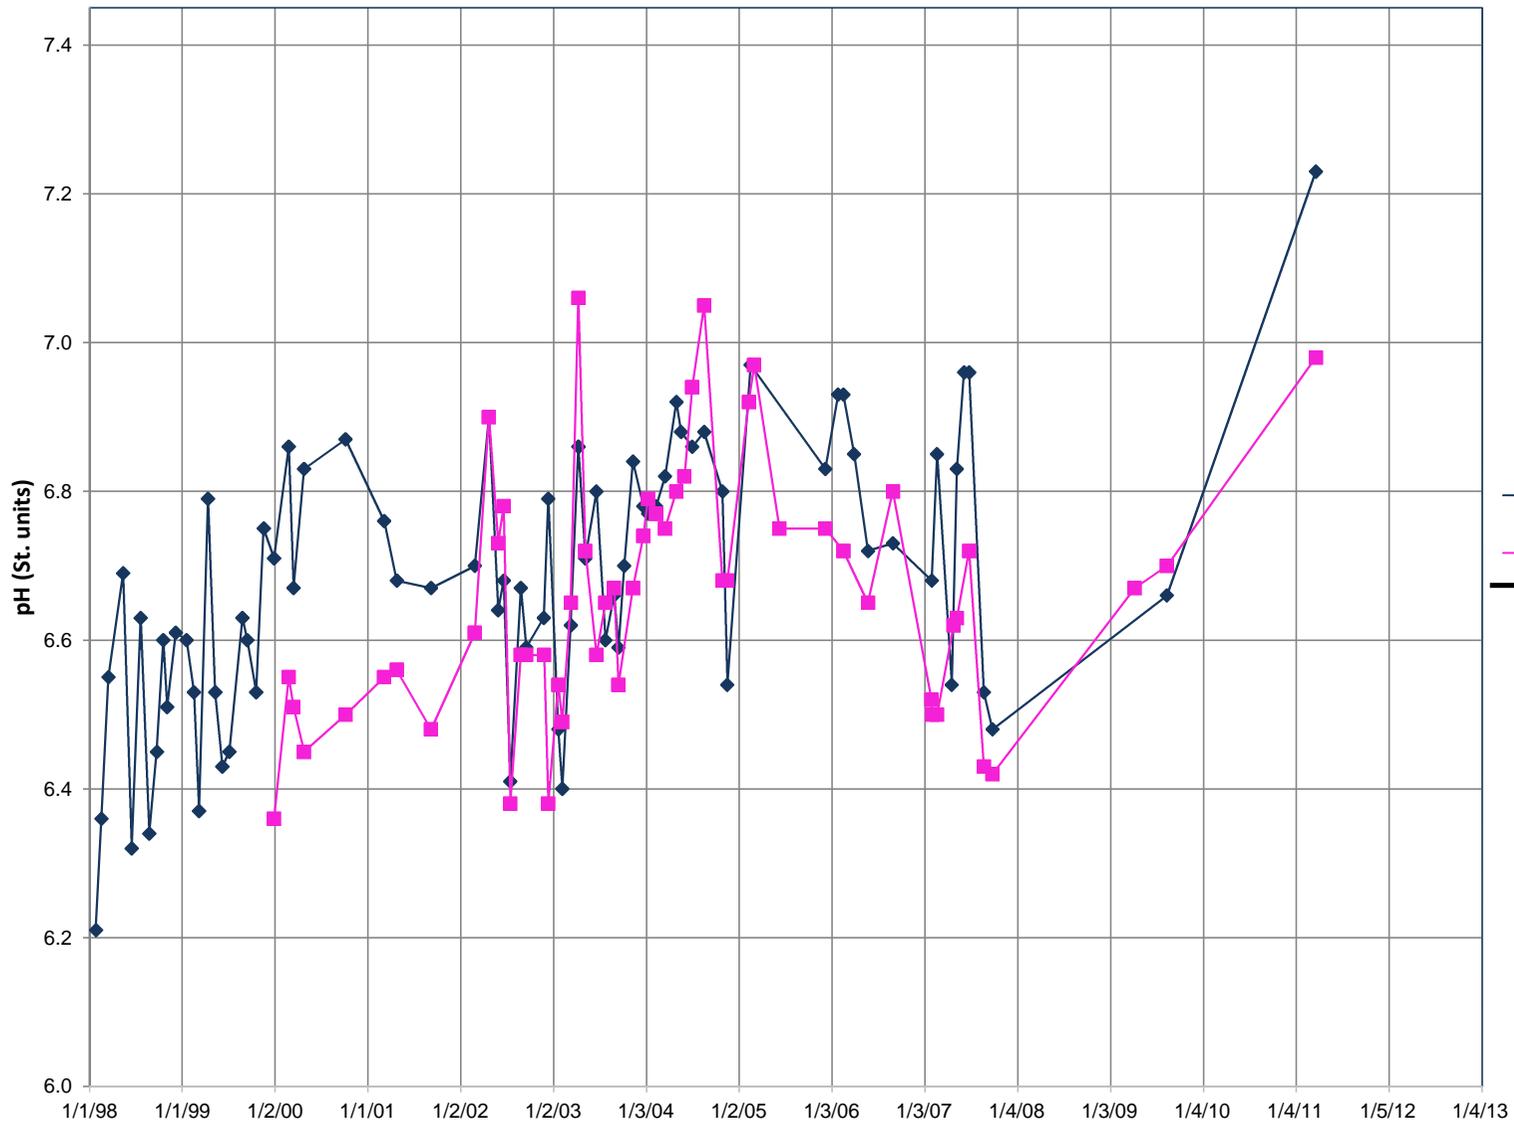
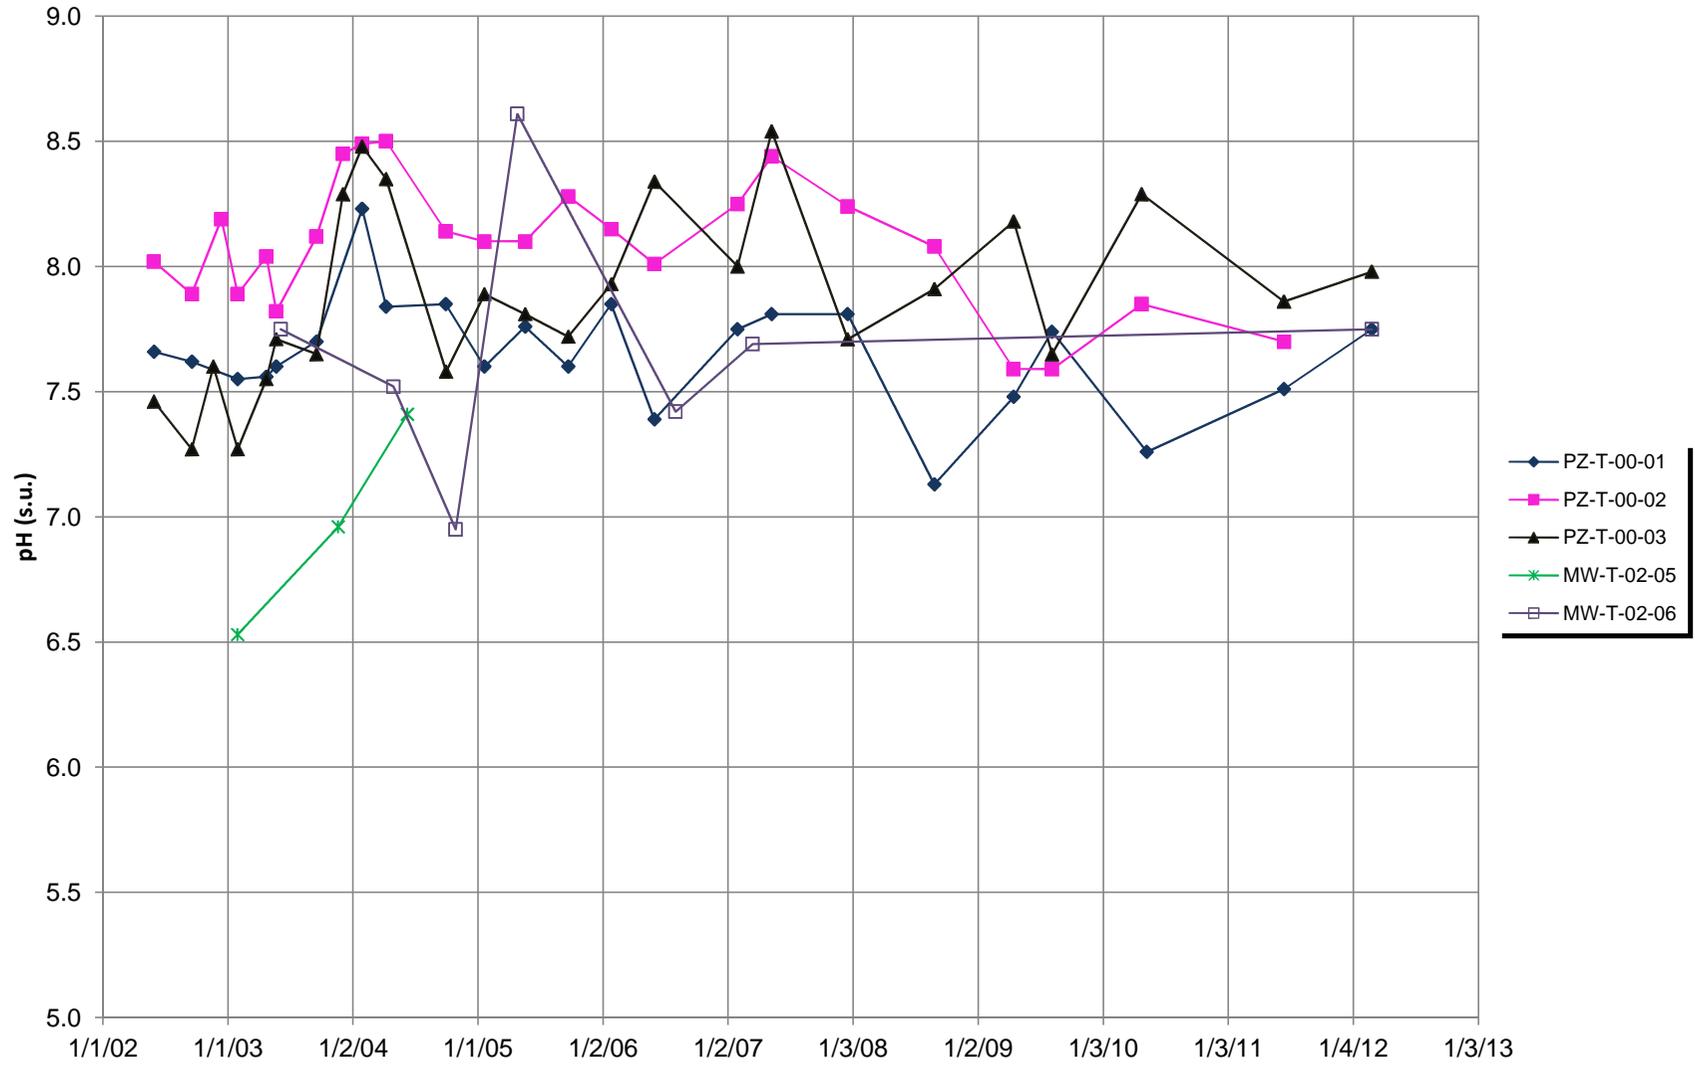
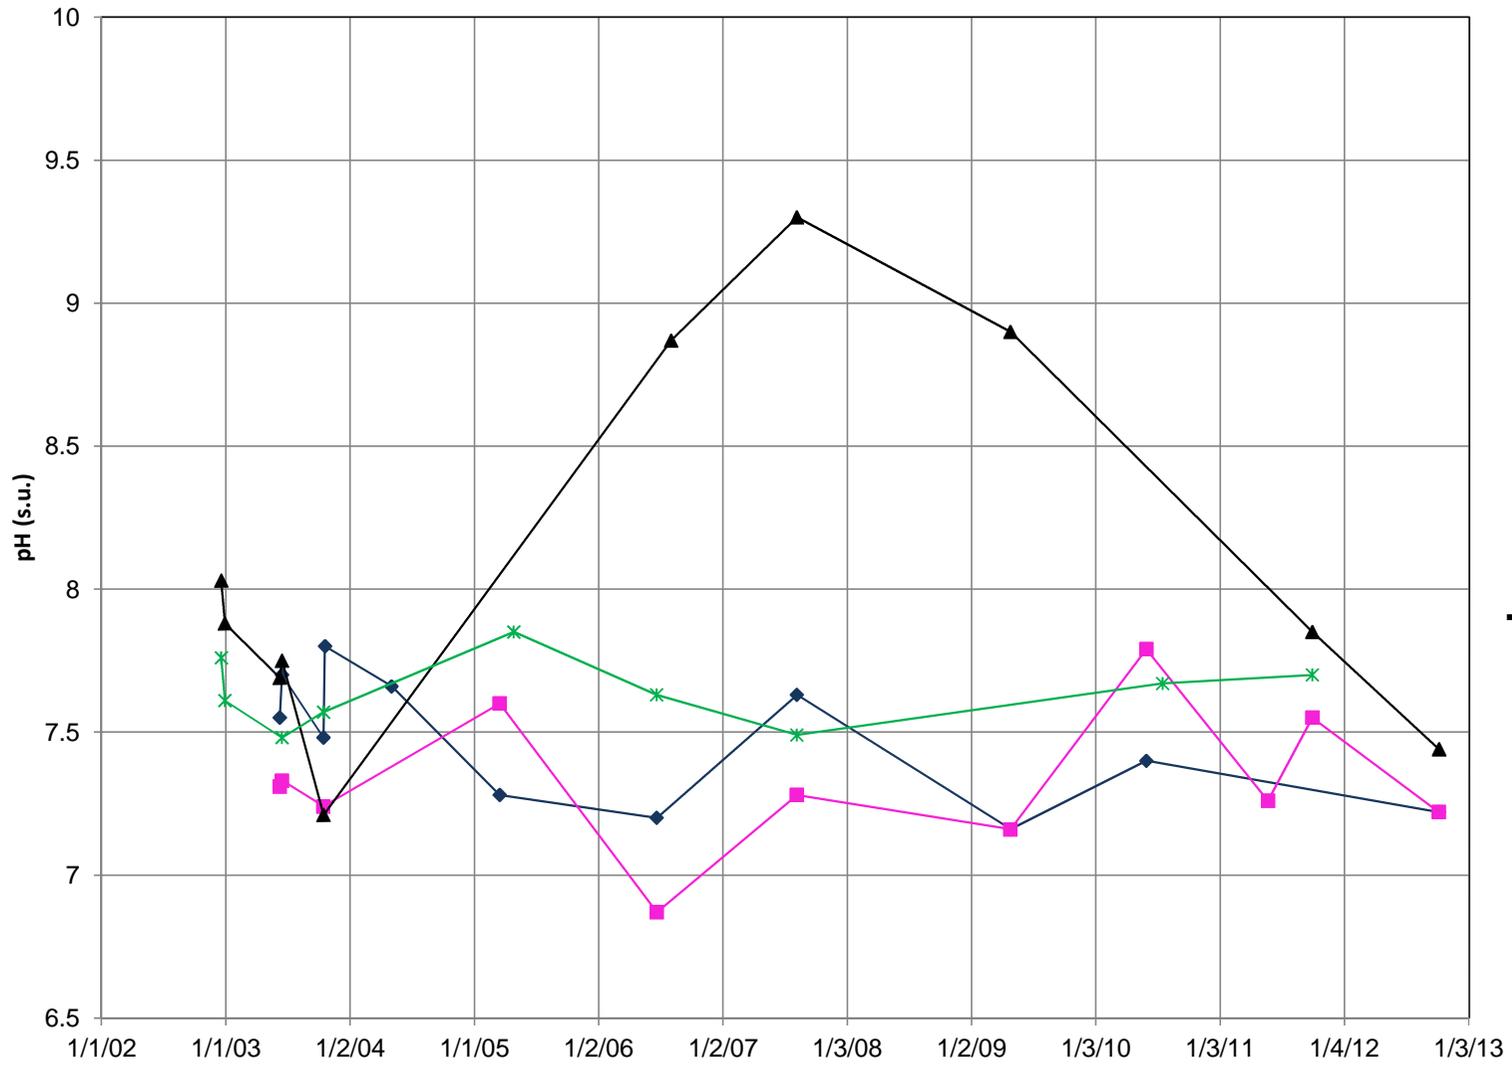
Most values of pH remained between 6.0 and 8.5 for all internal monitoring site samples in 2012 (Figures 2.20a, b and c). PZ-T-00-01, PZ-T-00-2 and PZ-T-00-3, which screen the lower ten feet of the tailings pile, have the highest pH on average of the internal monitoring sites. This is likely a result of microbial sulfate reduction and equilibration with carbonate in the saturated zone of the pile. The wet wells produce water with slightly lower pH (generally between 6.5 and 7.0), reflecting minor influences from groundwater (organic acids) and oxidized surface waters (acidity from thiosalt, sulfide and iron oxidation). With the exception of SL-T-02-06, the suction lysimeters all have pH values between 6.87 and 8.03. SL-T-02-06 exhibited pH values above 8.5 between 2006 and 2009 and returned to a pH below 8.0 during the 2011 sampling event. The higher pH in SL-T-02-06 was likely a result of sulfate reduction.

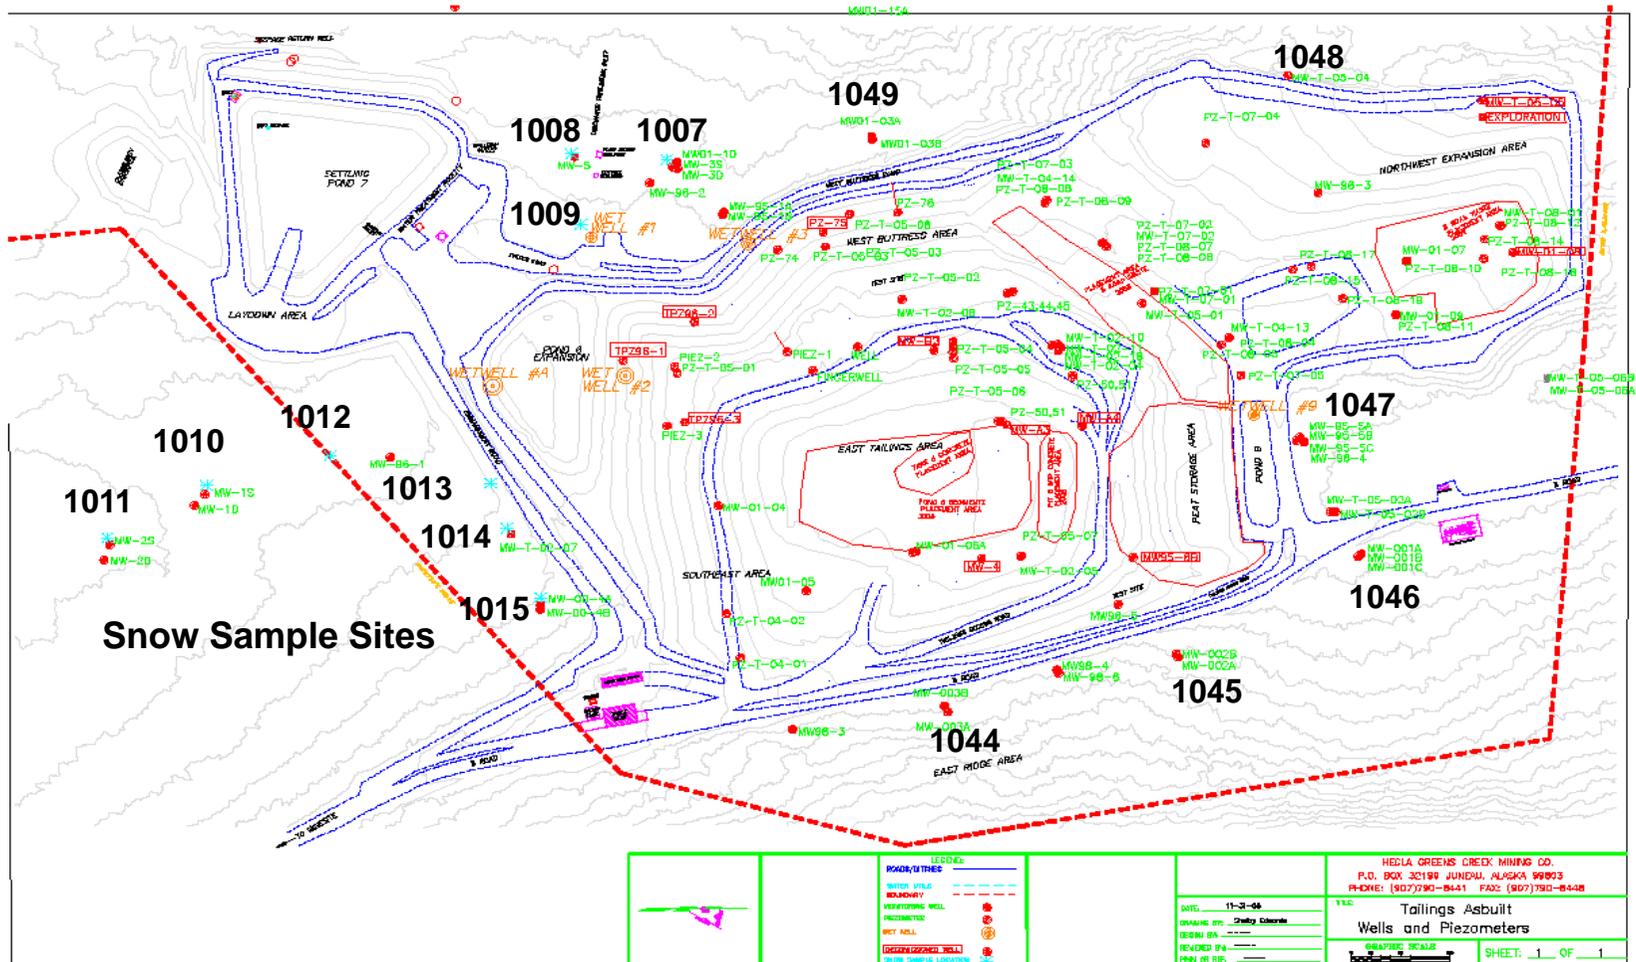
Figure 2.35 Tails Snow Sample Sites

Snow samples were collected just prior to the loss of snow cover each spring in 2007, 2008, 2009, and 2011. Sample locations are shown on Figure 2.35. Additional sites were added in 2009 to provide data around the entire pile. The objective of the sampling was to quantify the amount of tailings dust that had accumulated on the snow pack when conditions for dust loss were greatest (typically December through February). The samples were analyzed for total lead concentrations, and a lead load per square meter was calculated (Table 2.8). The 2006 to 2009 data contained a calculation error. The data reported below have been changed to correct the error.

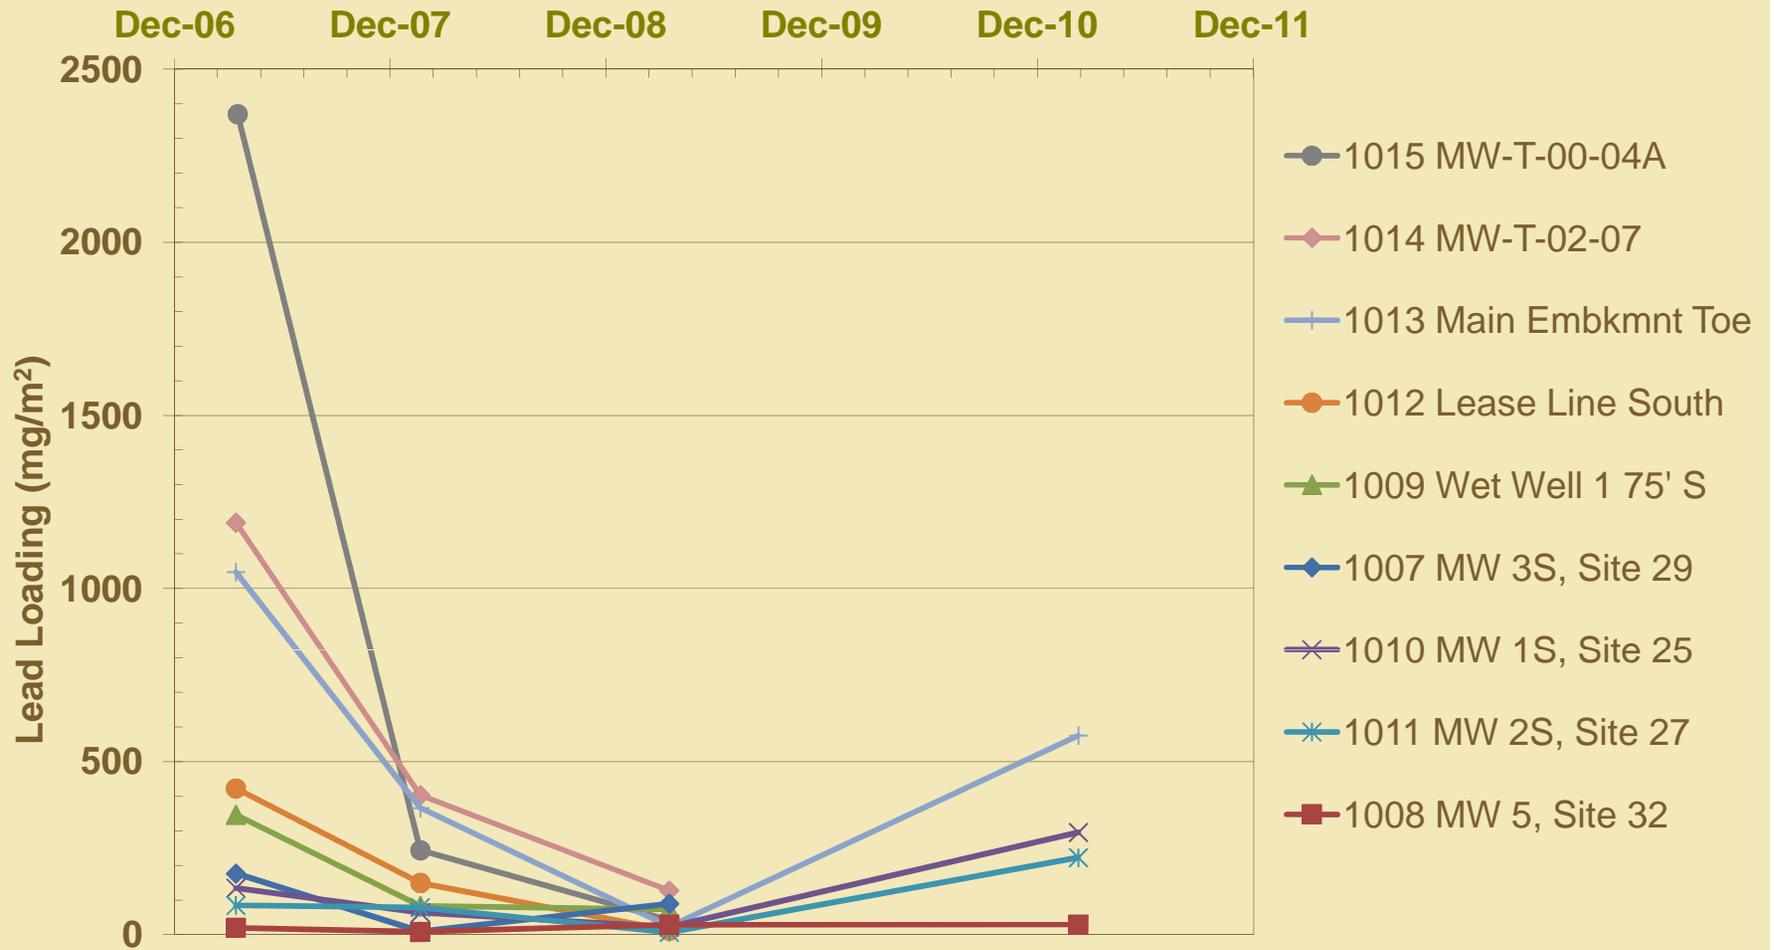
Figure 2.36 Tails Snow Dust Lead Load vs Distance

The data indicate that the loading is observable up to 1600 feet from the pile (Figure 2.36). Several factors, including fewer dust-producing weather events, a shorter snow accumulation period and improved abatement measures, likely contributed to the reduction in calculated loading values since the first year of sampling.

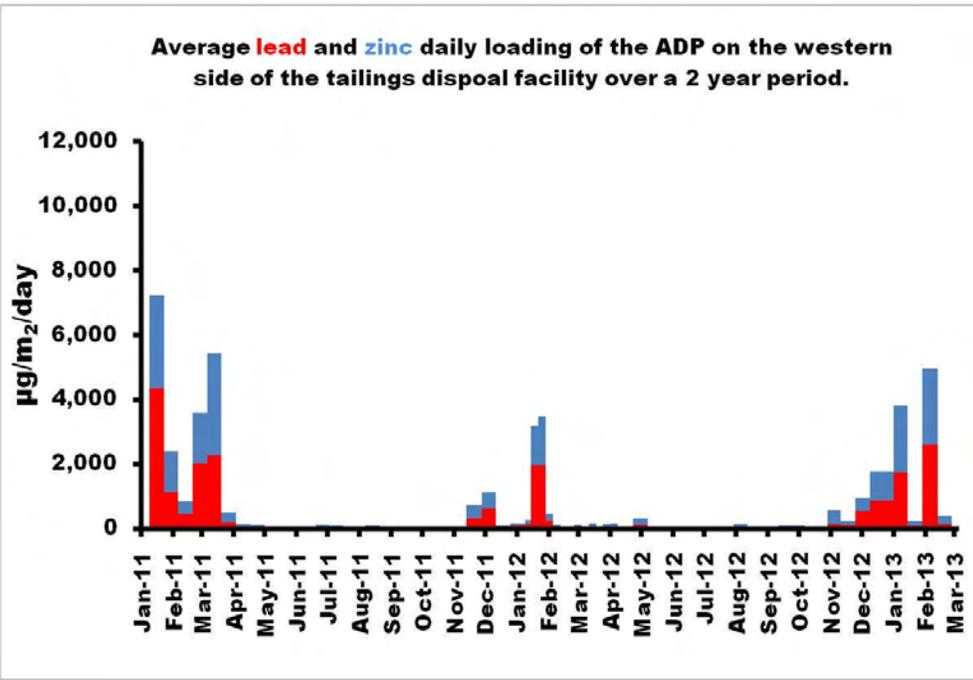
Figure 2.37

This data supports and verifies the statements made previously about the seasonality (winter) of this issue (Figure 2.37): it occurs under cold dry desiccating conditions with moderate wind speeds from the north or northeast. Out of the five ADP systems deployed in 2011, three received a higher rate of loading than the other two; they were ADP systems in the west, southwest, and south. Out of these three systems the south had the highest yearly accumulative lead load of 172,474 ug/m²/year and the west system was similar with accumulative lead load of 168,699 ug/m²/year. The system to the southwest was approximately 1/5th of these values with a lead load of 35,908 ug/m²/year (Table 2.9). This lower load may reflect that the ADP system here is farther away from the pile than the other two.

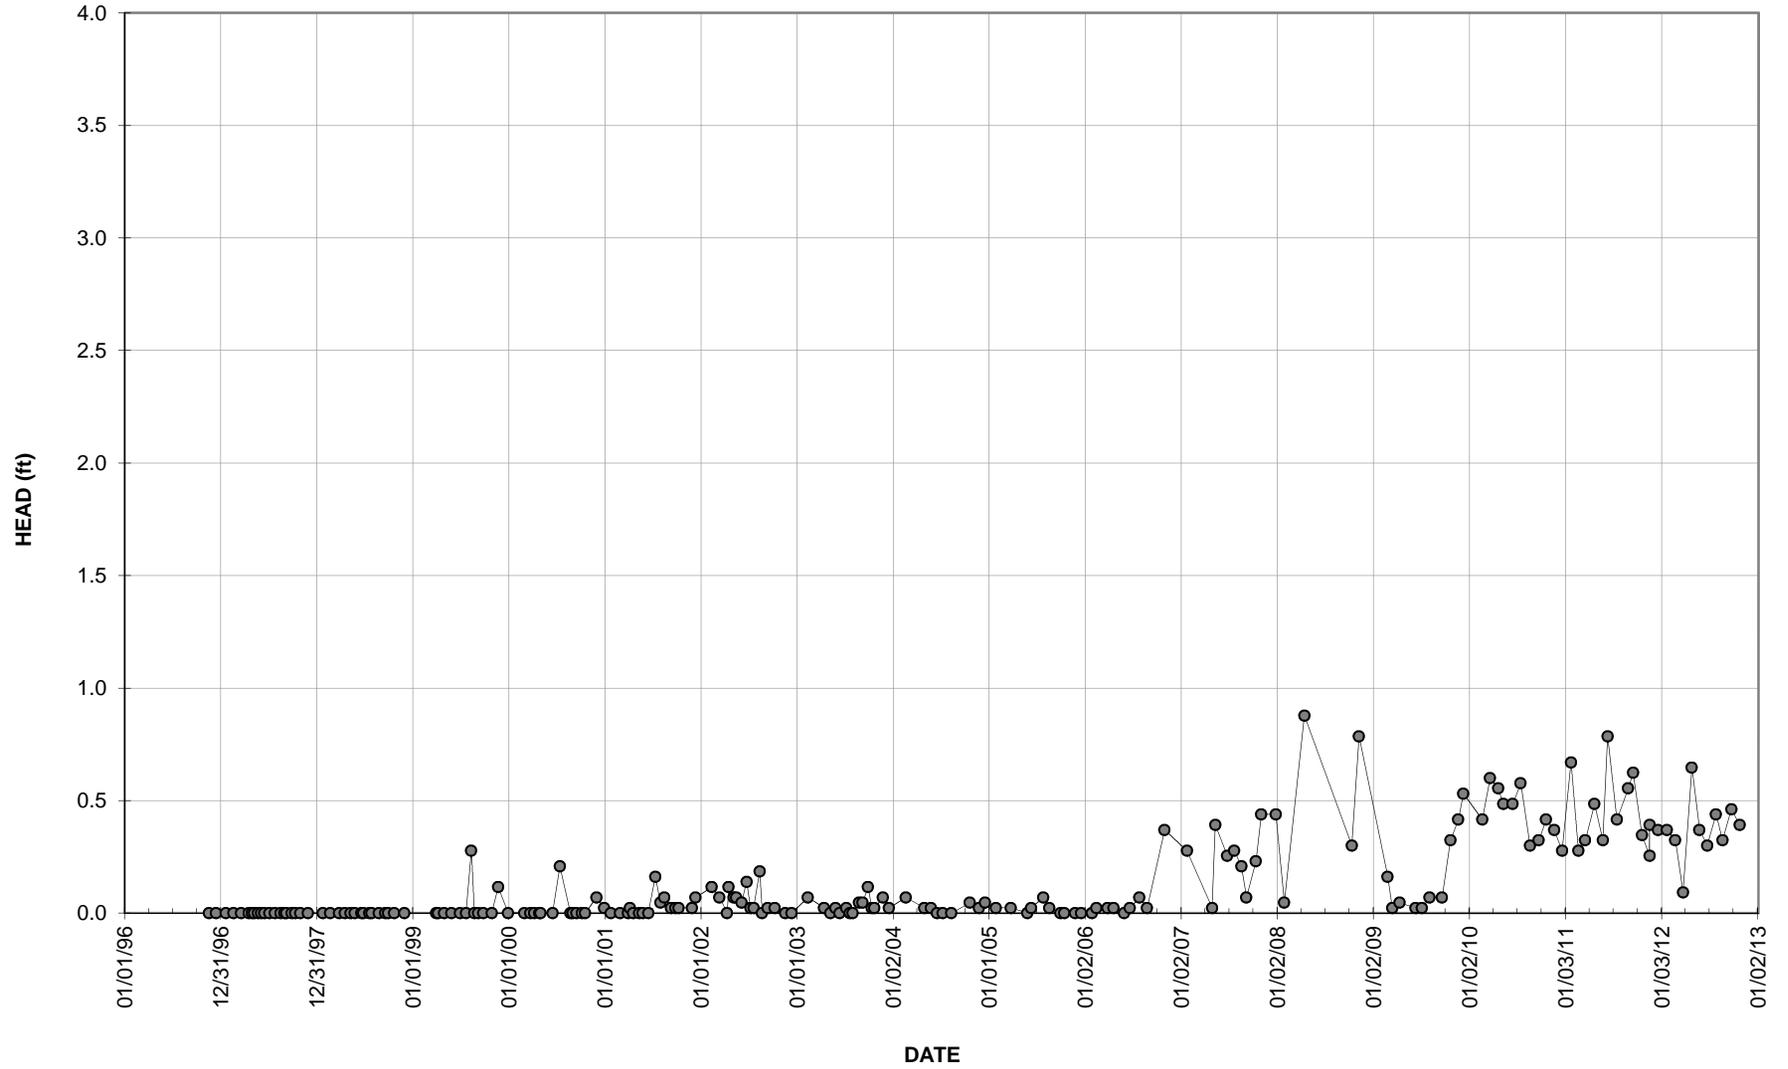
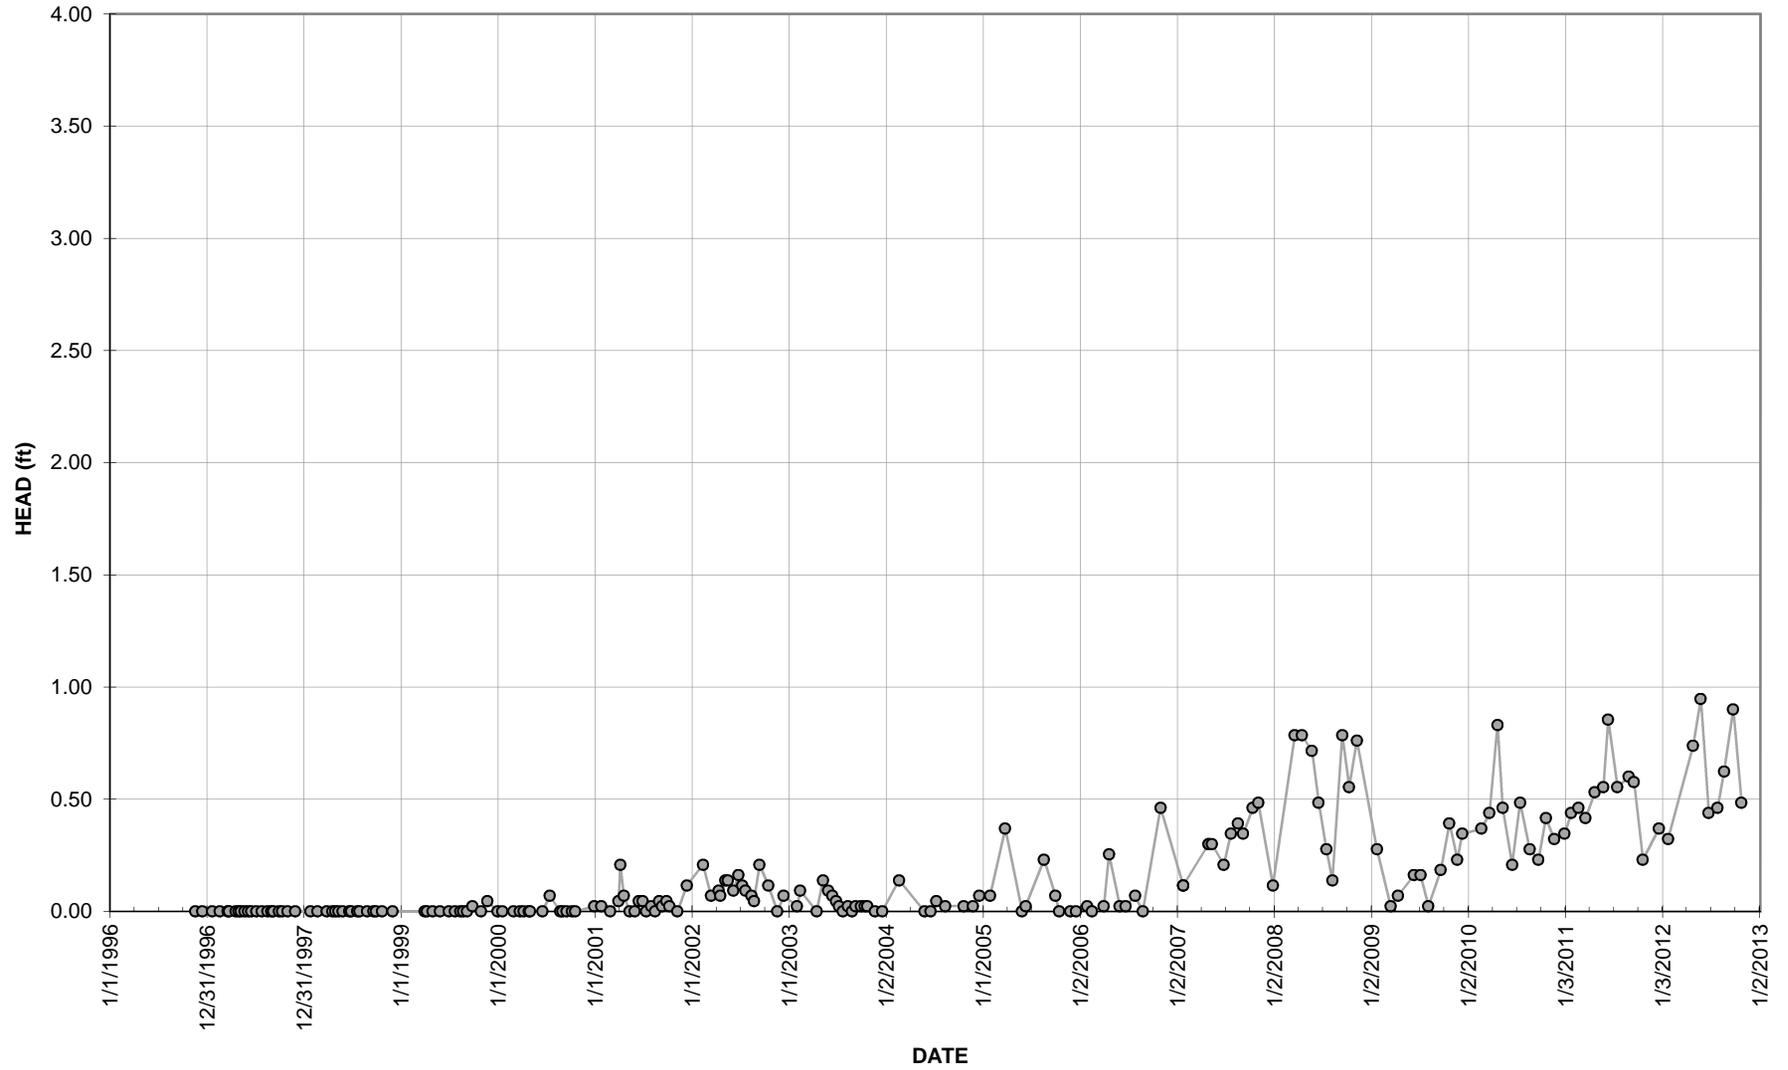
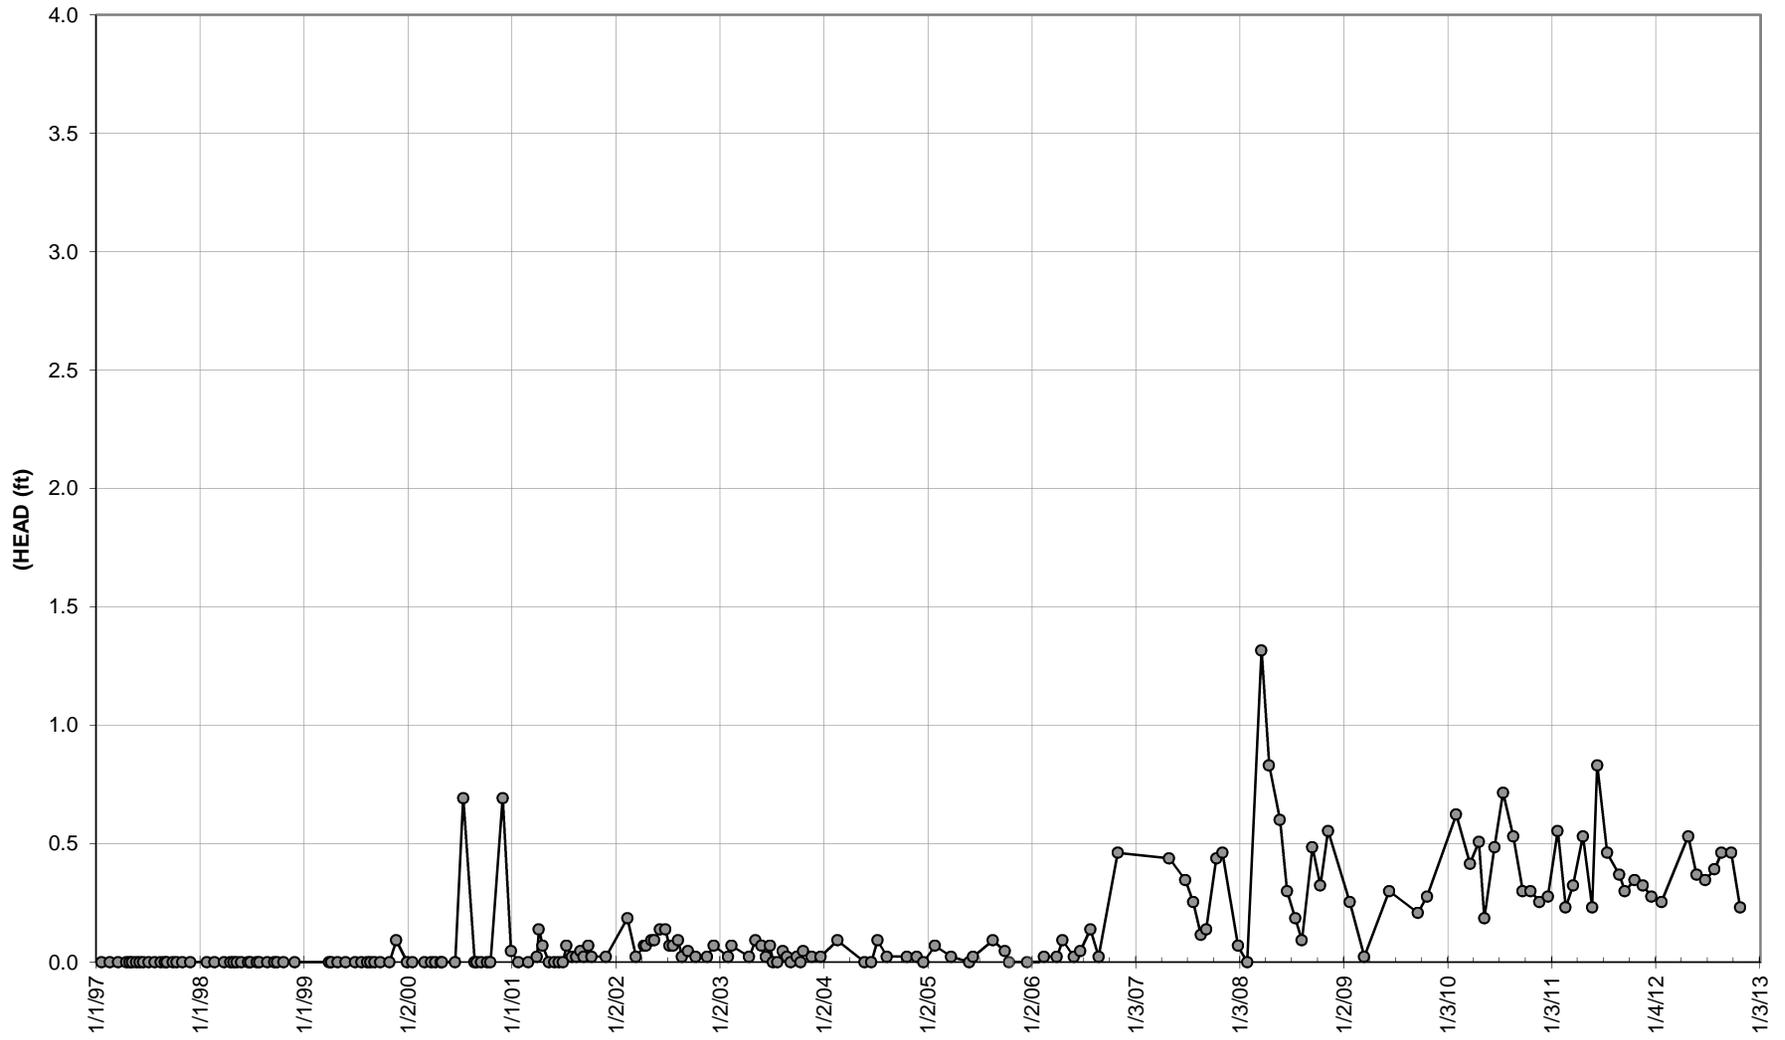
Well and piezometer water level data are provided in Figures 3.1 to 3.12. The lack of significant pressure in piezometers installed close to the base of Site 23 (piezometers 52-55, Figures 3.1 to 3.4) demonstrates that the pile remains free draining. This is consistent with the construction of a network of finger drains under the pile and a blanket drain at the pile toe. Comparison of historic versus modeled flow from the finger drains and the curtain drain indicated they are performing as designed and as necessary (EDE 2004). See Appendix 2 for piezometer and finger drain locations. The lack of pore pressure at the toe indicates that pile stability has been maximized. Water levels from several monitoring locations are shown in Appendix 2. The inferred water table is 30 to 60 feet below the base of the production rock pile material up-slope of the Site 23 active placement area and 5 to 20 feet below the base of material placed in Site D and the toe of Site 23, respectively (see also Figures 3.5 to 3.12). MW-23-00-03 data showed an atypical drop in water elevation in August 2007. However, data collected after that date are within the historical data range. Observations from wells completed in the colluvium below the sites indicate that perched water tables and braided flow paths exist beneath the site (e.g. compare Figure 3.6 and 3.7). This unit also shows large (up to 10 feet) fluctuations in head levels, which are consistent with perched, confined conditions and channel-like flow. There is a distinct seasonal pattern to the water level fluctuations beneath Site 23/D, particularly in the alluvial sands (Figures 3.9 and 3.11).

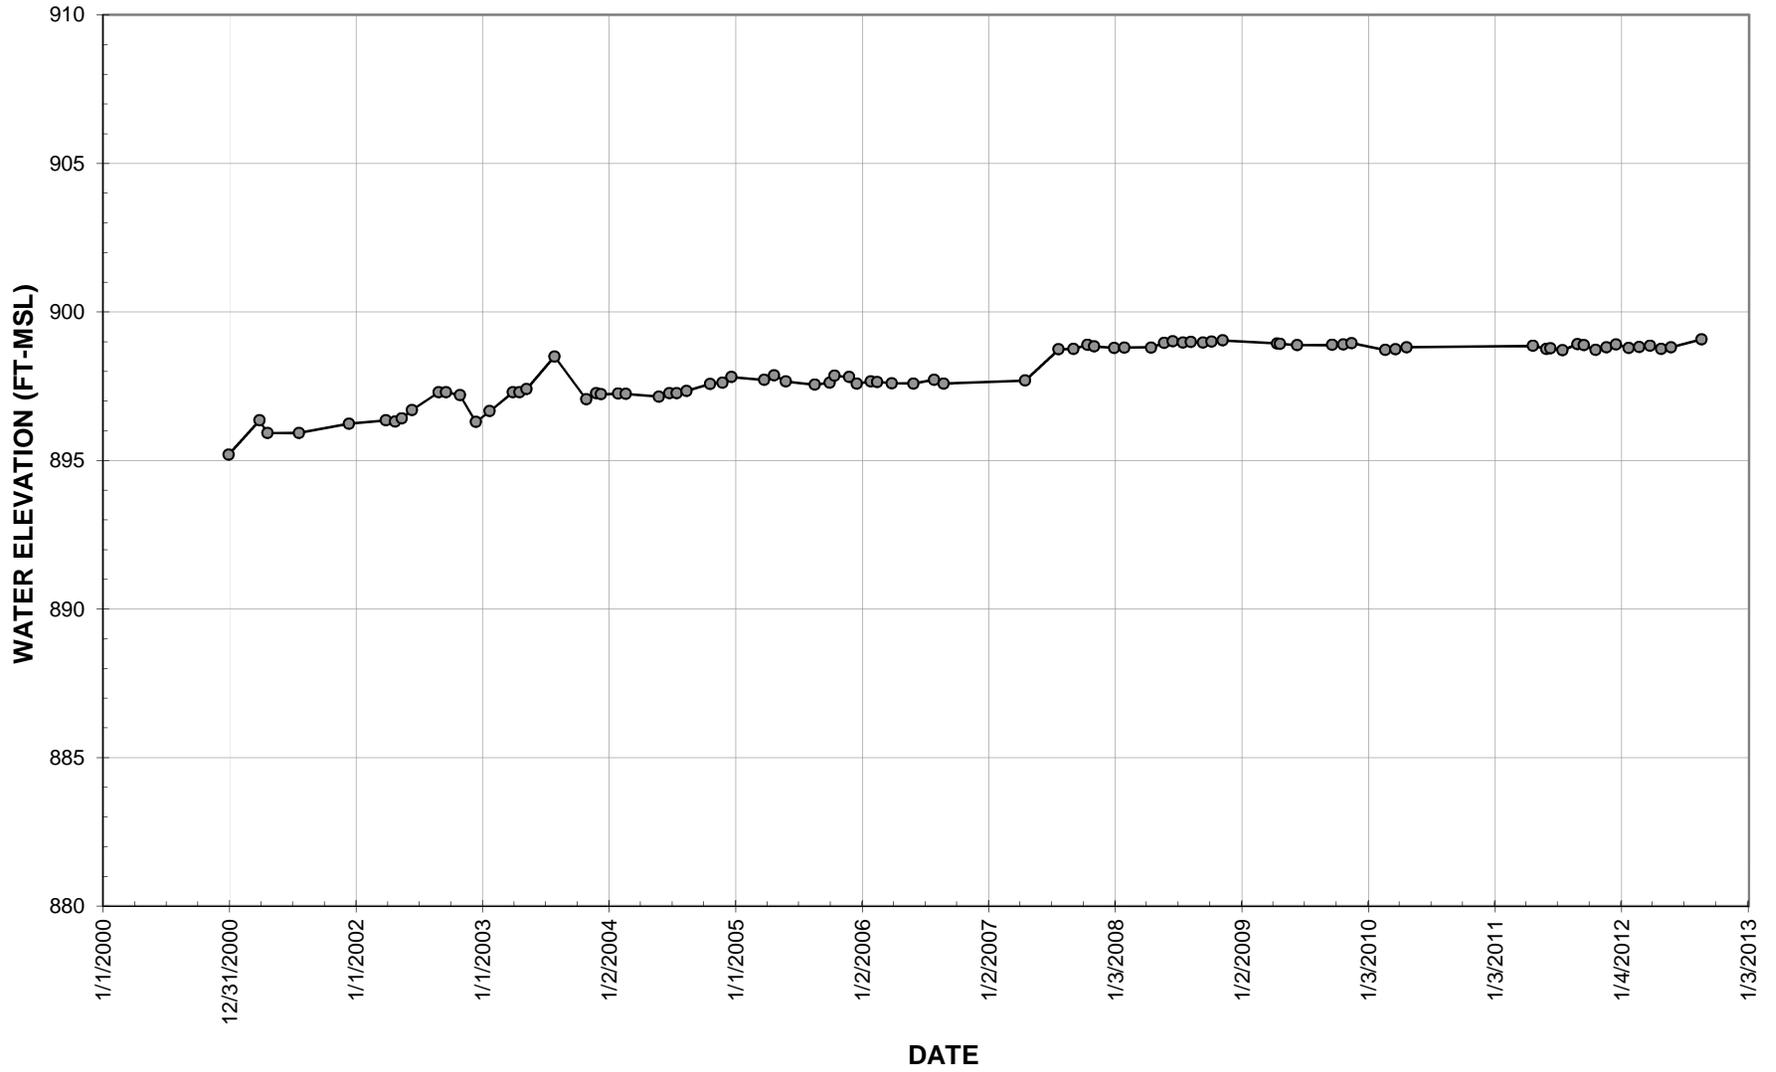
Figure 3.8 Water Level Data for Well MW-23-98-01

The silty/clay till that underlies the colluvial unit impedes downward flow and has an upward hydrologic gradient caused by its confining the more permeable bedrock below it. MW-23-98-01 (Figure 3.8) is completed in the till unit and indicates a water table near the top of the till, which is approximately 100 feet below the existing topographic surface. Alluvial sands occur between the colluvial unit and the silt/clay till near the toe of Site 23 and under Site D. Data from MW-23-A4 and MW-D-94-D3 (Figures 3.9 and 3.11) indicate that the sands are saturated. A curtain drain installed in between Site D and Site 23 in 1994 collects water that flows at the base of the colluvial unit and the top of the alluvial sands (see as-built and sections). This drain helps reduce pore pressures in the foundation of Site D, as well as capturing infiltration waters from Site 23.

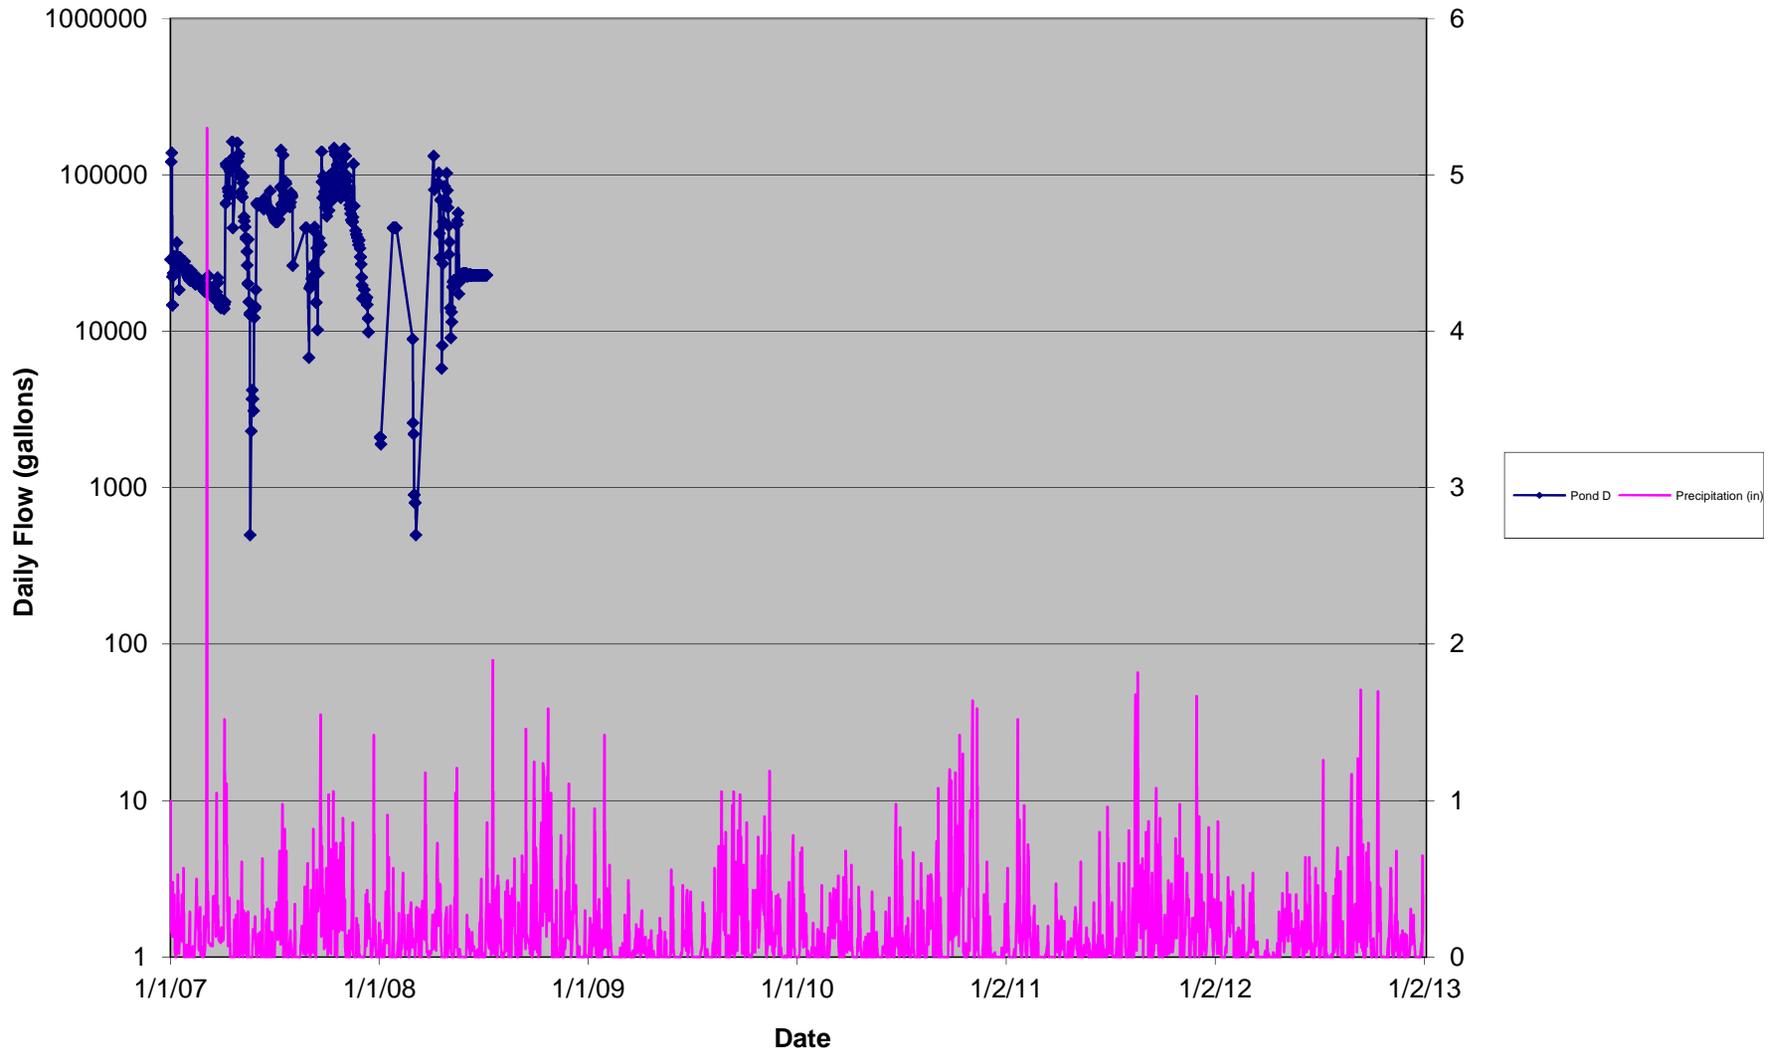
FIGURE 3.13 POND D FLOW DATA

Flow data for Pond D are shown with precipitation in Figure 3.13. The Pond D flow meter was not operating from July 2008 through 2012 due to changes in pumping/piping as noted above. Once all equipment is in place and operating, flow measurements will resume.
