**TAILINGS AND PRODUCTION ROCK SITE
2012 ANNUAL REPORT**

Hecla Green Creek Mining Company

April 15, 2013

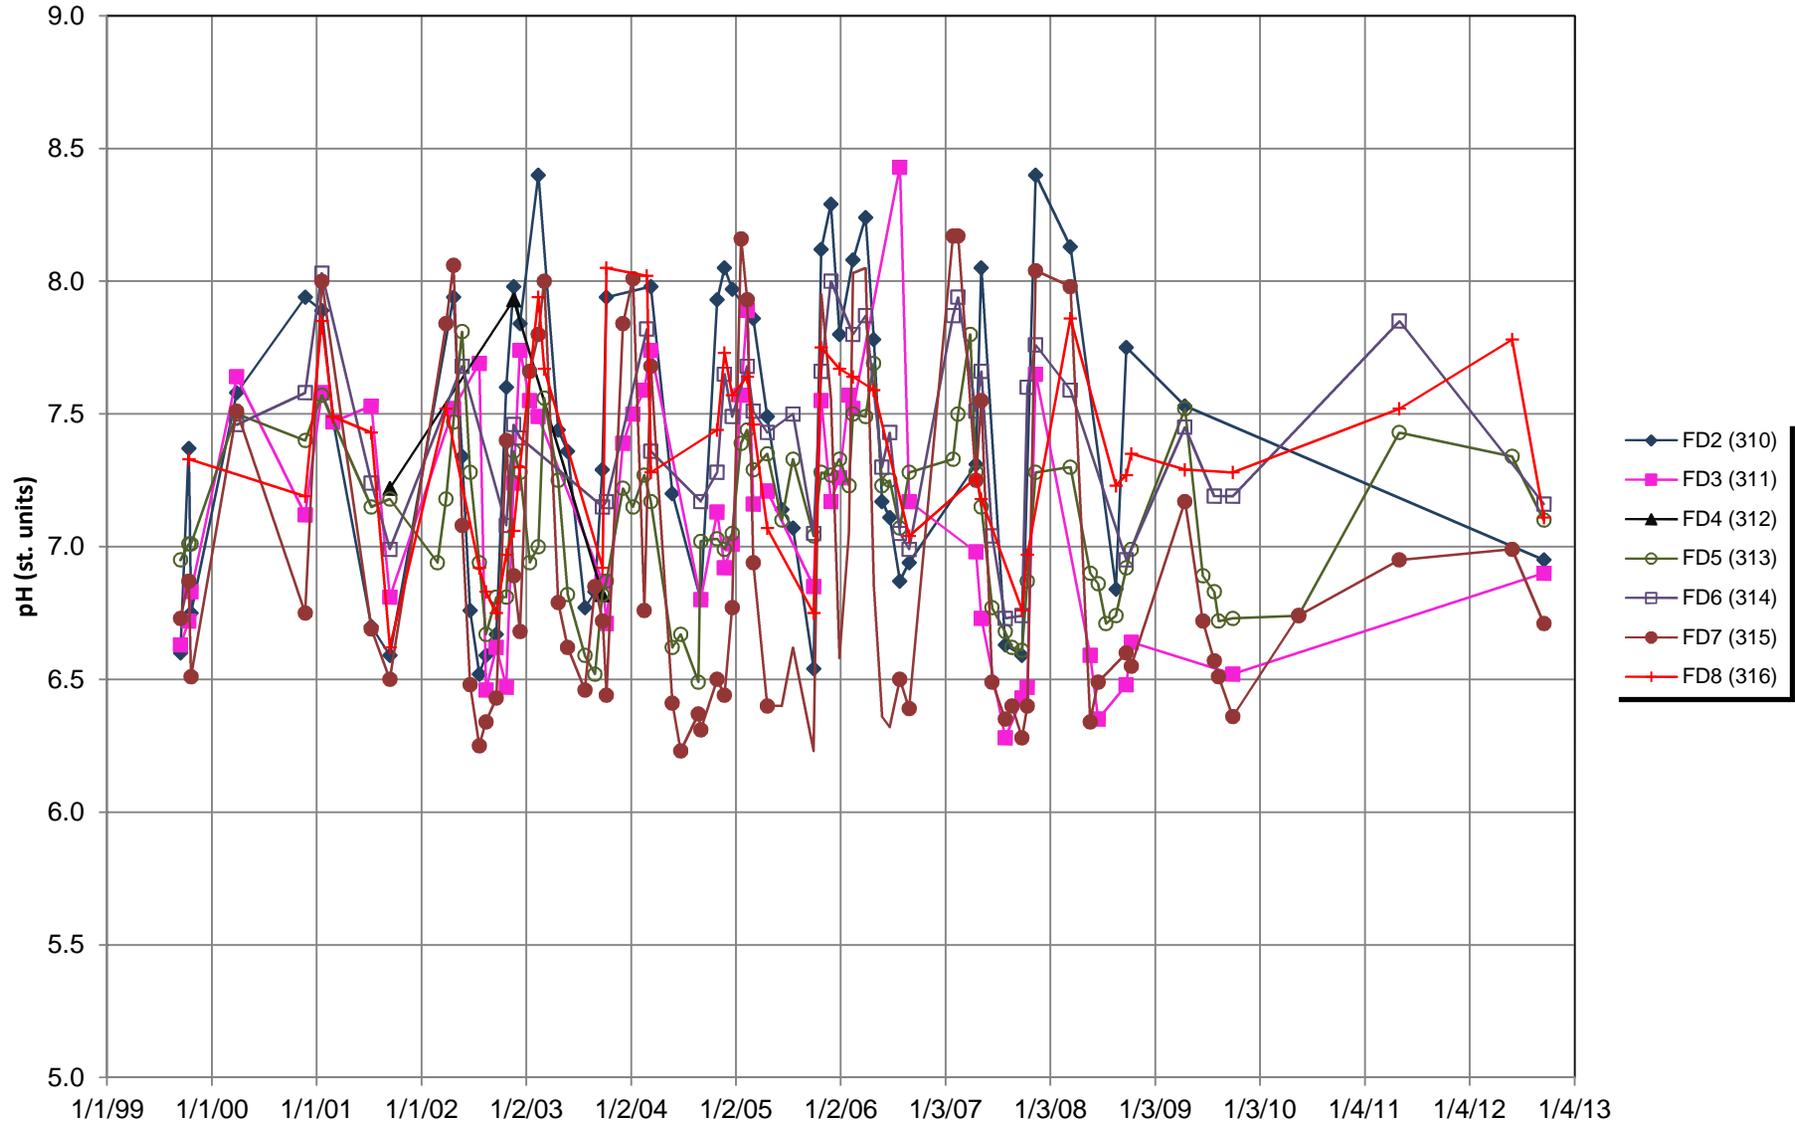
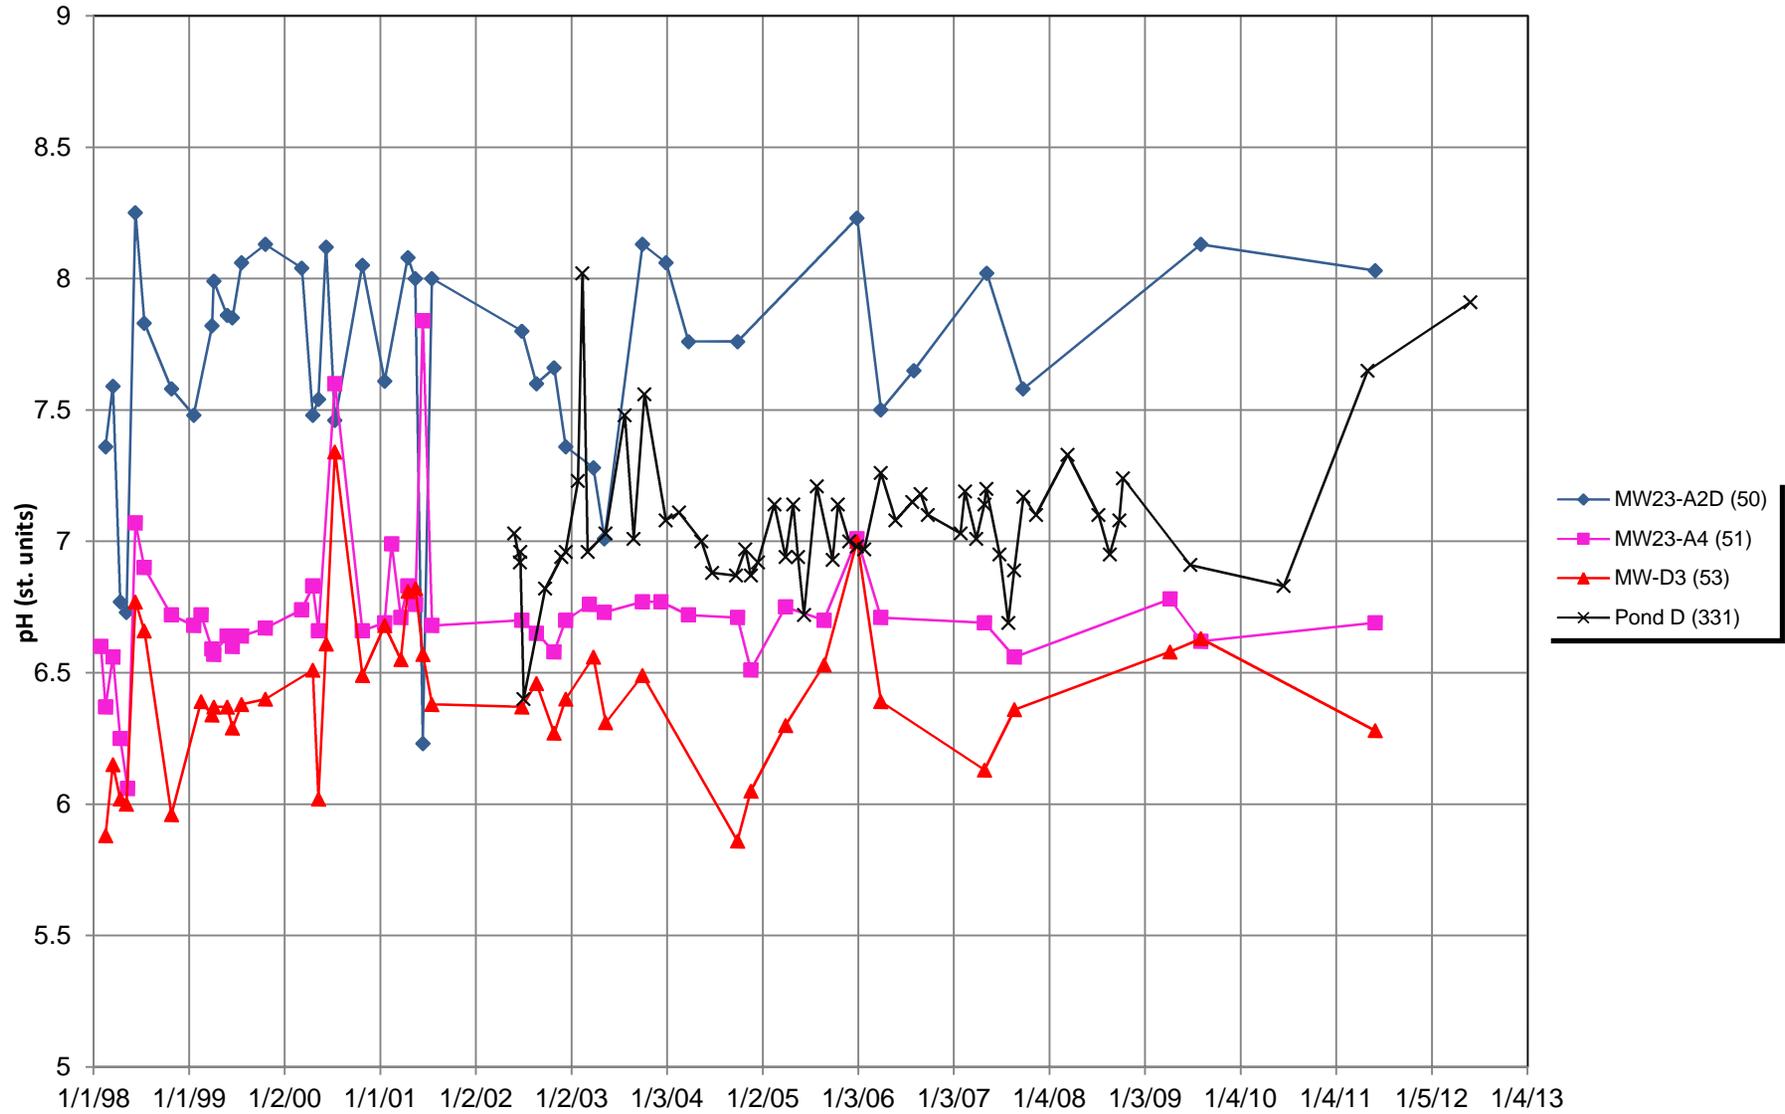
Figure 3.14a shows the pH of waters collected from Site 23 Finger Drains 2 through 8, and Figure 3.14b shows the pH of monitoring wells MW-23-A2D, MW-23-A4, MW-D3 and Pond D (see as-built in Appendix 2 for locations). Values of pH were between 6.3 and 8.0 for all internal monitoring sites sampled in 2012. The lower pH values (generally pH 6.0 to 7.0) were recorded in MW-23-A4 and MW-D3, both of which are completed in alluvial sands beneath Site 23 and Site D, respectively. MW-23-A2D, which screens colluvium upgradient of Site 23, typically has the highest pH (generally pH 7.0 to 8.5). The Site 23 finger drains fluctuate at values between those of the monitoring wells. Figures 3.14a and b suggest that waters from different foundation units have different pH values and that Site 23 and Site D contact waters and the materials with which they are in contact exhibit sufficient buffering capacity to prevent acidification of site drainage in the near term. Seasonal fluctuations are apparent in the finger drains with highest pH values occurring in winter months and lower pH in mid to late summer.

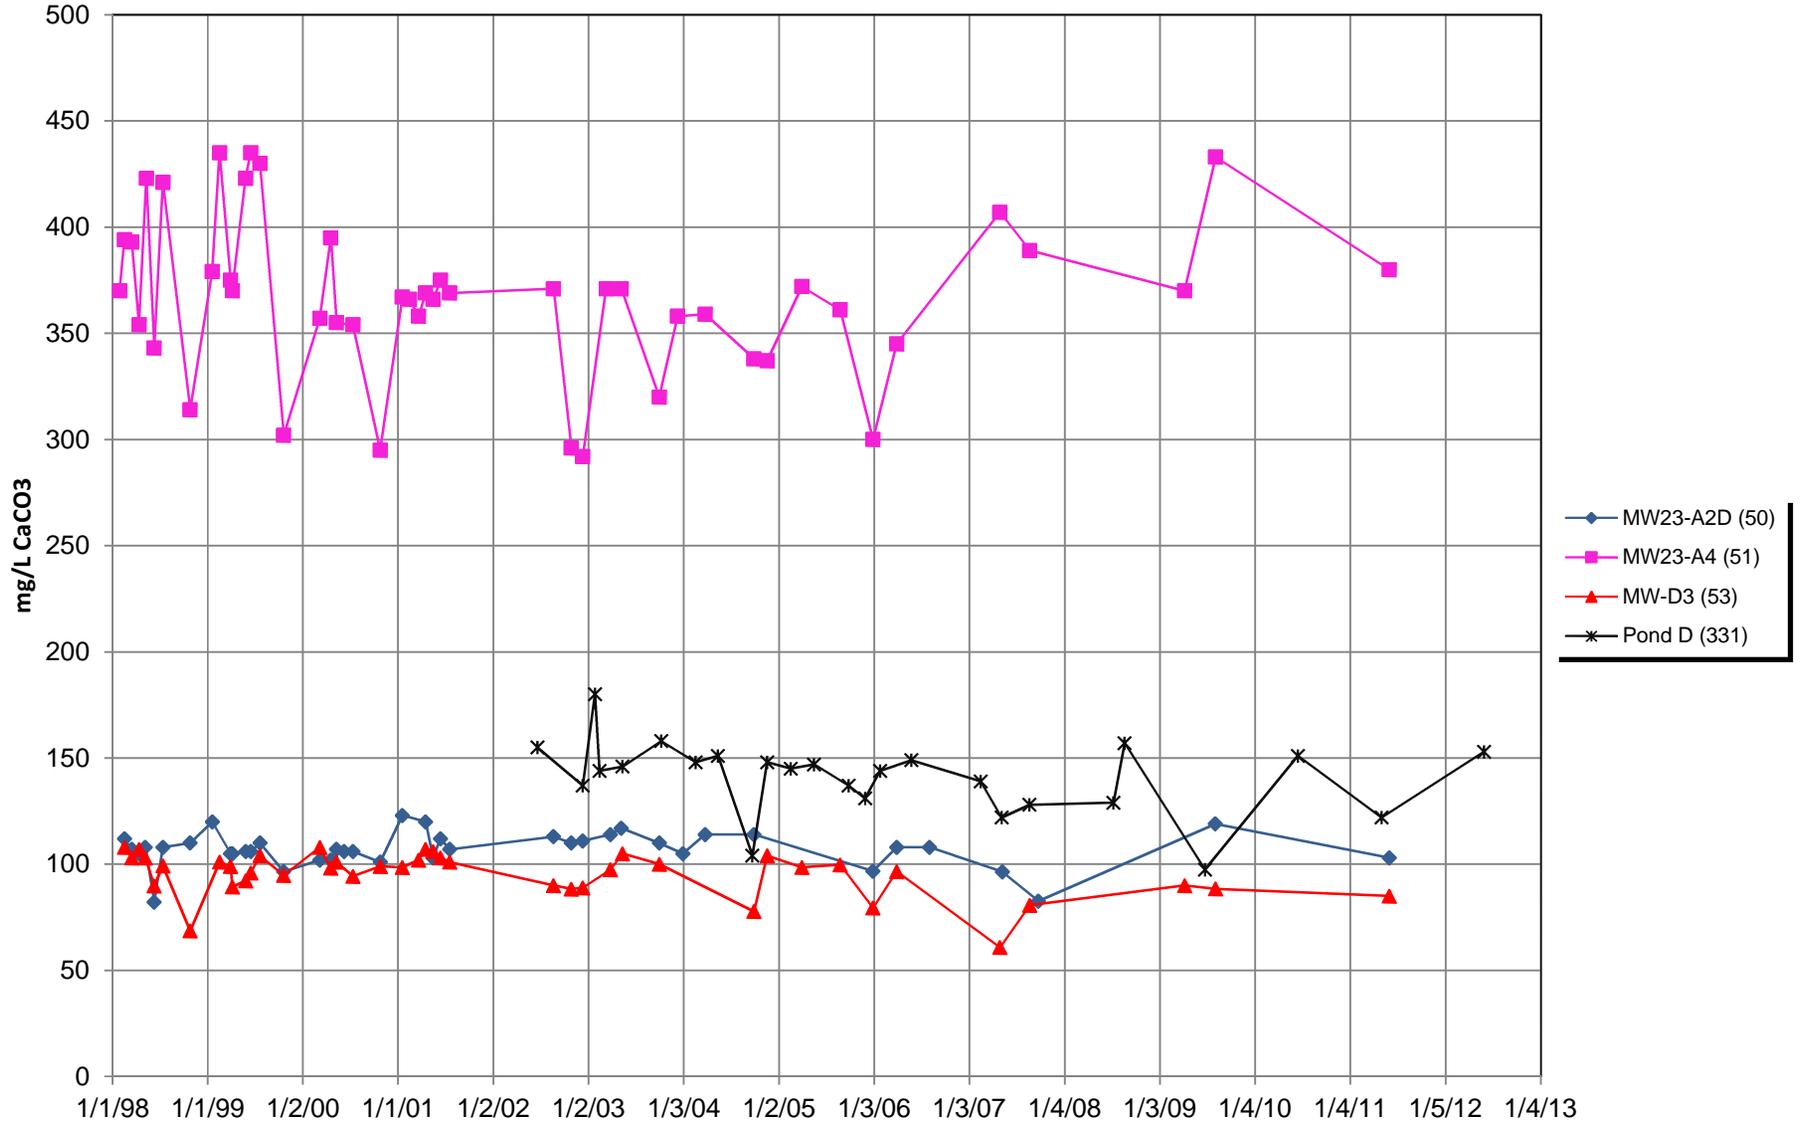
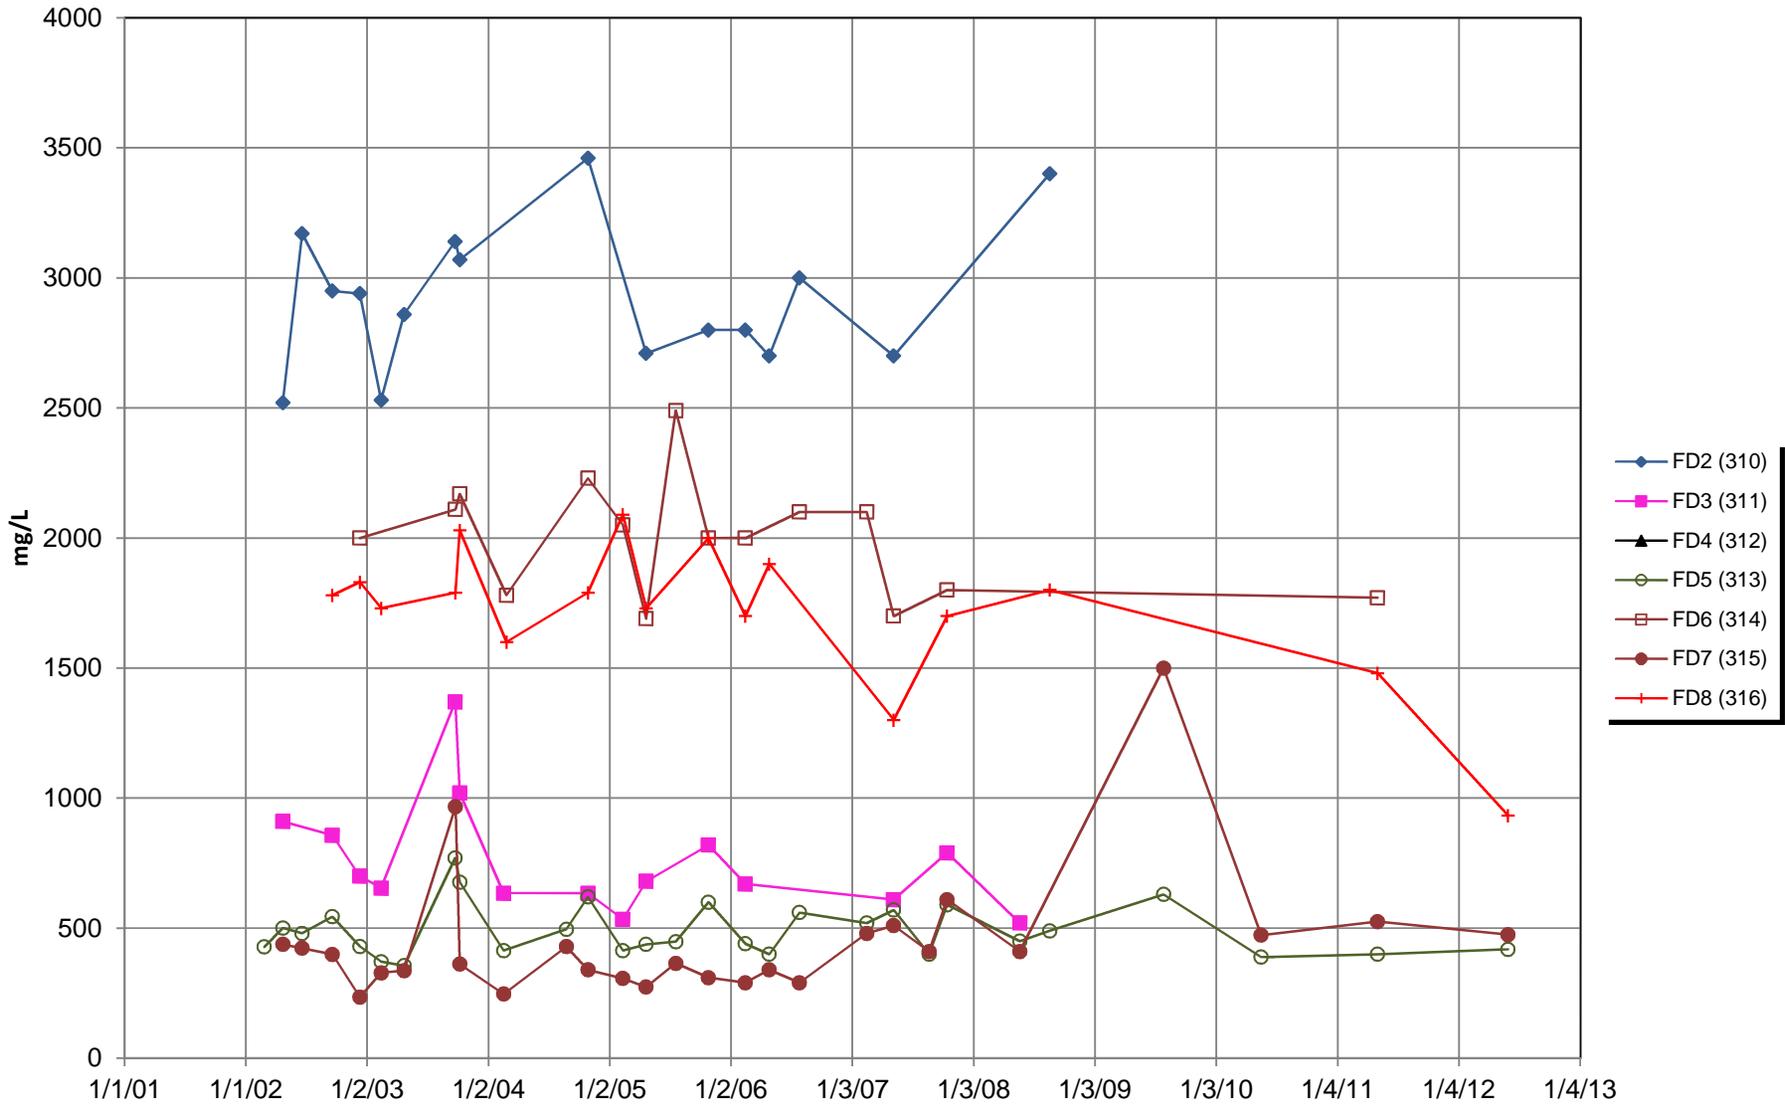
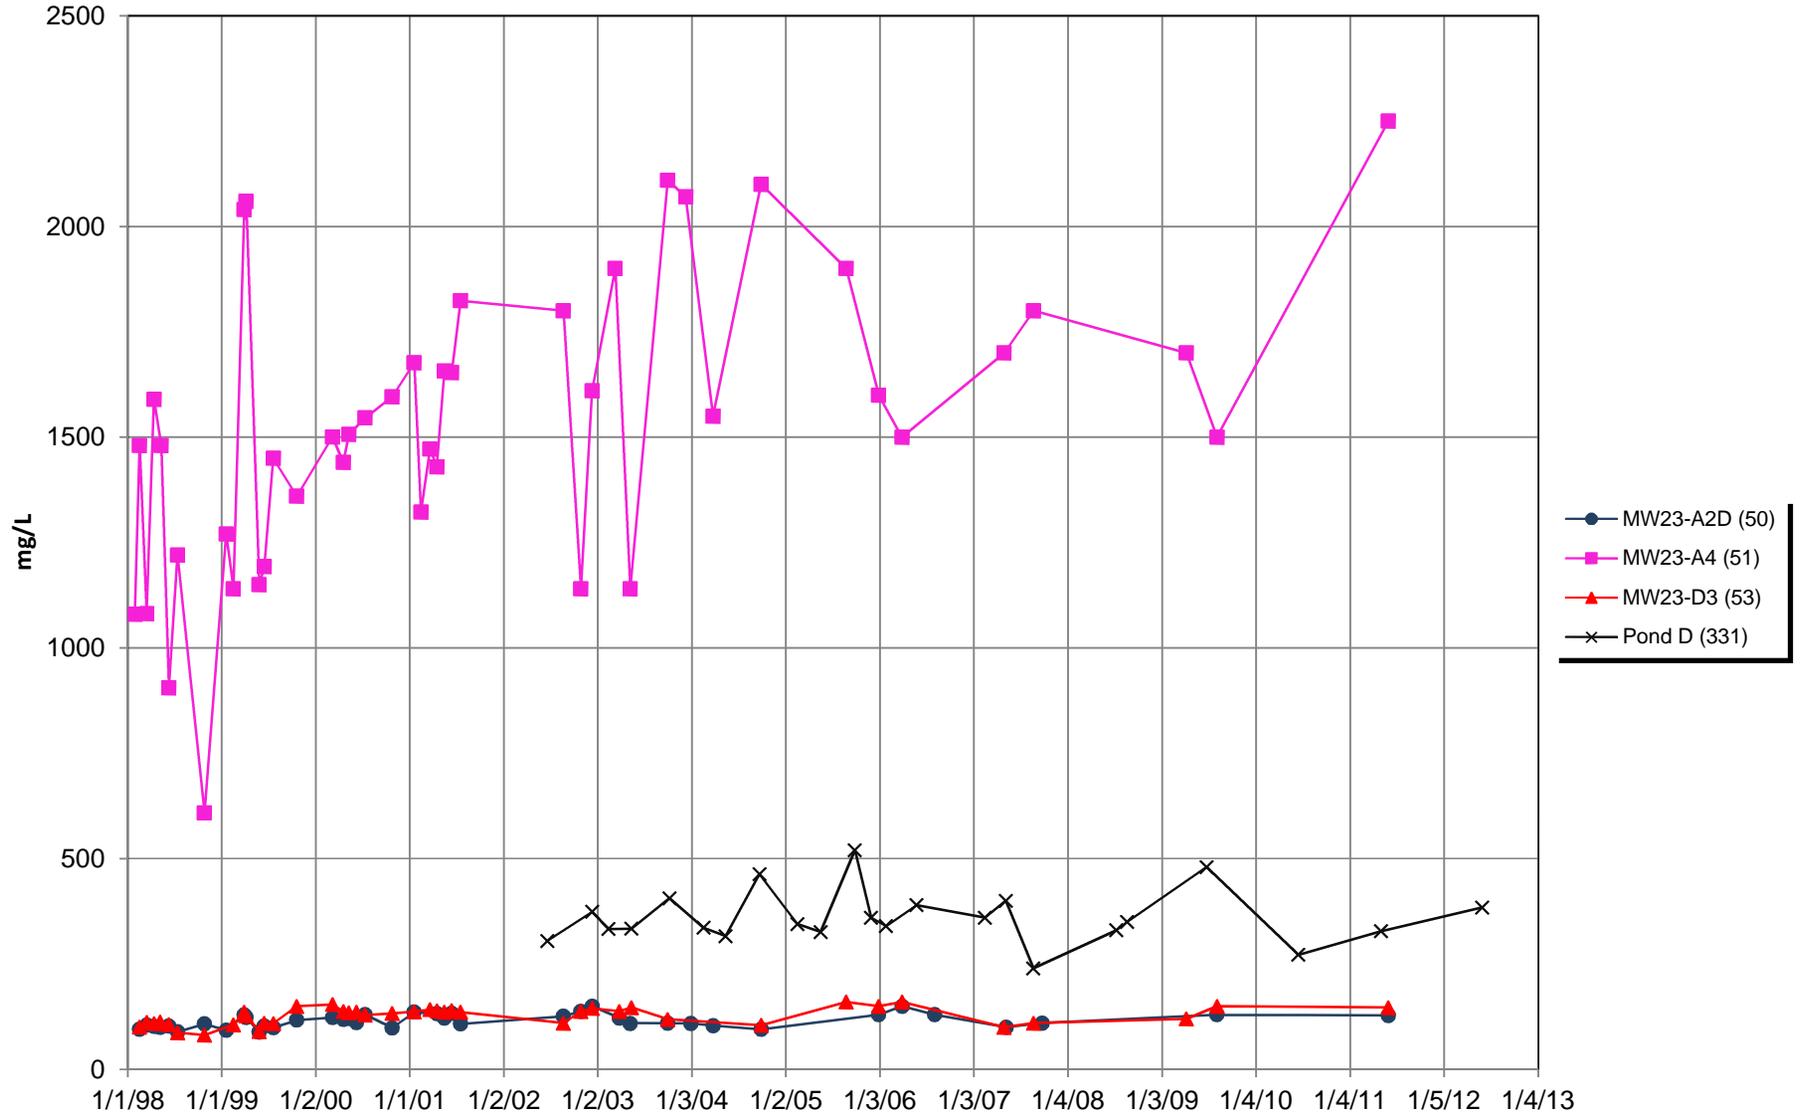
As with pH, high alkalinity values (Figures 3.15a and b) indicate that the waters are well buffered. Fluctuations in alkalinity correlate with those of other parameters, such as hardness (Figures 3.16a and b) and conductivity (Figures 3.17a and b), and also appear to be seasonal. Carbonate minerals in the production rock contribute to the high alkalinity of the drainage from the finger drains. Alkalinity is lowest in samples with the highest groundwater component (e.g. the monitoring wells, Pond D, 23FD-5 and 23FD-7). Calcium and magnesium are the primary contributors to hardness (Figure 3.16a) and reflect dissolution of carbonate minerals, such as calcite and dolomite. Carbonate dissolution neutralizes acidity formed by sulfide oxidation, which is also the source of sulfate shown in Figure 3.18a.

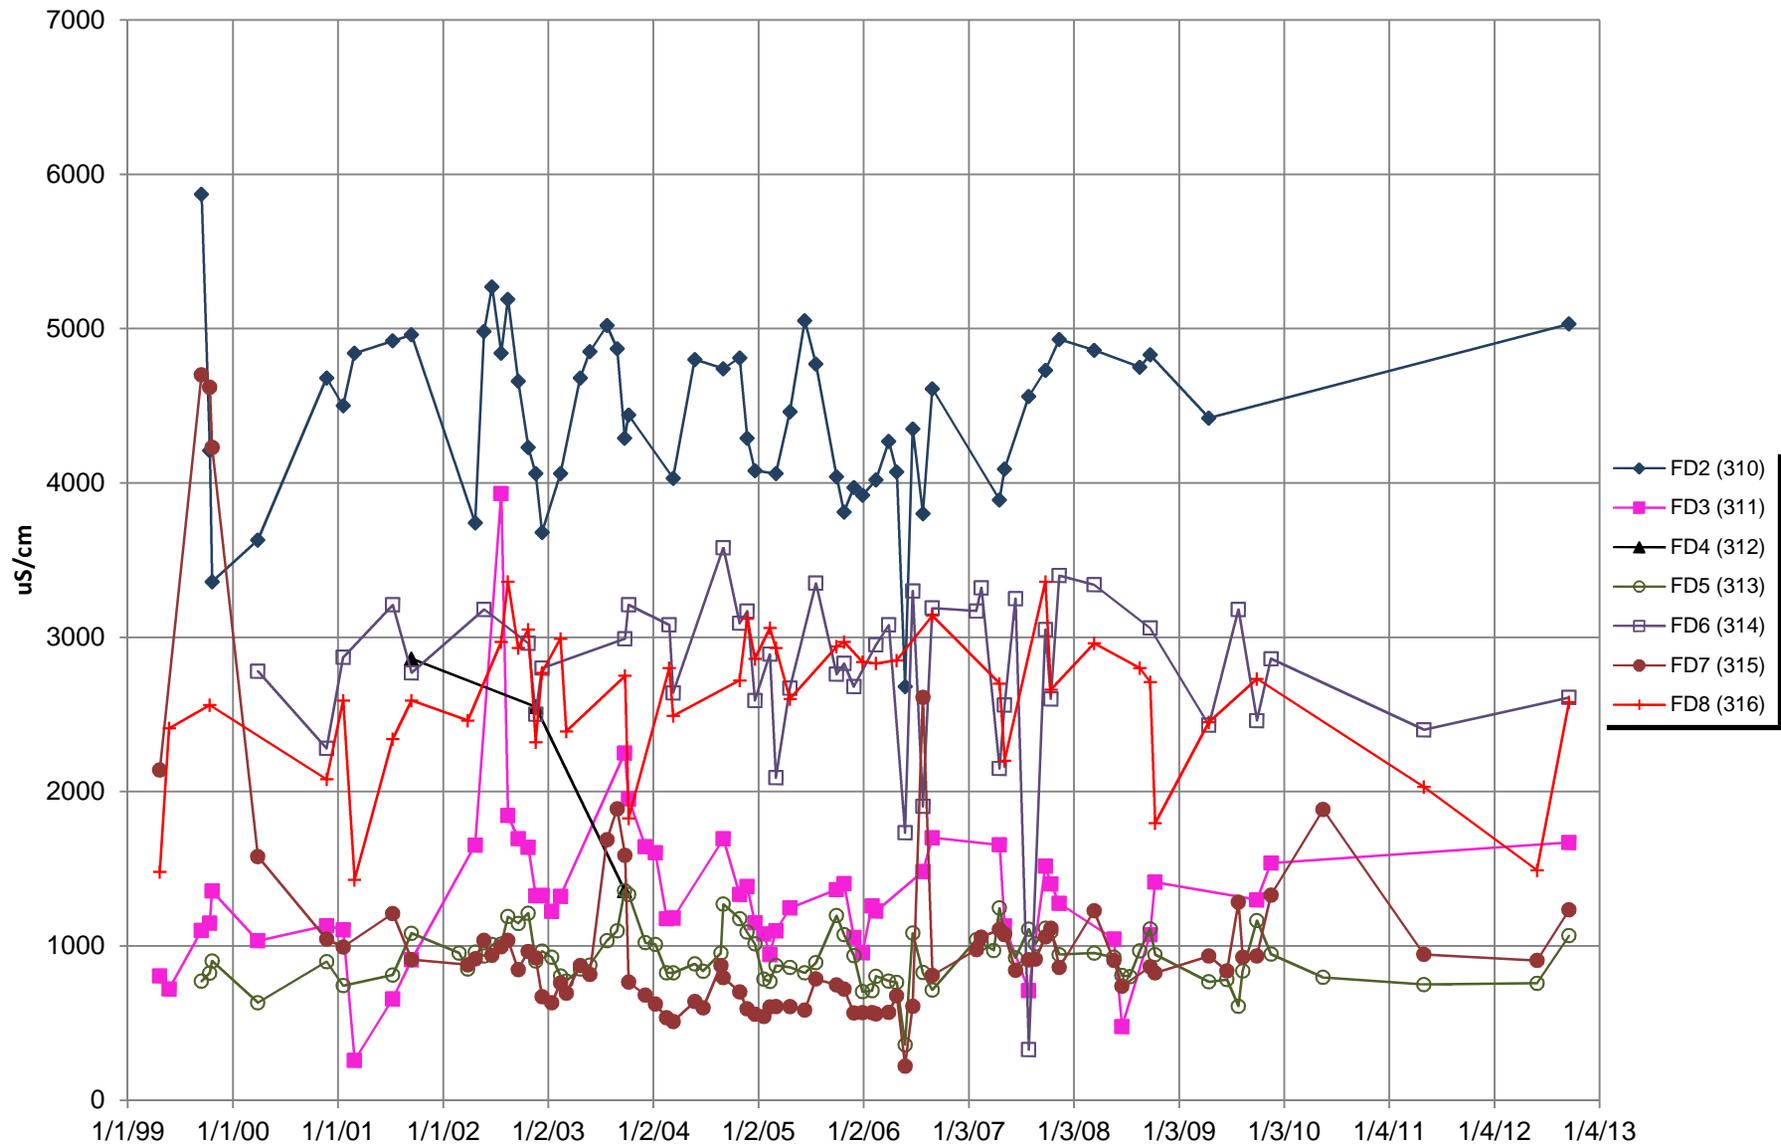
Figure 3.17a GREENS CREEK SITE 23/D INTERNAL MONITORING SITES:
FINGER DRAINS - CONDUCTIVITY

Finger Drain 23FD-2 has the highest conductivity but consistently low flow, suggesting no significant influence from groundwater. In fact, lack of flow from this drain typically precludes sampling. In 2009 it was dropped from the routine sampling list. The higher conductivity of the site contact waters reflects a larger dissolved load caused by weathering of the production rock. As with tailings, pyrite oxidation and carbonate dissolution contribute dissolved ions such as sulfate, bicarbonate, calcium and magnesium to the contact waters, increasing their conductivity. Sulfate concentrations for the finger drains and groundwater wells are plotted in Figures 3.18a and 3.18b and match closely the relative value patterns of conductivity. The drier than average spring and summer in 2009 and 2010 likely contributed to a greater buildup of oxidation products and reduced groundwater contribution to the water balance. This may result in higher conductivity and sulfate values for some sample sites.

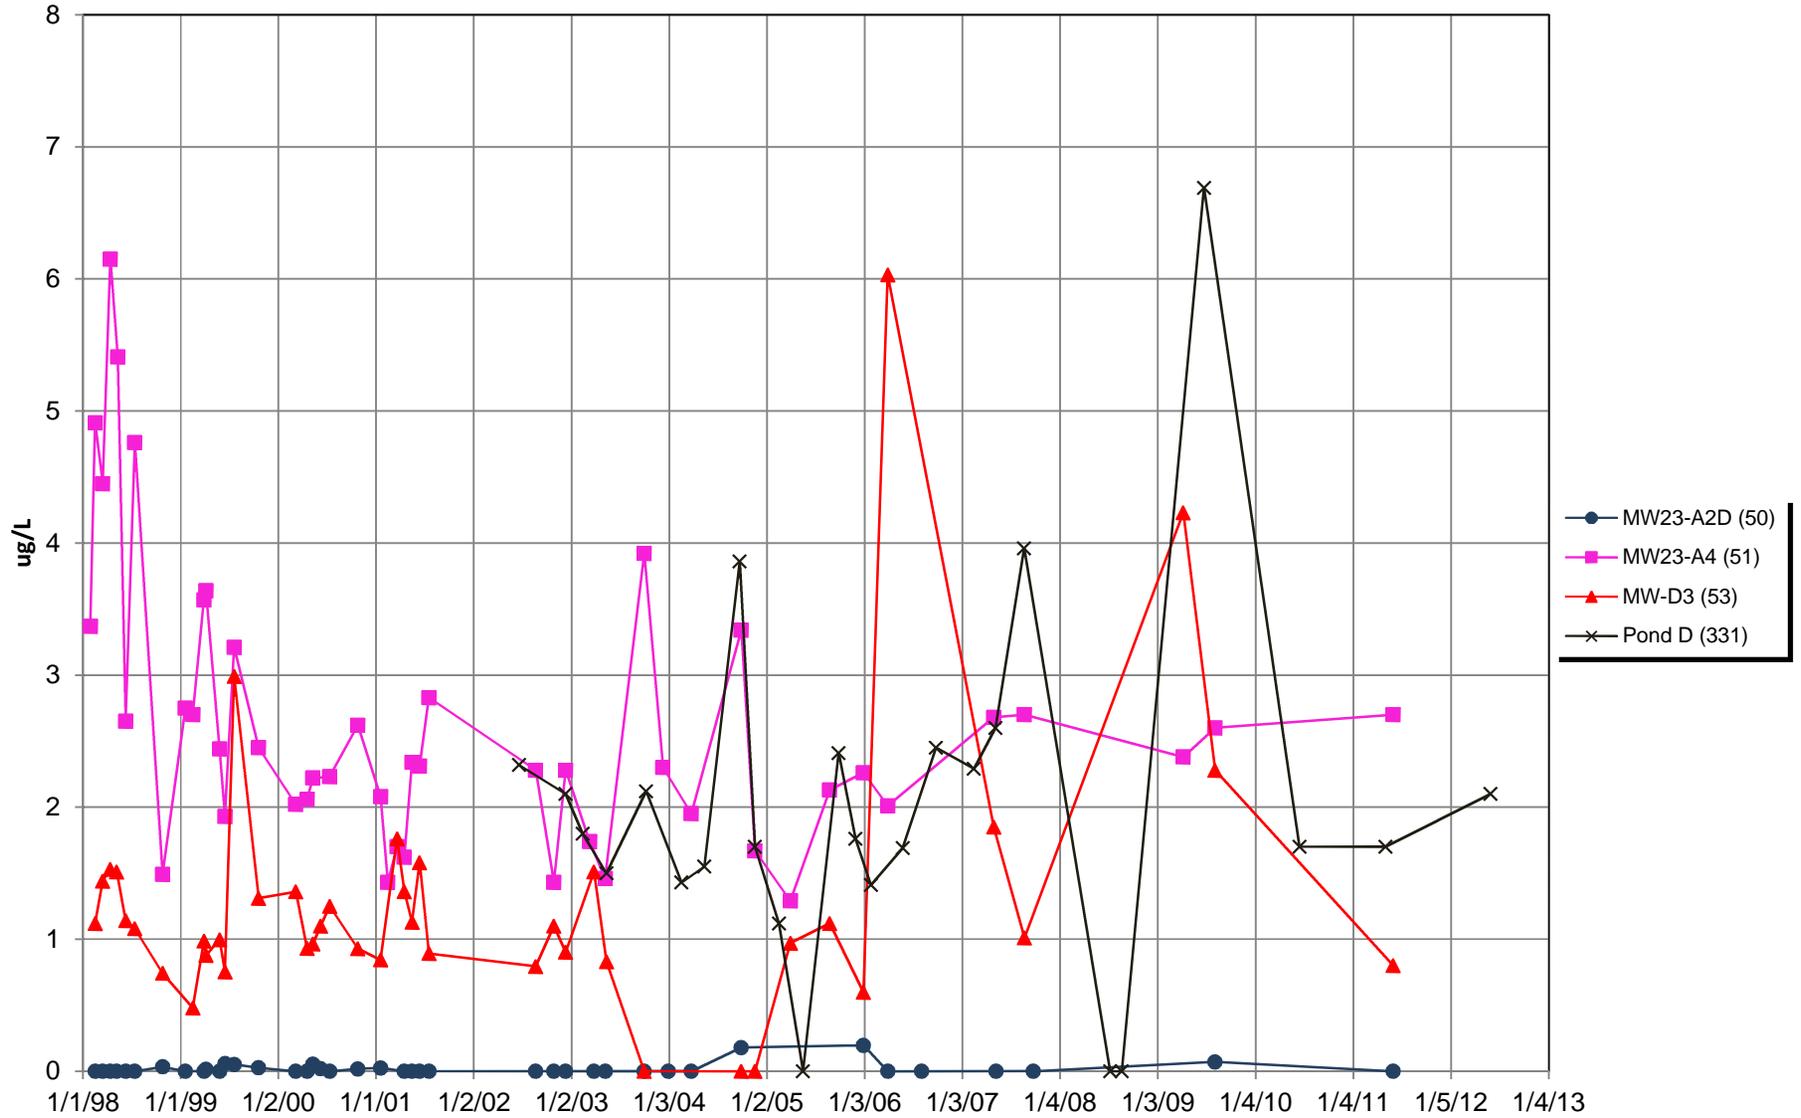
Figure 3.22a GREENS CREEK SITE 23/D INTERNAL MONITORING SITES:
FINGER DRAINS - COPPER DATA
(Non-detectable analyses plotted as zero)

The concentrations of copper and lead (Figures 3.22a and b and 3.23a and b) are considerably lower than that of zinc in the Site 23/D internal monitoring sites. Both of these metals show the same general trends as zinc with the exception of one anomalous lead result in a sample from 23FD-2 in 1999. The nickel concentrations presented in Figures 3.24a and b support the

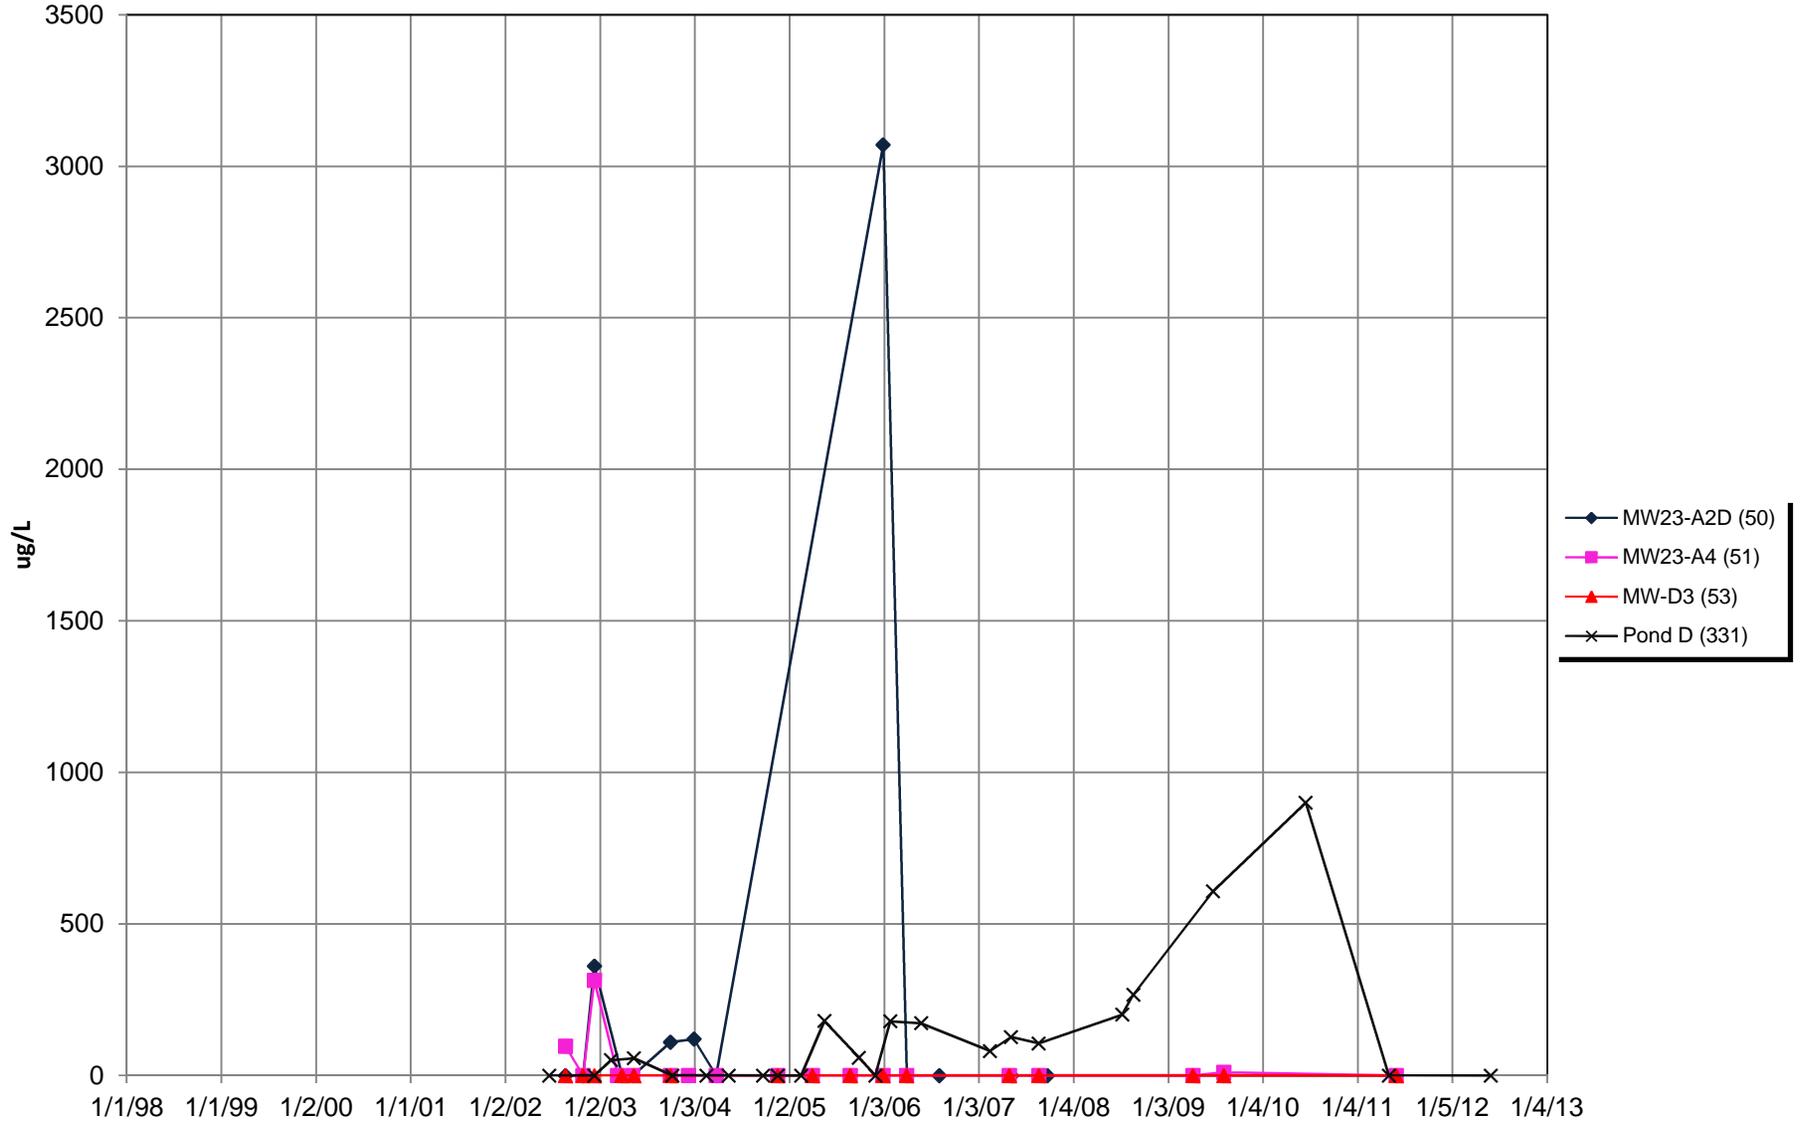
**Figure 3.26a GREENS CREEK SITE 23/D INTERNAL MONITORING SITES:
FINGER DRAINS - MANGANESE DATA
(Non-detectable analyses plotted as zero)**

Manganese concentrations (Figures 3.26a and b) are generally less than 50 ug/L for MW23-A2D, MW23-A4, and three of the finger drains (23FD-3, 23FD-5 and 23FD-8). The other three finger drains (23FD-2, 23FD-6 and 23FD-7) and MW-D3 and Pond D have elevated manganese concentrations, indicative of the different redox conditions. Precipitation/dissolution of iron oxyhydroxides and manganese oxides controls the concentrations of iron and manganese in these waters. After further evaluation, the previously reported increase in iron concentrations as been determined to be an analytical error.

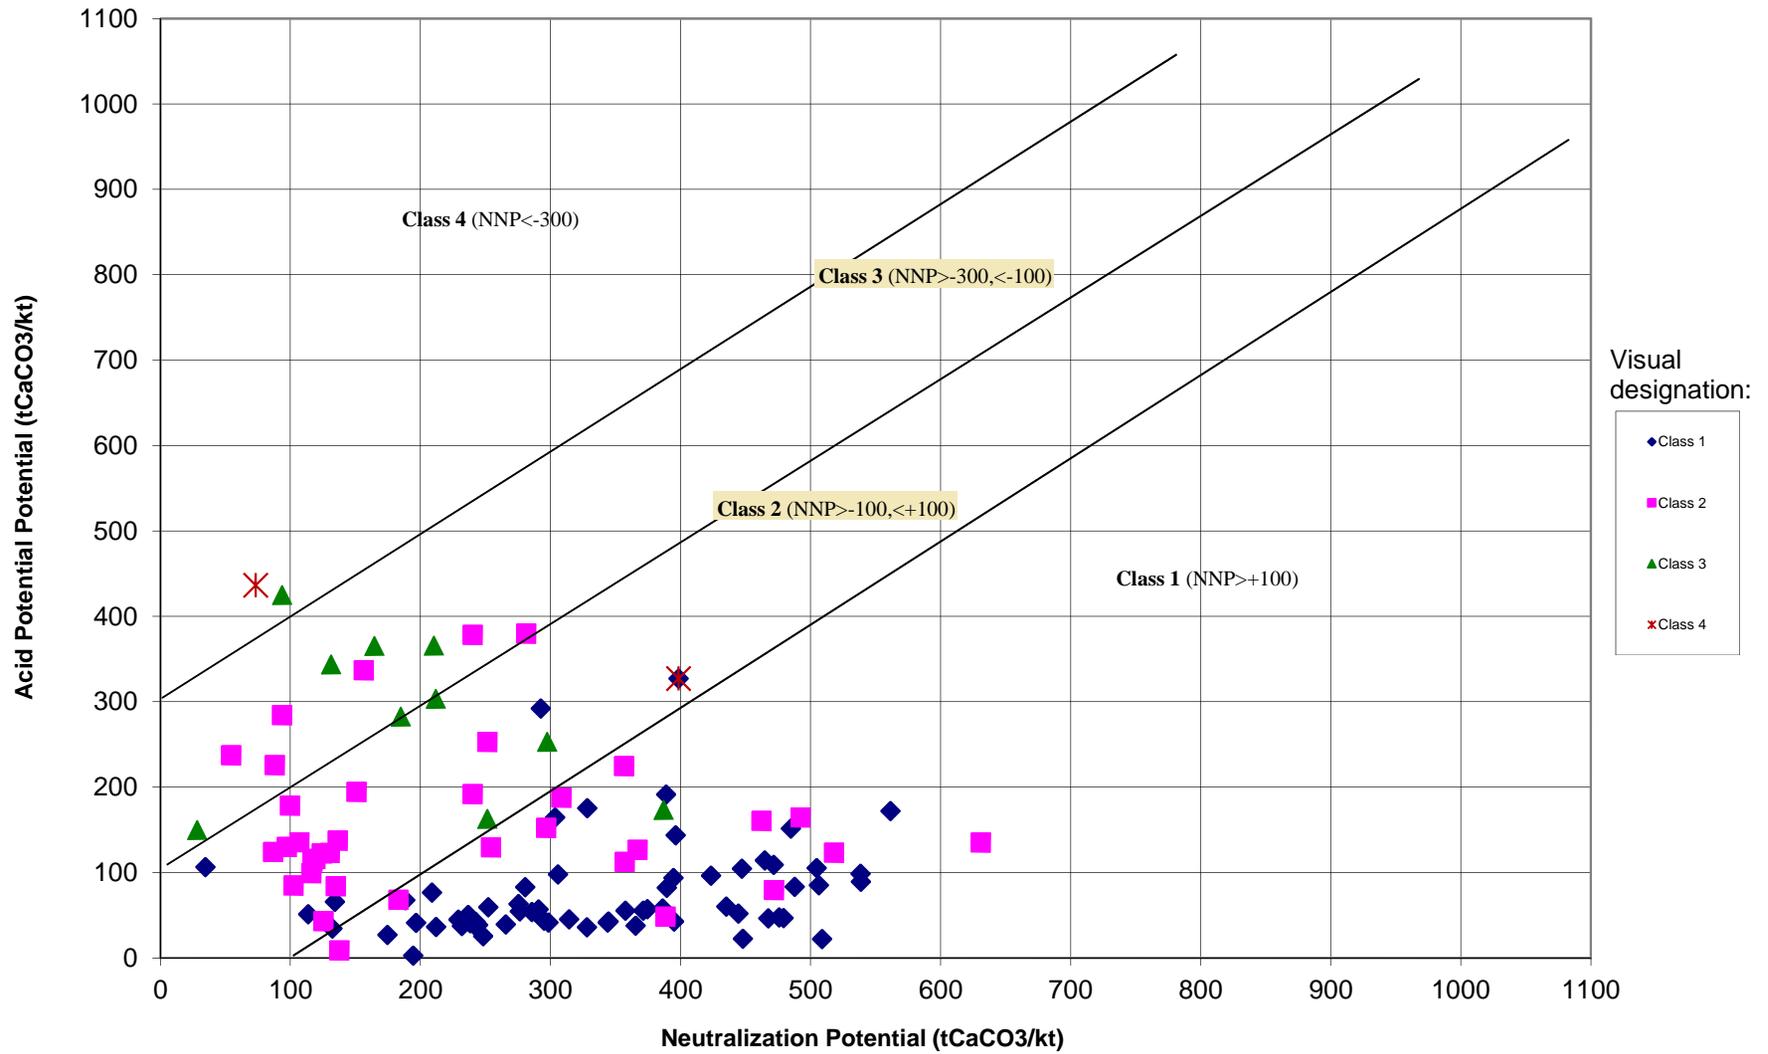
FIGURE 3.29a SITE 23 ABA DATA

No ABA data were taken from Site 23 in 2012. 2010 ABA results from the Site 23 active placement areas are shown in Figure 3.29. Active placement area ABA results from previous years as well as the 2006-2008 grid data are also shown on Figure 3.29. The AP to NP distribution in the Site 23 samples differs from that of the underground rib samples. The Class 2 and Class 3 stockpiles areas are frequently empty except for a safety berm, which is constructed of Class 1 rock in the absence of other material. It is probable that several of the samples included this berm material. The grid sampling is also skewed toward higher NNP values because most of the outer surface of the pile is covered with Class 1 rock.

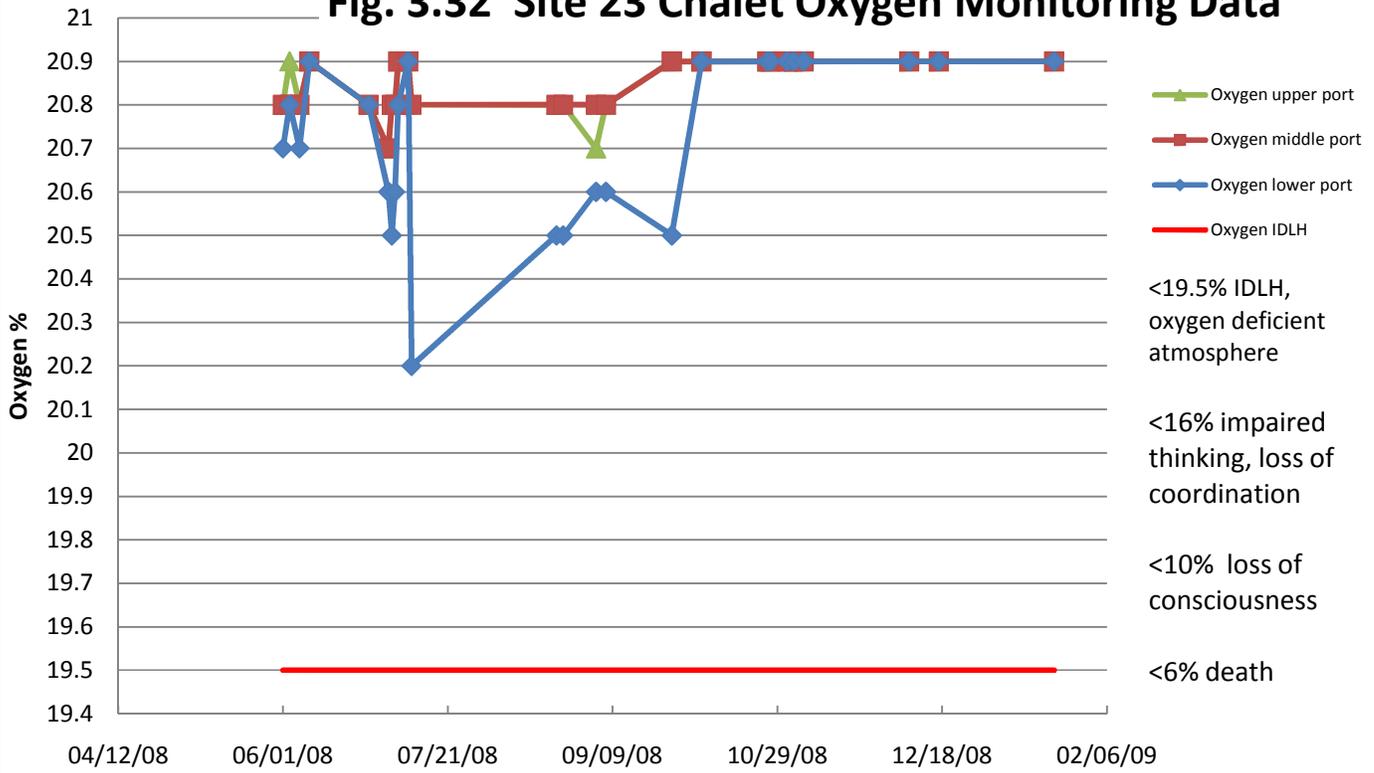
Fig. 3.32 Site 23 Chalet Oxygen Monitoring Data

In 2008 HGCMC began monitoring oxygen and carbon dioxide concentrations in the instrumentation trench building (the “Chalet”) installed over the cover plot to determine if conditions were unsafe for human entrance. Gas levels showed a slight seasonal fluctuation, but did not approach unsafe levels. Figures 3.32 and 3.33 show oxygen levels decreased slightly and carbon dioxide levels increased slightly in the summer months and were at atmospheric conditions in the winter months (20.9% oxygen and 0% carbon dioxide). These monitoring results are consistent with the conceptual model of pile gas transport. When the internal temperature of the pile is colder than the external air temperature, oxygen-deficient, carbon dioxide-rich air flows out the toe of the pile. When the pile temperature is warmer than external air temperature, oxygen rich air is drawn in at the base of the pile.

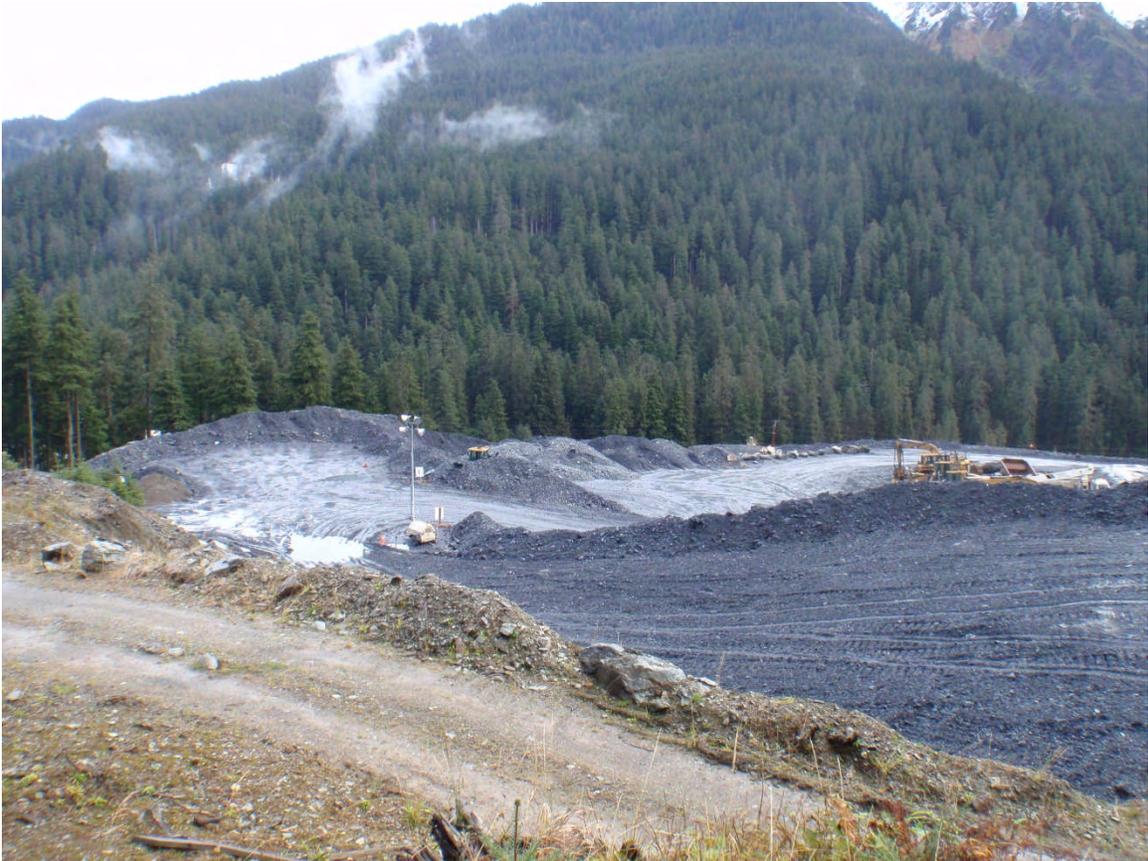
Figure 3.34 Site 23 - October 2012

Figure 3.34 shows a photo of Site 23 in October 2012. The interim disposal area at Site 23 is shown in Figure 3.35.

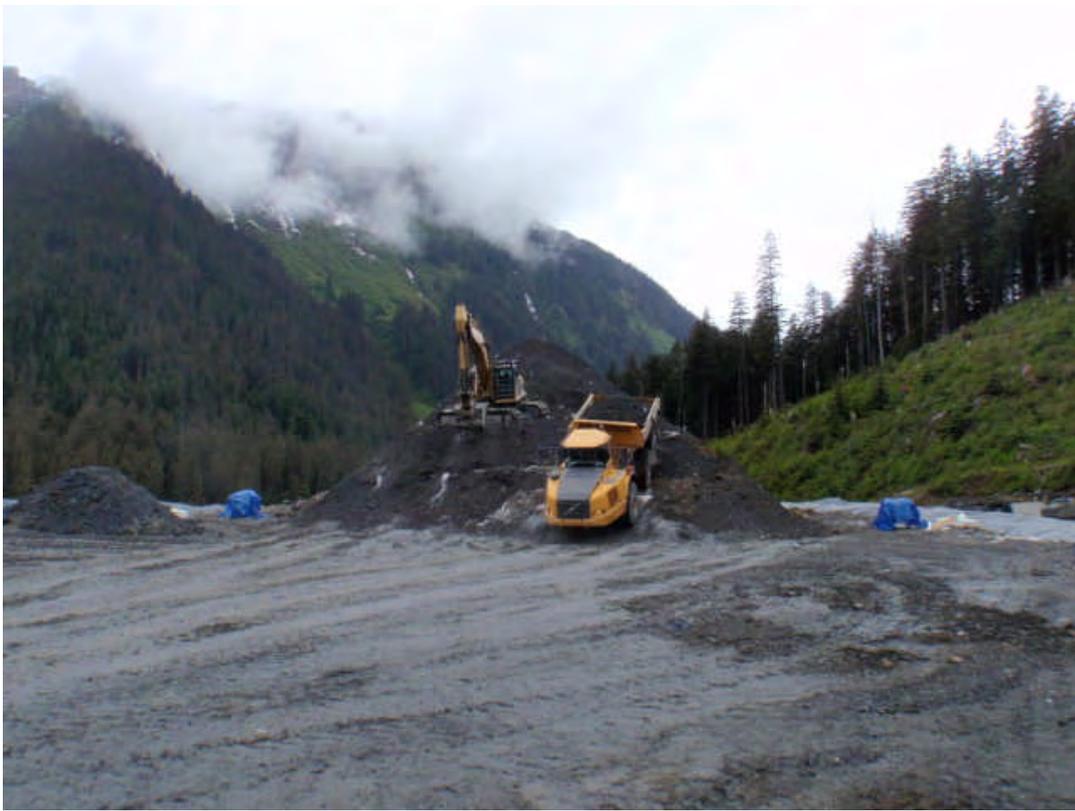
Figure 3.35 Site 23 Temporary Disposal Area- June 2011

In 2008, HGCMC received approval from ADEC to construct an interim disposal area for waste rock to be backfilled underground (see photo Figure 3.35). This 25,000 cubic yard capacity area was constructed to aid in concurrent reclamation efforts and can potentially be utilized on a continual 12-month schedule. This is a large increase over the previous 920 remuck bay which had a seasonal 700 cubic yard capacity. The area is layered with 6" of sand; a 36 mil reinforced polypropylene liner, another 6" layer of sand, 3' of class 3 production rock, and finally a geofabric layer. An HDPE pipe collects water from the area which is sloped to a central collection point. The water collected in this area drains to Pond 23. Material placed in this area is treated with up to 1 wt% lime. Waste rock from the B and D Pond berms, the 1350 and segments of the pipeline excavation were placed at the Site 23 temporary disposal area. These materials are backfilled underground as space and resources become available.
