## INSPECTION REPORT: GREENS CREEK MINE

Date of Inspection: Friday September 2, 2016  
Date of Report: Wednesday September 21, 2016  
USDA Forest Service Inspector: Richard Dudek

Ranger District: Admiralty National Monument  
Weather Conditions: Sunny. Temperature: Mid 60's °F.

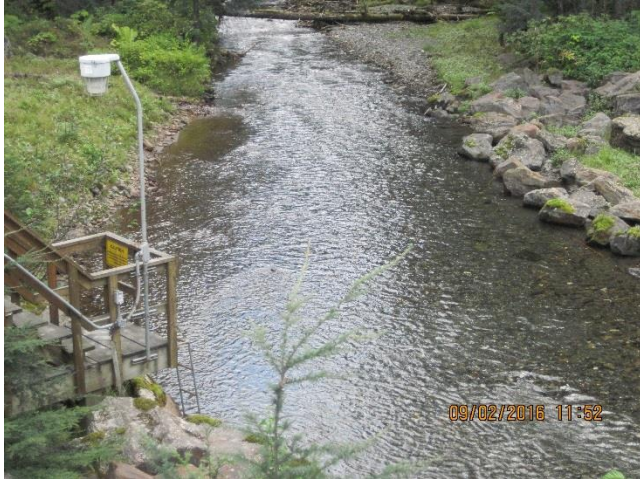
**Photo 10. Greens Creek.**

Greens Creek (Photo 10) flow rate for the day was 21.3 cubic feet per second (cfs). The 920 Bridge's splashguards are preventing sediments from entering into Greens Creek (Photo 11). Surface operations are maintaining the sump and rock dam (Photo 12) across from DB-01. The ore pad (Photo 13) was active with haul trucks depositing mined rock material. The warehouse area was tidy and in order with all liquid chemicals and petroleum products properly stored with secondary containment (Photo 14).

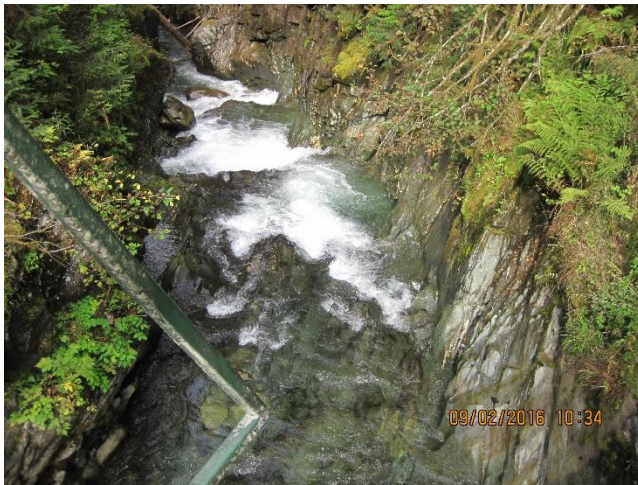
**Photo 17. Downstream image of the Greens Creek fish pass.**

The Greens Creek fish pass was reconstructed as part of the approved Record of Decision for the 2013 Environmental Impact Statement (EIS) for the Tailings Disposal Facility (TDF) Expansion. The construction of the fish pass included installing three concrete steel-capped weirs (Photo 15-16). HGCMC was also issued a fish habitat permit (FH11-1-0123) by the Alaska Department of Fish and Game (ADF&G). This permit authorizes HGCMC to maintain the fish pass in perpetuity. During Bio-monitoring in 2015 and 2016, juvenile Coho were observed at Site 54, which is approximately 3 miles upstream of the fish pass. This is evidence that the previous fish pass structure was not significantly damaged to the point of preventing fish passage. During the site visit, Kate Kanouse of the ADF&G stated that all though not observed at the present time, Pink salmon (*Oncorhynchus gorbuscha*) might be present elsewhere in the stream (Photo 17). Therefore, yearly bio-monitoring should be sufficient to determine fish passage beyond this natural barrier.
